ALLTEX HOME INSPECTIONS

PROPERTY INSPECTION REPORT

Concerning: 809 WILLARD ST., Houston, TX 77006
(Address or Other Identification of Inspected Property)

By: Stephen Perry, Lic #7854 08/31/2020
(Name and License Number of Inspector) (Date)

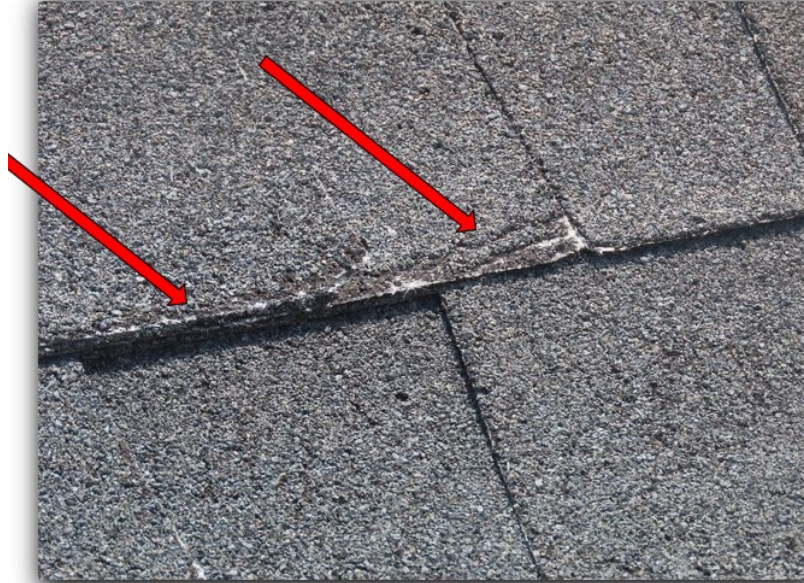
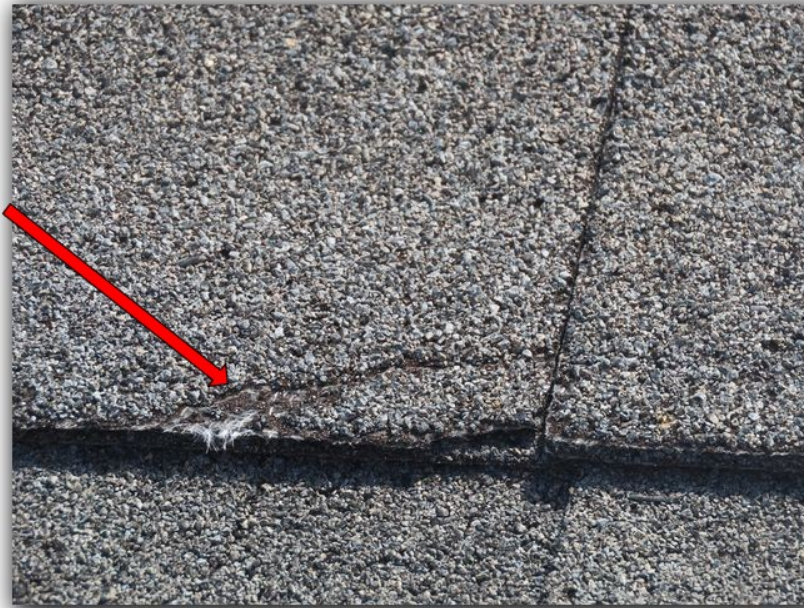
- **HAIL DAMAGE THAT NEEDS EVALUATION AND REPAIRS BY A ROOFING EXPERT.**

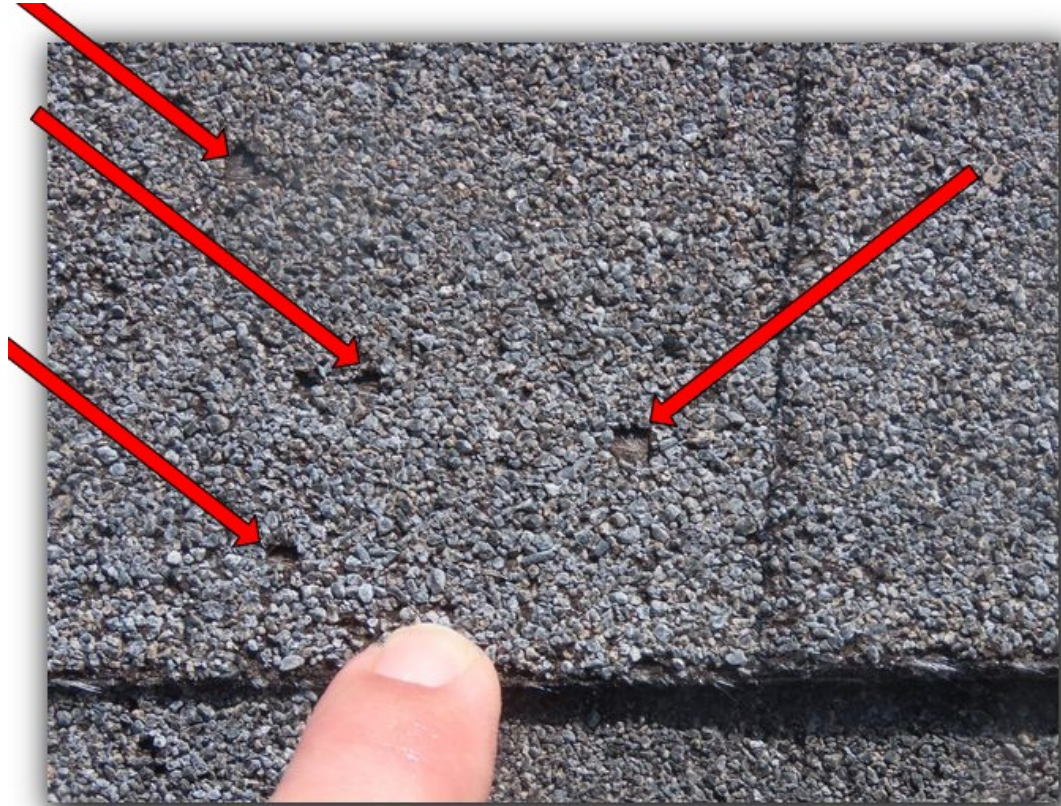
- **EXCESSIVE GRANULE LOSS IN SOME LOCATIONS DUE TO AGE THAT NEEDS EVALUATION BY A ROOFING EXPERT.**

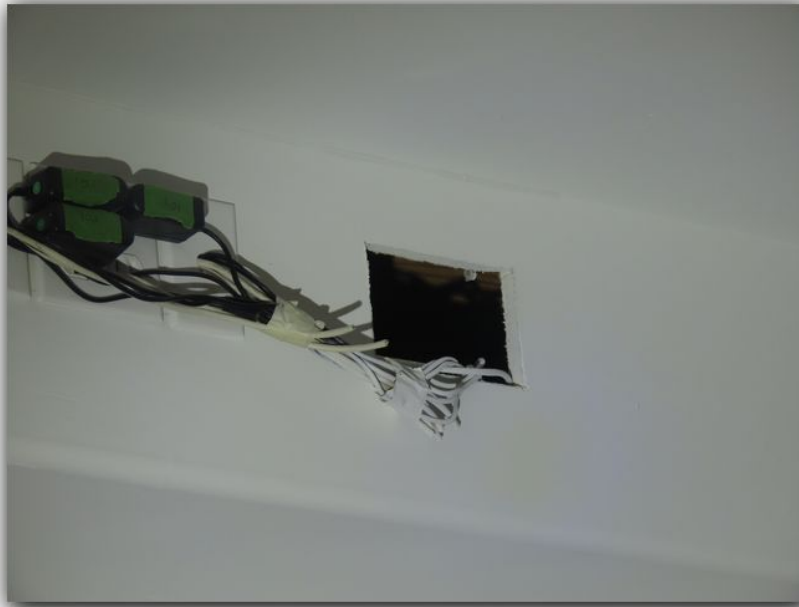
- **SOME HOLES CUT OUT IN THE DRYWALL OF THE GARAGE UPPER WALL THAT NEEDS REPAIRS.**

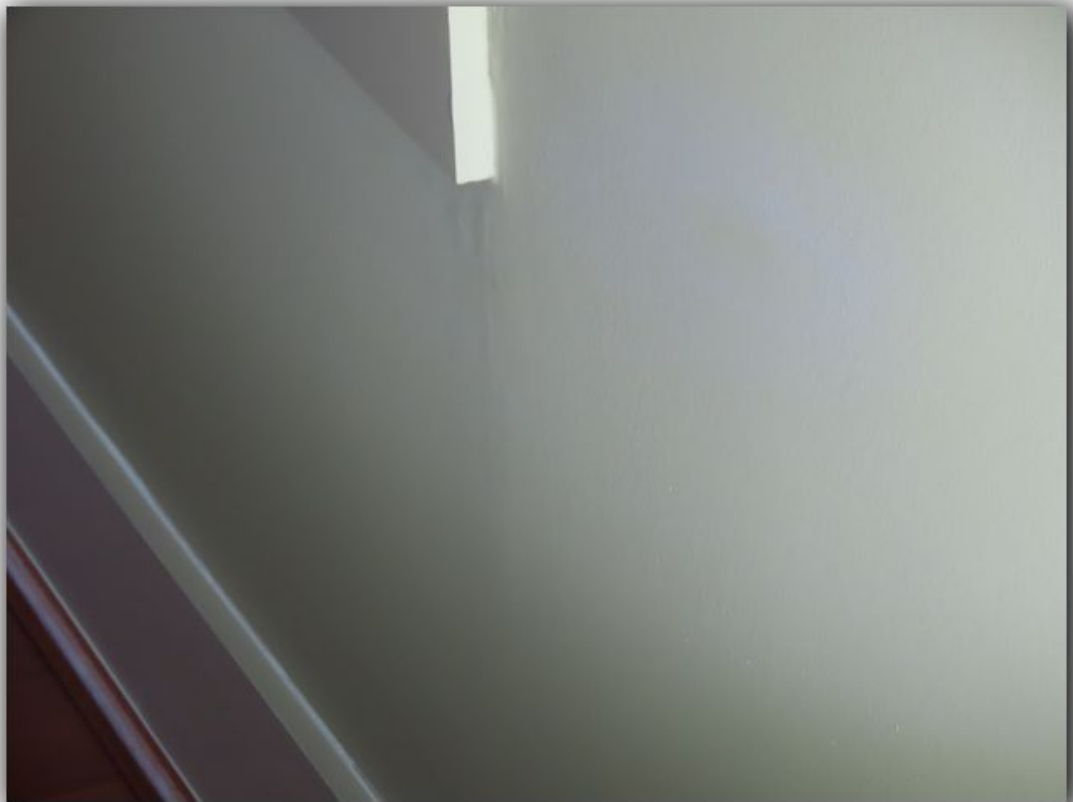
- **SOME PATCHWORK PAINTED OVER AT THE LOWER WALLS AND NEAR THE**

RIGHT CORNER WINDOW FRAME AND WALL CORNER THAT IS THE STUCCO SIDE/FRONT WALL OF THE HOME AS WELL. RECOMMEND AN INVASIVE STUCCO INSPECTION AND MOLD INSPECTION BE PERFORMED BY A LICENSED MOLD INSPECTOR AND STUCCO EXPERT TO ENSURE NO POTENTIAL FRAMING DAMAGE/WATER DAMAGE/MOLD IS PRESENT.(INFRARED CAMERA DID NOT SHOW ANY ACTIVE MOISTURE PRESENT)

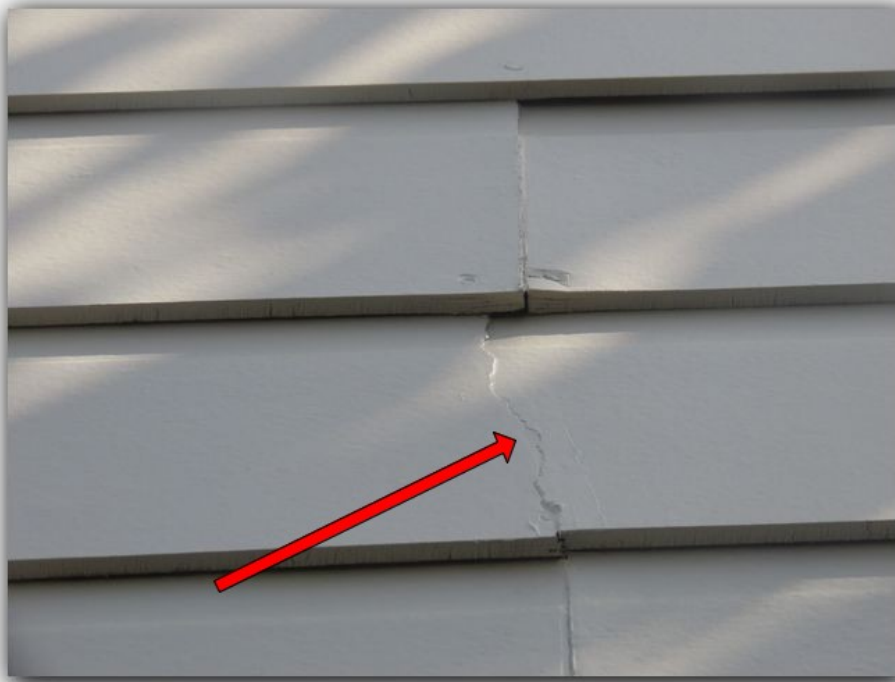
Some cracks at the Cement board siding in a few locations that can indicate some structural settlement that needs evaluation and repairs by a siding repair expert.

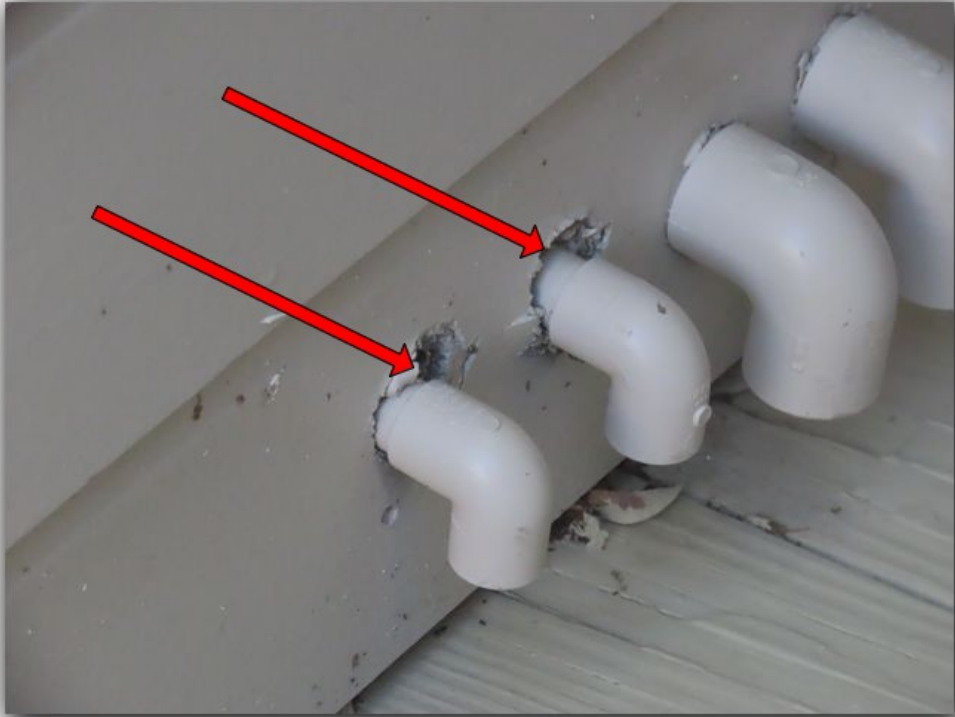
Caulking / sealant is separated or missing in some areas

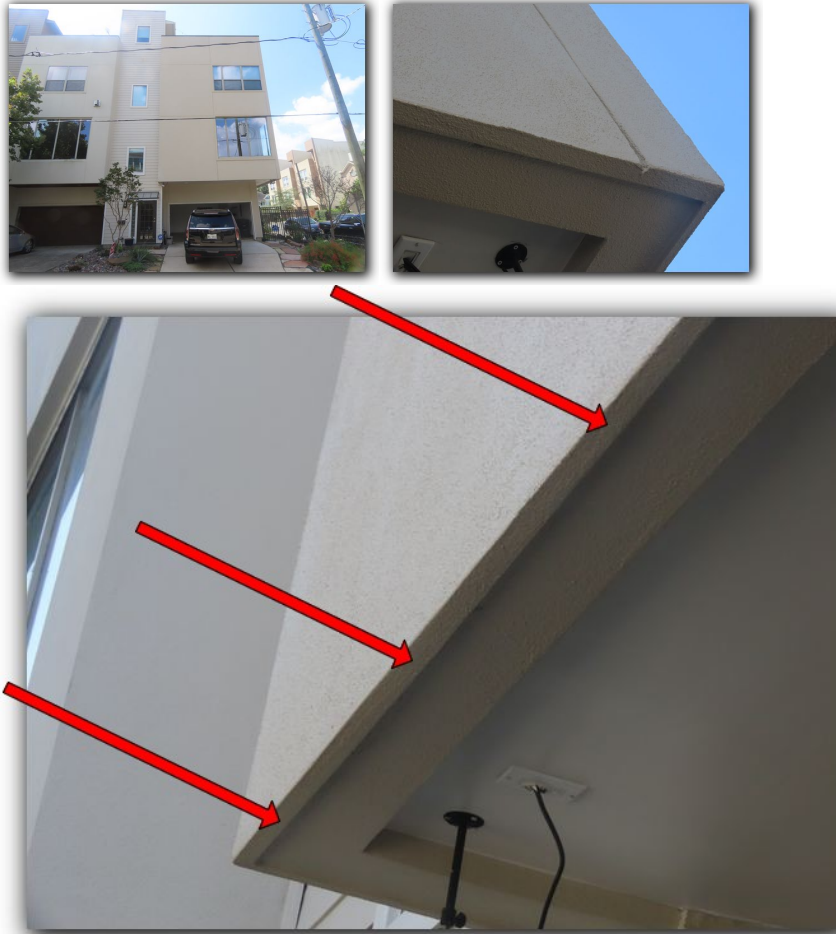
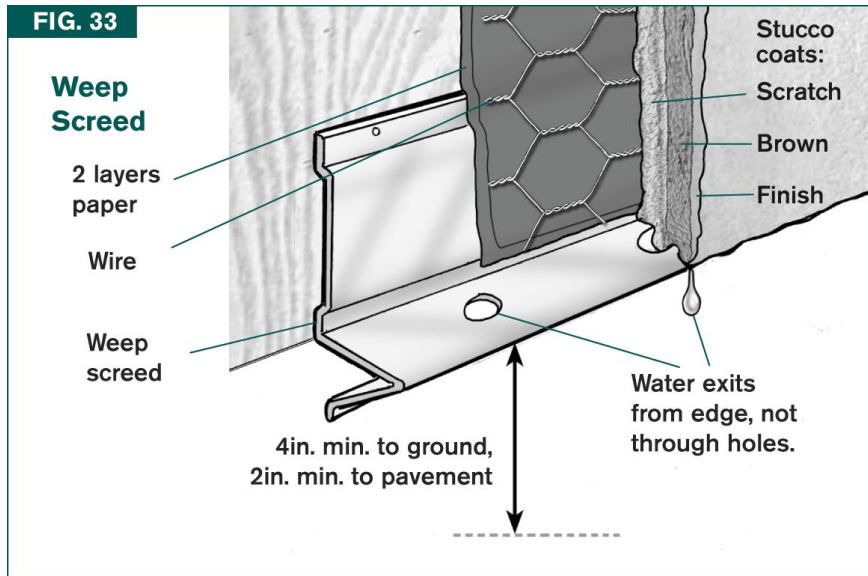
DEFICIENCY- NO WEEP SCREED PRESENT FOR THE BOTTOM OF THE "CANTILEVER" OF THE LOWER WALL TERMINATION OF THE STUCCO AS IS NORMALLY REQUIRED FOR PROPER DRAINAGE OF MOISTURE.(EXPAMPLE IMAGE ALSO IS SHOWN OF WEEP SCREED)

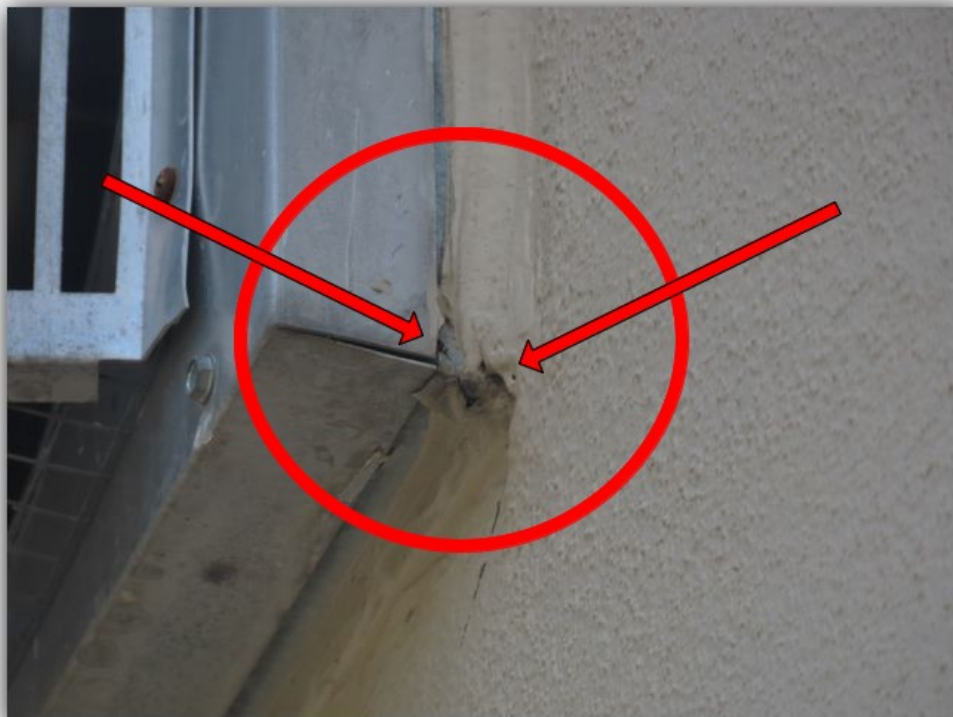
DEFICIENCY- THE FIREPLACE WALL VENT HAS SOME

AREAS THAT NEEDS ADDITIONAL CALKING APPLIED

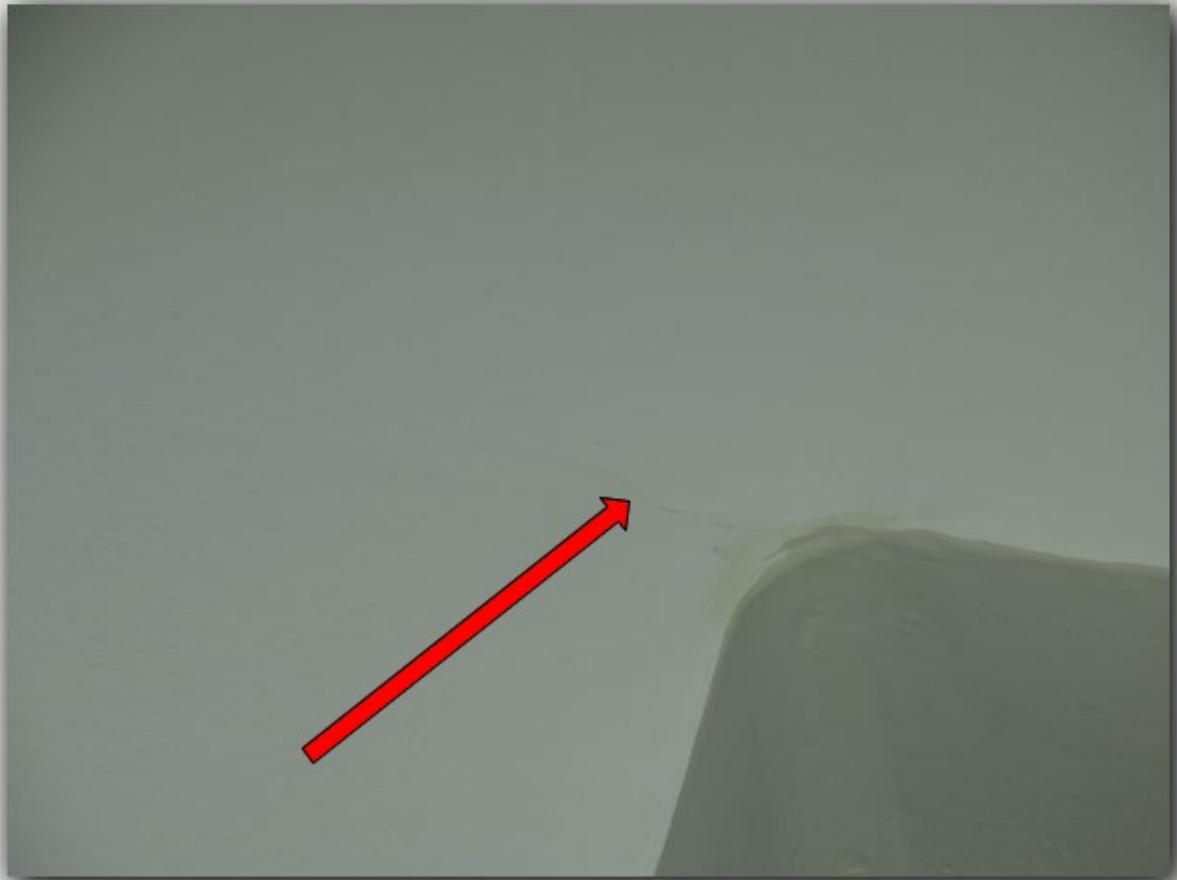
Ceiling cracks in some areas

- **INDICATING STRUCTURAL SETTLEMENT THAT NEEDS TO BE PATCHED/FINISHED/TEXTURED AND MONITORED FOR ANY FURTHER CRACKING**

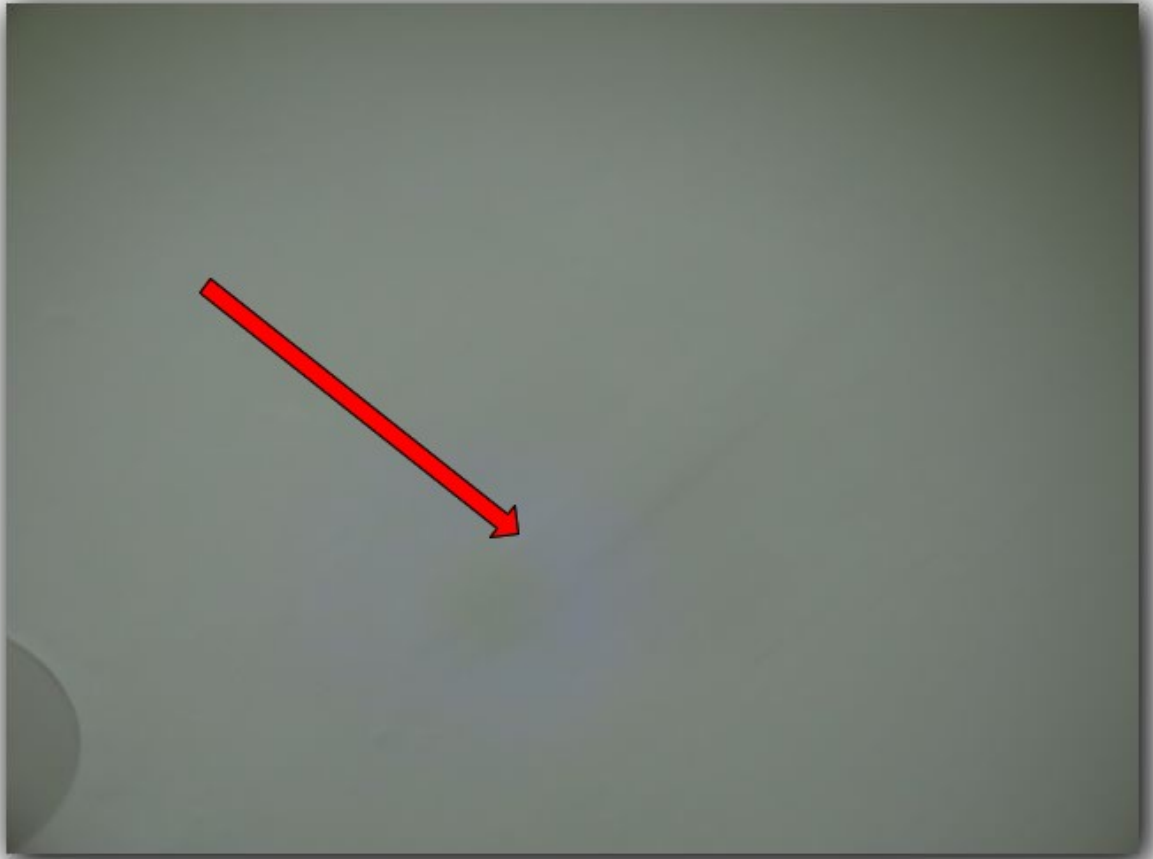
- **WATER STAINS PAINTED OVER ON THE KITCHEN CEILING THAT IS BELOW THE MASTER BATH; INFRARED CAMERA DID NOT SHOW ANY ACTIVE MOISTURE. RECOMMEND EVALUATION BY A PLUMBER TO ENSURE THERE ARE NO LEAKS PRESENT AND ALSO RECOMMEND A MOLD INSPECTION BY A LICENSED MOLD INSPECTOR.**

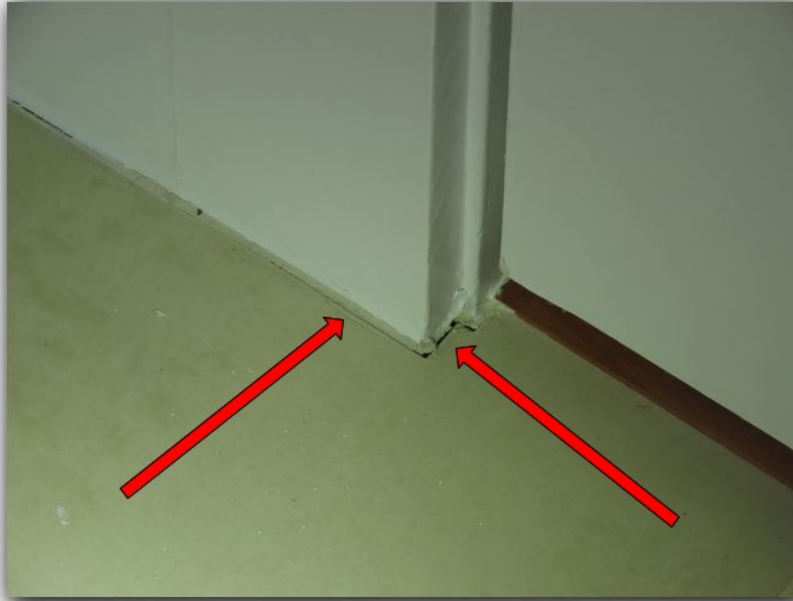
Floor cracks in some areas
SOME SEPARATIONS IN THE TILE FLOORING AND THE BASE BOARD/DOOR
FRAME TRIM AT THE MASTER BATHROOM THAT CAN INDICATE STRUCTURAL
SETTLEMENT.

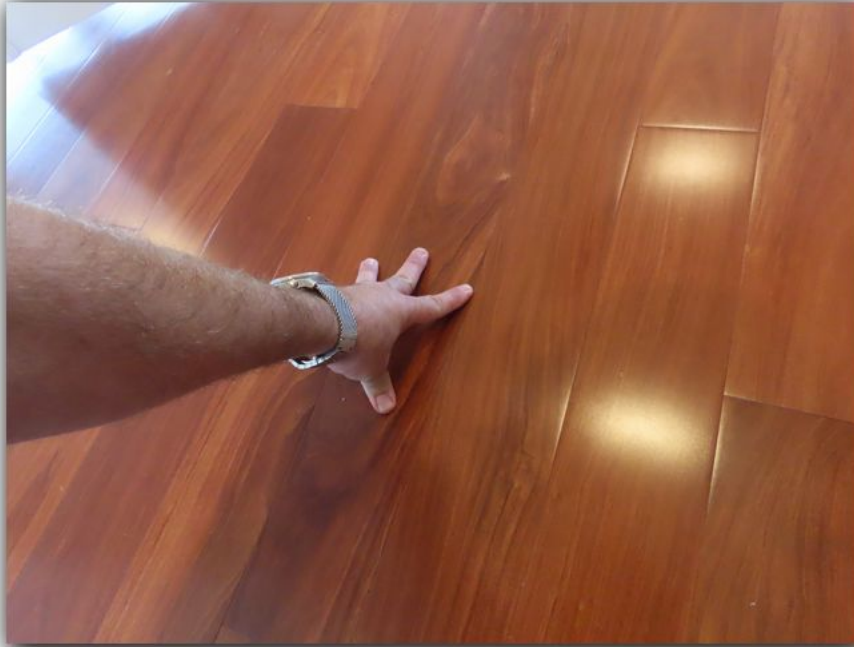
- **THE THIRD FLOOR FLOORING IS CREAKING WHEN WALKED ON MAKING EXCESSIVE NOISE THAT NEEDS EVALUATION AND REPAIRS BY A FLOORING REPAIR CONTRACTOR. THIS ALSO IS COMMON WITH STRUCTURAL SETTLEMENT.**

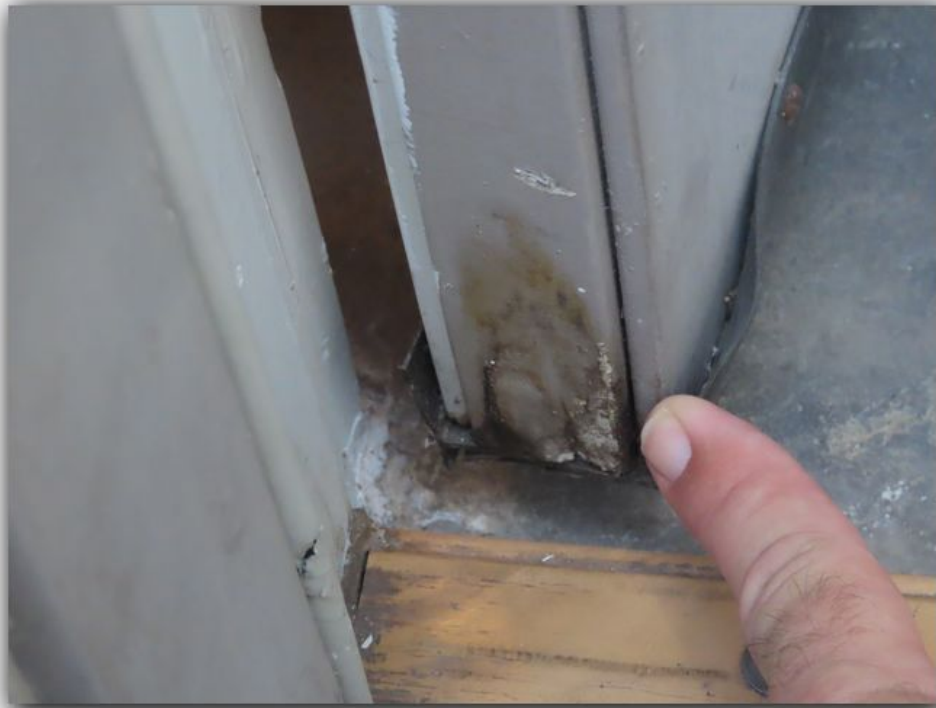
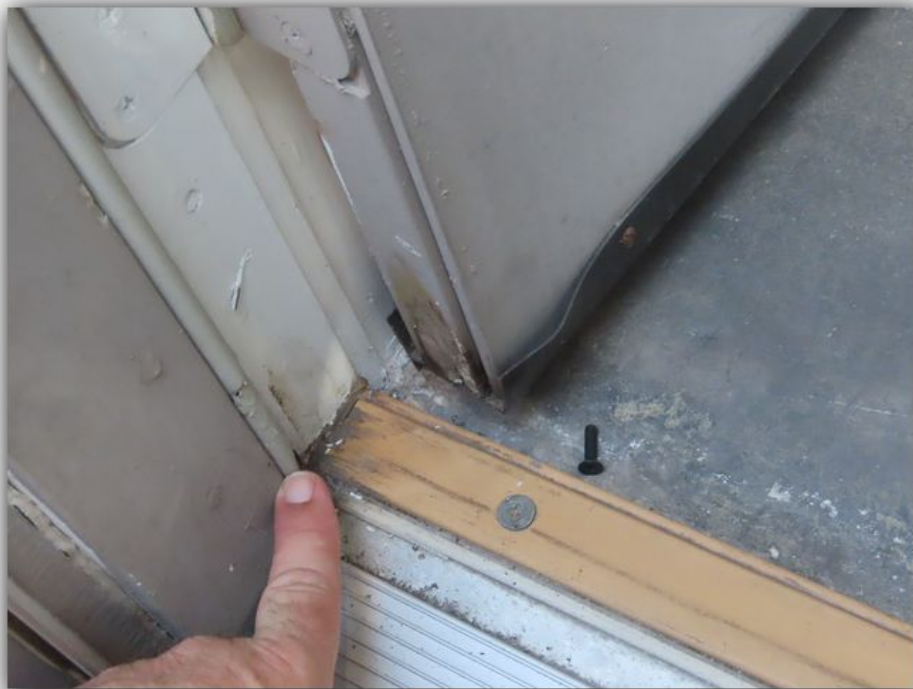
SOME DRY ROT AT THE BOTTOM OF THE BACK DOOR AND DOOR FRAME TRIM OF THE JAMB THAT NEEDS REPAIRS.

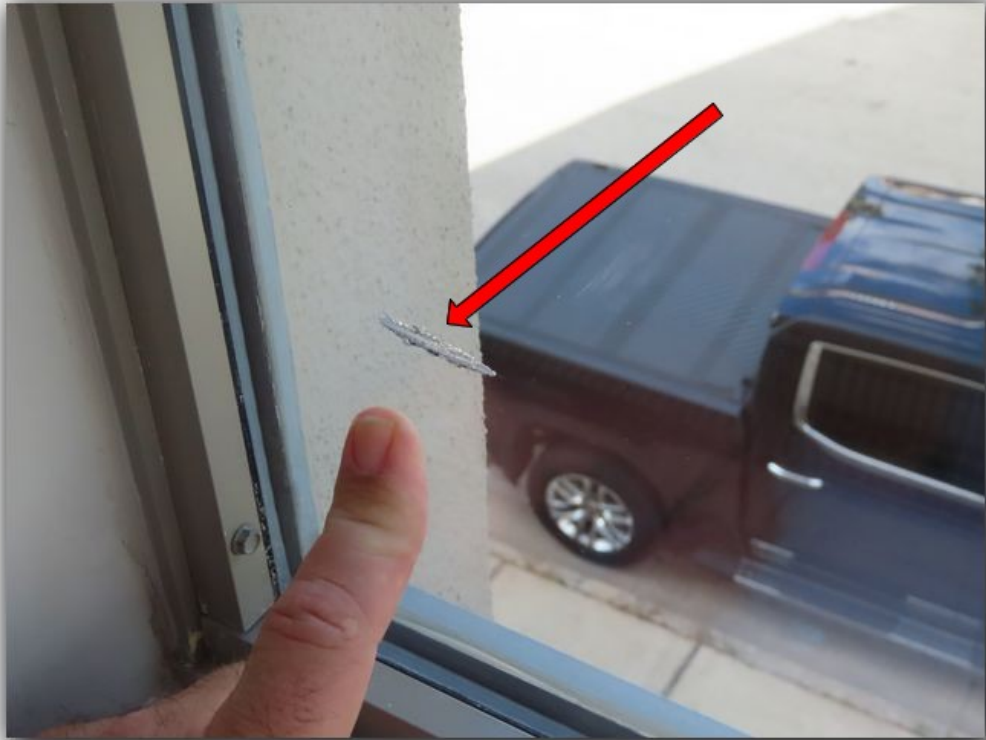
Some glass panes are loose, damaged or missing; THE DEN WINDOW ON THE RIGHT BACK SIDE WINDOW OF THE DEN HAS CHIPPED/DAMAGED GLAZING THAT NEEDS TO BE EVALUATED BY A WINDOW REPAIR EXPERT FOR REPAIRS OR POTENTIAL WINDOW REPLACEMENT.

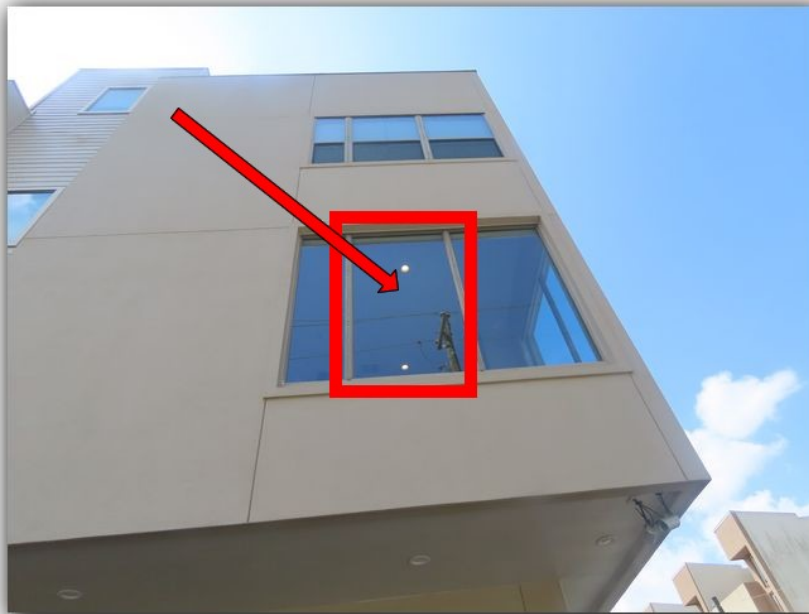
Thermal pane window seals have failed, moisture is present(THE UPSTAIRS BACK GUEST BEDROOM UPPER SASH AND THE DEN FRONT CENTER LARGE WINDOW BOTH APPEAR TO HAVE BROKEN SEALS. THIS REQUIRES WINDOW SASH REPLACEMENT WHEN THE SEALS ARE BROKEN. RECOMMEND EVALUATION BY A WINDOW REPAIR EXPERT.

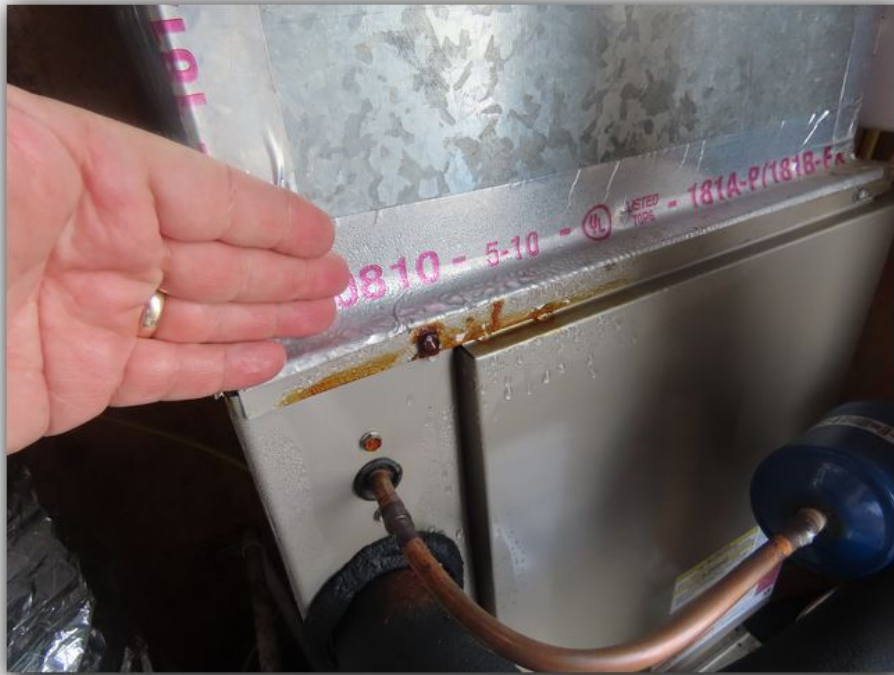
DEFICIENCY- Air handler plenum is not

**properly sealed(UPSTAIRS) WITH
CONDENSATION PRESENT; IN NEED OF REPAIR
BY A LICENSED HVAC PROFESSIONAL.**

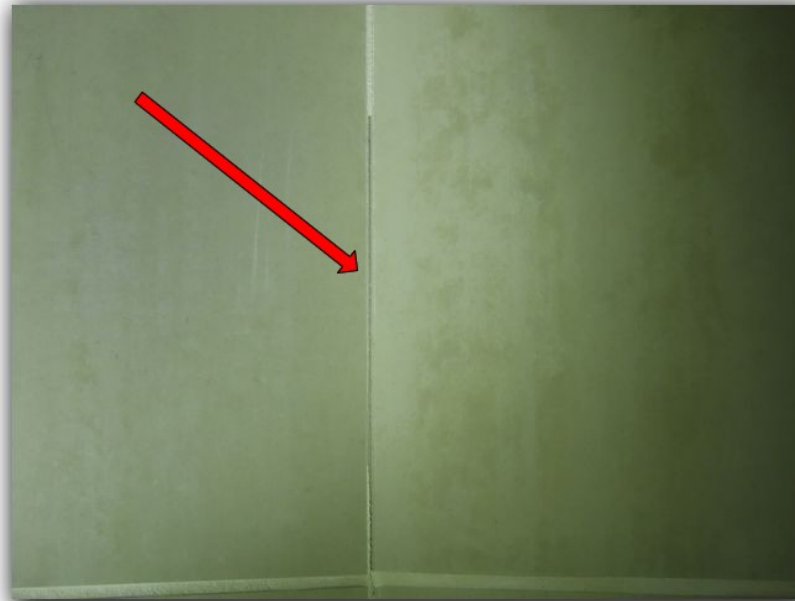
Caulking or grout missing or damaged(SEVERAL ENCLOSURES OF THE TUBS AND SHOWER, AND COMMON WITH STRUCTURAL SETTLEMENT)

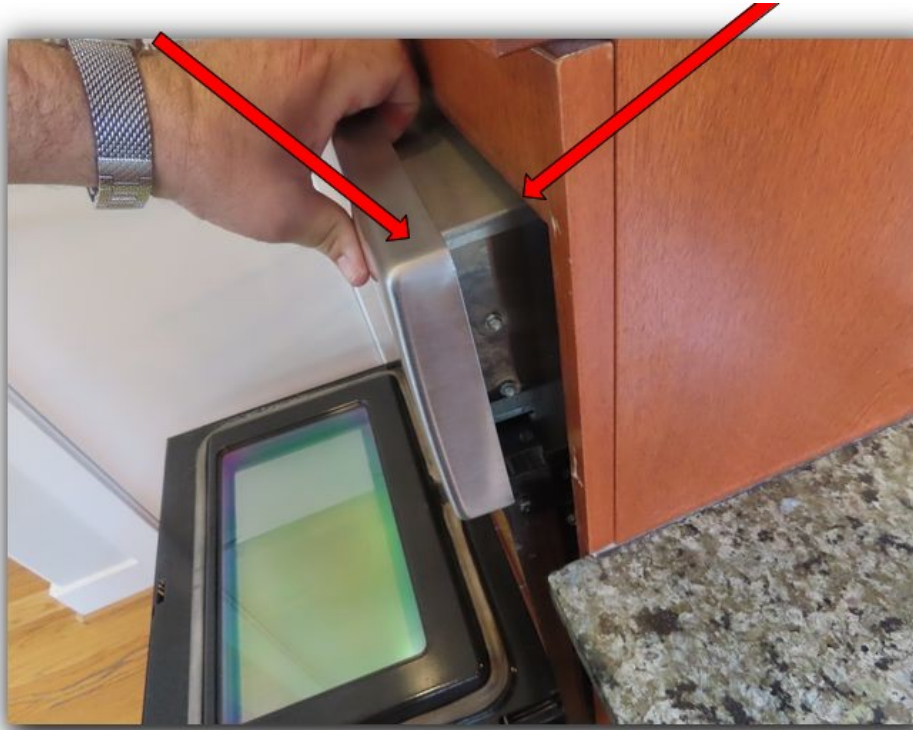
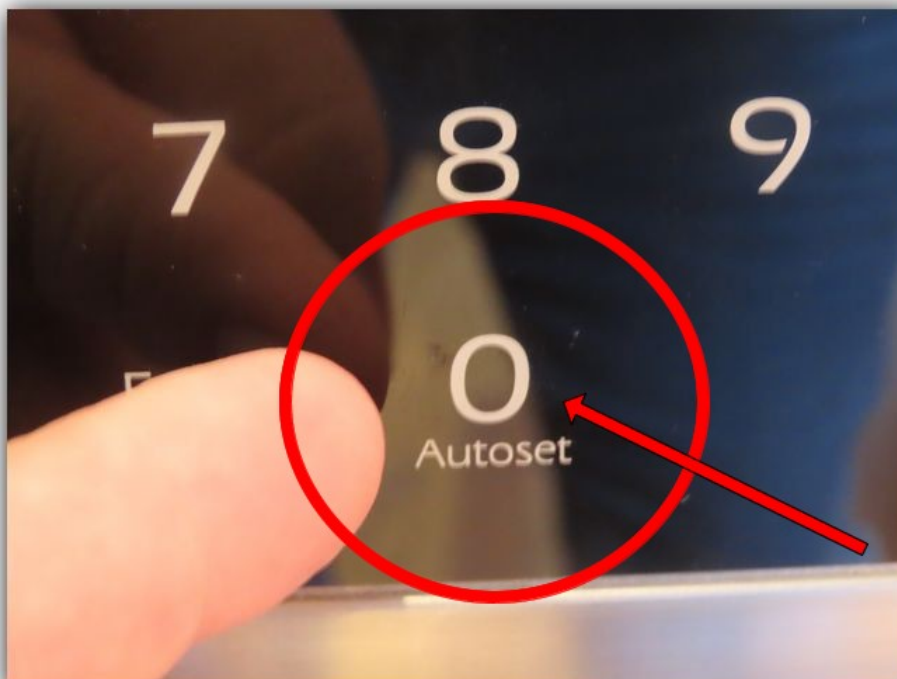
THE OVEN IS LOOSE INSIDE THE WALL AND NEEDS TO BE SECURED AND THE DIGITAL DISPLAY FOR SETTING THE OVEN TEMP. DID NOT FUNCTION FOR THE "ZERO" DIGIT ALL OTHER DIGITS DID FUNCTION FINE BUT NOT ZERO. HAD TO SET THE TEMP TO 351 RATHER THAN 350 FOR TESTING THE OVEN. IN NEED OF EVALAUTION AND REPAIRS BY AN APPLIANCE REPAIR PERSON.

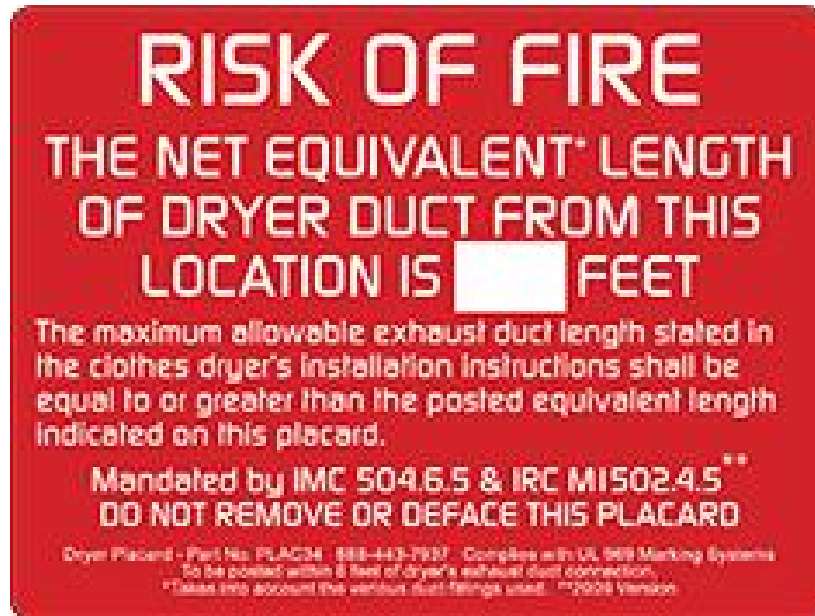
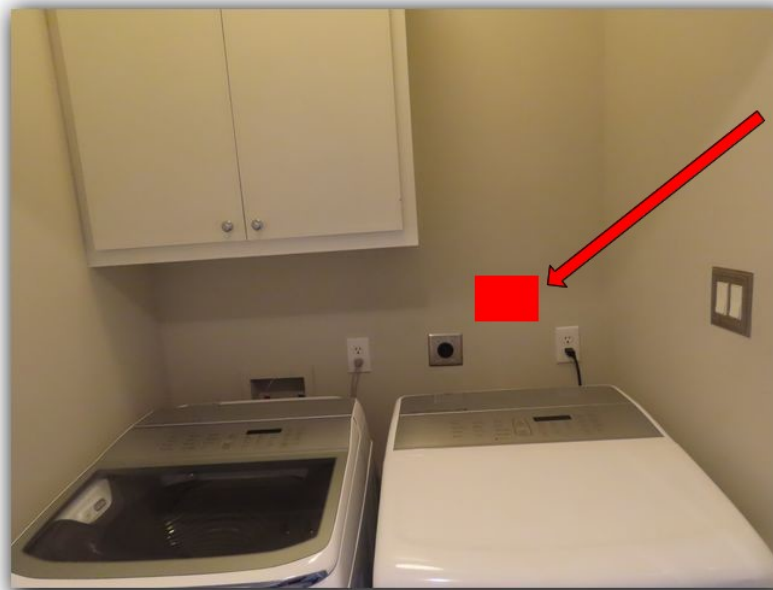
- The dryer duct is a long span that extends into the upper wall and attic and terminates to a roof vent. Long span dryer ducts are recommended to have a "booster assist fan" installed that helps prevent lint from being trapped inside the duct and provides improved clothes dryer performance as well.**
- IT IS RECOMMENDED TO HAVE THE CLOTHES DRYER DUCT PROFESSIONALLY CLEANED OUT ANNUALLY FOR IMPROVED CLOTHES DRYER PERFORMANCE AND FIRE SAFETY PROTECTION.**

☑ Deficiency- IT IS NOW REQUIRED TO HAVE A DISPLAYED SIGN IN THE LAUNDRY ROOM THAT SHOWS THE NET EQUIVALENT LENGTH OF DRYER DUCT DISTANCE FROM THE WALL TERMINATION IN THE LAUNDRY ROOM TO THE ROOF TERMINATION/EXTERIOR TERMINATION.
