**Better Residential Home Inspections, Inc.**

## PROPERTY INSPECTION REPORT

**Concerning:** 15831 Chimney Rock Rd, Missouri City, 77489  
(Address or Other Identification of Inspected Property)

**Report Identification: 181004A**

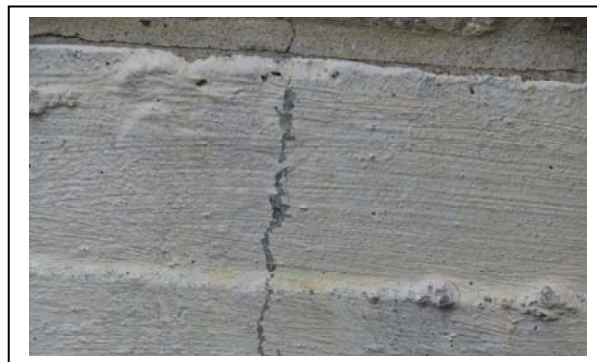
**NOTE:** Minor cracks were viewed in the front grade beam.

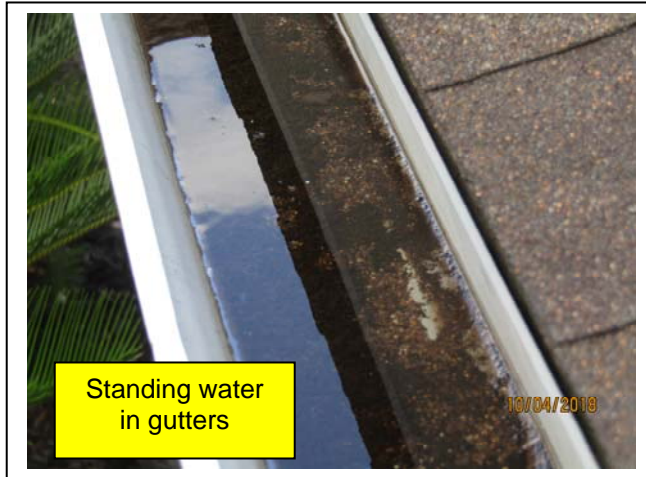
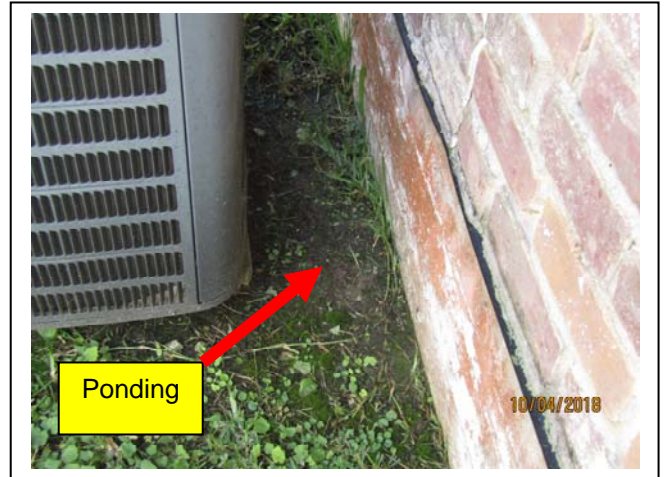
- The gutters were in *fair* condition during the inspection. Some inadequate sloping and standing water was viewed. Appropriate repairs are needed.
- Soil grade and drainage levels viewed at the left and rear areas of the house do not adequately direct atmospheric or roof surface waters away from the grade beam foundation. Re-grading, channeling, and/or area drains can improve this condition at the affected location.

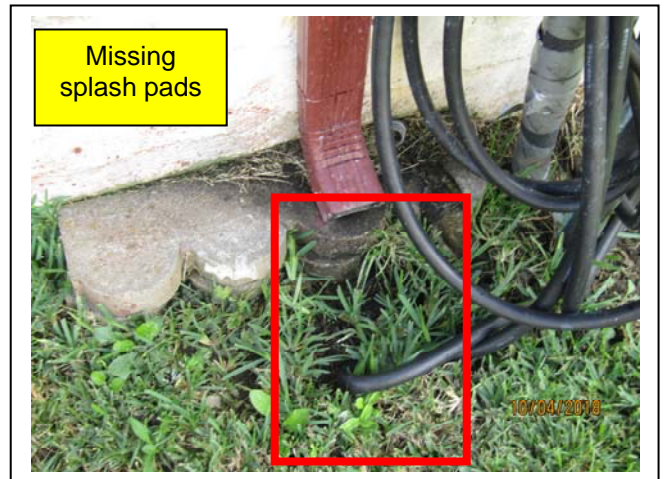
- The splash pads or irrigation pipes were missing from the bottom of the downspouts at some locations next to the grade beams. Discharging water next to the slab can create adverse conditions and settling in the future.

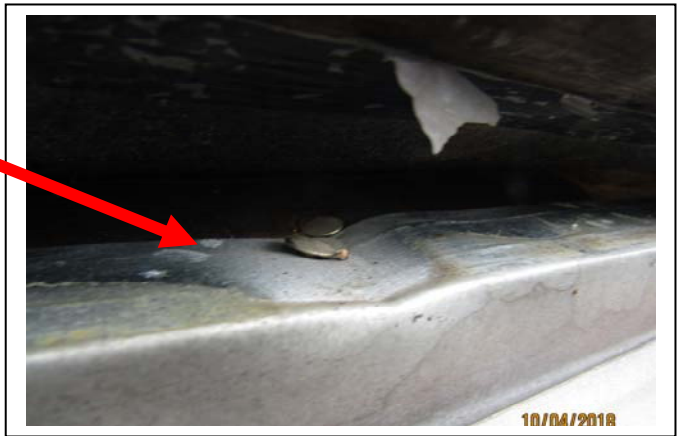
- The underlying felt paper was not properly installed on the top edge of the bottom metal eave stripping at the lower sections of the roof surfaces. This condition is in direct conflict with the manufacturer's installation requirements and TREC roof flashing deficiencies.

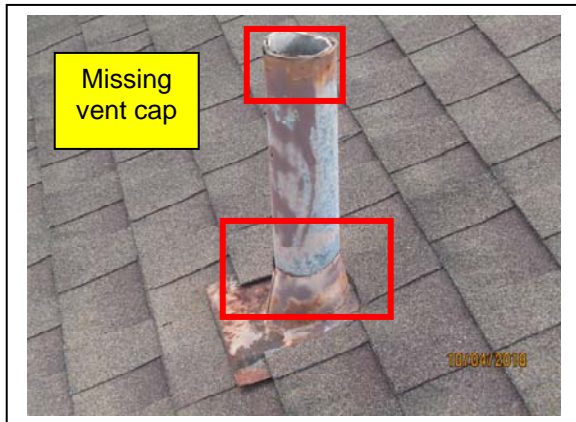
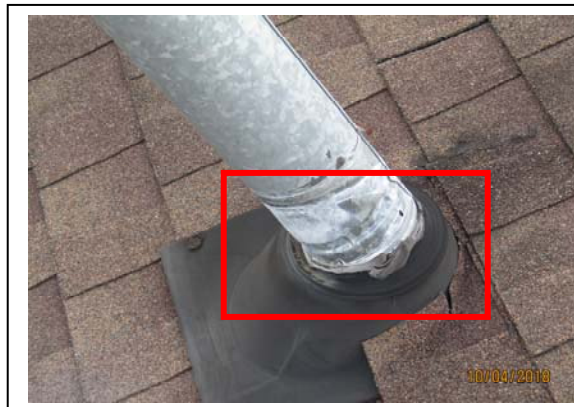
- The water heater and furnace vent pipe storm collars are missing and water is entering the attic during rainy conditions. Sealant repairs are needed.

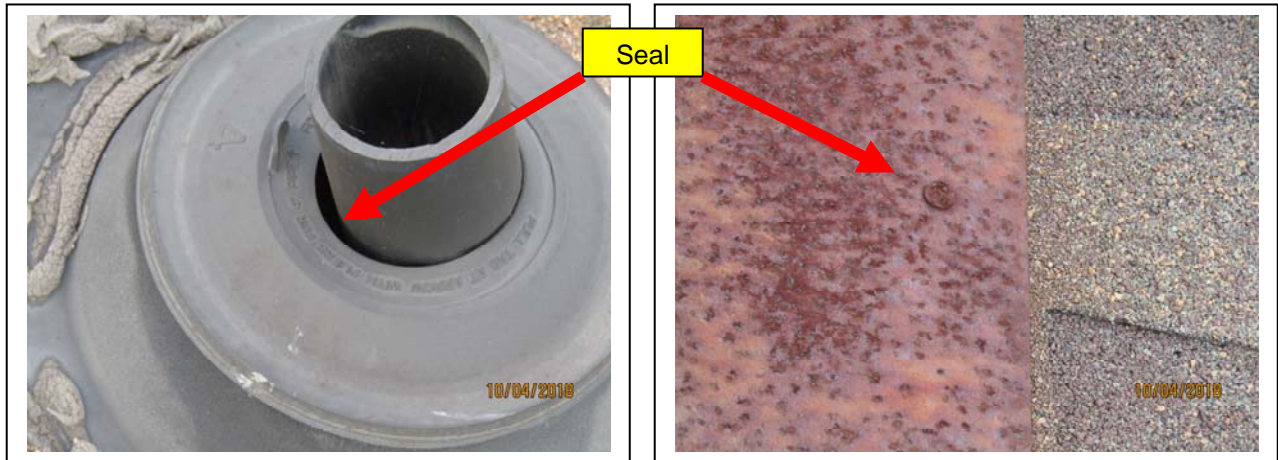
- Some of the rubber roof boots on the vent pipes need to be sealed at the neck area where rubber separation has occurred around the pipes.
- Exposed roof fasteners (nails) were viewed on the surfaces located at the ridge, flashings, and penetration areas. The manufacturer requires these fasteners to be sealed with an approved roof sealant for the prevention of moisture penetration into the structure. Minor repairs are needed.

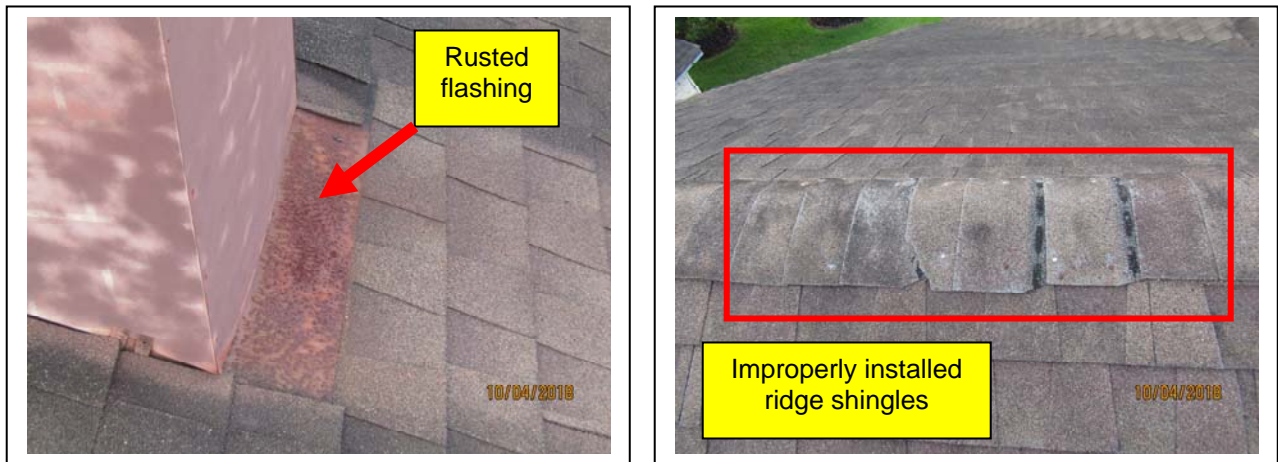
- Some metal flashings at the chimney base are rusted. The application of a quality anti-rust paint or replacement of the metal will resolve this condition.
- Damage and/or improperly installed shingles were viewed on *but not limited to*: the upper right ridge. Shingle repairs are needed.

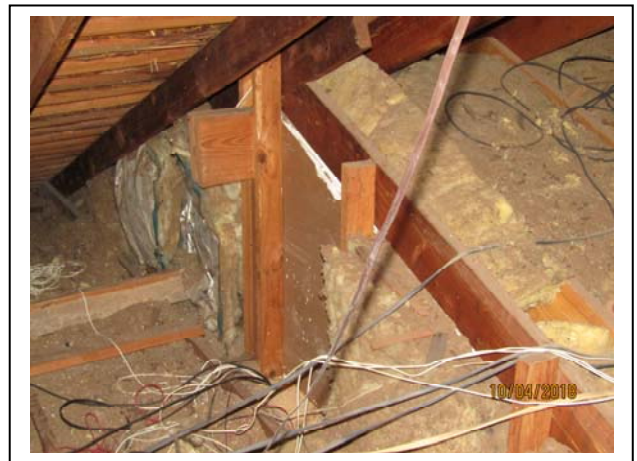
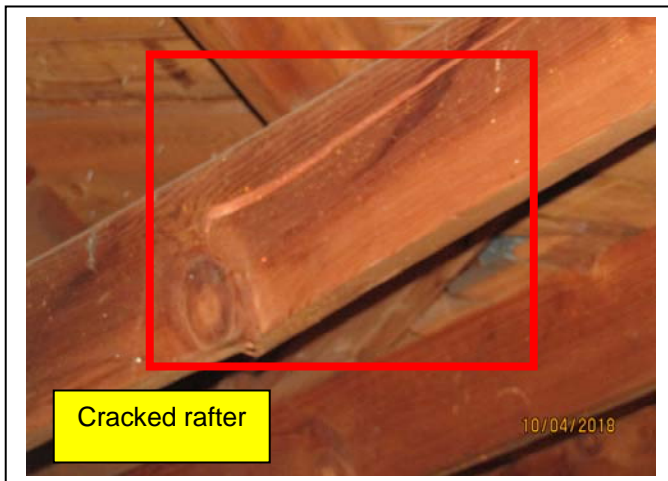
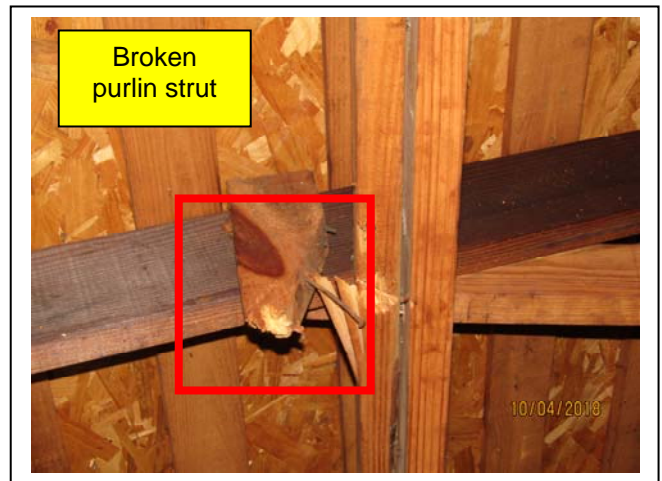
- Missing vertical bracings, under sized purlins, missing purlins, and sagging structure were viewed in the attic area. Strengthening the roof structure would improve structural integrity and resist future movement. While this improvement is not considered priority, it can often be accomplished without a great deal of difficulty.

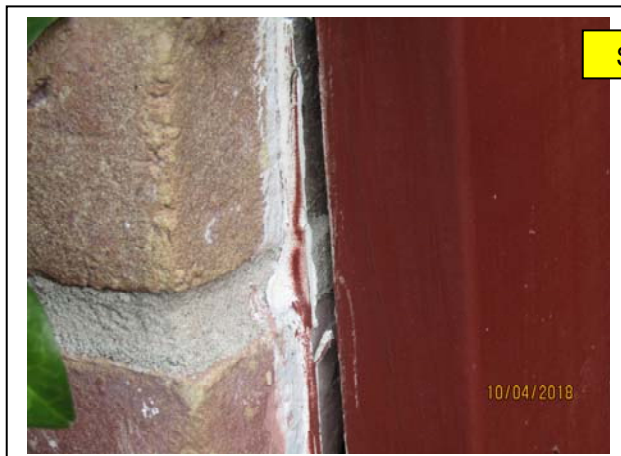
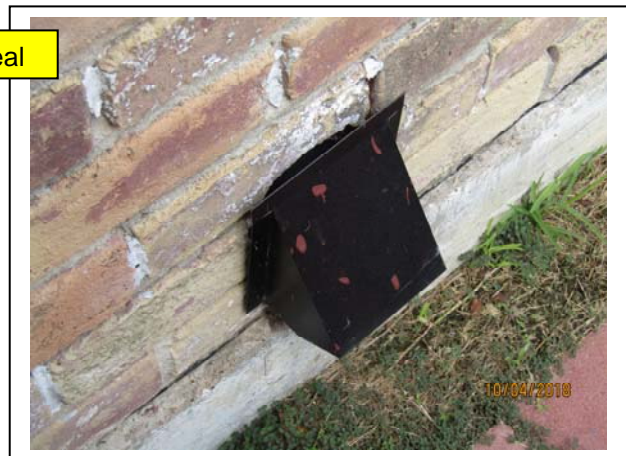
- All exterior wall penetrations need to be properly sealed at the wall coverings. Cracks, gaps, and separations allow water to “wick” along the penetrations back into the interior structural portion of the wall. Minor sealant repairs should be performed around all vent caps, garage door jambs, and any other unsealed wall penetration.

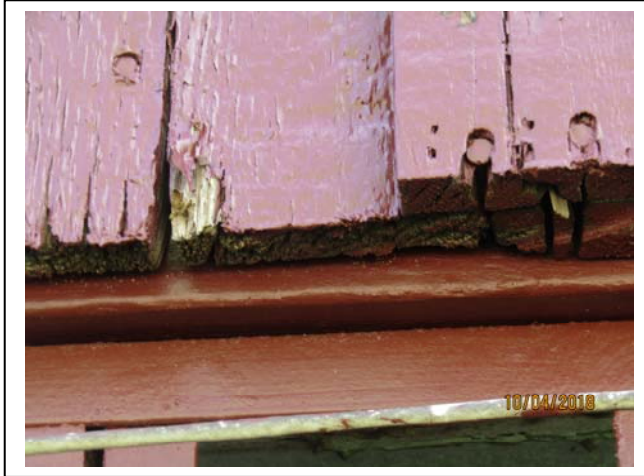
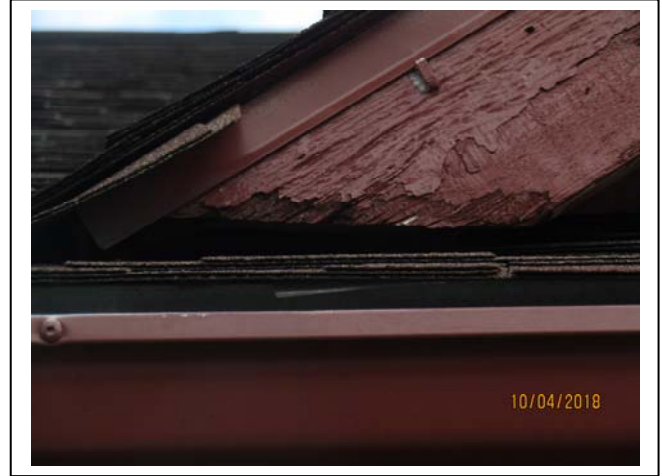
- Deteriorated/weathered wood areas were viewed at *but not limited to*: front gable fascia and left siding. All deteriorated wood areas should be replaced and not just covered with wood filler, caulk, and/or paint. Other areas of deterioration may be hidden under painted, sealed, or non-accessible or viewable surfaces.

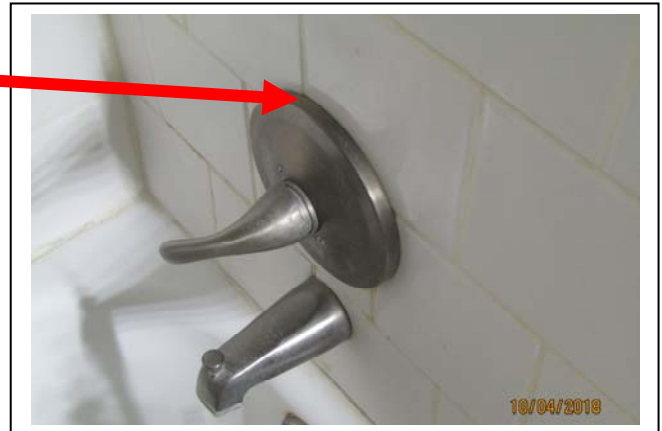
- The trim rings located on the tub and/or shower faucets need to be properly sealed at the wall surface for the prevention of water penetration to the inside wall structure.

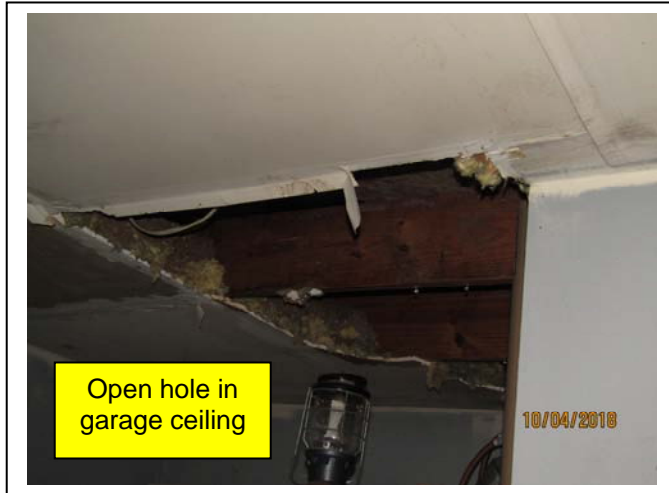
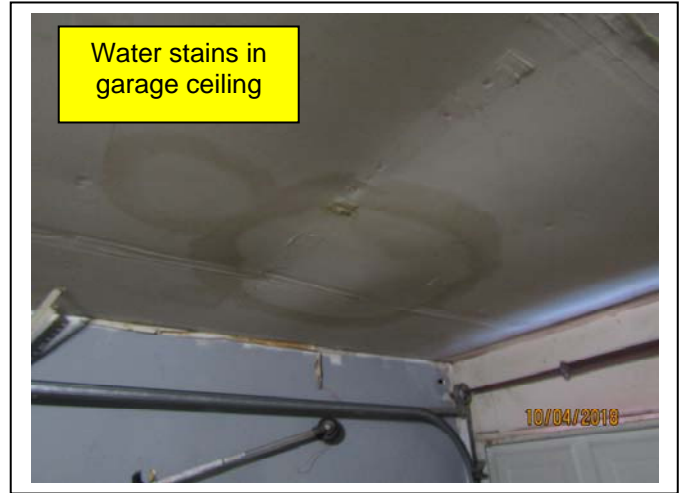
- The fire-blocked ceiling in the garage area is deficient. All holes need to be protected with a fire-retardant product (drywall, hardiboard, or Dricon-treated wood) to act as a fire-blocking barrier between the garage and attic/living areas. It is highly recommended that drywall be installed for safety entry/exit issues and better fire protection to the living areas. (Ref: IRC R309.2 Separation required.)
- Readily visible stains were viewed on the ceilings located in *but not limited to*: garage. All discolored areas need to have the stain source located, investigated, and properly sealed if necessary.

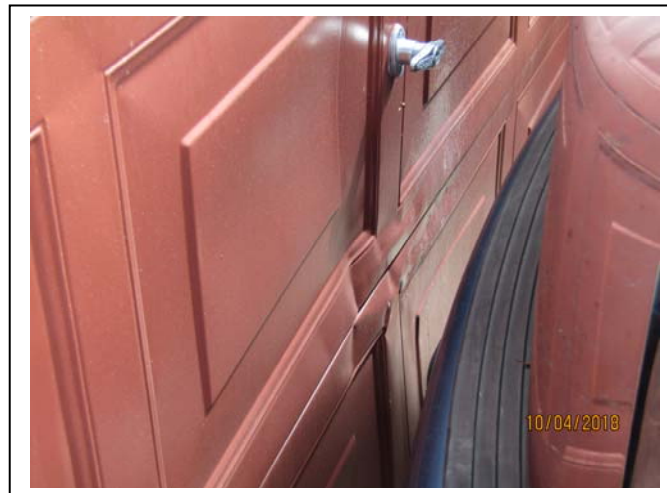
- Burglar bars with a double dead bolt locking device was viewed at the front porch. All locking devices should be operational without a tool or a key when located at a primary or secondary egress passage from a building.
- The door between the garage and the living area should have automatic door closer or spring-loaded hinges, solid-core, weather-stripped, and/or fire-rated to prevent fire from readily entering and spreading into the living areas. (Ref: IRC R309.1 Opening protection.)
- Both the garage panel doors are damaged and need appropriate repairs performed.

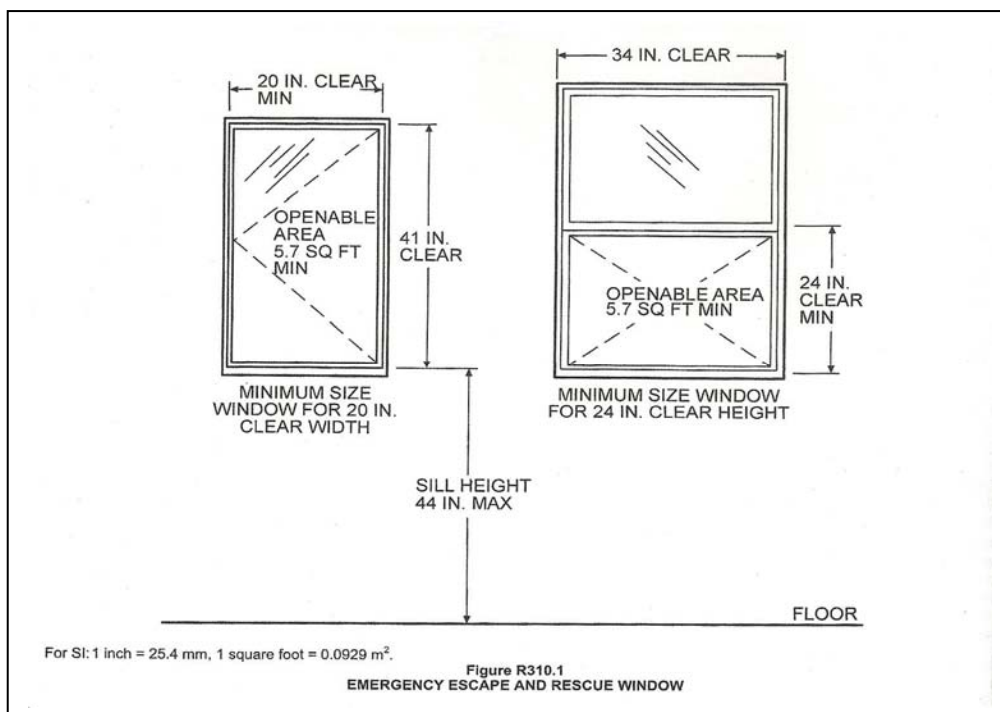
**NOTE:** The maximum safe height allowed for a sleeping area (bedroom) window sill from the floor to the sill surface is 44 inches. The windows located in some of the bedrooms were higher than the code allows for a safe secondary egress in case of an emergency. Since this is not a correctable item, other alternatives should be considered.

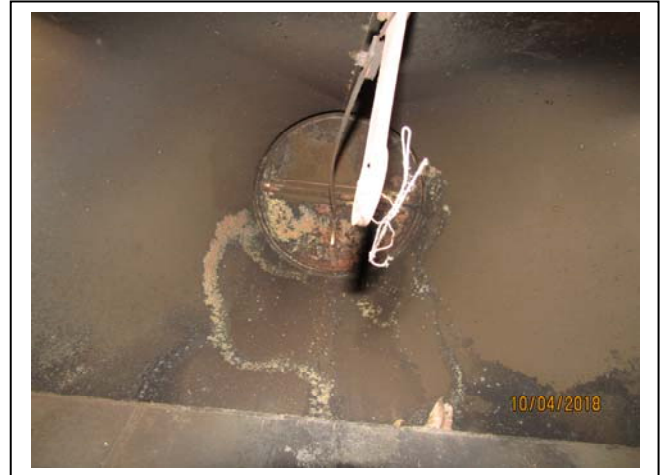
- **Minor water stains were viewed in the upper firebox area.**

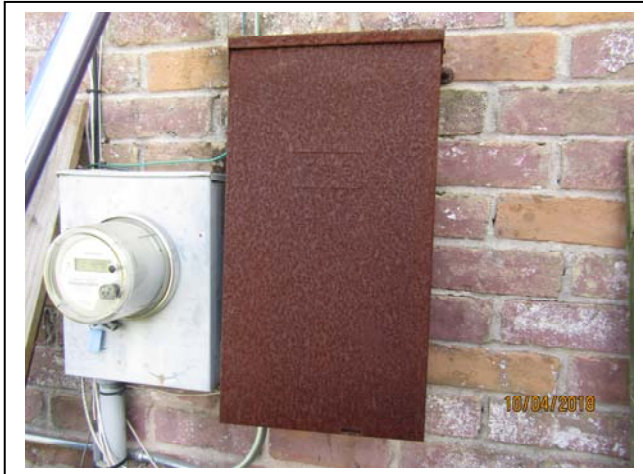
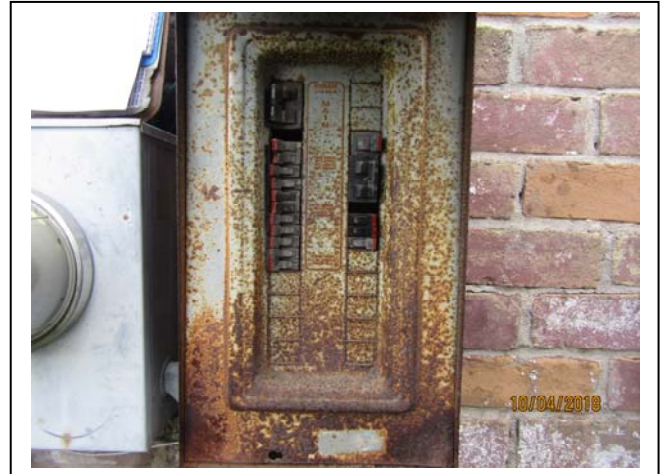
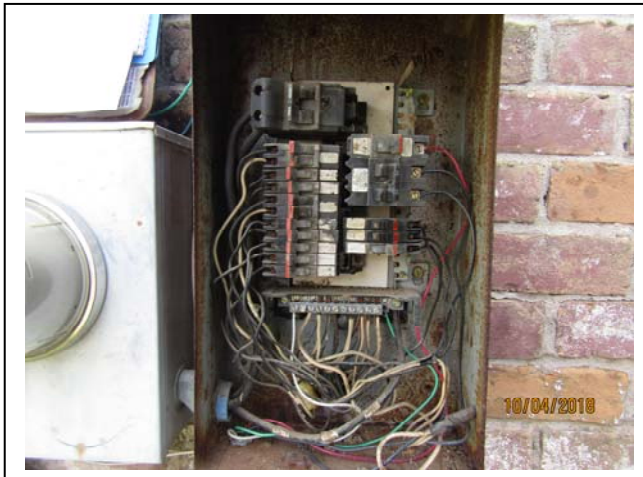
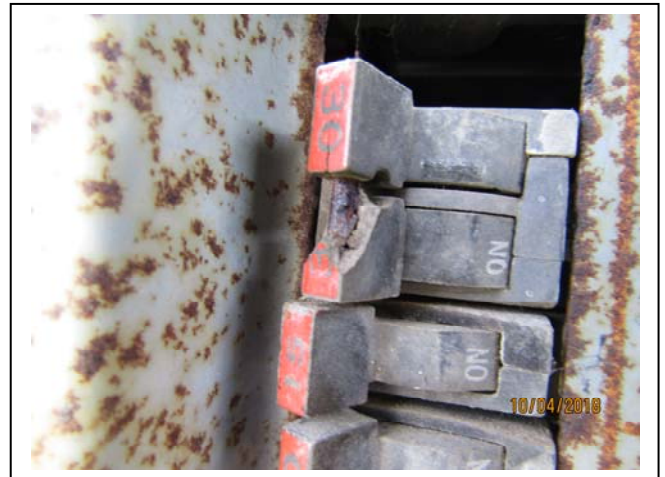
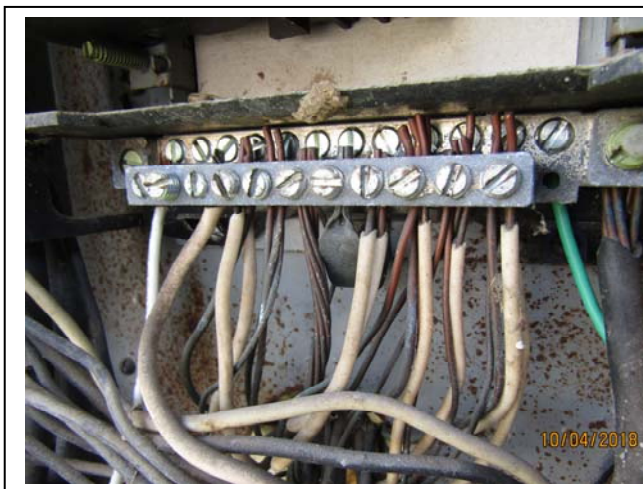
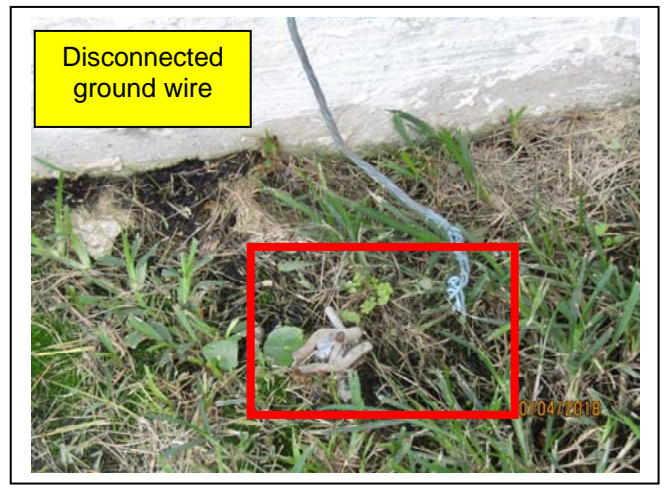
- **AS OF SEPTEMBER 1, 2015** the Texas Real Estate Commission has determined that the lack of a properly-bonded gas system in a house is a hazardous deficiency. The gas meter piping system was not viewed as being properly bonded/grounded to today's current requirements. (See TREC FORM OP-1 or the bottom of page two of this report)

- A Federal Pacific Electric "Stab-Lok" brand breaker panel has been installed in the unit. This particular older panel (not currently manufactured any more) has been involved in some electrical related fires. This condition is a safety defect. In my opinion, I recommend that this electric panel be replaced with an upgraded panel that is installed to the current NEC code by a qualified licensed electrical contractor. Check the internet website below for further *opinionated* information. (Ref: [www.angieslist.com/articles/your-federal-pacific-circuit-breaker-panel-safe.htm](http://www.angieslist.com/articles/your-federal-pacific-circuit-breaker-panel-safe.htm))

- The ground wire connection (clamp, wire, and rod) for the electrical service was disconnected at the clamp.
- The service box was excessively rusted. Panel replacement is needed.

- The panel was not labeled at the breakers and the circuit terminations could not be identified.
- The securing screw to the inside panel cover is missing and needs to be installed.

- One of the breakers inside the panel box is broken and needs replacement.

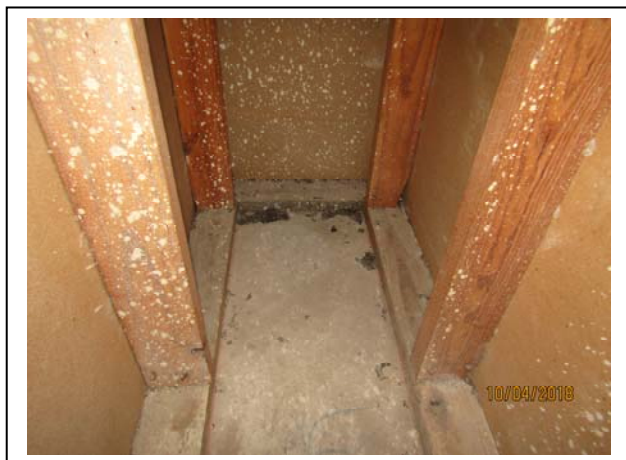
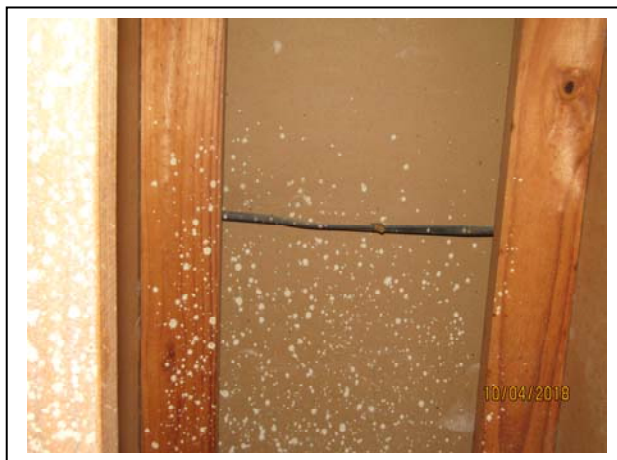
- The return air chase located in the *lower-zoned* system is dirty and the inside walls are not properly sealed. This condition will allow unfiltered air to enter the coil area and reduce the efficiency of the system.
- High voltage wires were viewed inside the return air chase. All electrical equipment should be covered with sheetrock and segregated from the return air flow system for the prevention of possible unsafe gases being spread throughout the living area if overheating or burning should occur.

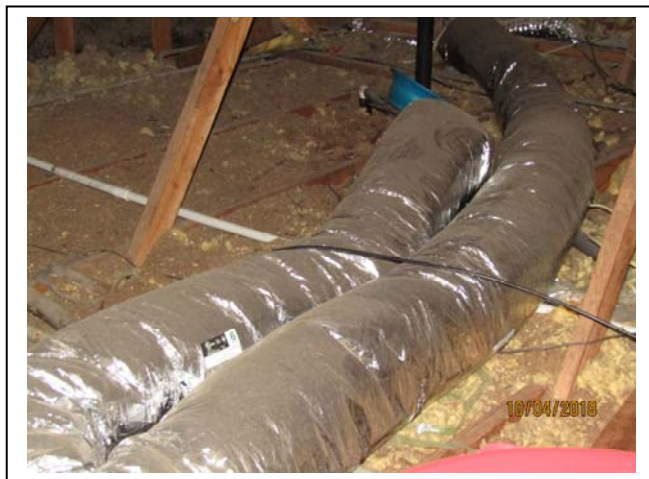
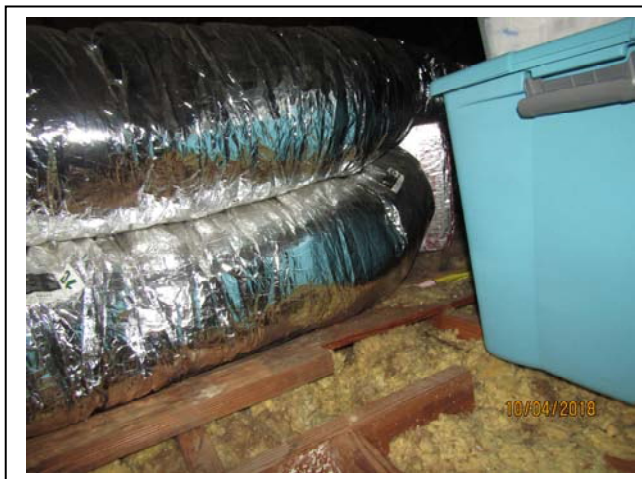
- The ductwork in the attic area has been improperly laid on the attic flooring and/or insulation. This condition will allow condensation build-up between ductwork and the contacted surfaces. All ductwork should be hung with plastic strapping in accordance with the UBC or IRC mechanical building codes.
