Special Consult

1516868-SCI-1-TDF

Address: 23434 Dukes Run Drive, Harris County
Project: Breckenridge Forest Section 10
Lot/Blk: 3/2 Plan: 1650 v4 B R
Client: Express Homes Houston North Strand: 1516868R2
Complete: Mar 18, 2019 4:30 PM PO: PO 241074
Structure: Main House
Notified:

Owner is concerned that the cracks in the hall bath tile relates to foundation performance. Some recent repairs in the walls were not able to be photographed , but current defects are attached. Also elevations were taken of the floor surface.

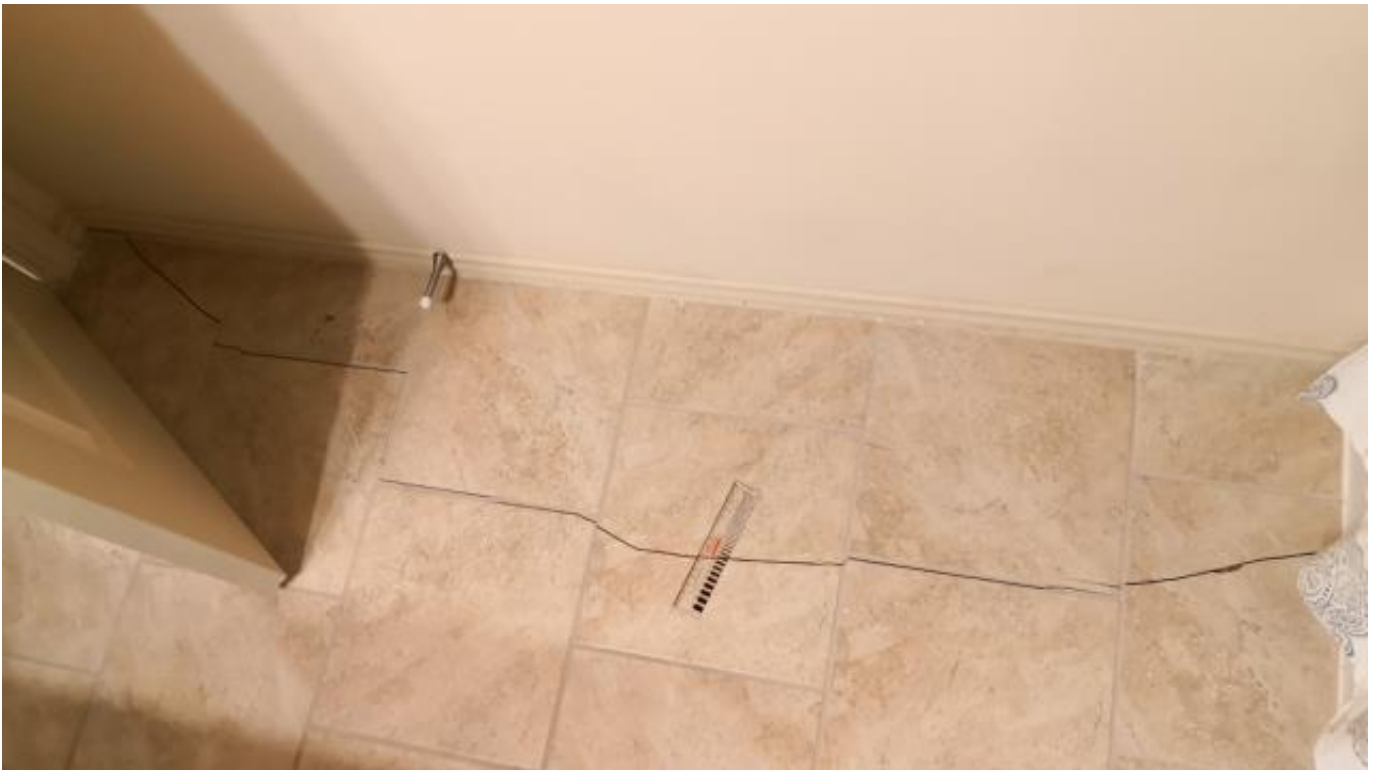
PIC 1 - main concern is this tile crack

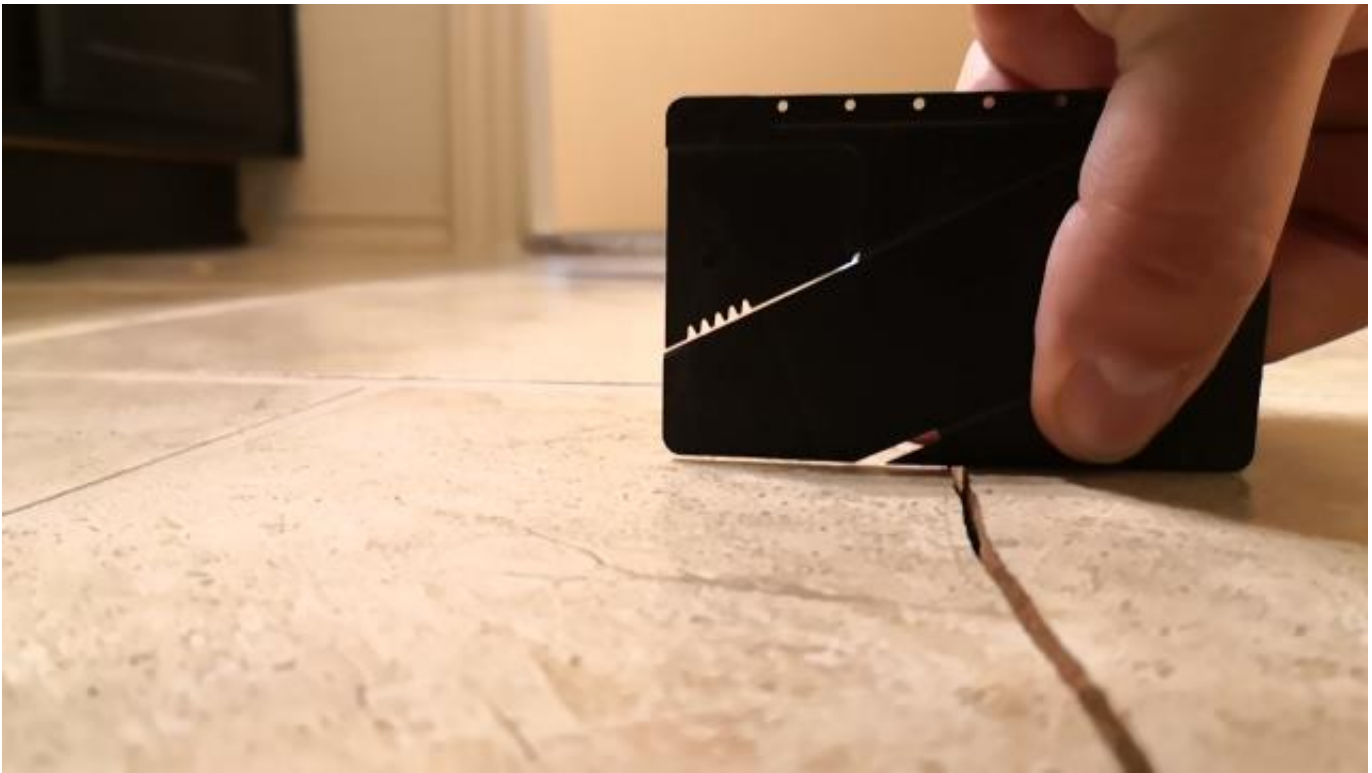
PIC 1b - the rear of the home is higher than the front of the home as measured across the tile crack

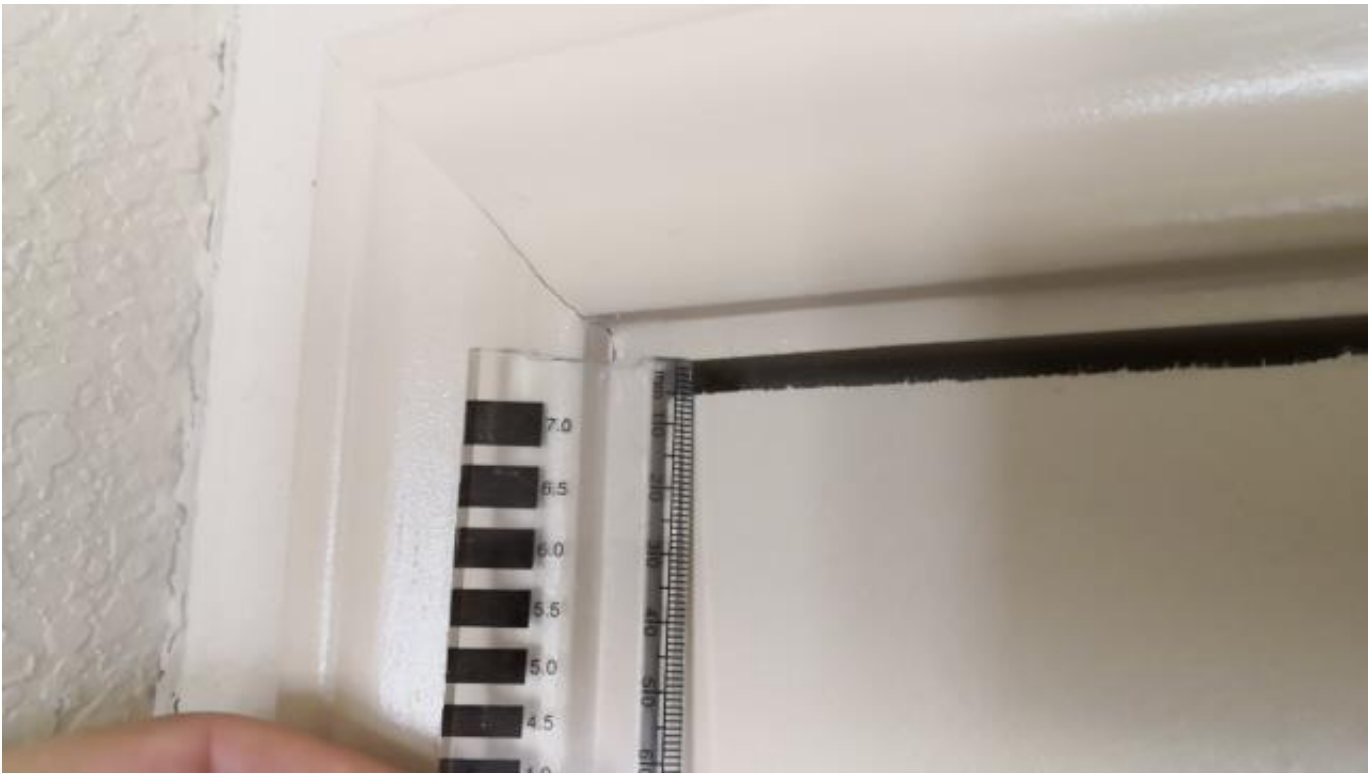
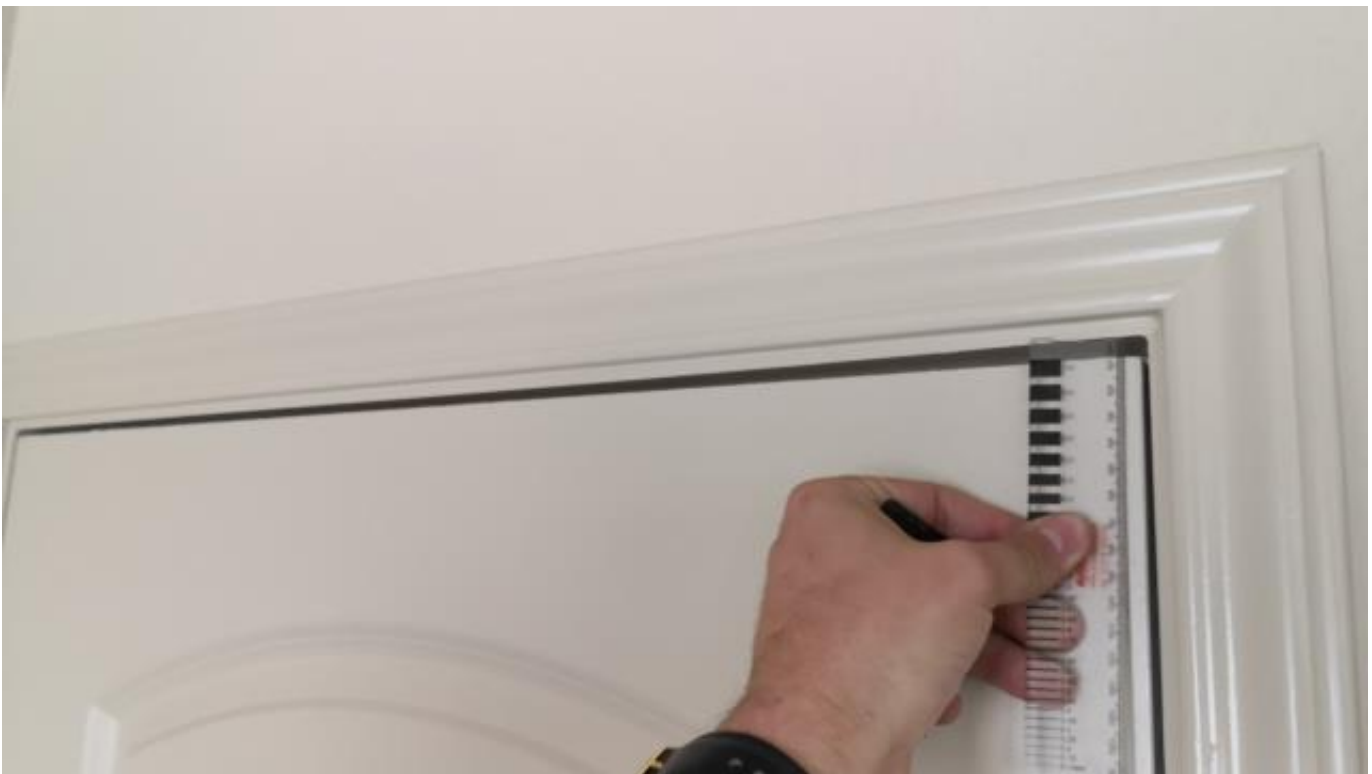
PIC 2 - master bedroom door is racked. It does not latch any longer.

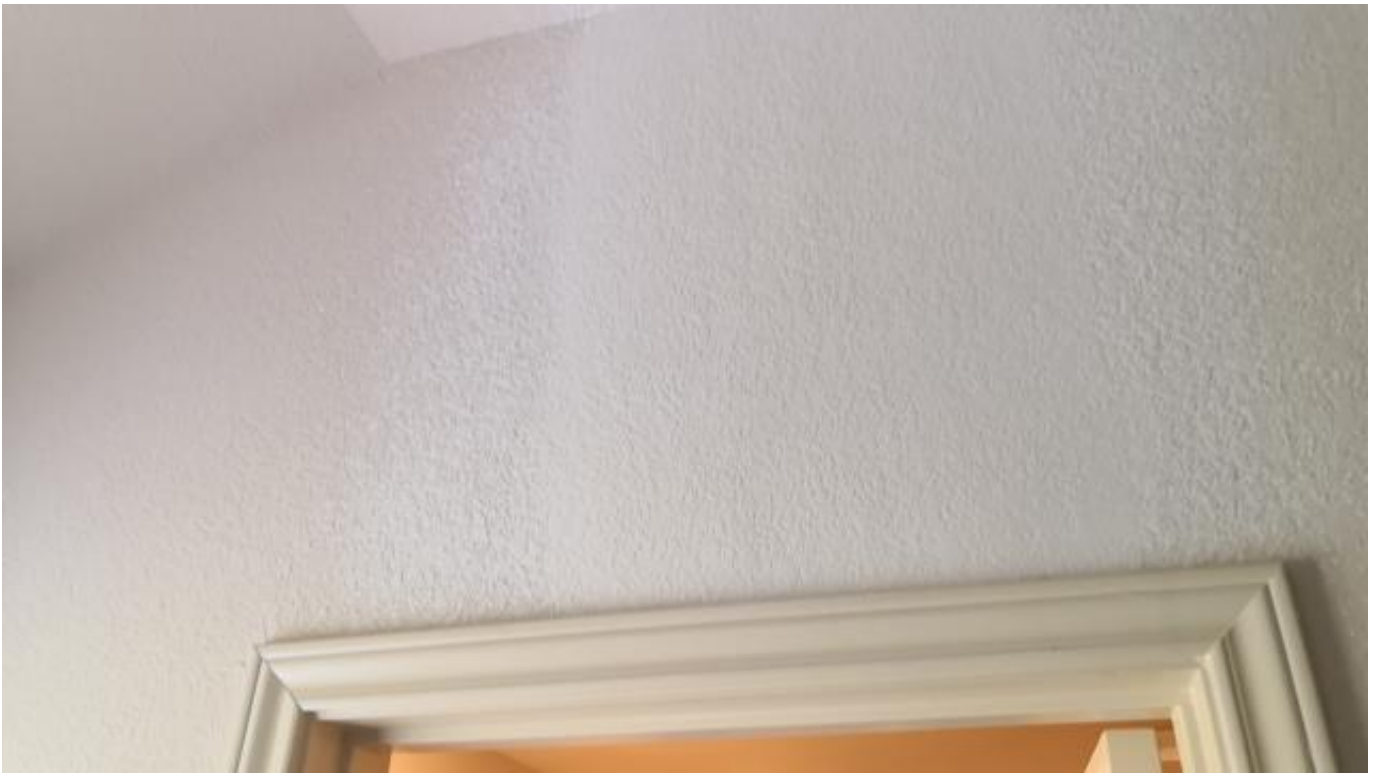
PIC 3 - master bath header was recently repaired.

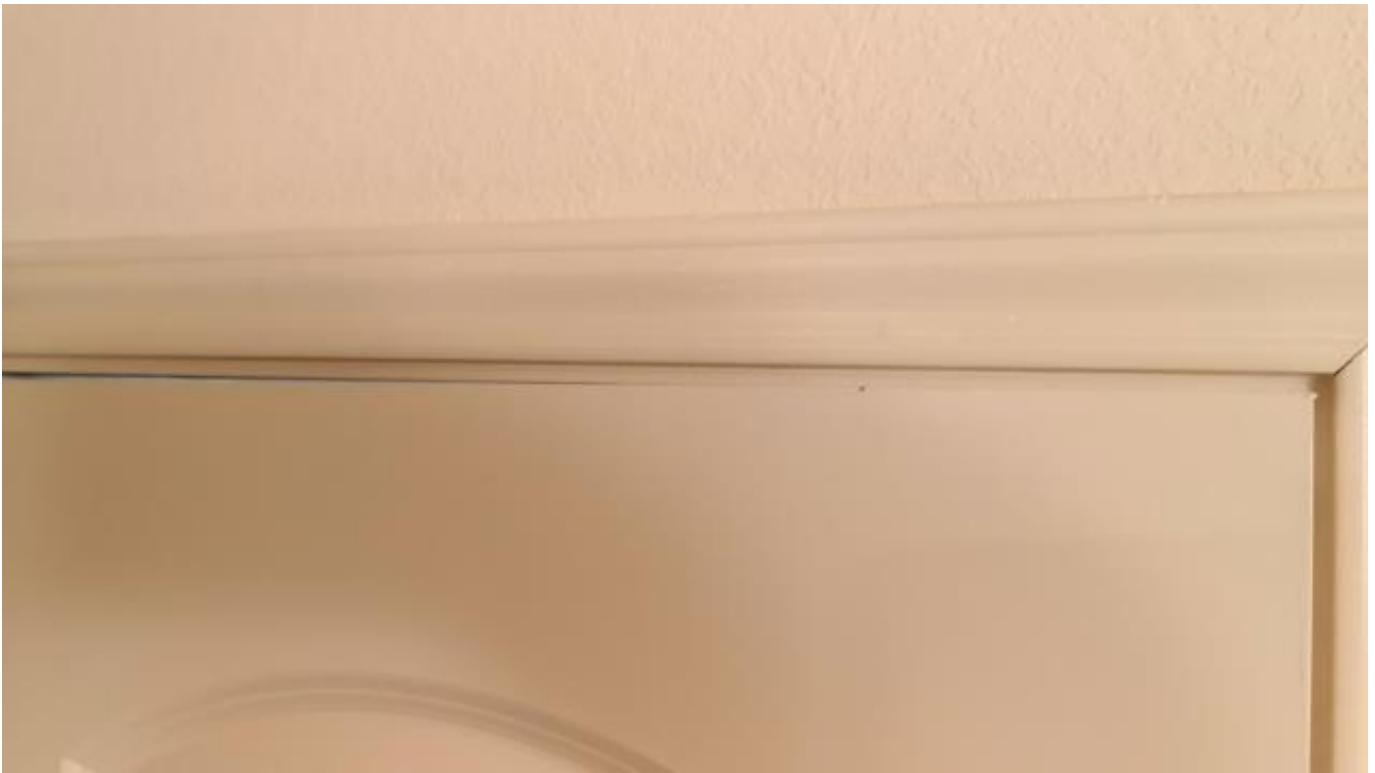
PIC 4 - master bath door is racked and rubs. Does not close any more.

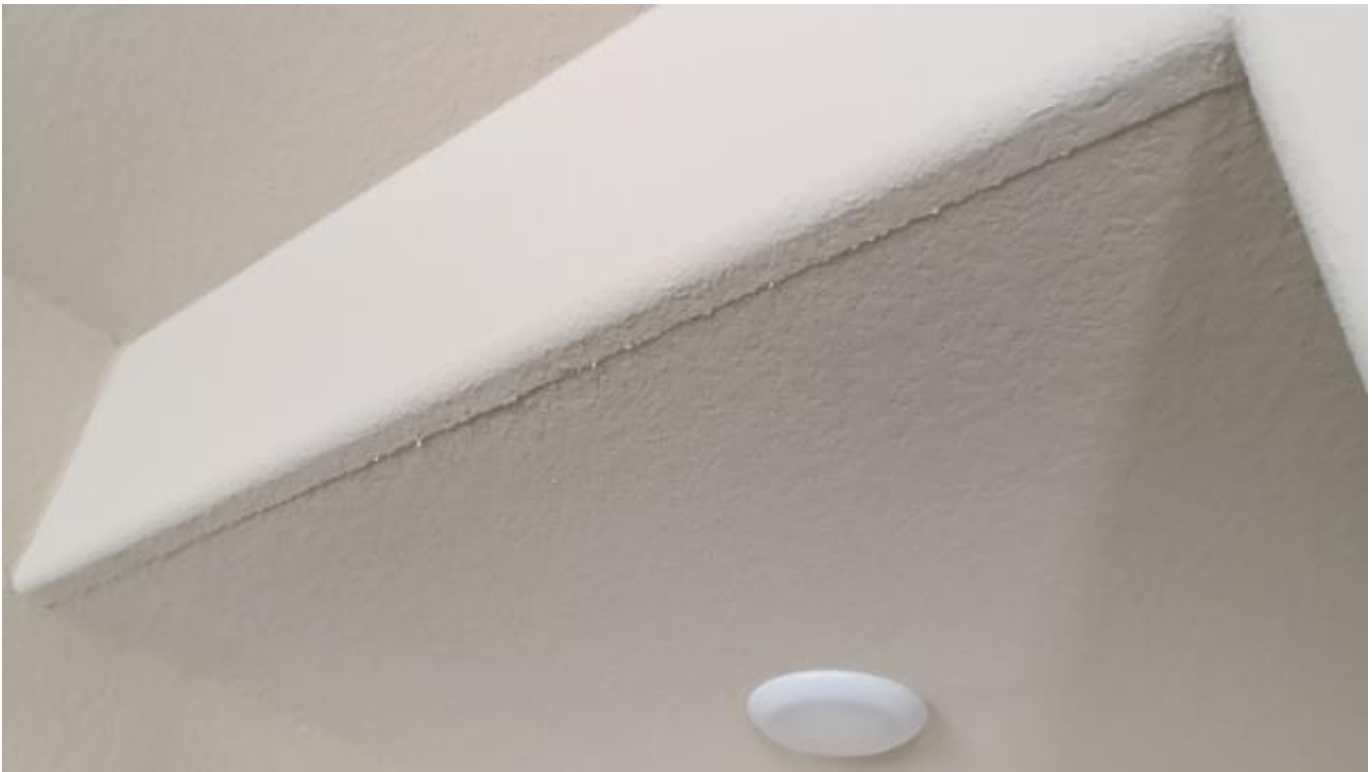
PIC 5 - ceiling crack

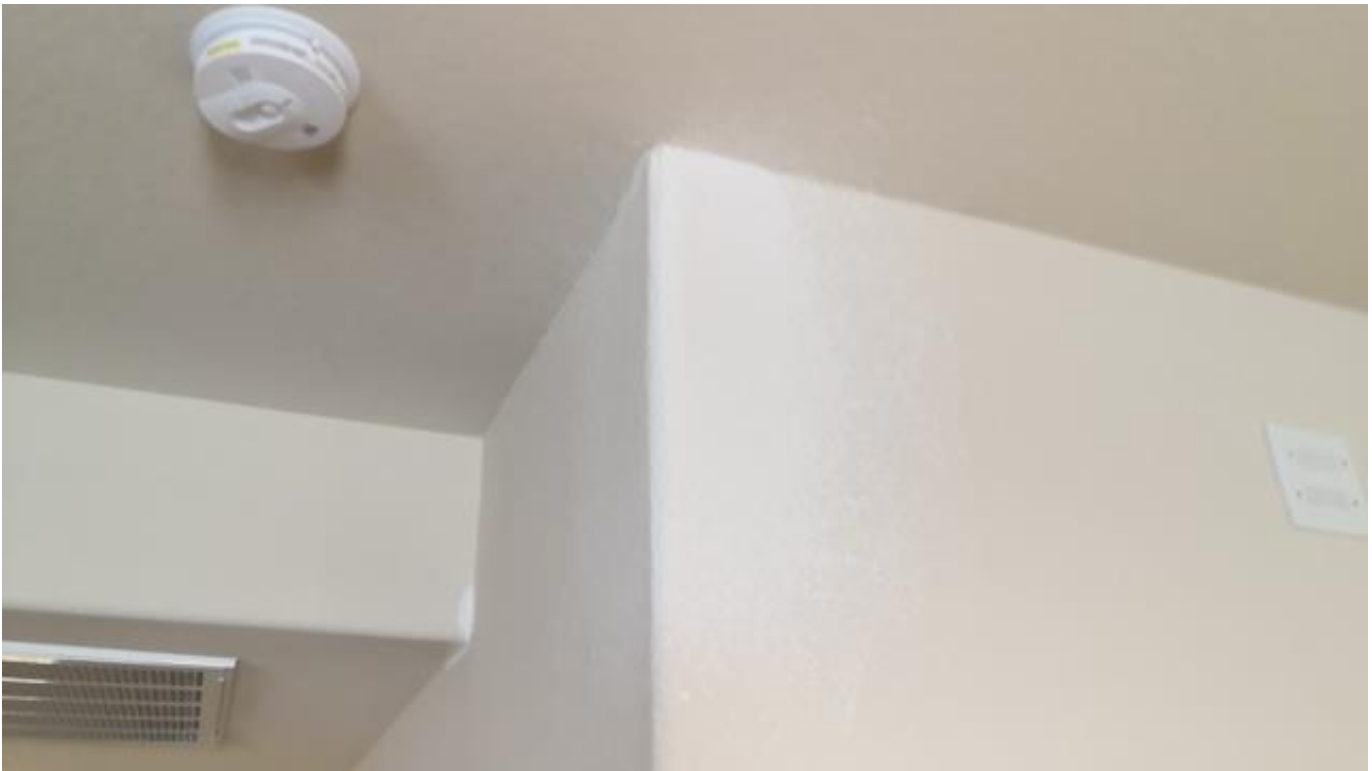
PIC 6 - texture repair conceals cracking at wall / ceiling intersection.

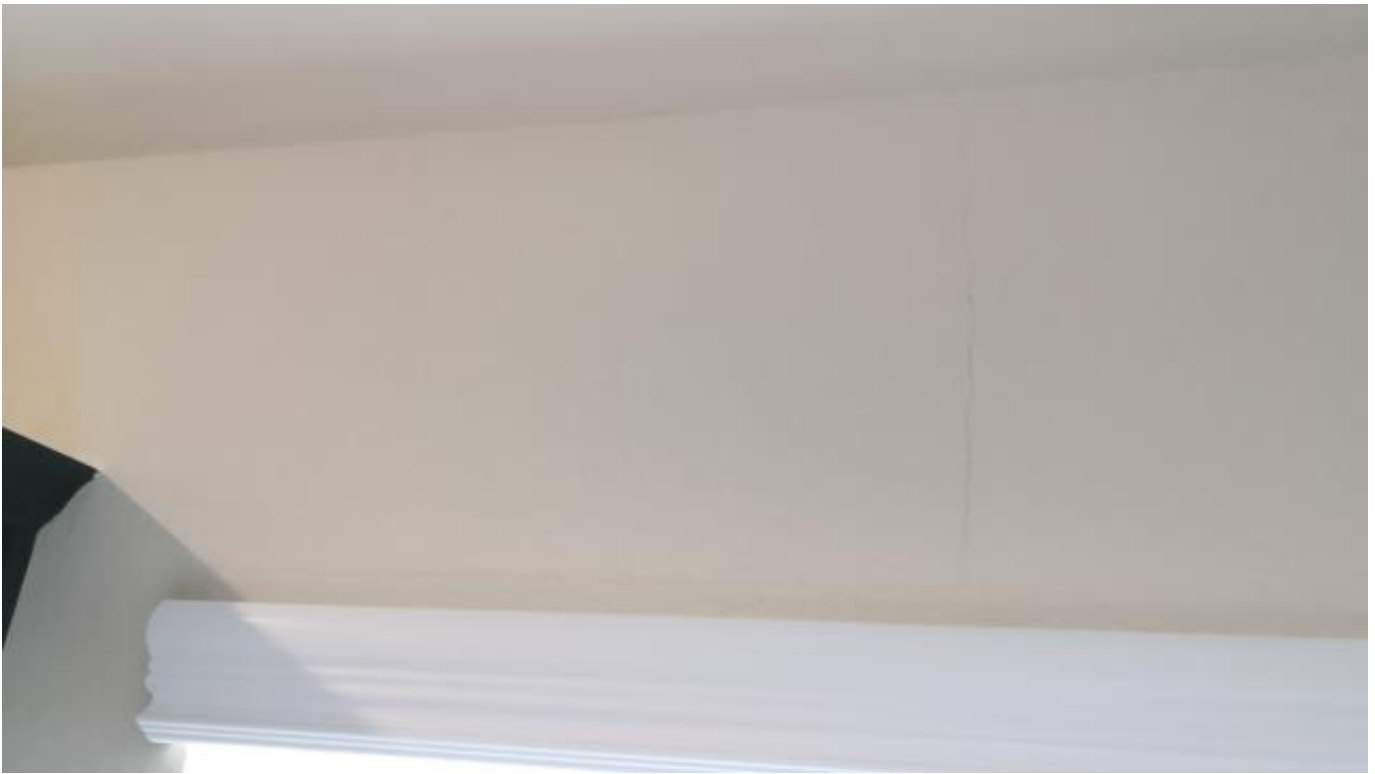
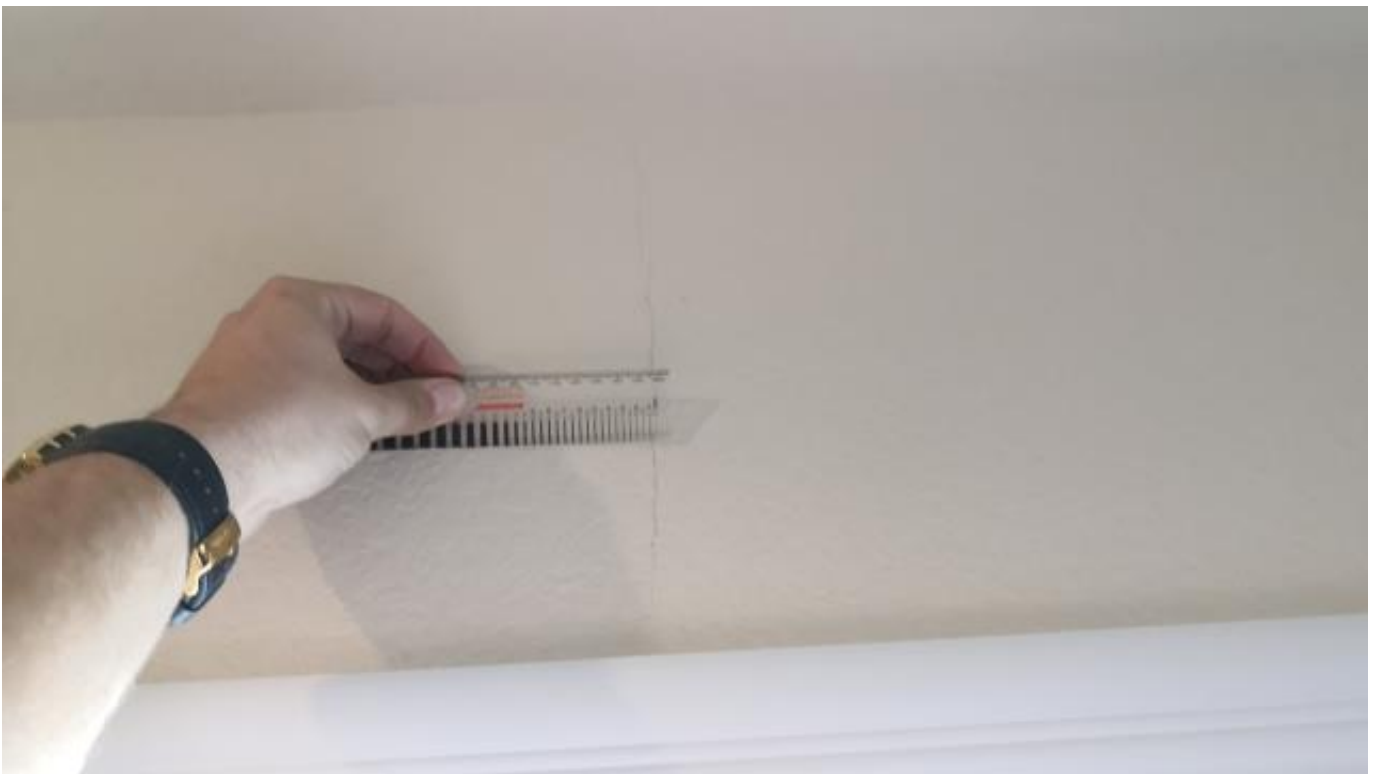
PIC 7 - header of window has crack

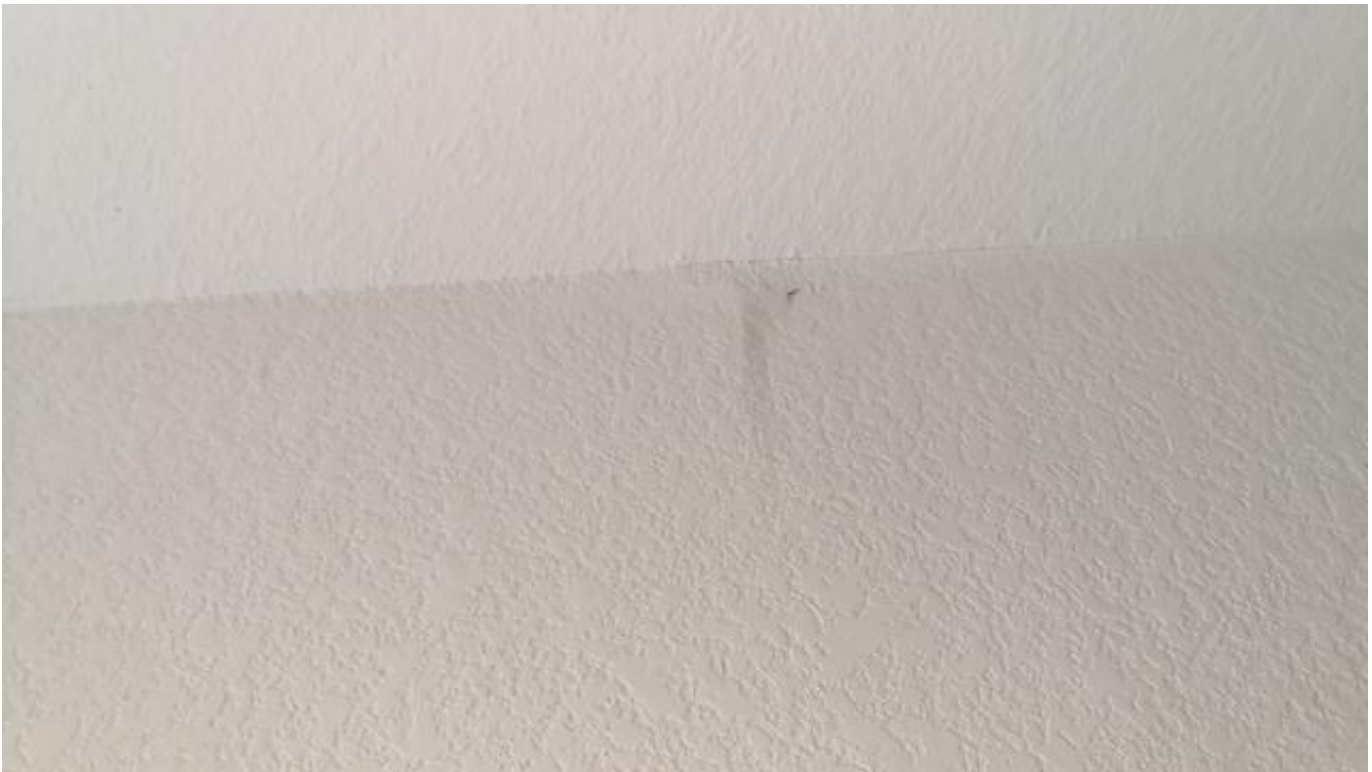
PIC 8 - wall at living room has this irregularity near ceiling.

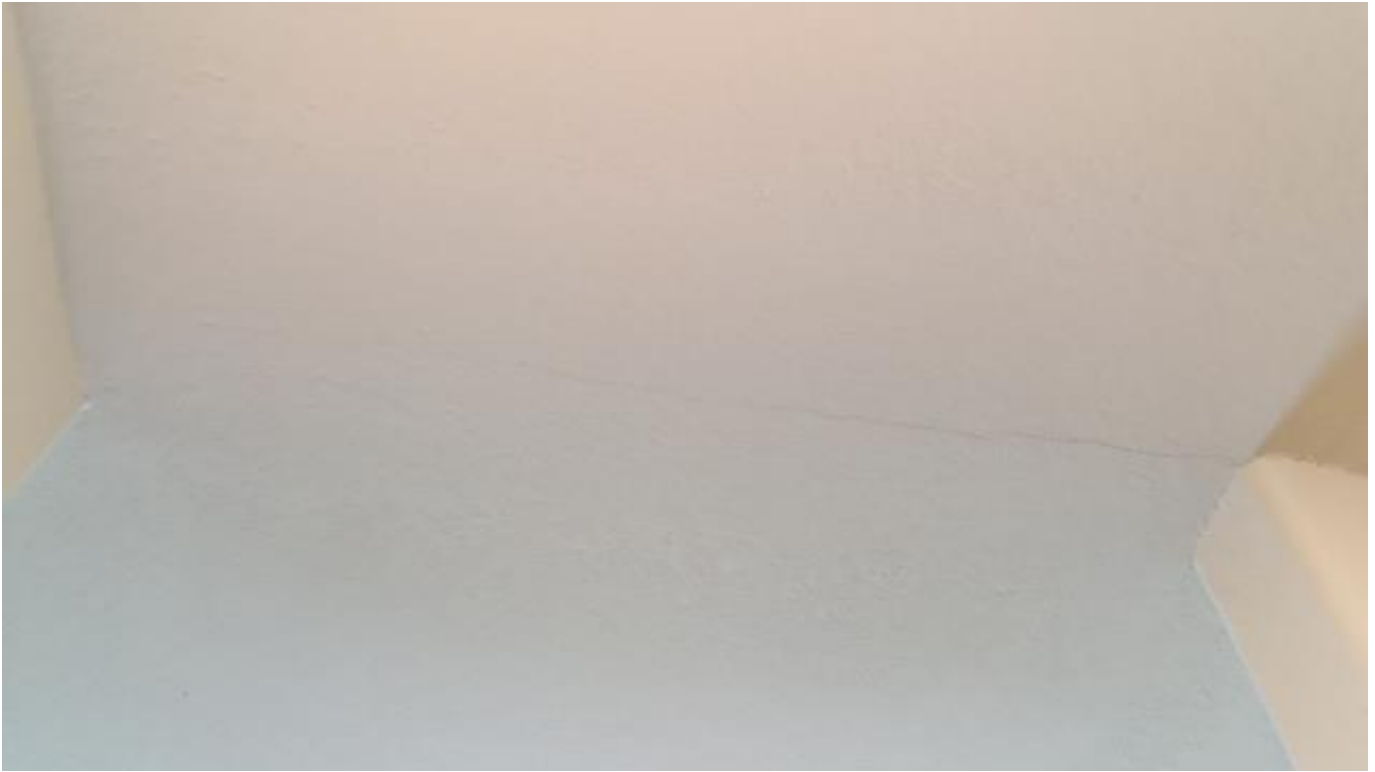
PIC 9 - ceiling crack

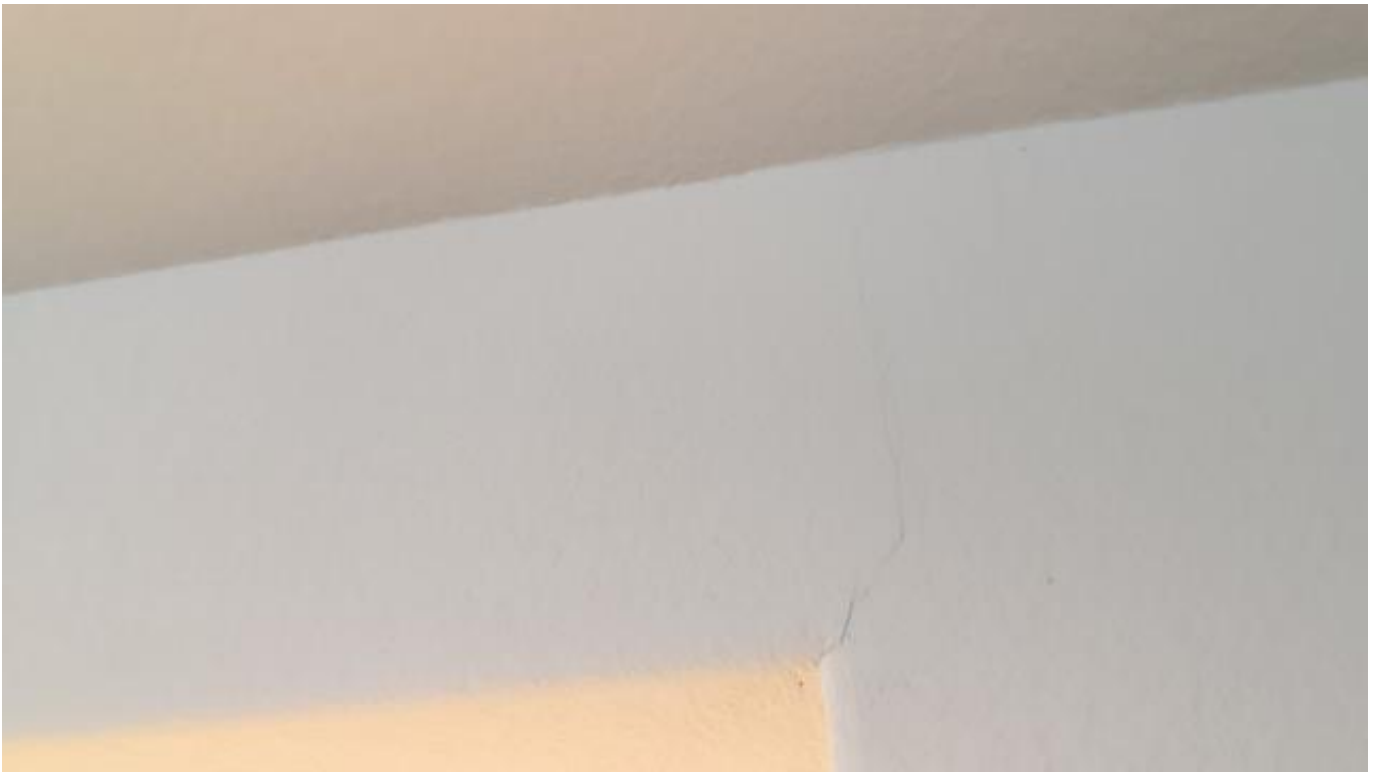
PIC 10 - corner crack at opening

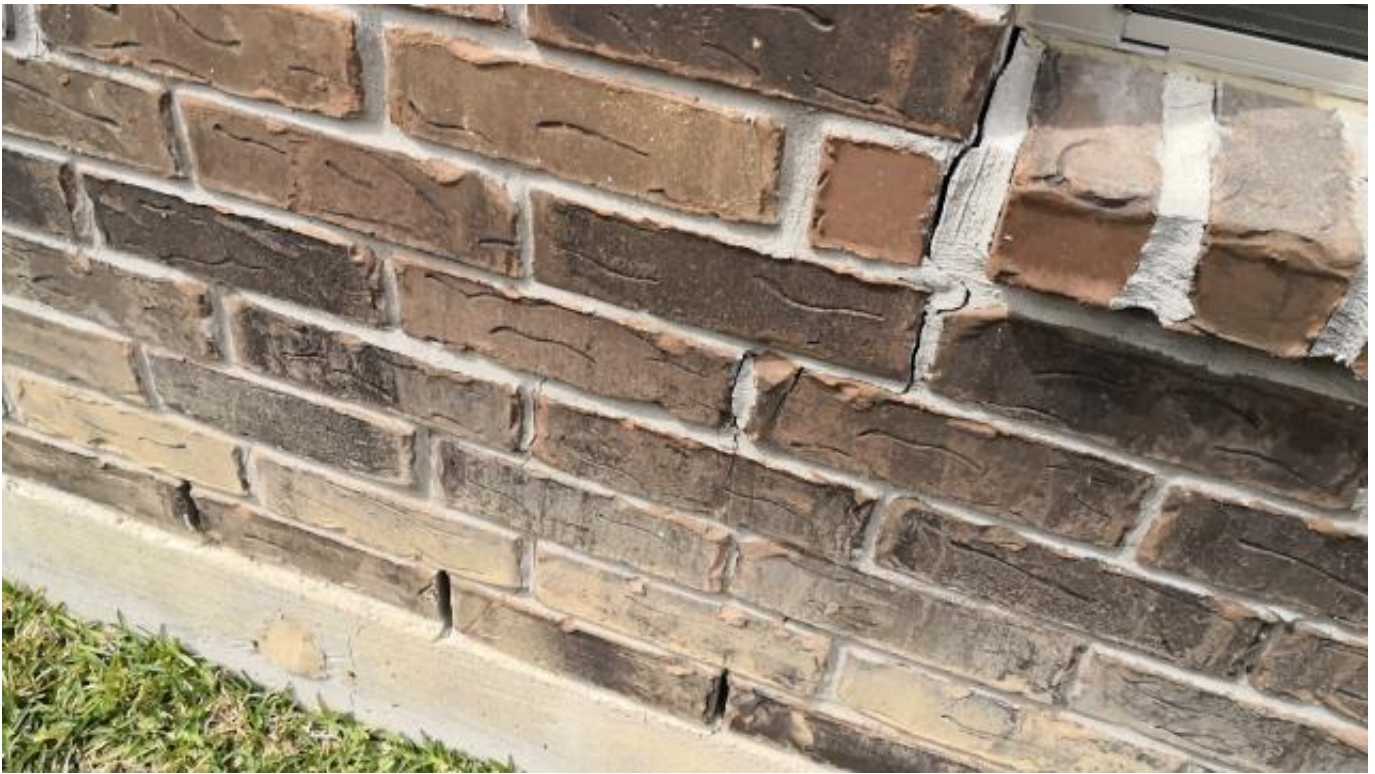
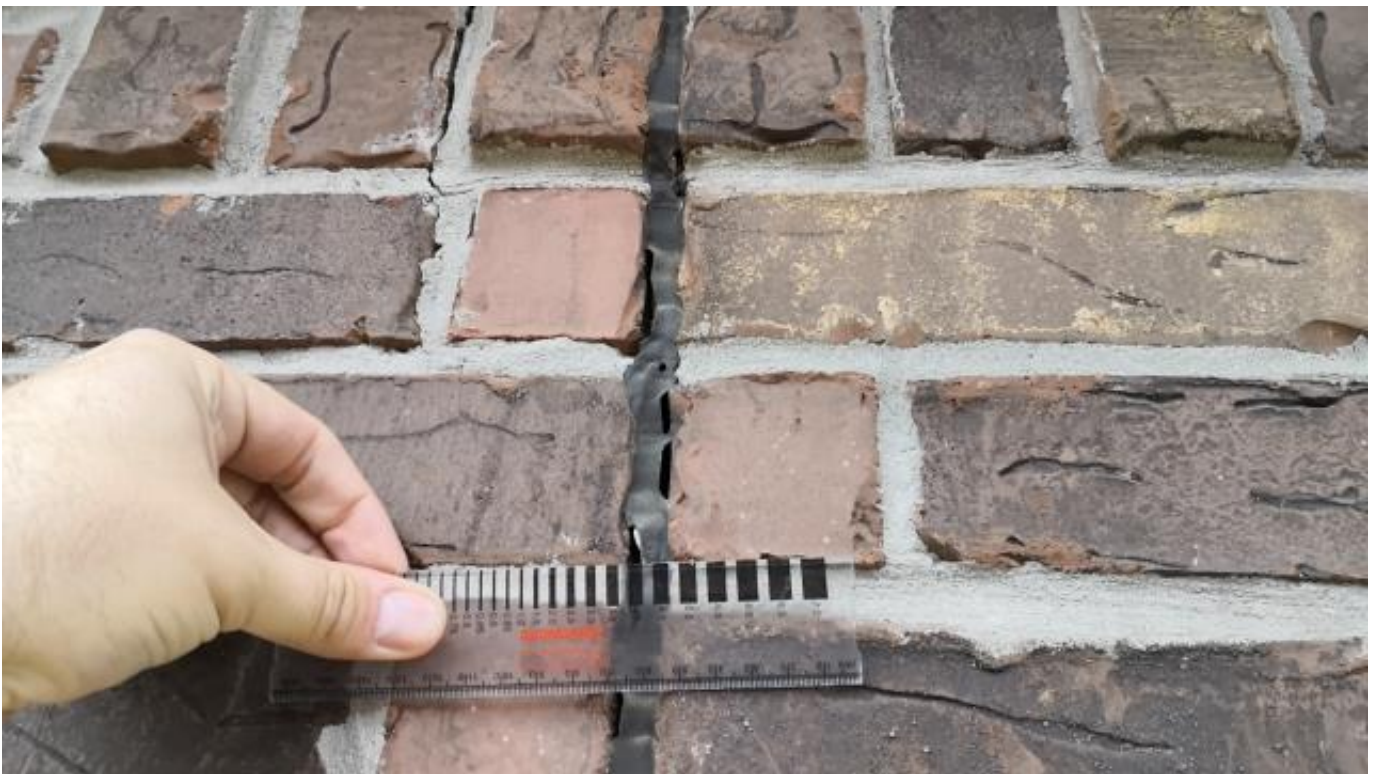
PIC 11 - this window has defects at wood lintel and sill. Also a pattern of cracks extending toward a slab crack below. Adjacent is a brick expansion joint that widens as it extends upwards.

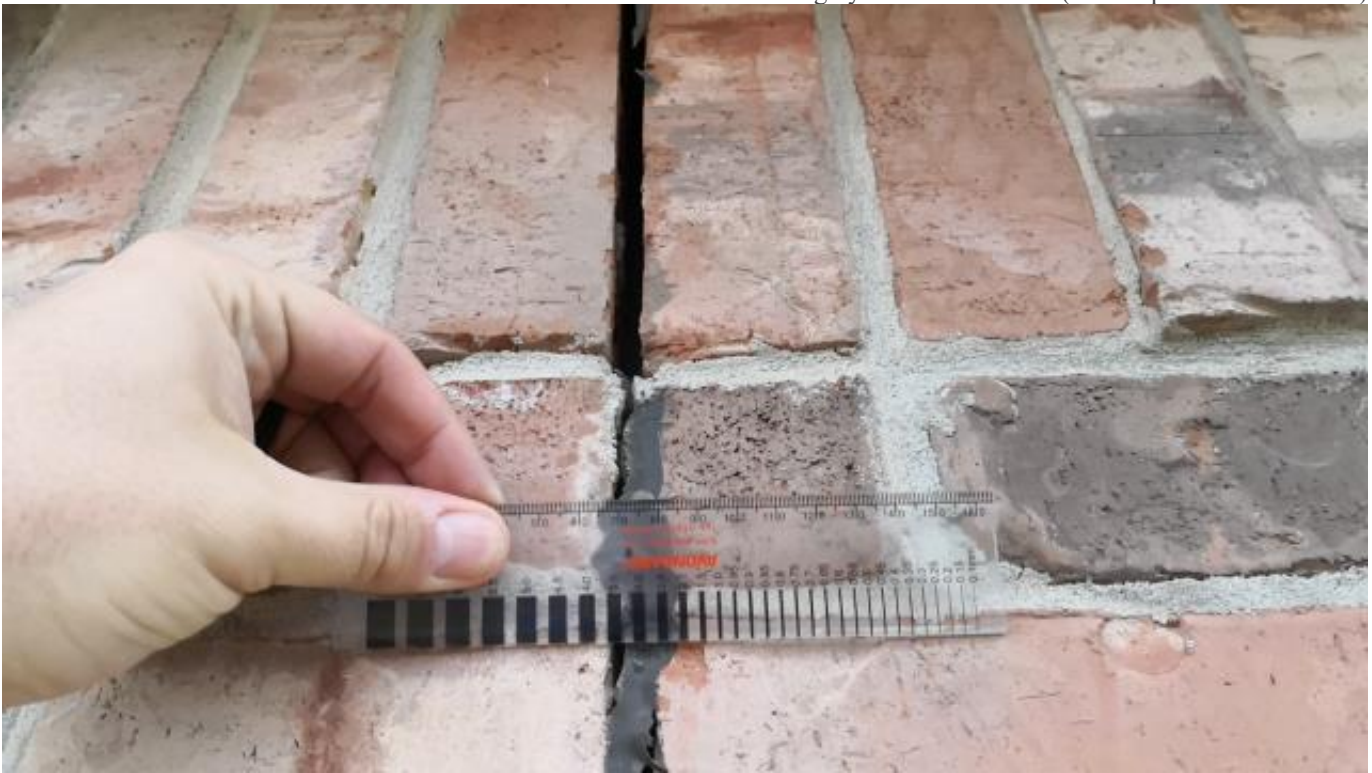
PIC 12 - Neighboring home has similar but not as pronounced defect in roughly the same location (not to open a can of worms)

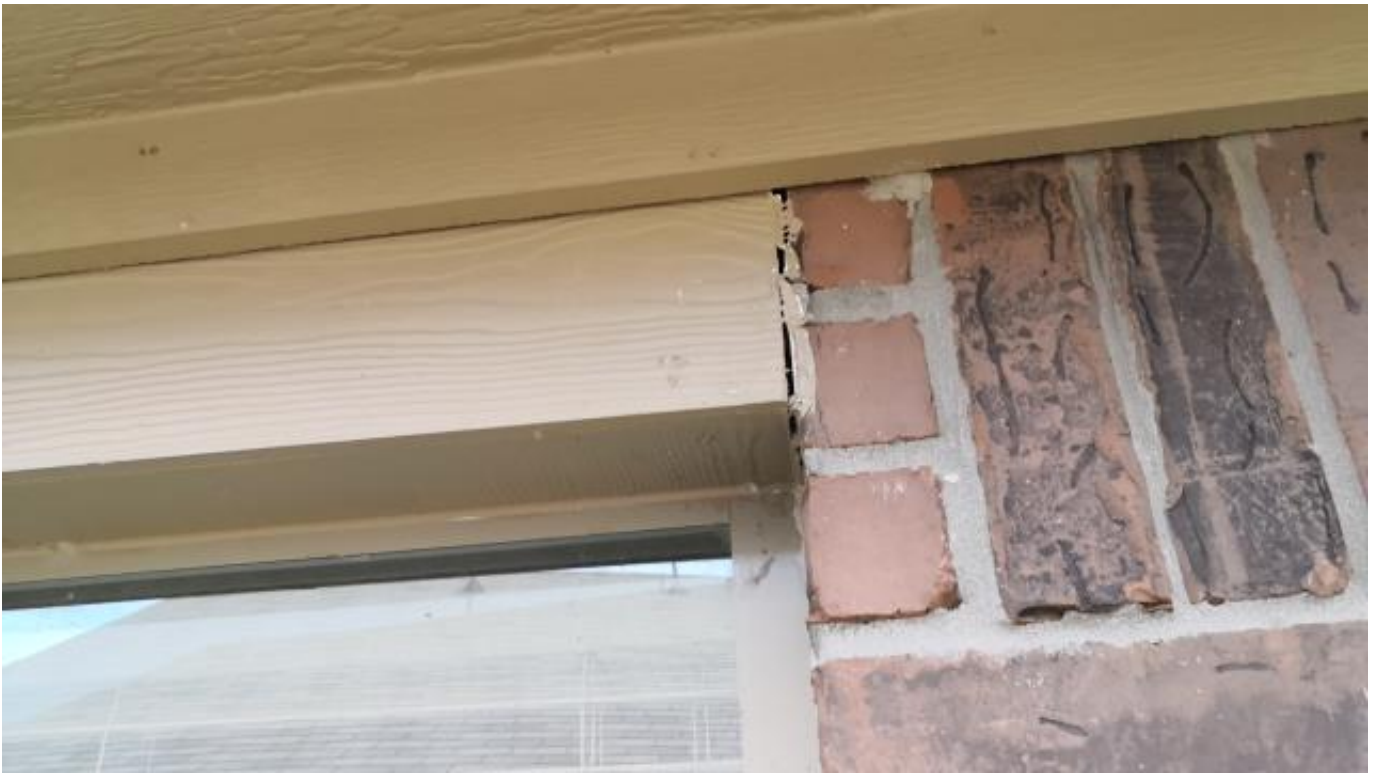
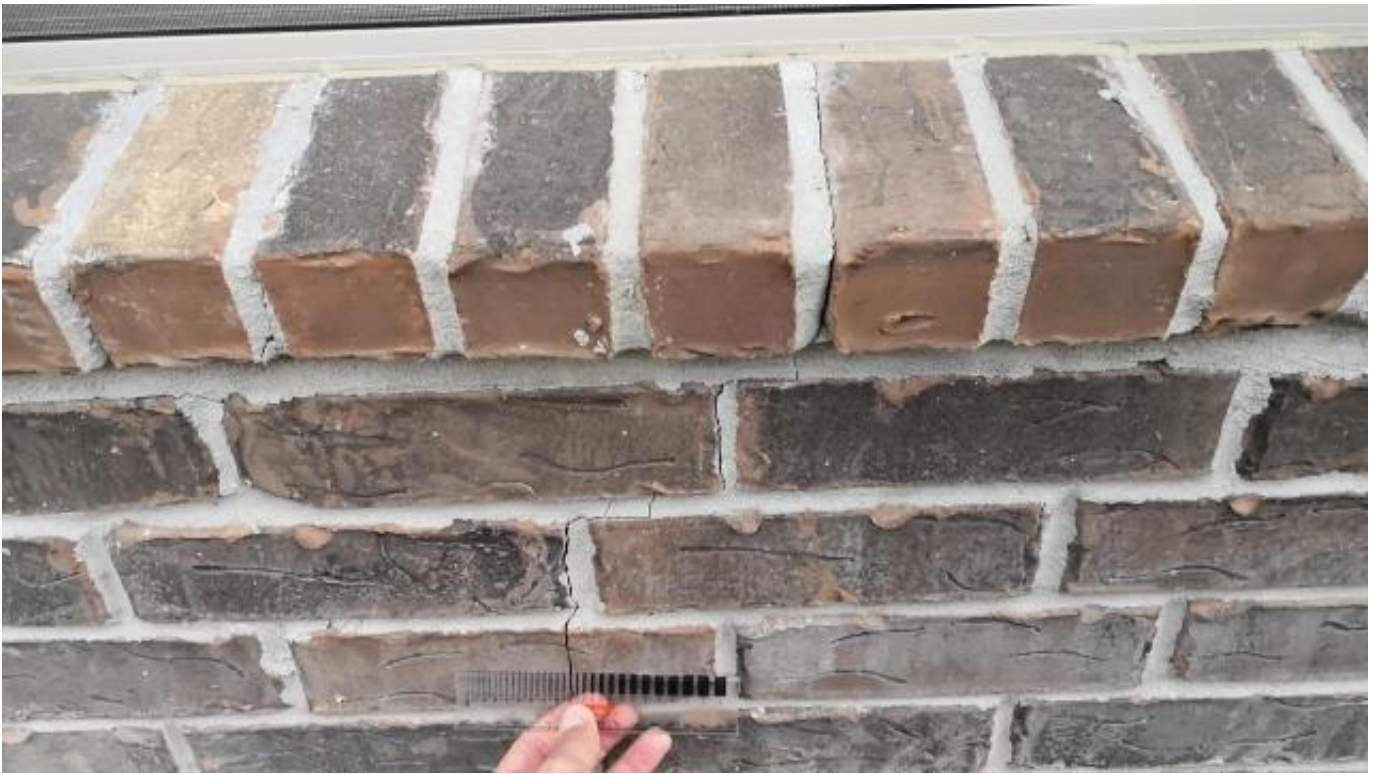
PIC 13 - this window has defects at wood lintel and sill. Also a pattern of cracks extending toward a slab crack below. Adjacent is a brick expansion joint that widens as it extends upwards.
