STRAND

March 19, 2019

Express Homes Houston (North)
400 Carriage Hills Blvd
Conroe, TX 77384

REF: Breckenridge Forest Section 10
23434 Dukes Run Drive
Harris County, Texas
Lot: 3 Block: 2

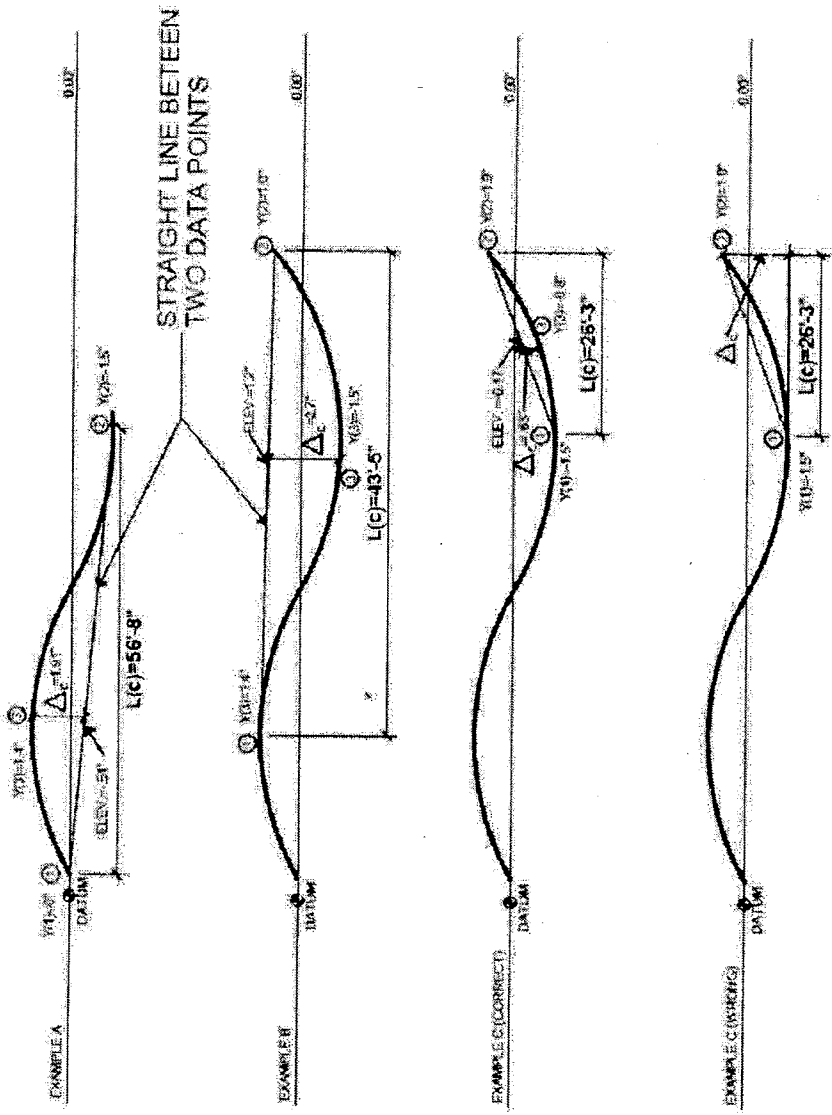
Deflection:

A review of the elevation readings for this foundation shows a worst case deflection of 0.81" over an approximate 67 ft distance from the rear right to the front left of the foundation. The PTI tolerance for deflection, based on a L/360 deflection criteria, is 2.23" for this distance. The worst case tilt was found from the rear left to the front left of the foundation and measured at a 0.27% slope. The accepted tolerance for tilt according to the PTI is 1%. Based upon these performance guidelines set forth by the PTI performance document, the foundation is within tolerance for both deflection and tilt.
