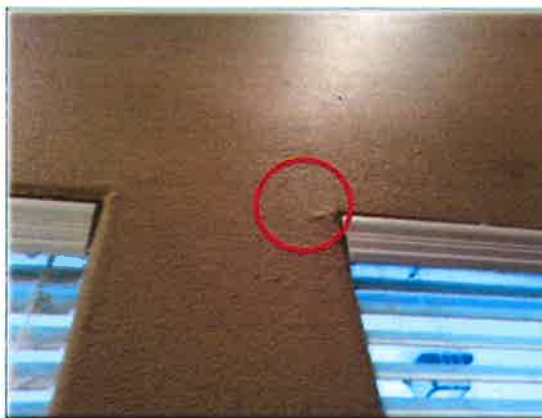
Cracked and peeling paint observed. Location: Back and middle. Room: living room, which is caused from high concentration of moisture; recommend repairs. (note: the balcony above appears to have had repairs in the past) This area was not wet at the time of inspection.

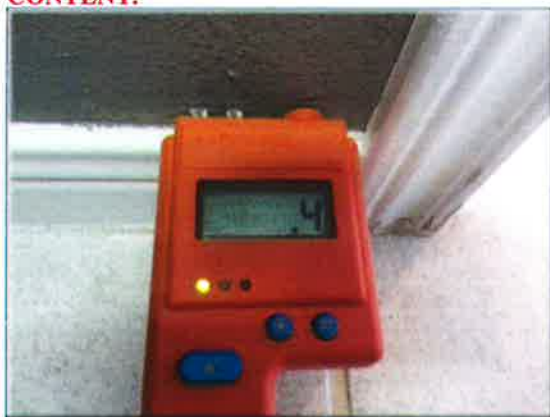
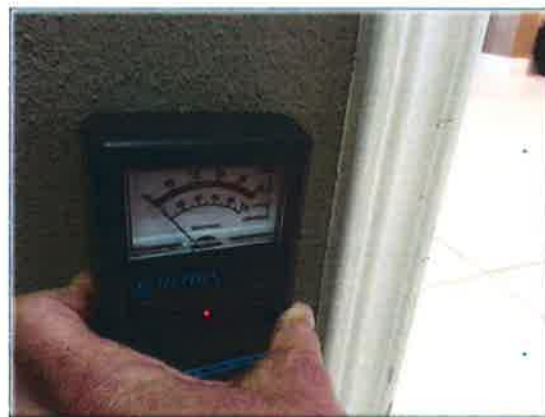
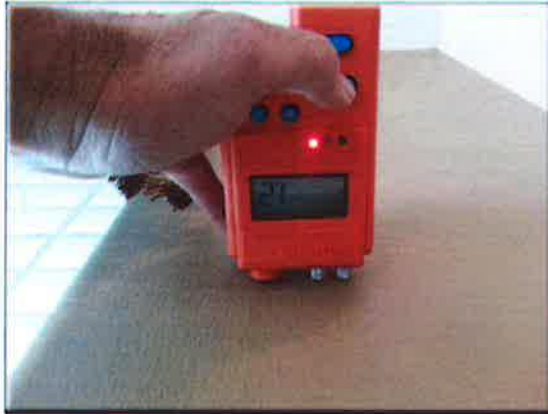
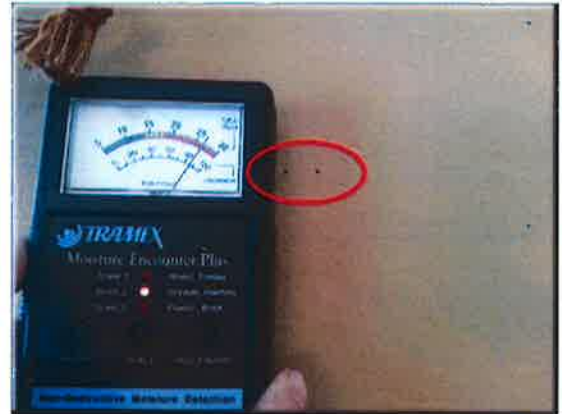
Elevated readings from an electronic moisture meter were observed at the Front and Right of the breakfast room. 4-29-2017 UPDATE: HIGH READINGS FOUND AGAIN WITH THE NON-DESTRUCTIVE METER. A PIN TYPE METER USED TO VERIFY AND DID APPEAR TO HAVE HIGH MOISTURE READINGS IN THIS AREA.

TO GAIN ACCURATE COMPARISON, AN AREA CONSIDERED DRY WAS SAMPLED IN THE LAUNDRY ROOM. THE DRY READING WAS .4 AND WITHIN ACCEPTED MOISTURE CONTENT.

THE HIGH MOISTURE CONTENT AREA ORIGINALLY NOTED HAD A READING OF 1.2 WITH A RED LIGHT INDICATOR SHOWING ABOVE ACCEPTED MOISTURE READINGS. THE SUSPECTED LEAK SOURCE IS DIRECTLY ABOVE FROM THE BALCONY IN MY OPINION.

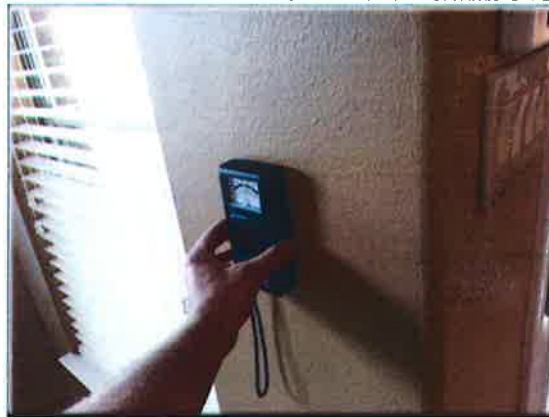
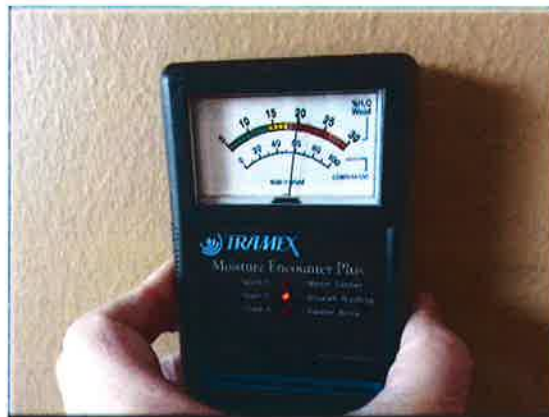
ORIGINAL INSPECTION PICTURES BELOW FROM THE AREA ABOVE.

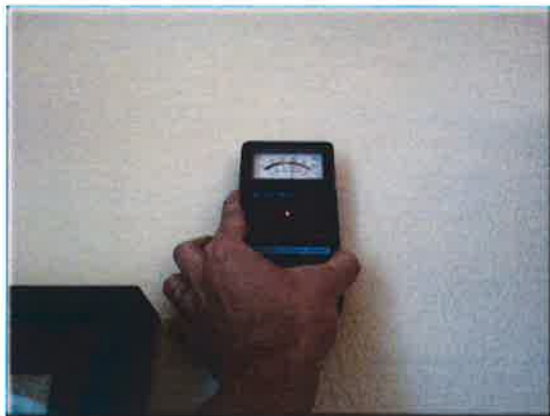
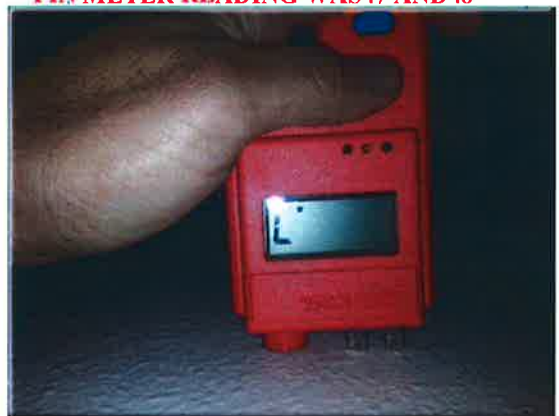
Elevated readings from an electronic moisture meter were observed at the Left and middle of the dining room. 4-29-2017 UPDATE: HIGH READINGS FOUND AGAIN WITH THE NON-DESTRUCTIVE METER. PIN TYPE METER USED TO VERIFY AND DID APPEAR TO HAVE ELEVATED MOISTURE READINGS IN THIS AREA COMPARED TO THE DRY AREA COMPARISION OF .3.

PIN METER READING WAS .7 AND .8

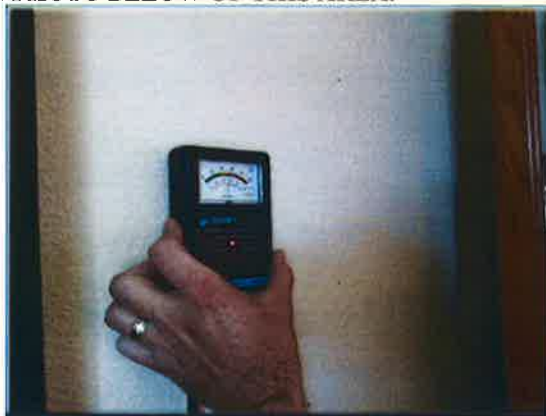
ORIGINAL INSPECTION PHOTO BELOW OF THIS AREA.

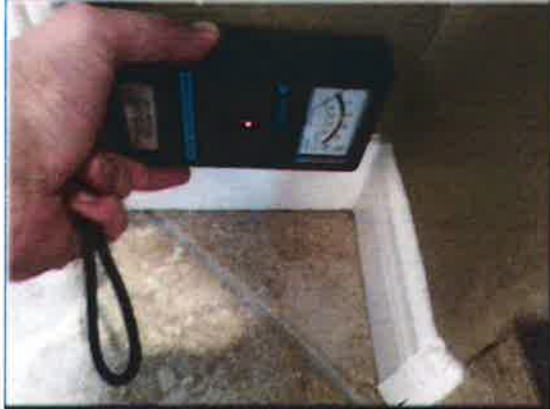
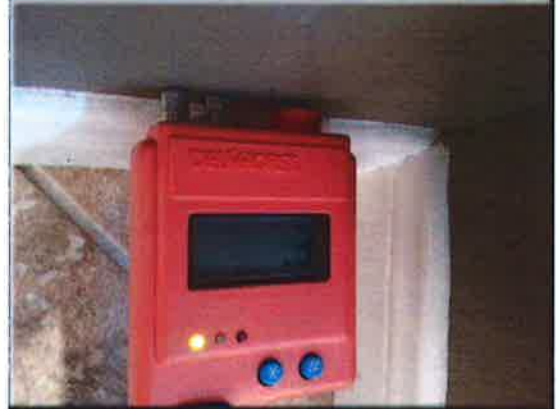
Elevated readings from an electronic moisture meter were observed at the Left and middle of the master bathroom. 4-29-2017 UPDATE: HIGH READINGS FOUND AGAIN WITH THE NON-DESTRUCTIVE METER. PIN TYPE METER USED TO VERIFY AND DID APPEAR TO HAVE HIGH MOISTURE READINGS IN THIS AREA. .3 DRY REFERENCE FOUND .7 ABOVE THE SHOWER.

DRY AREA AT THE BOTTOM OUTSIDE AREA OF THE MASTER SHOWER. .3

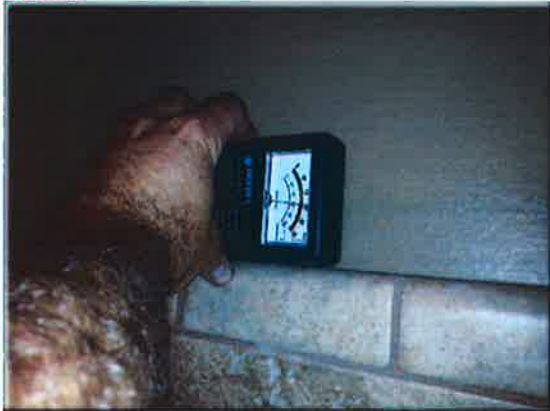
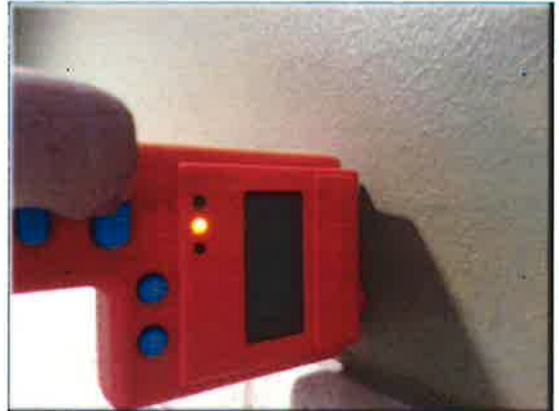
HIGHER READINGS BELOW ABOVE THE MASTER SHOWER .7 AND .8. (YELLOW INDICATOR LIGHT)

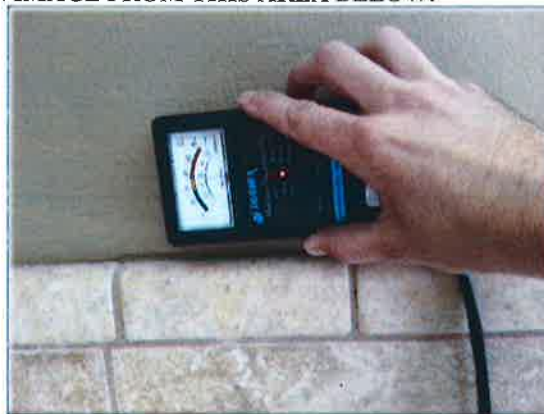
ORIGINAL INSPECTION IMAGE FROM THIS AREA BELOW.

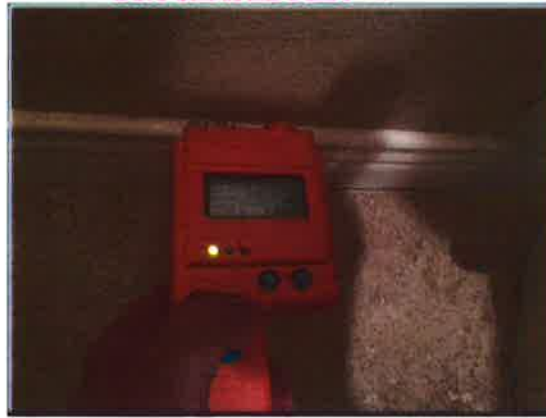
Elevated readings from an electronic moisture meter were observed at the Front and Right of the Master Bathroom Toilet Room. 4-29-2017 UPDATE: HIGH READINGS FOUND AGAIN WITH THE NON-DESTRUCTIVE METER. PIN TYPE METER USED TO VERIFY AND DID APPEAR TO HAVE HIGHER MOISTURE READINGS IN THIS AREA RELATIVE TO THE DRY SAMPLE TAKEN BEHIND THE TOILET AREA.

DRY SAMPLE BELOW.

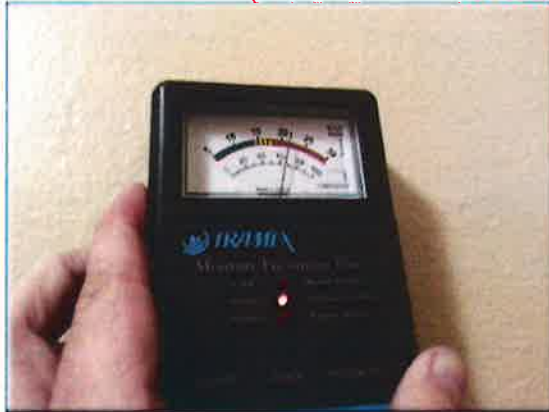
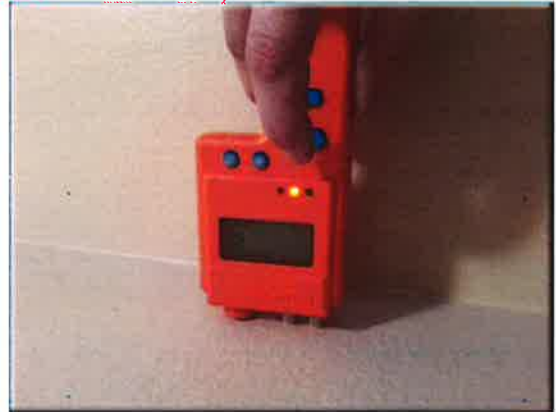
COMPARITELY HIGHER READINGS AT THE FRONT RIGHT OF THE MASTER TOILET ROOM OF .9 TO 1.0 (YELLOW INDICATOR LIGHT = MODERATE)

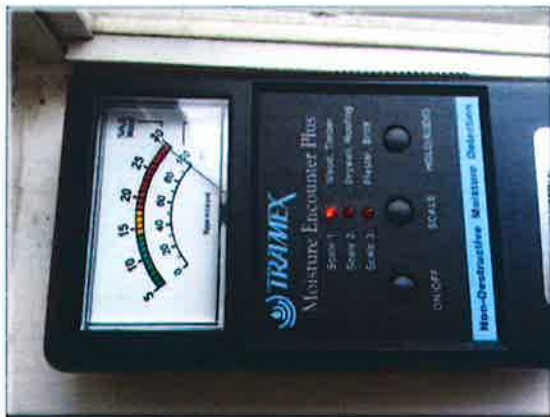
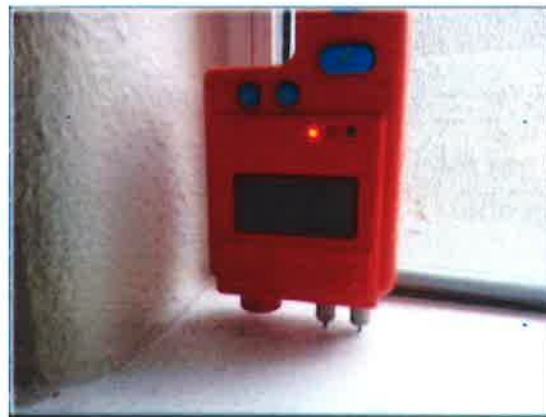
Elevated readings from an electronic moisture meter were observed at the Right and middle of the stairs window sill.

4-29-2017 UPDATE: HIGH READINGS FOUND AGAIN WITH THE NON-DESTRUCTIVE METER. PIN TYPE METER USED TO VERIFY AND DID APPEAR TO HAVE HIGH MOISTURE READINGS IN THIS AREA.

HIGH MOISTURE READINGS ABOVE 20% (WOOD SETTINGS MODE IN THE WINDOW SILL)

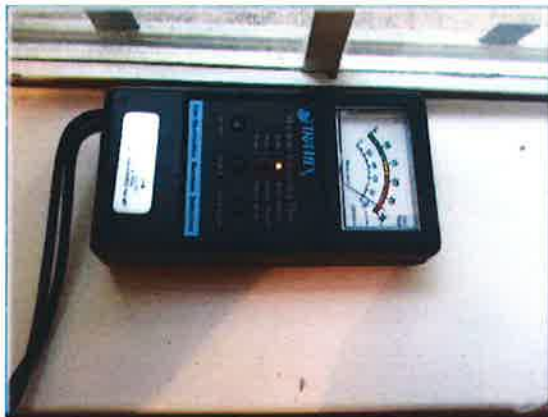
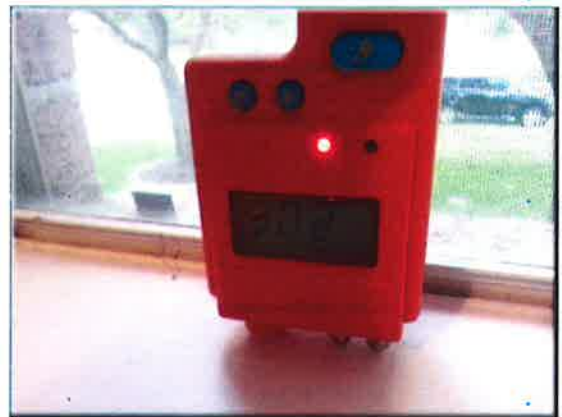
Elevated readings from an electronic moisture meter were observed at the Front of the upstairs front center bedroom. 4-29-2017 UPDATE: HIGH READINGS FOUND AGAIN WITH THE NON-DESTRUCTIVE METER. PIN TYPE METER USED TO VERIFY AND DID APPEAR TO HAVE HIGH MOISTURE READINGS IN THIS AREA. READINGS OBSERVED OVER 20%. Suspect cause of moisture is leaks around these upstairs windows.

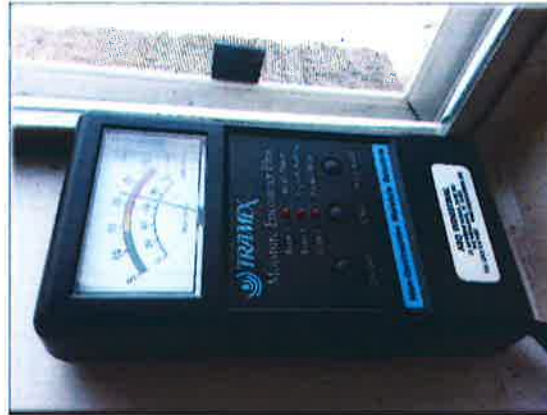
Elevated readings from an electronic moisture meter were observed at the Back and middle of the Upstairs common area near the balcony door. 4-29-2017 UPDATE: HIGH READINGS FOUND AGAIN WITH THE NON-DESTRUCTIVE METER. PIN TYPE METER USED TO VERIFY AND DID APPEAR TO HAVE HIGH MOISTURE READINGS IN THIS AREA.

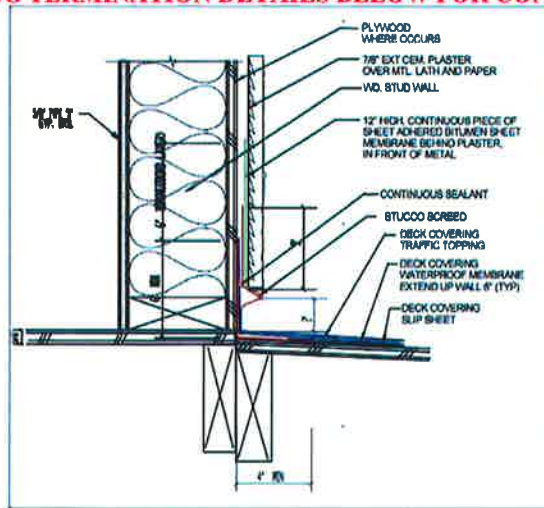
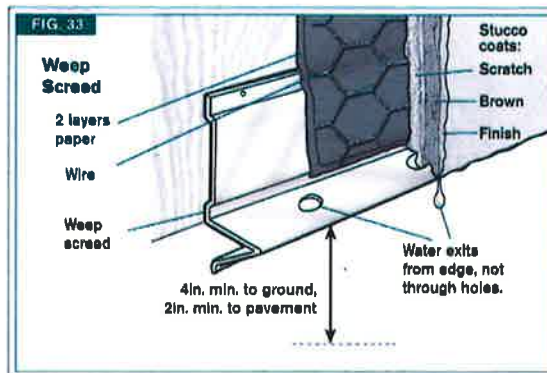
4-29-2017 CONCLUSION: IT IS MY OPINION THAT THE MAIN AREA OF CONCERN IS REGARDING THE BALCONY. THE CURRENT STUCCO SEALANT AT THE STUCCO WALL/FLOORING IS NOT ALLOWING THE STUCCO TO BREATHE AND DRY, WHICH IS ESSENTIAL FOR THIS TYPE OF WALL CLADDING. VISIBLE OBSERVATION BY CAMERA SNAKE FROM UNDER THE BALCONY DID NOT APPEAR TO SHOW EXCESSIVE DETERIORATION FROM THE 2 PENETRATION LOCATIONS HOWEVER SOME EVIDENCE OF LEAKS WAS PRESENT. REMEDIAL REPAIR IS REQUIRED TO HELP PREVENT FURTHER MOISTURE INTRUSION AND DAMAGE. REPAIR OPTIONS AVAILABLE INCLUDE REMOVING THE STUCCO AND REPLACING WITH A CLADDING SUCH AS FIBER CEMENT BOARD WITH A NEW VAPOR BARRIER THAT WILL ALLOW FULL DRAINAGE AND VENTING. INSTALLING VENTING UNDER THE BALCONY MAY ALSO AIDE IN DRYING. HAVE A COMPETENT SIDING INSTALLER REVIEW TO PROVIDE ADDITIONAL INFORMATION AND PRICING QUOTES. ADDING COVERING OVER THIS AREA MAY HELP PREVENT BACK-SPLASH FROM RAIN WHICH WAS A LIKELY PROBLEM IN THE PAST. ADDITIONALLY, SLOPE ON THE BALCONY FLOORING WAS LACKING NEAR THE BALCONY ENTRY DOOR WHICH APPEARED TO BE HOLDING MOISTURE. A SCUPPER DRAIN SHOULD BE ADDED IN THIS AREA AND ADDITIONAL SLOPE ADDED TO THE FLOOR TO FACILITATE FULL DRIANAGE. SEE THE LOWER SIDING TERMINATION DETAILS BELOW FOR CONSIDERATION.

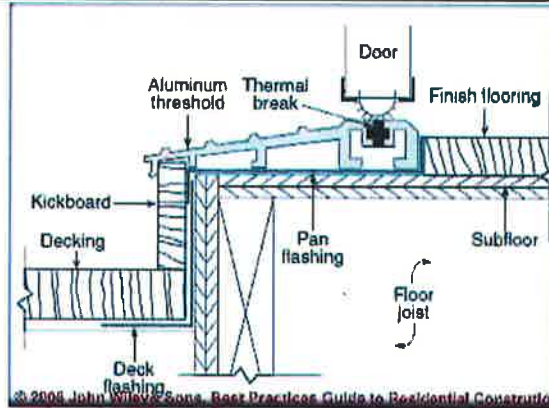
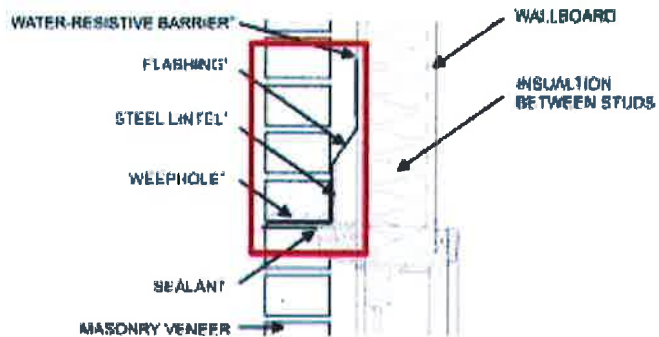
The metal Z-Flashing (also known as head flashing) was installed under the brick lintel instead of on top. Although there is nothing wrong with installing the flashing above the windows and doors, see IRC Figure 703.7 below on properly flashing above the lintel. The absence of proper flashing can allow water to enter into the wall cavity causing moisture damage.

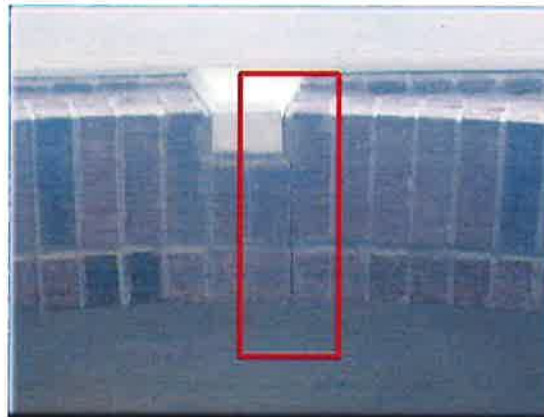
Small cracks were observed in the brick veneer wall on the home - Location: Each Side of the exterior. This is an indication that previous deflection or thermo-expansion has occurred, possibly due to slight framing settling, mortar deficiency or slight foundation movement or other. The cracks did not appear to be structurally significant in the inspectors opinion at the time of inspection; recommend re-pointing (repairing) mortar to prevent moisture intrusion. Example photos below for visual clarification. (note the largest crack was observed at the entry arch-way)

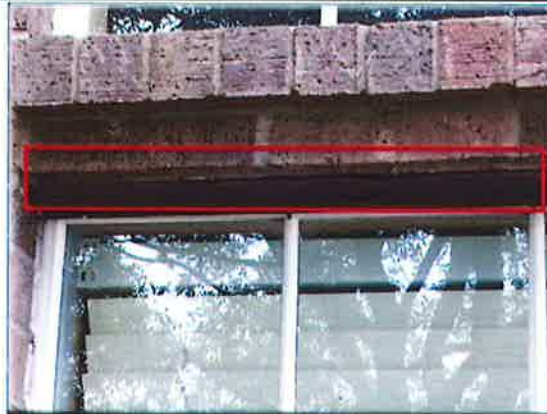
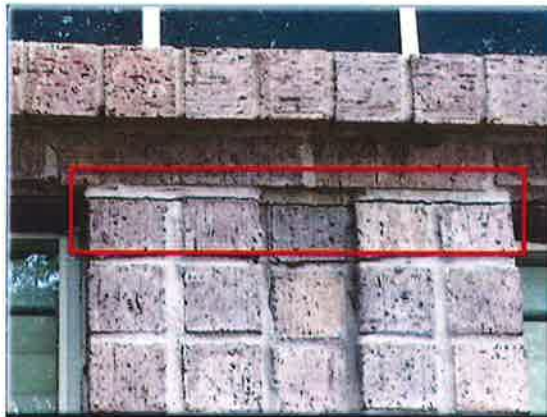
The Lintels, (steel angles above window/doors), are rusting; recommend maintenance to each lintel by a qualified contractor for repair to prevent further rust/deterioration. Example photo below for visual clarification.

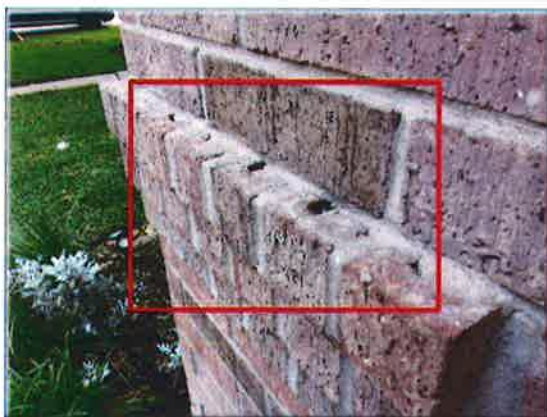
Recommend tuck-pointing (filling) missing areas of mortar around the brick walls of the home. Common example photo below for visual clarity.

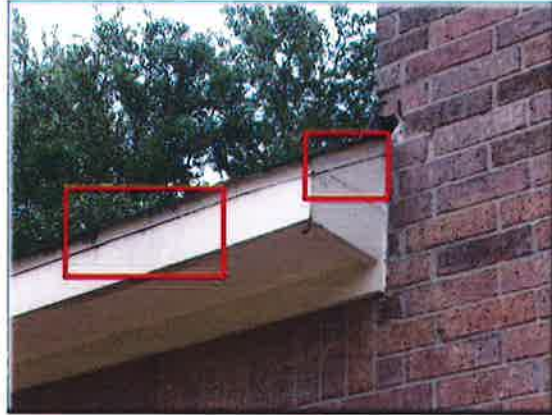
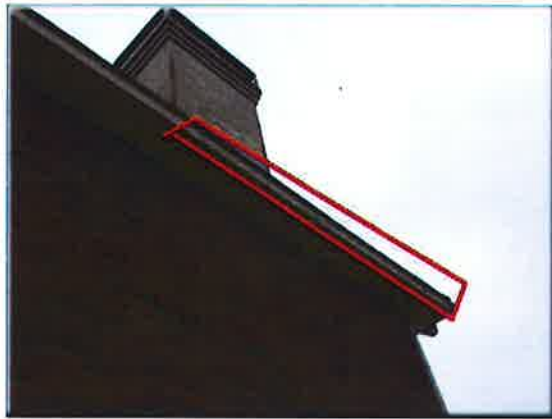
The fascia trim on the home is moisture damaged; recommend repairs by a qualified contractor.

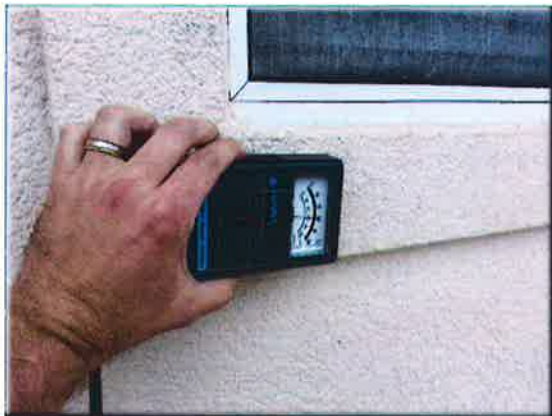
Elevated readings from an electronic moisture meter were observed at the Back and middle of the Balcony.

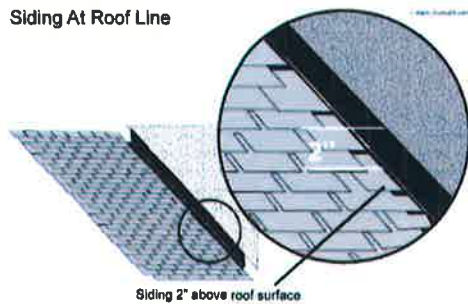
The siding has inadequate clearance between the lower edges of the siding and roof, where it intersects the roof plane. Normal clearance required is between 1 1/2 and 2 inches. See example below:

Rainwater running down the roof surface can saturate siding that is too close to the roofing. Siding and stucco should start 2" above roof line to help prevent water damage to the siding.

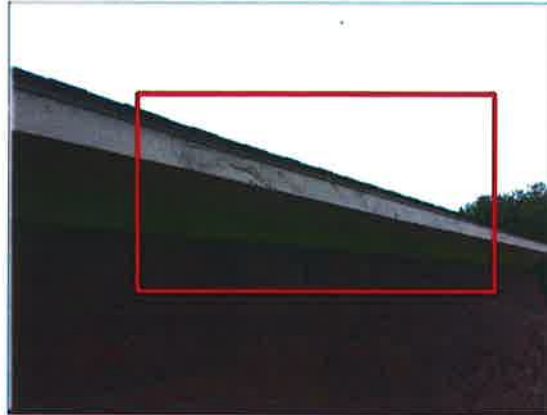
The fascia trim on the garage is moisture damaged; recommend repairs by a qualified contractor.

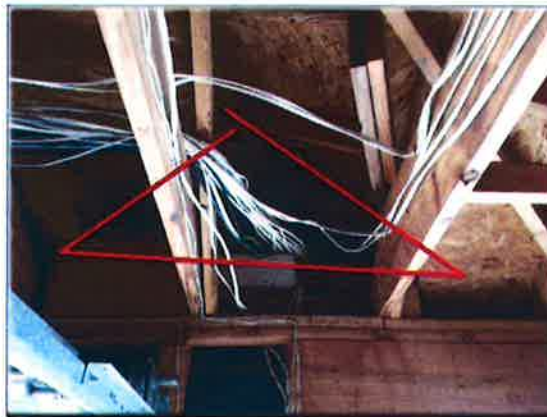
The breezeway on the inside of the garage is not fire blocked. If this is a new home it is required. For older homes it may not have been required when the home was built but it is recommended to seal the breezeway to prevent fire from being pulled into the home.
