BRYAN & BRYAN INSPECTIONS

Inspection Report For:
1727 Ball St, Galveston, TX 77550

Inspection Date: 4/15/2017

Prepared By: Chance Phillips TREC # 3899

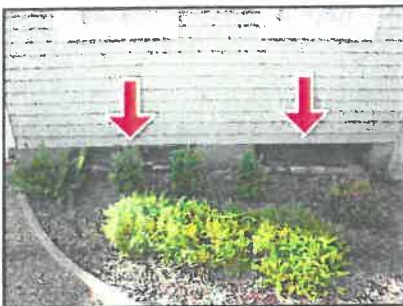
A. Item 1(Picture)

(1) The crawl space access appears to be open. This leaves access to rodents or other pest that may do damage to crawl space components.

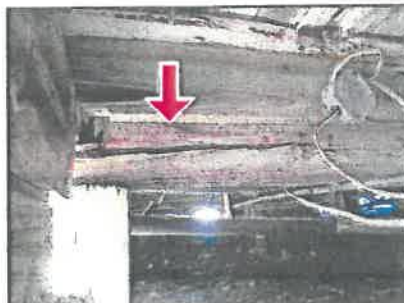
A. Item 3(Picture)

(2) Wood rot/deterioration was observed to the beam member(s) under the home. The inspector cannot determine the integrity of the wood. If further evaluation is desired, consult with a qualified contractor or structural engineer to determine the best method of remedy.

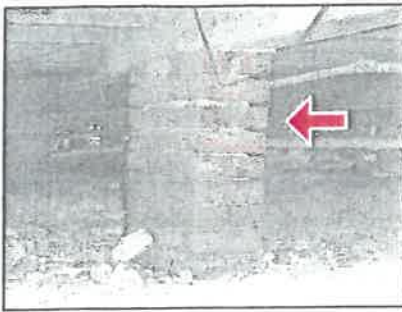
A. Item 4(Picture)

(3) Deterioration or leaning of masonry piers was observed. If further evaluation is desired, consult with a qualified contractor or structural engineer to determine the best method of remedy.

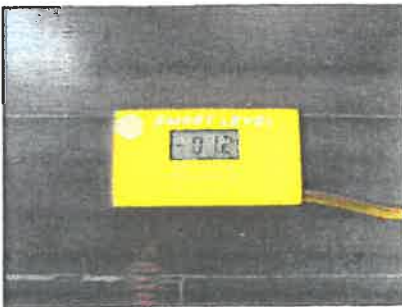
A. Item 9(Picture)

(4) Further evaluation of the foundation is recommended. There is evidence of structural movement that, in the inspector's **OPINION**, should be further evaluated by a structural engineer and/or qualified foundation company.

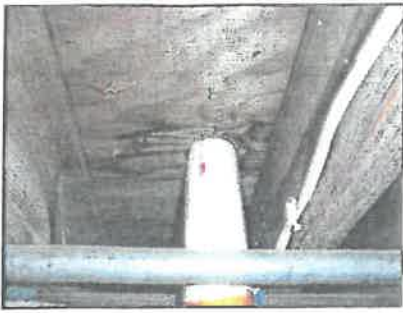
C. Item 9(Picture)

(5) Evidence of prior moisture intrusion is observed indicating a possible active or prior breach in the roof covering. Evaluate and remedy as needed.

Location: Garage/laundry

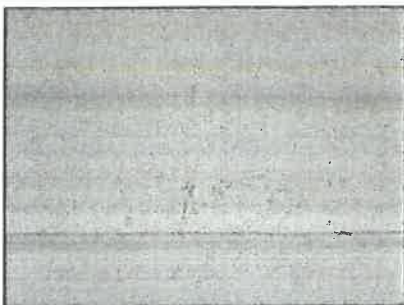
E. Item 24(Picture)

(3) Stress cracks are observed on the interior drywall. This is consistent with the structural movement of the home.

Location(s): Multiple Locations

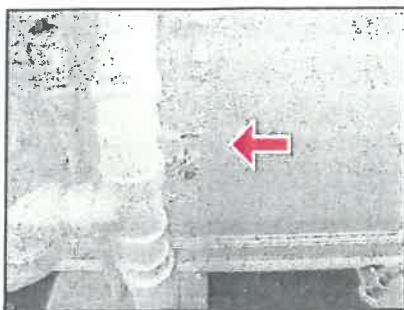
E. Item 28(Picture)

(4) Water damage was observed. No moisture was detected at the time of inspection using a surface moisture meter.

Location(s): Unit 4 bath

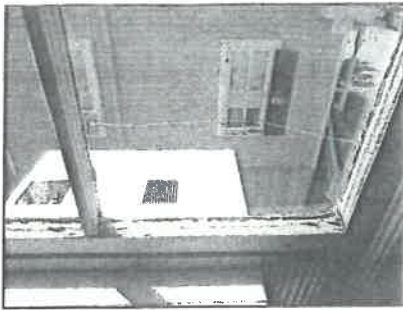
H. Item 2(Picture)

(3) Cracked window glass was observed.

Location(s): Multiple Locations

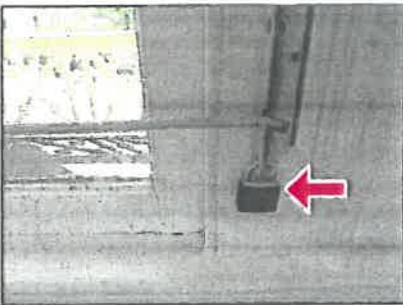
H. Item 11(Picture)

(4) Window metal bars have no apparent release mechanism. (Pad locks are improper) Safety hazard.

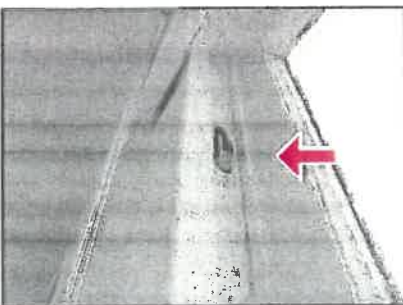
H. Item 12(Picture)

(5) Window(s) do not stay open properly due to lack of support/missing guide springs or counter weights. Location(s): Unit 2

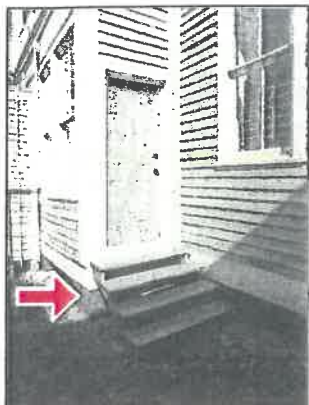
I. Item 1(Picture)

(1) There is a missing handrail/guardrail at the rear exterior stairs: Installation is recommended for safety. Multiple locations

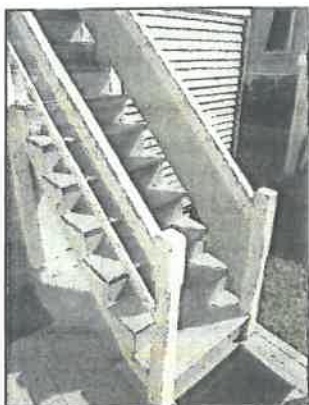
I. Item 4(Picture)

(2) The railing/guard balusters are installed horizontally which could allow them to be climbed on. Building standards recommend that balusters be installed vertical so that they cannot be climbed on.

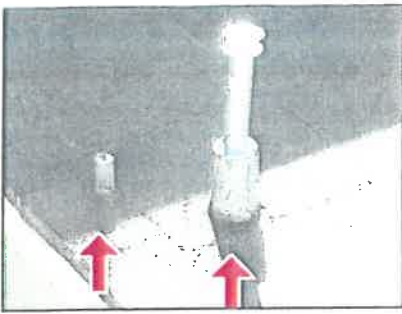
C. Item 7(Picture)

(4) Noted heavy tar around vent flashing. These are typically temporary repair measures. Tar may deteriorate over time. Monitor as needed.

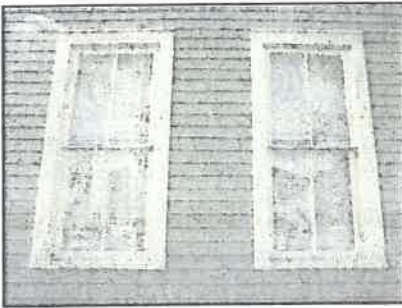
H. Item 1(Picture)

(1) Screens were observed damaged/missing.
Location(s): Multiple Locations

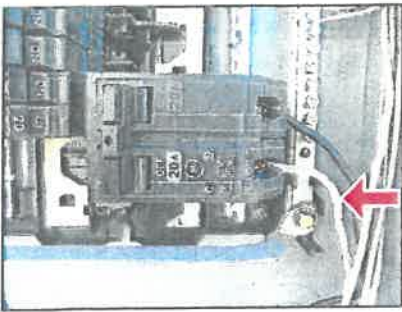
A. Item 10(Picture)

(7) White wires connected to breakers should be marked as hot with black or red electrical tape.

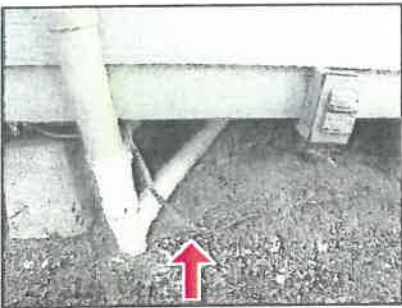
B. Item 2(Picture)

(2) Noted exterior wiring that has not been contained in protective conduit. For safety purposes, exterior wiring should be protected per the manufacturers specifications.

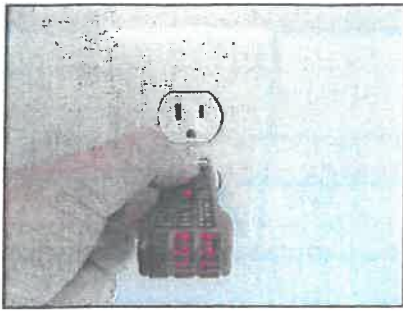
B. Item 6(Picture)

(5) Not all receptacles at locations in kitchens, bathrooms, garages, and the exterior are currently ground fault (GFCI) protected for safety, which is consistent with the age of the home. Current building standards now require all receptacles in these locations to be GFCI protected. If further evaluation or replacement is desired, contact a qualified electrician.

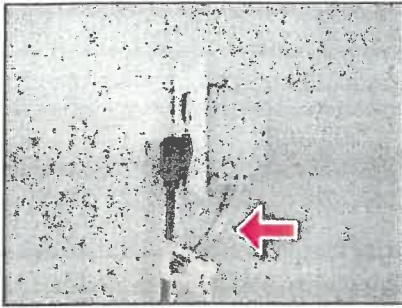
B. Item 7(Picture)

(6) Romex is exposed and subject to physical damage. Install behind walls or enclose in conduit for safety.

Location: Kitchen in unit 4

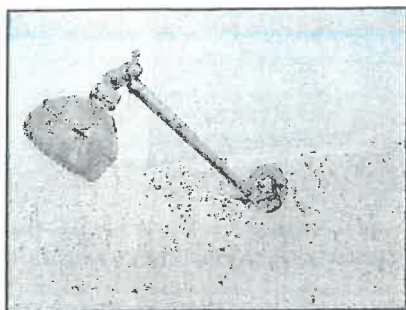
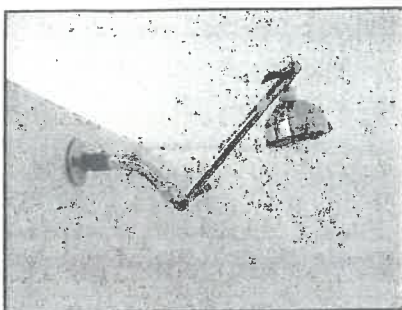
(3) Water lines appear to be unsecured or improperly secured behind the shower wall. Faucet handles move excessively when operated. Evaluate and remedy as needed.

Location(s): Unit 2, unit 4

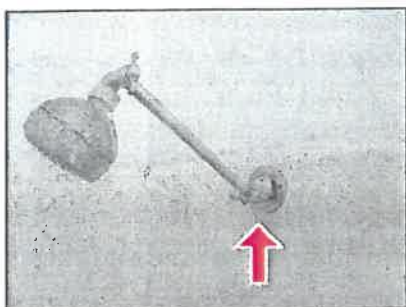
A. Item 4(Picture)

(4) Water leaks/sprays around the showerhead during operation; remedy as needed.

Location(s): Unit 2

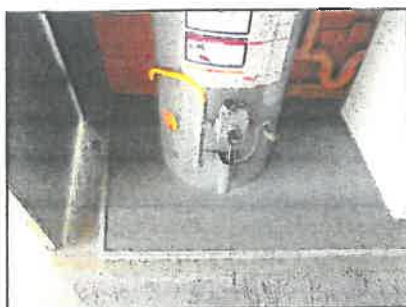
C. Item 7(Picture)

(4) Water heaters are not raised the recommended 18 inches above garage floor. Possible fire hazard.

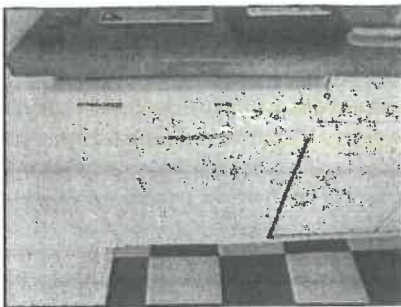
A. Item 1(Picture)

(1) The dishwasher did not operate properly when tested. Unit 3 (No water used)

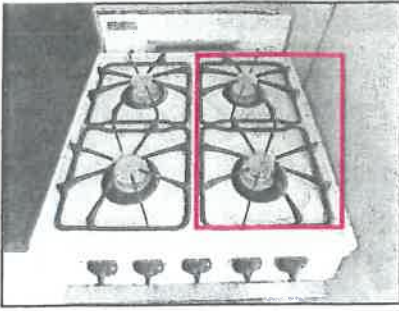
D. Item 7(Picture)

(4) The right burners were inoperative at the time of inspection. Evaluate and remedy as needed. Unit 2

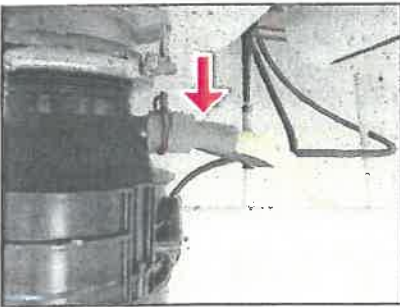
A. Item 2(Picture)

(2) Anti-siphon loop is not installed at the drain hose under the sink: the drain hose must be lifted at some point where it is higher than the hose connection to the drain (or disposal) to prevent water from back flowing from the drain (or disposal) back into the dishwasher. Unit 3, unit 4

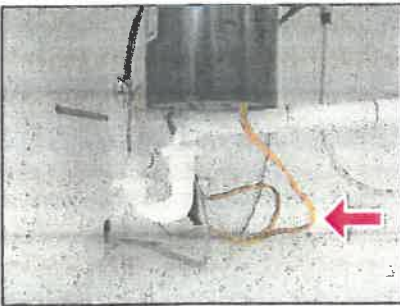
B. Item 3(Picture)

(2) Romex wiring is not properly secured in conduit under the kitchen sink at the disposal. Unit 3, unit 4

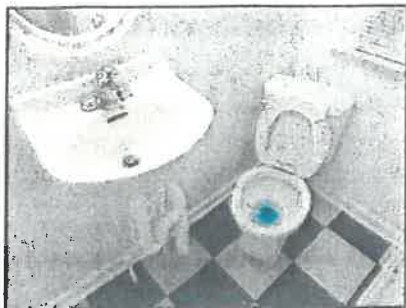
F. Item 1(Picture)

Current building standards recommend exhaust fans be installed if no openable windows are present in the bathroom. No bathroom exhaust fans were noted at the time of inspection. Unit 4
