## STRUCTURAL INSPECTION

4547 Bermuda Dr  
Sugar Land TX 77479

SEPTEMBER 2, 2020

REF: CONDITION OF PROPERTY SURVEY

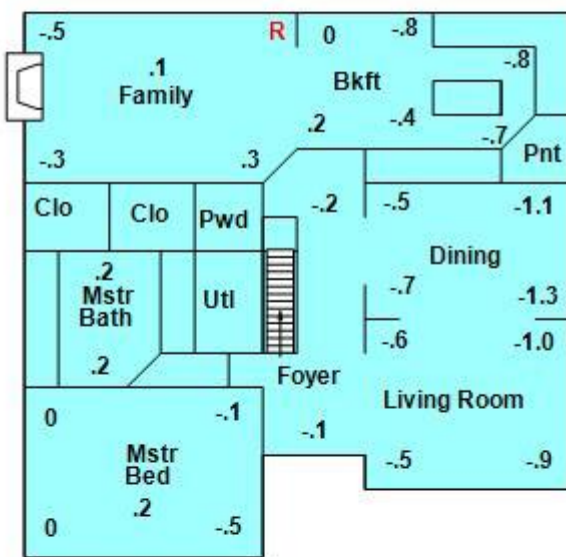
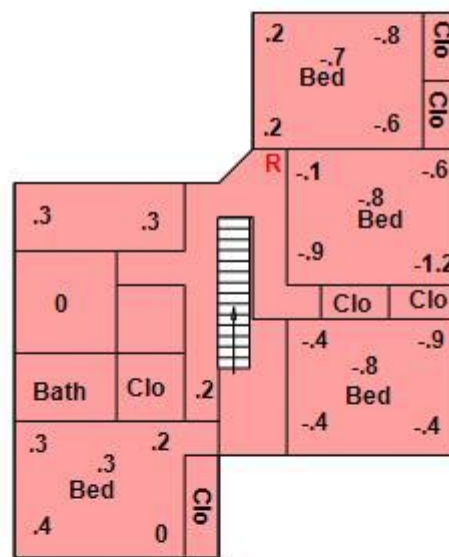
**Elevation Readings  
4547 Bermuda Drive**

See our field sketch below showing the elevation readings for this structure. Note that the "R" on the sketch is our randomly chosen starting reference point, where the elevation is 0, and all other elevation readings are taken relative to the reference point, and are measured in inches to the nearest 1/10 inch. If there is a step up or a step down into an area such as a garage, sunken room, balcony/patio area, or raised rooms, the elevation readings will have larger numbers due to the amount of the step.

The floors were checked with an electronic level, and were observed to be acceptably level throughout the house. The difference in elevation between the high point and low point was 1.6 inches. The high point was located at the family room, and the low point was located at the dining room. The unlevelness takes place over a horizontal distance of approximately 30 to 35 feet.

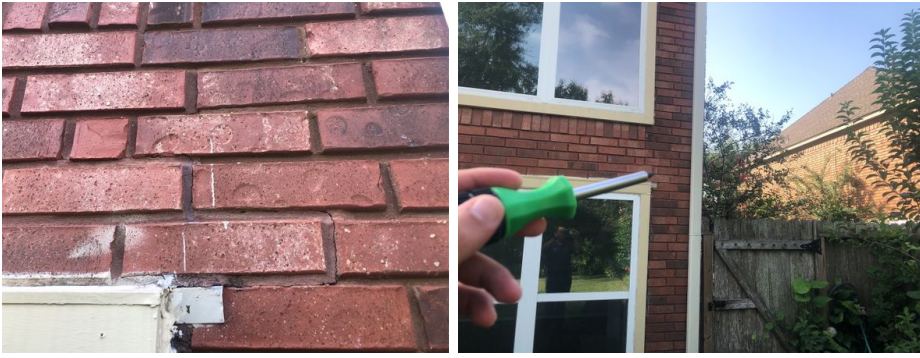
**Differential Movement: Veneer Cracks - Minimal**

We observed that cracks in the exterior veneer were minimal in number and degree at the time of the inspection.

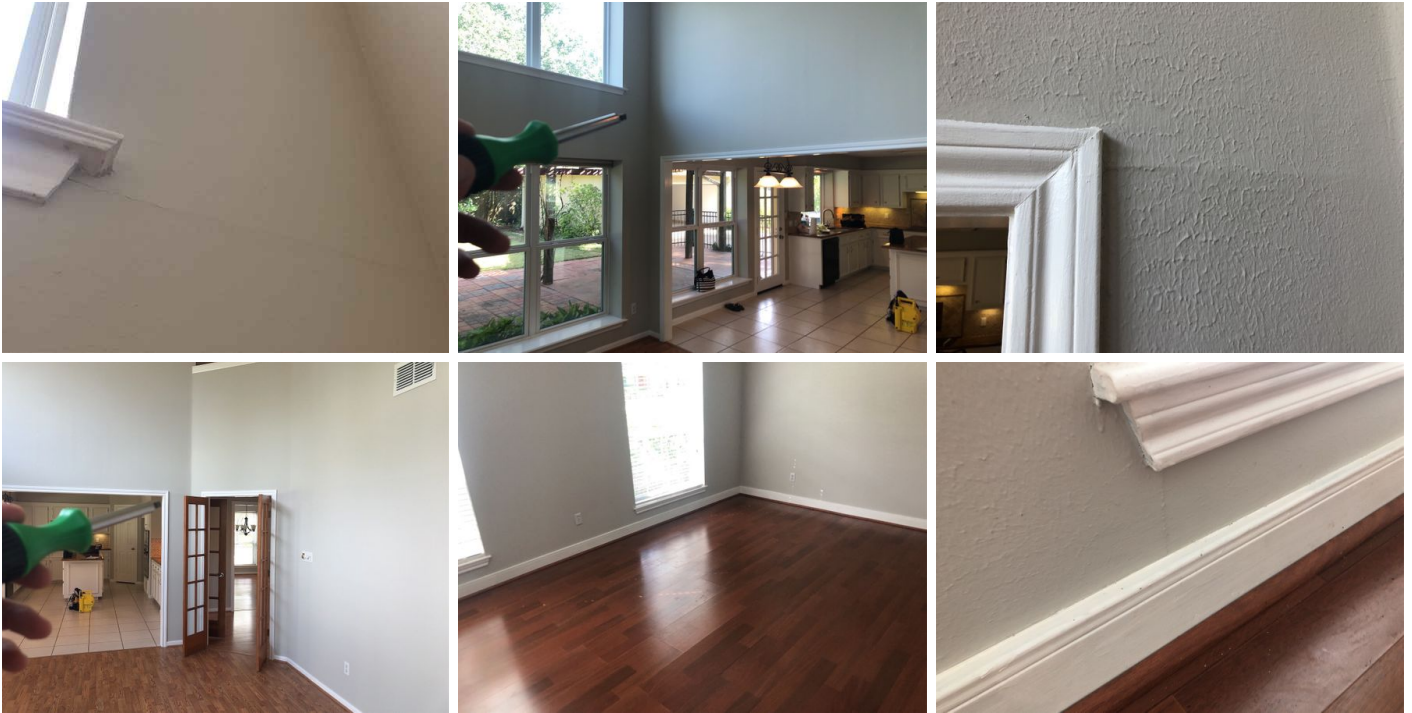
**Differential Movement: Sheetrock Cracks - Minimal**

We observed that sheetrock cracks were minimal in number and degree at the time of the inspection.

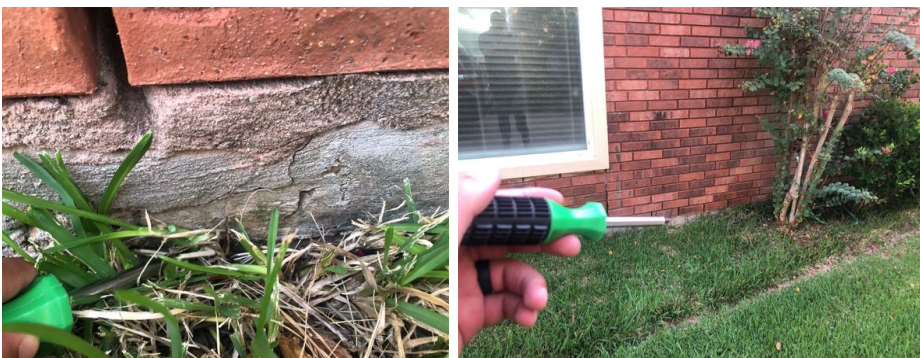
South

**Differential Movement: Concrete Cracks - Observed**

The foundation concrete was observed to have hairline cracks, including at the above locations.

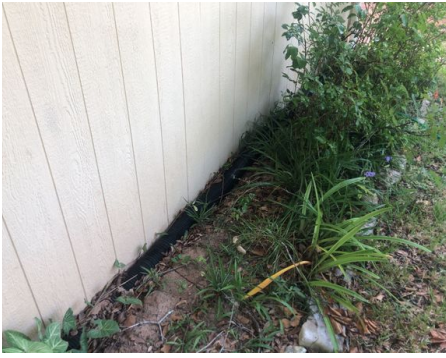
**Differential Movement: Slab Not visible - High Soil**

It is pointed out that a portion of the foundation concrete could not be viewed due to soil that was graded near or above the top of the foundation and/or heavy foliage growing against the house. The soil and/or foliage should be removed, and 3-4 inches of foundation concrete exposed.

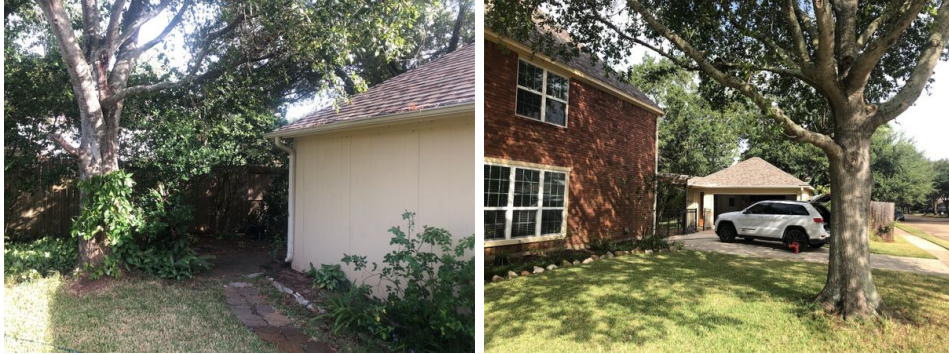
**TREES - RECOMMEND ROOT BARRIER**

Trees and/or foliage were observed in the vicinity of the house, which can contribute significantly to differential movement of the house foundation. Care should be taken to prevent the trees and foliage from removing an excessive amount of water from near the foundation of the house. Consideration should also be given to cutting the tree roots that extend under the foundation, and installing a root barrier to prevent any further moisture from being removed from under the interior of the house.

Contact a qualified professional.

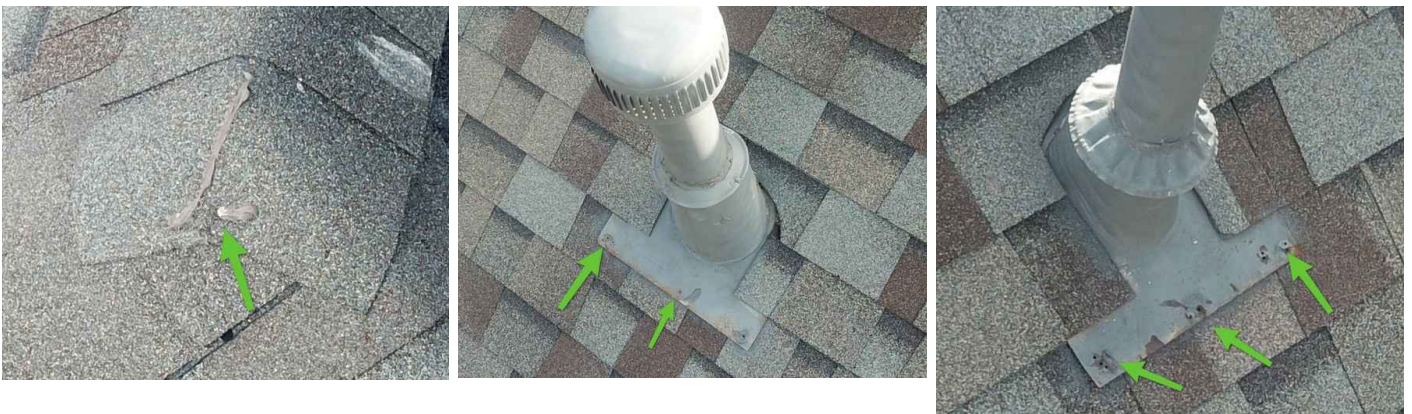
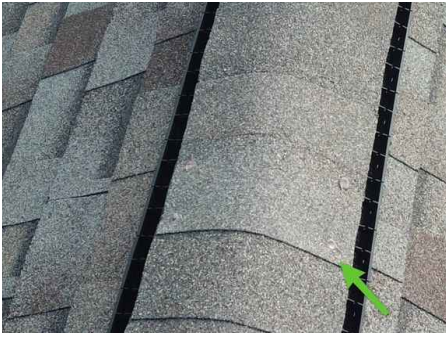
### Wear and Deterioration: Composition - Some

Nail Heads not Sealed

The composition roof surface was showing evidences of some deterioration of the roof surface as described above and shown below.

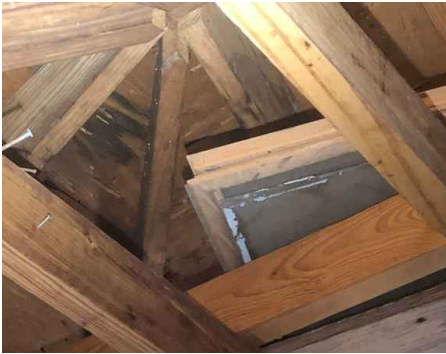
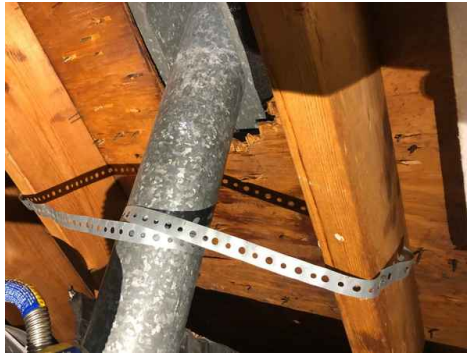
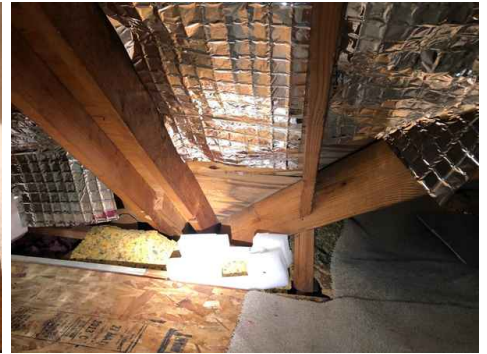
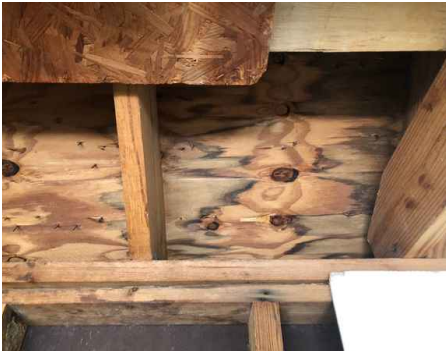
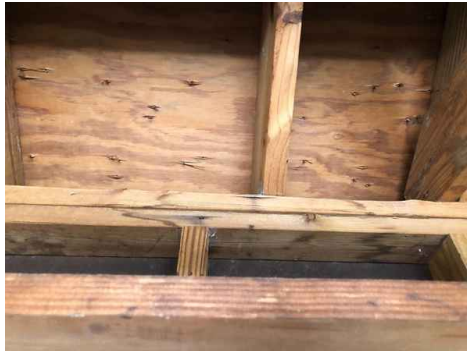
Garage attic, northeast valley in upper attic

### Roof Leaks: Attic stains appear to be from previous leaks

After observing the interior of the structure, evidences of current roof leaks were not visible. The absence of evidences of roof leaks does not guarantee that roof leaks were not present; rather, that no evidences of leaking were visible at the time of the inspection. Some stains were visible in the attic, but the stains appeared to be related to previous roof leaks. It is recommended that you check with the owner and/or a service company concerning the stains.

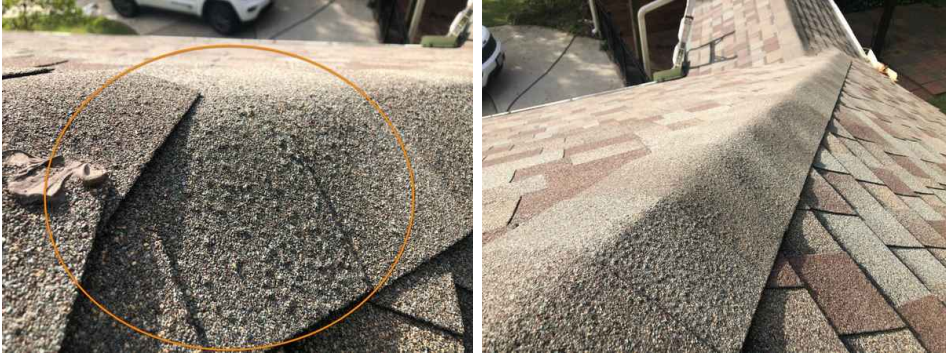
**DEFECTIVE SINGLES**

Some of the shingles appeared to be defective, as small bubbles were visible on the surface of the shingles. These bubbles are typically caused by moisture being introduced under the layers of felt during the manufacturing process, causing air bubbles in the felt. Over time, the bubbles will break off, exposing the base felt material, causing premature deterioration of the roofing shingles. It is recommended that a representative of the shingle manufacturer be contacted concerning this condition on the roof.

Contact a qualified professional.

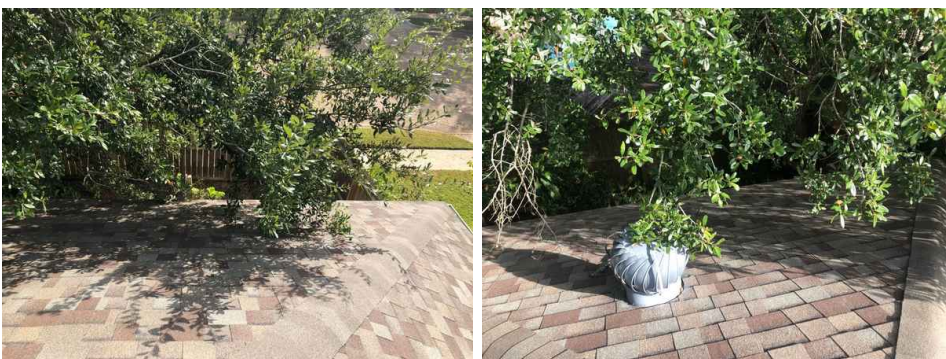
**ROOF: MISCELLANEOUS**

We observed some miscellaneous items related to the surface of the roof, including the items listed above. Have a roofing contractor provide a cost estimate to make any needed repairs.

Contact a qualified professional.

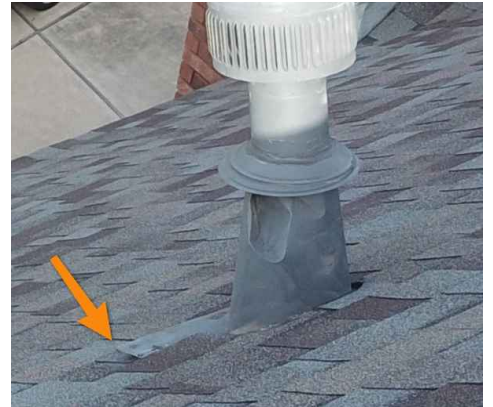
**FLASHING/COUNTER FLASHING**

We observed one or more conditions with the roof flashing as pointed out above. Have a roofing contractor provide a cost estimate to make all needed repairs

Contact a qualified professional.

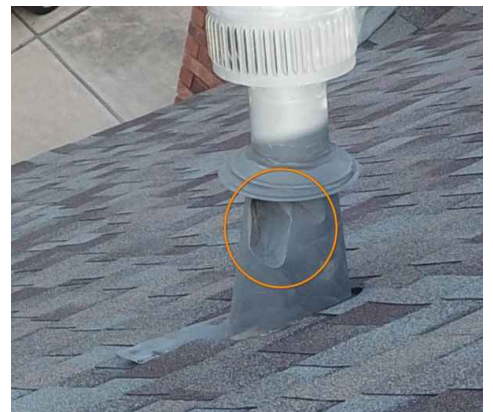
**ROOF JACKS**

Damaged

The roof jacks at the plumbing vent pipes were observed to have the conditions as described above. Further investigation with a roofing contractor is recommended to make all needed repairs.

Contact a qualified professional.

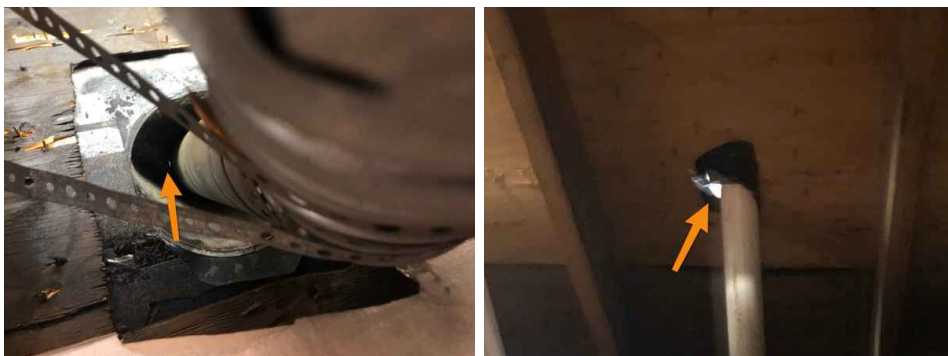
**DAYLIGHT VISIBLE AT VENT PIPES**

After observing the interior of the structure, evidences of roof leaks were visible in the attic, where we observed daylight where the vent pipe penetrated the roof jack. Further investigation is recommended with a roofing contractor to make any needed repairs.

Contact a qualified professional.

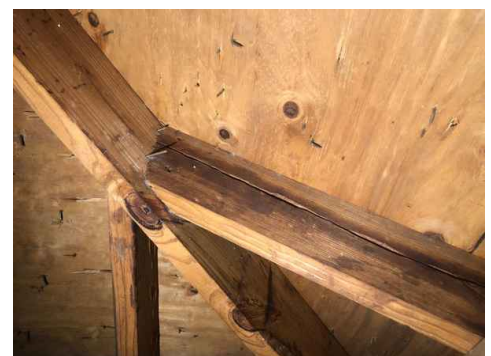
#### **REPAIR - SPLIT RAFTER**

One or more rafters in the attic were observed to be split, and need to be repaired.

Contact a qualified professional.

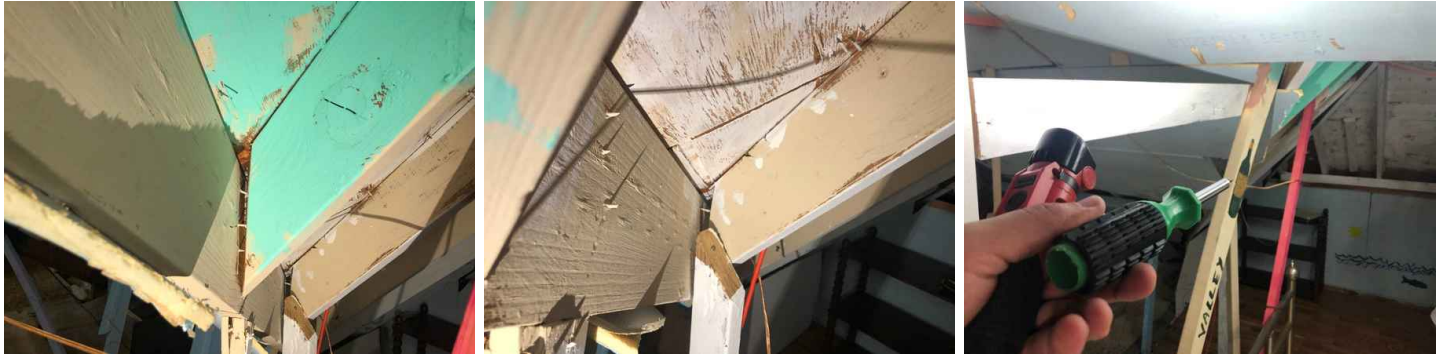
**REPAIR - RAFTER MITER CUT**

We observed rafters that were connected to a hip rafter or a valley rafter, and did not have a proper miter cut on the end of the rafter to allow the rafters to fit flush against the hip/valley rafter. The rafters should fit flush against the hip/valley, and repair is recommended, with make-up pieces of rafter with a proper miter cut be "sistered" onto the rafter and fit flush against the hip/valley rafter.

Contact a qualified professional.

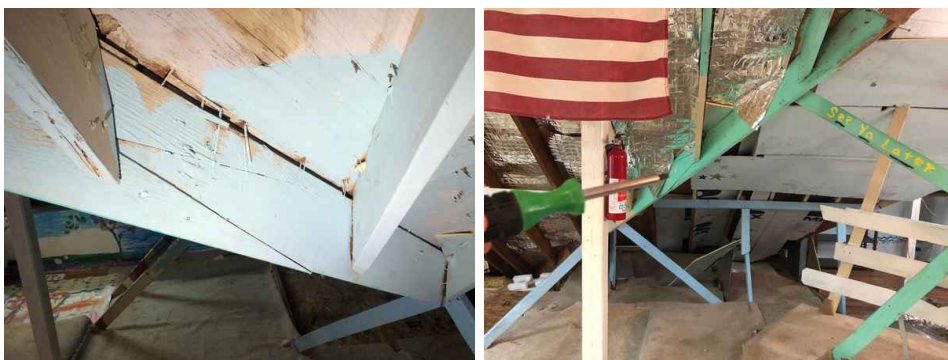
**REPAIRS - SPLICED, NOT BRACED**

Contact a qualified professional.

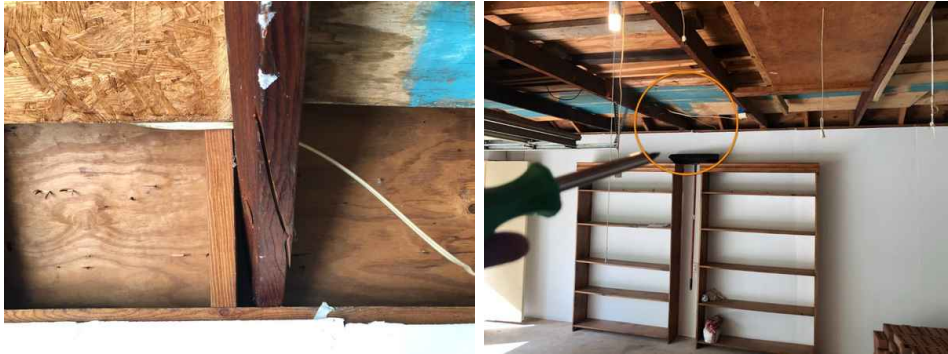
**REPAIRS - CRACKED**

One of the ceiling joists was observed to be cracked and deflected, and repair is needed.

Contact a qualified professional.

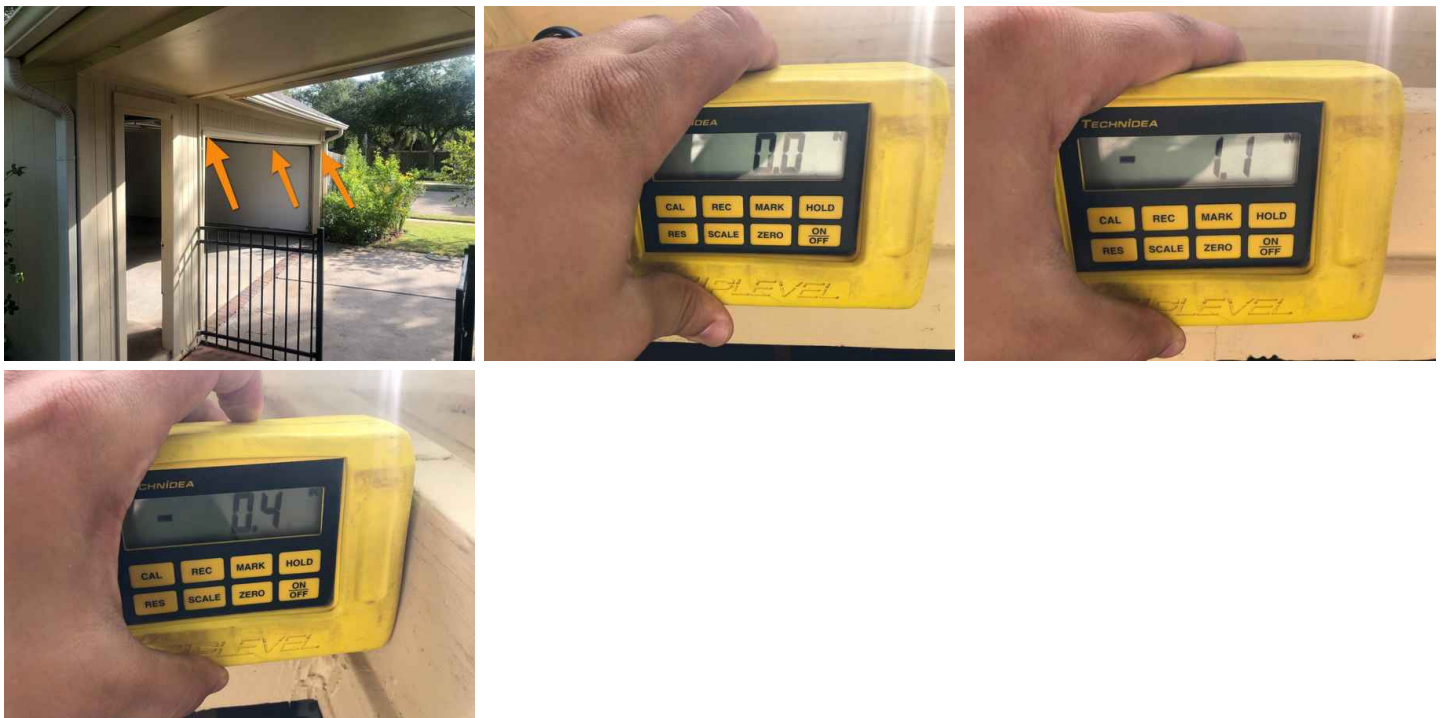
**GARAGE HEADER DEFLECTED**

The header over the garage door was visibly deflected, and has deflected beyond an acceptable degree (allowable deflection = one inch deflection in a 30-foot horizontal distance ( $L/\Delta = 360$  per the building code)). For an 18-foot garage opening, the maximum allowable deflection is 0.6 of an inch. We observed a 0.9 inch deflection at the time of inspection, which is excessive. Therefore, the header was not performing its intended function and repairs are recommended at this time.

Contact a qualified professional.

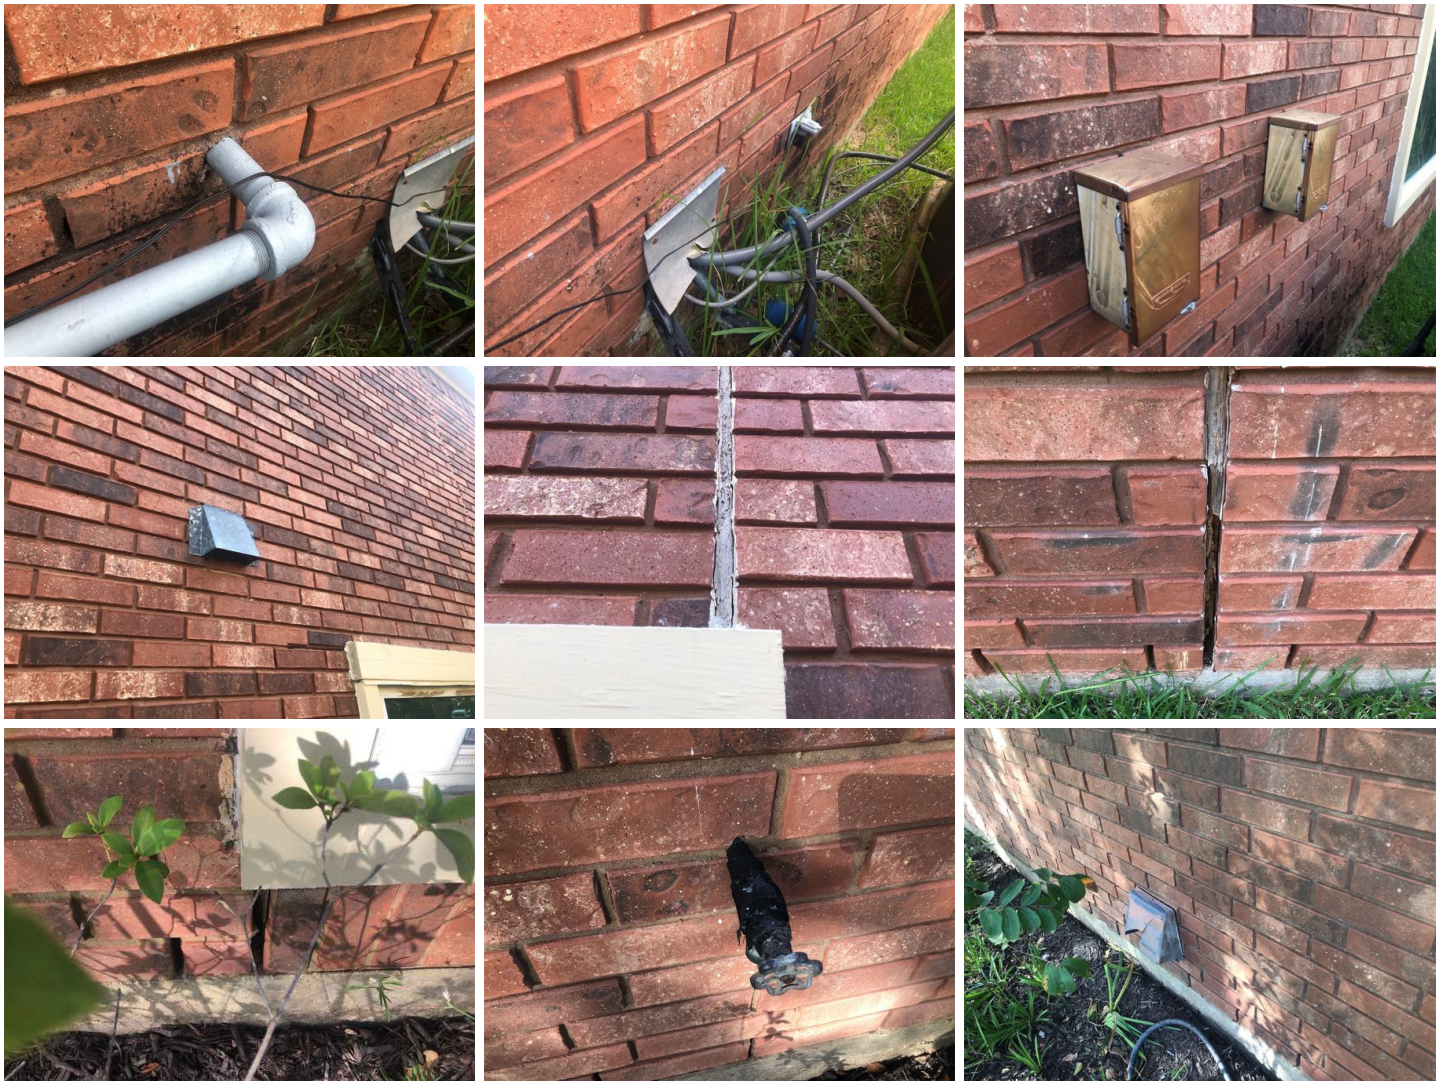
HVAC Lines, Caulking Cracked/Missing, Hose Bibb, Vent Caps, Piping

A substantial vulnerability to water penetration was observed at penetrations/openings through the exterior building envelope, and it is recommended that all penetrations/openings be sealed against water penetration. Typical examples on a structure may include light fixtures, air conditioning refrigerant lines, water piping, gas piping, vent caps, windows, doors, expansion joints, etc. Below is a representative sample of locations and/or photographs showing some, but not necessarily all, locations where there is a vulnerability to water penetration. Have a contractor provide a cost estimate to seal all vulnerable areas on the exterior building envelope against water penetration and/or open up any clogged weepholes in the veneer.

Contact a qualified professional.

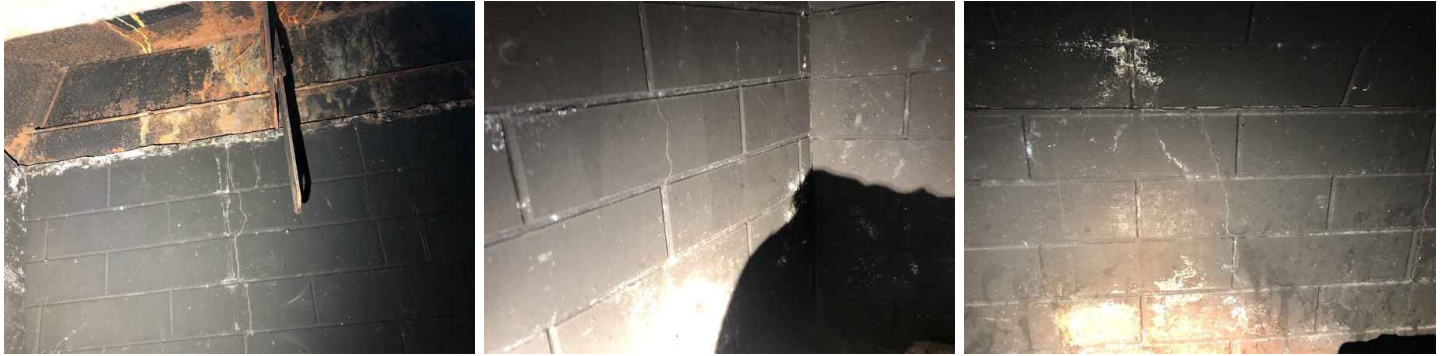
**FIREBRICK MORTAR CRACKED**

The mortar between the firebricks in the fireplace was cracked and missing in areas, and needs to be tuckpointed with a high temperature (refractory) mortar.

Contact a qualified professional.

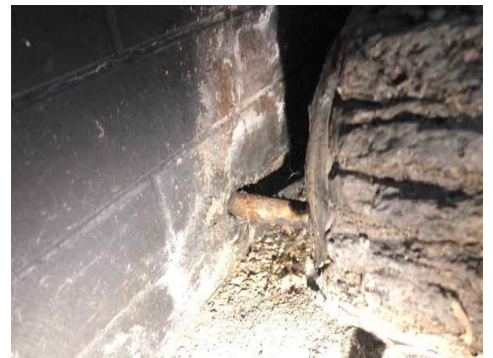
**GROUT MISSING - LOG LIGHTER PENETRATION**

Mortar was observed to be missing at the firebox at the point where the log lighter penetrates the firebrick.

Contact a qualified professional.

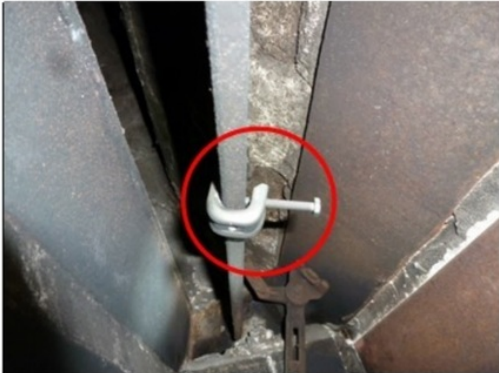
**DAMPER - C CLAMP MISSING**

The fireplace was equipped with a ceramic gas log. The smoke chamber and flue pipe were free from built-up soot, the damper was operational, and the firebox was properly sealed. While the draw of the chimney was not able to be checked, no evidences of poor draw were visible, and no repairs were needed to the fireplace. It is pointed out that the damper was not equipped with a spacer device to prevent the damper from closing completely. This device keeps the damper open slightly, even when it is in the closed position, to prevent combustion gases from building up in the living space should the gas log be operated when the damper is closed. It is recommended that the clamp be installed for safety purposes.

Contact a qualified professional.

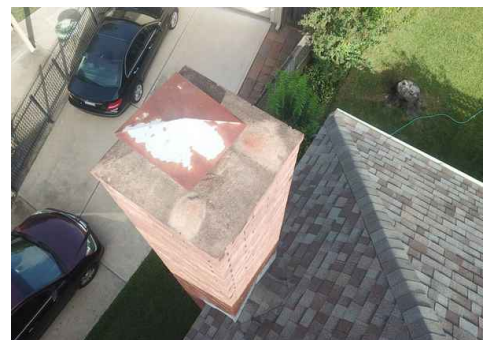
**WEATHER CAP - RUSTED**

The top of the chimney flue had a metal spark arrester/weather cap installed in the flue to prevent water penetration down the chimney. The cap was rusted and needs to be cleaned and sealed to prevent further deterioration.

Contact a qualified professional.

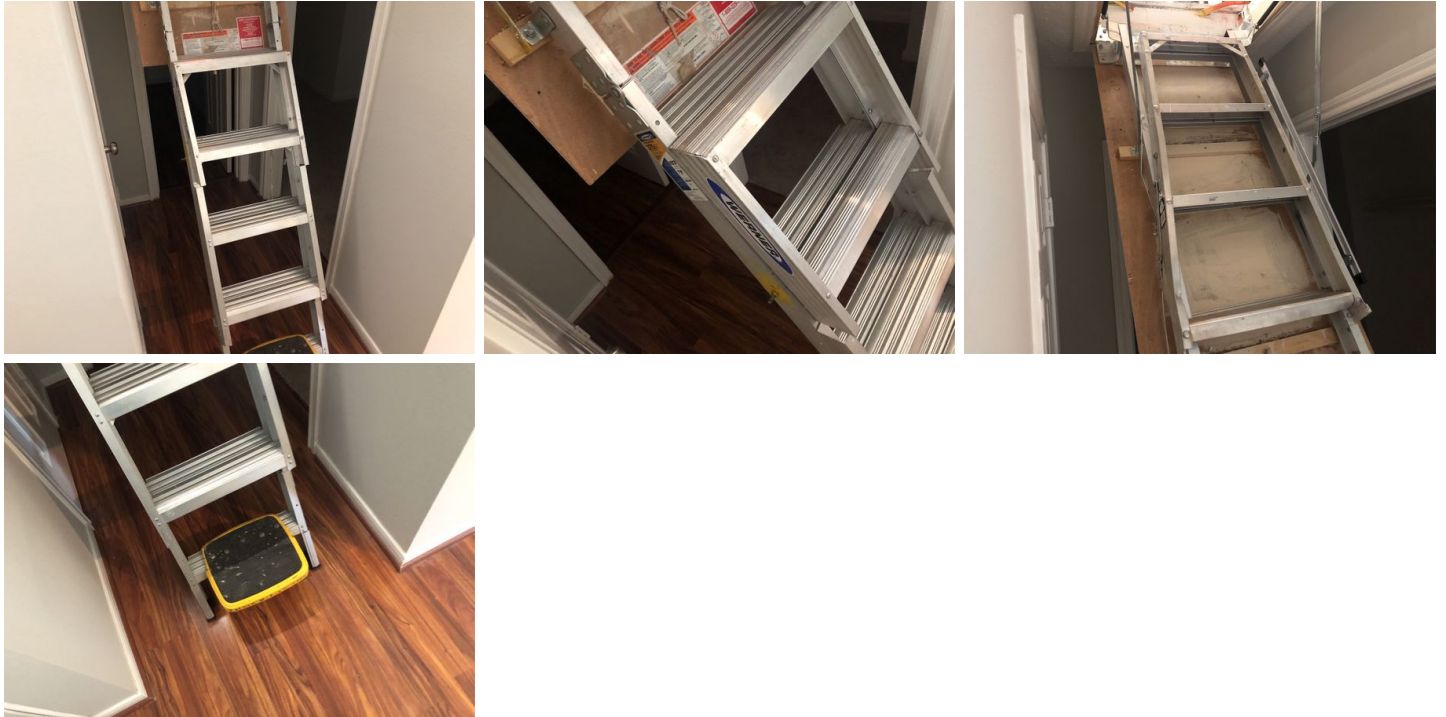
### LADDER MODIFIED

The ladder was modified and we cannot ensure the safety of continued use of the ladder. Consideration should be made to replace the ladder.

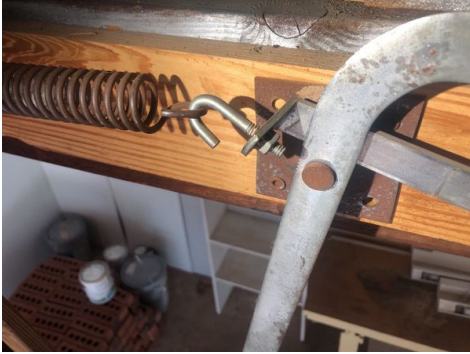
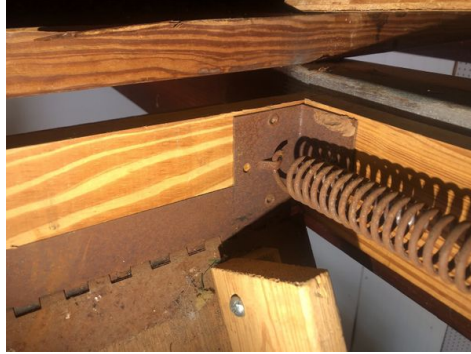
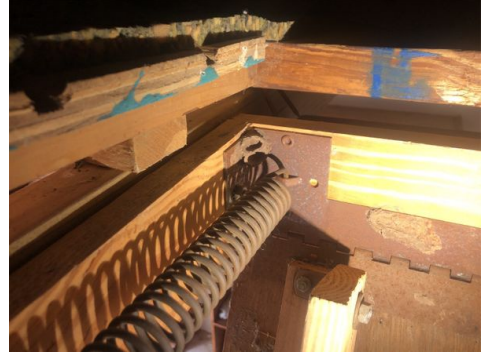
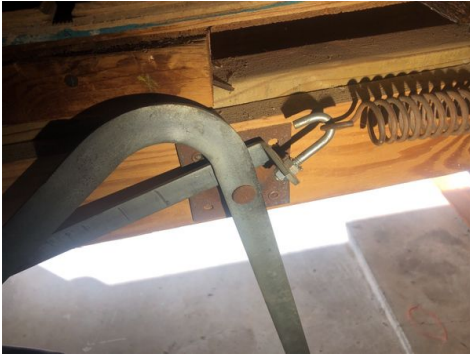
**LADDER ATTACHMENT IMPROPER**

Nails missing in spring arm pivot, Nails missing in corner brackets

The stair assembly was not properly installed or secured to the framing members, and repair is needed for safety purposes. The condition(s) can be a safety hazard, and repair is needed, as an improperly installed stair assembly can possibly collapse.

Contact a qualified professional.

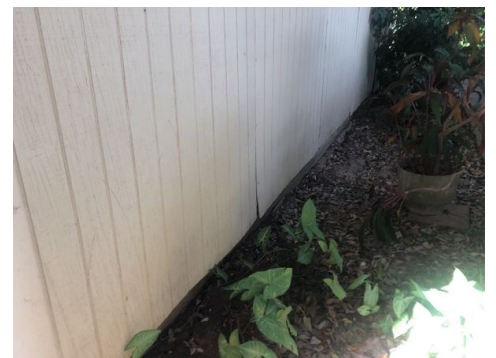
#### **LOOSE**

The wood siding was loose and needs to be resecured. Have a contractor provide a cost estimate to make all needed repairs.

Contact a qualified professional.

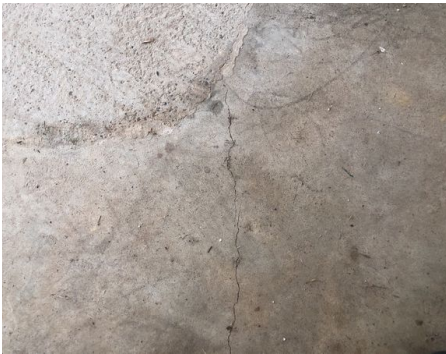
#### Garage: Foundation Cracked

The concrete floor of the garage was observed to have several cracks, but was still functional at the time of the inspection. However, the portion of the cracks that were visible were observed to be approximately 1/16-1/8 inch wide. The exterior perimeter of the garage has experienced some settlement, but the degree is not such at this time to recommend foundation releveling. The garage foundation should be monitored in the future for additional movement as it can be expected that additional movement can take place.

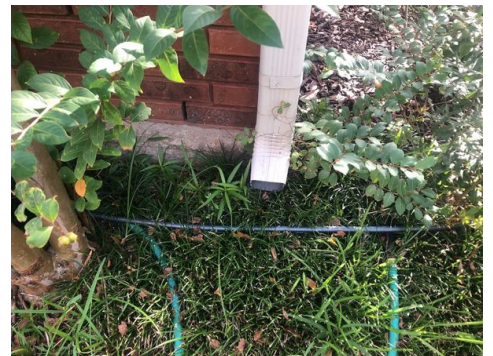
The downspout was missing a splash block.

Contact a qualified professional.

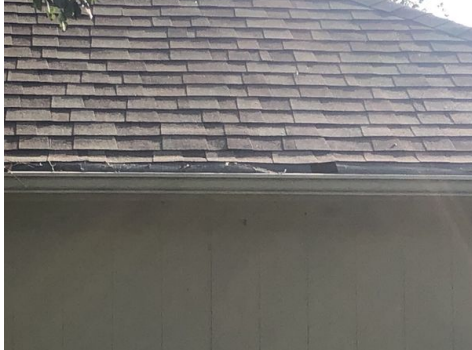
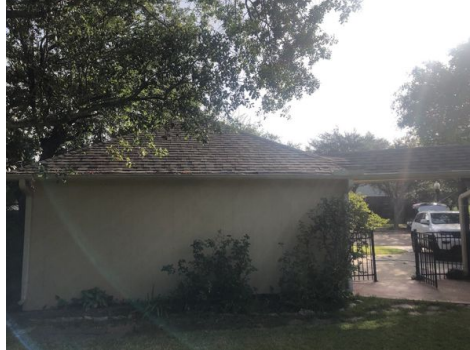
**SCREENS LOOSE/MISSING**

The screens were loose and/or missing at the gutters, and need to be repaired.

Contact a qualified professional.

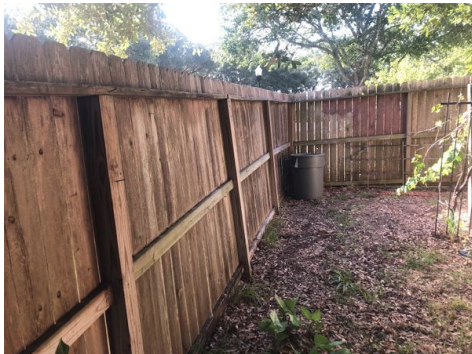
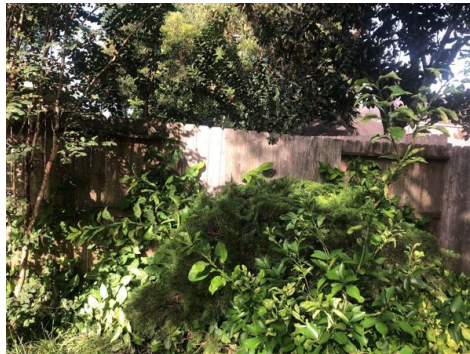
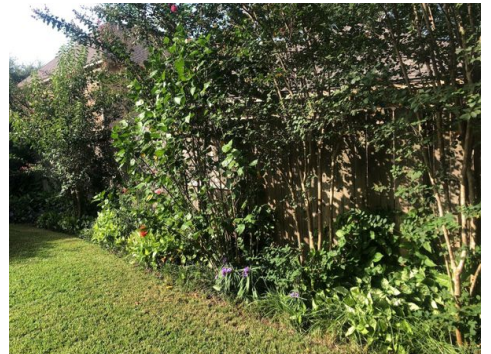
**WOOD FENCE**

The wood fence was in need of some repairs.

Contact a qualified professional.

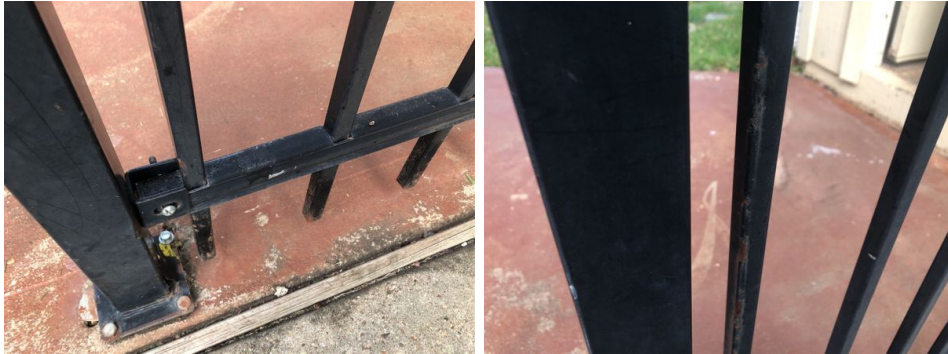
**WROUGHT IRON GATE**

Rusted

The wrought iron gate was in need of some repairs.

Contact a qualified professional.

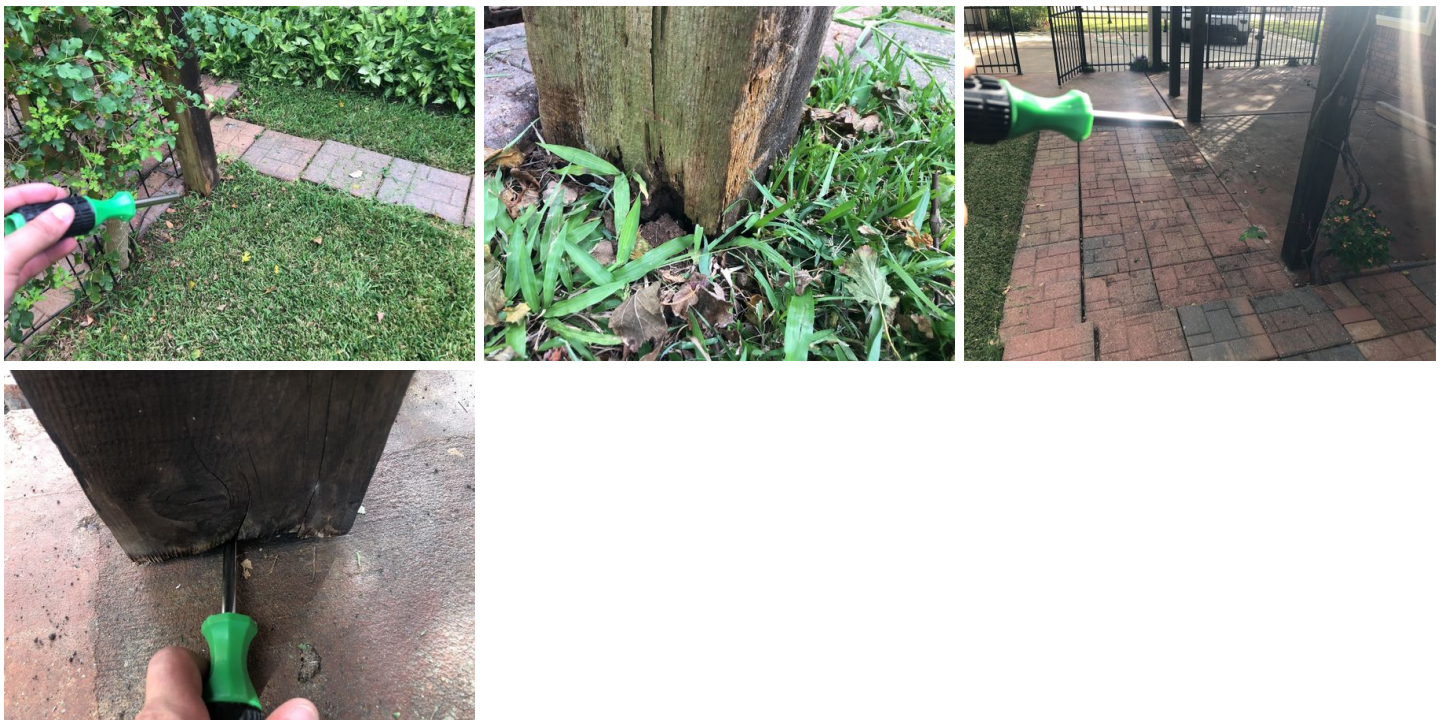
**WOOD ROT**

Wood rot was observed and needs to be replaced. Have a contractor provide a cost estimate to determine the entire scope of the wood rot, and provide a cost estimate to replace all rotted wood in the house.

Contact a qualified professional.

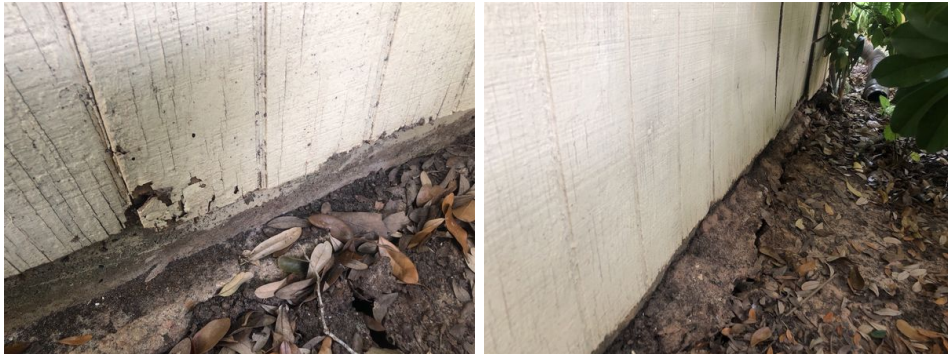
**WEATHERED**

We observed weathered wood at the exterior of the house. The wood does not appear to be rotted at this time, but if the wood is not sealed and painted, it can be anticipated that deterioration will occur quickly, with replacement of the wood becoming necessary. Further investigation with a contractor is recommended to obtain a cost estimate to seal and paint the exterior wood.

Contact a qualified professional.

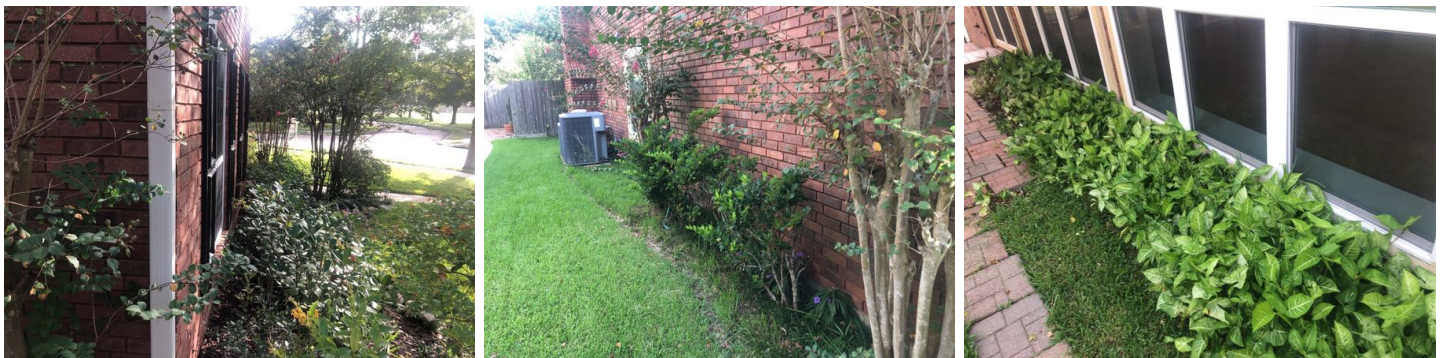
**FOLIAGE TOUCHING HOUSE**

Contact a qualified professional.

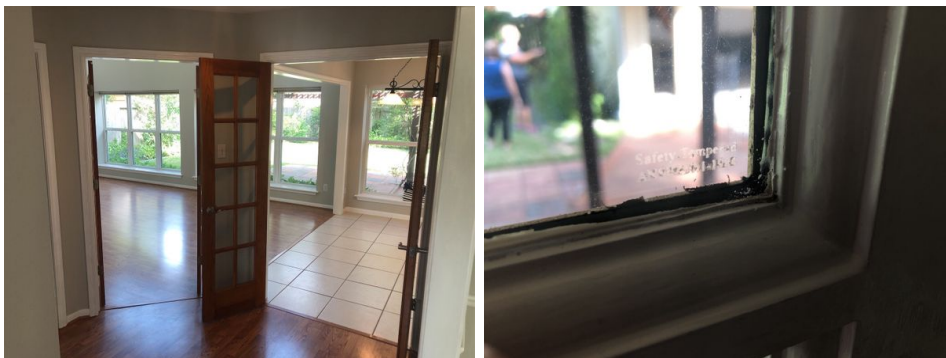
**GLASS NOT SAFETY GLASS**

Contact a qualified professional.

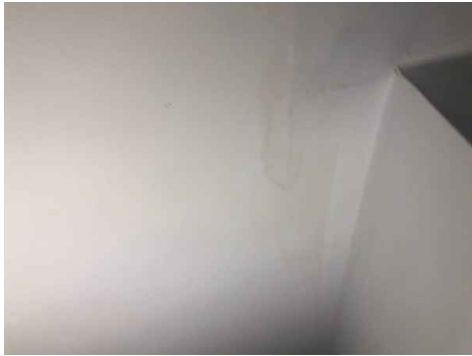
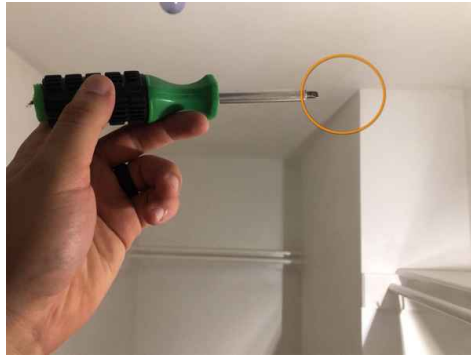
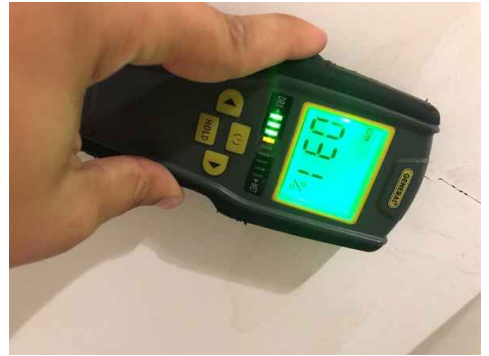
**WATER STAINS SOURCE UNKNOWN**

Stain in orange circle was wet at the time of inspection

Contact a qualified professional.

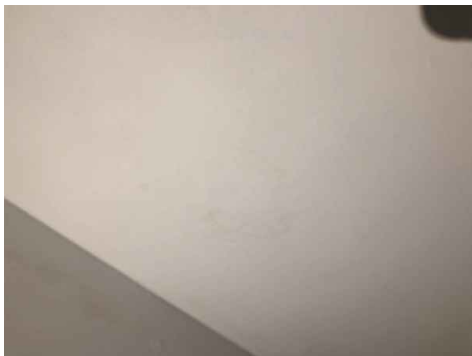
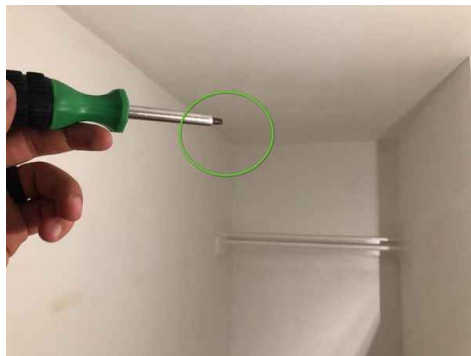
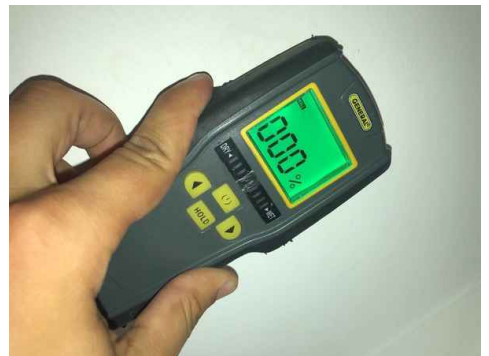
Stain in the green circle was dry at the time of inspection
