MECHANICAL INSPECTION

4547 Bermuda Dr
Sugar Land TX 77479

Gary Turner & Debra Turner
SEPTEMBER 2, 2020

PROPERTY INSPECTION REPORT

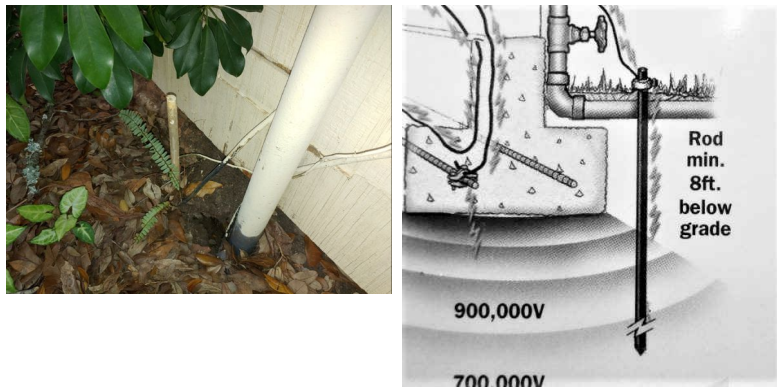
The ground rod was sticking out of the ground a few inches, and, since ground rods are typically 8 feet long and all 8 feet of the rod are required to be in the ground, it is recommended that the ground rod be pounded down flush with the top of the ground. The clamp on the rod should be an acorn clamp is approved for direct burial in the ground.

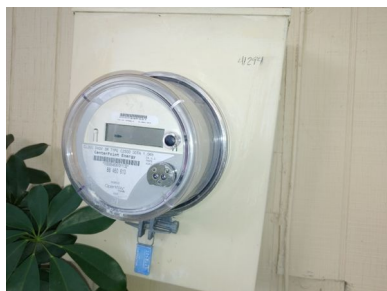
2: Meter Loose

The meter base was loose on the wall and needs to be properly secured.

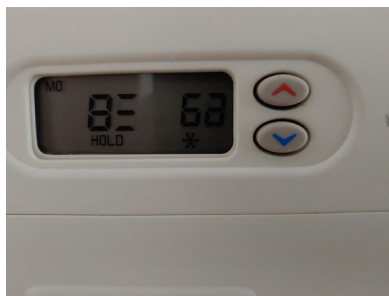
2: Thermostat - Damaged

The thermostat was damaged and needs to be repaired or replaced.

Read out malfunctioning

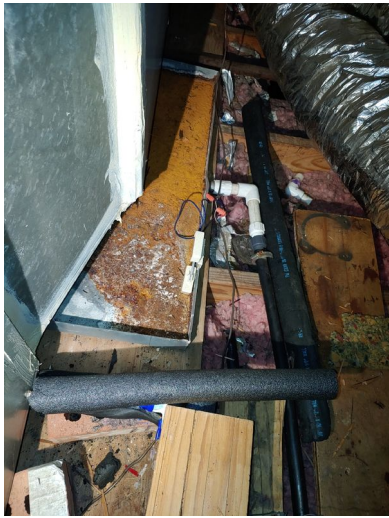
3: Overflow Pan - Rust

2nd floor System

Excessive rust was observed in the overflow pan under the coil, apparently due to water backing up at the primary drain line and overflowing into the pan. No water was observed in the overflow pan at the time of the inspection, however since the equipment was only operated for a short time during the inspection, It is recommended that the primary drain line and the coil be checked by an air conditioning service company and that the rusted overflow pan be replaced.

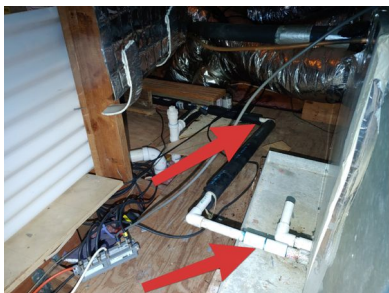
4: Primary Drain Line - Missing insulation

A portion of the primary condensate drain line was missing insulation which can cause the drain line to "sweat" and drip water. The drain line should be insulated for the first 10 feet to prevent condensation from forming on the drain line.

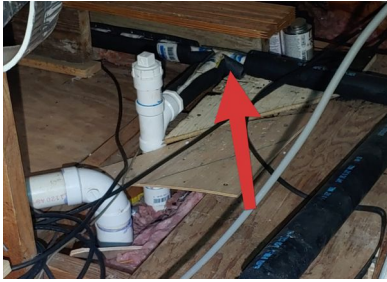
5: Primary Drain Line - Terminated in plumbing trap in attic

The primary condensate drain lines terminate into a plumbing trap in the attic. This condition can allow sewer gases to back up into the house and HVAC system. The drain lines should be rerouted to an approved location.

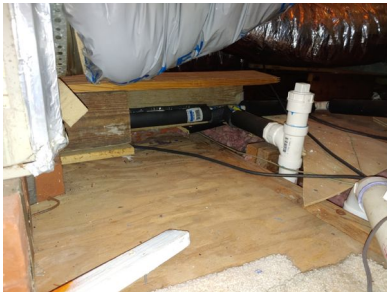
6: Primary Drains - Connected together in attic

The primary condensation drain line for the evaporator coils connect together in the attic rather than terminating independently. The condition can reduce drain performance. Consideration be given to separating the drain lines and terminating each drain line independently in an approved manner.

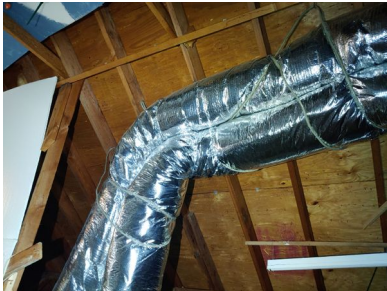
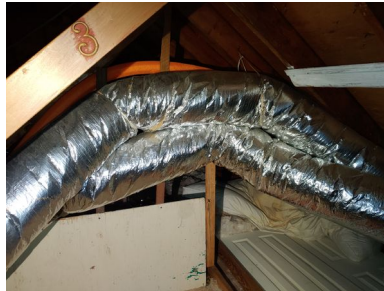
We observed that some of the air ducts in the attic were in contact with each other, which can cause condensation to form on the outside of the ductwork. It is recommended that the ducts that are touching be separated. Typically, this is done by inserting a piece of fiberglass batt insulation or duct board between the ducts.

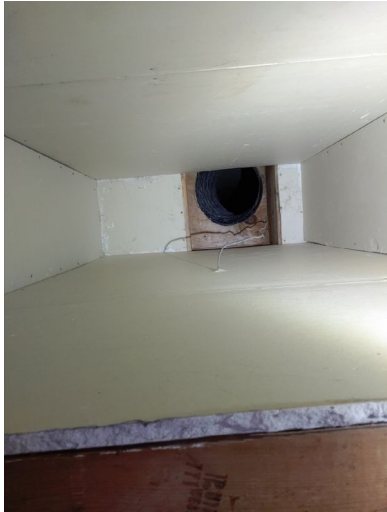
The chase was not sealed properly and was drawing unconditioned air from the floor and/or wall cavities into the system. Have the chase sealed against air leaks.

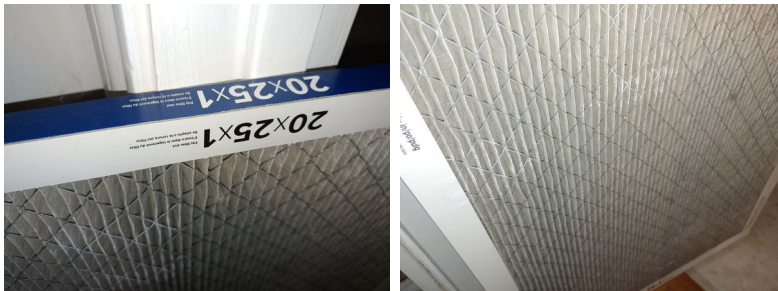
4: Air filters - Dirty

The filters were dirty and need to be replaced. Dirty filters can allow the evaporator coils to become dirty along with the ductwork systems, which can affect the performance of the systems.

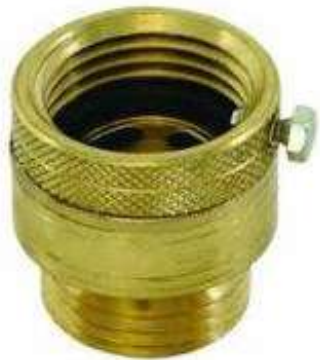
1: Vacuum Breaker - Missing

The atmospheric vacuum breaker devices were missing at one or more of the hose bibbs, and it is recommended that they be installed to prevent cross connections, which can allow contaminated water to enter the potable water supply.

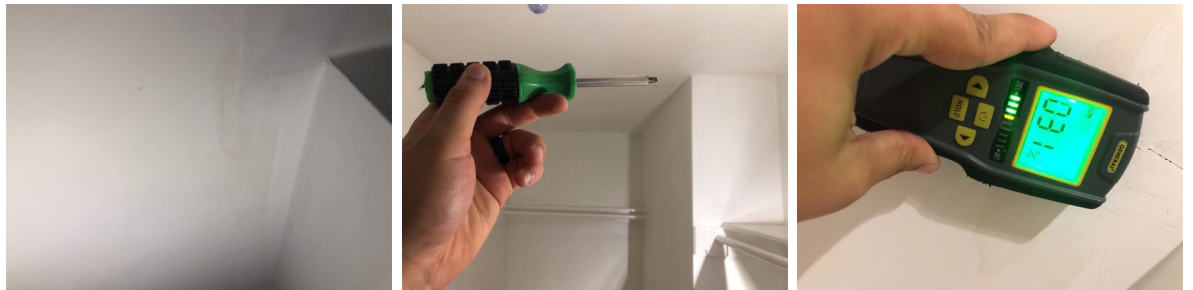
2: Water Stains - High moisture detected

2nd floor closet adjacent to bathroom

Water damage/stains were observed indicating a current or previous leak. The source of the condition was not determined, with certainty, at the time of the inspection. The stains were checked with a moisture meter and elevated moisture levels (15% or higher) were observed at the time of the inspection. Further investigation is recommended with a contractor to determine the source of the condition and to make any necessary repairs to correct the moisture condition and, if present, any secondary damage.

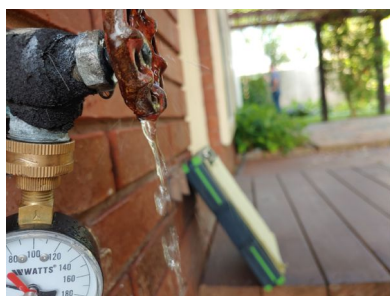
4: Hose Bibb - Leaking at valve stem

Back Porch

A leak was observed at a hose bibb around the valve stem.

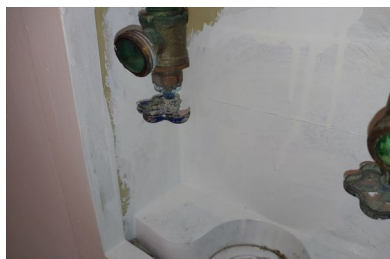
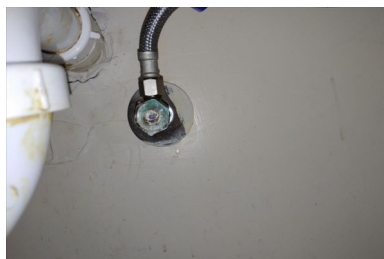
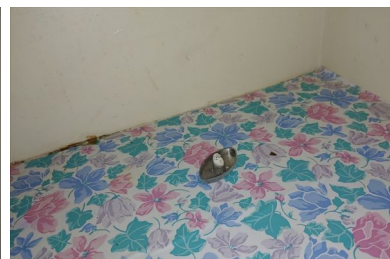
5: Water Valve - Handle damaged

Utility Room, Master Bath at right sink

The handle on the water valve was damaged and needs to be replaced.

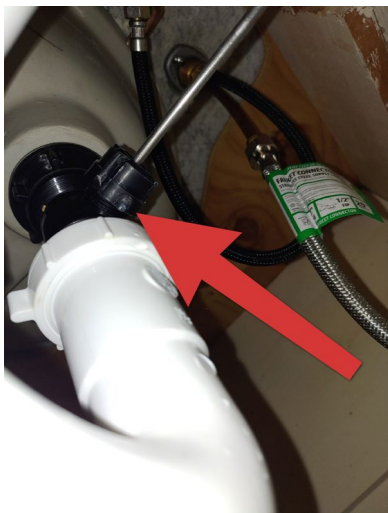
6: Sink Drain - Leak at stopper linkage

The drain line was leaking at the point where the stopper linkage attaches to the sink drain.

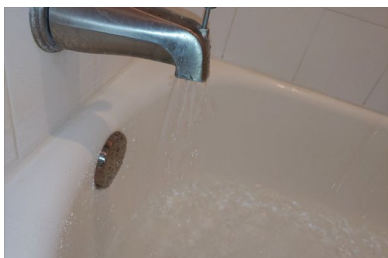
The diverter valve was leaking water past the valve when the valve was turned to the shower.

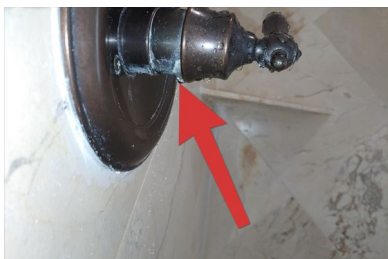
9: Shower/Tub - Valve leaking

Master Bath

The faucet was leaking at the one or more of the valve stems and needs to be repaired.

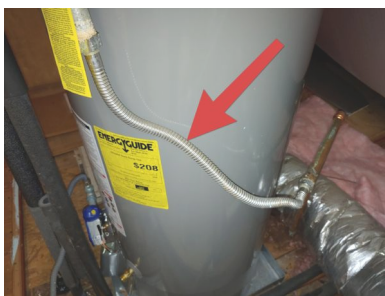
A portion of the drain line for the temperature/pressure relief valve was a flexible drain material and needs to be replaced with an approved material for this application.

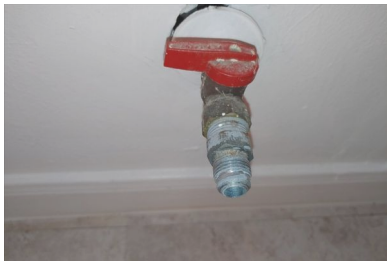
An unused gas valve that was not capped was observed. The unused gas valve needs to be properly capped to prevent accidental gas leaks.

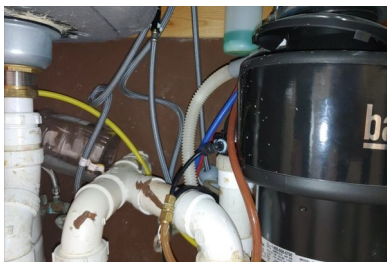
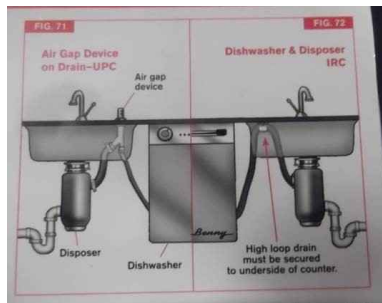
The drain line under the sink was not equipped with an anti-siphon device, nor was it looped up so that the top of the loop is at least six inches above the entrance of the drain line into the disposal. It is recommended at least that the drain line be looped to prevent the water from the garbage disposal from siphoning back into the dishwasher, or an anti-siphon device installed.

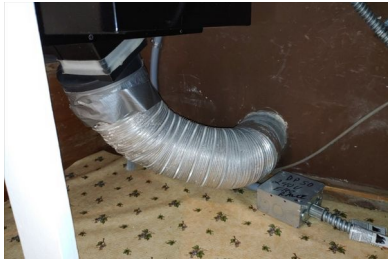
One or more sections of the vent pipe for the equipment was a flexible vent material, rather than rigid sheet metal vent pipe. An approved sheet metal vent pipe is required. Flexible vents can allow a buildup of grease in the joints of the flex duct, which is a known fire hazard.

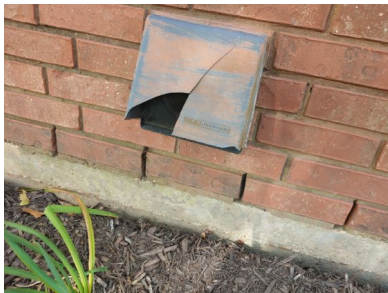
2: Vent Pipe - Cover damaged

The exterior vent cover was damaged and should be repaired or replaced.
