Summary Only

Property Address:
321 Juniper St.
Lake Jackson Tx 77566

Buchanan Home Inspection
Jared Buchanan 22516 22516
buchananhomeinspectioninfo@gmail.com
409-655-8323

General Summary

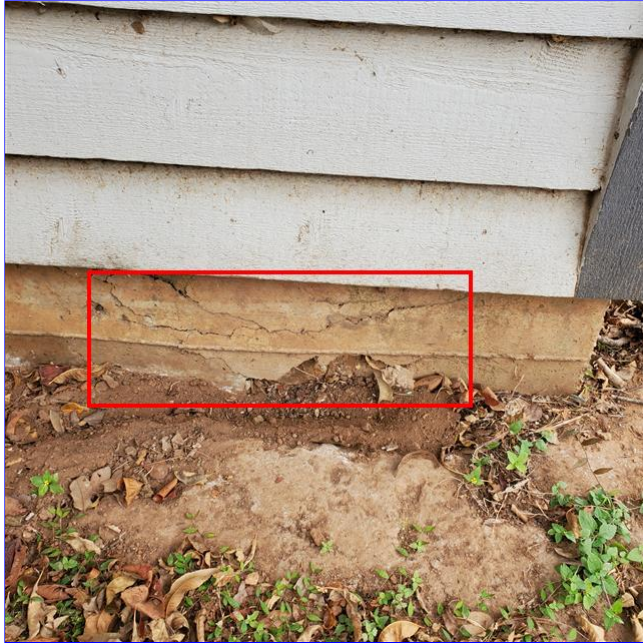
The garage foundation was leaning at the left side of the garage and was damaged at the back of the garage. There were also cracks in the garage floor that indicates possible foundation issues and should be further evaluated by a professional foundation contractor.

A. Item 1(Picture) Damage foundation at the back of the garage needs repair.

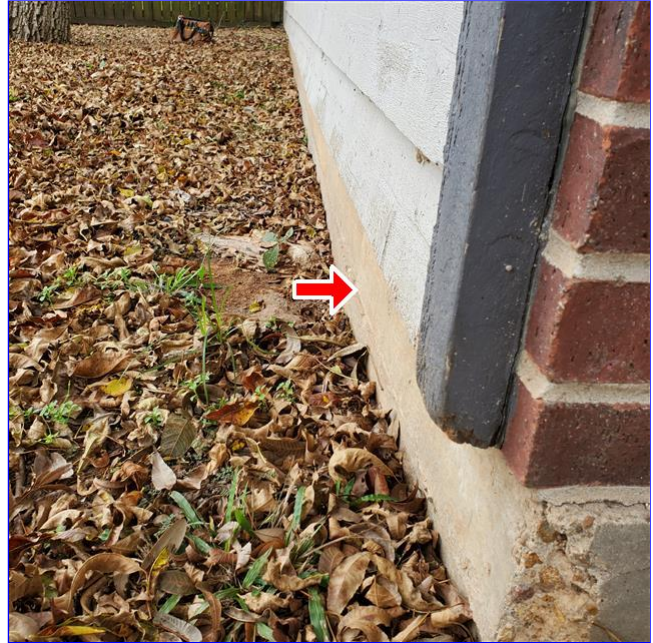
A. Item 2(Picture) Bowed foundation wall at the left side of the garage near the front entrance door of the garage. This needs further evaluation by professional contractor and repair, as needed

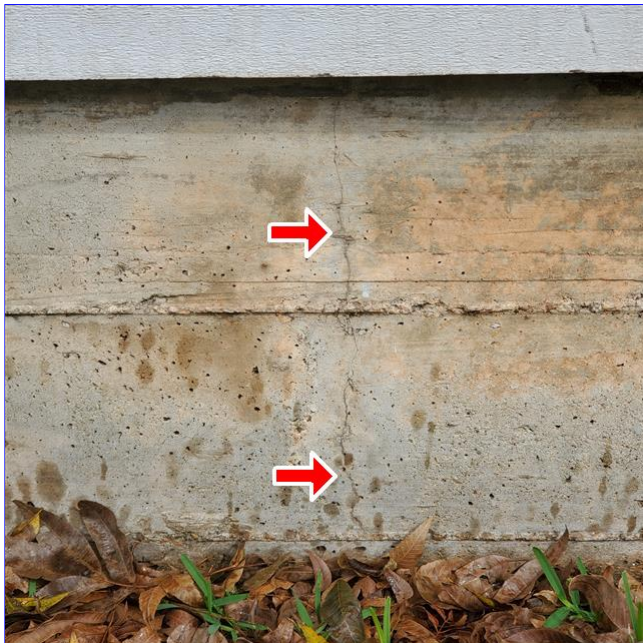
A. Item 3(Picture) Hairline crack in the foundation at the back of the home by the master bathroom.

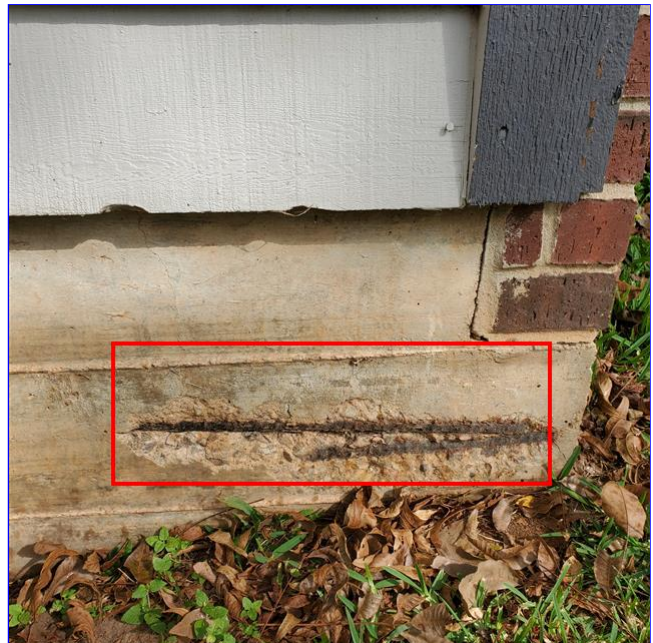
The majority of the home foundation appeared to be operating as intended, however, there was exposed rebar and a crack in the foundation at the back left corner of the home. This needs further evaluation and repair by a professional foundation contractor.

A. Item 4(Picture) exposed rebar in foundation at the back left corner of the home needs repair to help prevent further damage.

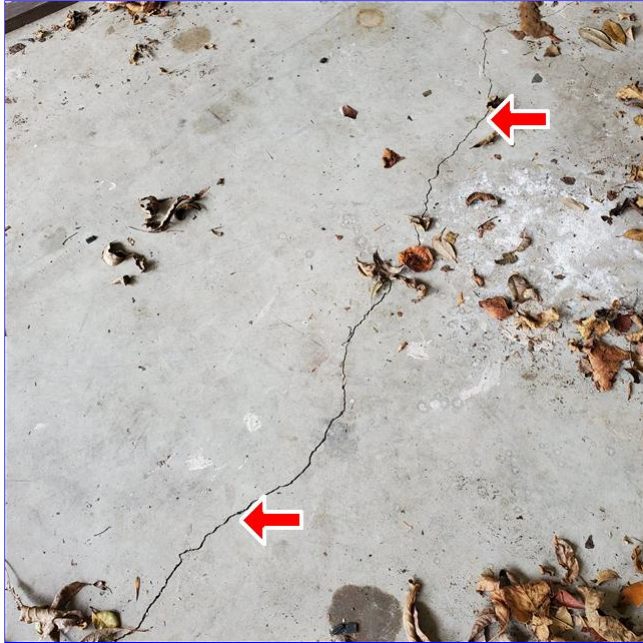
A. Item 5(Picture) There are a few fairly large cracks in the garage floor, which indicates possible foundation issues and need further evaluation.

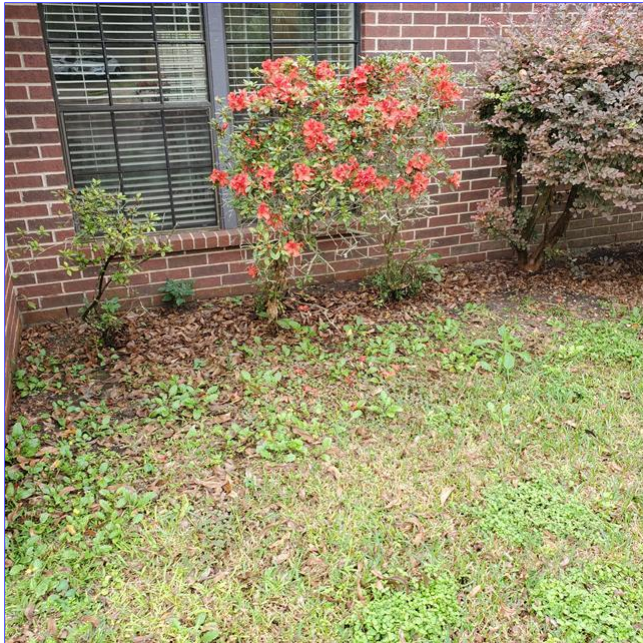
B. Item 1(Picture) The soil at the front of the home is within 4in of brick wall coverings and needs to be lowered.

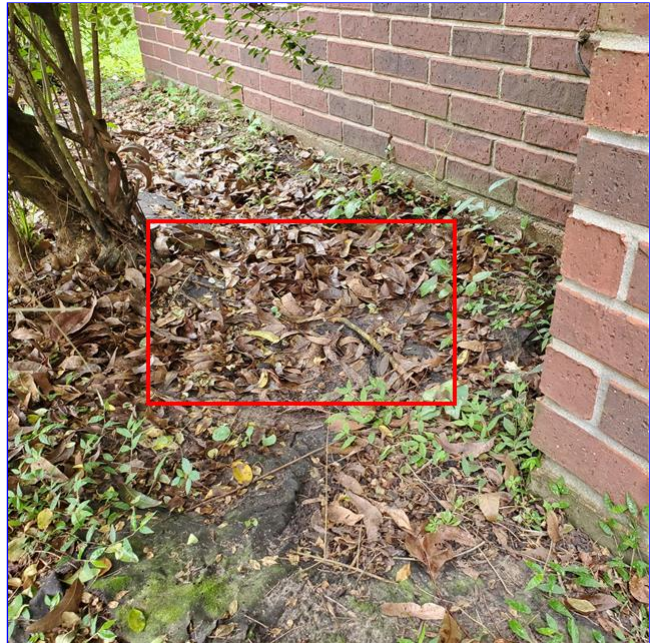
B. Item 2(Picture) area for potential ponding water at the front of the home near the left side of the home.

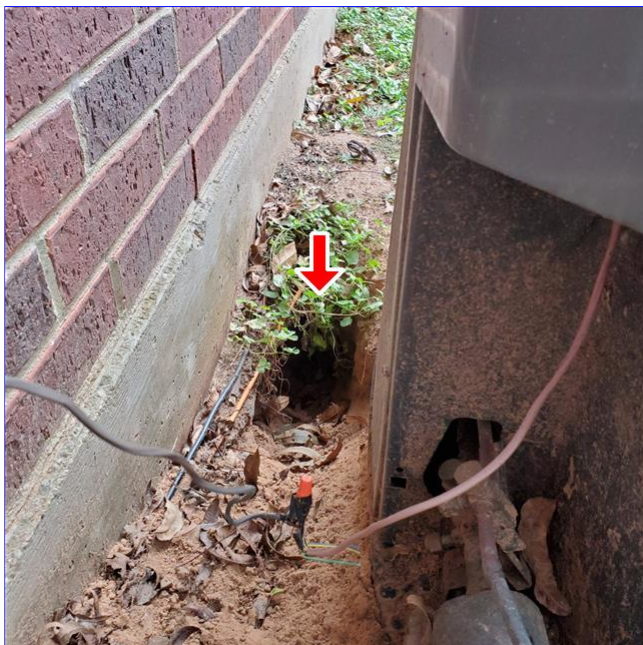
B. Item 3(Picture) Possible critter hole going under the foundation at the left side of the home by the AC condenser. This needs remedy to help prevent moisture from entering under the foundation and causing damage.

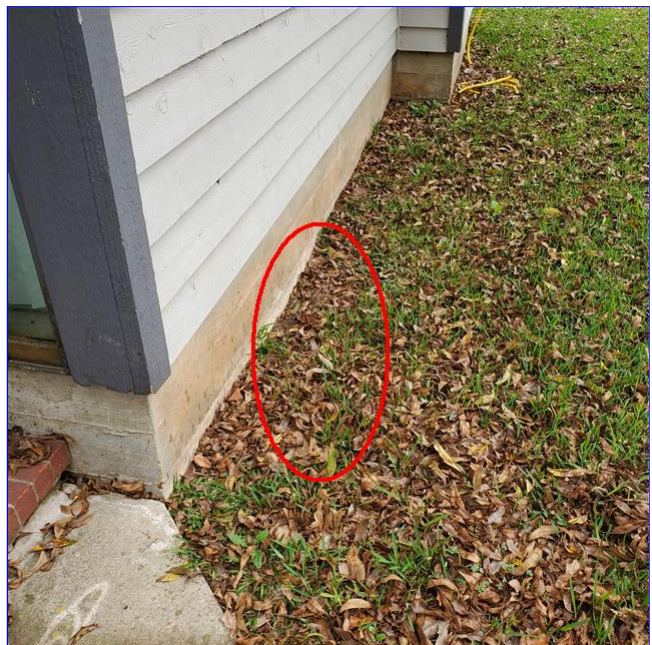
B. Item 4(Picture) Area for potential ponding water at the back of the home by the master bedroom.

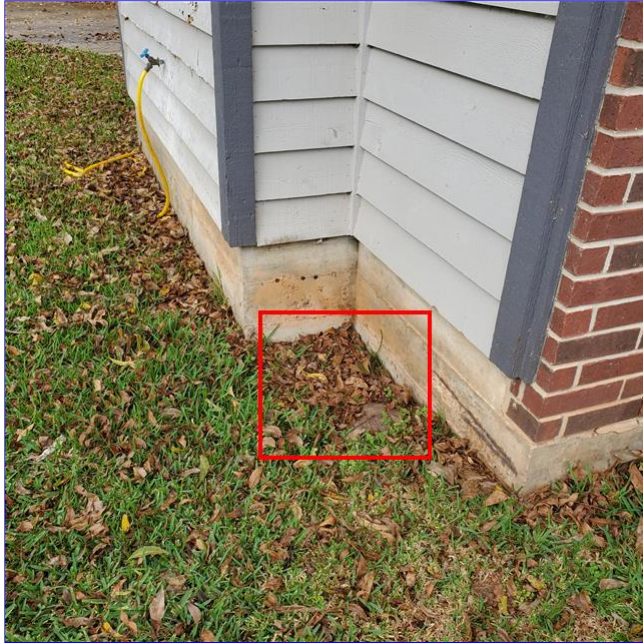
B. Item 5(Picture) area for potential ponding water at the back of the home by the master bathroom.

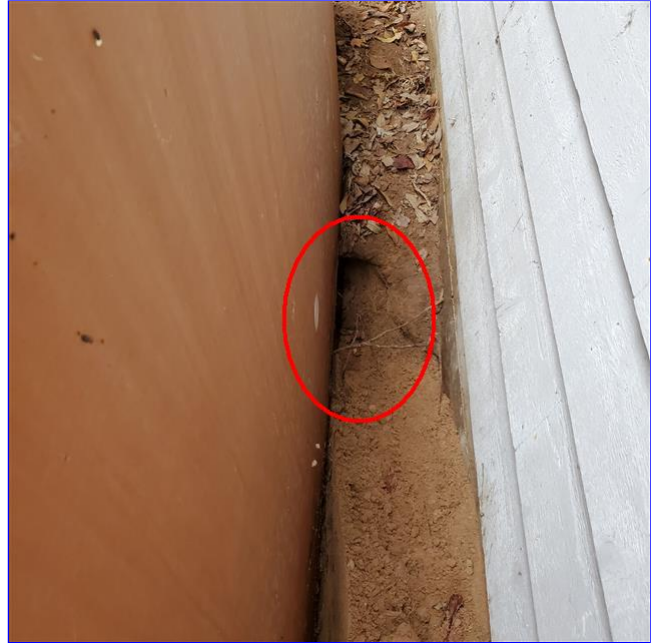
B. Item 6(Picture) Possible critter hole going under the foundation at the right side of the garage.

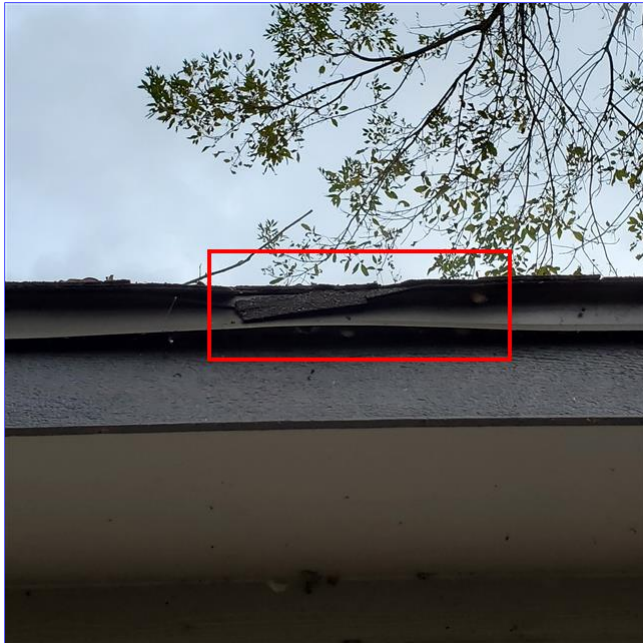
C. Item 1(Picture) Damaged shingle and bent drip edge at the back facet of the garage.

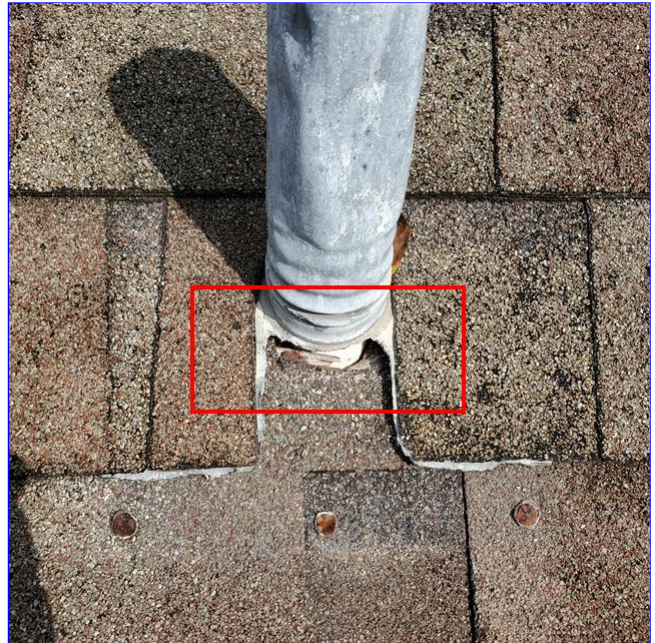
C. Item 2(Picture) Damaged pipe flashing approximately above the kitchen needs repair.

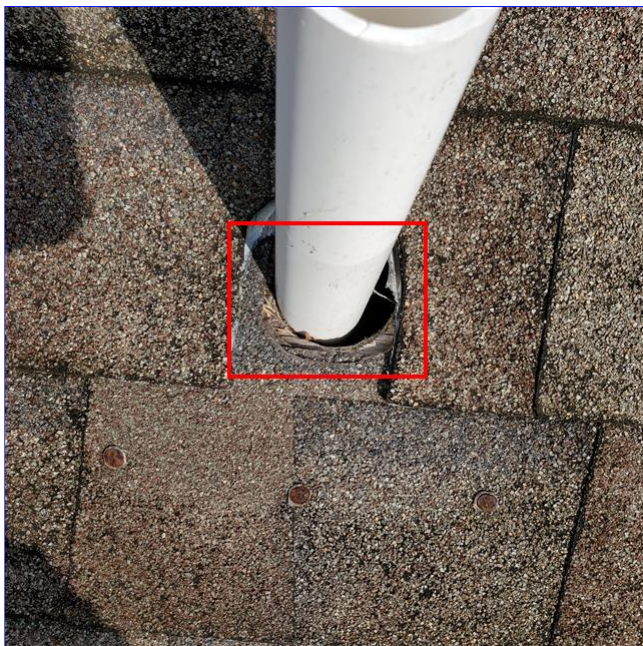
C. Item 3(Picture) Missing pipe flashing around plumbing vent pipe above the laundry room.

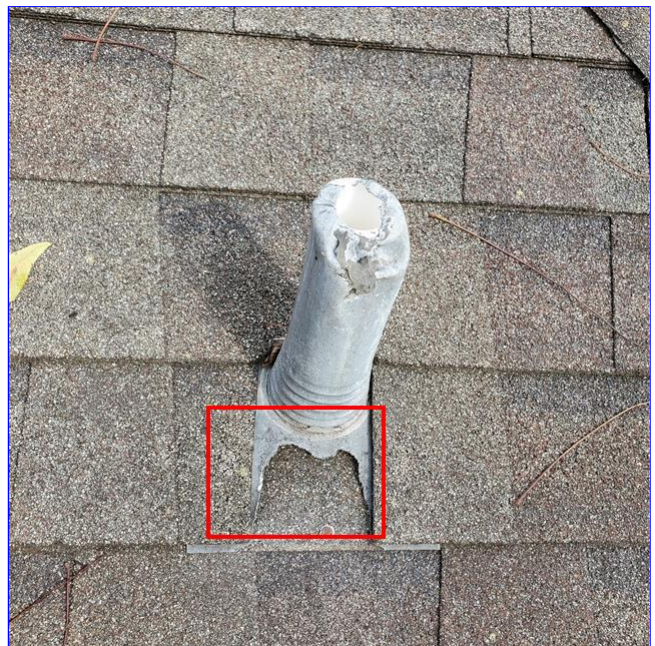
C. Item 4(Picture) Damaged vent pipe flashing on vent pipe approximately above the master bathroom.

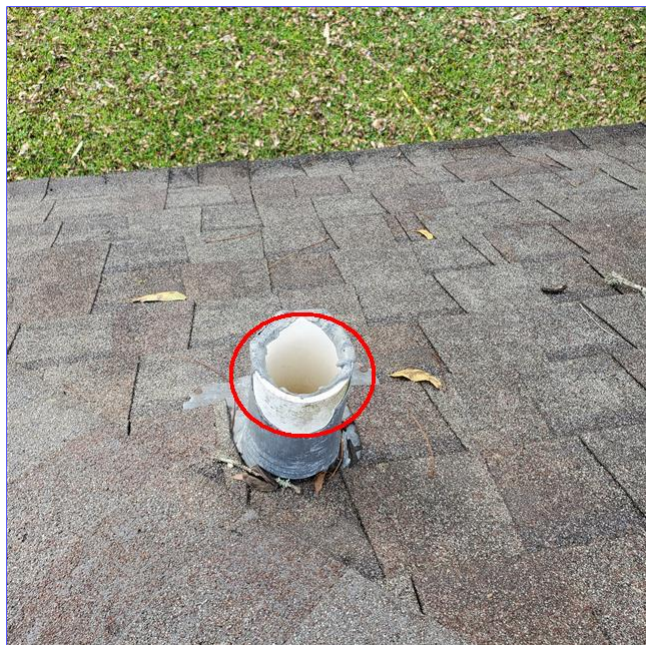
C. Item 5(Picture) Damaged vent pipe flashing on vent pipe approximately above the master bathroom toilet.

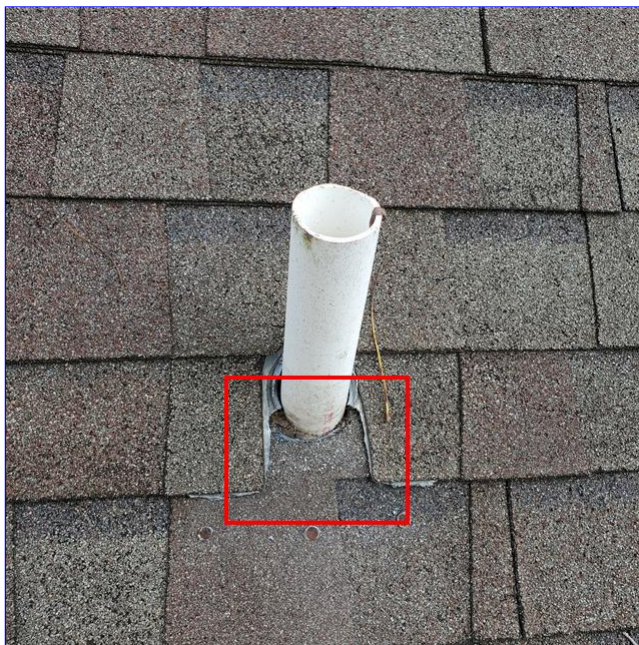
C. Item 6(Picture) Missing vent pipe flashing on vent pipe approximately above the hallway bathroom.

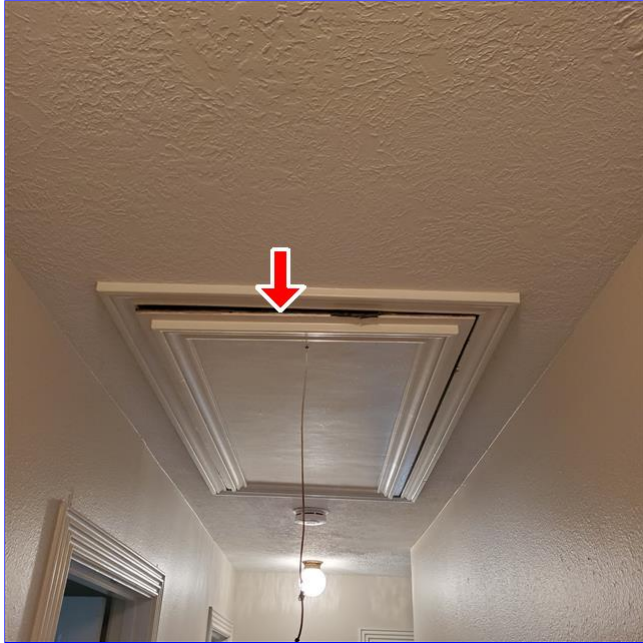
D. Item 1(Picture) Gap in the attic access needs to be sealed to help prevent loss of conditioned air.

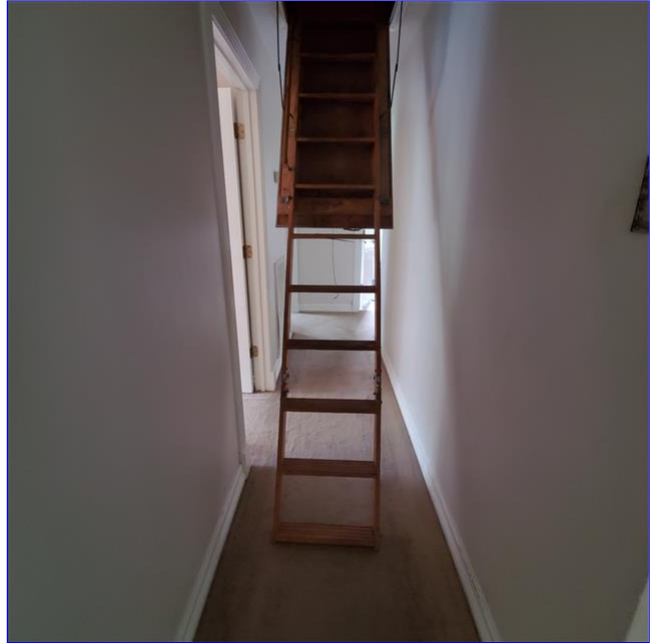
D. Item 2(Picture) The attic ladder is aged in flimsy and should be replaced for safe entry into the attic.

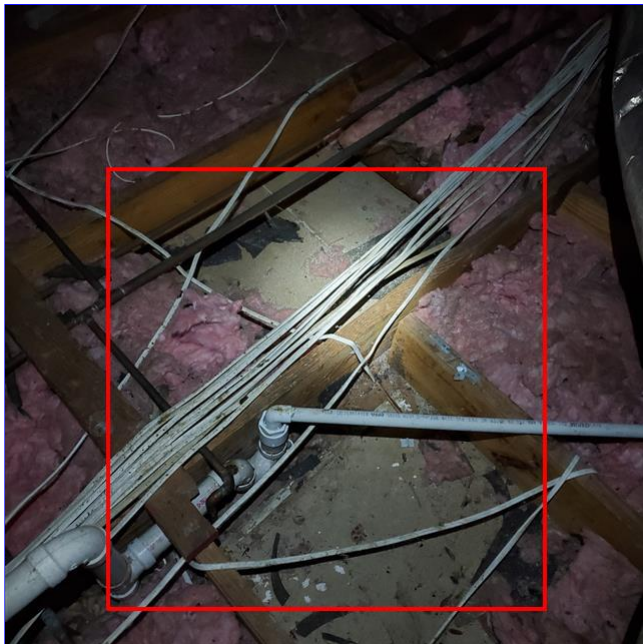
D. Item 3(Picture) Voids in attic insulation approximately above the hallway bathroom.

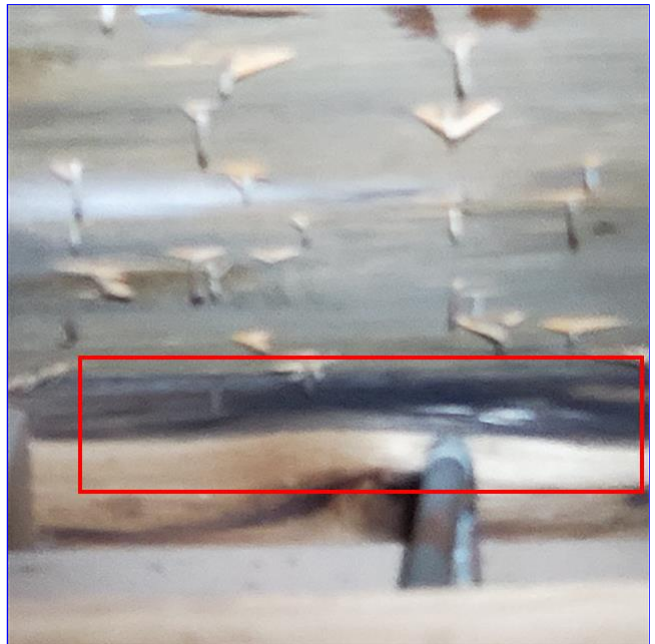
D. Item 4(Picture) Rotting fascia noted at the back of the home from inside the attic.

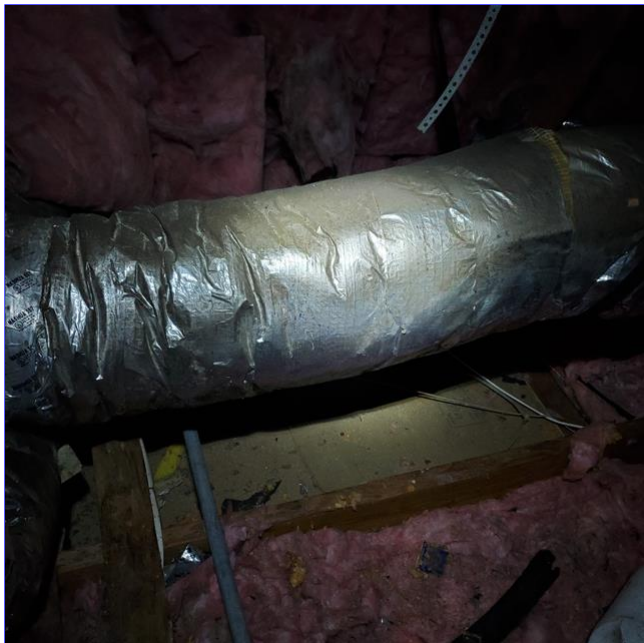
D. Item 5(Picture) Void in insulation approximately above the hallway.

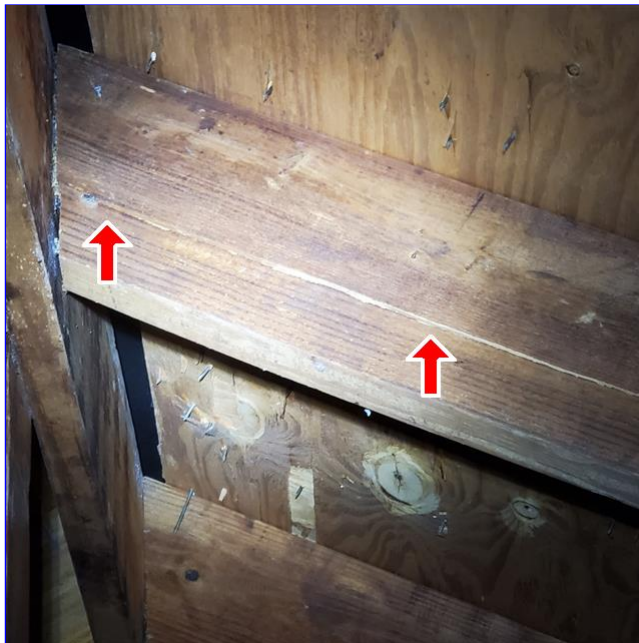
D. Item 6(Picture) Split rafter noted in the attic at the vaulted ceiling in the living room.

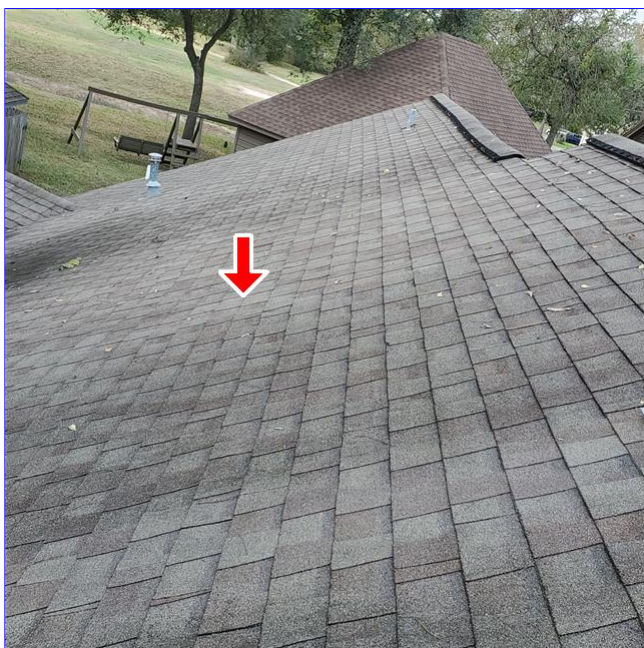
D. Item 7(Picture) Slight hump in roof structure on the back facet approximately above the living room. This is approximately where the fairly large crack in the ceiling is and needs further evaluation.

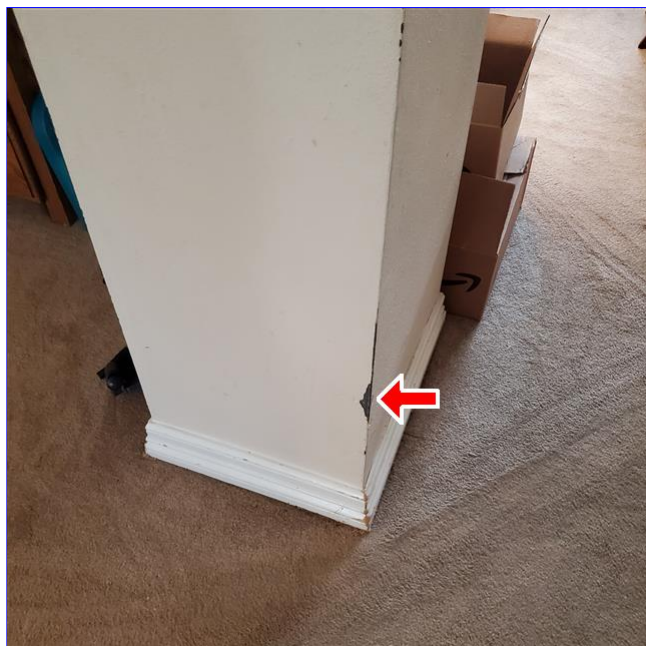
E. Item 1(Picture) Cosmetic damage to wall in the living room. Evaluate and repair as needed

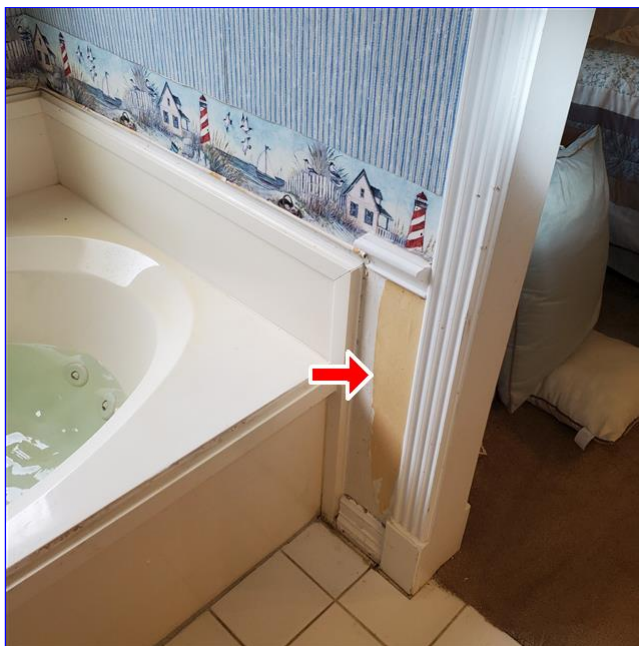
E. Item 2(Picture) Cosmetic damage to wall in the master bathroom by the HydroMassage tub. Evaluate and repair, as needed. Also recommend caulking between the wall and the HydroMassage tub to help prevent water from entering this area and causing damage to property

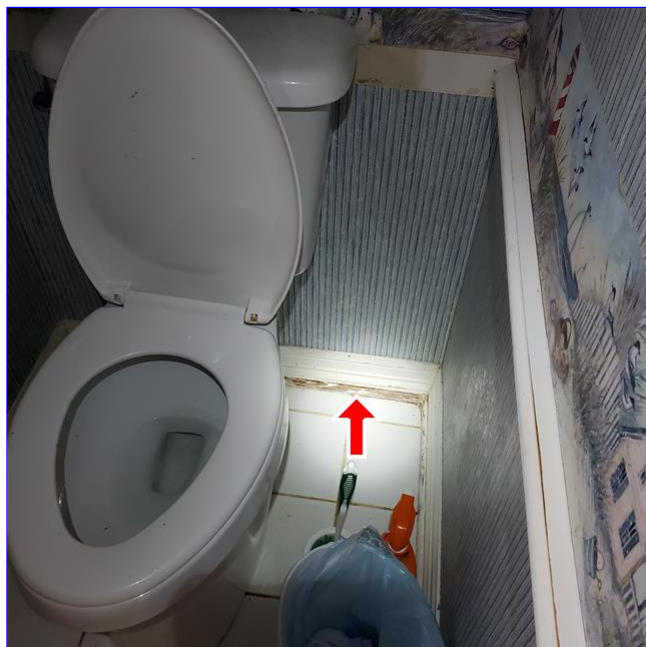
E. Item 3(Picture) Possible water damage noted on the floor in the master bathroom toilet area behind the toilet. Unsure of cause that recommend further evaluation and monitoring, at minimum.

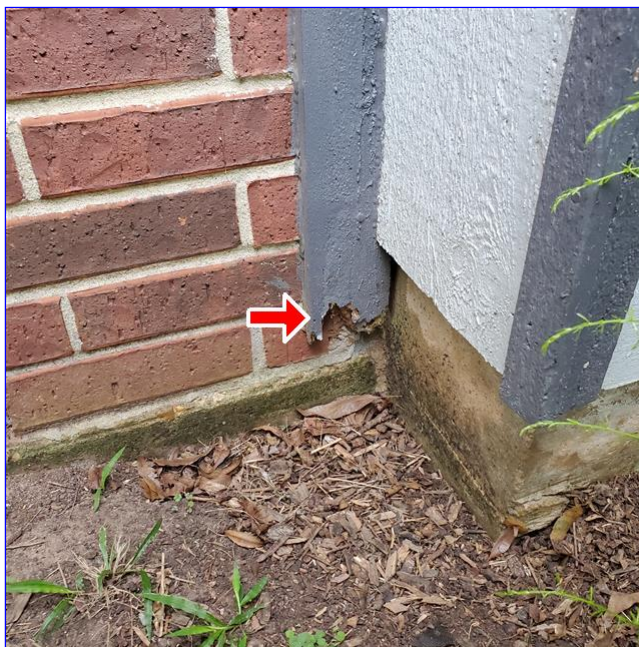
E. Item 4(Picture) Rotting trim at the front of the home, by the middle hallway bedroom window needs repair.

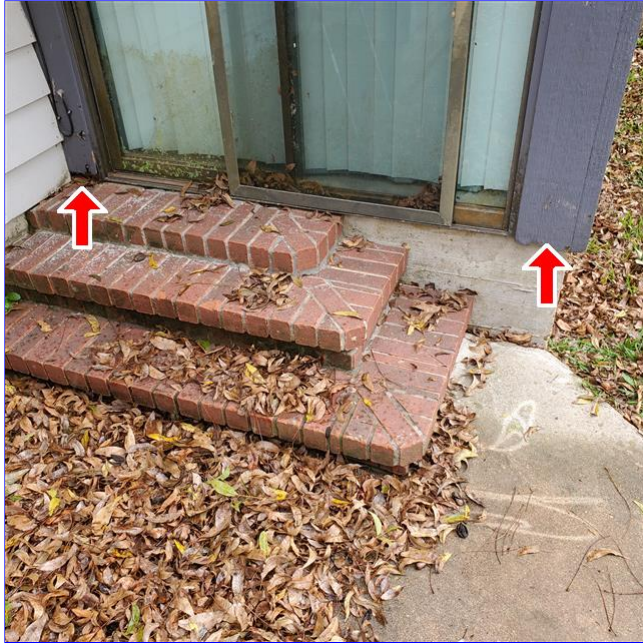
E. Item 5(Picture) Rotting trim by the master bedroom sliding glass door needs repair.

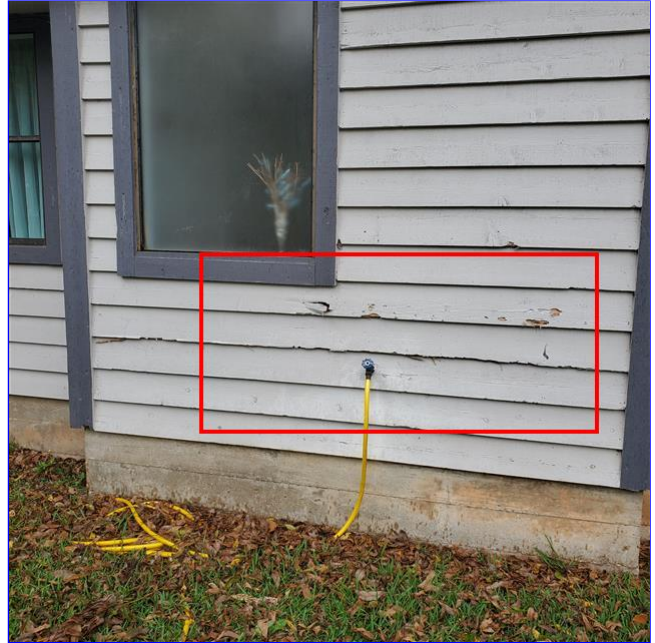
There was rotting siding on the exterior wall at the back of the home, at the master bathroom, that needs repair by a professional contractor. Keep in mind that we do not remove siding to inspect for rotting framing and it is possible that framing is rotting behind this area and may need repair. This needs further evaluation and repair by a professional contractor.

E. Item 6(Picture) Rotting siding at the back of the home at the master bathroom.

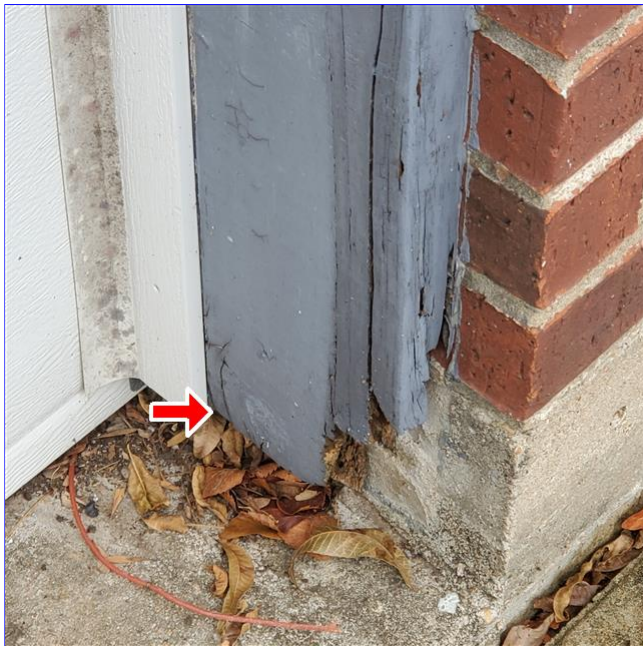
E. Item 7(Picture) Rotting trim was noted on both sides of the garage door on the left and needs repair.

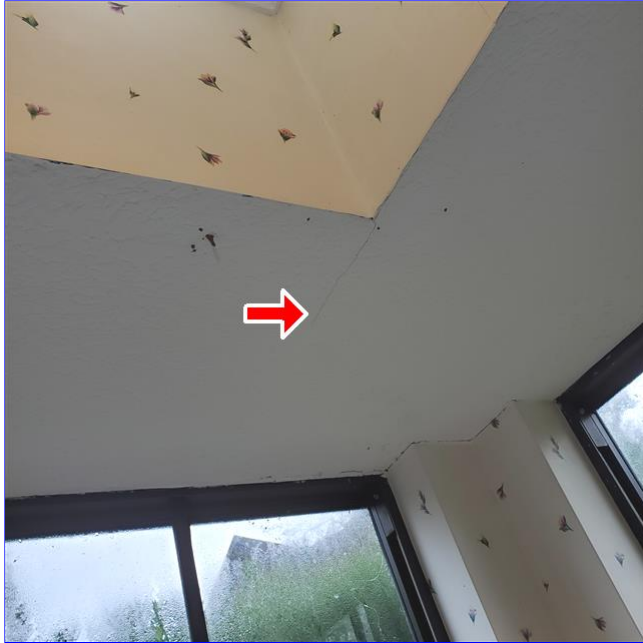
F. Item 1(Picture) Hairline crack in the ceiling above the kitchen sink appears cosmetic but should be sealed and monitored for growth and a structural engineer contacted if growth occurs.

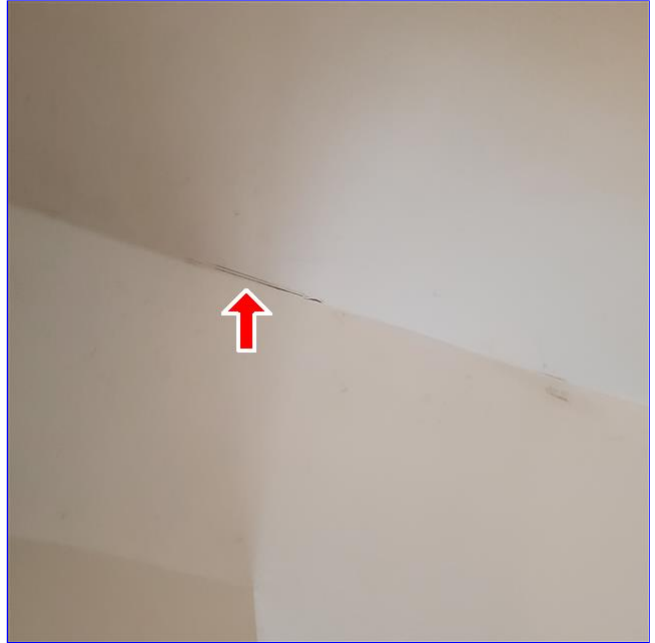
F. Item 2(Picture) Tape peeling from the ceiling in the living room appears cosmetic but should be sealed and monitored.

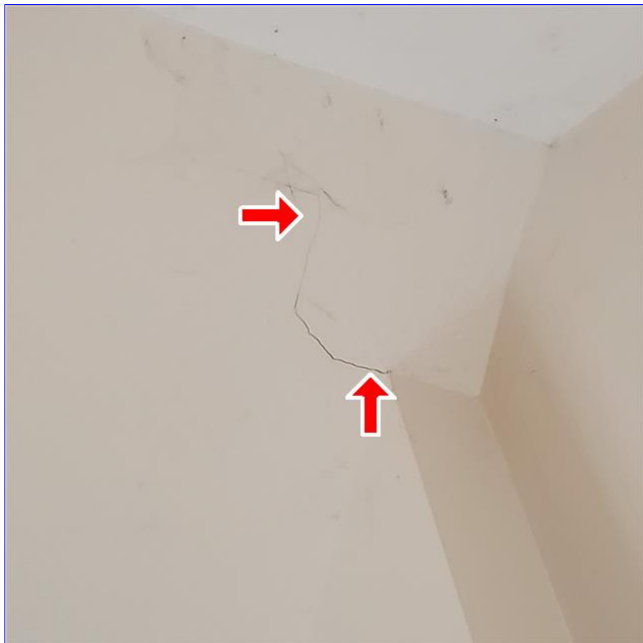
Fairly large crack in the living room ceiling may not be cosmetic and should be evaluated further by a professional contractor to determine cause.

F. Item 3(Picture) Fairly large crack in the living room ceiling. This crack may not be cosmetic and should be evaluated further.

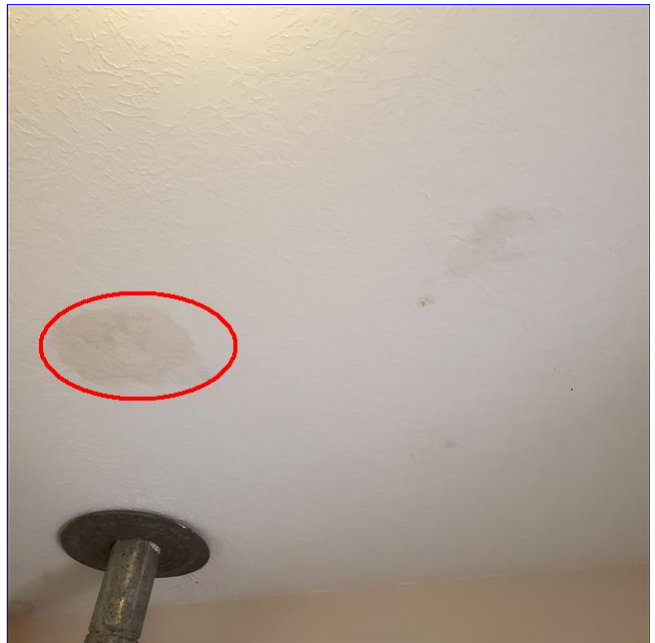
F. Item 4(Picture) Water stains noted on the ceiling in the laundry room. This did not appear wet at time of inspection but should be monitored.

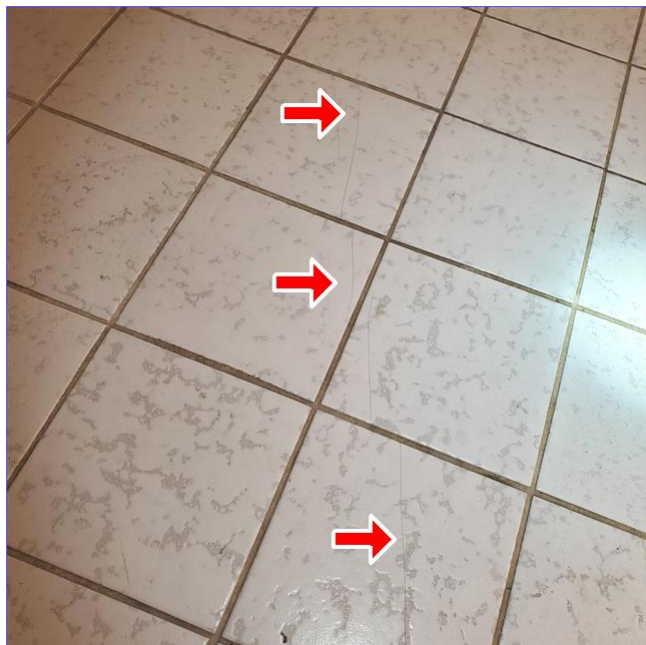
F. Item 5(Picture) Hairline cracks noted and tile at the front entrance. I'm sure if this is cosmetic or structural but does not appear to be severe at the moment but should be evaluated and repaired, if needed.

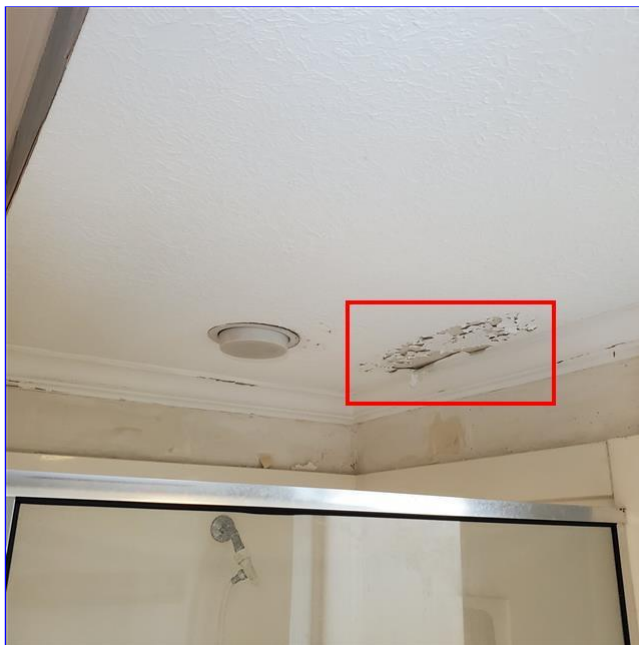
Peeling paint in the master bathroom may be due to high humidity levels, as there is no exhaust fan or openable window in this room. Recommend further evaluation by a professional contractor to determine cause and give estimates on cost of repairs needed.

F. Item 6(Picture) Peeling paint noted above the master bathroom shower.

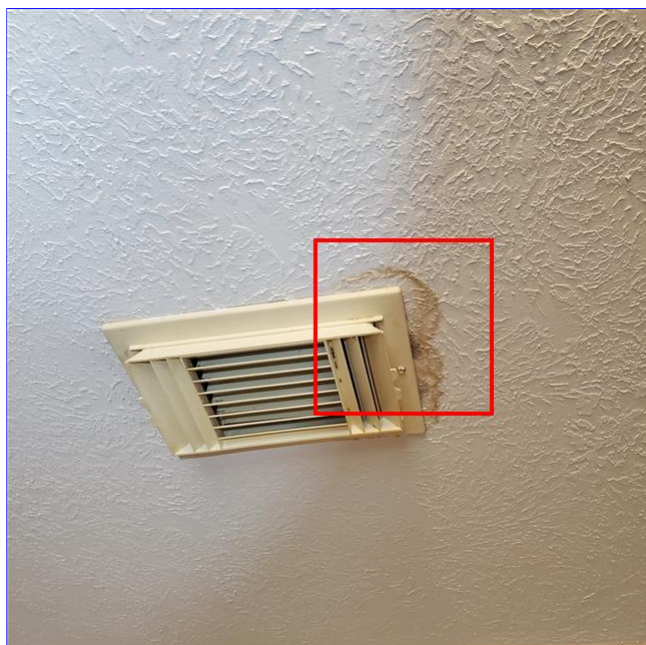
F. Item 7(Picture) Water stain around vent register in the hallway bedroom on the right at the end of the hallway is possibly due to condensate event, however, this area was not wet at time of inspection and should be further evaluated and monitored, at minimum.

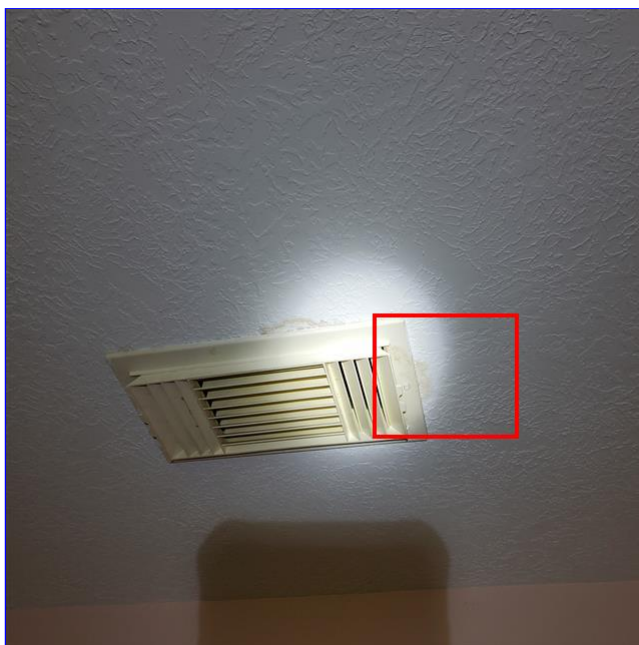
F. Item 8(Picture) Stain on ceiling around vent register in the bedroom to the left at the end of the hallway.

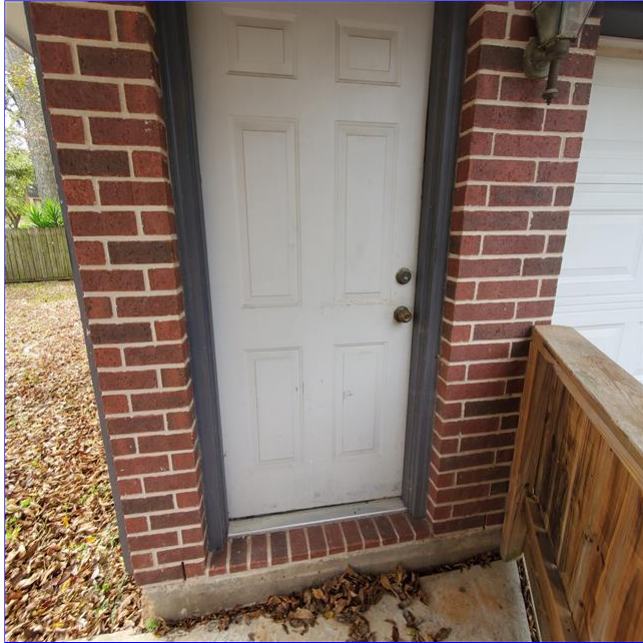
G. Item 1(Picture) The garage entrance door does not latch properly and needs repair.

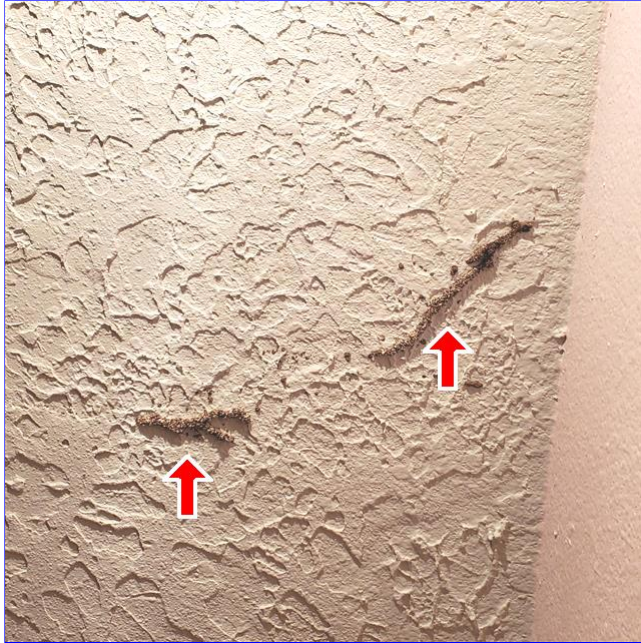
There are some possible signs of wood destroying insects in the closet of the bedroom on the left at the end of the hallway at time of inspection. Recommend having a full wdi inspection by a licensed WDI inspector.

L. Item 1(Picture) Evidence of possible wood destroying insects was noted in the closet of the bedroom to the left at the end of the hallway.

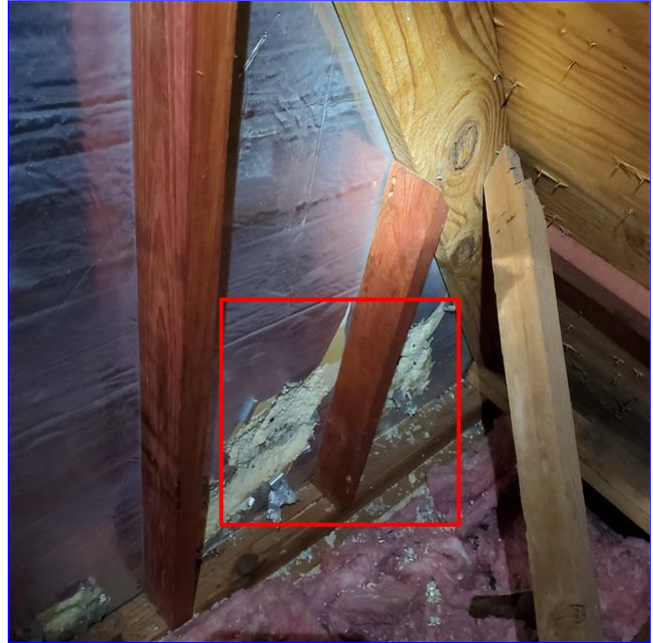
L. Item 2(Picture) Possible evidence of critters was noted in the attic. No critters were noted in attic at time of inspection but should be evaluated further.

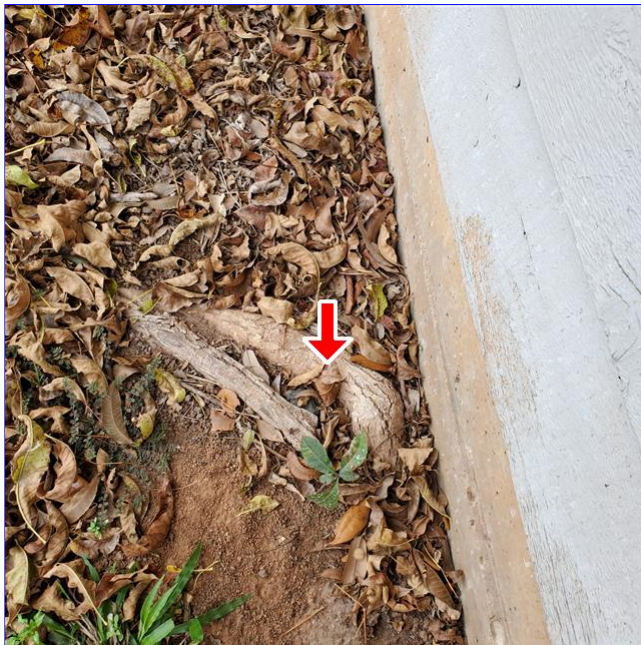
Tree root growing under the foundation of the garage at the left side of the garage can cause damage to foundation and needs remedy by a professional arborist.

L. Item 3(Picture) Tree root growing under the foundation of the garage at the left side of the garage.

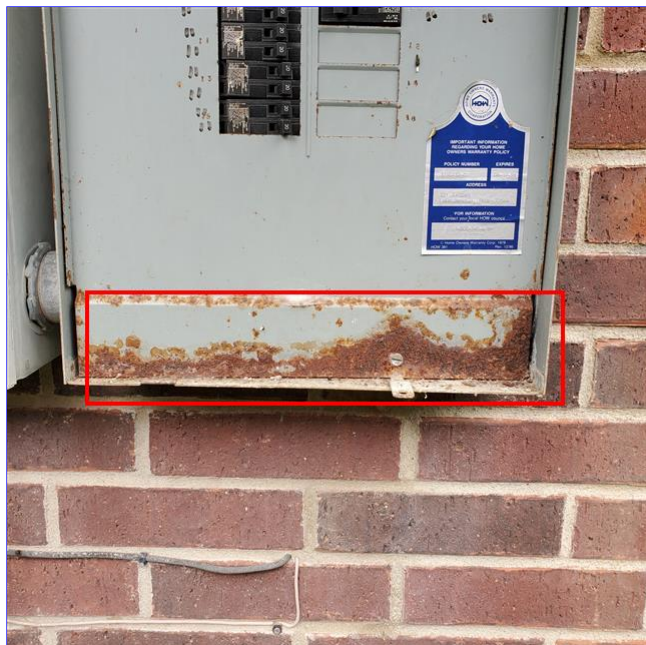
A. Item 1(Picture) The dead front cover on the electrical panel is Rusted and should be repaired/ replaced to help prevent further damage.

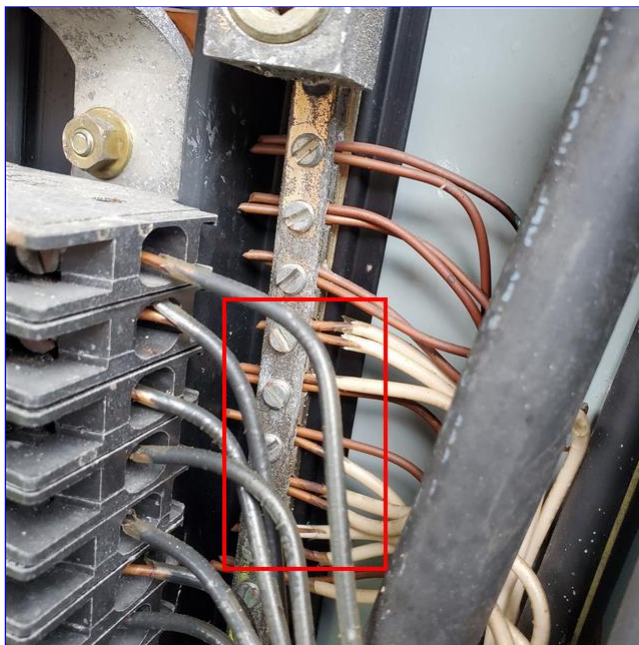
Multiple white wires under set screws on neutral bus in electrical panel. This is typical in homes of this age but can make it difficult to isolate a circuit. Recommend further evaluation and repair, as needed, by a licensed electrician.

A. Item 2(Picture) Multiple white wires noted under set screws on the neutral bus in the electrical panel.

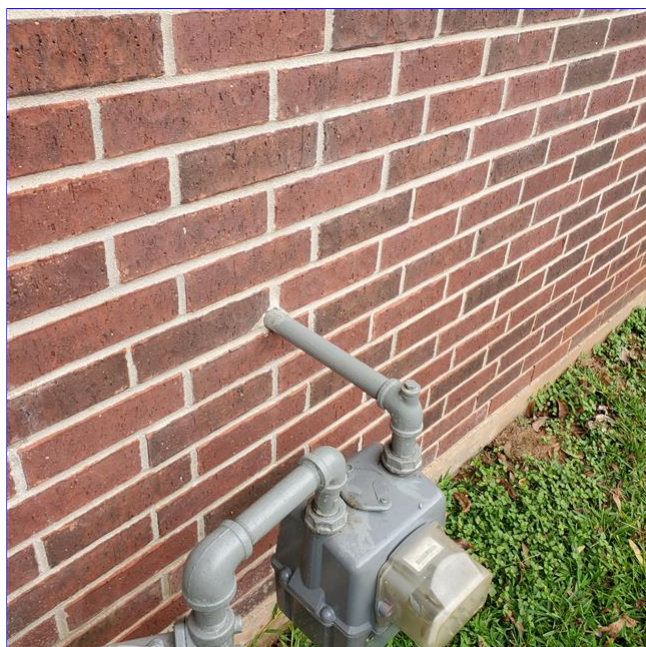
Above ground gas piping did not appear to be bonded to electrical system. This may not have been required when the home was built but is recommended for safety today. Recommend further evaluation and repair, as needed, by a licensed electrician.

A. Item 3(Picture) Above-ground gas piping is not bonded to the grounding electrode system.

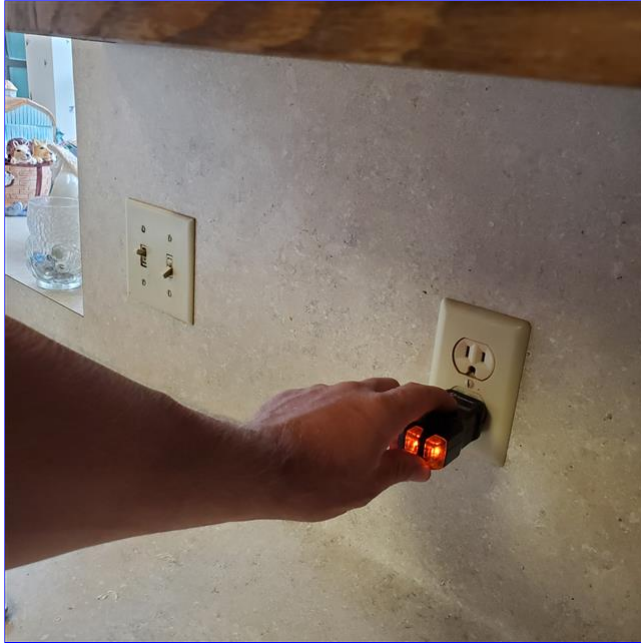
B. Item 1(Picture) Electrical receptacles above kitchen counter tops are not GFCI protected. This may not have been required when the home was built and his grandfather again what is the current requirement for safety.

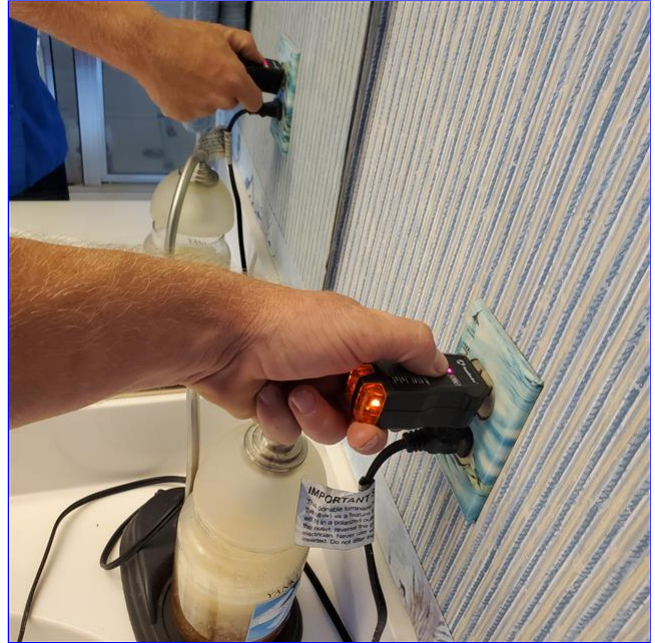
B. Item 2(Picture) Electrical receptacles in the master bathroom or not GFCI protected. This was required when the home was built and needs replacement for safety.

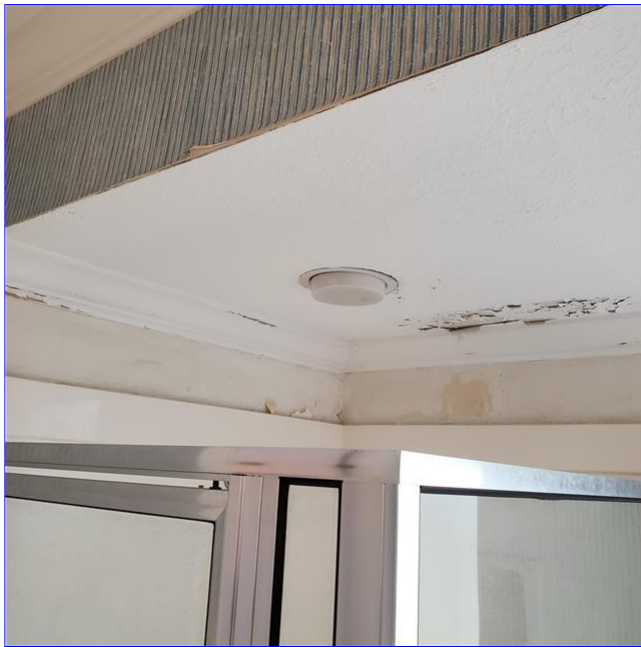
B. Item 3(Picture) The light above the master bathroom shower was not working at time of inspection and needs further evaluation.
