Summary Only

Property Address:
321 Juniper St.
Lake Jackson Tx 77566

Buchanan Home Inspection
Jared Buchanan 22516 22516
buchananhomeinspectioninfo@gmail.com
409-655-8323

General Summary

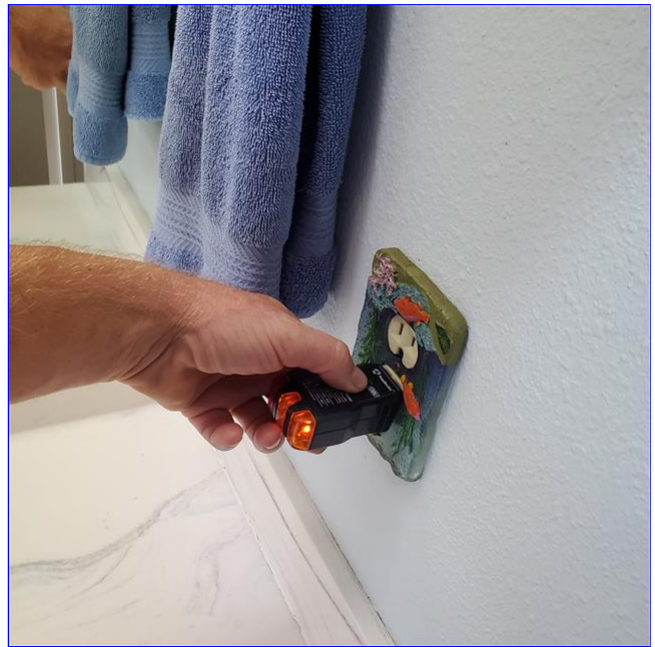
B. Item 4(Picture) Electrical receptacles in the hallway bathroom or not GFCI protected and need to be replaced for safety.

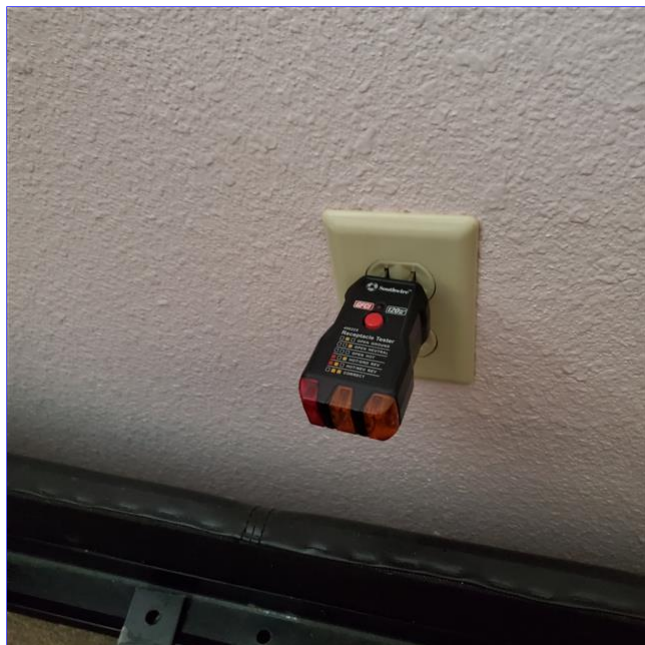
B. Item 5(Picture) Electrical tester could not be inserted in the top portion of the receptacle on the South Wall in the bedroom to the left at the end of the hallway. Unsure of cause but recommend further evaluation and repair.

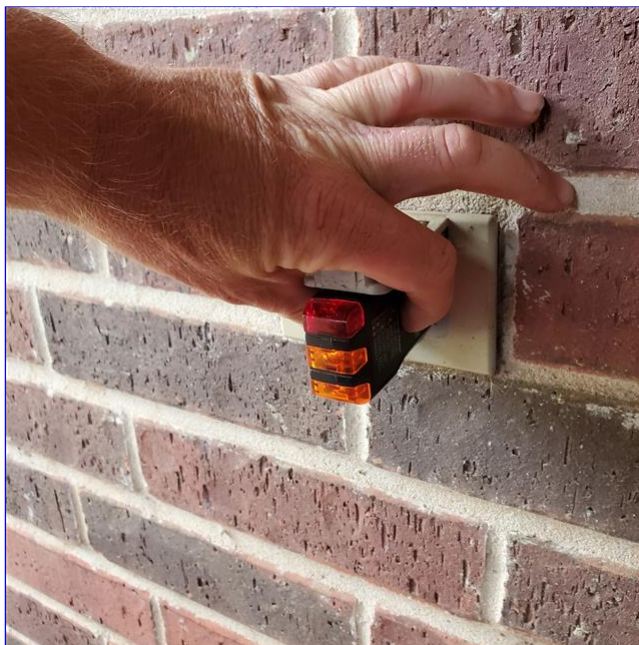
B. Item 6(Picture) Exterior electrical receptacle by the front door is not GFCI protected. This was required when the home was built and needs repair for safety.

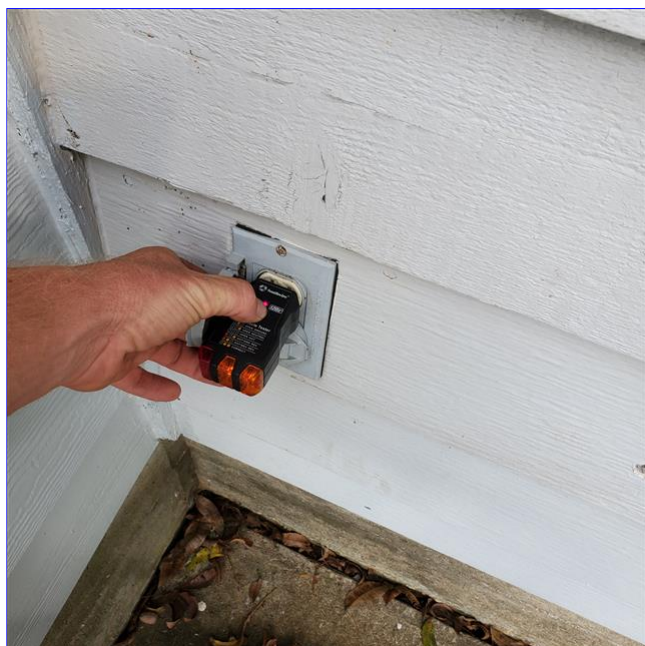
B. Item 7(Picture) the electrical receptacle at the back of the home, by the fireplace chimney, is not GFCI protected and is loose from the wall and needs to be replaced.

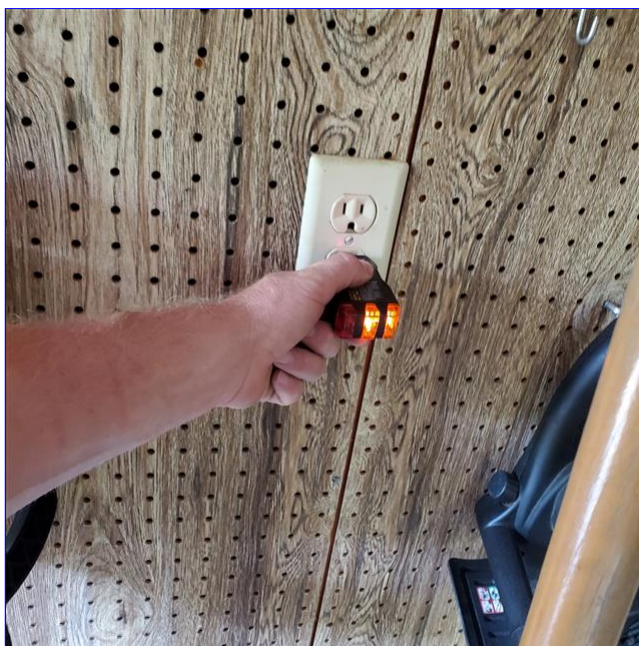
B. Item 8(Picture) The electrical receptacles in the garage were not GFCI protected. This was required when the home was built and needs to be replaced.

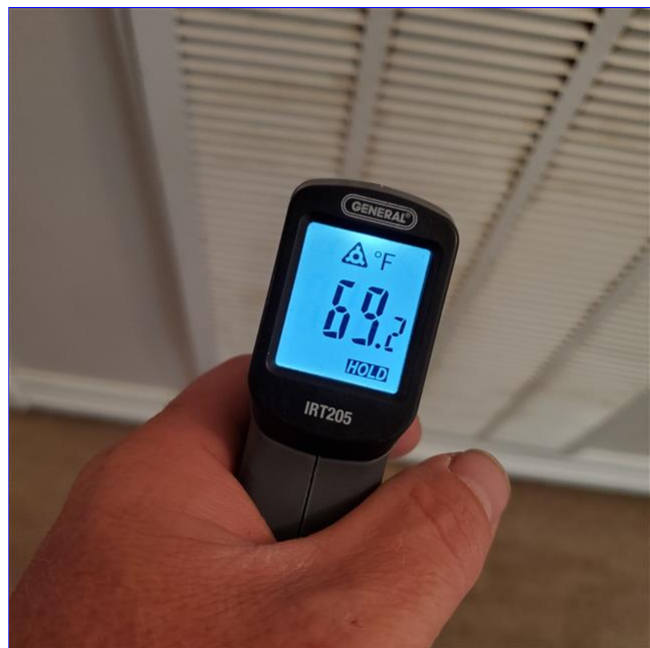
B. Item 1(Picture) The return air temperature was approximately 69 degrees. There should be a 14 to 22 degree drop between return and Supply air temperature.

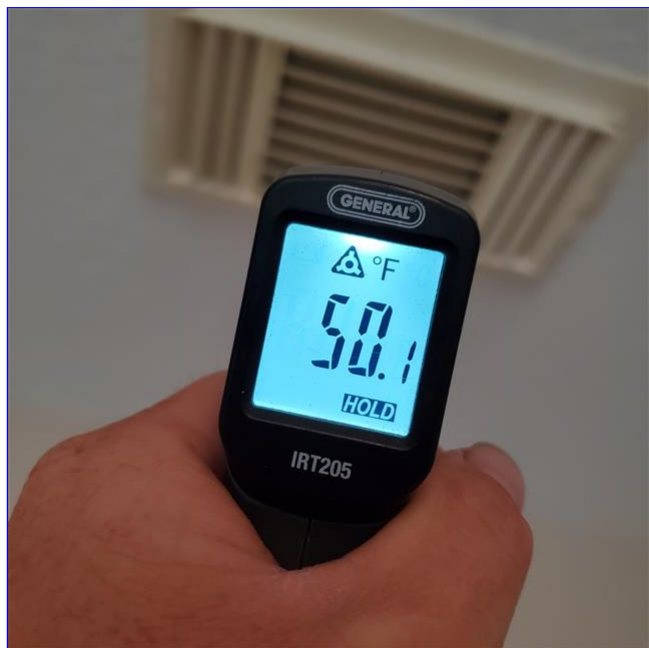
B. Item 2(Picture) Supply air temperature was approximately 50 degrees. There was a 19 degree drop between return and supply air temperature, indicating the cooling equipment was cooling adequately at time of inspection.

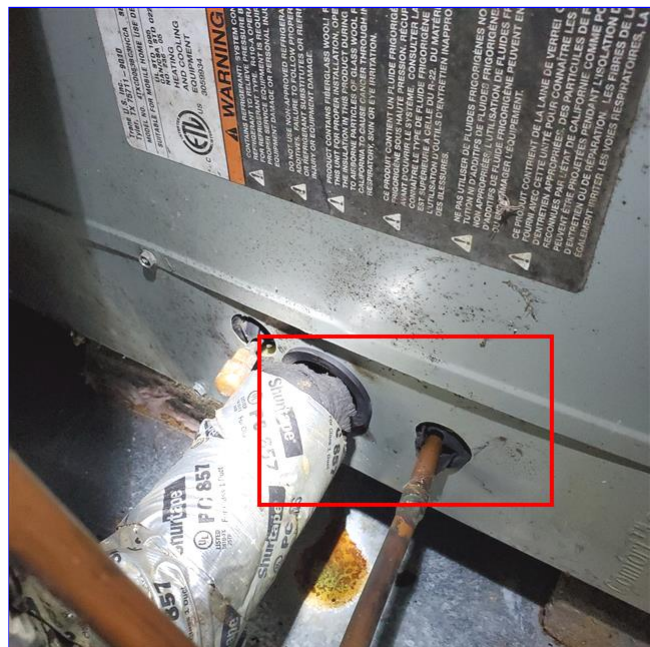
B. Item 3(Picture) There are gaps around the coolant lines at the evaporator coil, in the attic, that need to be sealed to help prevent condensation in this area.

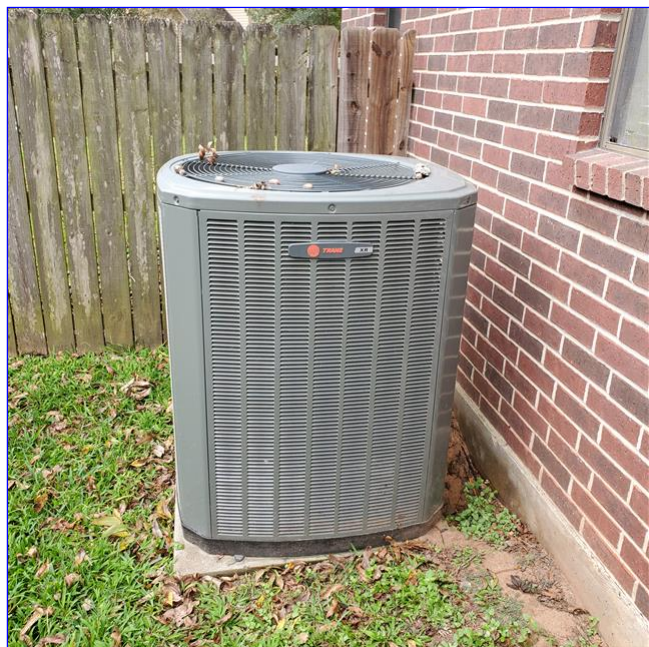
B. Item 4(Picture) General view of AC condenser. This unit was manufactured in 2015, typical life expectancy is 15 to 20 years.

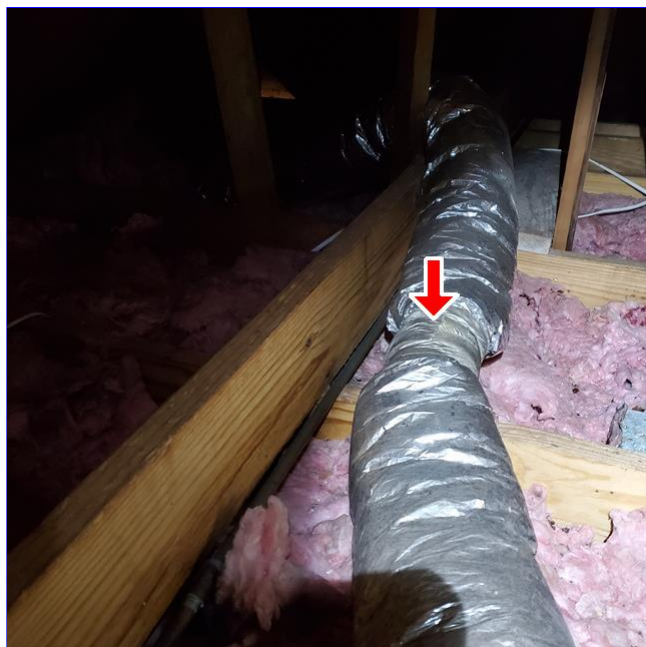
C. Item 1(Picture) Constricted duct above the hallway bedroom to the right at the end of the hallway. This can cause poor air flow and condensation on/in duct and needs repair

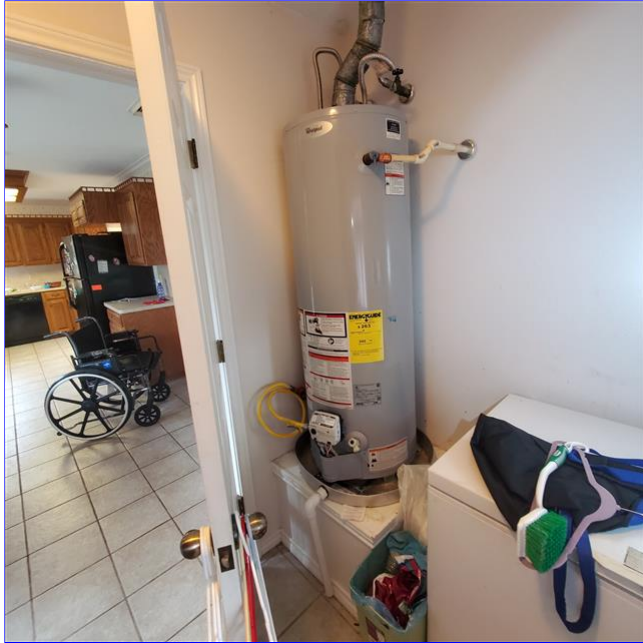
C. Item 1(Picture) General view of Whirlpool 40 gallon gas water heater. this unit was manufactured in 2015, typical life expectancy is 8 to 12 years.

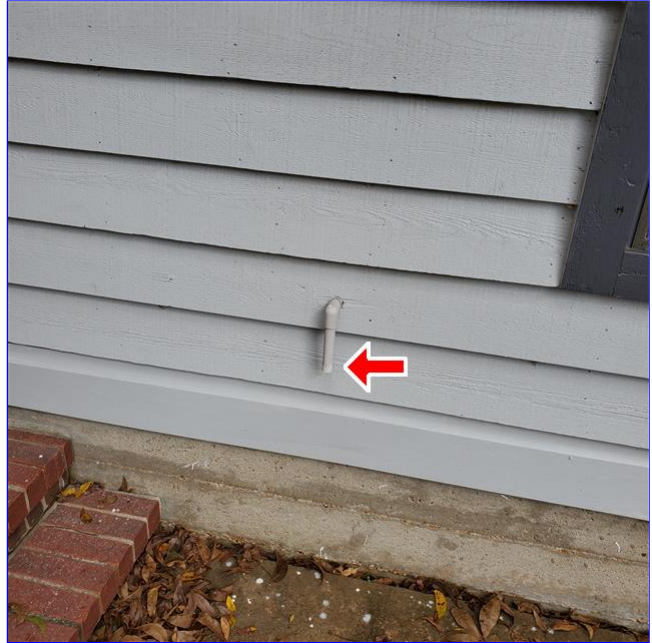
C. Item 2(Picture) TPR drain extension piping, at the back of the home, needs to be extended to within 6 to 24 in of the ground for safety.

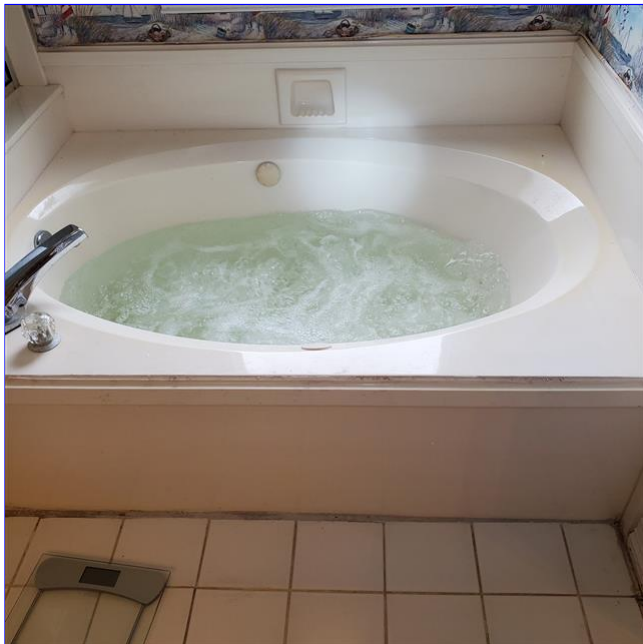
D. Item 1(Picture) The access panel for the HydroMassage tub circulation piping and pump is sealed close. we do not break this seal to help prevent damage to property and the pump motor and circulation piping was not inspected.

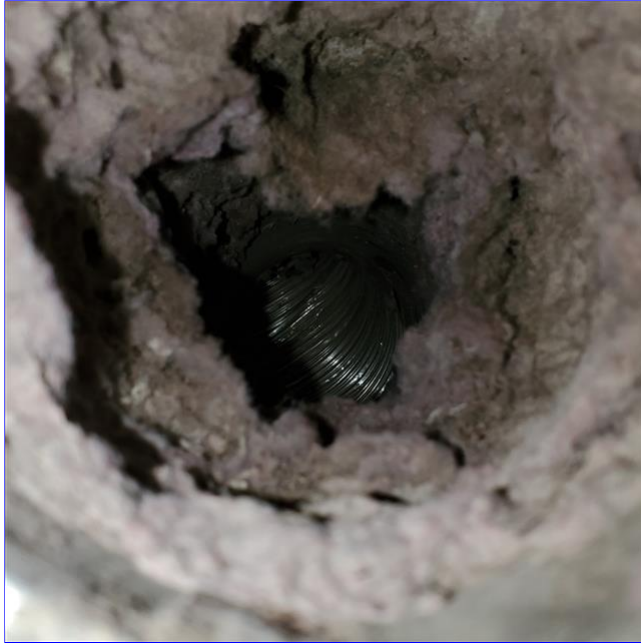
H. Item 1(Picture) The dryer exhaust is full of debris and needs to be cleaned to help prevent possible fire hazard.

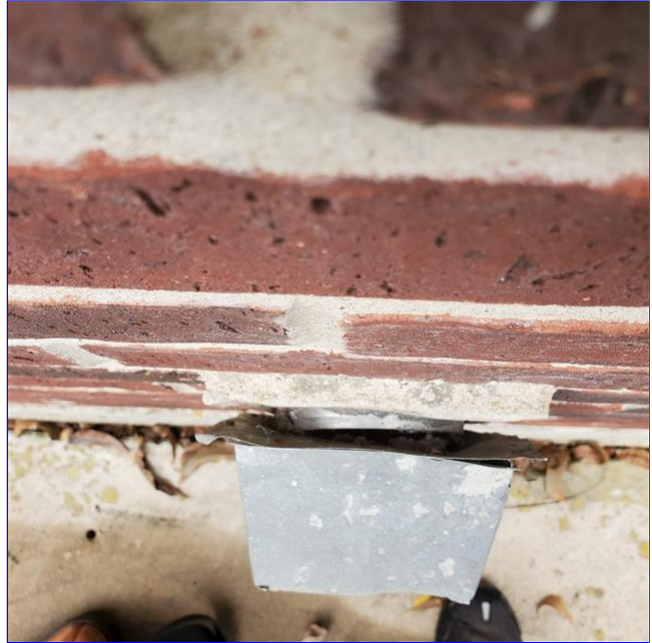
H. Item 2(Picture) The exterior of the dryer exhaust vent is loose and needs to be secured.
