PROPERTY INSPECTION REPORT

Prepared For: Luigi Molina
(Name of Client)

Concerning: 3106 Cherry Hills Missouri City, Tx. 77459
(Address or Other Identification of Inspected Property)

By: Arturo Marquez TREC PI#2685 10/06/2020
(Name and License Number of Inspector) (Date)

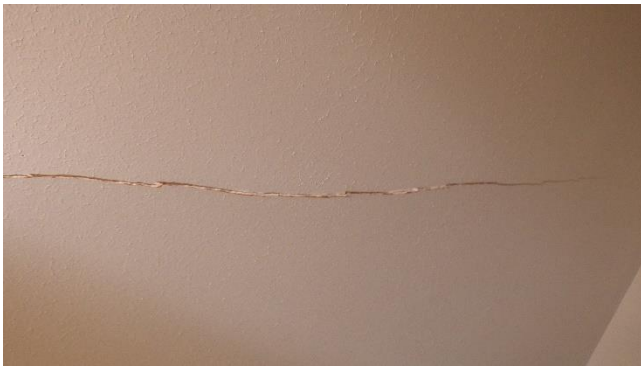
Comments: Cracks were observed on the living room wall and on hallway ceiling, see sample picture. **However, it is this inspector's opinion this foundation is currently performing its' intended function.** None of the traditional signs of foundation problems/excessive differential movement were observed such as: doors and windows out-of-square, doors and windows sticking, or gaping at attic framing members.

A monitoring and maintenance program should be initiated in an effort to minimize possible future differential movement.

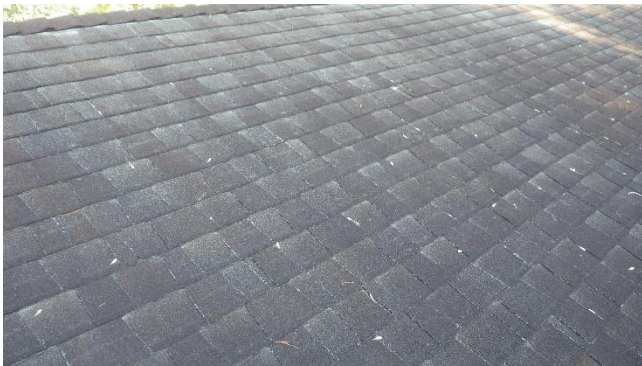
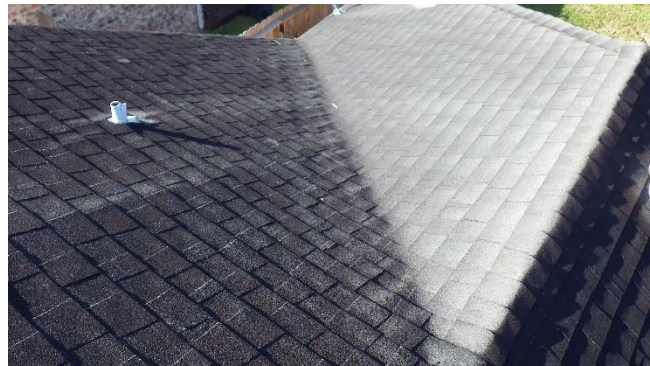
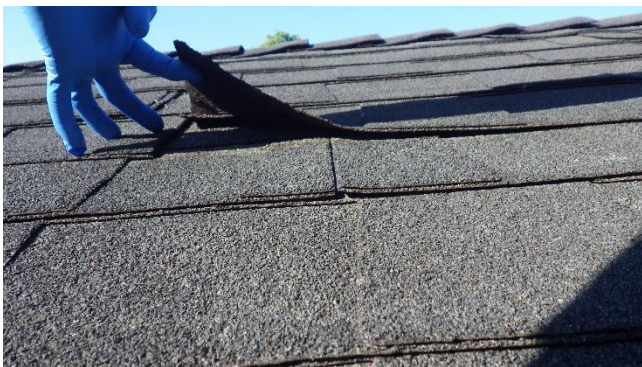
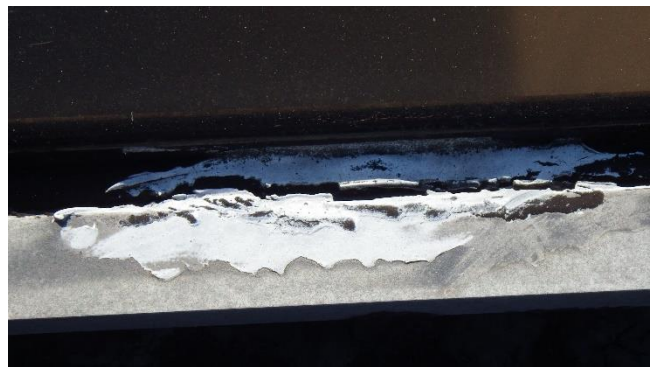
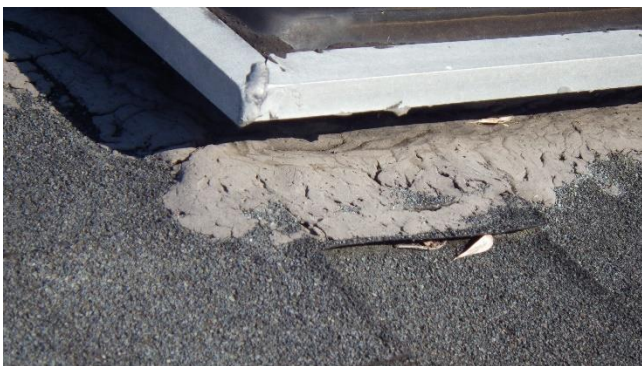
Comments: It is this inspectors opinion the amount of discoloration, granular loss, and brittleness indicate this roof coverage to be within its last quarter of expected useful lifespan. The overall condition of this roof covering was observed currently operable, see sample pictures.

However, inadequately adhered and easily lifted tab ends were observed, see sample picture.

The temporary repair using sealant around the skylight was observed deteriorated, see sample pictures.

Need to contact a qualified roofer for further evaluation regarding any necessary corrections.

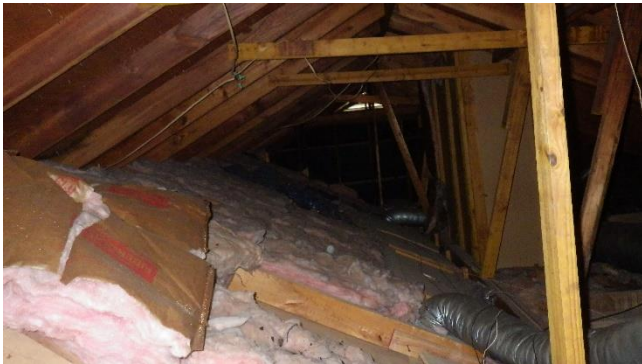
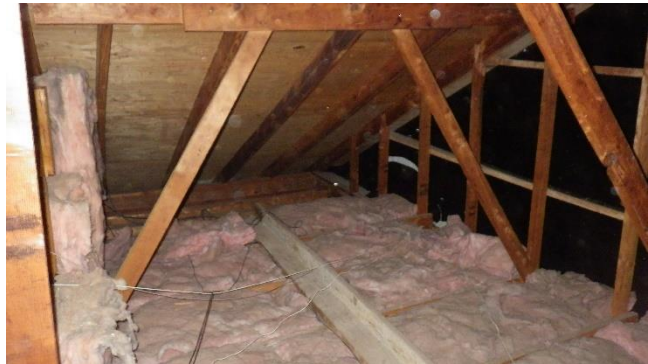
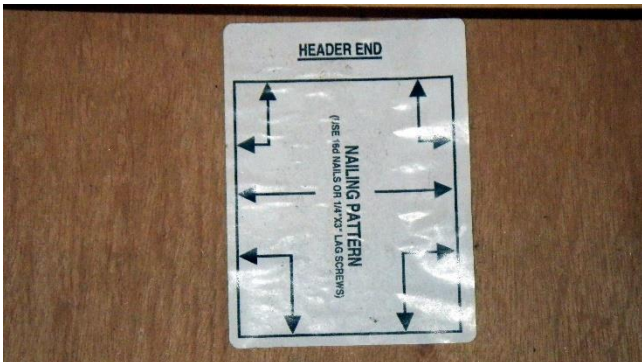
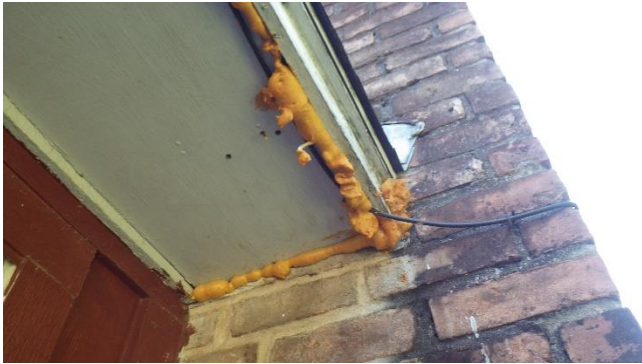
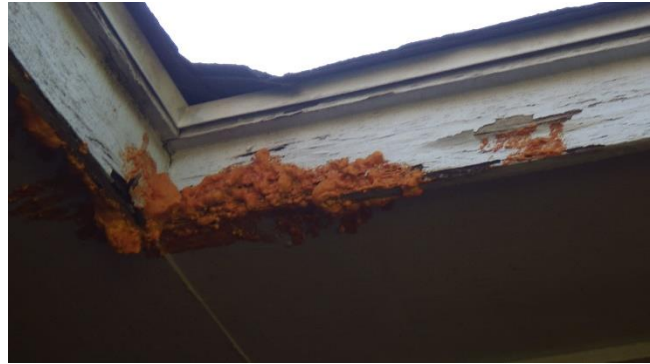
Comments: Visible components were observed currently operable, [see attic sample pictures](#).

Torn screen observed on left gable vent.

Deteriorated paint deteriorated and sealant, and minor moisture damage with temporary foam repairs were observed at rear soffit and fascia, [see sample pictures](#).

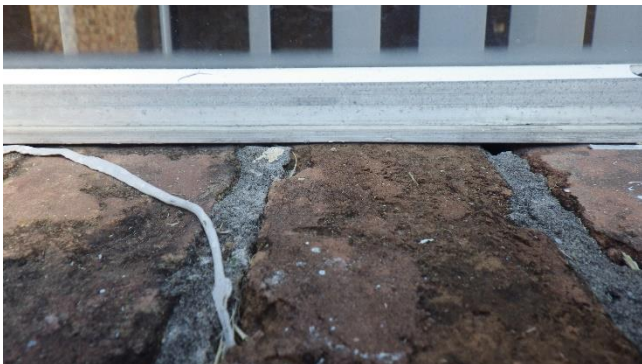
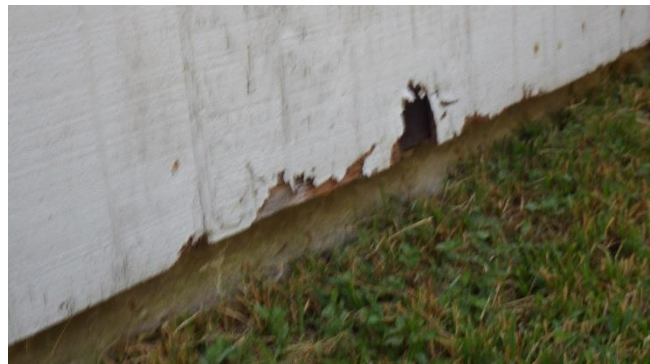
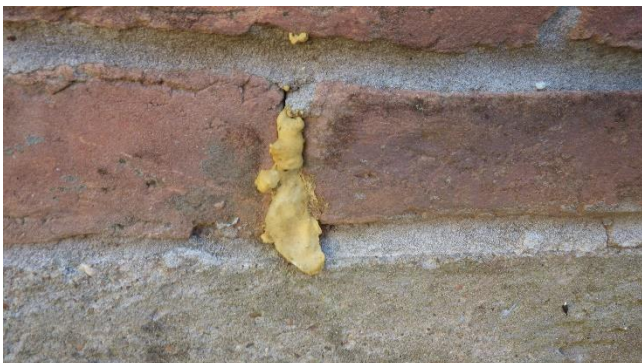
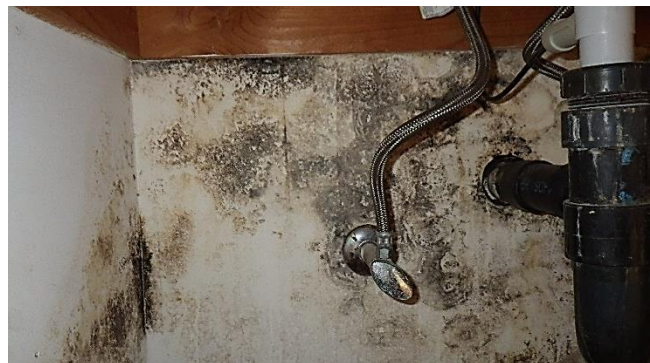
Deteriorated paint and some minor moisture damage were observed at front porch area siding and rear siding, see sample picture.

Several weep holes were observed covered up, see sample picture; weep holes are necessary to facilitate proper ventilation of wall cavity.

Evidence of possible microbial growth was observed underneath spare bathroom sinks, see sample picture; if this is a concern, a proper mold inspection should be performed.

Moisture stains and/or moisture damage were observed in master bathroom on baseboards and lower wall next to tub.

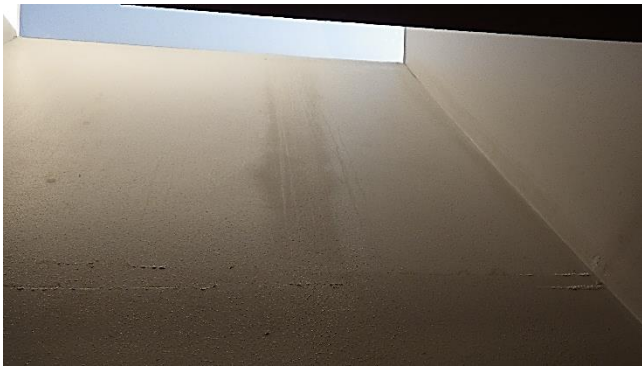
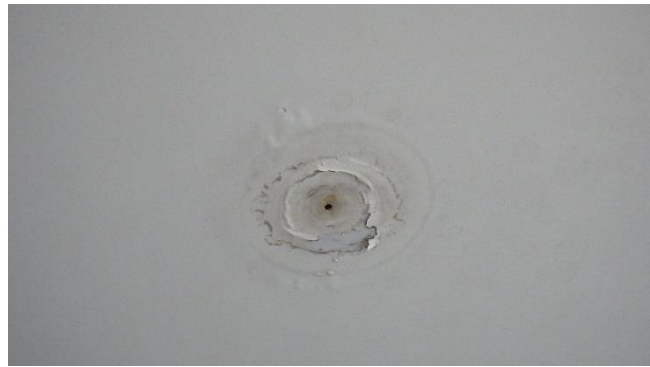
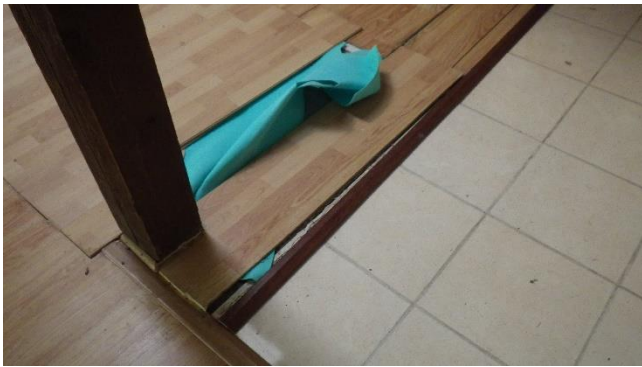
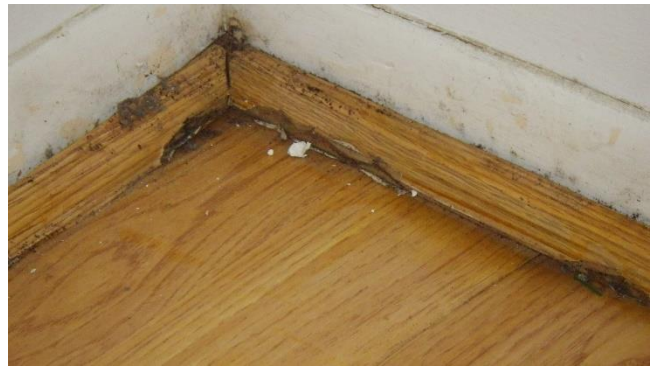
However, moisture stains were observed underneath skylight and on garage ceiling, see sample pictures. This indicates possible roof or plumbing leaks; further leak investigations should be performed.

Damaged and/or loose floor covering was observed in dining room, see sample picture.

Moisture damage and warped floor covering were observed in front right bedroom closet, see sample picture.

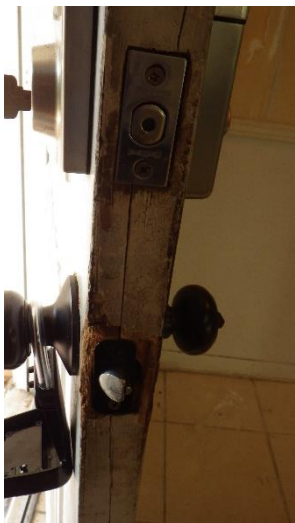
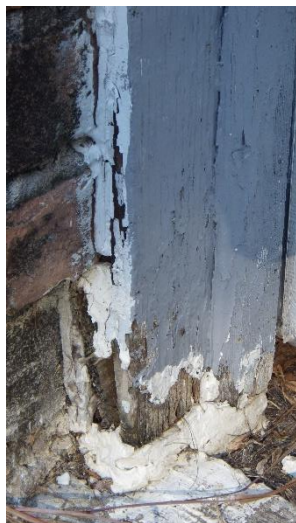
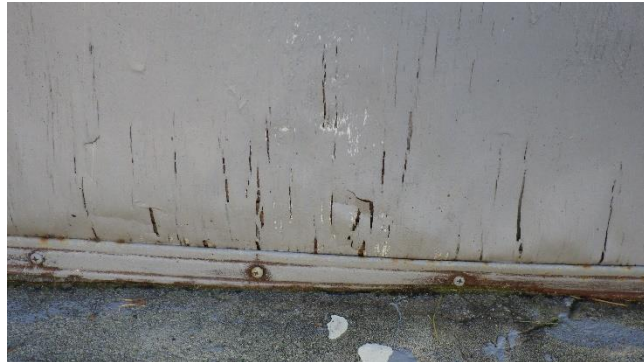
However, the front entrance door is cracked damaged along door style, see sample picture.

Deteriorated paint, deteriorated sealant, and/or some moisture damage were observed on garage overhead door jamb and trim, and on garage side exit door panel, see sample pictures.

Cracked/bent and/or corrosion damage were observed on garage overhead door upper and lower panels.

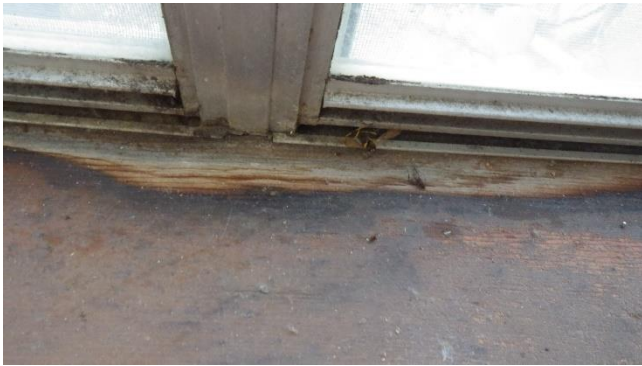
Deteriorated paint and/or moisture stains were observed on den rear window sills and casings, see sample picture. This indicates possible leaks and or condensate problems.

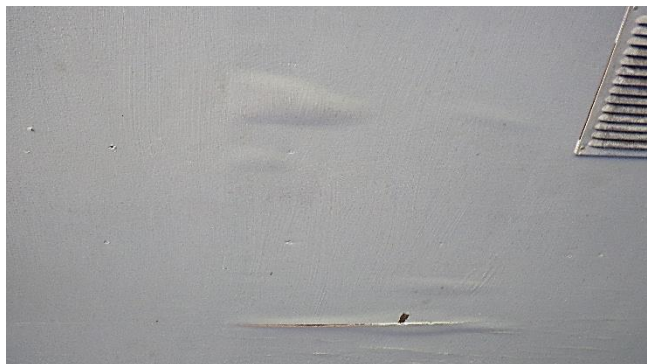
However, deteriorated and/or blistering paint were observed on rear patio ceiling, see sample picture. This indicates a possible roor leak.

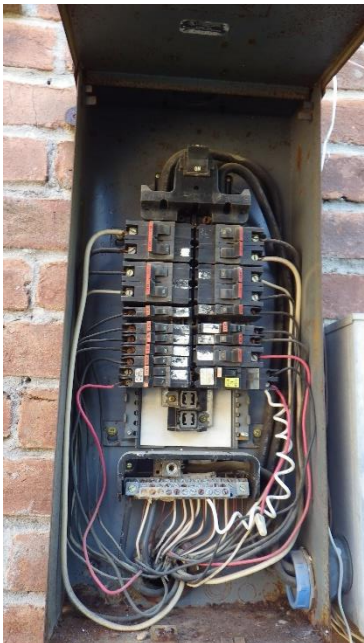
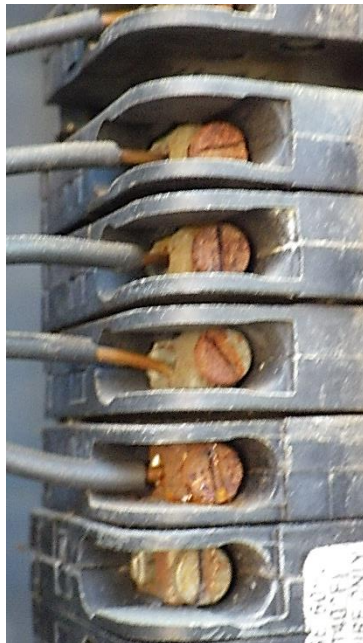
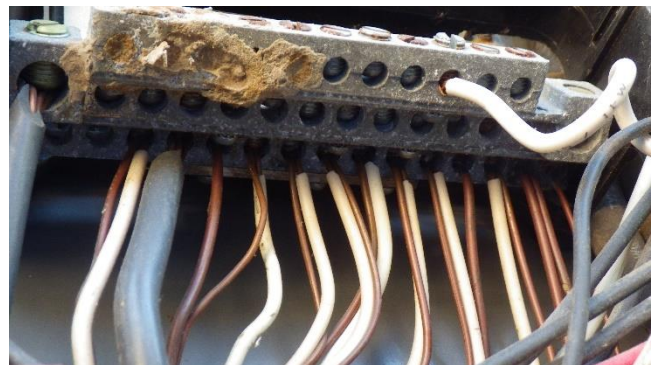
A. **Service Entrance and Panels** *Comments:* Load calculations were not performed. This is a Federal Pacific panel box with a 125amp main breaker, see sample picture. System was observed currently operable.

The rust observed on several circuit wire/breaker connections, see sample picture, indicates possible moisture intrusion to cabinet interior.

No bonding was observed at gas or water piping.

The grounding cable is loose/not secured to grounding rod.

These items present potential safety hazards.

Need to contact a qualified electrician for further evaluation regarding any necessary corrections.

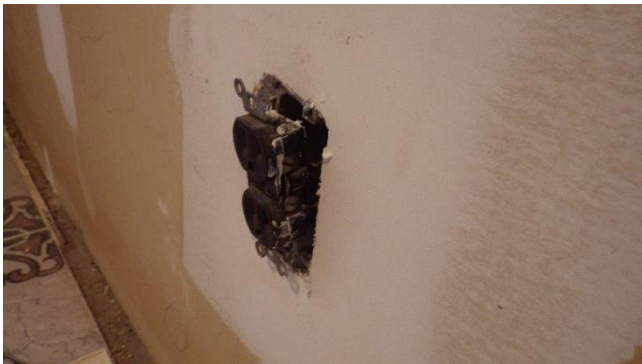
Loose/unsecured receptacles were observed in dining room and in breakfast area, see sample picture.

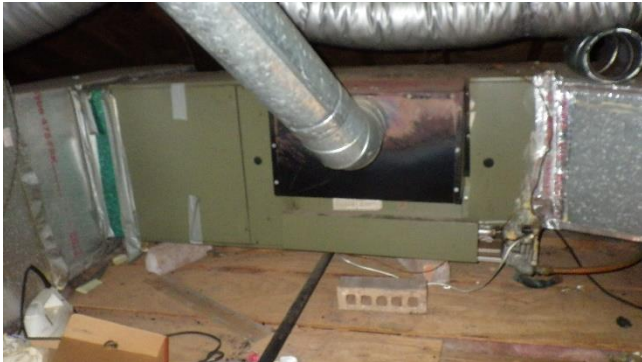
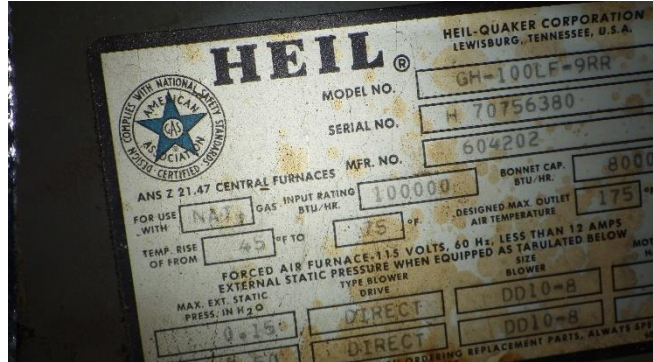
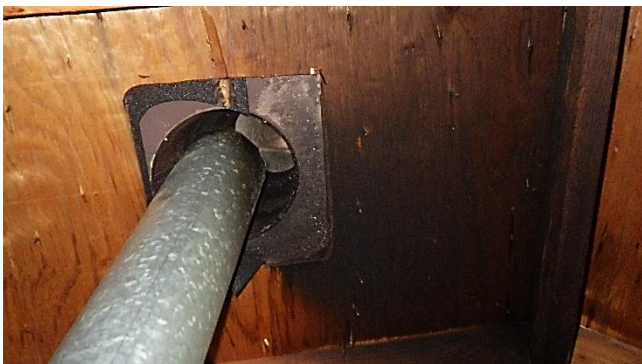
The vent stack does not vent adequately to the exterior, [see sample picture](#); and, no combustion cap observed at vent termination.

The copper gas branch line should be replaced with a proper flexible branch line.

Unit lacks a sediment trap at gas line connection.

Need to contact a qualified technician for further evaluation regarding any necessary corrections.

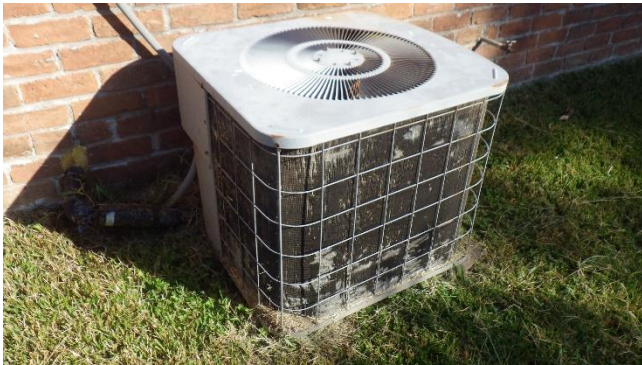
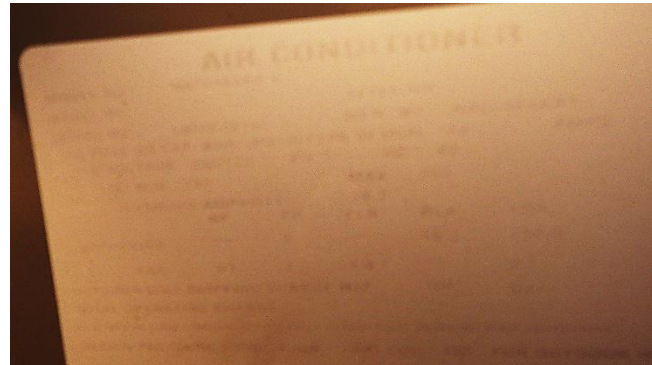
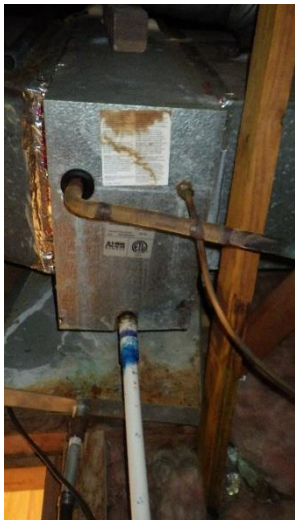
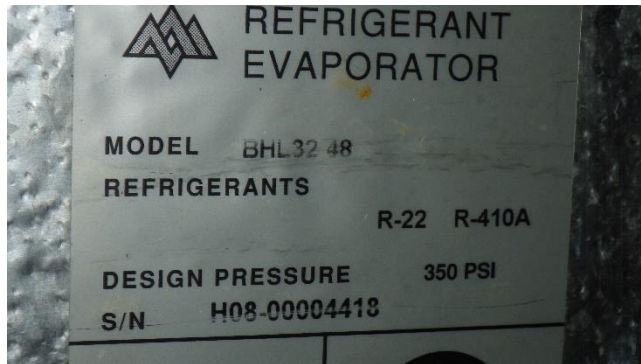
Comments: The I.D. plate on condenser was not adequately legible, see sample pictures. The I.D. plate on coil indicates it to be a 2008 model, see sample pictures. A 22 degree temperature differential reading (46F.-68F.) was detected between the upstairs supply and return. System was observed currently operable.

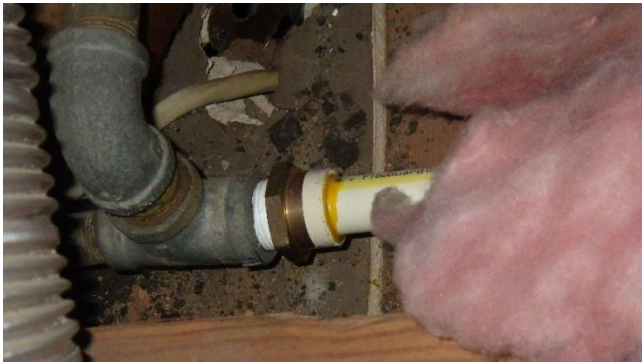
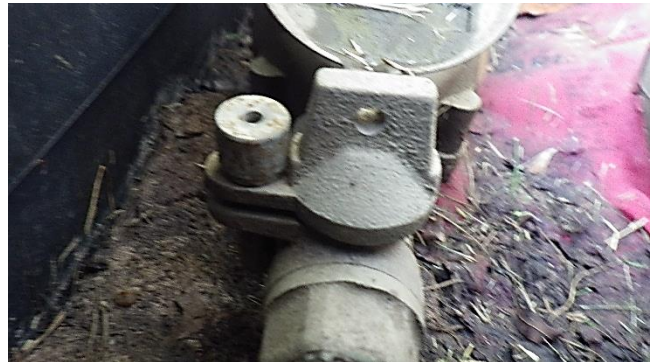
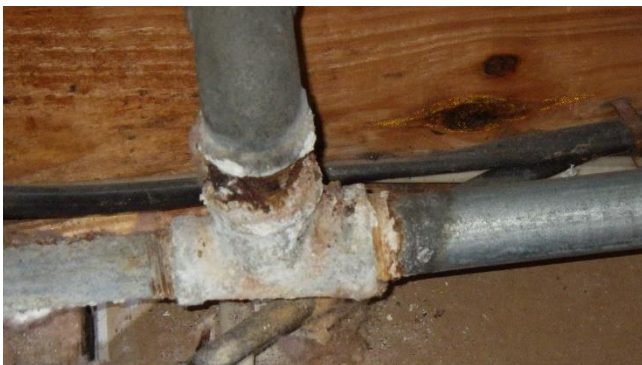
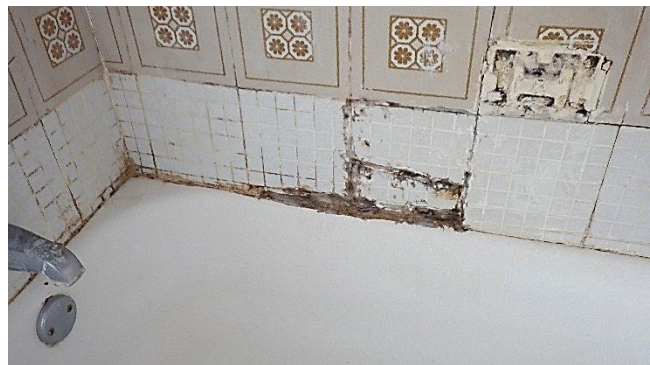
Comments: Partially visible galvanized and some cpvc water supply lines were observed, [see sample picture](#). A lock was present at the meter valve, [see sample picture](#); this prevented a proper operational status inspection of system. **System and fixtures should be properly evaluated when water is made available.**

However, evidence of a possible leak was observed at a water line connection located in right attic area, [see sample picture](#).

Damaged and/or missing wall tile and deteriorated grout were observed around master bathtub, [see sample picture](#).
