**SUMMARY**  
1321 Altavilla Ln, League City TX 77573  
Noel Perkins  
September 22, 2020

Keith Holderfield  
TREC #24000  
Bryan & Bryan Inspections  
(281) 484-8318  
office@inspectorteam.com

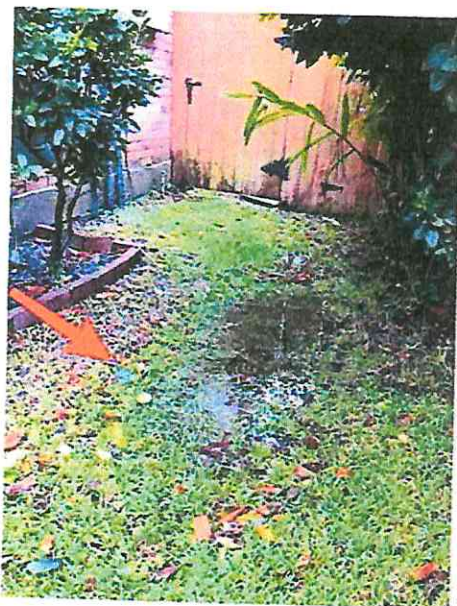
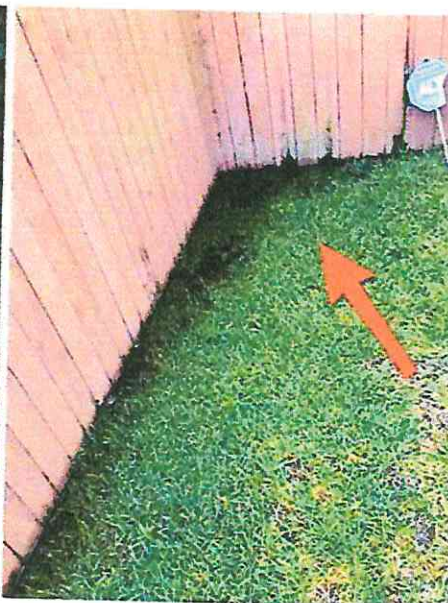
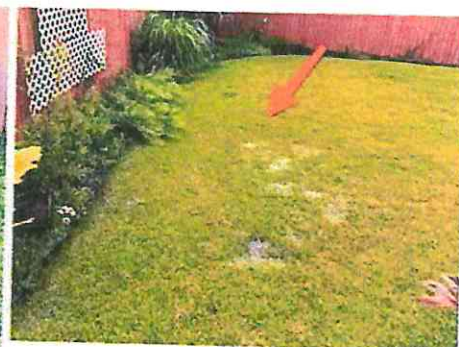
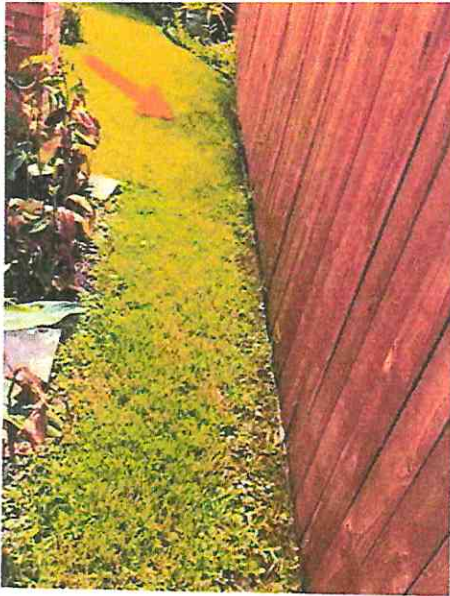
REAR, LEFT & RIGHT EXTERIOR

**GRADING & DRAINAGE: STANDING WATER**

Standing water was observed which could indicate poor drainage and/or grading. Monitoring and/or having landscaping contractor remedy drainage/grading is recommended. Grading & Drainage:

Contact a qualified landscaping contractor

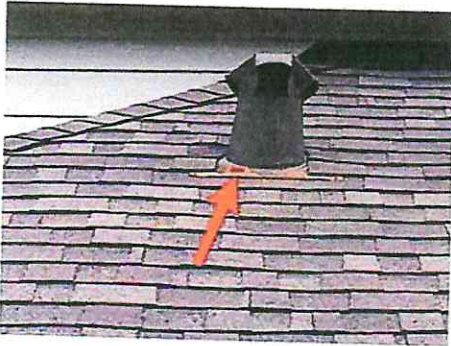
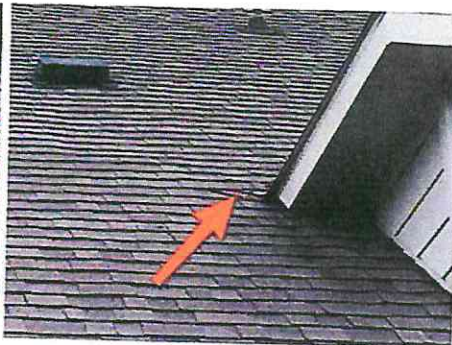
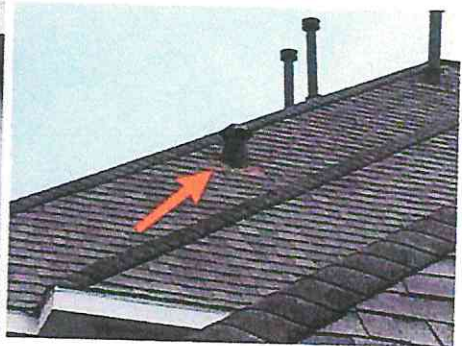
REAR SIDE

**FLASHING: RUSTED FLASHINGS**

Rusted flashings were present. Remedy as needed.

Contact a qualified roofing professional.

*Corrected*

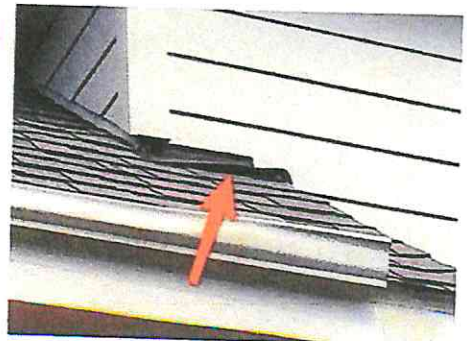
REAR SIDE

**FLASHING: LIFTED**

Flashing sections are lifted. Remedy as needed.

Contact a qualified roofing professional.

*repaired*

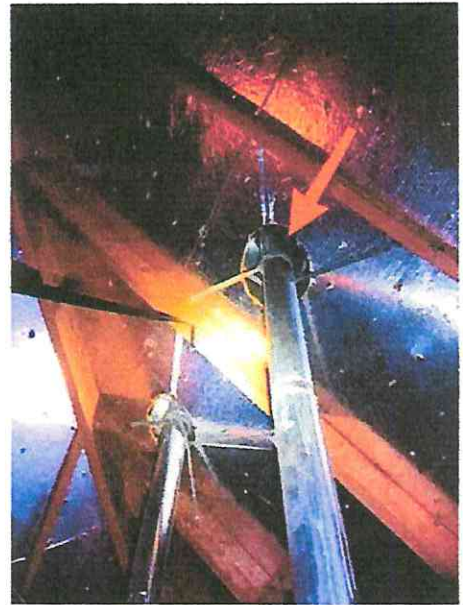
**FLASHING: DAYLIGHT VISIBLE**

Daylight was visible in the attic around vent jacks or flashings. This can indicate poor weatherproofing and should be investigated further by a qualified roofing professional.

Contact a qualified roofing professional.

*repaired*

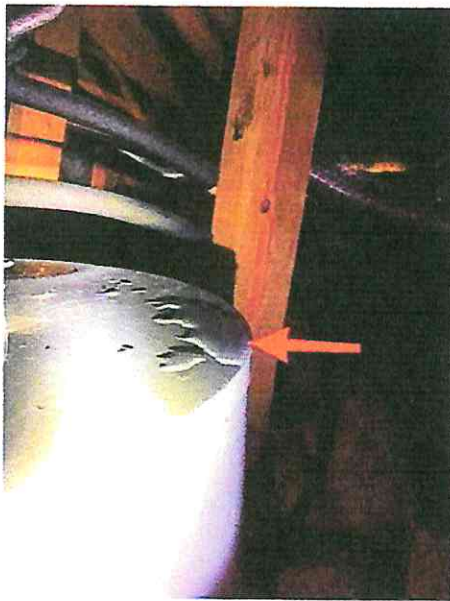
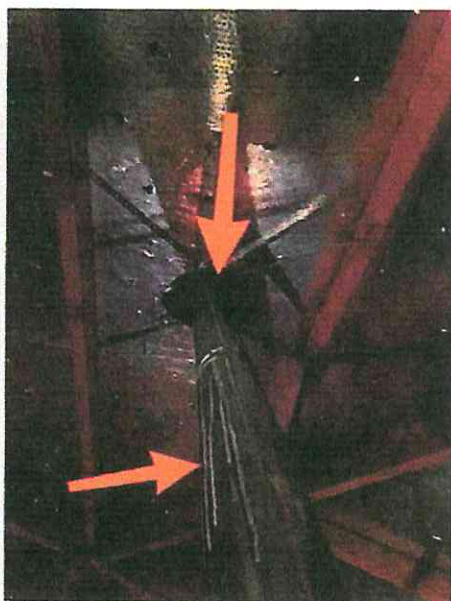
WATER HEATER

**SHEATHING: EVIDENCE OF PRIOR MOISTURE**

Evidence of prior moisture intrusion was observed. Evaluate and remedy as needed.

Contact a qualified roofing professional.

*repaired*

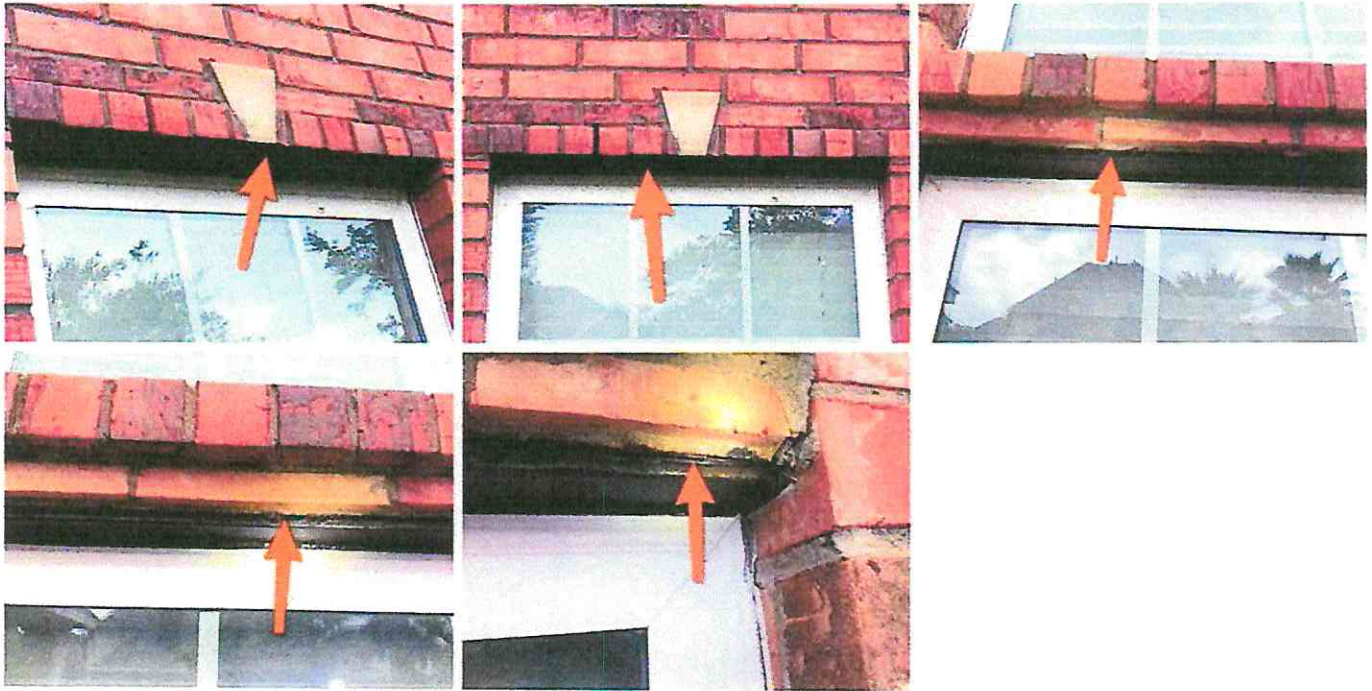
FRONT & REAR EXTERIOR

**EXTERIOR MASONRY: RUSTED LINTELS**

Rusted lintels were present at the time of inspection.

Contact a qualified masonry professional.

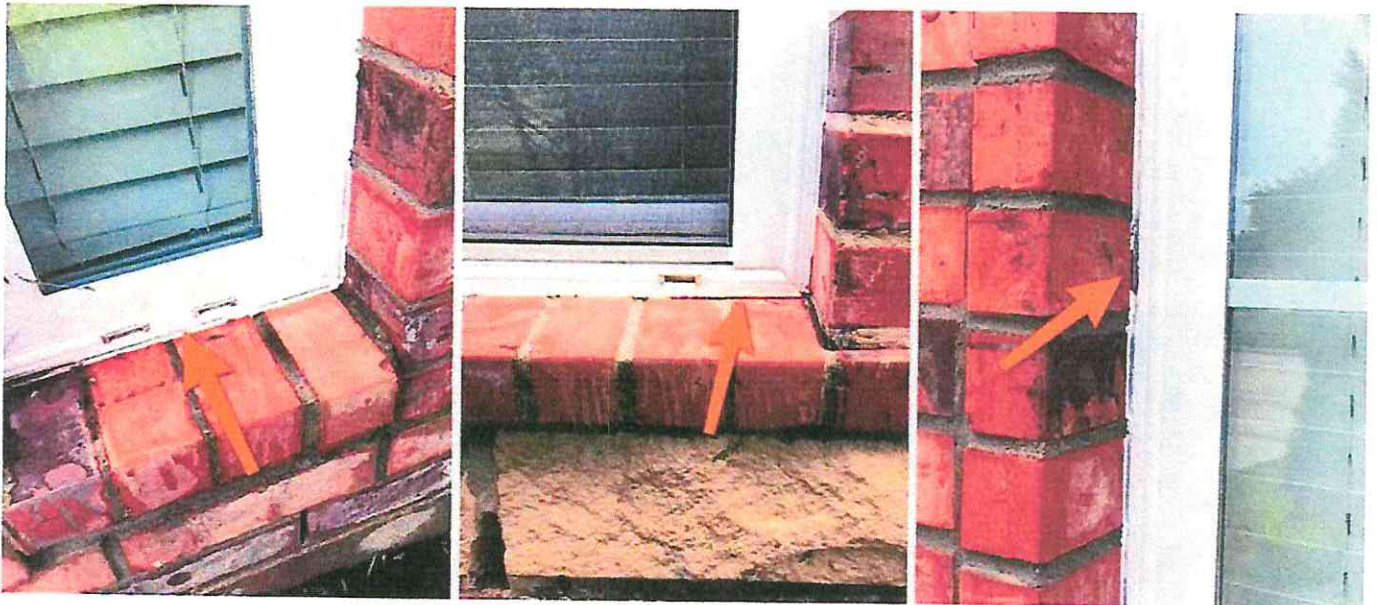
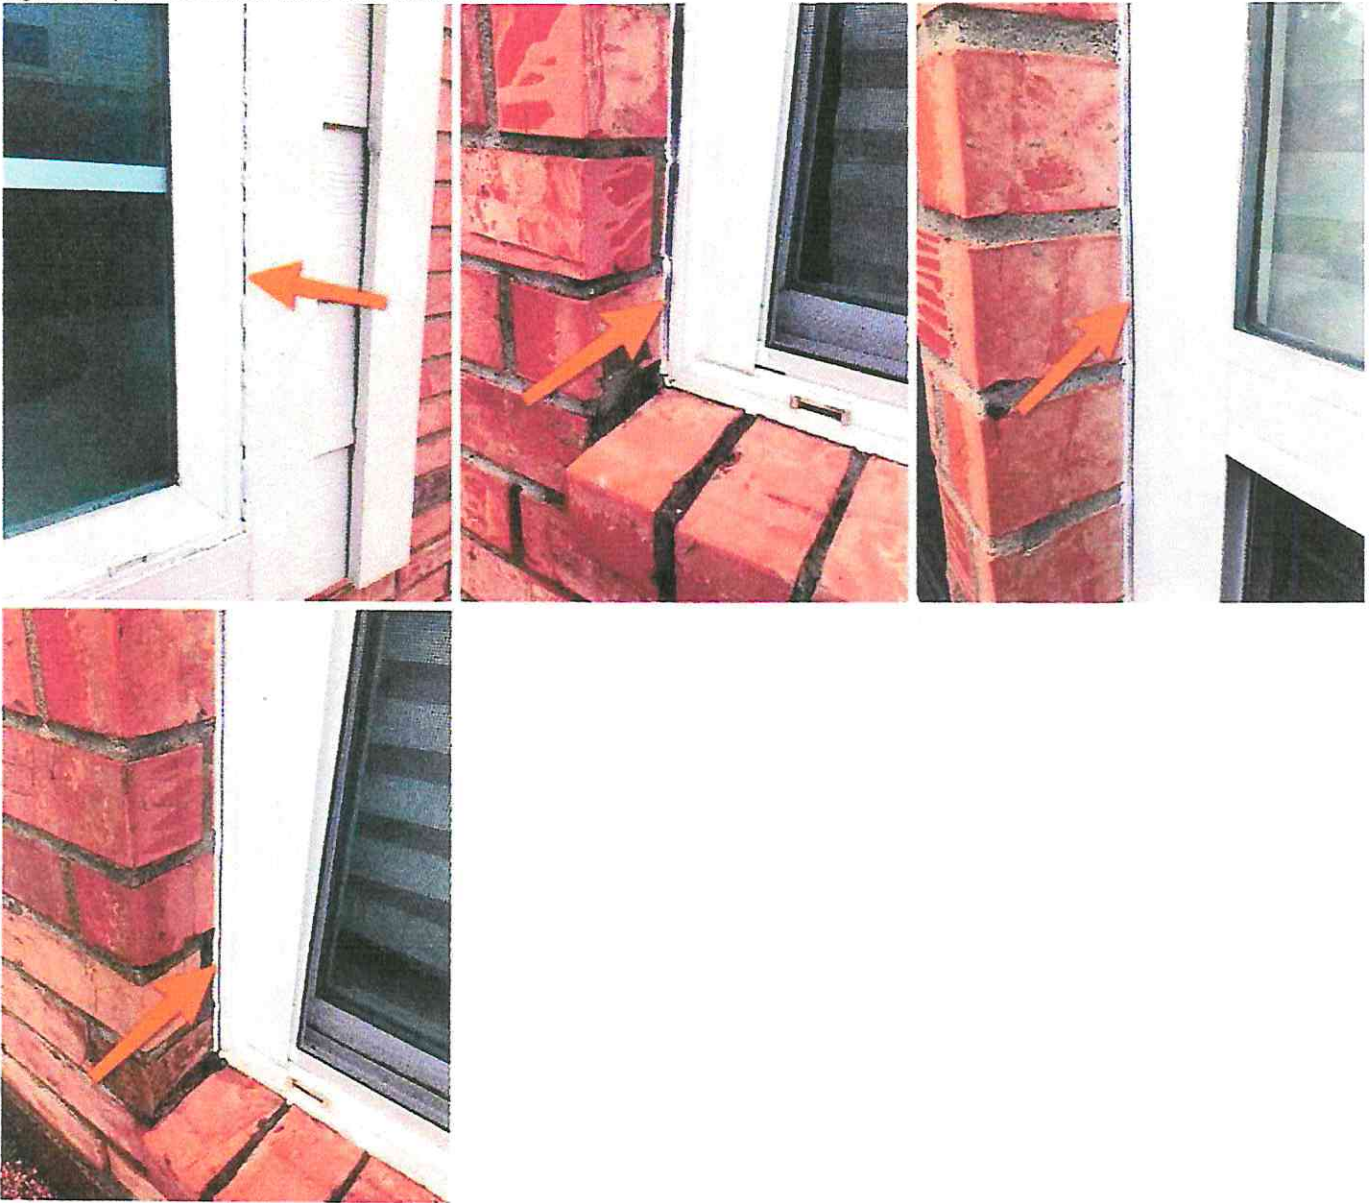
**EXTERIOR- CAULKING: DETERIORATED/MISSING AROUND WINDOW FRAMES**

Caulking around window frames was missing or deteriorated. Caulking around window frames is an important barrier to moisture intrusion. Most exterior sealants have a lifespan of 5 to 8 years and should be regularly maintained with that lifespan in mind. Evaluate and remedy as needed.

Recommendation  
Contact a qualified professional.

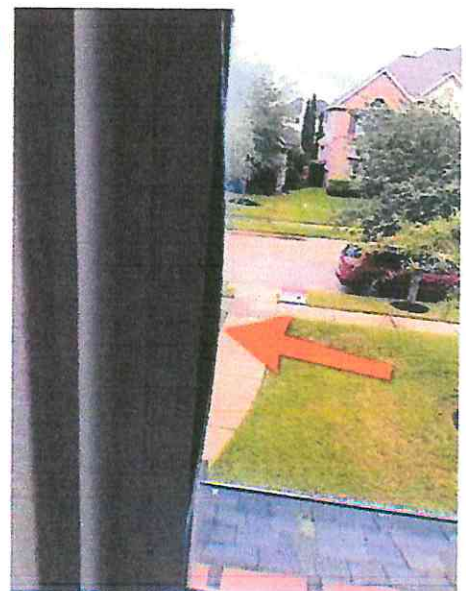
2ND FLOOR MIDDLE BEDROOM

**EVIDENCE OF A FAILED SEAL**

Observed condensation between the window panes, which indicates a potentially failed seal. Evaluation and remediation by a window professional as necessary.

Contact a qualified window repair/installation contractor.

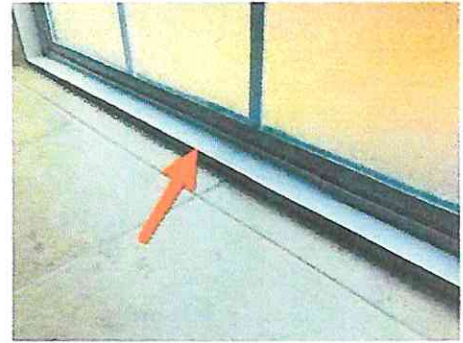
PRIMARY BATHROOM

**EVIDENCE OF WATER LEAK**

There is evidence of moisture penetration observed at window(s). Evaluate and remedy as needed.

Contact a qualified window repair/installation contractor.

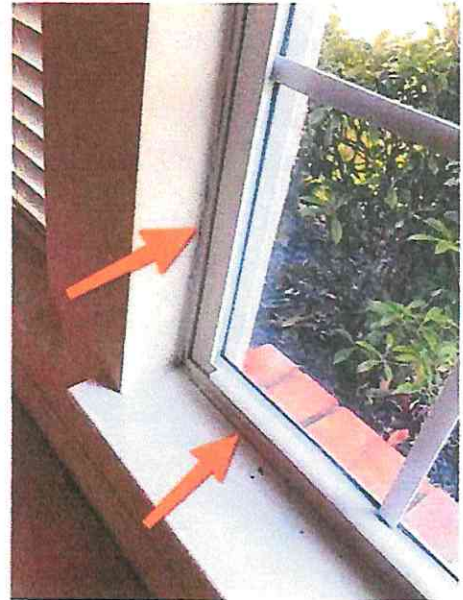
MULTIPLE LOCATIONS

**CAULKING: MISSING/DAMAGED**

Contact a qualified professional.

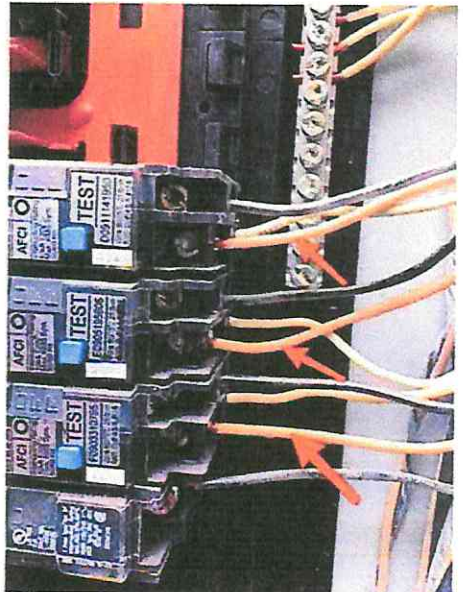
**WHITE WIRES NOT MARKED**

White wires connected to breakers are not marked with black or red electrical tape to indicate that they are "hot". Remedy as needed.

Contact a qualified electrical contractor.

*evaluated by elec.*

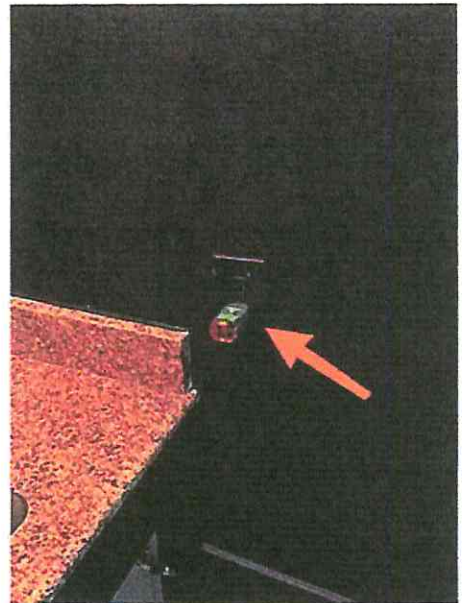
THEATER ROOM

**RECEPTACLES: NO POWER**

Receptacle had no power. Evaluate and remedy as needed.

Contact a qualified electrical contractor.

*repaired  
replaced*

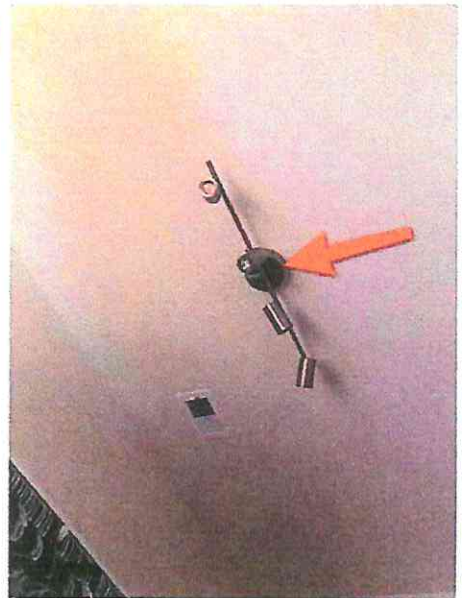
PRIMARY BATHROOM CLOSET

**LIGHT: INOPERABLE**

One or more light fixtures were not operating at time of inspection. Cause was not determined. Remedy as needed.

Contact a qualified electrical contractor.

*working -  
replaced  
light bulbs  
Replaced w/ led  
high eff. light*

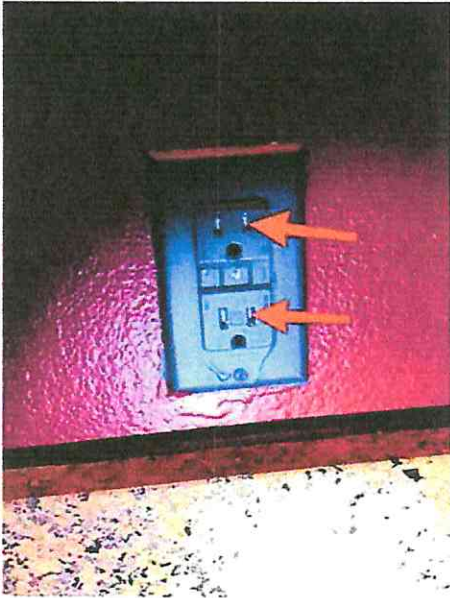
THEATER ROOM

**RECEPTACLES: DEBRIS IN RECEPTACLE**

Debris was observed in a receptacle. Evaluate and remedy as needed.

Contact a qualified professional.

*replaced*

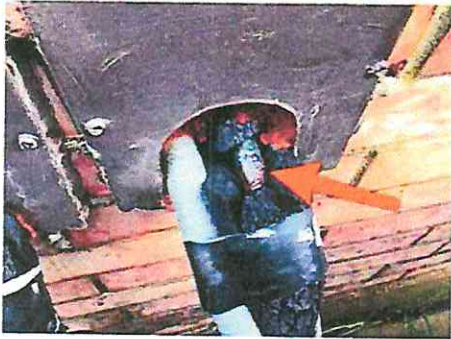
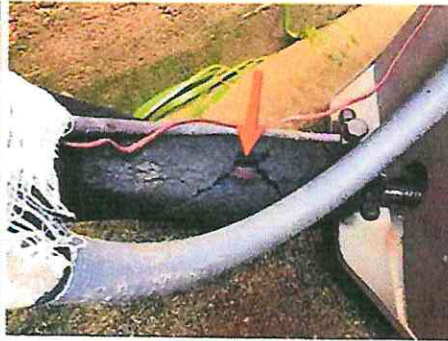
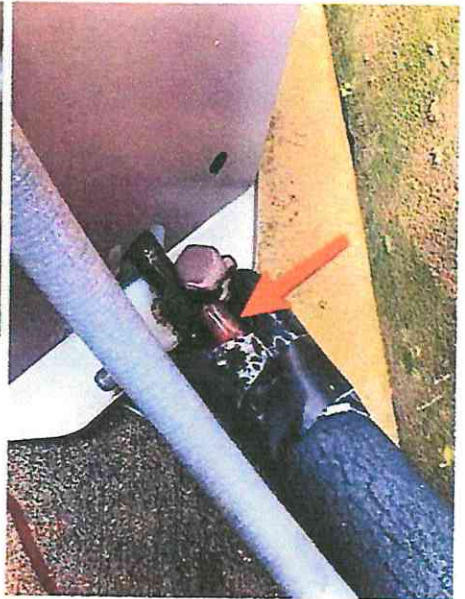
**CONDENSER: INSULATION MISSING OR DAMAGED ON REFRIGERANT LINES**

Missing or damaged insulation on refrigerant line can cause energy loss and condensation. Remedy as needed.

Contact a qualified HVAC professional.

*Completed Repair*

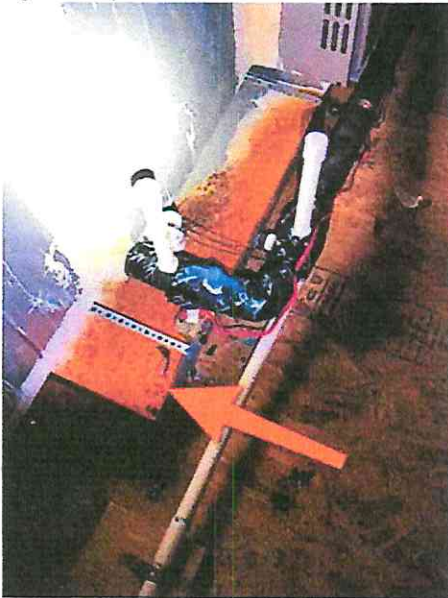
**CONDENSATE SYSTEM: RUSTED EMERGENCY PAN**

The emergency overflow pan is rusted. Further evaluation by an HVAC professional is recommended.

Contact a qualified HVAC professional.

*Evaluated  
See invoice  
Hvac*

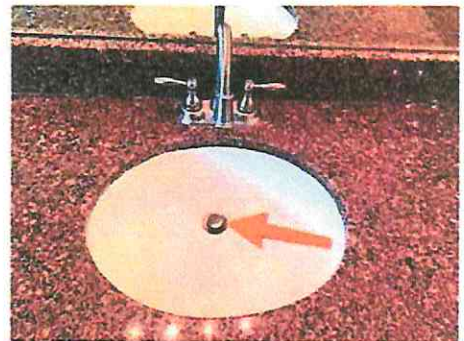
PRIMARY BATHROOM

**FIXTURE: DRAIN STOPS MISSING OR INEFFECTIVE**

Drain stops had issues that prevented them from working properly (holding water). Remedy as needed.

Recommendation  
Contact a qualified plumbing contractor.

*repaired*

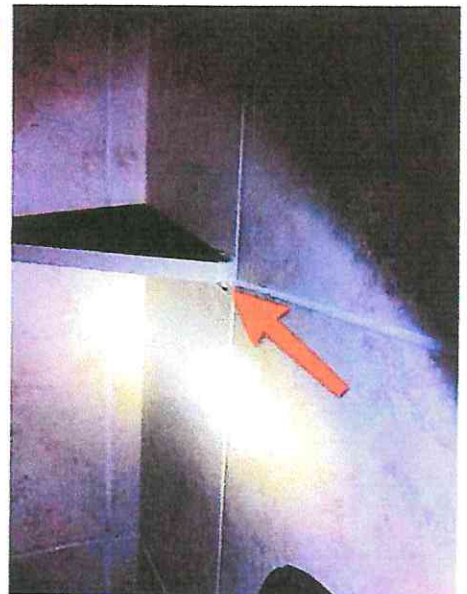
PRIMARY BATHROOM

**SHOWER: MISSING/DETERIORATED CAULKING OR GROUT**

Recommendation  
Contact a qualified professional.

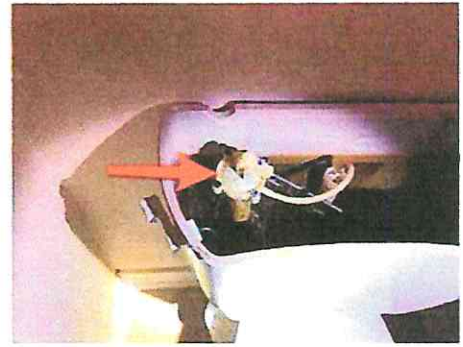
PRIMARY BATHROOM

**TOILET: LEAKING FILL VALVE**

The fill valve inside the commode tank was leaking. Remedy as needed.

Contact a qualified plumbing contractor.

*Repaired*

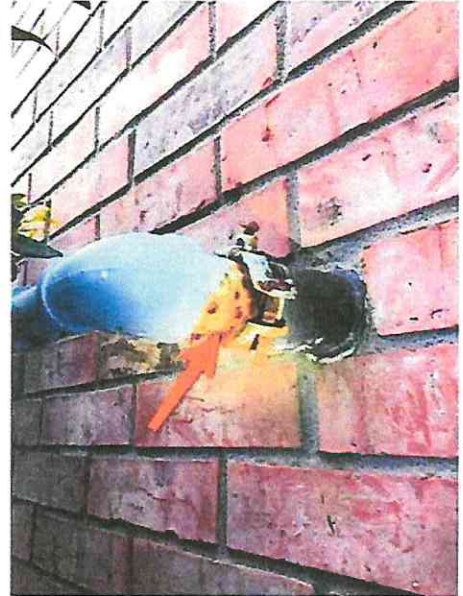
**GAS PIPING: RUSTED SERVICE LINE**

The gas service line running from the meter into the home was rusted.

Remedy as needed

Contact a qualified plumbing contractor.

*Corrected*

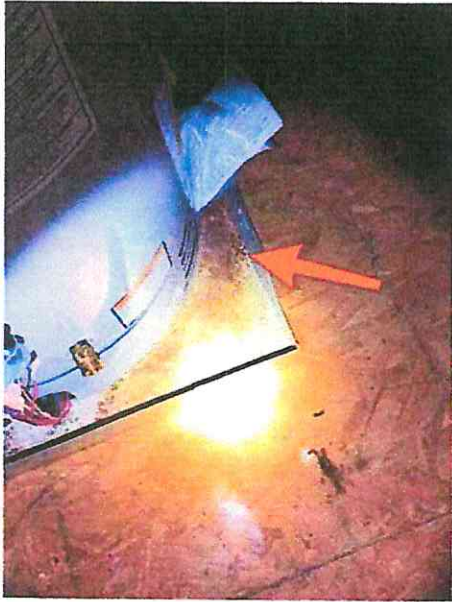
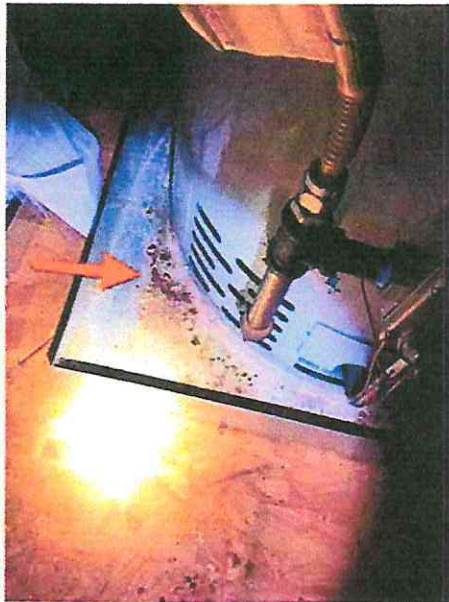
**TANK: RUST IN OVERFLOW PAN**

The overflow pan is rusting. The pan may not be watertight. Evaluation and remediation a qualified plumbing contractor is recommended.

Contact a qualified plumbing contractor.

*Replaced*
