Home Inspection - TREC

PROPERTY INSPECTION REPORT

Concerning: 106 Anchusa St Lake Jackson, TX 77566

By: Art Byrd - 1171

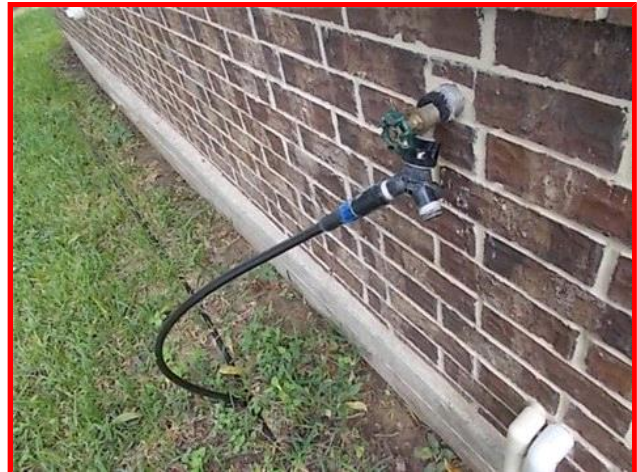
Missing Backflow Prevention at Hose Bib

Section	Remarks
Structural Systems	<p>Roof Covering Materials #1 Remarks: Limited assessment of the roof due to design.</p> <p>Doors (Interior and Exterior) Problem: The trim at the rear door is rotted. Corrective Action: Contractor to assess all trim around the home and repair / replace all affected trim. Obtain a cost estimate from a qualified and insured contractor.</p> <p>Porches, Balconies, Decks, and Carports Problem: A crack was observed in the rear patio. Corrective Action: Contractor to repair / seal the crack in the patio.</p>
Plumbing Systems	<p>Water Supply System and Fixtures Problem: Backflow prevention is missing at the rear faucet. Corrective Action: Plumber to install backflow prevention at all exterior faucets.</p>

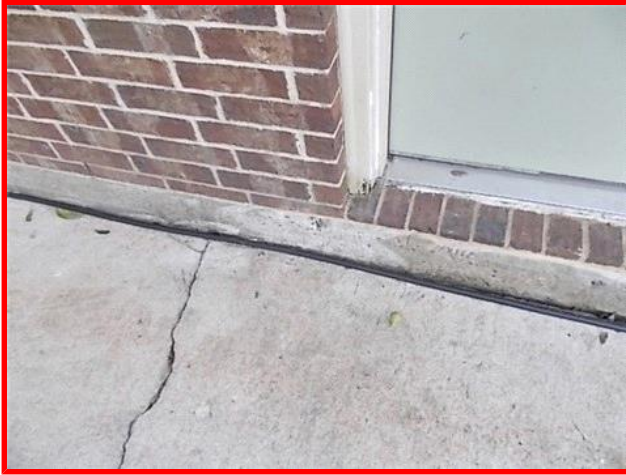
Rotted Trim at Rear Door & Crack in Rear Patio
