PROPERTY INSPECTION REPORT

Concerning: 7666 Buena Vista Street, Houston, TX 77087
(Address of Inspected Property)

By: Chris Jeansonne, TREC: PI 22922 10/15/2020
(Name and License Number of Inspector) (Date)

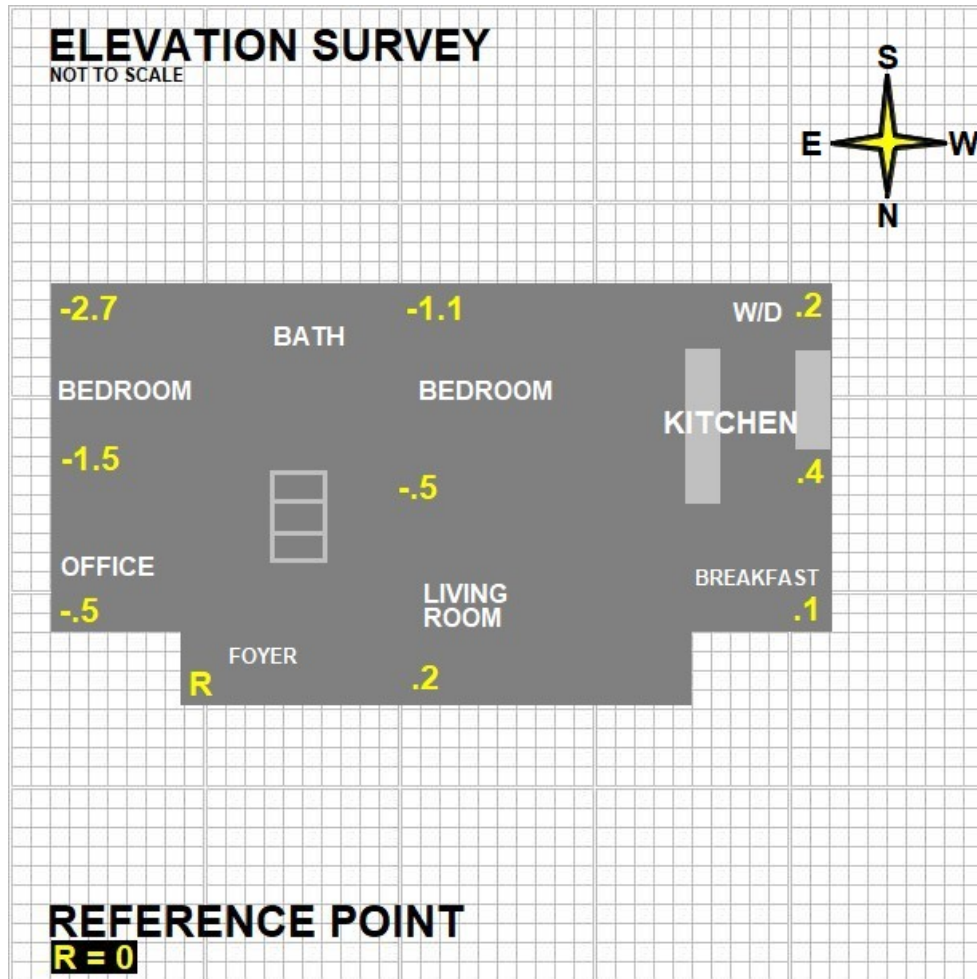
A foundation elevation survey was conducted during the inspection. The floorplan below represents data gathered using a Zip Level or similar instrument and adjusting for floor covering height differences. i.e. differences between tile, carpet and wood flooring(except step down to garage). Measurements are listed to the nearest 1/10th of an inch. Greatest variance was 3.1 inches.

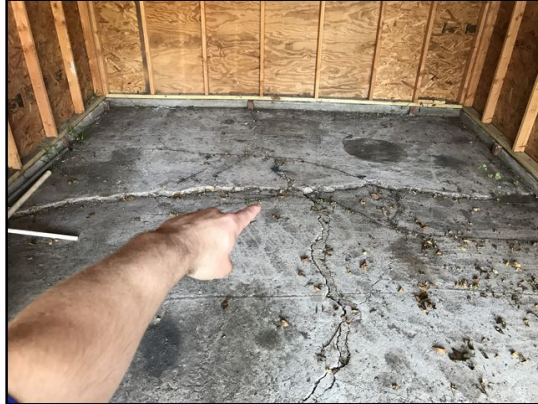
Differential movement/settlement of garage observed; Generally, garages lack adequate reinforcement to effect a proper repair for settlement; IE: It is generally not economically feasible to fix a bad garage foundation unless a total replacement is warranted.

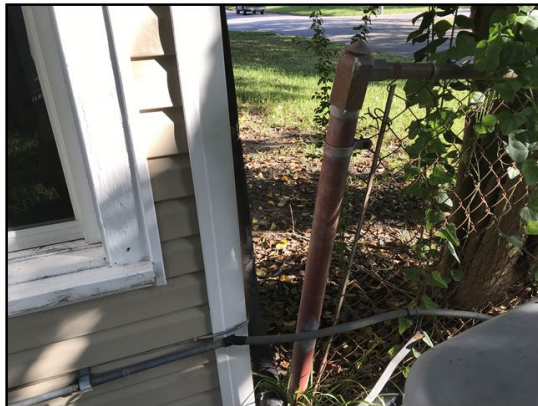
Recommend repair to areas of damaged/leaning back yard fencing and or gate.

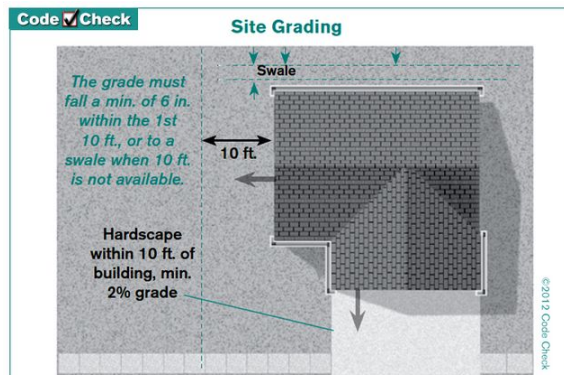
Soil grade and drainage patterns around some areas of the house do not appear to properly direct water away from the foundation to aid in controlling runoff water and could cause differential movement of the foundation or water penetration during heavy rains.

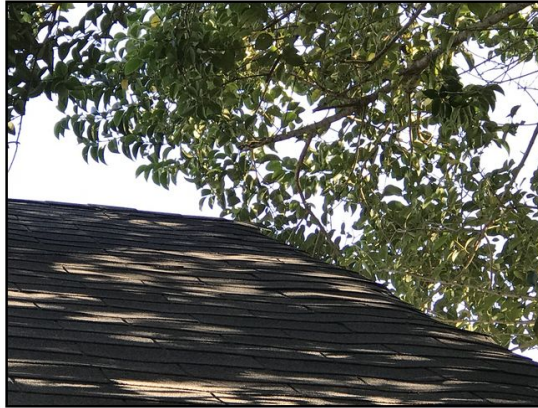
Tree limbs in contact with the roof can/ will damage the roof.

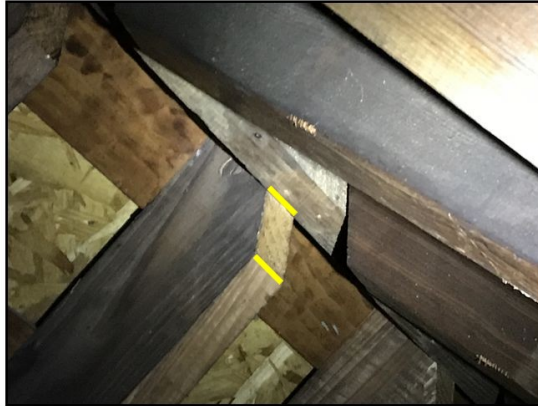
Ridge and/or valley board(s) not deep enough to support ends of rafters, recommend the addition of 2x4 below the bottom end of the ridge/valley board to support the end of rafters.

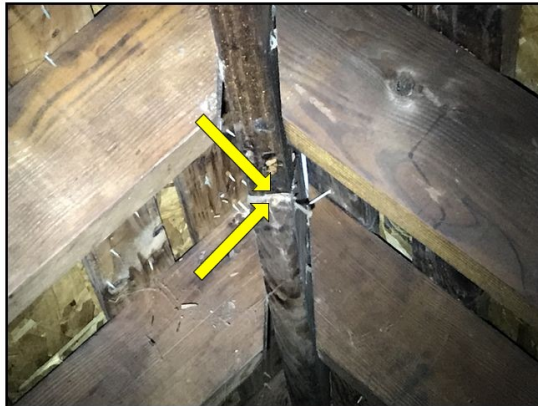
Observed ridge and/or valley rafter splice(s) not properly supported in the attic. Recommend repair as splices are separating or may separate; south attic above the bath.

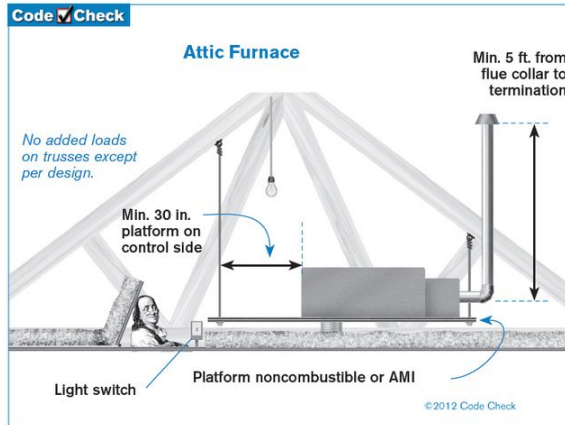
Floor decking in the attic is inadequate for service personnel servicing the HVAC system. Code [IRC 1305.1.3] requires a minimum of a 30-inch deep platform in front of the unit.

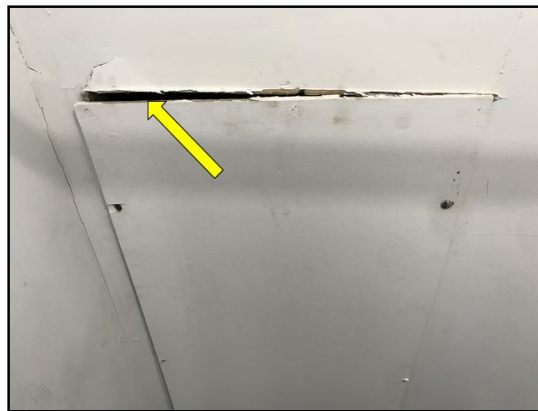
Attic access door is not properly secured the attic HVAC entry location. Does not close.

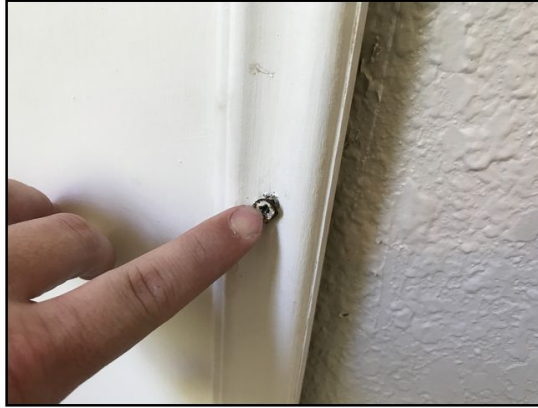
One or more attic access doors were not accessible due to the securing screws being stripped. Recommend replacing stripped/damaged screws.

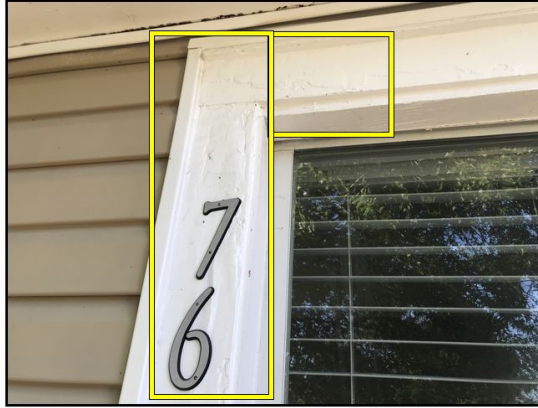
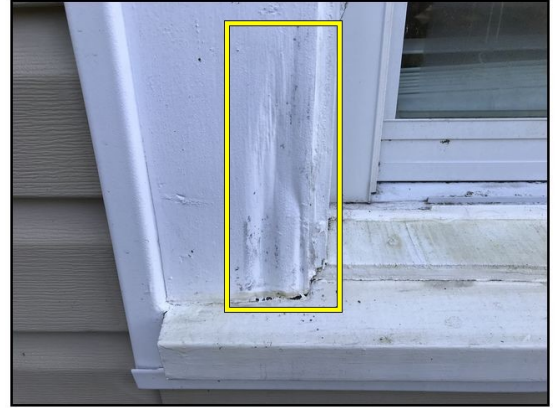
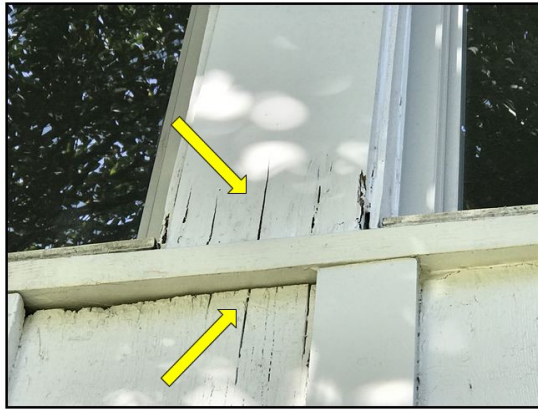
Wood rot observed on areas of house/garage.

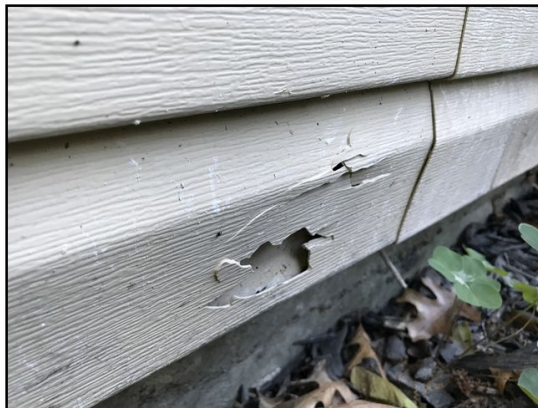
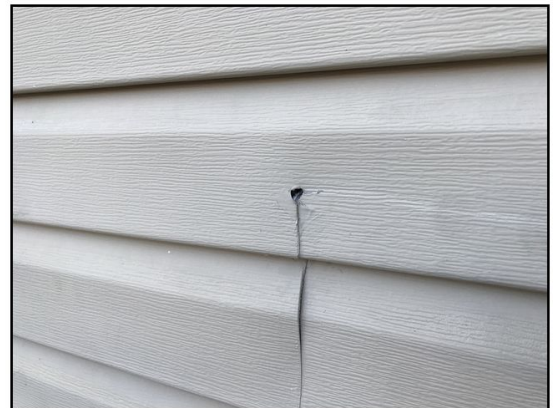
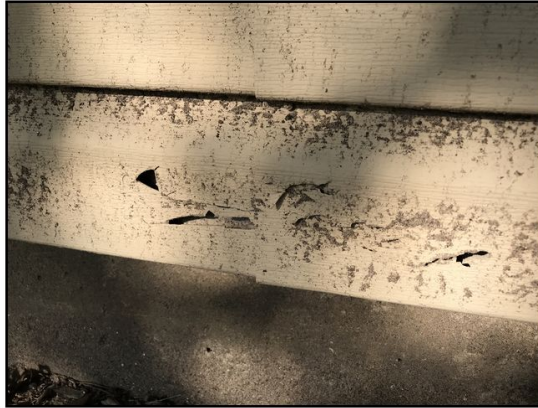
Damaged/cracked siding should be repaired to prevent water penetration.

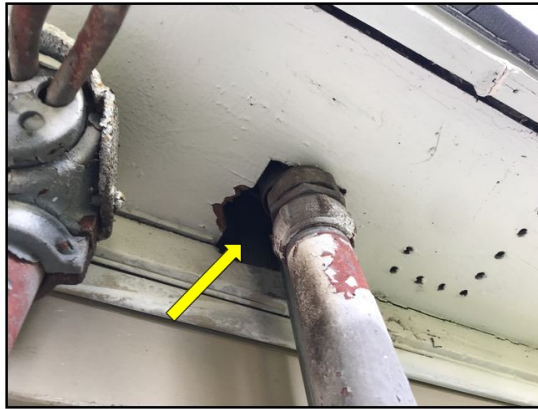
Potential rodent entry; south side of home at the soffit.

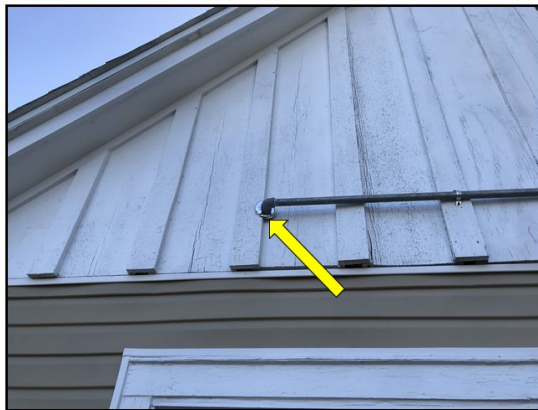
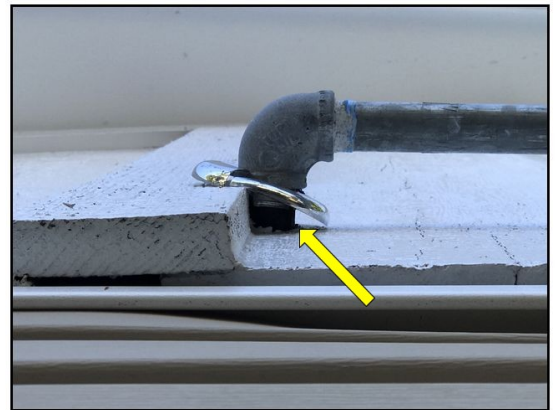
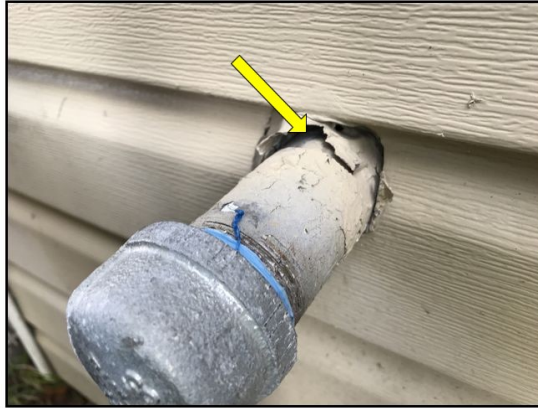
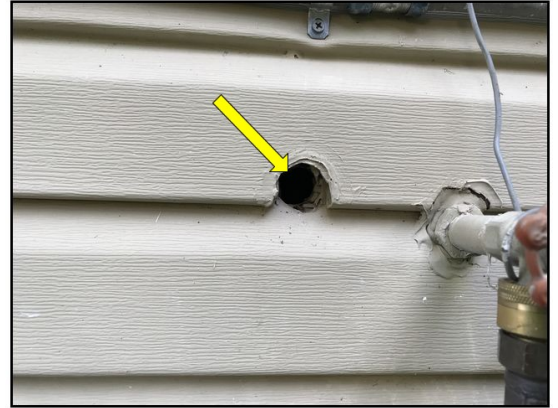
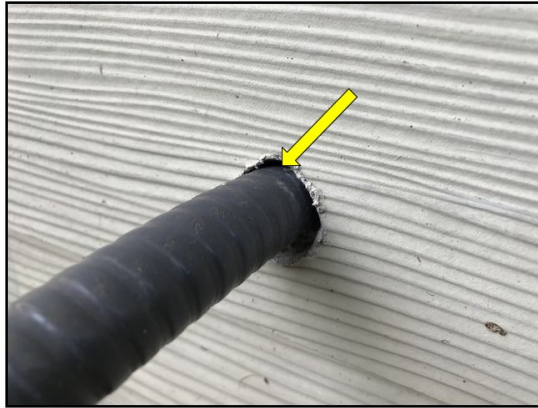
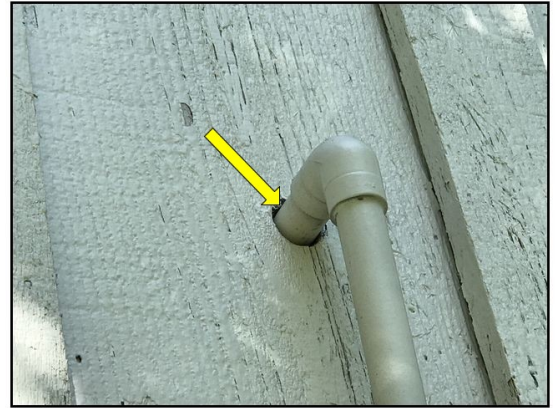
Need sealing/caulking around all holes and exterior siding penetrations on top and both sides, (leave the bottom open) to prevent water entry. Including but not limited to dryer, bath and range top vents, light fixtures, etc.

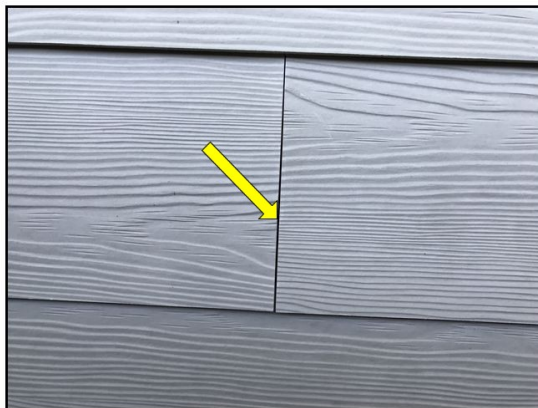
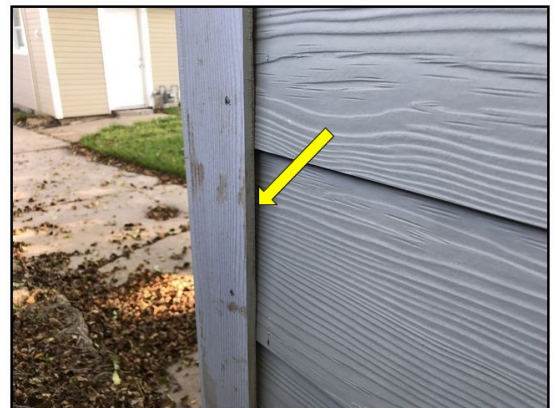
Caulking missing and/or deficient around windows / vertical trim / joints in siding. May allow wind driven rain entry.

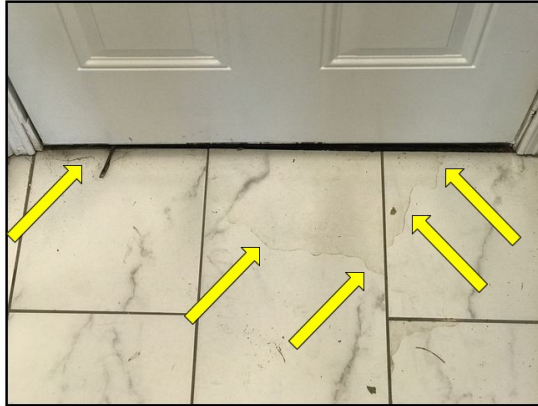
Water stains observed on the tile flooring by the back door. The back door is lacking weather stripping and a threshold with a water channel. Not wet at the time of inspection. Recommend review/repair.

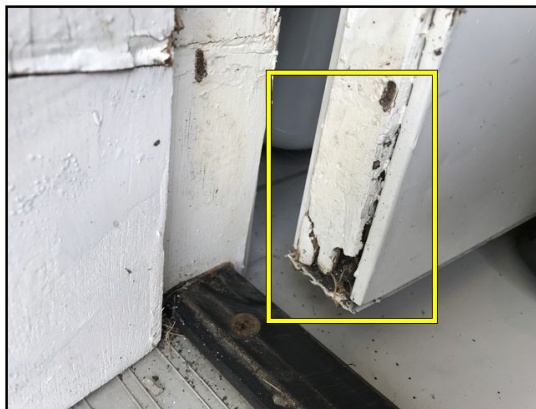
Wood rot of lower door and/or jamb; back door.

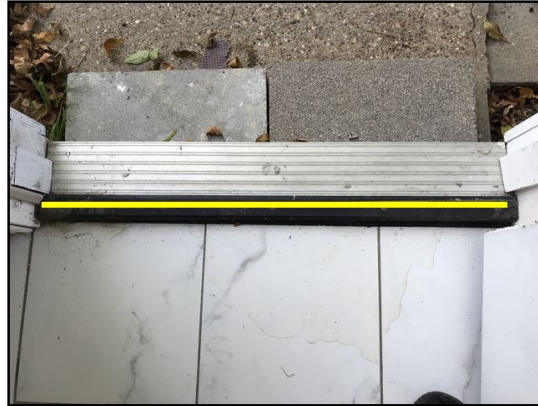
An improper threshold used on exterior doors without roof overhang protection from wind-driven rains will probably result in water damage from intermittent water entry. Recommend replacement with metal type threshold with rainwater channels that directs water back to the exterior.

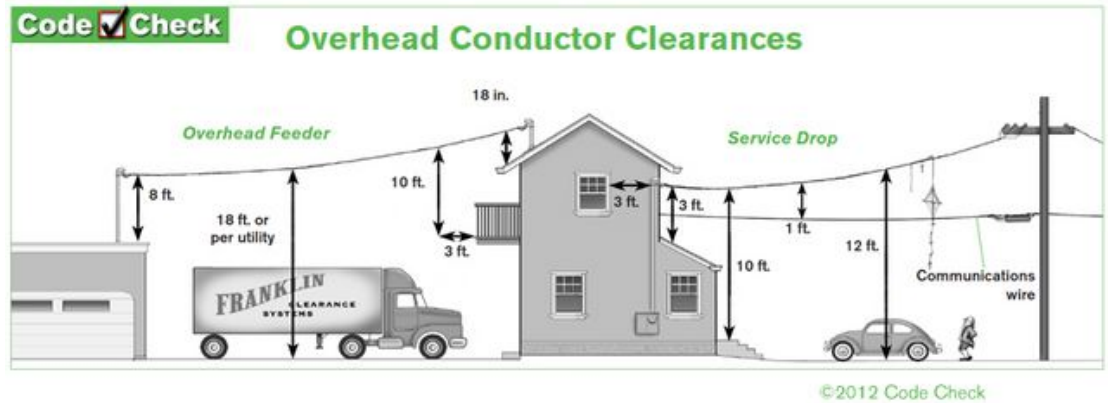
The low elevation of power lines at/near the house/garage is an electrocution hazard. Code requires a minimum clearance of 10 feet & 12 feet over walkways and driveways respectively; use caution when near, or have lines raised/buried.

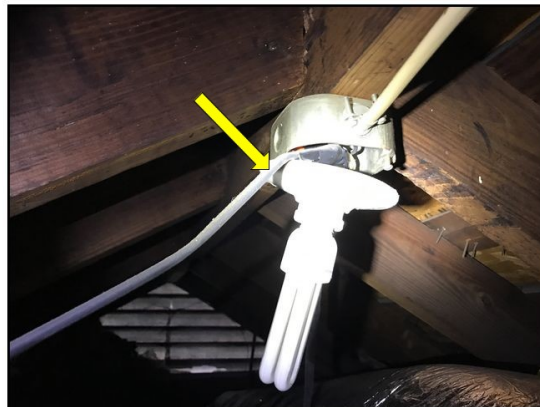
Improper wiring observed, wiring tapped into an existing light fixture; above the attic ac unit.

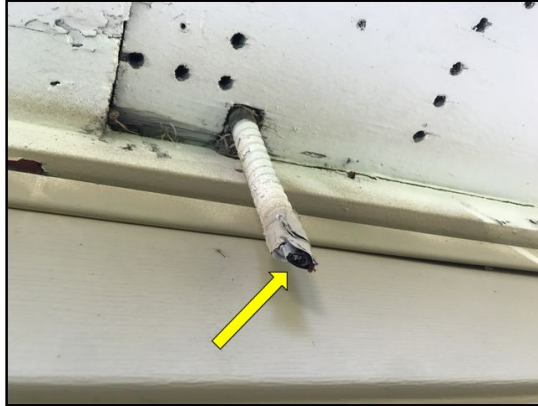
Wire improperly terminated, including but not limited to the following location; south exterior soffit of the home.

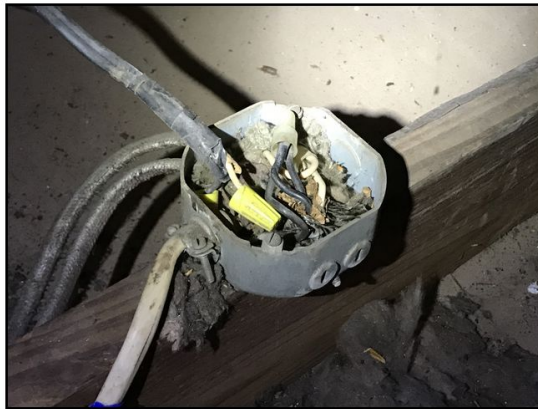
Wire connections are not enclosed in proper electrical junction box(s), or electrical junction box(s) do not have covers in place, including but not limited to the following location; attic.

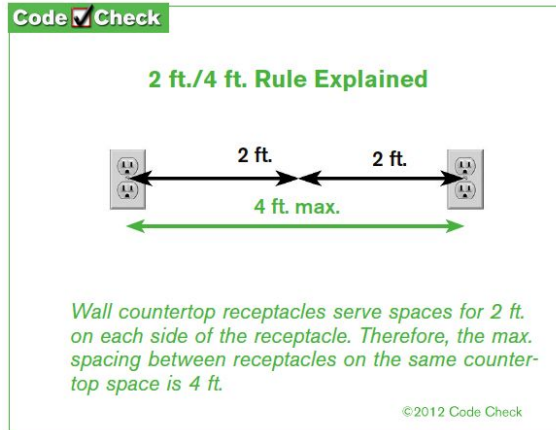
Missing the required number of outlets serving kitchen counter(s) as required by IRC 3801.4.1 National Electric Code 210-52c1; which requires that no point along counter greater than 24 inches from small appliance receptacle(s).

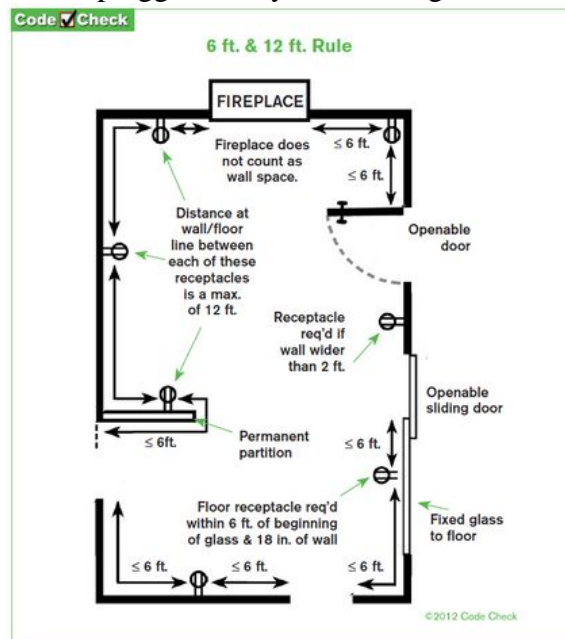
Missing required outlet(s) as required by National Electric Code 210-52a. A 6-foot cord can be plugged in anywhere along the wall. Per IRC 3801.2.1

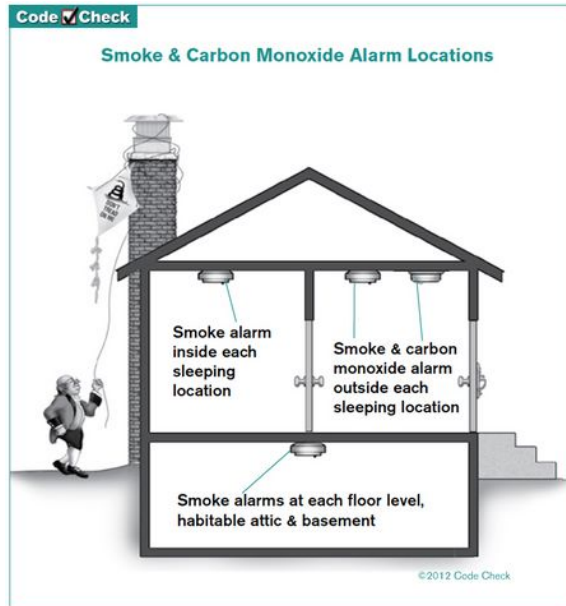
There appears to be an inadequate number and/or improper location of smoke detectors in the home. Smoke detectors should be located on each level of the home as well as inside AND outside of all sleeping rooms. Consult the smoke detector manufacturer's instructions regarding the specific placement of detectors.

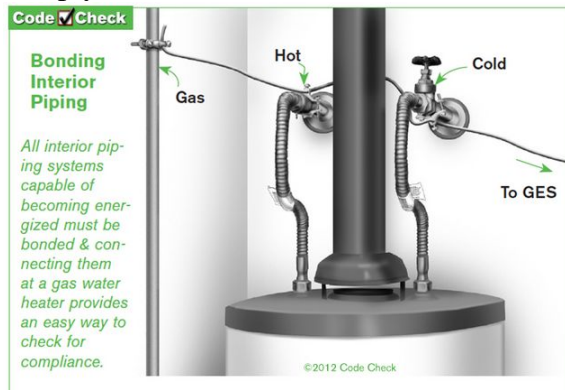
Gas and hot/cold water lines are not properly bonded near the water heater. This does not comply with the most recent electrical code.

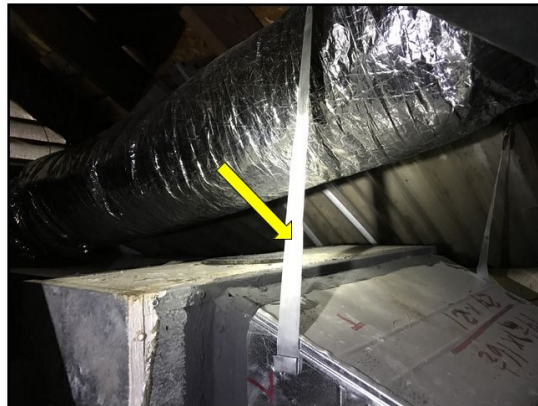
Metal straps that support the AC/Heating unit are required to be taped to help technicians from getting cut on the sharp sheet metal.

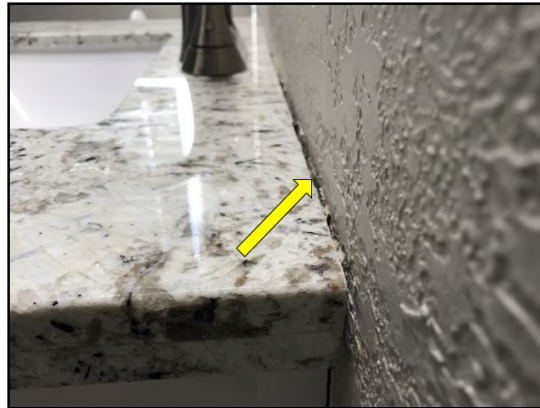
The first floor bathroom sink is pulling away from the wall. Recommend repair.

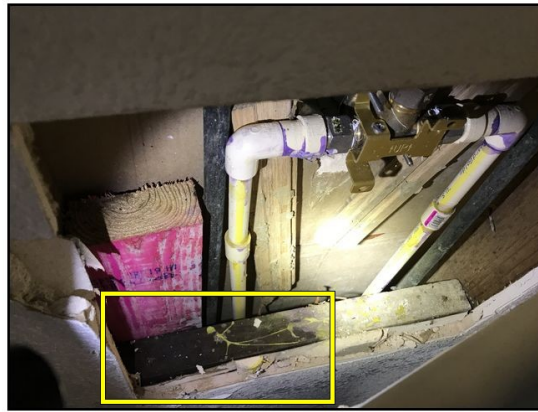
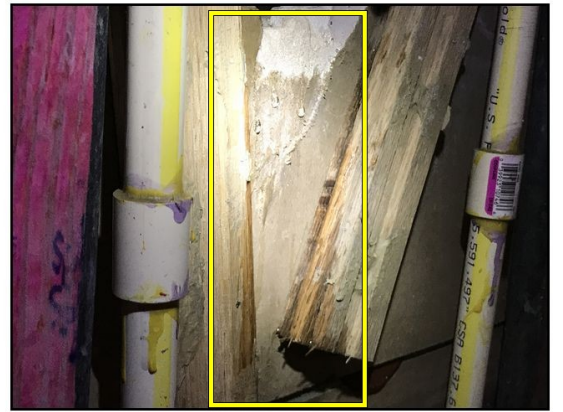
Shower leaks water behind the wall, Indication shower pan and/or drain fitting requires repair/replacement; first floor.

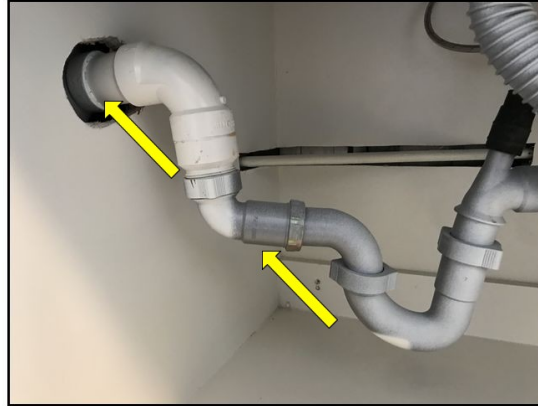
Improper slope of the drain line observed. The line does not tilt in a downhill direction for proper drainage; kitchen sink.

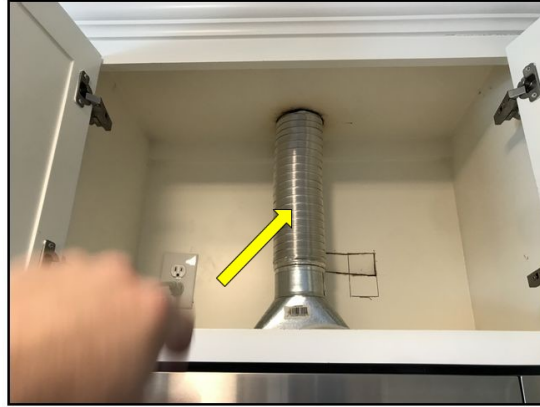
Improper vent duct material used; Current industry standards requires smooth interior single-wall duct constructed of galvanized steel, stainless steel or copper. The duct serving the hood shall have a smooth interior surface. Per IRC 1503.1.

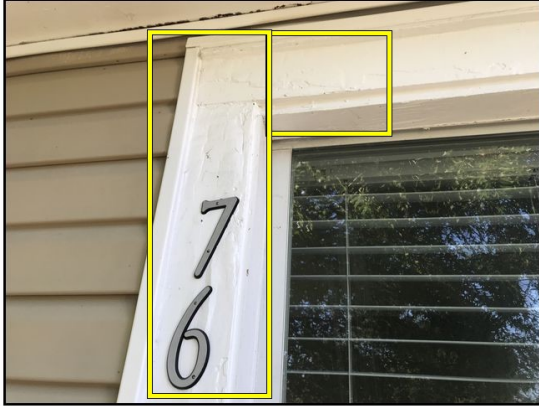
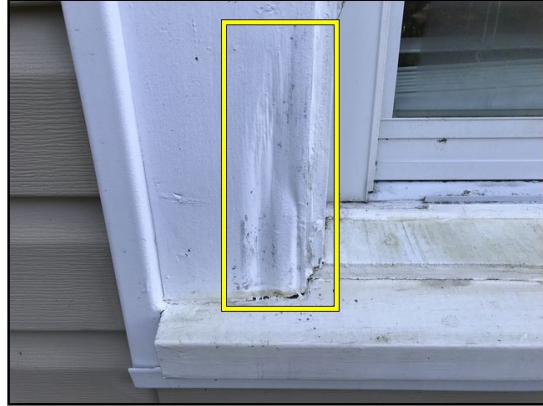
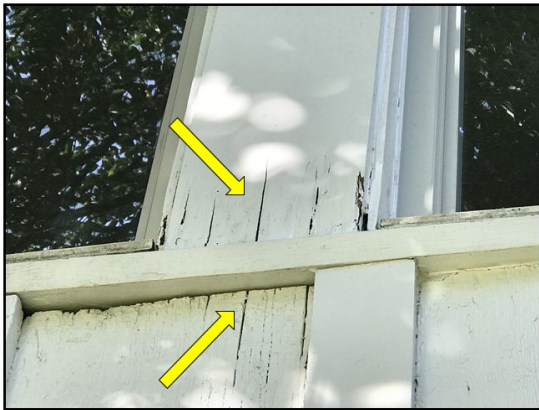
Wood rot observed on areas of house/garage.
