HOUSTON METROPOLITAN INSPECTIONS UNLIMITED, LLC

PHONE: 713 828 0310 713-829-2484 OR PROPERTY INSPECTION REPORT

Concerning: 4423 VANDERMERE CT, KINGWOOD TEXAS

OCT. 5, 2020

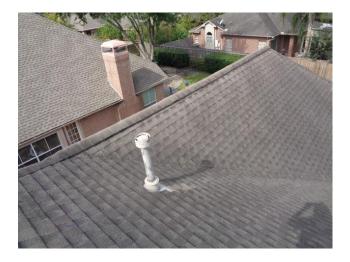
There are signs of normal aggregate loss, deterioration, shrinkage & curling of shingles due to age of roof. There were no visible signs of active water penetration on the (accessible) roof decking or sheetrock. Note: If the home has been recently painted, this limits my visibility of water stains.

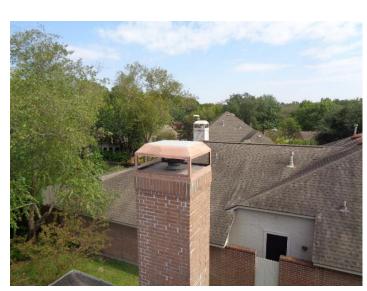
There have been visible repairs made to the bricks.

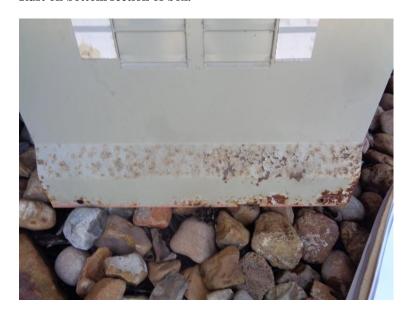
The main breaker is 150 AMPS; however, the service wires were 1/0 AL which is only rated for 125 AMPS.

Rust on bottom section of box.

I recommend replacement of the electrical box. It appears it may have been under the flood waters. Also, the box is a challenger, which some insurance companies will not insure. Check with your insurance company.

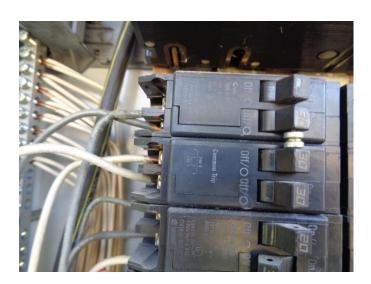
The handle ties are missing on the 220 circuits.

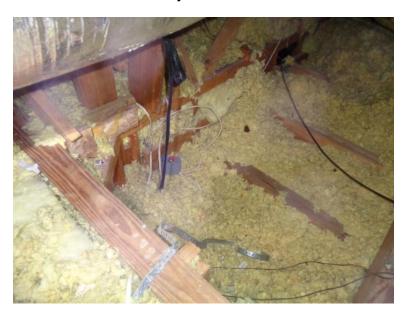
A cover is needed on the junction box.
