Inspection Report

Property Address:
5847 Farwell Drive
Houston Texas 77035

PROPERTY INSPECTION REPORT

By: Donivan Harvey 20964 / RSCH-ONE Inspections 5/17/2021

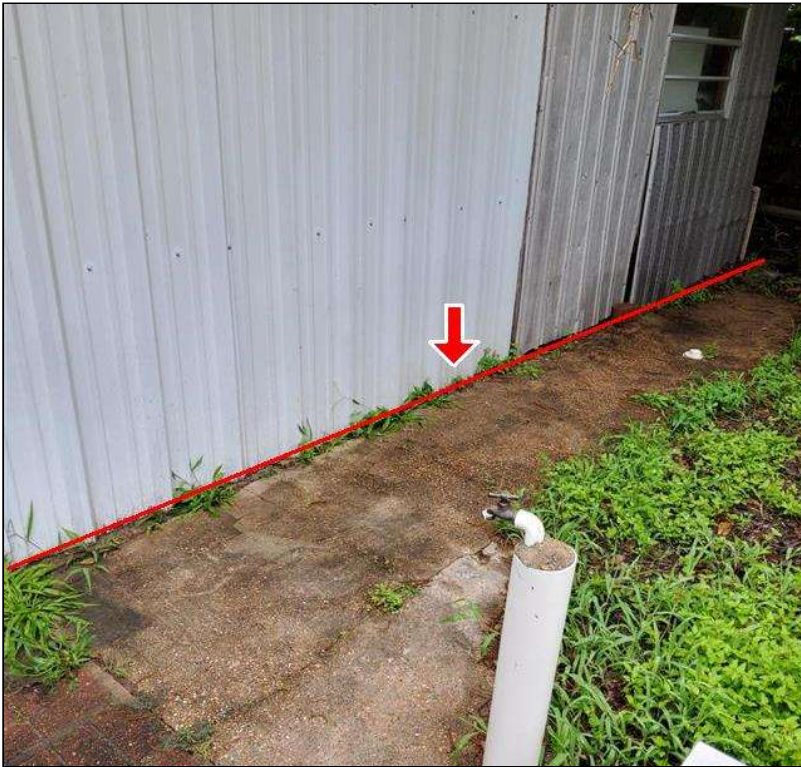
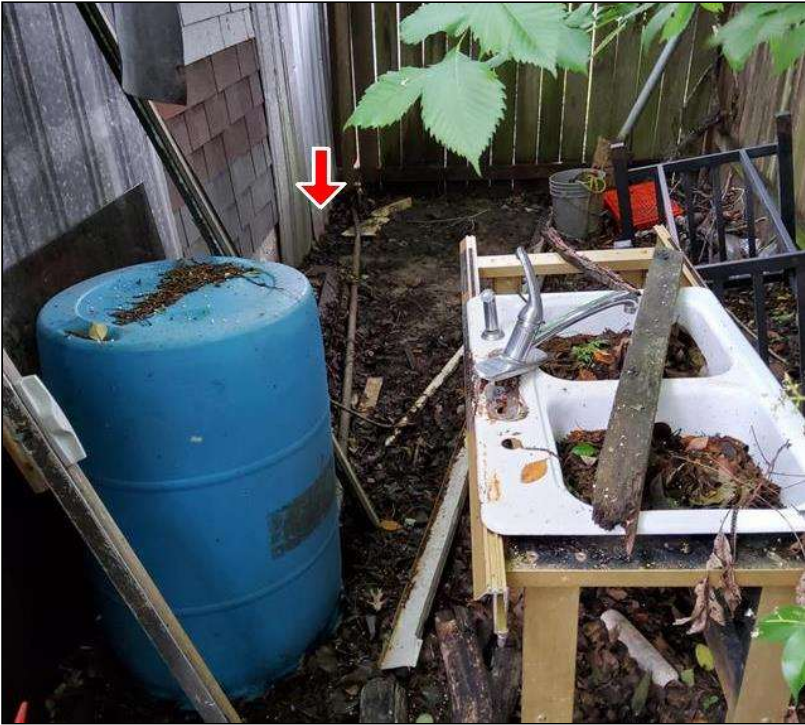
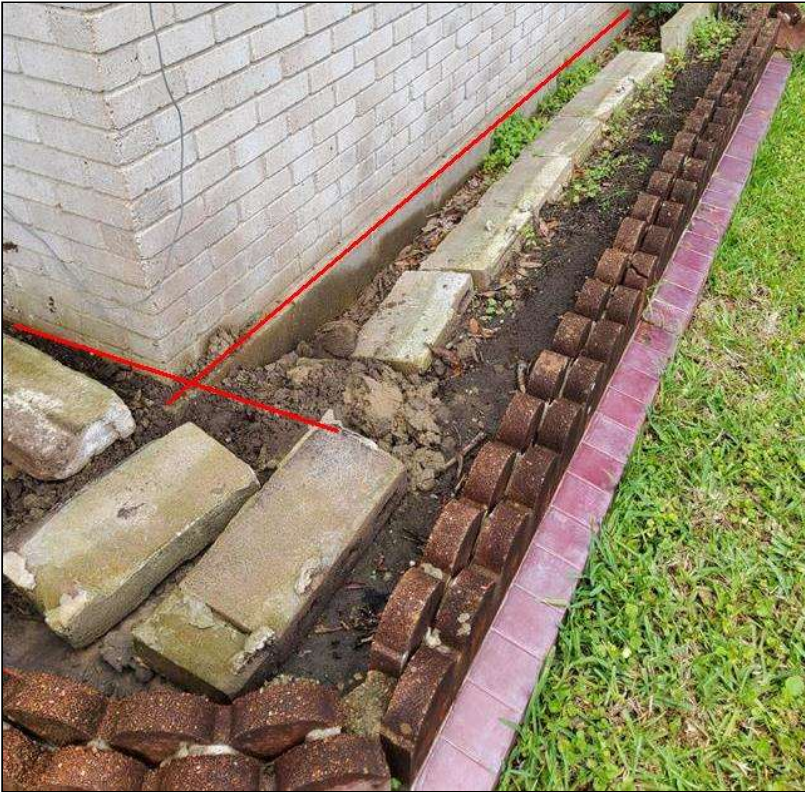
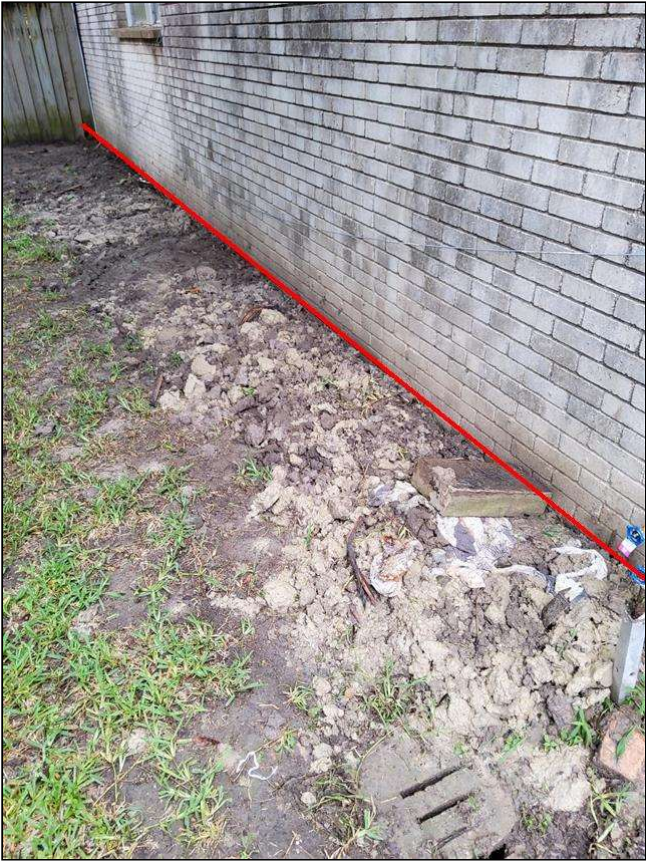
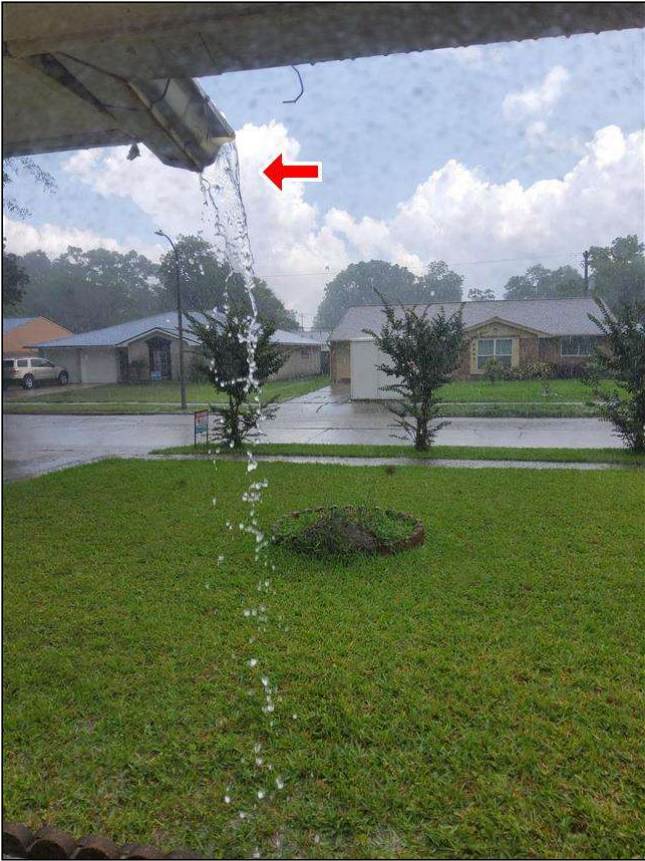
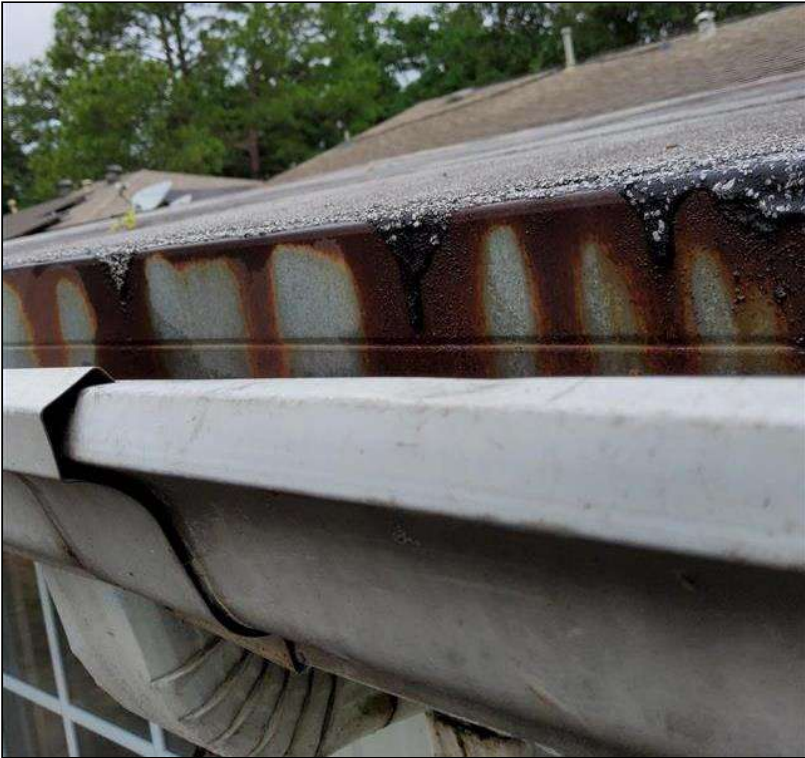
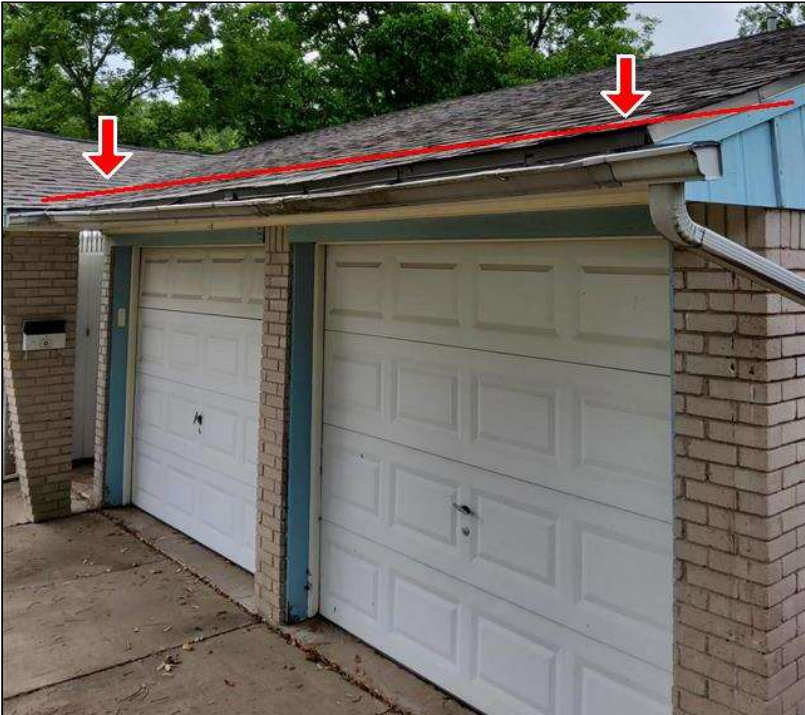
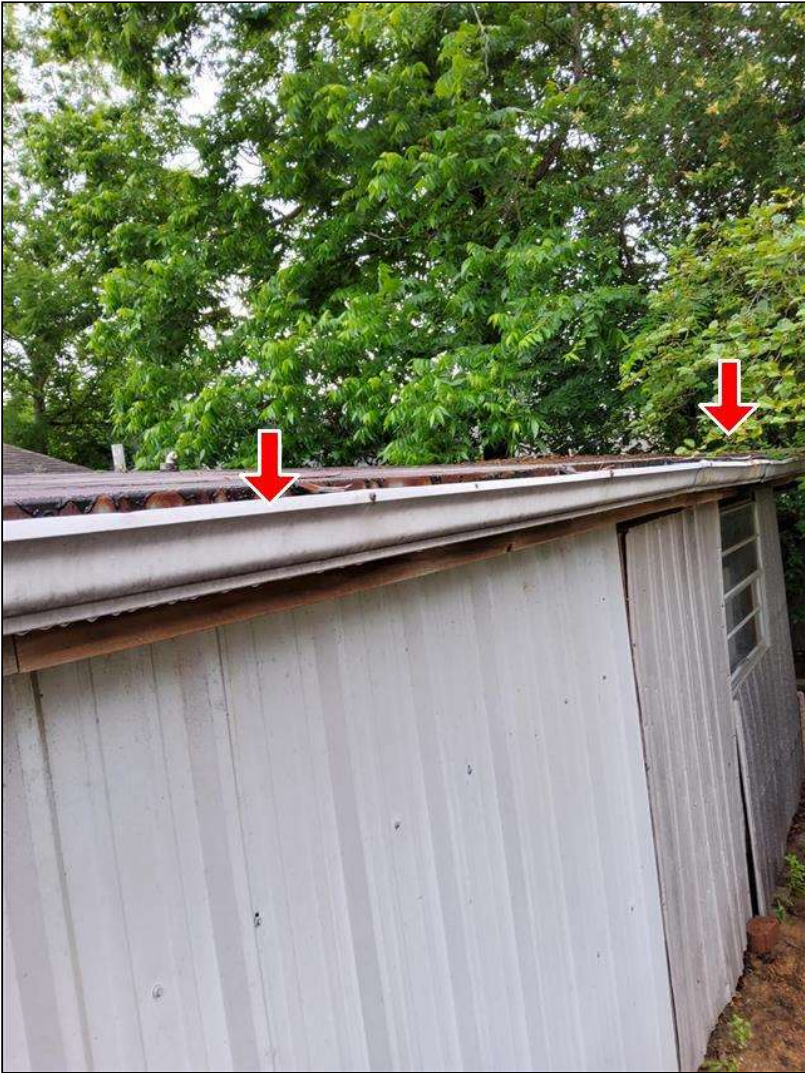
B. 1) The grade around the home is considered deficient and does not meet the minimum standard practiced. Standard states that a minimum of 4 inches of the entire foundation has to be exposed at all times, and the grade must slope away from the foundation. The grade (soil) slope must have a drop of 6 inches for the first 10 feet of grade, if the grade width is 10 feet or more, if the grade width is not 10 feet or more, then the slope must be a minimum of 2% of the width of the grade. Recommend having this looked at further by a licensed landscaping company and all required repair and correction be made.

2) The entire gutter system on the home is degraded and no longer performing as intended, several areas of the gutters were leaning forward or coming away from the fascia boards, causing the gutter system to not function, while causing water damage to the fascia and soffit boards on the roof. These issues are considered deficient and do not meet the minimum standard practice.

Recommend having these issues looked at further by a licensed professional and all required repairs be made.

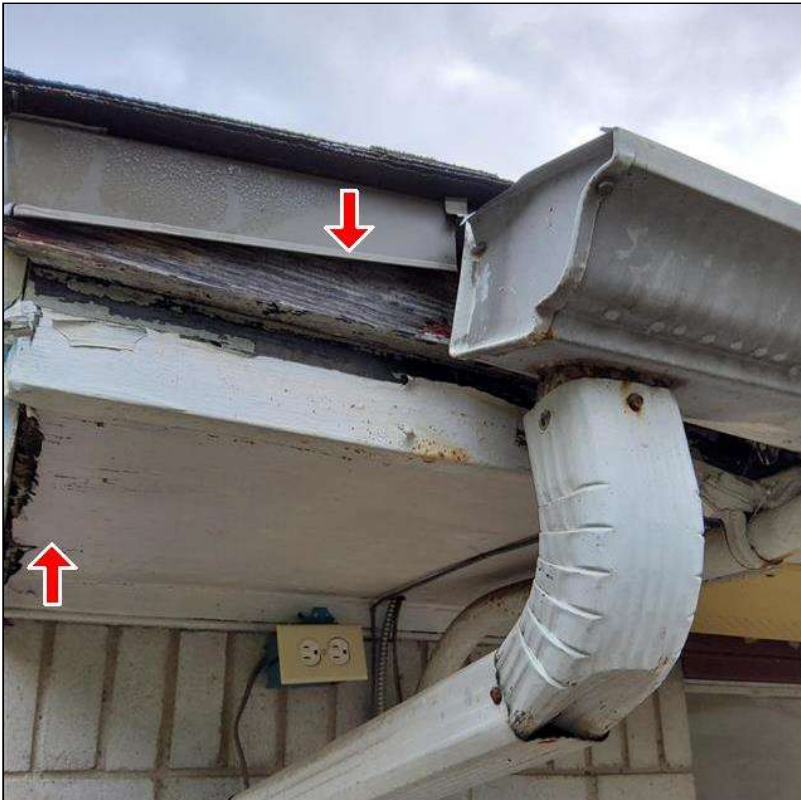
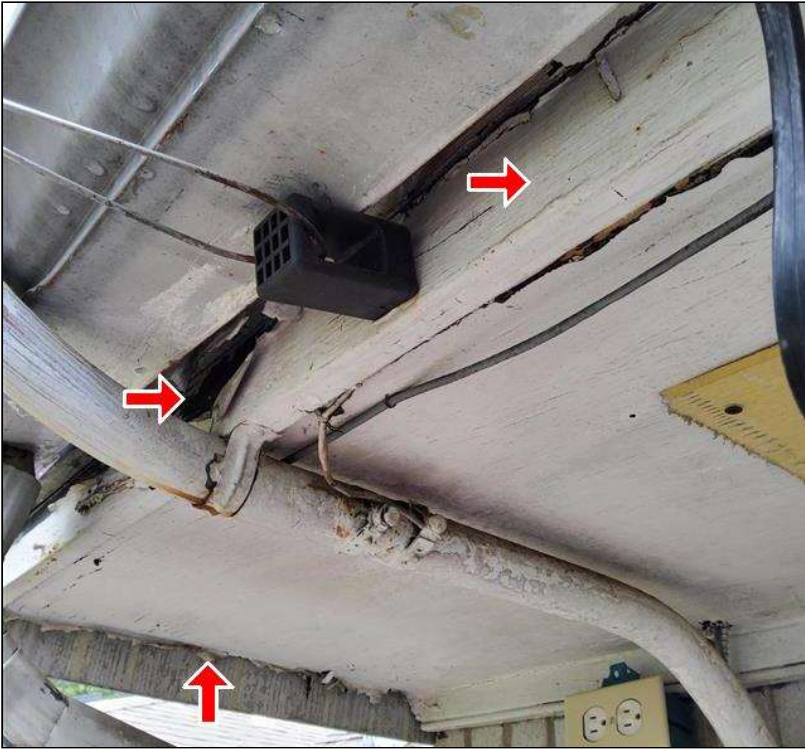
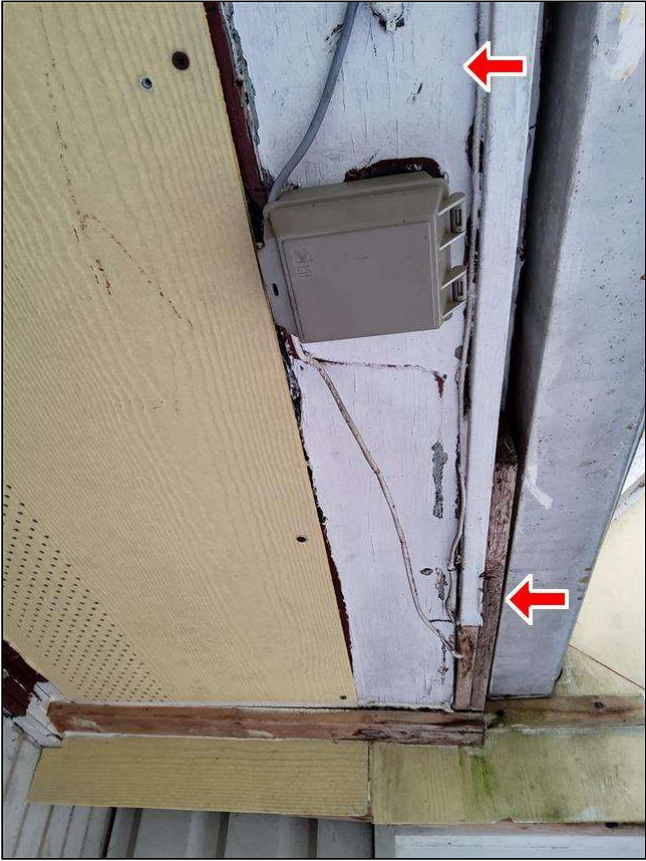
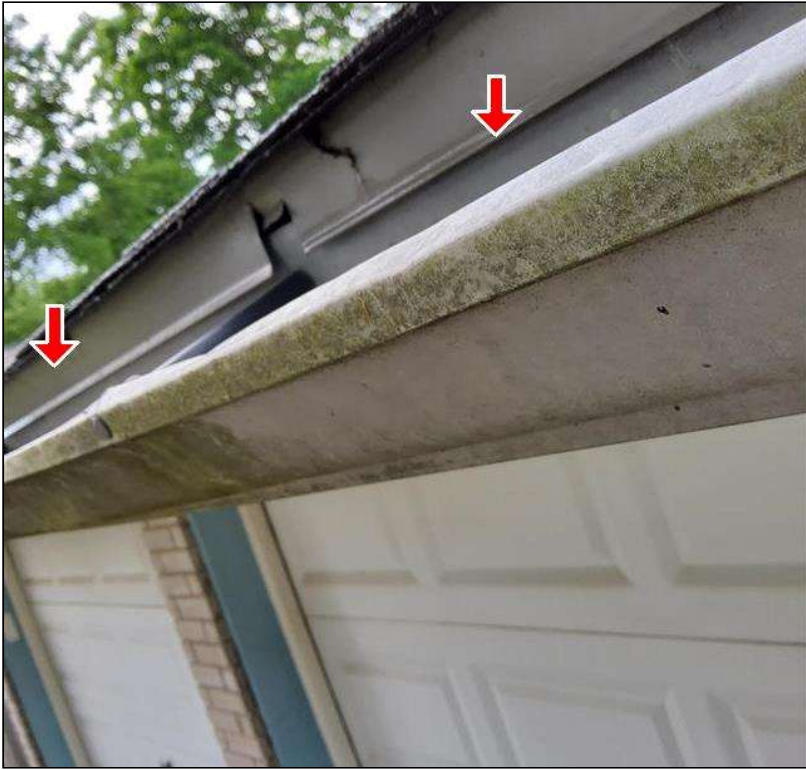
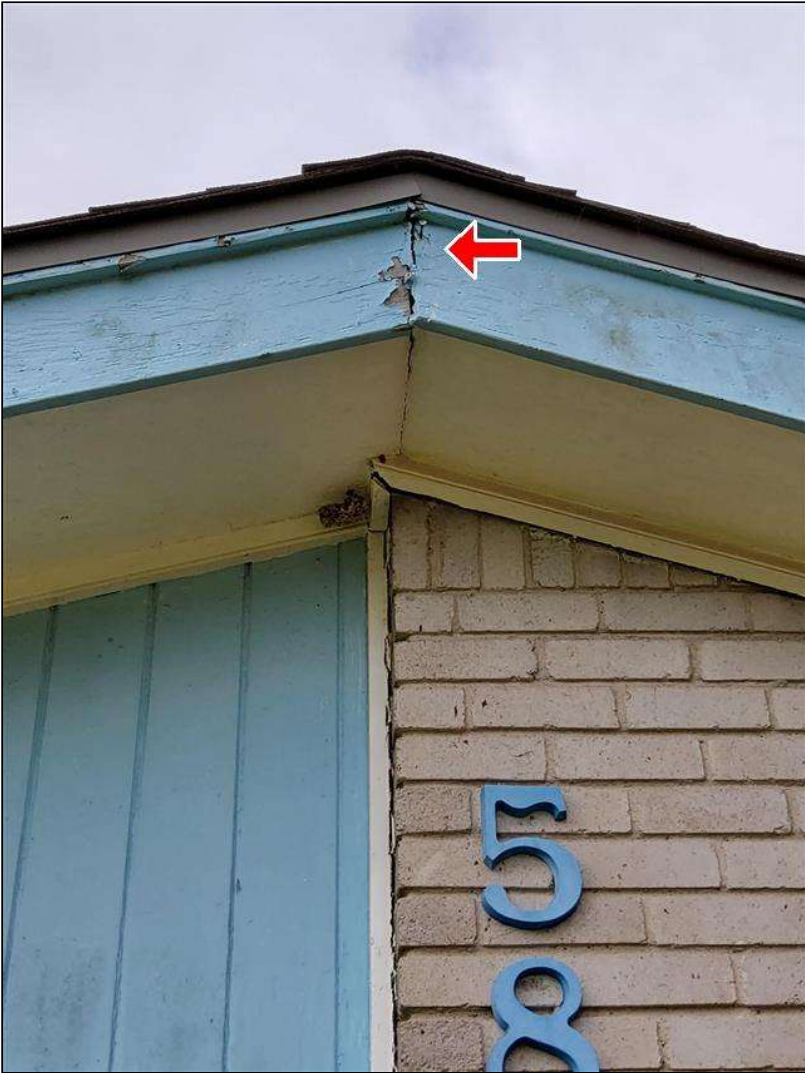
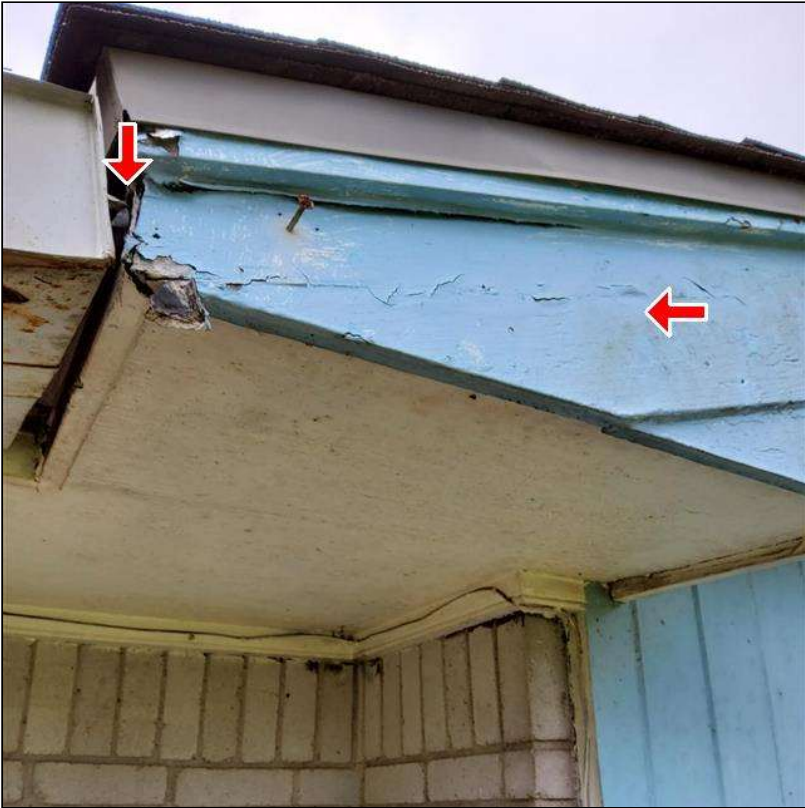
C. 1) The fascia and soffit boards/screens on the home are degraded from moisture damage, this is considered deficient and do not meet the minimum standard practice. This will lead to the roof decking, rafters and other supporting members being damaged.

2) The rake flashing material that is visible at the front of the home, over the garage doors is considered deficient and does not meet the minimum standard practice. The rake flashing material is cut into pieces, leaving gaps where moisture can cause damage to the fascia boards, and roof decking.

3) The flashing material being used on the roof, located on both sides and back of the home are degraded from rust damaged and is not installed properly, this has allowed the flashing material to rust, this can lead to the degraded areas of the flashing material leaking, causing water damage to the roof decking and other roof supporting members.

Recommend having these issues looked at further by a licensed roofer and all required repairs be made.

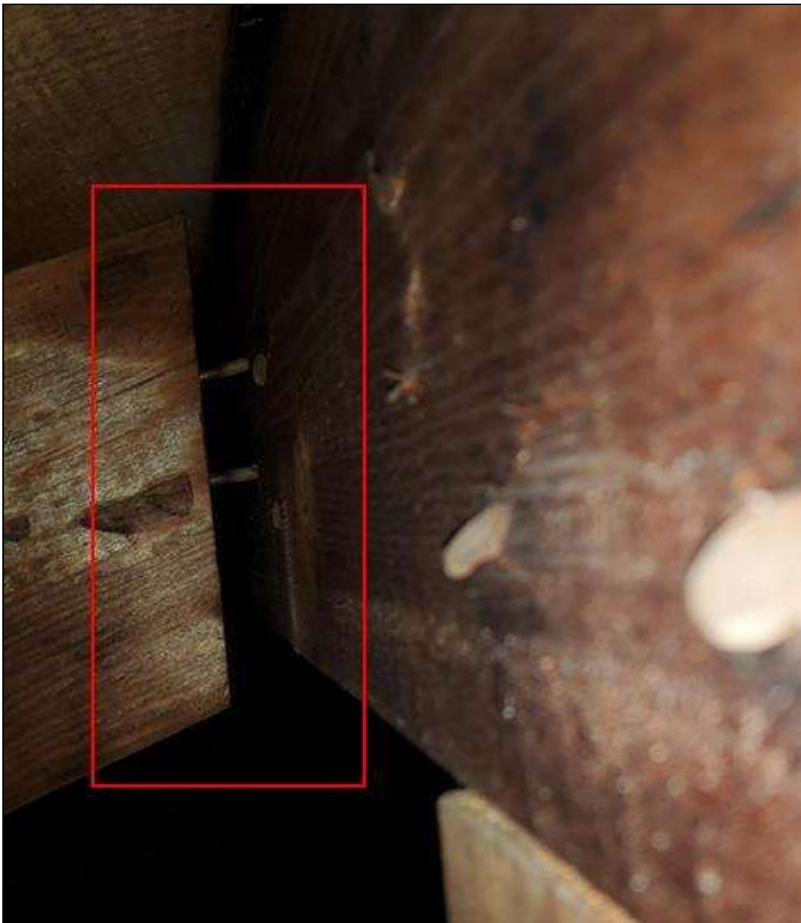
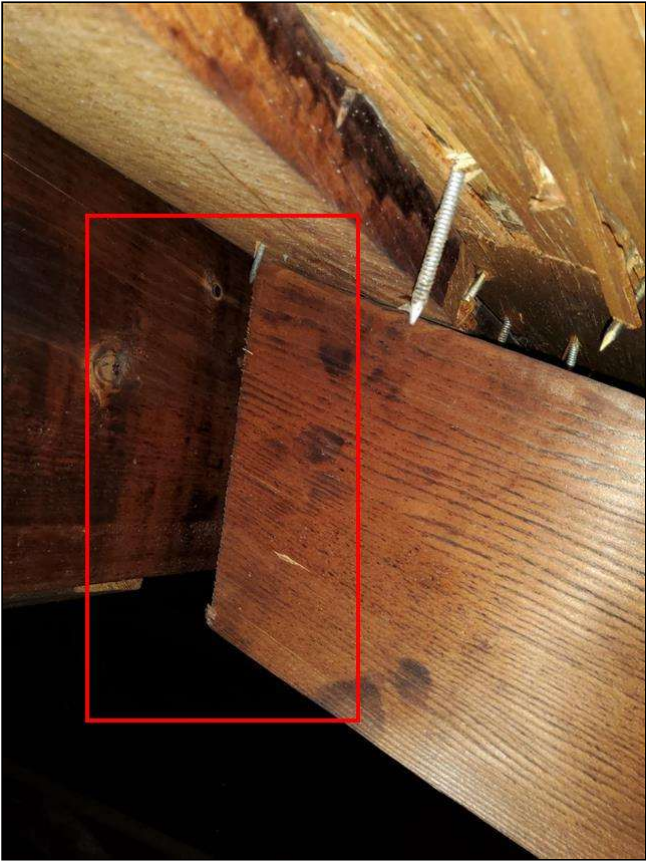
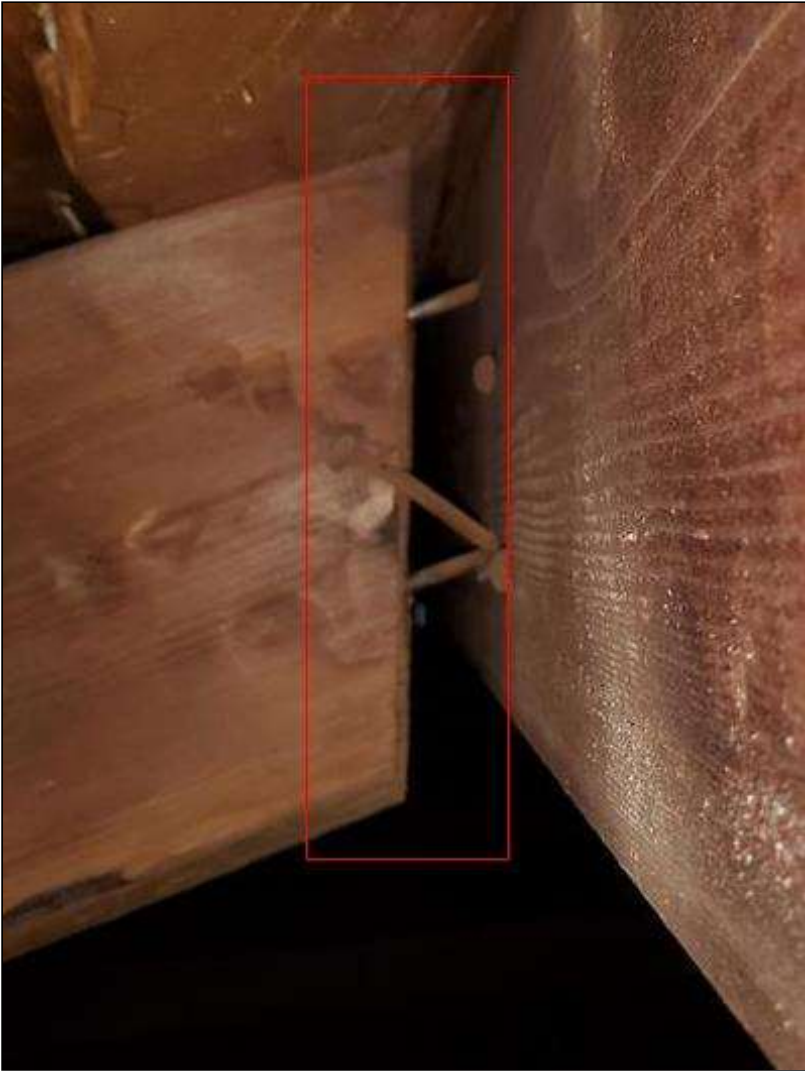
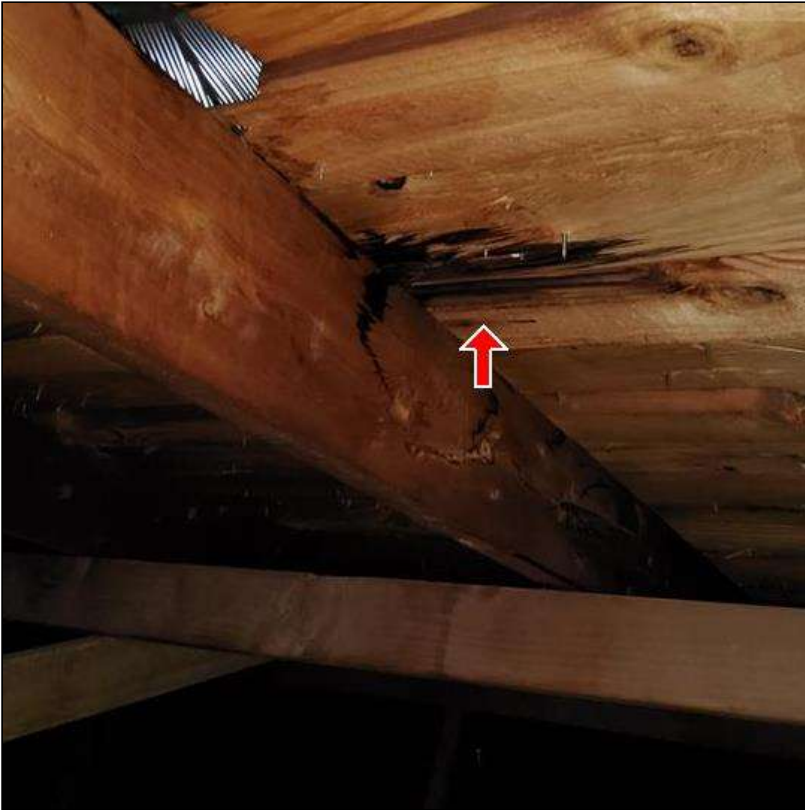
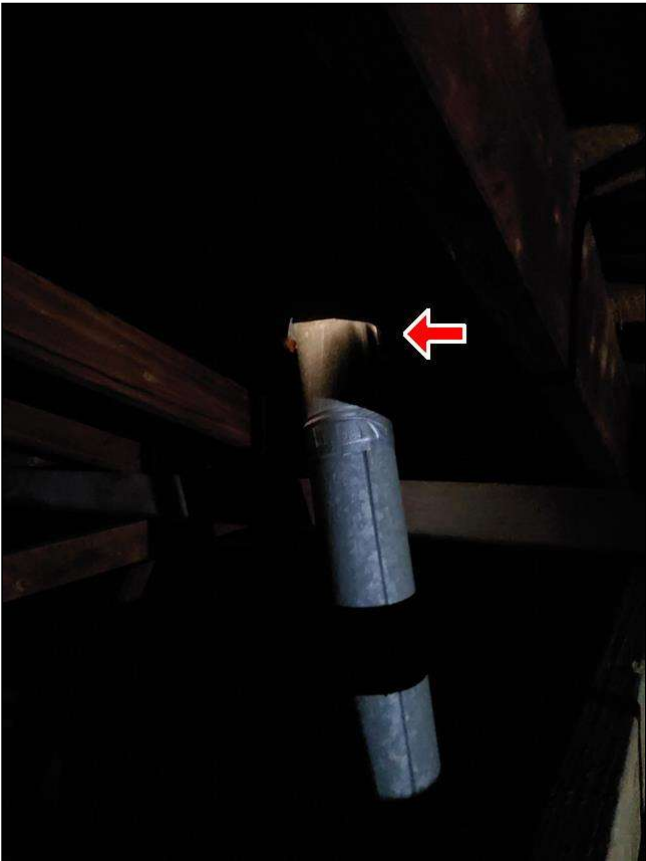
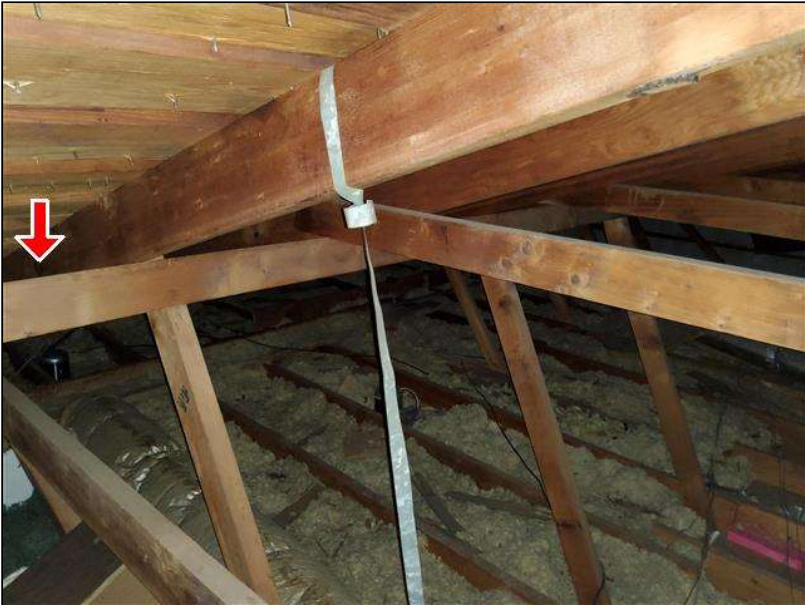
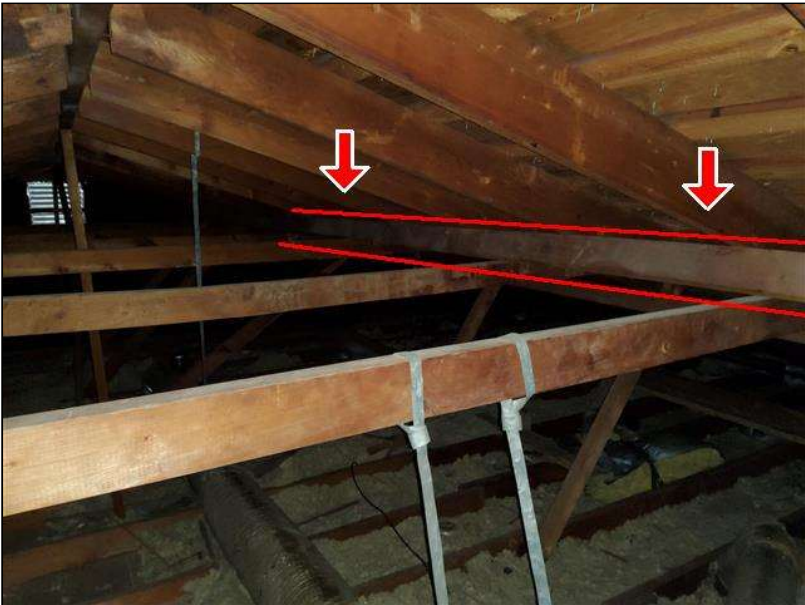
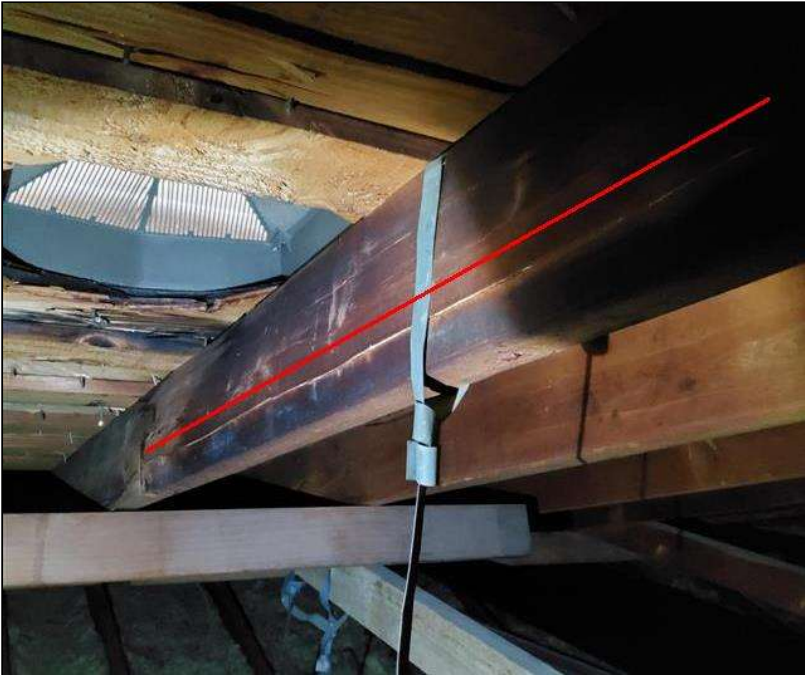
D. 1) Previous water damage was noted on the roof decking, directly over the attic hatch in the home. No sign of current moisture damage was noted, but this is considered deficient and does not meet the minimum standard practice, and needs to be looked at further by a licensed roofer or general contractor to be repaired.

2) Light is going into the attic space from under the roof jack for one of the vents, this is considered deficient and do not meet the minimum standard. This issue can lead to moisture getting under the raised area of the roof jack, causing damage to the roof decking and other supporting members.

3) Multiple rafters were observed pulling away from the ridge beam and twisting at the time of inspection. This is considered deficient as it is an indication that the foundation may not be performing as intended which is putting stress on the roof structural framing members in the attic.

4) Undersized purling bracing was observed beneath rafters in the attic at the time of inspection. This is considered deficient as the minimum standard of practice requires purling bracing be at least as large as the rafters above that they support.

5) Multiple cracked/split rafters were noted at the time of inspection. This is considered deficient and does not meet the minimum standard of practice, as this is an indication that the foundation may not longer be performing as intended, which is putting stress on the structural framing members in the attic.

Recommend having these issues looked at further by a licensed roofer and all required repairs be made.

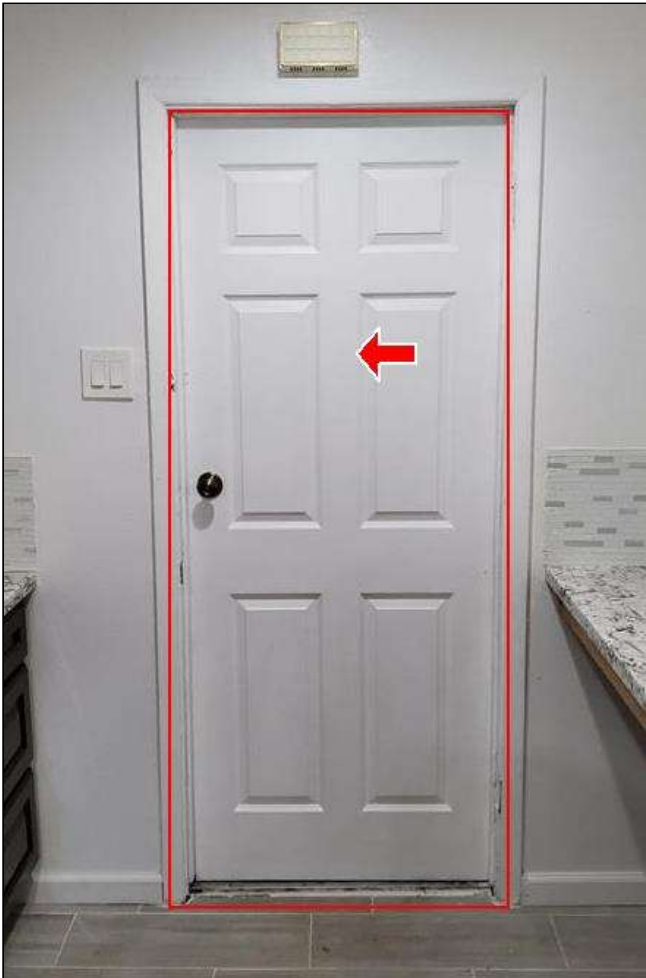
E. Item 1(Picture)

E. 1) The occupant door leading from the home into the garage is considered deficient and does not meet the minimum standard practiced. The occupant door acts as a fire barrier between the home and the garage, while helping prevent gases and fumes from entering the home. Standard states that the door must be a solid wood or metal door and must be self closing at all times. The occupant door does not meet any of the minimum requirements.

Recommend having these issues looked at further by a licensed general contractor and all required repairs be made.

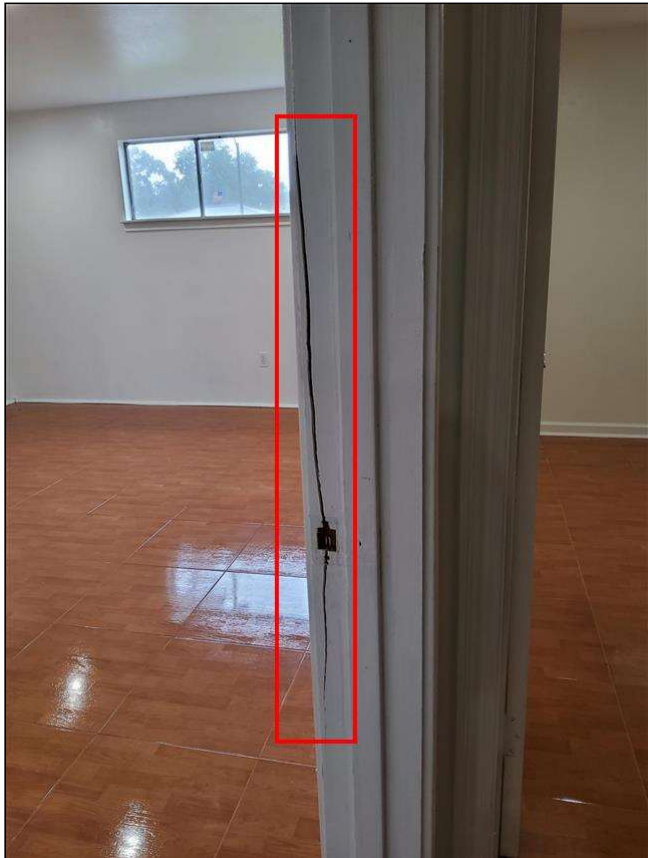
E. Item 2(Picture)

2) The door frame on the front left guest bedroom door is broken, this is considered deficient and does not meet the minimum standard practice. This can lead to the door not being able to remain close.

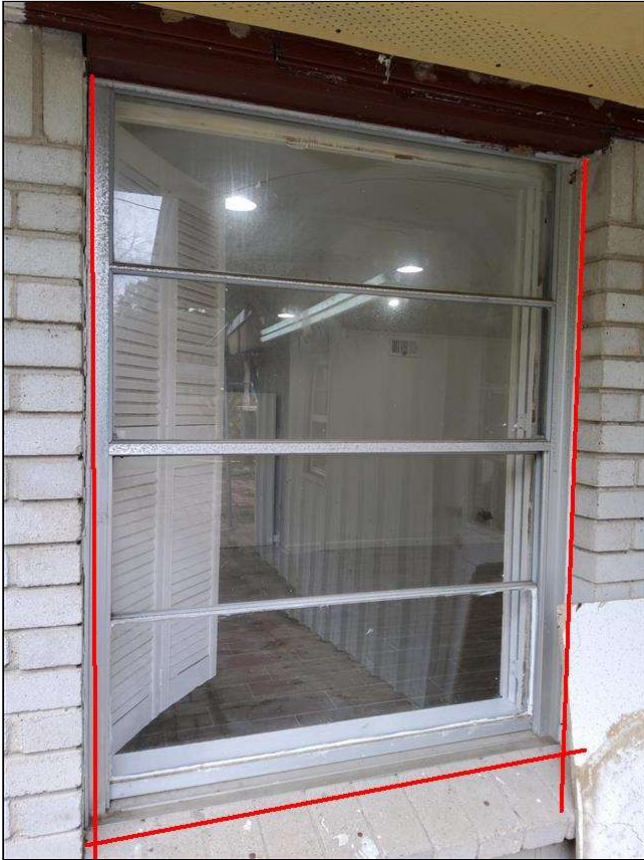
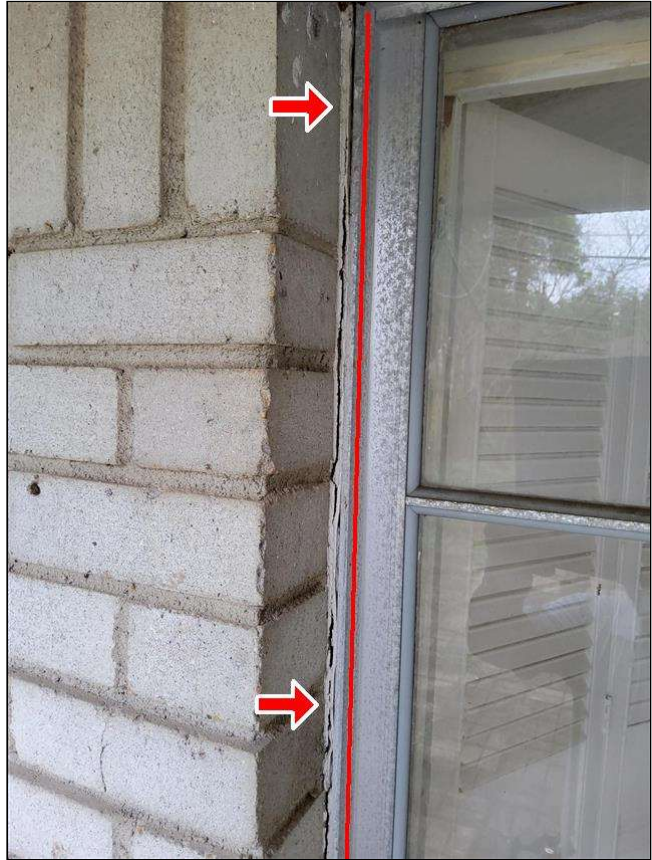
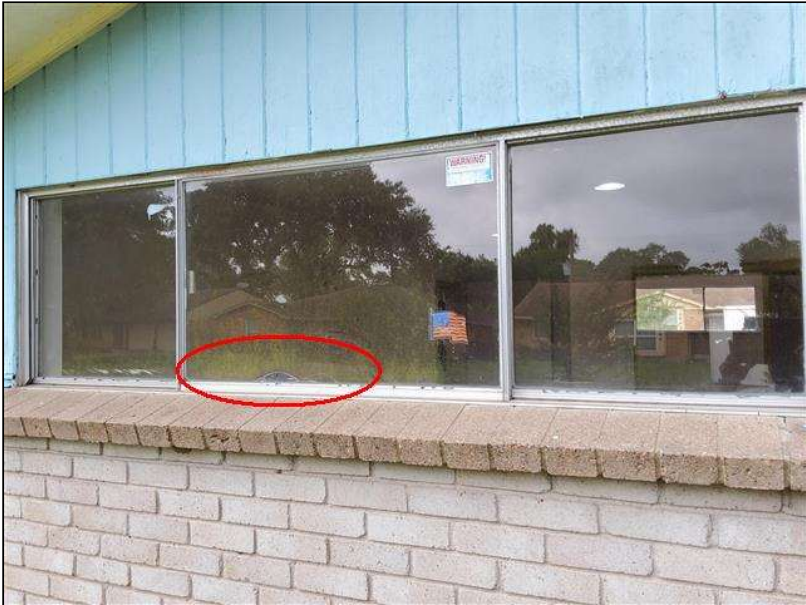
F. 1) The caulking around the exterior and interior of all the windows is degraded and no longer functioning as intended. The caulking is used to help prevent water from getting under the window frame, while helping prevent air from going into and leaking out of the home.

2) The front window is broken, this has diminished the energy efficiency of the window, which causing the window to become a safety and security hazard. This is considered deficient and does not meet the minimum standard practice.

Recommend having these issues looked at further by a licensed general contractor to be repaired.

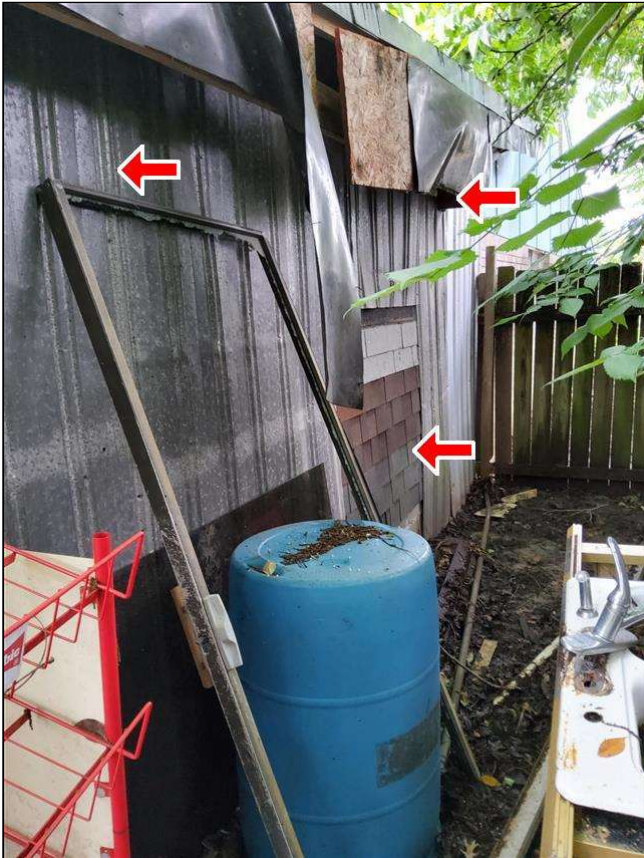
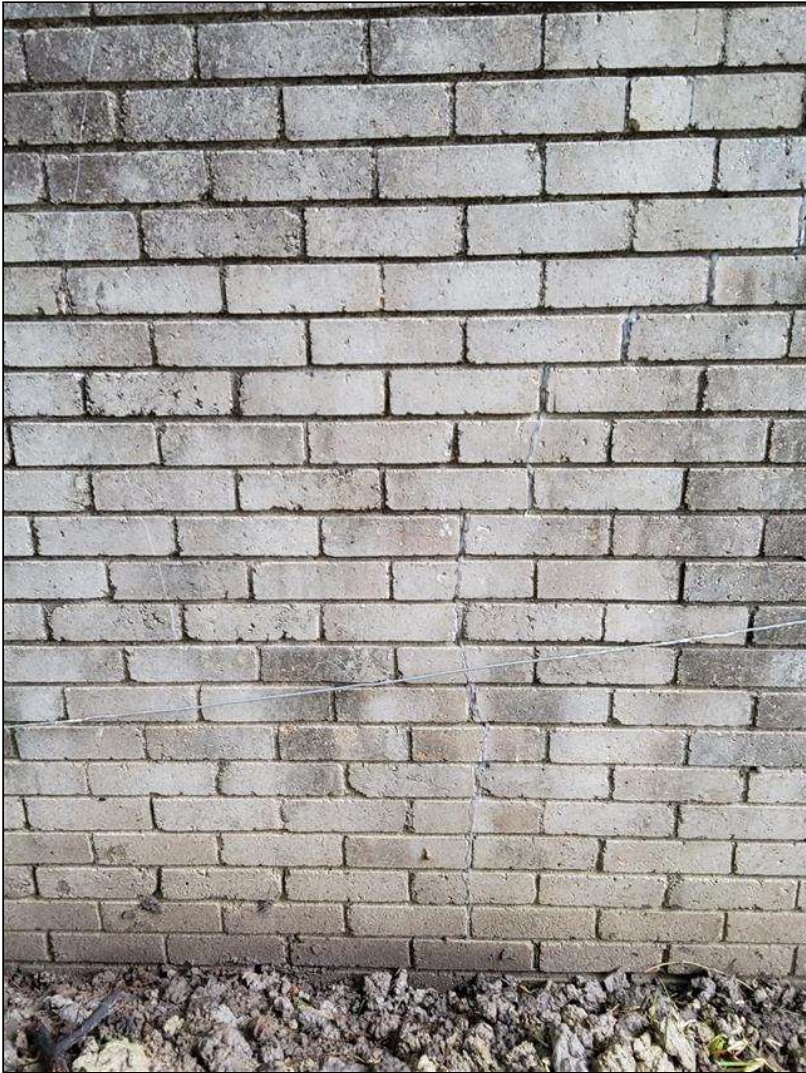
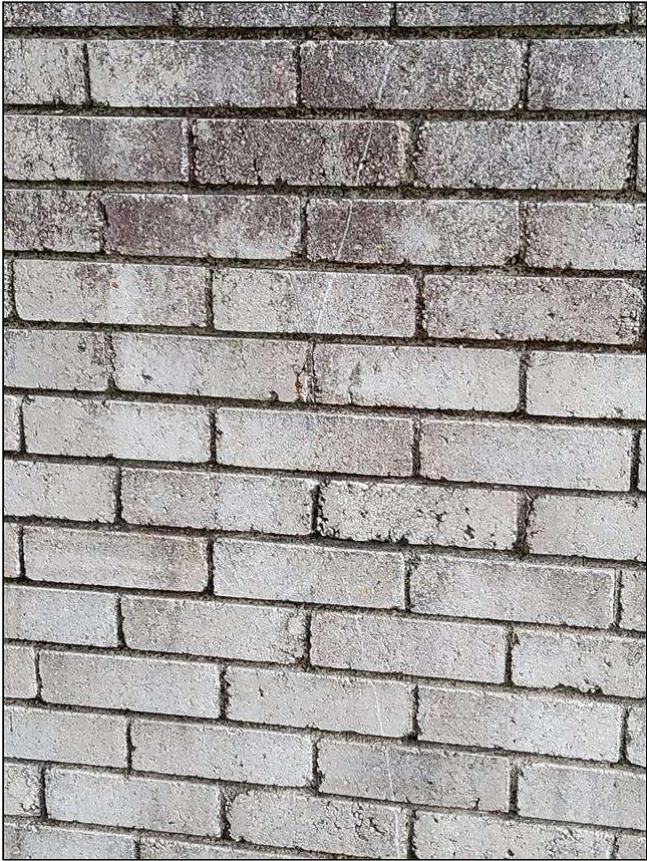
G. 1) Roof shingles are being used as a siding material on the left side of the home, and the siding material at the back and left side of the home are sitting to close to the grade (ground) this is considered deficient and does not meet the minimum standard practice/required. Standard requires a minimum of 4 inches of the entire foundation be exposed at all times, this is to help prevent moisture and wood destroying insects getting into the home.

2) Repaired cracks were noted in the siding material (bricks) on the left side of the home, this is an indicator that the foundation may no longer be performing as intended, resulting in the bricks being damaged, resulting in the bricks not performing as intended. This issue is considered deficient and does not meet the minimum standard practice.

Recommend having these issues looked at further by a licensed general contractor and all required repairs be made.
