Inspection Report

Property Address:
5847 Farwell Drive
Houston Texas 77035

PROPERTY INSPECTION REPORT

By: Donivan Harvey 20964 / RSCH-ONE Inspections 5/17/2021

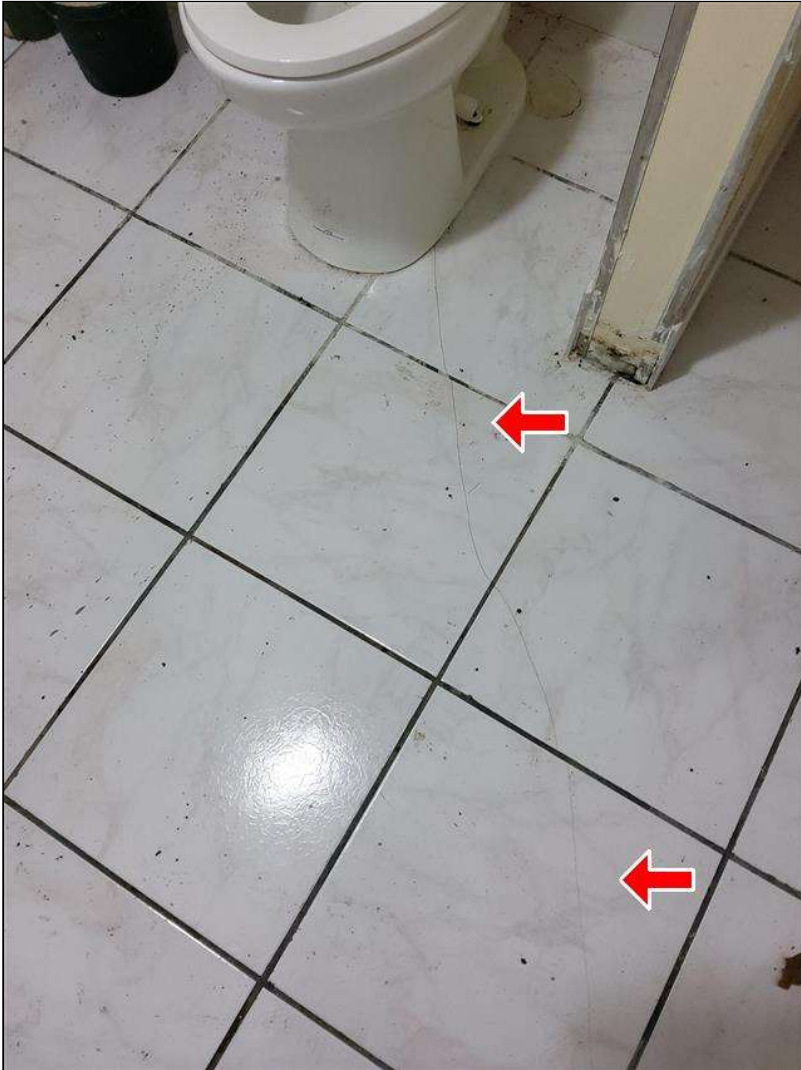
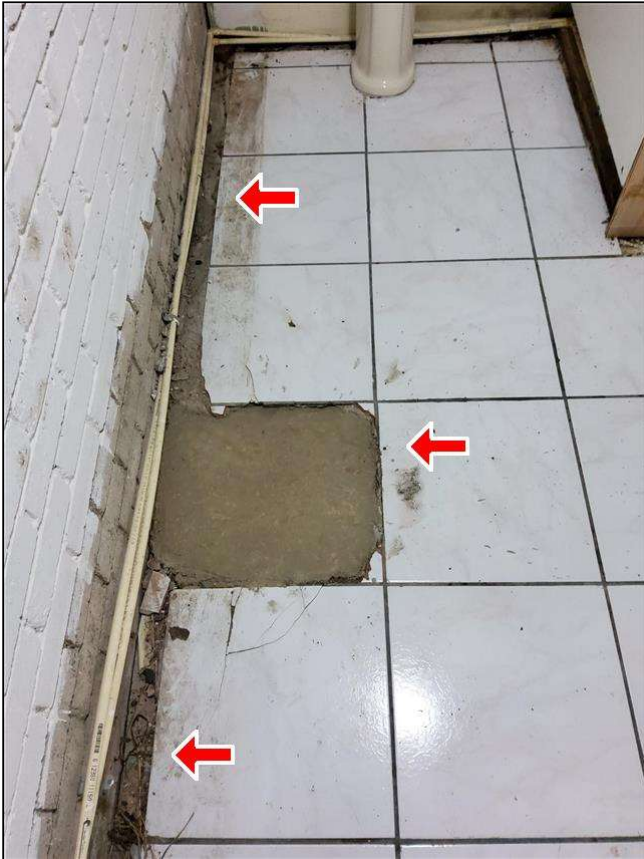
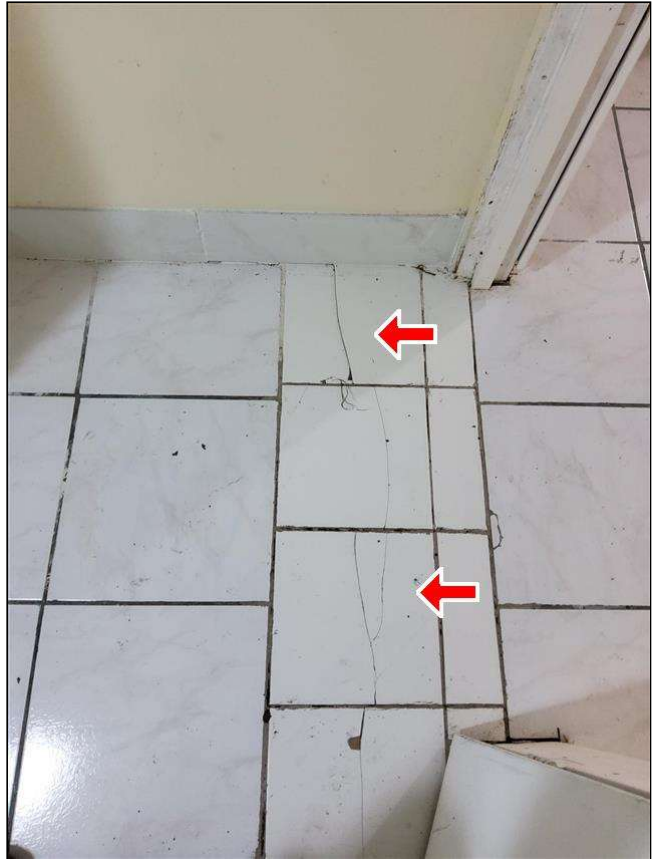
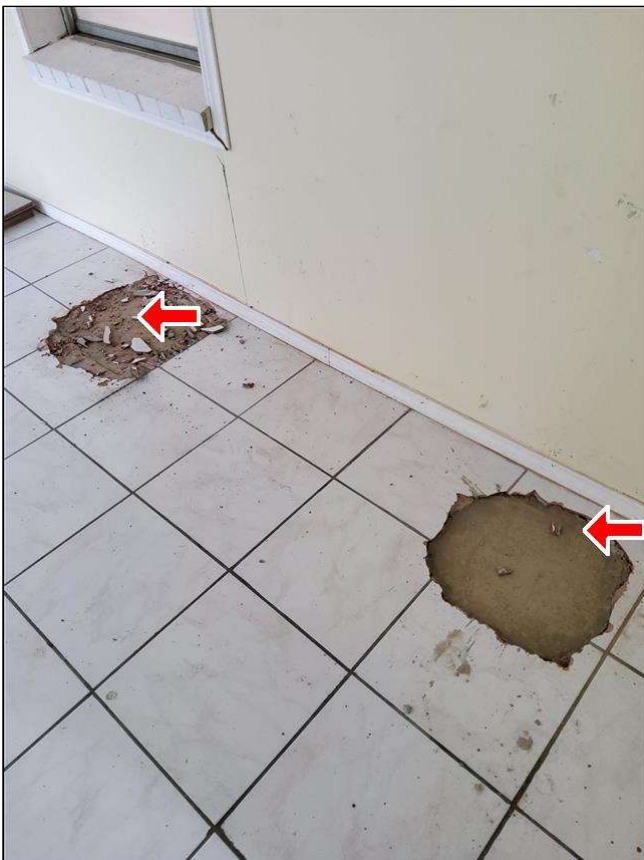
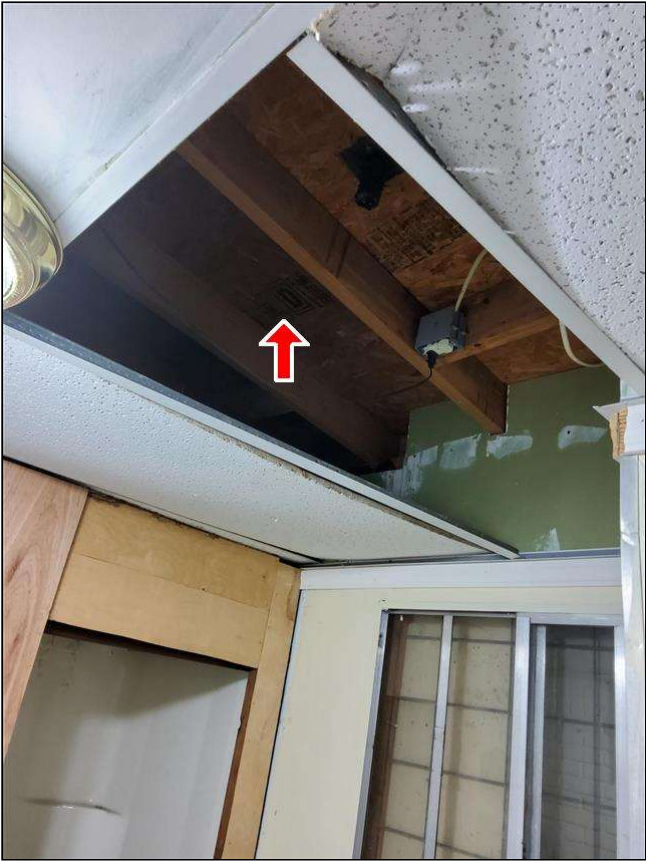
H. 1) Cracks were noted going through several tiles on the addition part of the property, this is an indicator that the foundation is not performing as intended, causing damage to the floor material, which can become a physical injury hazard.

2) Multiple damaged/broken tiles were noted in the addition back area of the home, this is considered deficient and is a physical injury hazard. This does not comply with the minimum standard practice.

Recommend having this looked at further by a licensed general contractor and or flooring company and all required repairs be made.

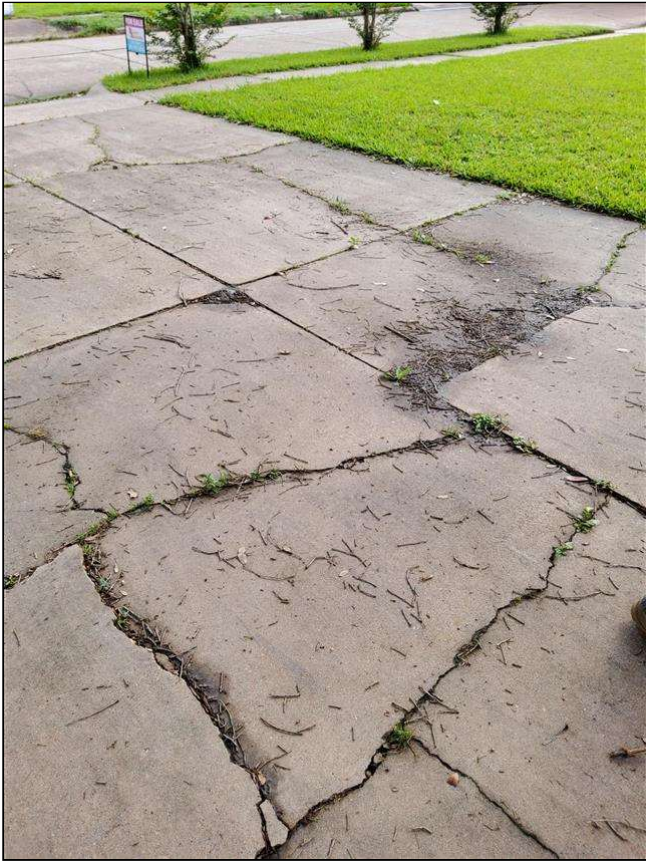
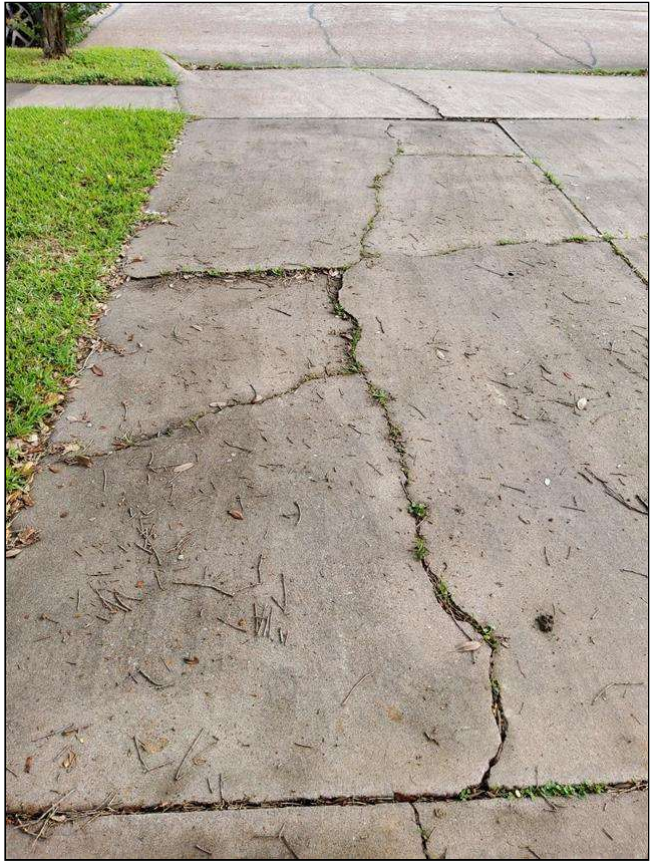
K. The drive and walkway slabs are not even, this is considered a trip and fall hazard and can cause damage to car tires and rim. This issues is considered deficient and do not meet the minimum standard practice. Recommend having this looked at further by a licensed general contractor and all required repairs be made.

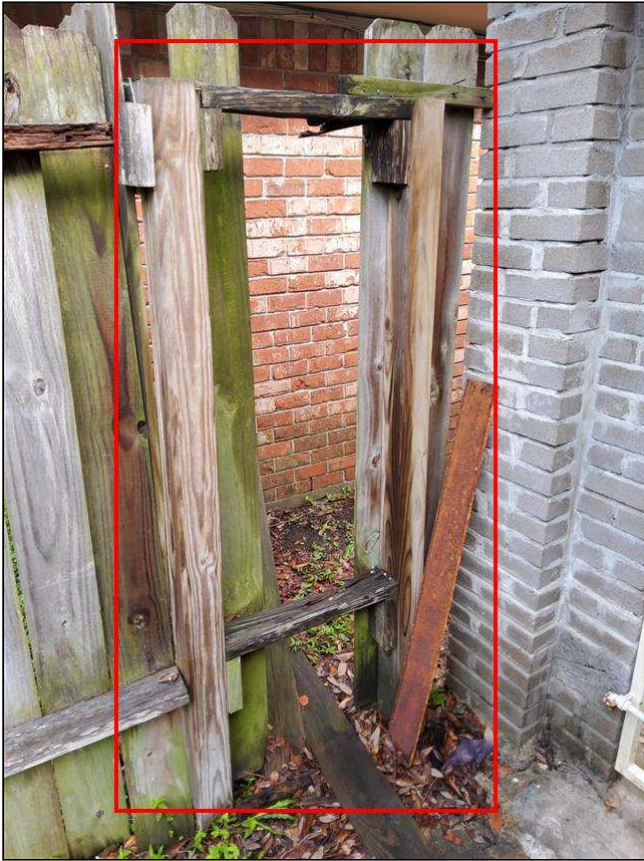
L. Item 1(Picture)

L. 1) A section of the fence by the right side entry gate is missing, this is considered a safety and security hazard that does not comply with the minimum standard practice/required. Recommend having this looked at further by a licensed general contractor and all required repairs be made.

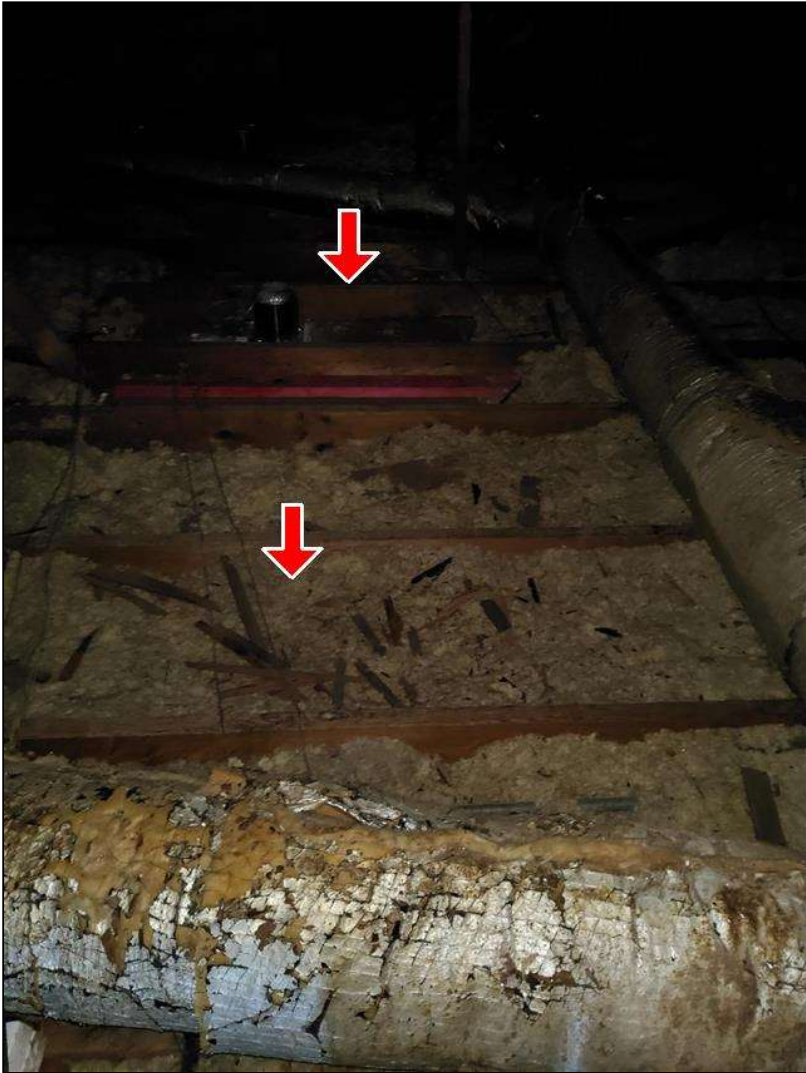
L. Item 2(Picture)

2) Insufficient insulation was noted in the attic space of the home, this is considered deficient and does not meet the minimum standard practice. Standard requires a minimum of 12 inches of R30 or greater insulation to be in the attic space over the habitable area of the home. Recommend having this looked at further by a licensed general contractor to be repaired/corrected.

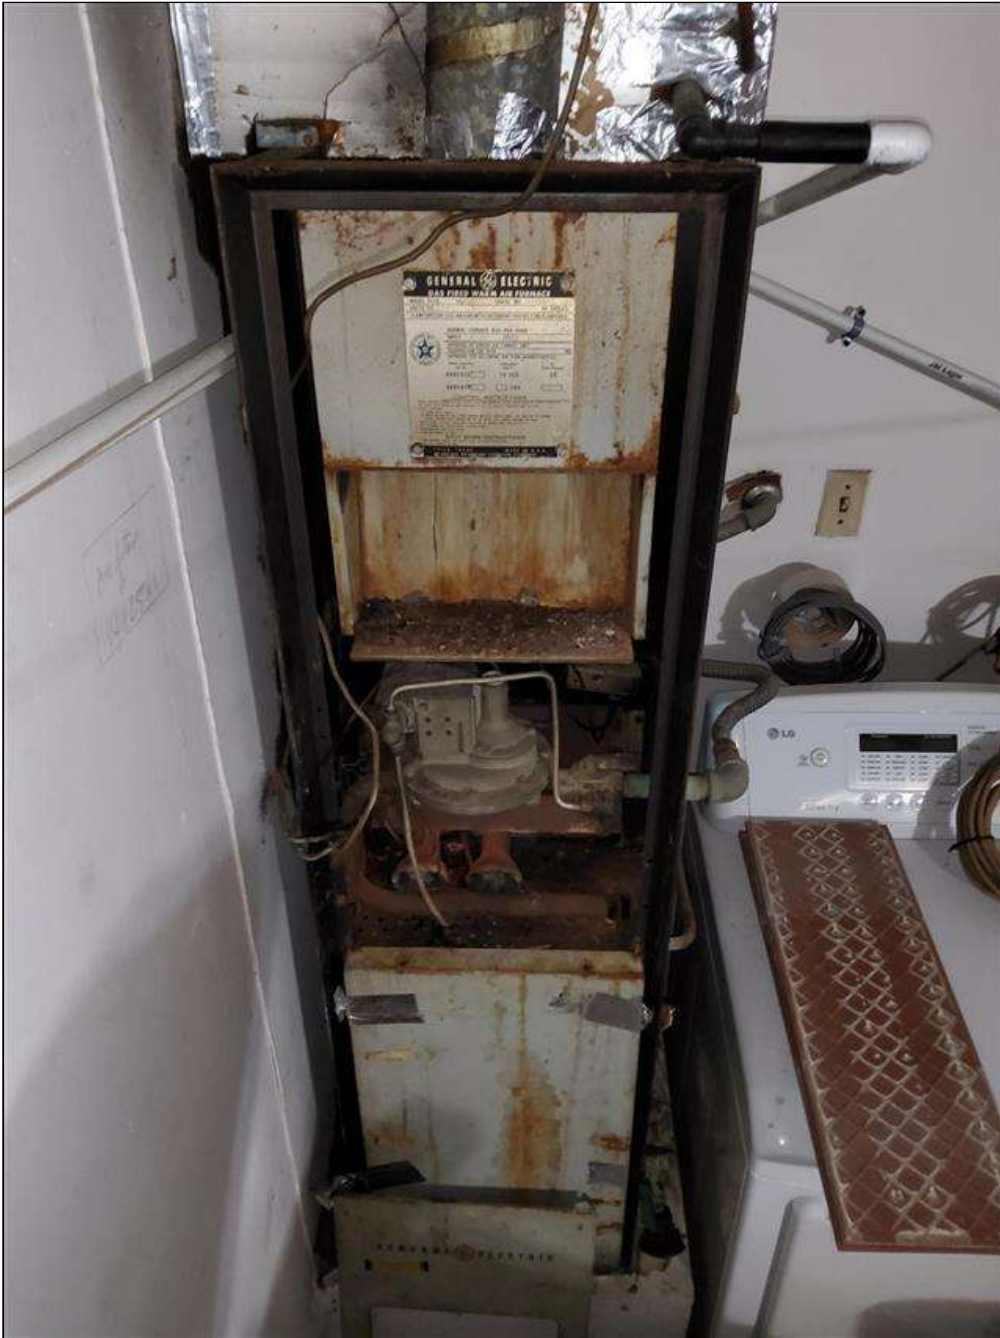
A. Item 1(Picture)

A. The interior air handling system is considered deficient and appears to have reached the end of his life expectancy. Multiple areas of the system shows signs of rust corrosion, this can lead to the system not performing as intended. Recommend having this looked at further by a license HVAC tech and all required repairs we made

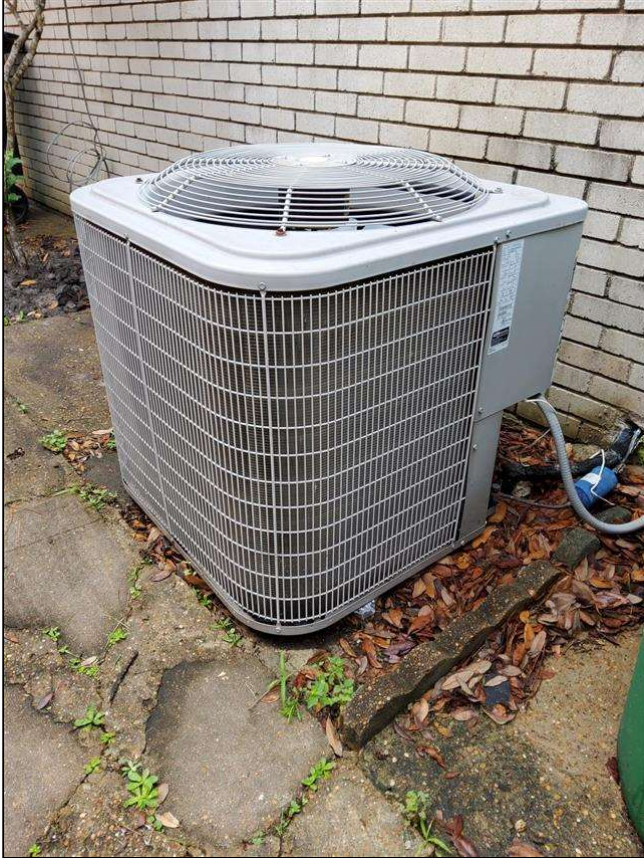
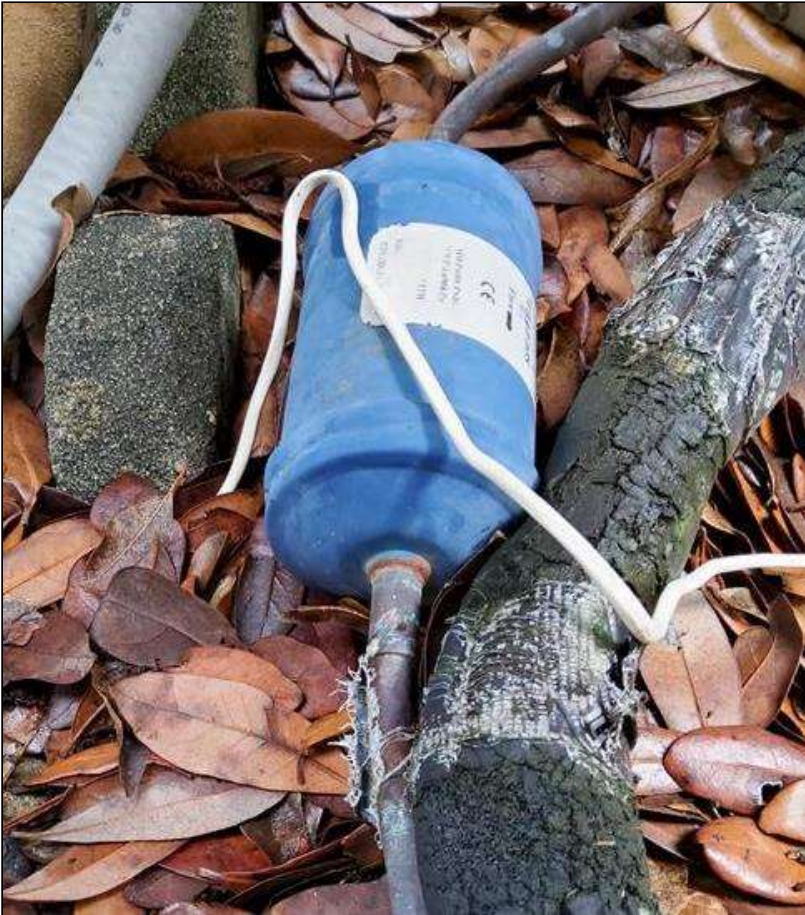
B. 1) The filter on the low pressure line by the exterior air handler units is degrading, this can prevent the unit from performing as intended. This is considered deficient and does not meet the minimum standard practice.

2) The coil on the interior air handler unit is dirty, this can prevent the coil from performing as intended, forcing the unit to work longer and harder, to keep the home cool at its desired temperature. This is considered deficient and does not meet the minimum standard practice. Recommend having this looked at further by a licensed HVAC Tech and all required repaired and servicing be done.

3) The exterior air handler unit is not sitting level on the base, and the base is not sitting a minimum of 3 inches above the ground. These issues are considered deficient and do not meet the minimum standard. Standard requires that the air handler be level on its base, this is to allow the unit to perform as intended, while sitting on a base that is a minimum of 3 inches above the ground, this is to help prevent dirt from getting into the coils/ducts on the unit, which will force the unit to work longer and harder. These issues can shorten the life expectancy of the unit.

Recommend having this looked at further by a licensed HAVC Tech and all required repairs and servicing be done.

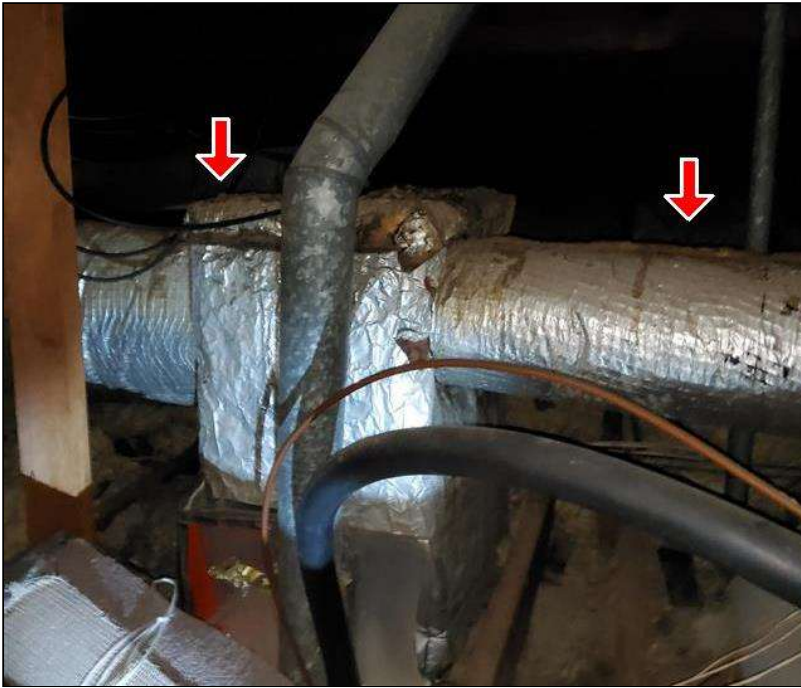
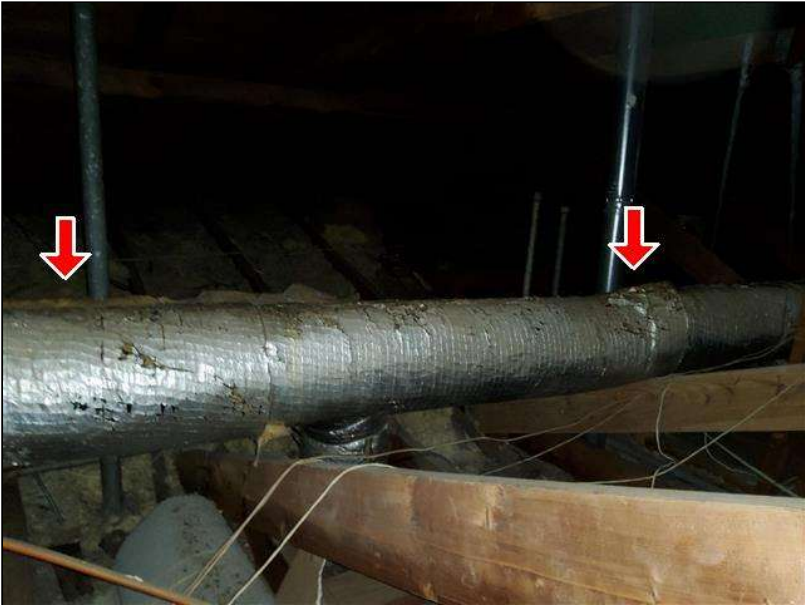
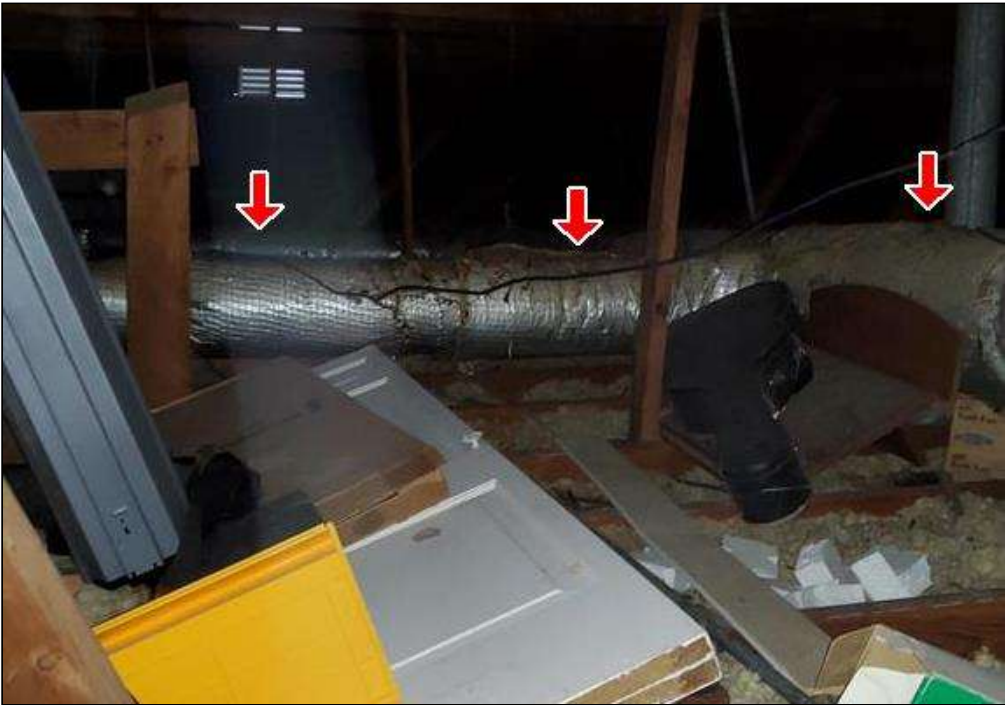
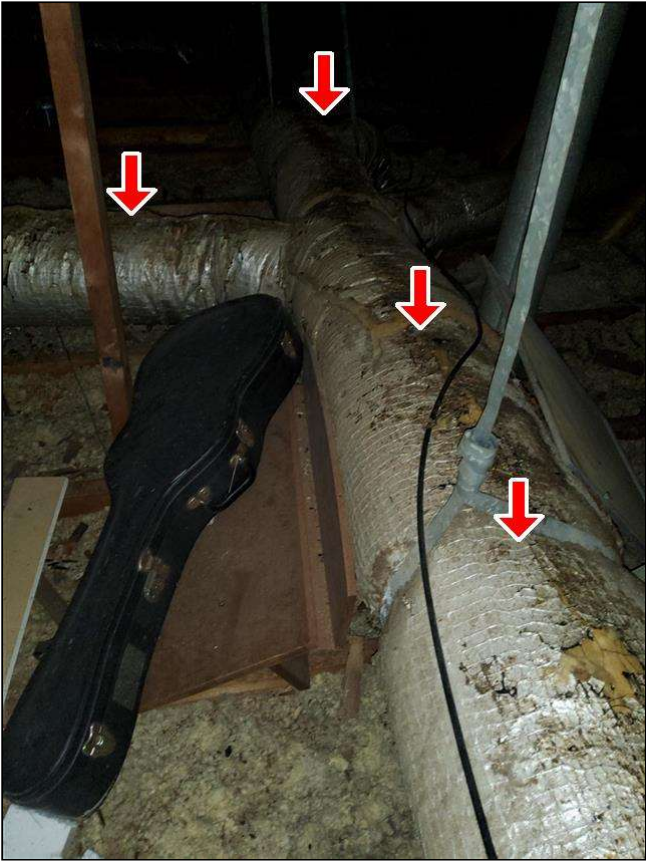
C. All of the A/C ducts are old, degraded and no longer functioning as intended, and have passed their life expectancy. This is causing the unit to work longer and harder keeping the home cool, by allowing air to leak from the degraded ducts. This is considered deficient and does not meet the minimum standard practice. Recommend having this looked at further by a licensed HVAC Tech and all required repairs be made.

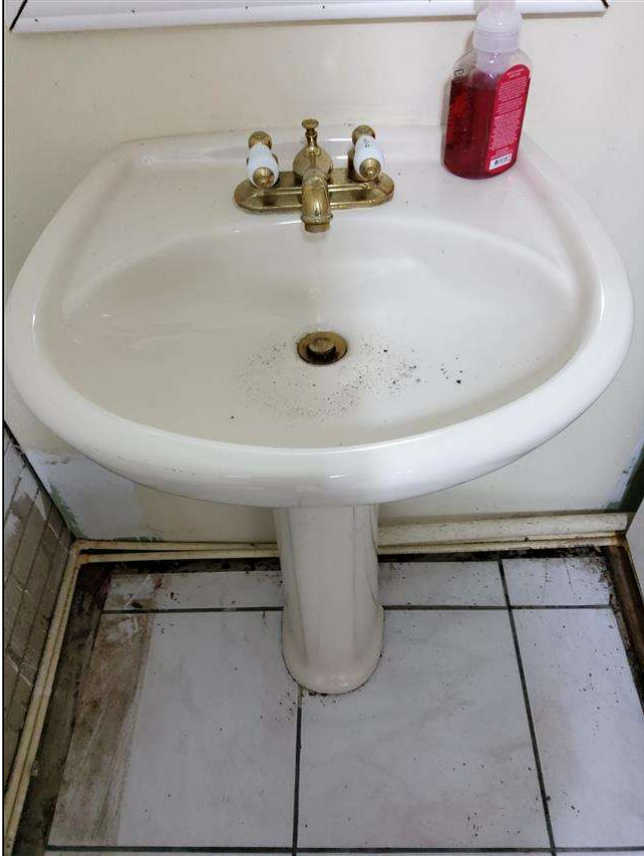
A. Item 1(Picture)

A. 1) The plumbing fixtures in the back bonus area of the home were not able to be inspected, this was due to no water going to the fixtures, this is considered deficient and does not meet the minimum standard practice.

2) The toilet in the guest bathroom continuously run, this will lead to higher then normal water bills. This issue si considered deficient and does not meet the minimum standard practice.

Recommend having these issues looked at further by a licensed plumber and all required repairs be made.

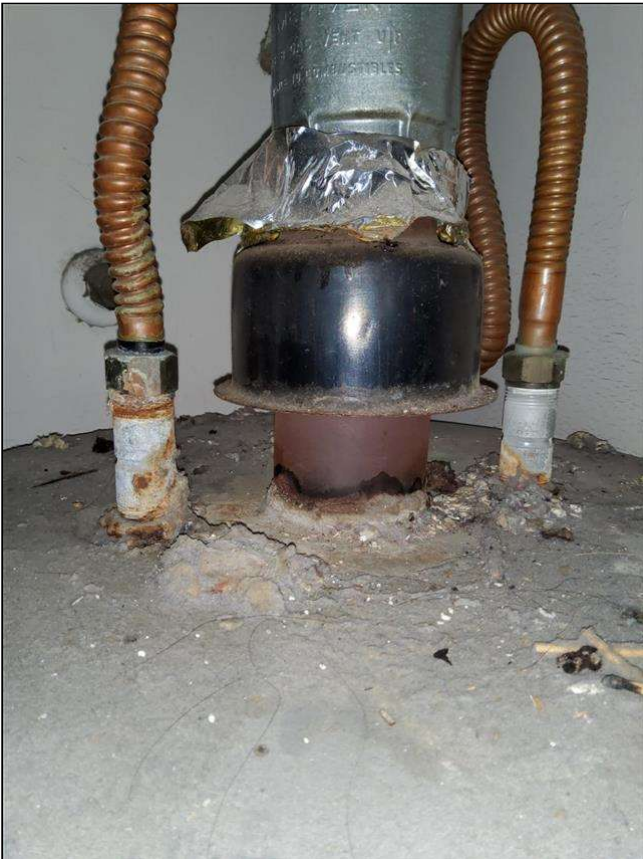
C. Item 1(Picture)

C. 1) The water heater is considered deficient and do not meet the minimum standard practice. Standard requires all water heaters be placed at a minimum of 18 inches off the floor, sitting in a drain pan, with a drain line from the T&P valve and drain pan terminating on the exterior side of the home, unless in the garage, the drain pan drain line can terminate halfway down the slope section of the floor.

Recommend having the water heater looked at further by a licensed plumber and all required repairs be made.

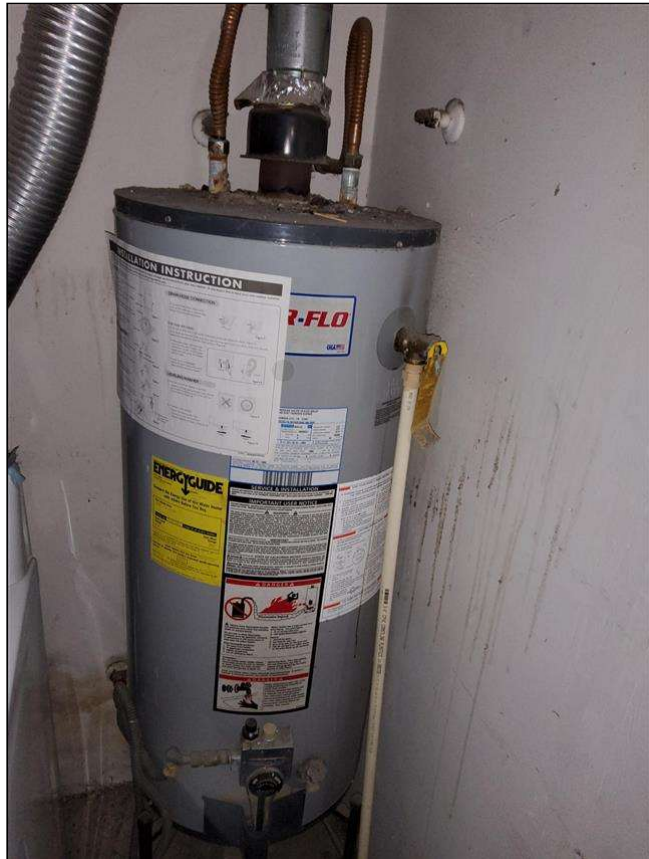
C. Item 2(Picture)

2) Corrosion damage was noted on the water line connections to the water heater, and around the connections to the cold water shut off valve, this can result in the water heater leaking, preventing the home from having hot water. This is considered deficient and does not meet the minimum standard.

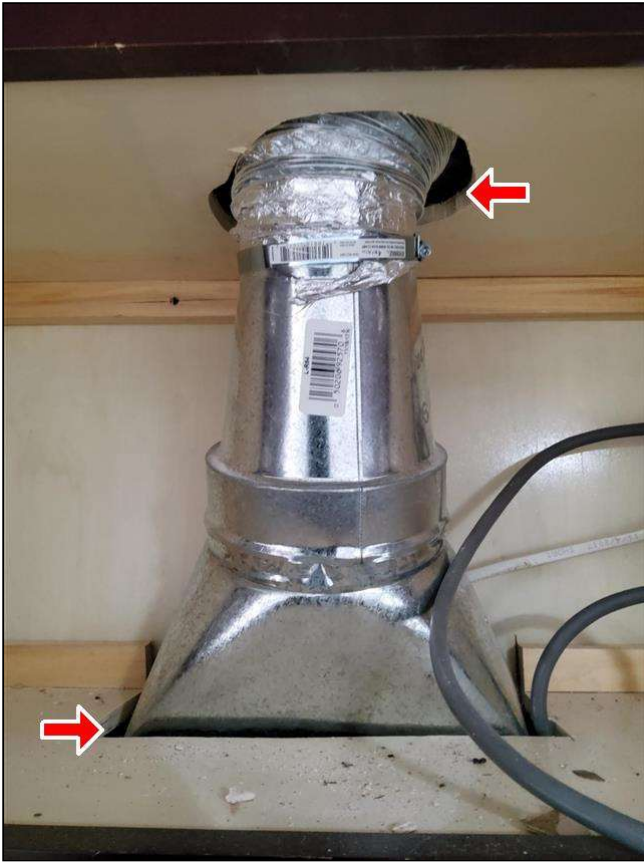
C. Item 1(Picture)

C. The exhaust vent in the cabinet over the cooktop exhaust is not seal around the area going out of the home, this is considered deficient and does not meet the minimum required standard practice. Standard states that all opening must be properly sealed, this is to prevent air escaping the home and vent. Recommend having this looked at further by a licensed general contractor to be repaired.

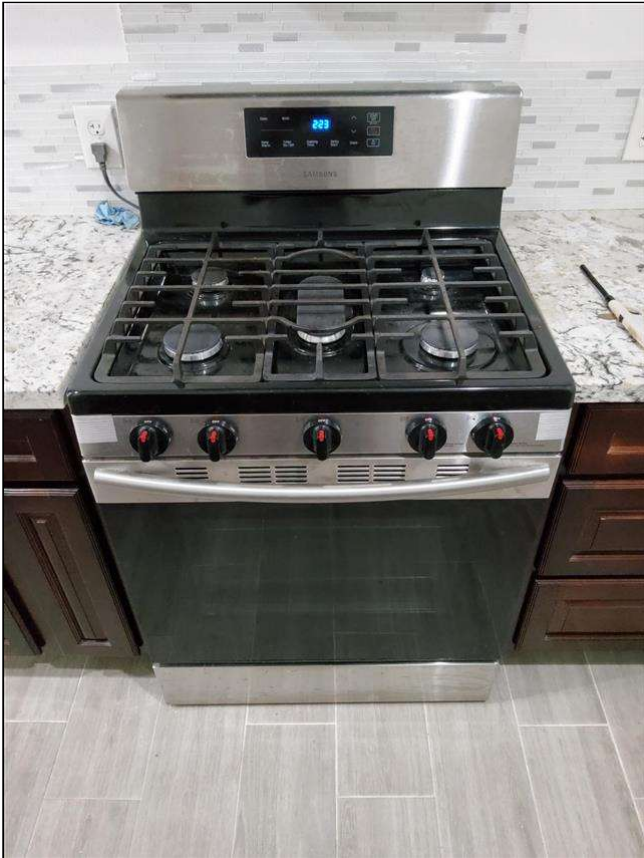
D. Item 1(Picture)

D. The anti tipping device is not installed on the stove, this device is used to help prevent the stove from tipping over, which can be a safety fire, and physical injury hazard. Standard required that this be installed on the stove. Recommend having this looked at further by a licensed general contractor and all required repairs be made.

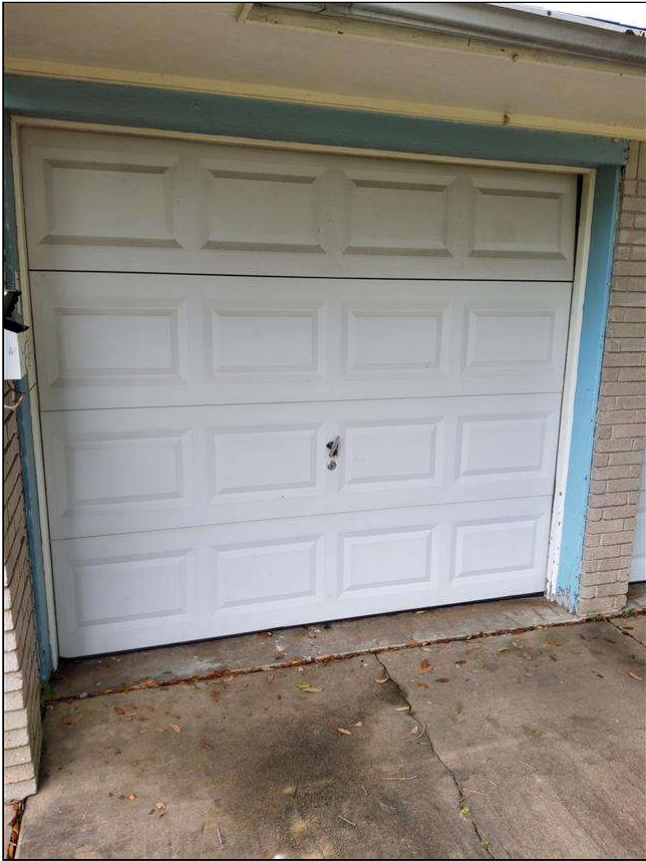
G. Item 1(Picture)

G. The left garage door does not close properly, this is considered deficient and does not meet the minimum standard practice, this issue can lead to the door not functioning as intended. Recommend having this looked at further by a licensed garage door operator company and all required repairs be made.

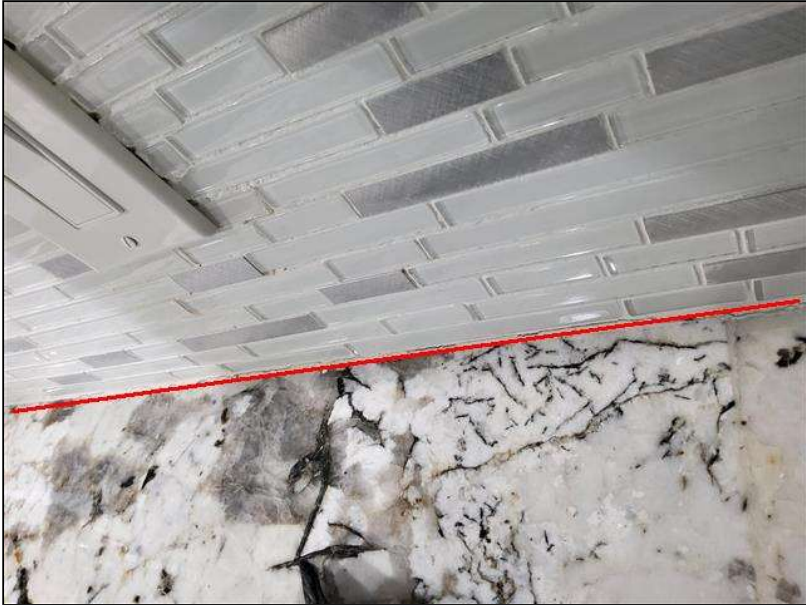
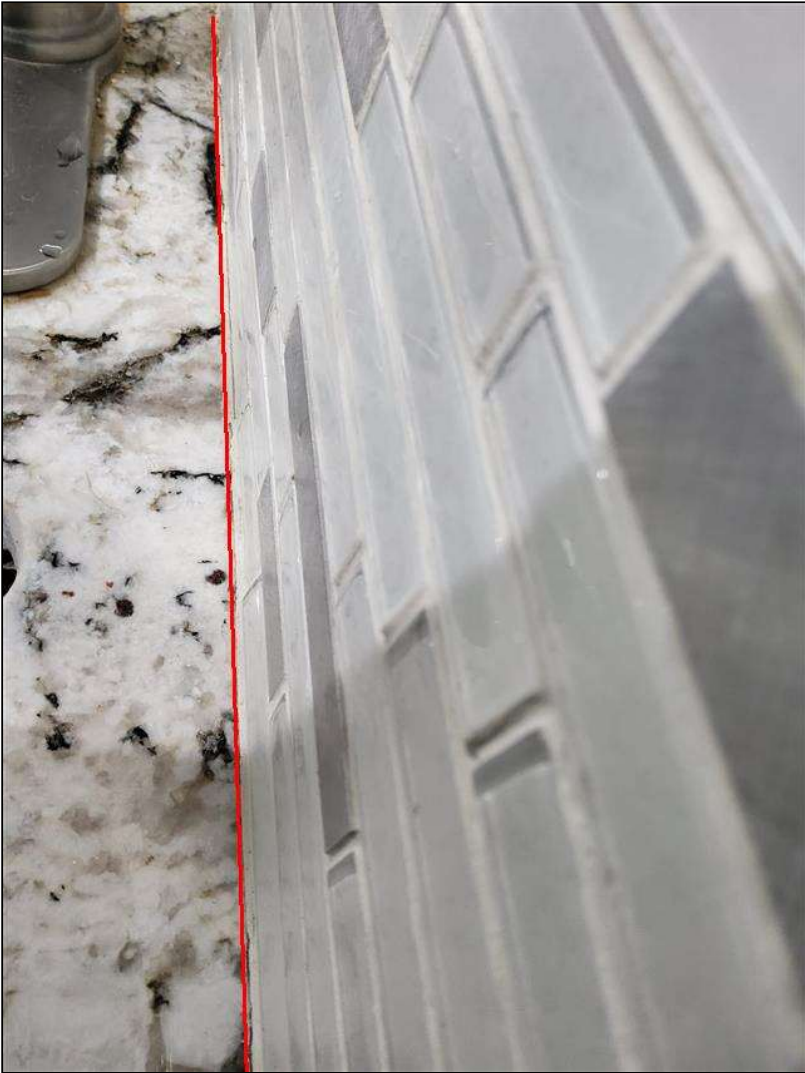
I. The grout between the bottom of the back splash and counter top by the kitchen sink is degraded and no longer functioning as intended. This issue can allow moisture to get behind the degraded area. This is considered deficient and does not meet the minimum standard practice. Recommend having this looked at further by a licensed general contractor and all required repairs be made.
