## **PROPERTY INSPECTION REPORT**

**Concerning:** 17219 Park Lodge Drive, Spring, TX 77379  
(Address or Other Identification of Inspected Property)

**By:** Michael Barnes, Lic #22055 NACHI 17010801 10/16/2020  
(Name and License Number of Inspector) (Date)

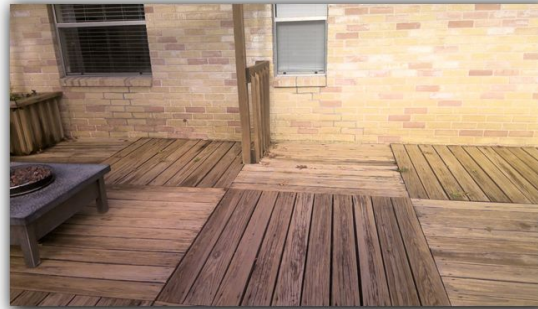
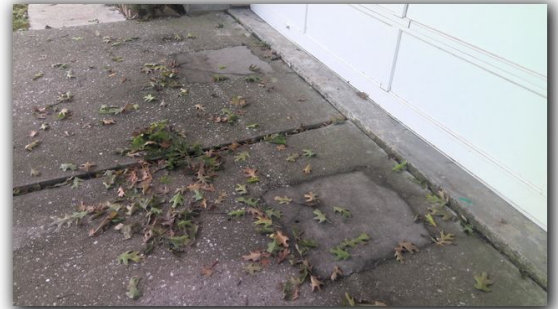
**PERFORMANCE OPINION:** The residence was observed as having a concrete slab on grade foundation. The foundation was blocked from view in some locations so I was unable to observe the entire slab. There was evidence of prior foundation repairs and movement such as sticking doors, separation at windows, cracks in brick and mortar, etc. I recommend obtaining any information and transferable warranties related to the repairs. Much of the interior of the home had been remodeled so some indicators may have been hidden. Out of an abundance of caution I recommend having the he foundation evaluated.

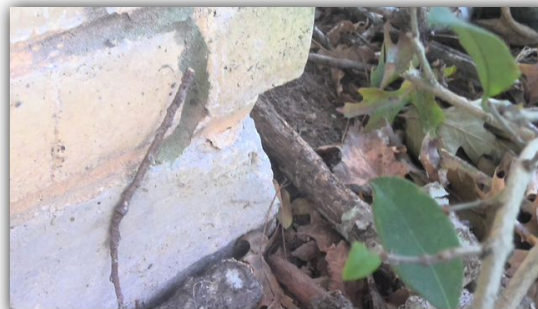
**REPAIR ITEM:** There were corner pops on the structure. Corner pops are not an uncommon occurrence on concrete slab foundations and typically have no bearing on the function of the foundation. I do recommend they be sealed with hydraulic cement to prevent the possibility of moisture and/or pest penetration.

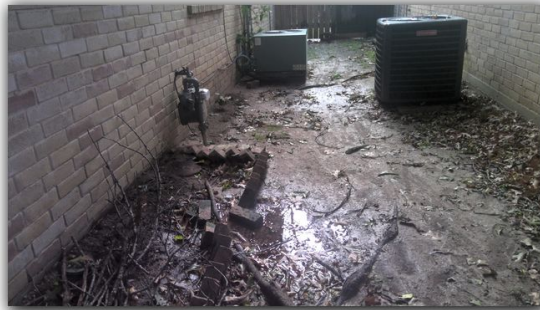
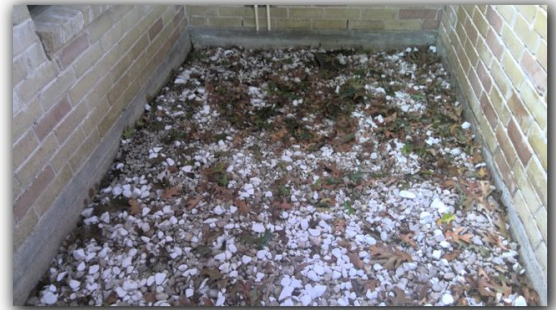
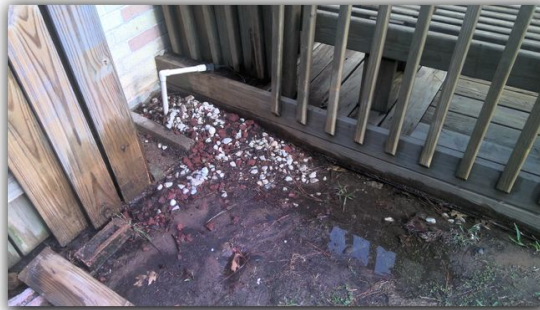
**REPAIR ITEM:** The drainage needed to be corrected so water is directed away from the foundation. There should be a minimum of 6 inches of fall within 10 feet away from the foundation. The water shall be directed to drains or swales to ensure drainage away from the structure. This will help prevent water from collecting around the foundation which could result in water penetration and/or foundation issues over time.

**REPAIR ITEMS:** Adding gutters to the perimeter of the home will aid drainage and erosion control

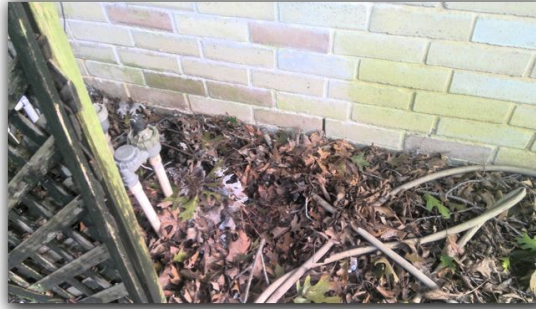
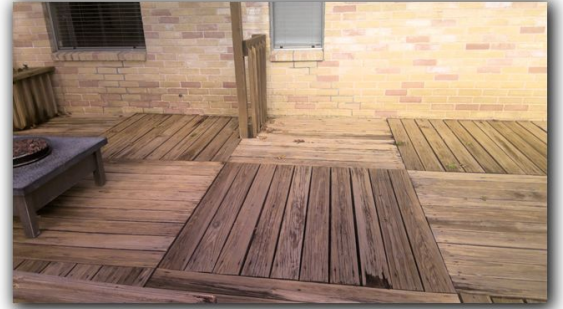
**REPAIR ITEM:** The soil/vegetation, and/or decking/cement was too high on the foundation. The perimeter of the structure needed to be examined and remediated where there is not four inches of foundation exposed for masonry veneer (i.e. brick, stone, etc.) and six inches for all other materials (i.e. wood, vinyl siding, etc.). The current condition may allow water to penetrate the walls.

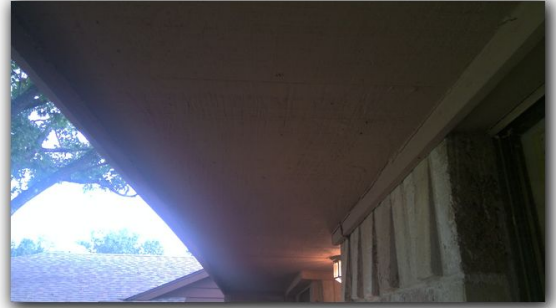
**REPAIR ITEM:** The attic ventilation was inadequate at the time of the inspection. Poor ventilation increases heat in the attic and living space in addition to decreasing the life of the roof covering and any appliances located in the attic such as HVAC equipment and water heaters.

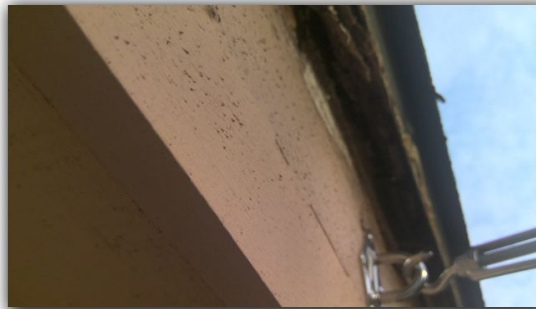
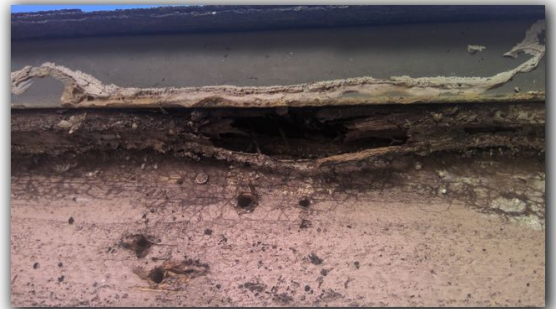
**REPAIR ITEM:** There was wood rot on the soffit and fascia. I recommend replacement of damaged wood.

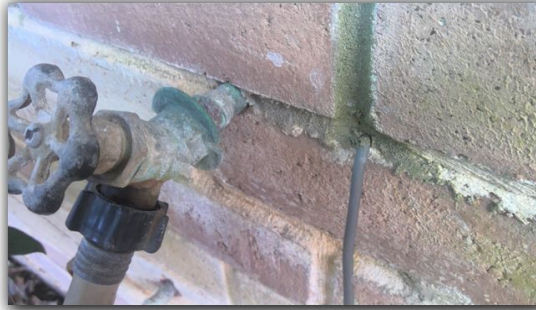
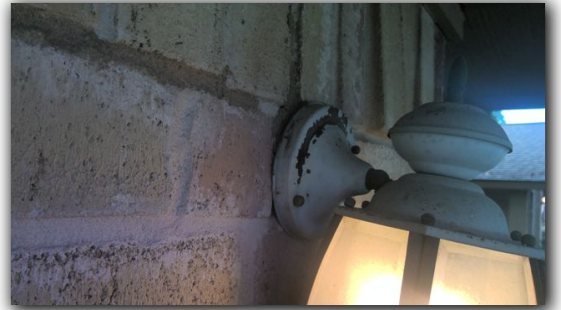
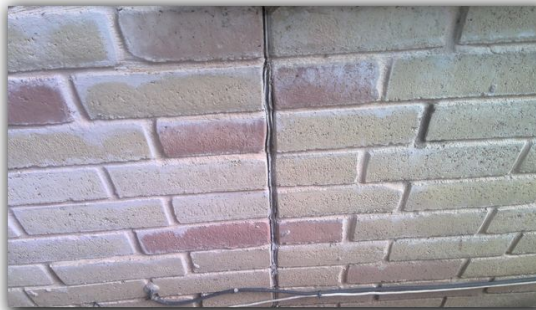
**REPAIR ITEM:** Monitor all exterior wall penetrations and all locations where two different building materials meet. Over time the caulk used in these areas will deteriorate and caulk or hydraulic cement will need to be re-applied. Some such locations include the following: around light fixtures, expansion joints, hose bibs, electrical panels, vents, door & window frames, etc to name a few.

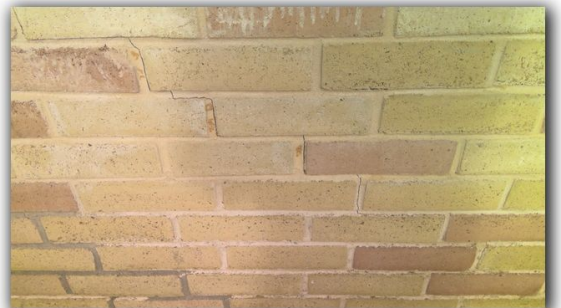
**REPAIR ITEM:** There were cracks in the brick and/or mortar. This may have been the result of a foundation or structural issue. I recommend sealing the cracks to prevent possible water and/or pest intrusion that could eventually damage the components behind the brick.

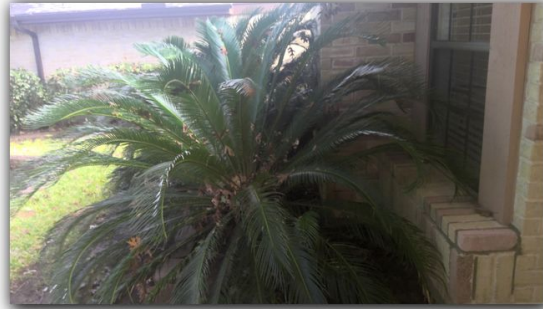
**REPAIR ITEMS:** I recommend keeping vegetation trimmed away from the exterior walls.

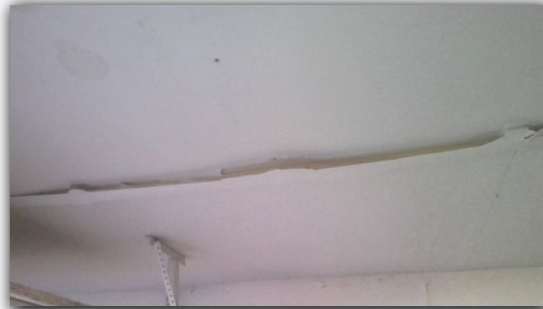
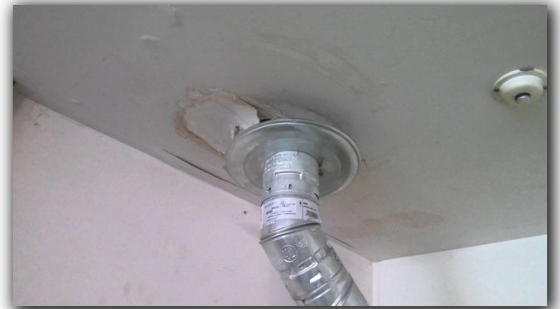
**REPAIR ITEM:** There was evidence of prior water damage on interior ceilings. There were no indications of active leaks at the time of the inspection.

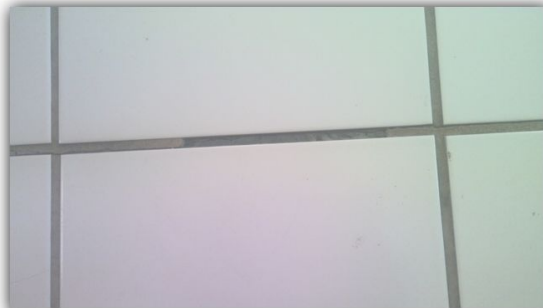
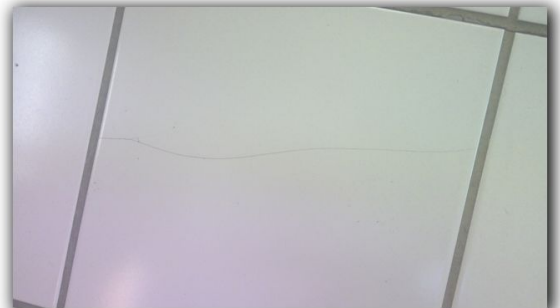
**REPAIR ITEM:** There were cracks in tiles and grout on interior floors. This may be the result of prior foundation movement.

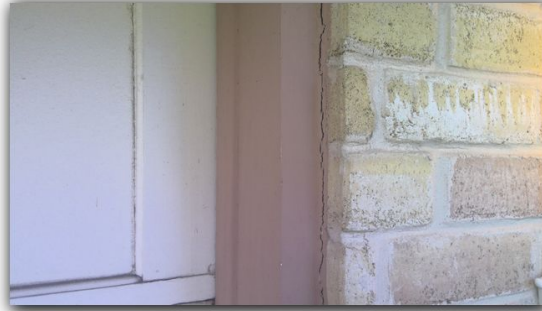
**REPAIR ITEM:** The caulking around exterior doors has deteriorated and should be re-sealed to prevent moisture and/or pest intrusion.

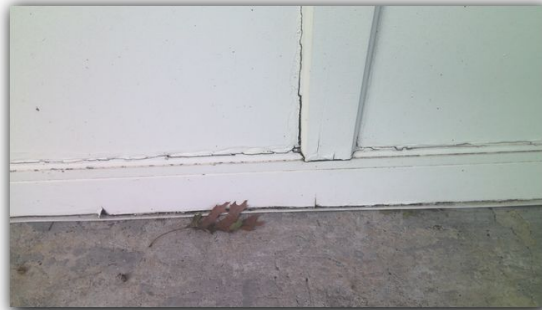
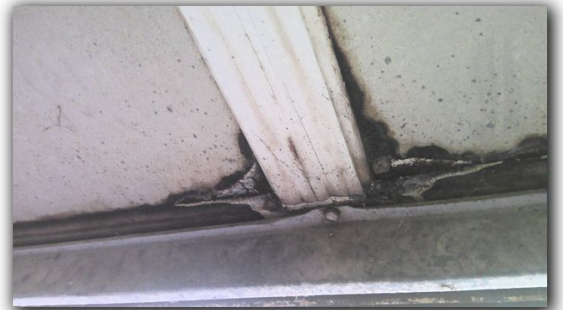
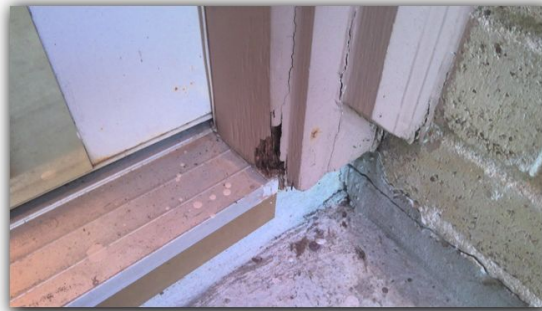
**REPAIR ITEM:** There was evidence of wood rot, rust, and water damage on exterior doors and frames.

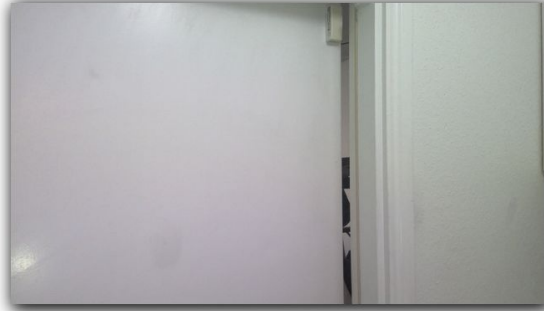
**REPAIR ITEM:** The door into the garage is recommended to be self closing.

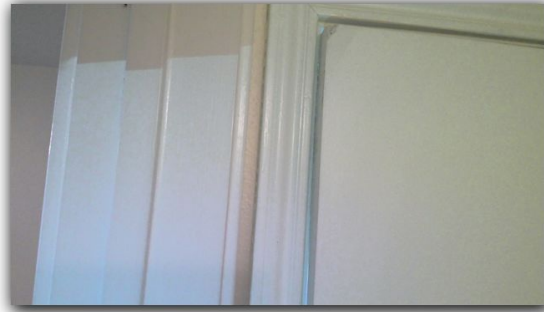
**REPAIR ITEM:** Some doors would not close properly at the time of the inspection.

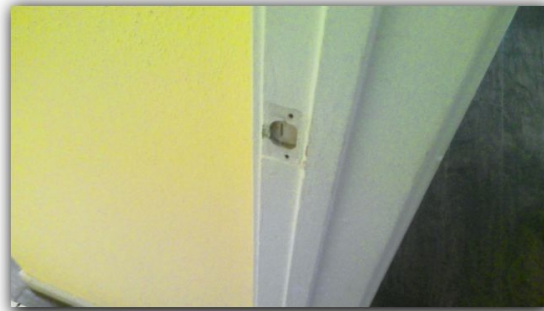
**REPAIR ITEM:** There were doors with missing hardware.

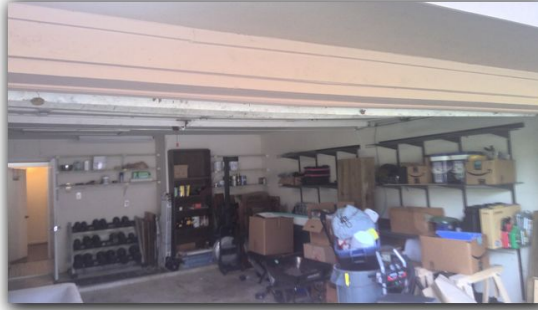
**NOTE:** The door frame over the garage opening had a slight sag.

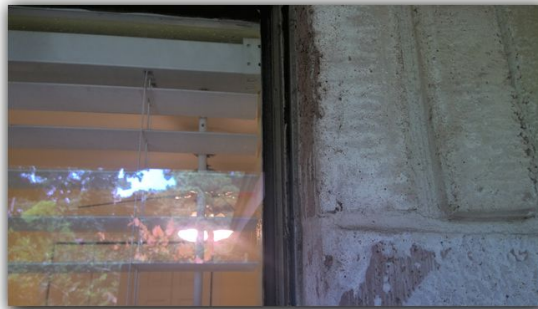
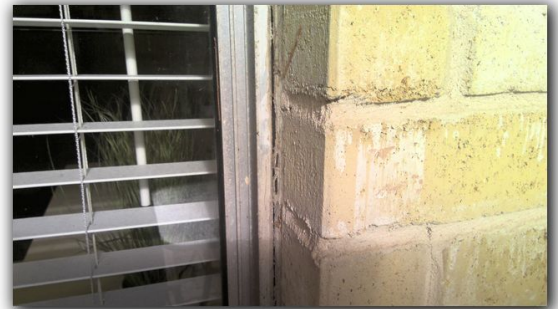
**REPAIR ITEM:** The trim around several of the windows had deteriorated caulk and should be sealed to prevent moisture and pest intrusion. (Some of the separation may have been the result of foundation or structural movement.)

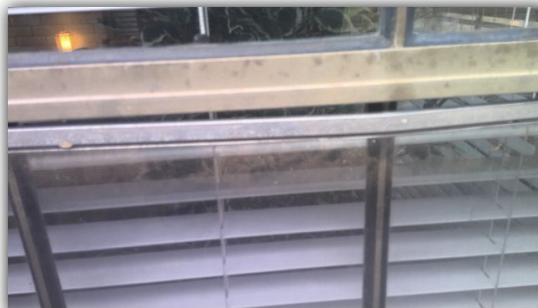
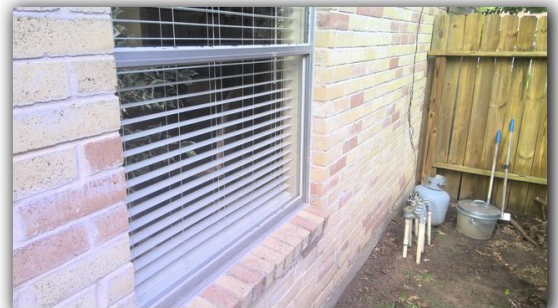
**REPAIR ITEM:** There were some windows that had damaged or missing screens. I recommend replacement of the screens.

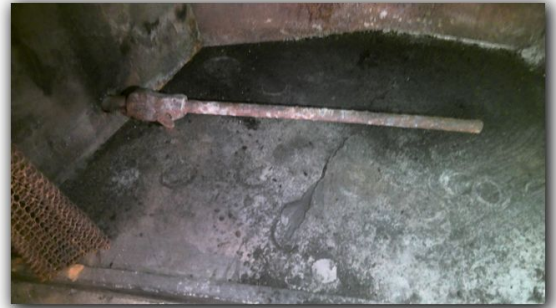
**SAFETY CONCERN:** The inside of the firebox was cracked and the gas line was damaged. I repairing the damage firebox and repair/replacement of the gas line.

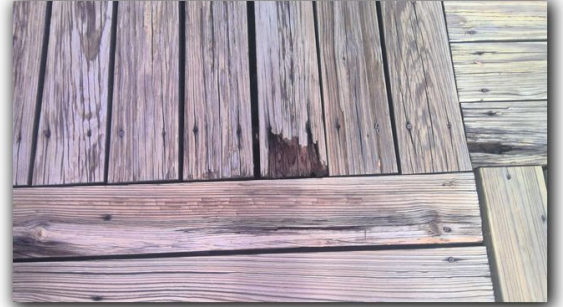
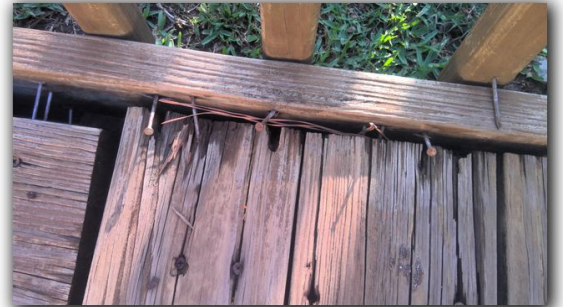
**REPAIR ITEM/SAFETY CONCERN:** The deck on the rear of the home had several issues. There was wood to ground contact, wood rot, loose rails, exposed nails, etc. I recommend repair/replacement.

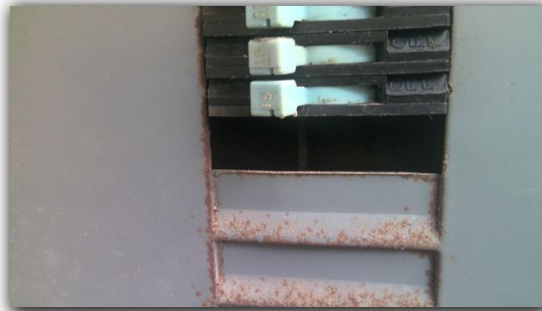
**SAFETY CONCERN:** There is an open slot that needs to be covered with a blank.

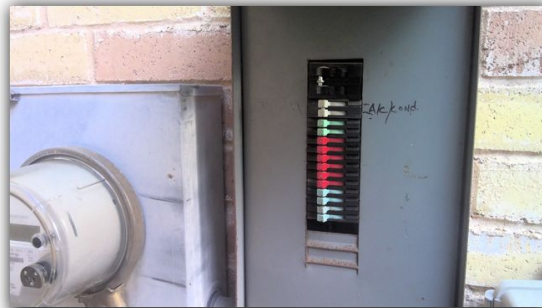
**SAFETY CONCERN:** This old style panel is often removed. These panels pose a higher risk of fire. I recommend having this panel evaluated by a licensed electrician.

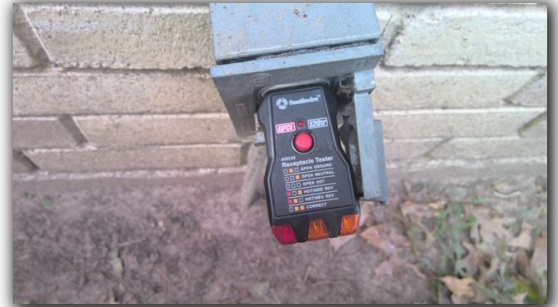
**REPAIR ITEM:** There was an outlet on the left side of the home that was not properly installed and not functional at the time of the inspection.

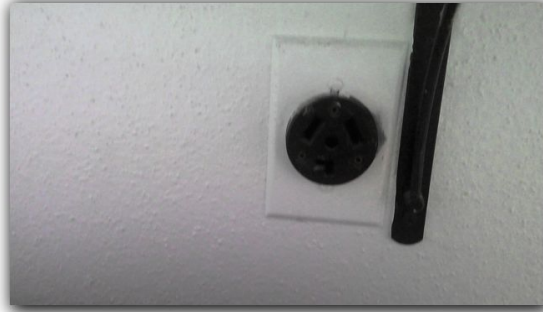
**REPAIR ITEM:** The outlet for the electric dryer is the old style 3 prong. This will not work on many of the newer dryer plugs. I recommend upgrading this plug.

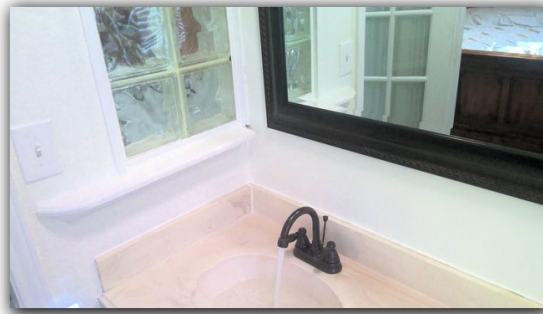
**REPAIR ITEM:** According to current standards all bathroom sinks must have a GFCI protected outlet within 3' of a sink. The left side sink in the primary bathroom did not meet this standard.

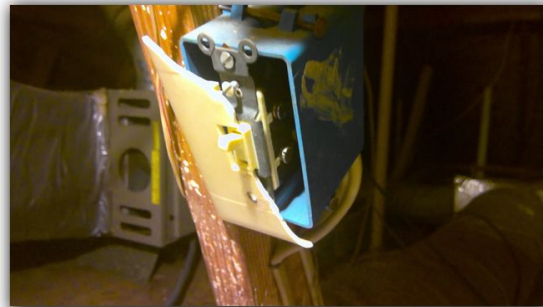
Attic

**SAFETY CONCERN:** There were broke/damaged cover plates on outlets and/or switches.

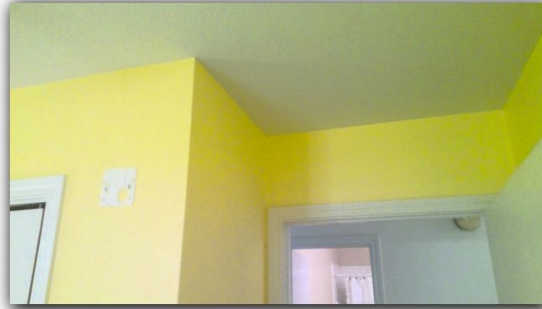
**SAFETY CONCERN:** Bedrooms were missing smoke detectors. Smoke detectors are required in all bedrooms, in the hallway outside bedrooms, on each floor, and required to be interconnected so when one alarm sounds it will activate all other alarms in the home.

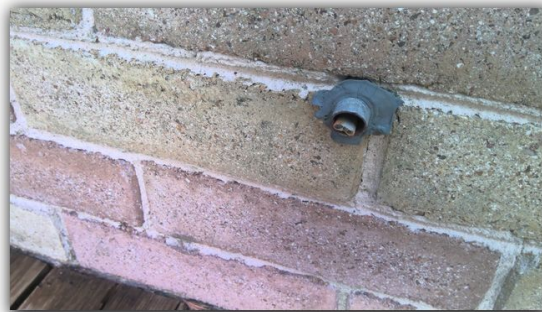
**SAFETY CONCERN:** There was electrical wiring on the rear of the home that was not properly terminated.

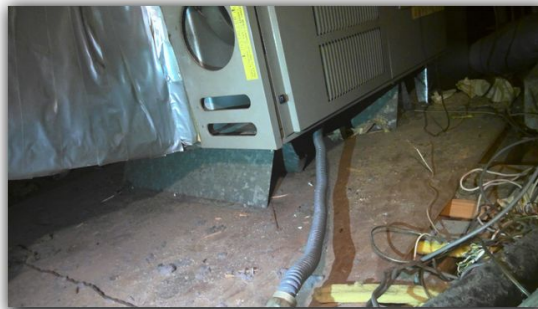
**SAFETY CONCERN:** A flexible gas line was penetrating through the appliance wall.

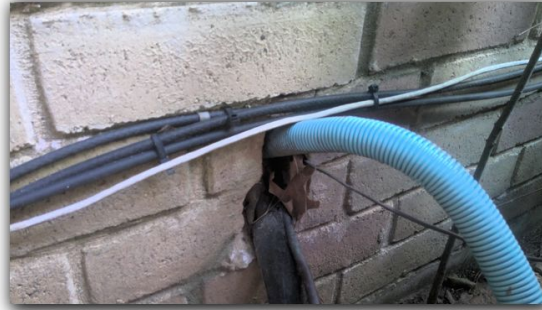
**REPAIR ITEM:** The area where the HVAC lines enter the exterior wall needs to be sealed with steel wool and expandable foam to prevent pest intrusion. This is one of the most common entry points for rodents.

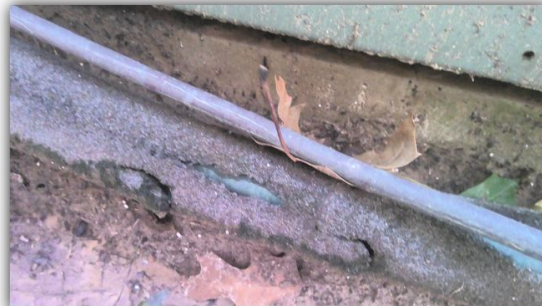
**REPAIR ITEM:** The suction line insulation on the exterior compressor unit needed to be repaired or replaced.

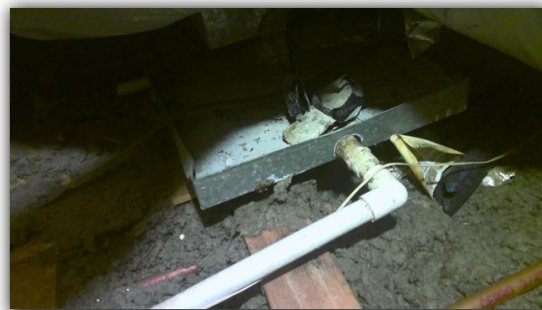
**REPAIR ITEM:** I recommend installing a float switch on all AC pans. A float switch will turn the AC off if the pan does not drain properly and fills with water. This would help prevent water damage to interior surfaces.

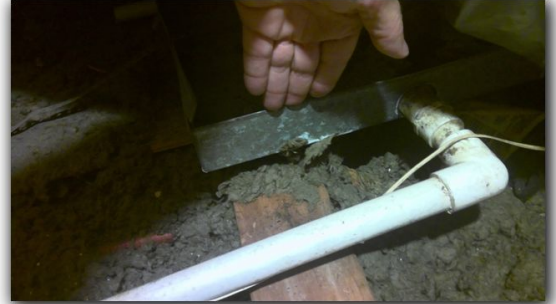
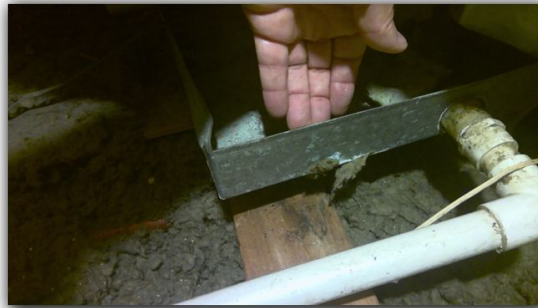
**REPAIR ITEM:** The secondary drain pan had debris that should be removed and was not installed correctly.

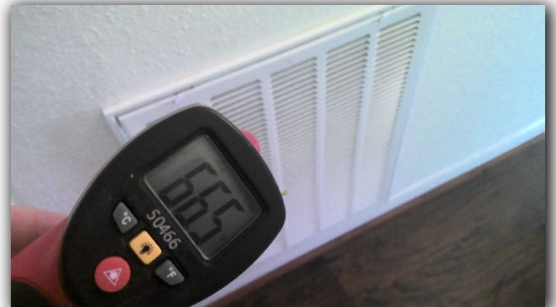
**REPAIR ITEM:** According to TREC standards A/C units should have a minimum of a 14 degree differential between supply. I recommend evaluation and repair by a licensed HVAC technician.

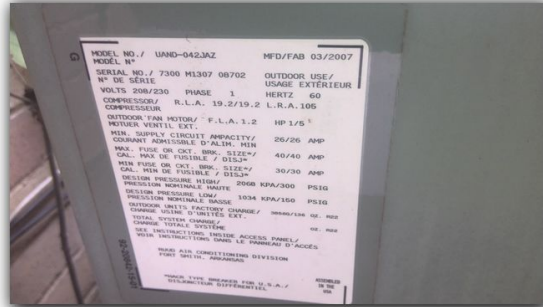
**NOTE:** The older unit operates on R-22. R-22 is no longer being manufactured or imported in the US. As a result, the R-22 refrigerant has and will continue to increase in cost.

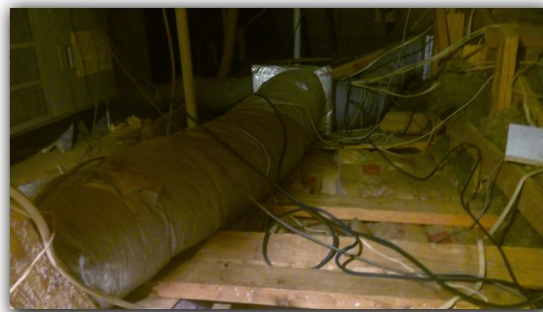
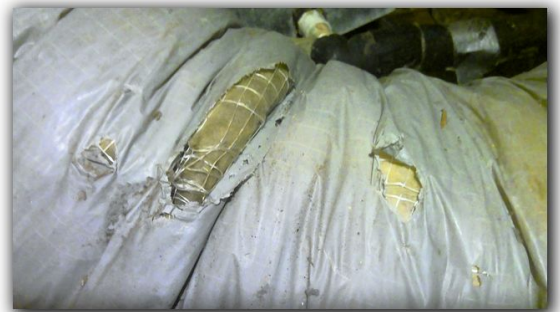
**REPAIR ITEM:** There were multiple locations where ducts were in contact with each other and/or not properly suspended by strapping every 4' as required by current standards. Ideally the ducts would be installed in such a way as to **not** come in contact with each other or other building materials. At a minimum, insulation should be placed between ducts that are in contact with each other.

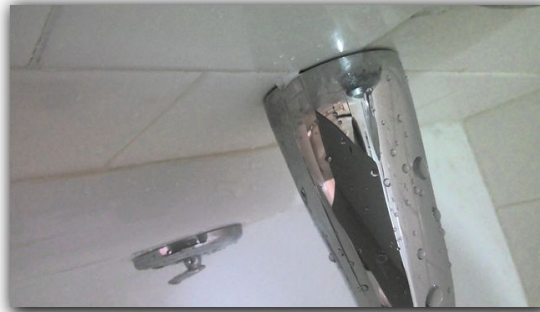
**REPAIR ITEM:** Caulk around shower heads, tub spouts, and tub/shower enclosures, and tub/floor intersections to prevent water damage to sub-floors and behind walls and fixtures.

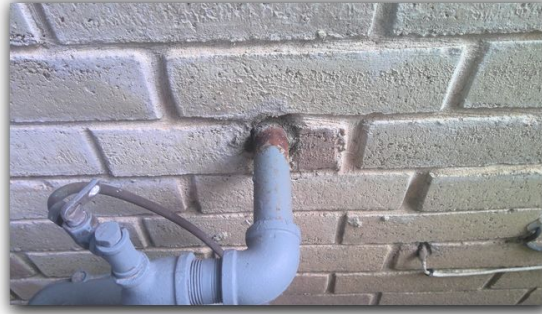
**SAFETY CONCERN:** Gas pipes should not be installed in solid walls unless the pipe is in an open chase or in a casing (sleeve) to protect the pipe from settlement stress and corrosion.

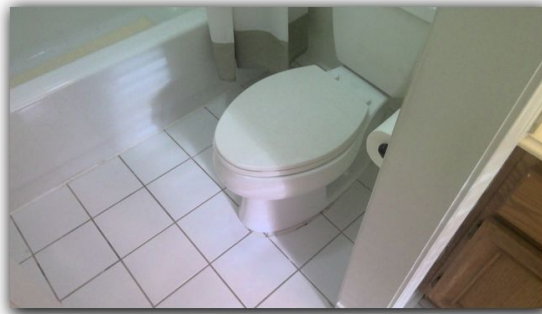
**REPAIR ITEM:** There were commodes loose at the floor. Secure in place to help prevent leaks. (It is likely the wax ring will need to be replaced.)

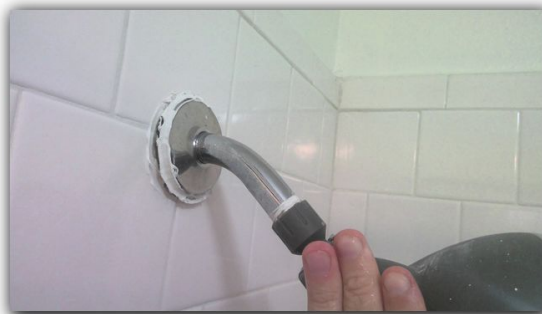
**REPAIR ITEM:** There were shower heads that were loose and needed to be secured in place.

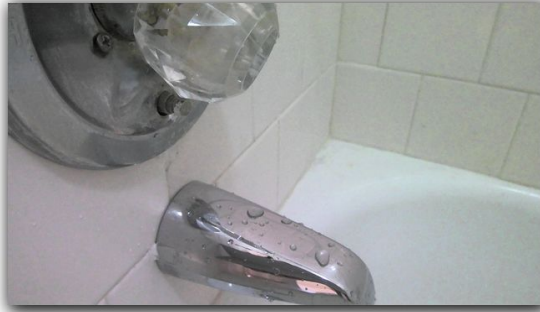
**REPAIR ITEM:** The shower diverter were not operating as designed at the time of the inspection. I recommend repair/replacement by a licensed plumber.

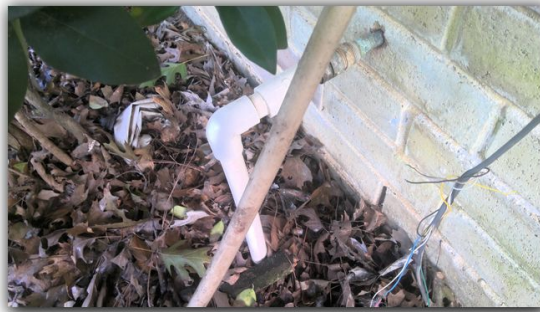
**REPAIR ITEMS:** Damaged/missing insulation. I recommend insulating exterior water lines to protect from freezing.

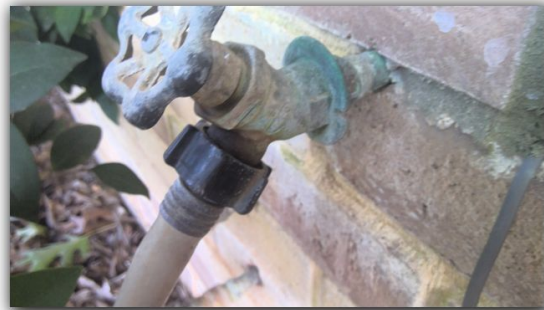
**REPAIR ITEM:** An anti-siphon device was missing on hose bibs.

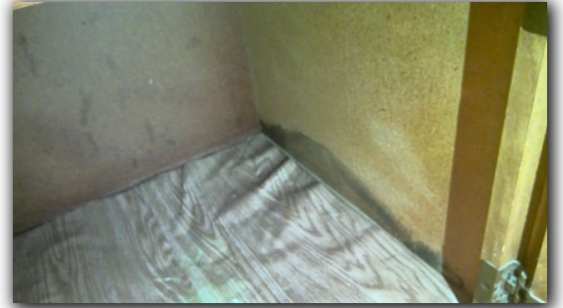
**REPAIR ITEM:** There was evidence of prior water damage and organic growth under sinks.

**NOTE:** Signs of prior water damage should be investigated further to determine if there is hidden damage and/or organic growth.

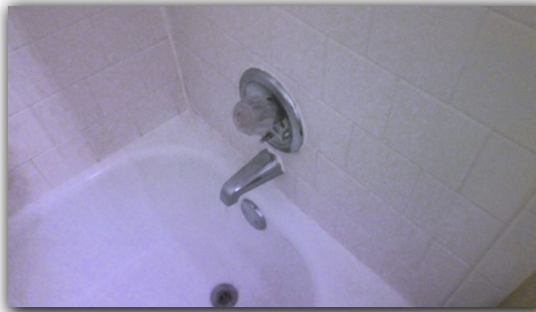
**REPAIR ITEM:** There were drains/stoppers that were missing, not properly installed, and/or not functioning as designed at the time of the inspection.

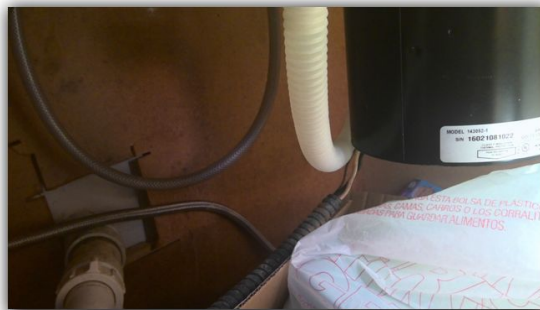
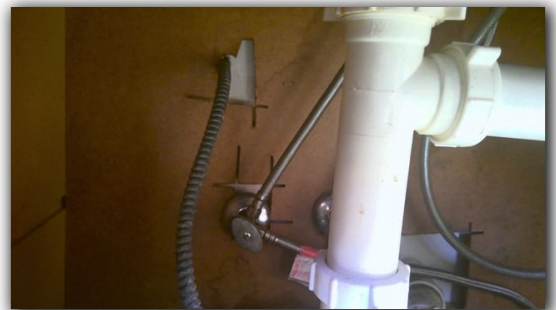
**SAFETY CONCERN:** The wiring entering the disposal was not protected from sharp edges. I recommend installing a grommet to secure and protect the wiring. Over time the vibration from the disposal will likely wear through the protective rubber coating. As a result, the wire may energize the disposal creating a shock hazard. The unit was also hardwired vs having a GFCI protected outlet as required by current standards.

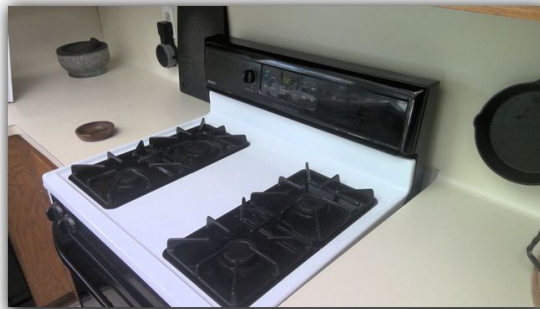
**SAFETY CONCERN:** There was no anti tip device installed on the stove.

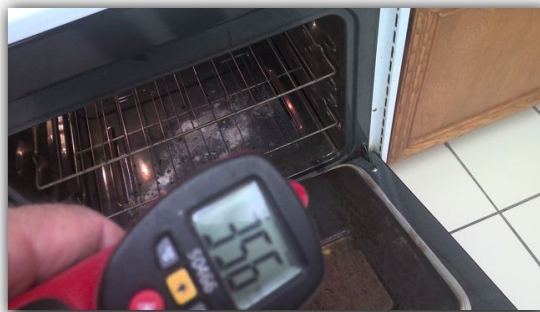
Tested at 350°F, Variance noted: +6 °F (max 25°F)

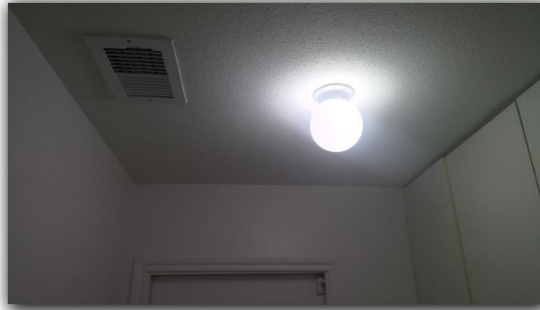
**REPAIR ITEM:** The laundry room did not have an exhaust fan. This is not unusual on a home this age.

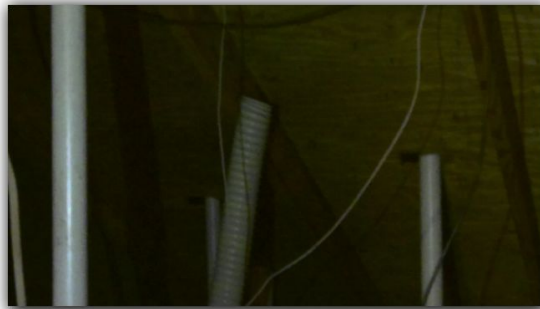
**REPAIR ITEM:** The mechanical exhaust fans were venting into the attic. They should vent to the exterior of the building envelope.

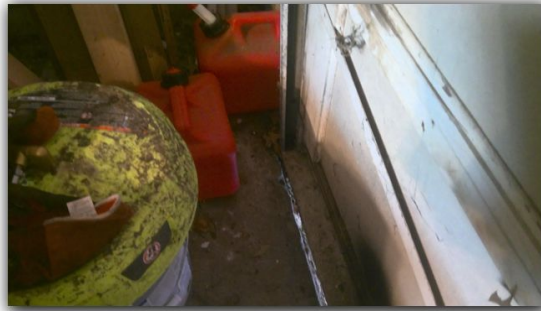
**SAFETY CONCERN.** There was no photoelectric sensors. I recommend installing sensors 6" or less above the floor.

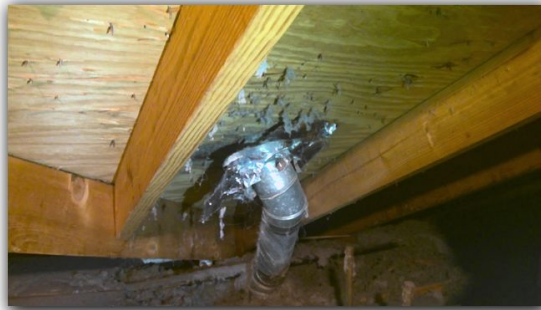
**REPAIR ITEM:** The dryer was venting into the attic. It should vent to the exterior of the building envelope.
