# Vested Property Inspection

# **Inspection Report**

Property Address: 10915 Langdon Lane Houston Tx 77072

Date: 10/31/2020	Time: 09:30 AM	Report ID: 10915-103120
Property:	Customer:	Real Estate Professional:
10915 Langdon Lane Houston Tx 77072	Mrs. Lan Nguyen

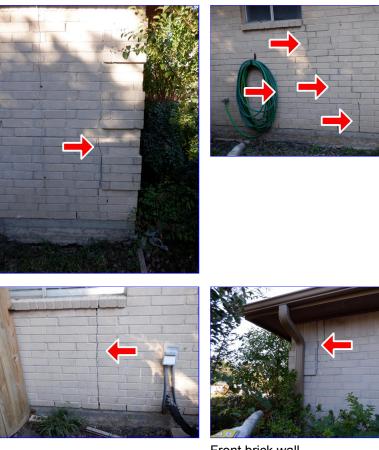
♦ (4) There were several locations of foundation have been previously repair and signs of foundation & brick wall cracks. Unable to determine at the time of inspection. Ask the owner on this matter, document warranty and have a qualified foundation engineer to evaluate for further information.

Rear foundation crack

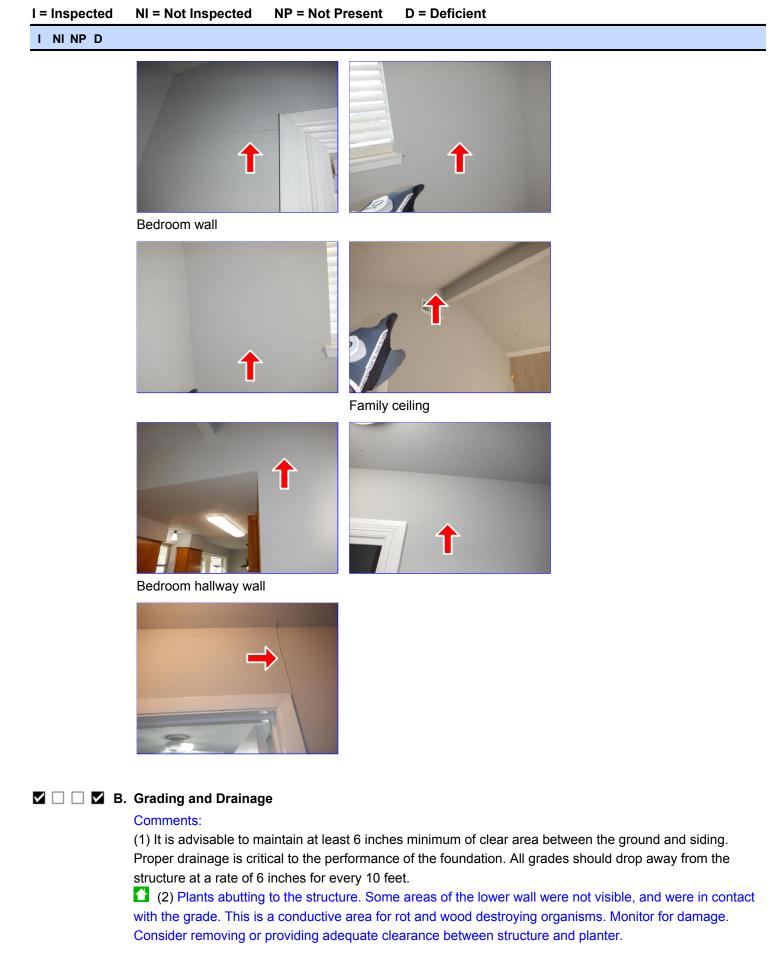
(5) There was still some movement of foundation at the time of inspection, this type of foundation shifting\movement can cause interior\exterior wall from separating,hair line crack (ie. brick wall, window, corner wall & ceiling). Have a foundation contractor to evaluate for more information.

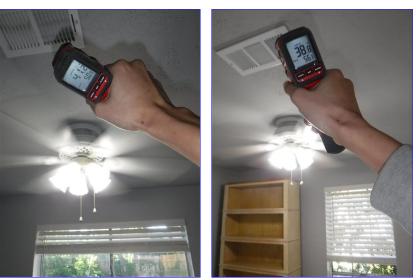
(4) The ambient air test was performed by using thermometers on the air handler of both Air conditioners to determine if the difference in temperatures of the supply and return air are between 14 degrees and 22 degrees which indicates that the unit is cooling as intended. The supply air temperature on your system read 39 degrees, and the return air temperature was 58 degrees. This indicates the range in temperature drop is normal.

Bedroom @41F
