**A Home Inspection Report On
10915 Langdon Lane, Houston, TX
Sold by Sylvia Reyes, Listed By**

Sunday, December 27, 2020

PROPERTY INSPECTION REPORT

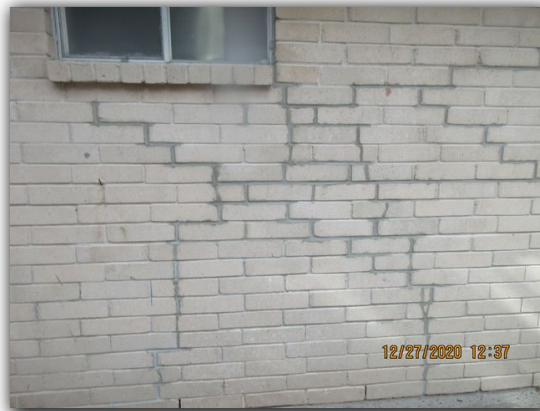
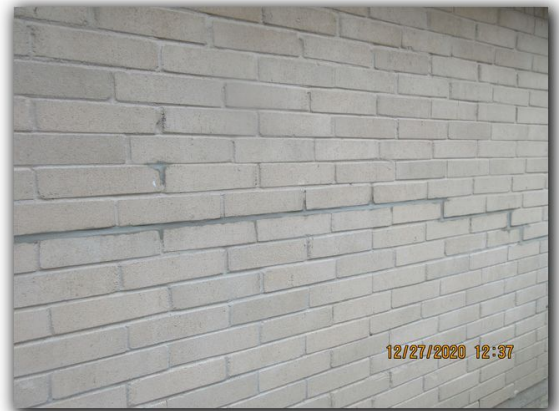
1. Home is a one story home with an attached garage.
2. There is evidence of foundation settlement, the stress cracks on the brick veneer have been patched.

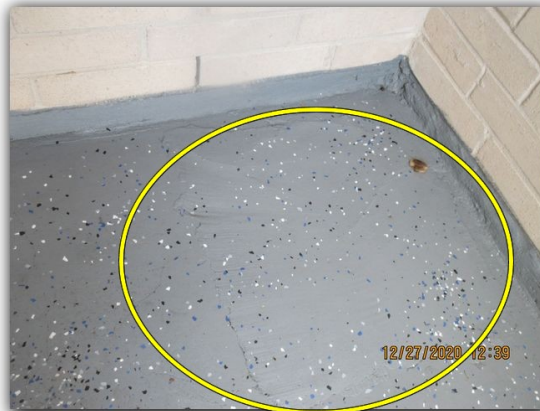
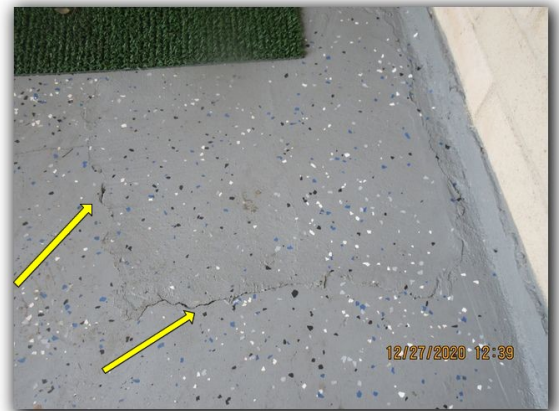
Foundation Repairs:

3. Evidence of recent foundation repairs

4. Buyer should be provided with a pier placement plan indicating the extent of foundation repairs performed.

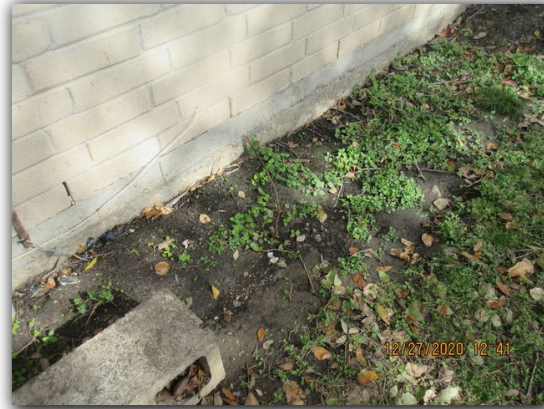
- 11. Various points around the perimeter beam of the foundation the soil is too high, it must be at least six inches from the ground to avoid water intrusion and/or pest infestation.

12. Note: Any area where the ground or grade does not slope away from the structure is to be considered an area of improper drainage. Six inches per 10 feet.

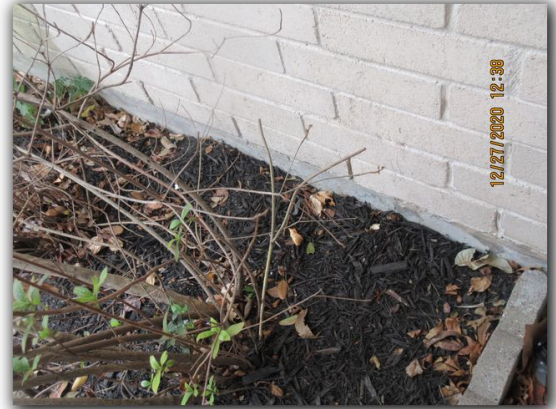
14. Ponding noted at several points around the foundation or near the foundation all low spots should be filled, compacted and caused to drain away from the foundation to avoid future foundation settlement issues.

15. It is recommended to install site drains to draw the water on the yard away from the foundation and towards the street as required by code.

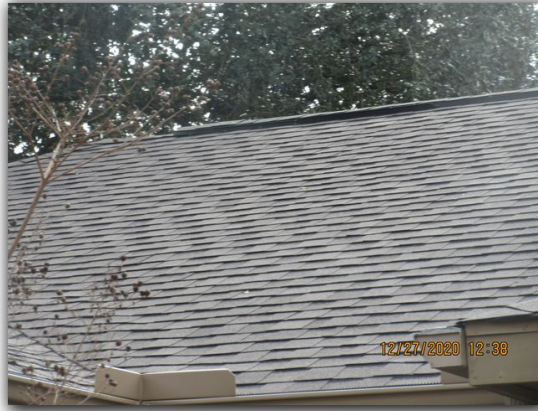
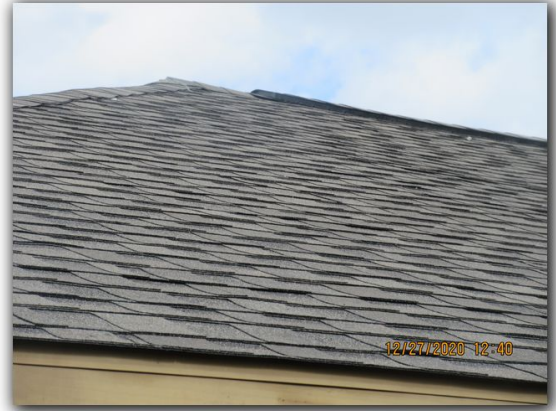
18. Shingles were not raised to count the nail order, it damages the shingle glue tab adhesion which is designed for only one seal.

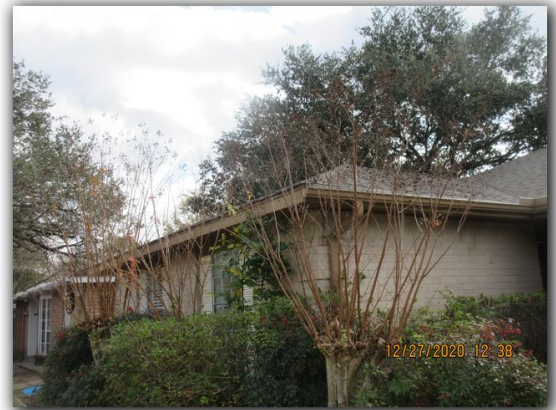
Tree Limbs:

19. There are various tree limbs that are in contact with the roof covering, all tree limbs must be at least six feet from the roof/shingles to avoid damage.

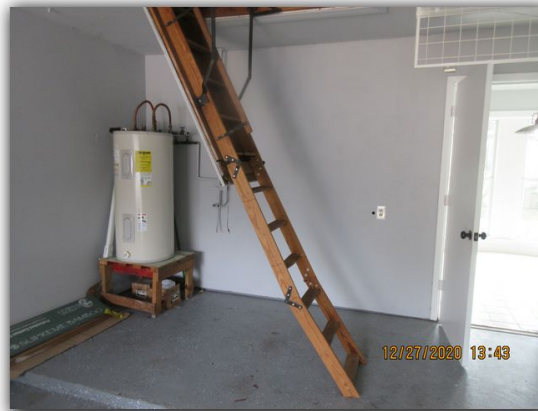
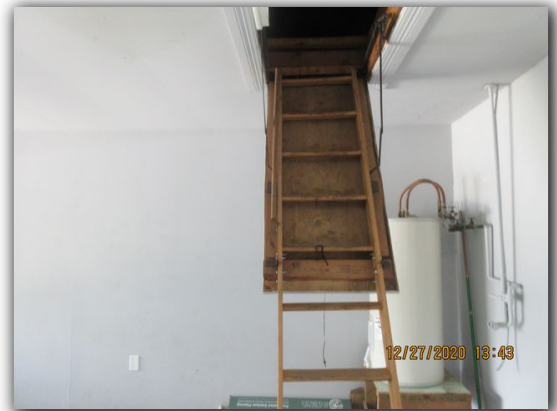
23. The attic ladder is in the garage.

24. Missing a clear landing at the top of the stairs as required by code.

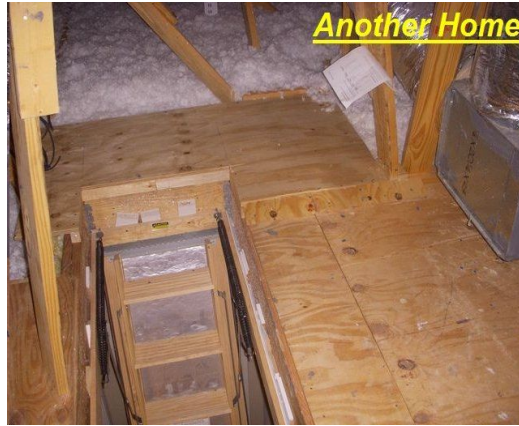
Decking & Work Platform:

26. Improper decking methods, attic decking must be solid plywood with no obstructions in front of the furnace as per code and as seen on the left lower photo below.

27. Improper decking materials, must have 3/4 inch plywood that is unobstructed to the furnace and at least 24 inches wide.

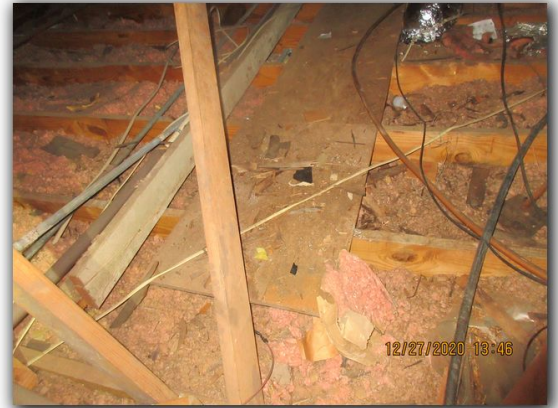
Insulation:

28. The insulation does not meet R-38 code requirements which is at least ten inches of insulation in all parts of the attic.

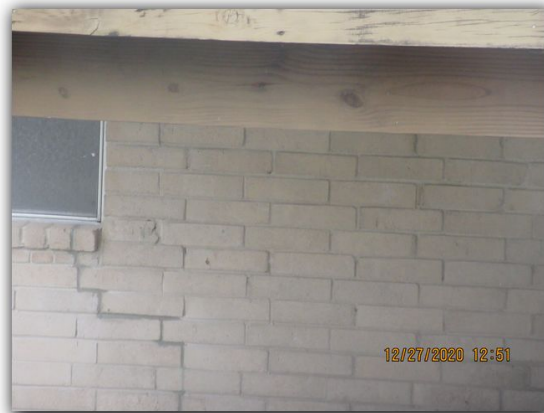
30. There are some patches on the brick as shown on the foundation section of this report and as seen below that indicated that the brick had stress cracks and are now cosmetic.

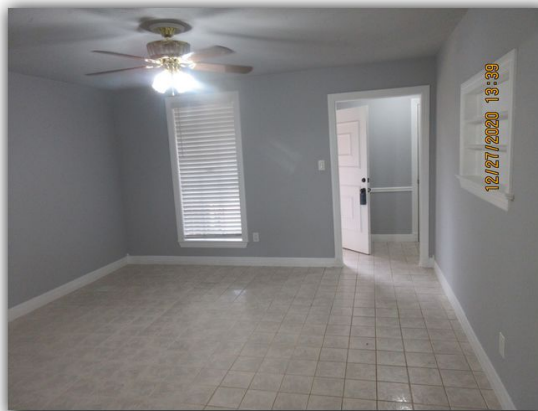
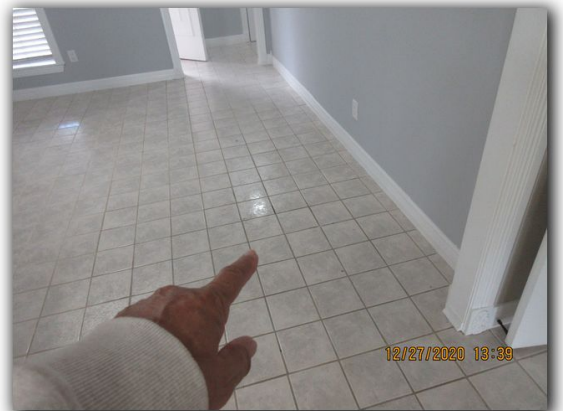
37. The ceramic flooring in the family room has a section that is "soft" and has lost its seal.

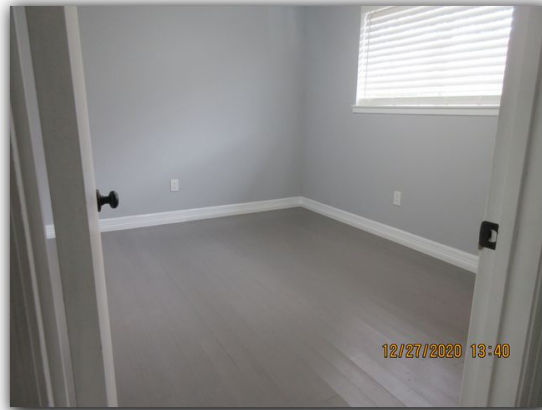
40. The wood flooring in one room has been painted and looks like it has some water damage, the owner should disclose if the home has flooded.

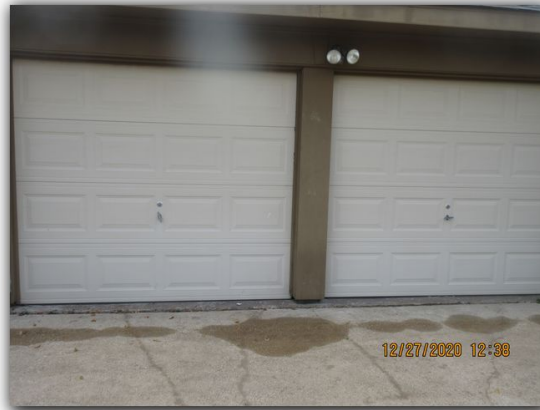
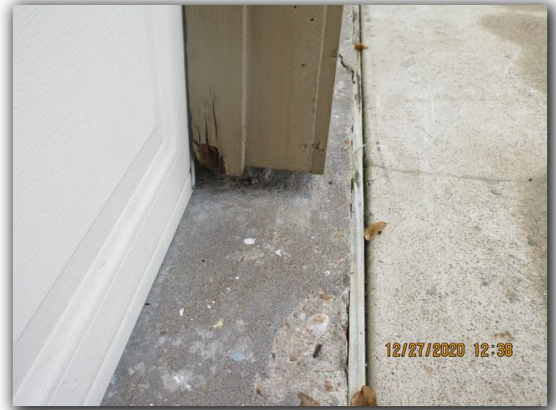
- 44. Garage door frame wood trim is too close to the ground, must be cut 45 degrees, painted at the base (sealed) and be two inches above the concrete floor to avoid water rot;

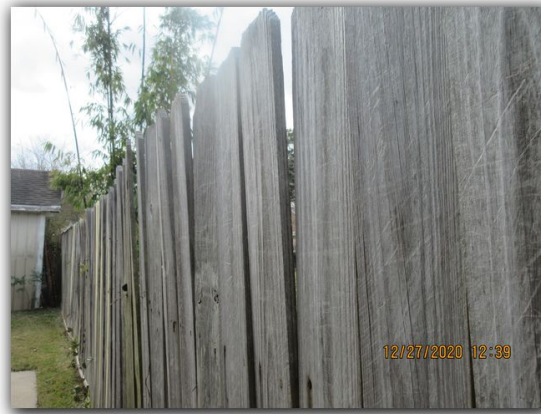
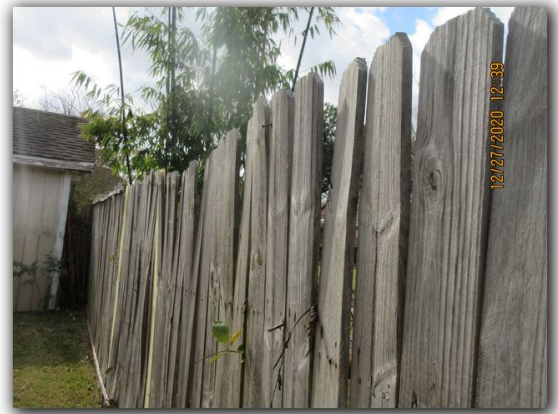
56. Wood perimeter fence is in need of repairs at various places

57. Some of the fence has minor wind damage.

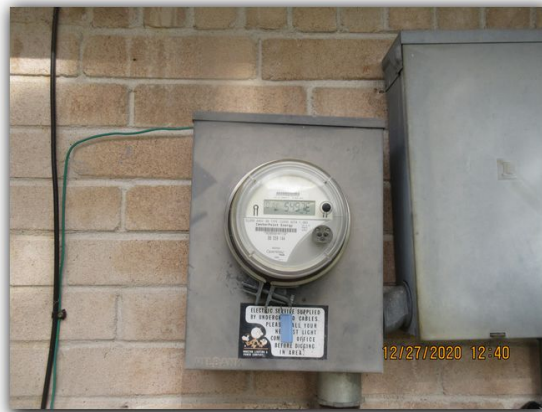
59. The main panel is missing a main breaker.

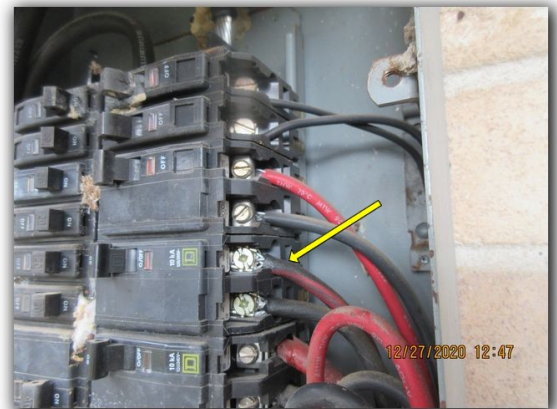
64. One leg of the 220 volt breaker appears to have been over heated.

65. The breakers are missing the anti-oxident on the aluminum wire at the connectors and breakers as per code.

66. The breakers are not for al/cu use.

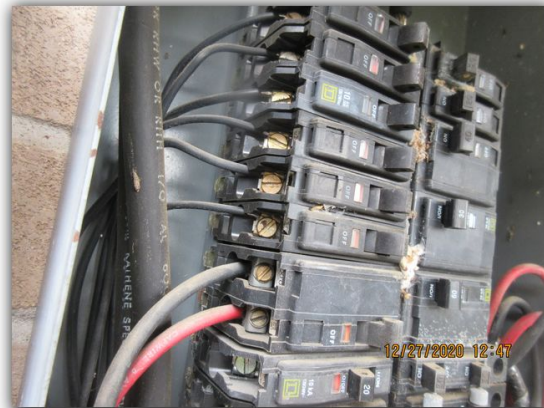
69. Home is missing arc fault protection on the GFI's as required by current code.

70. It is recommended that the breaker panel be replaced with one that has proper co/al breakers, main breaker and arc fault interrupters as per current code.

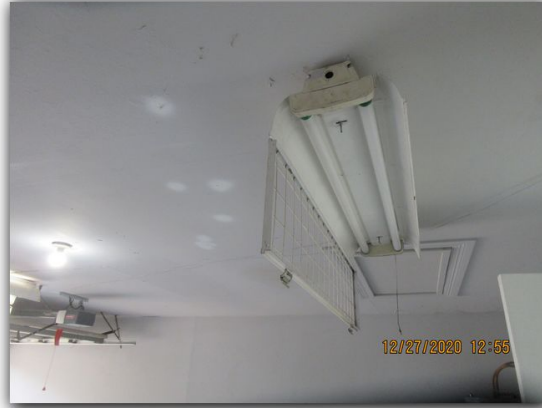
78. The garage light fixtures, secondary are in need of repair.

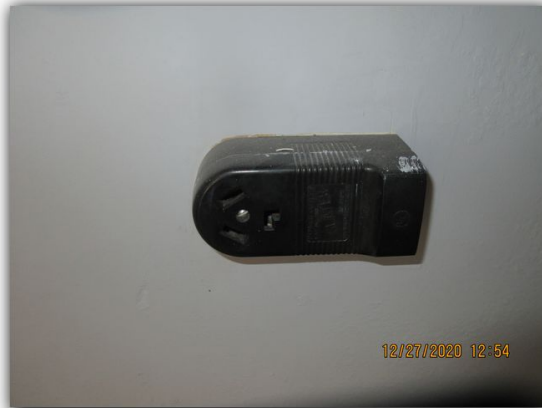
80. Missing four prong 220 volt receptacle on the dryer electrical connection has the obsolete three prong receptacle.

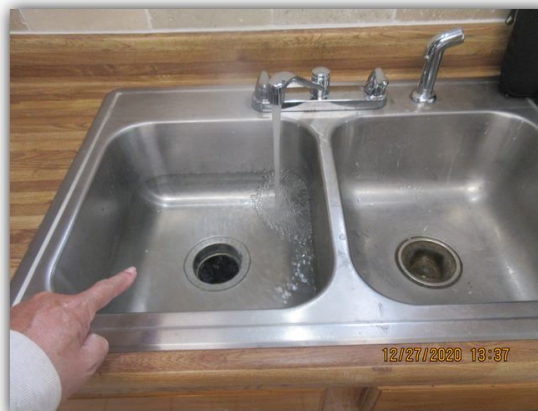
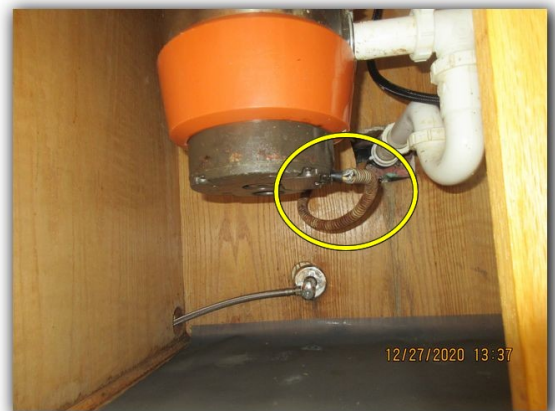
172Missing a connector at the electrical connection.

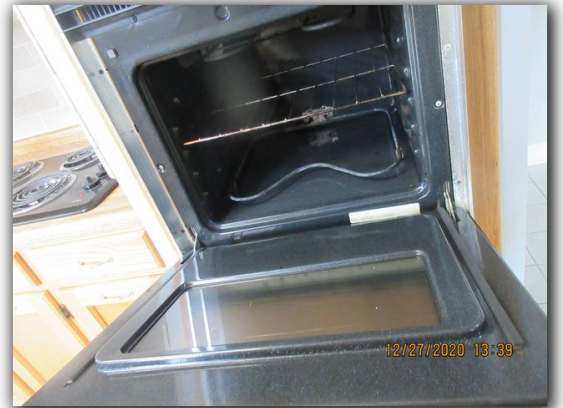
187The home has a wall mounted oven that needs service.

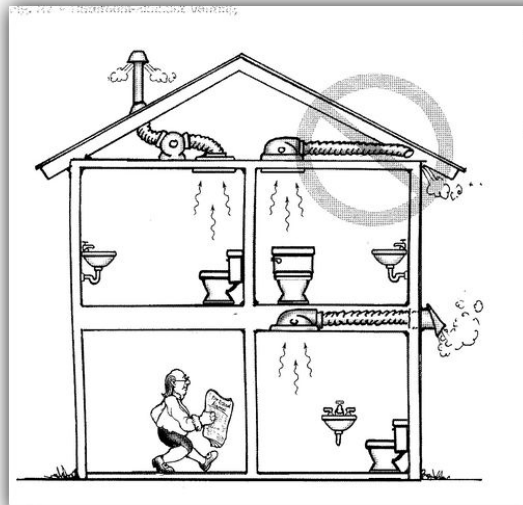
195 Improperly terminating flex vents into the attic, they must terminate to the exterior as per code.
