PROPERTY INSPECTION REPORT

Concerning: 10834 Olympia Dr. Houston, TX 77042

By: Gabe Fitzpatrick #21417

1/28/2020

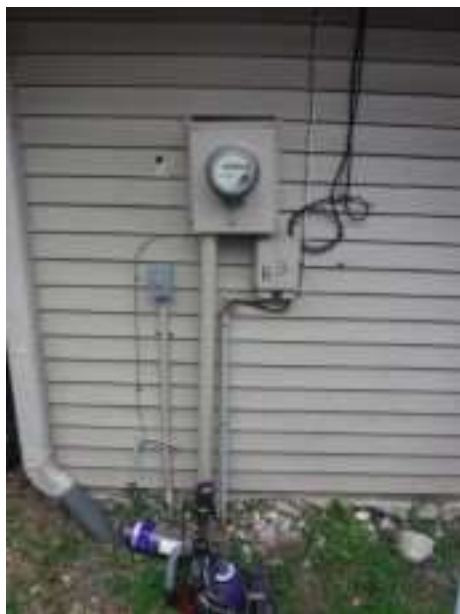
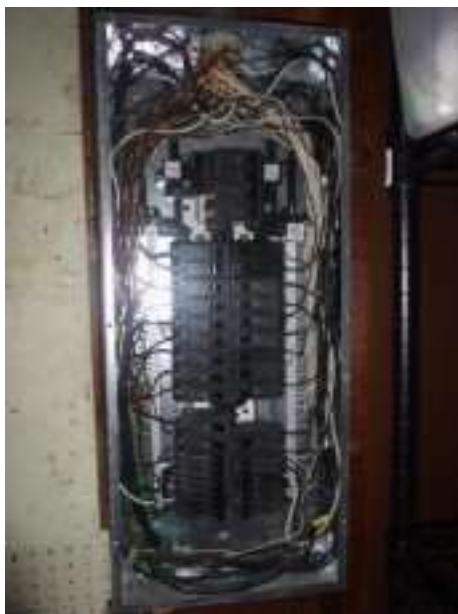
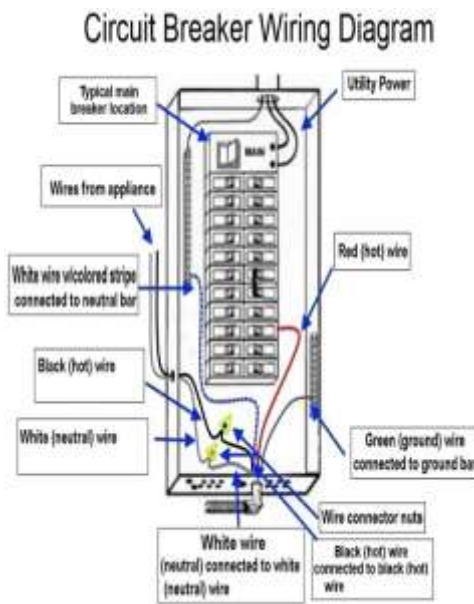
The grounding conductor to the ground rod was not equipped with a low voltage grounding block for the low voltage service.

Obtain Cost Estimate

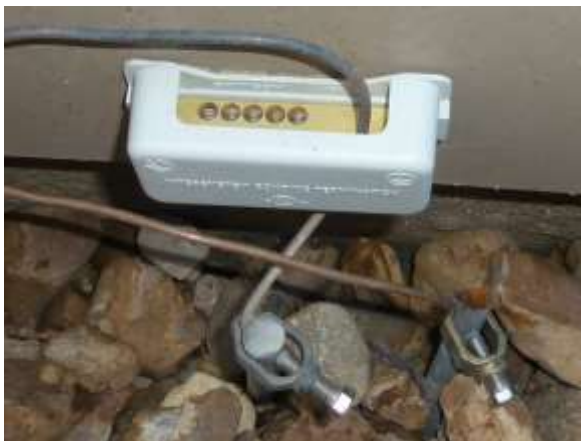
HEI File Photo

The ground rod was sticking out of the ground a few inches, and, since ground rods are typically 8 feet long and all 8 feet of the rod are required to be in the ground, it is recommended that the ground rod be pounded down flush with the top of the ground. The clamp on the rod should be an acorn clamp is approved for direct burial in the ground.

Obtain Cost Estimate

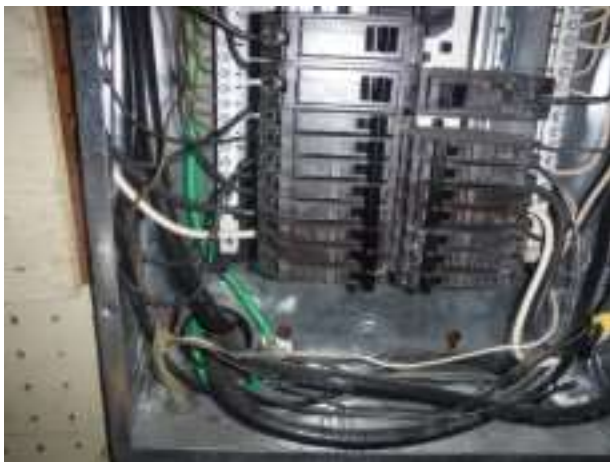
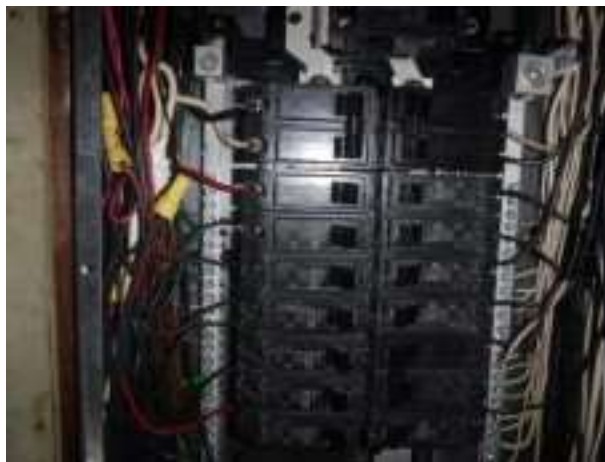
The circuit breaker for the condensing unit was rated higher (50-amperes) than the maximum size allowed by the manufacturer of the condensing unit (45-amperes). The breaker should be replaced by the size listed on the manufacturer's nameplate located on the condensing unit.

Obtain Cost Estimate

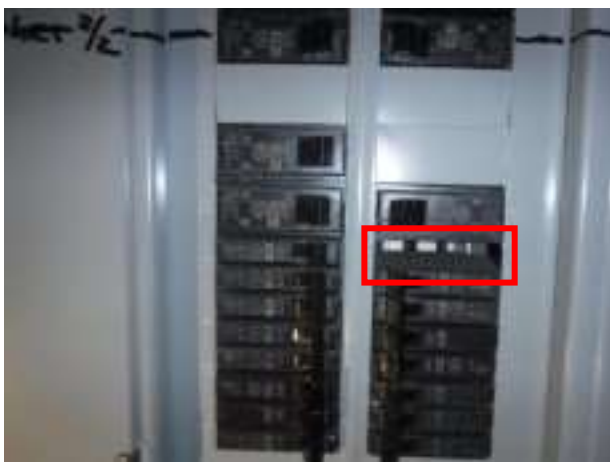
The dead front cover plate was missing one knock-out clip.

Obtain Cost Estimate

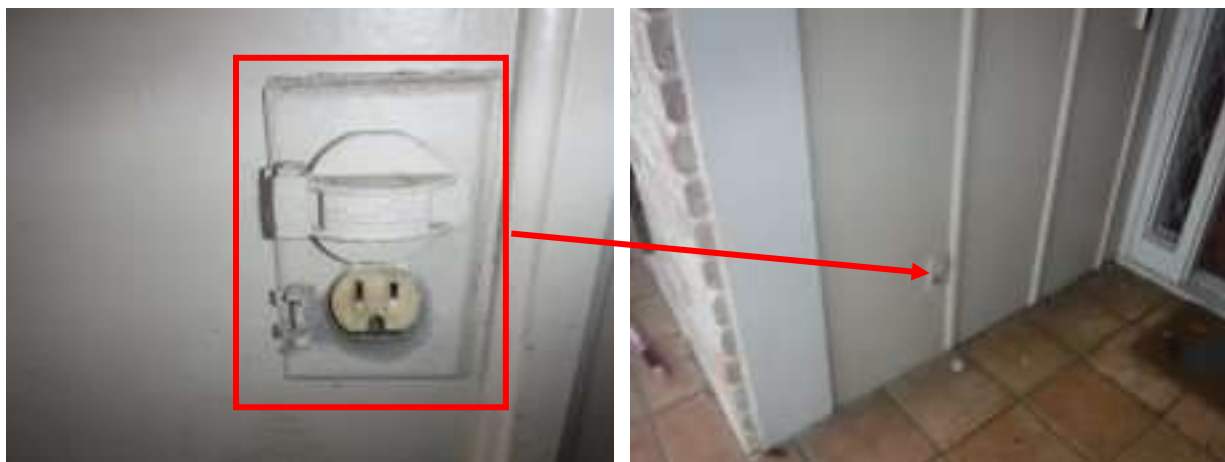
The cover plate(s) for the exterior outlet was damaged, and needs to be replaced with a weathertight cover plate. Locations included: Front entry

Obtain Cost Estimate

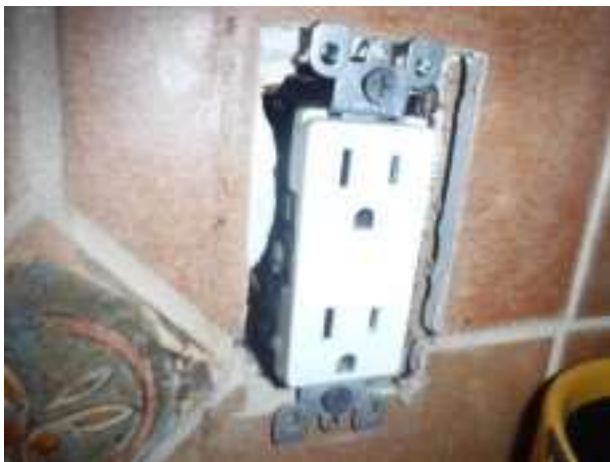
We observed outlets located in countertop backsplashes that were not protected by extender boxes. This is considered to be a fire hazard, and it is recommended that the extender boxes be installed.

Obtain Cost Estimate

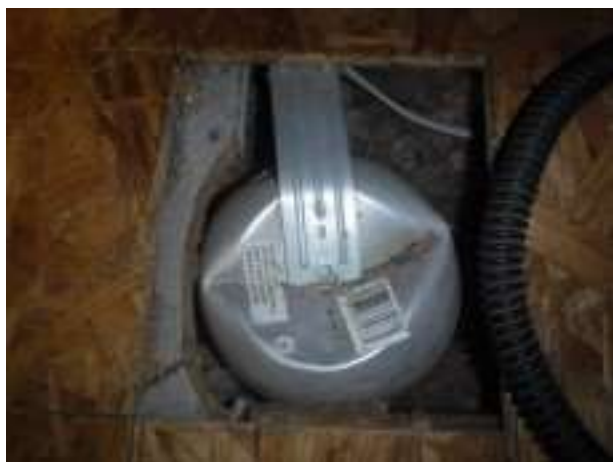
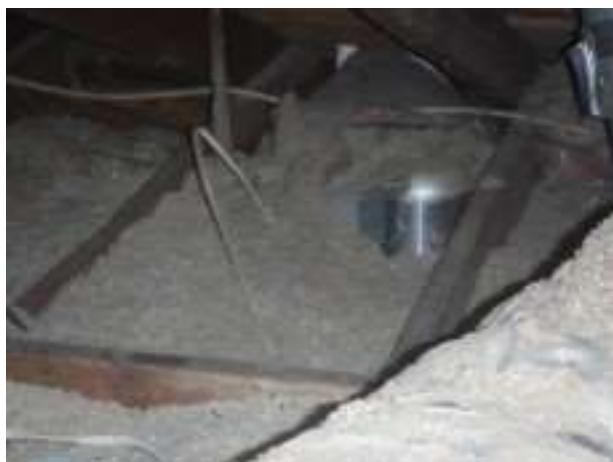
The insulation in the attic was in contact with the recessed lights, which may be a fire hazard. We saw no evidence on the outside of the recessed cans to indicate that the cans were rated as "IC", which is the manufacturer designation for "Insulation Contact". Further investigation is recommended, including dismantling the trim kit in the ceiling below. If the recessed cans are NOT "IC" rated, then the insulation needs to be pulled back, and a three inch air space provided around the lights to prevent overheating and a possible fire hazard.

Further Investigation Recommended

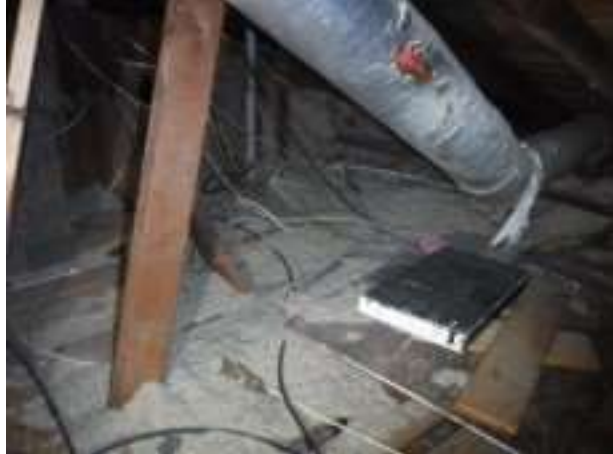
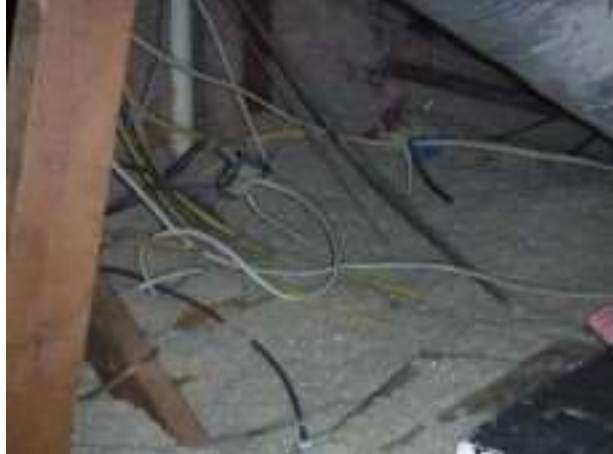
Wires were spliced and were not in a junction box, and repair is needed.
Locations included: Multiple locations in the attic

Obtain Cost Estimate

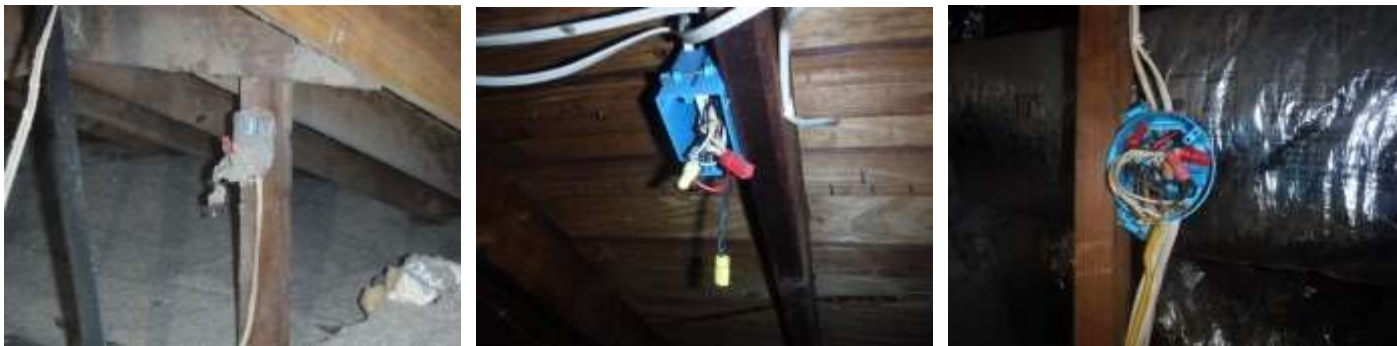
An open junction box(es) was observed.
Locations included: Multiple locations in the attic

Obtain Cost Estimate

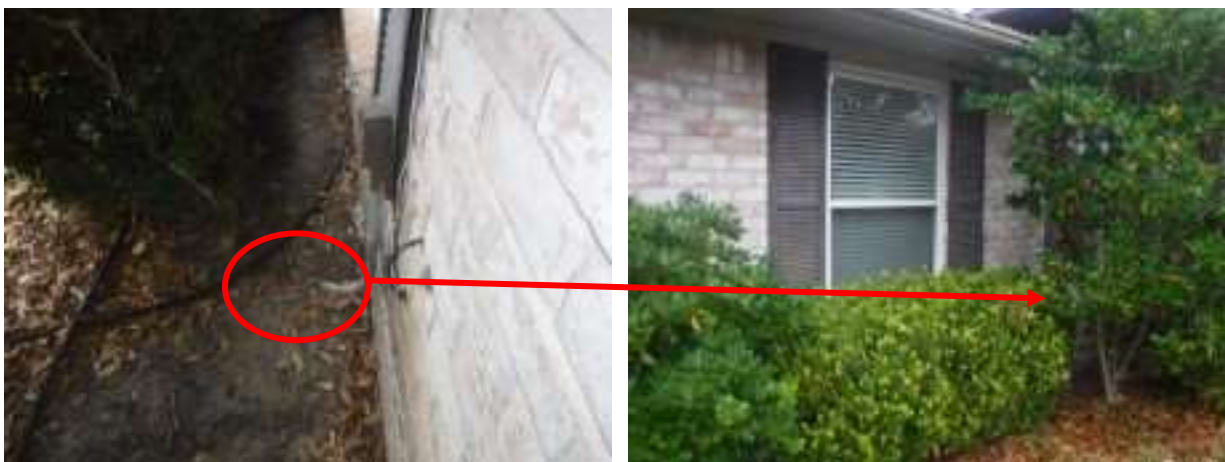
Wires that were not properly encased in a conduit or were only partially encased in a conduit were observed.
Locations included: South exterior

Obtain Cost Estimate

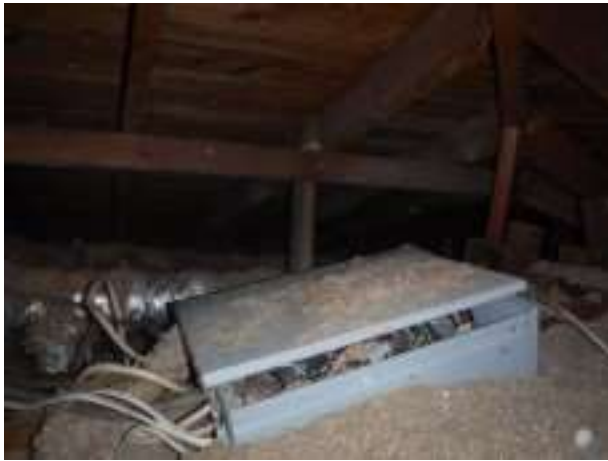
The cover on the large junction box at the north side of the attic does not secure closed. It is recommended the cover be secured for safety.

Obtain Cost Estimate

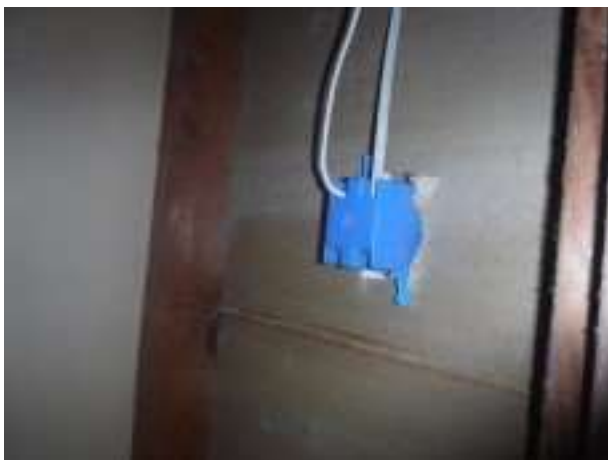
Wiring was observed inside the return air chase, and the wiring needs to be moved or encased in a metal conduit.

Obtain Cost Estimate

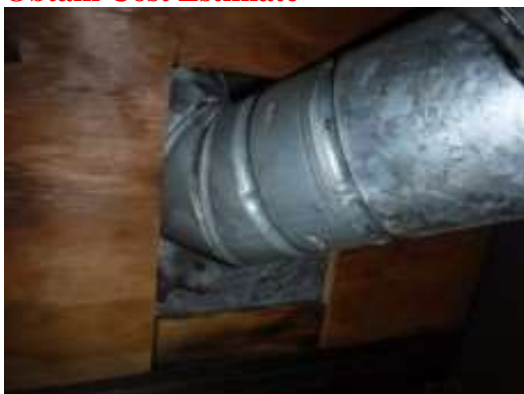
Double wall vent pipes require a minimum of one inch clearance to any material that is combustible. The vent pipe was located too close to a combustible material, which is a fire hazard.

Obtain Cost Estimate

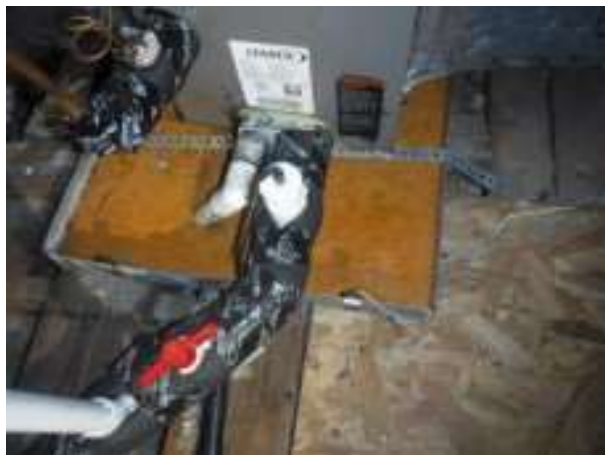
The overflow pan under the evaporator coil had rust in the pan, apparently from water overflowing the condensate drain line into the overflow pan. No water was in the pan at the time of the inspection, but, since we only ran the unit for a few minutes, it is recommended that the drain line be checked by an air conditioning service company.

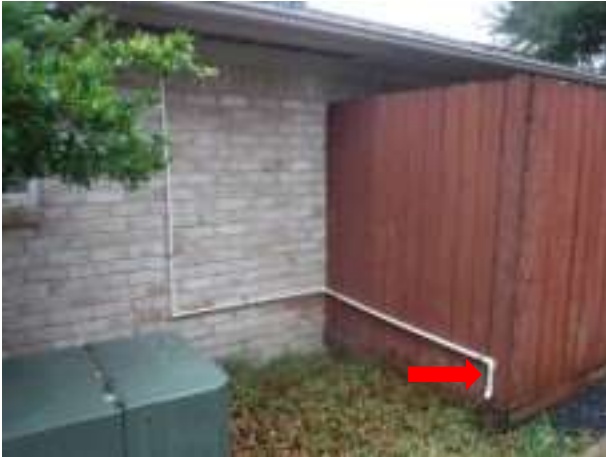
The primary drain line(s) are plumbed to the exterior of the house. The drain line(s) should be plumbed to a trapped interior drain line or a splash block should be placed under the drain line(s) to direct water run-off away from the foundation.

Obtain Cost Estimate

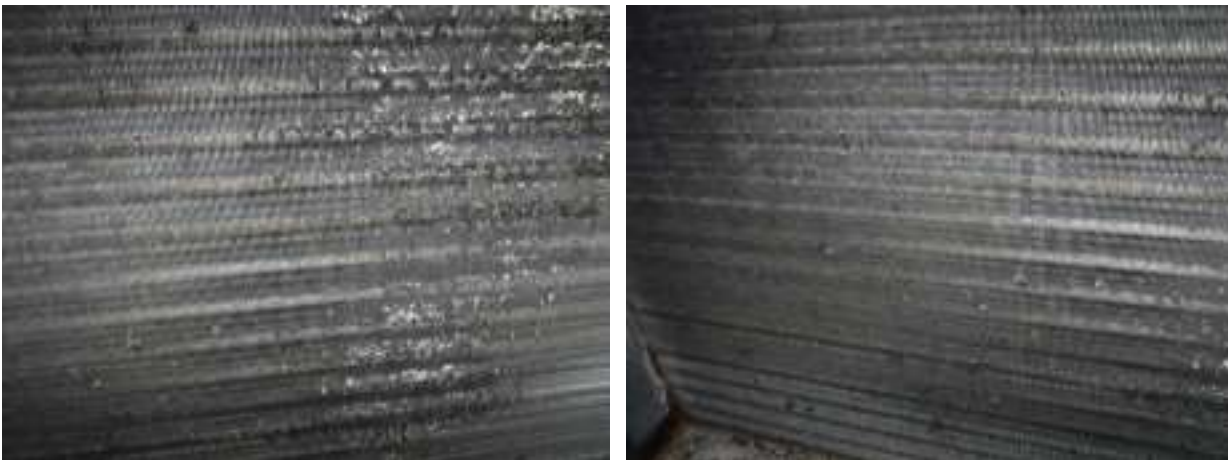
The bottom of the evaporator coils were visible and were clogged with debris. Have a service company clean the coils for proper operation.

Obtain Cost Estimate

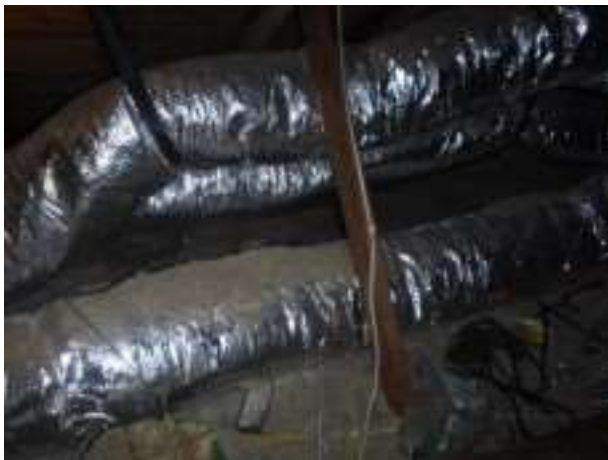
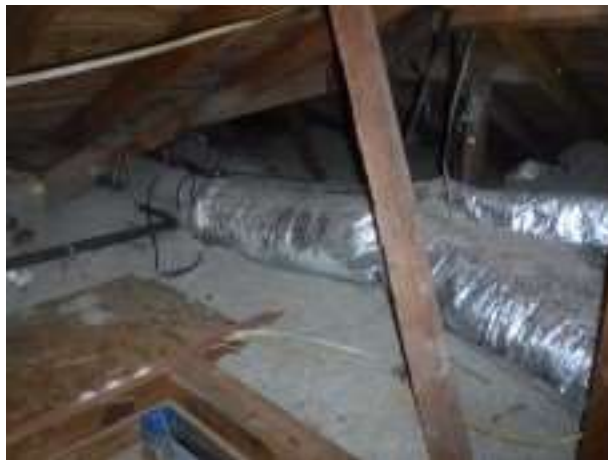
The ducts were laying on the insulation and ceiling joints and are not supported properly. The ducts should be supported in accordance with the manufacturer's installation instructions, which typically includes hanging the ducts from the rafters supported by 1 1/2 inch straps spaced approximately every four feet. Have a service company make the necessary repairs.

Obtain Cost Estimate

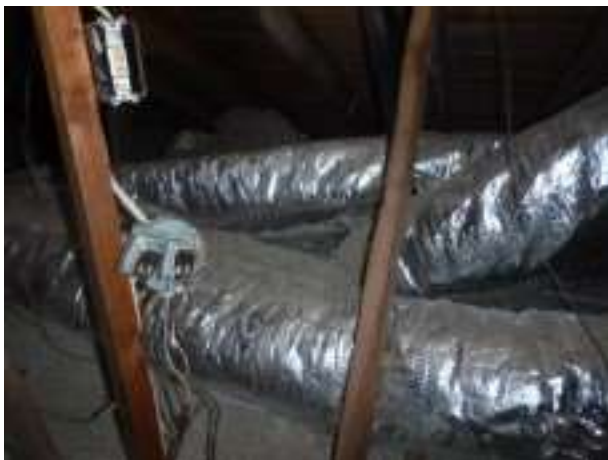
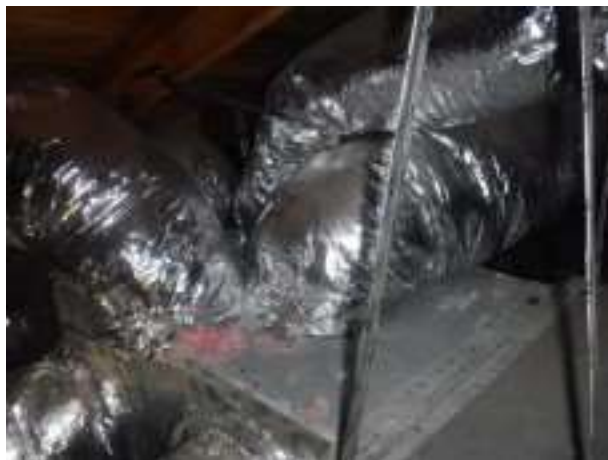
We observed that some of the ductwork in the attic was touching other ductwork, which can cause condensation on the outside of the ductwork. It is recommended that the ducts that are touching other ducts be separated, typically by inserted a piece of fiberglass batt insulation between the ducts.

Obtain Cost Estimate

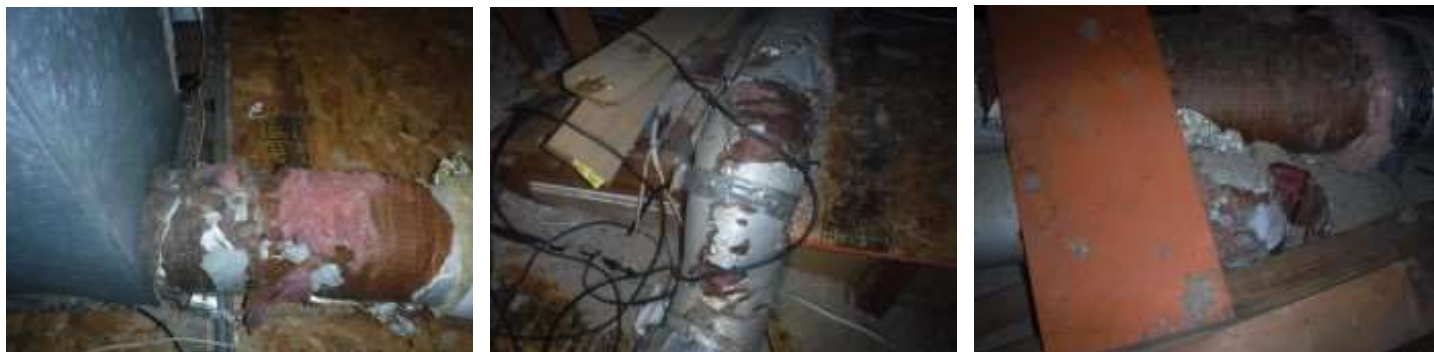
The insulation is damaged or missing on the ducting in the attic. A service company should be contacted to evaluate the ducting and provide a cost estimate for repair.

Obtain Cost Estimate

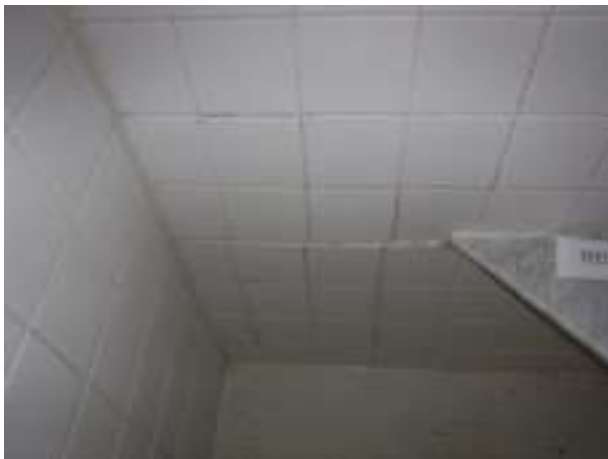
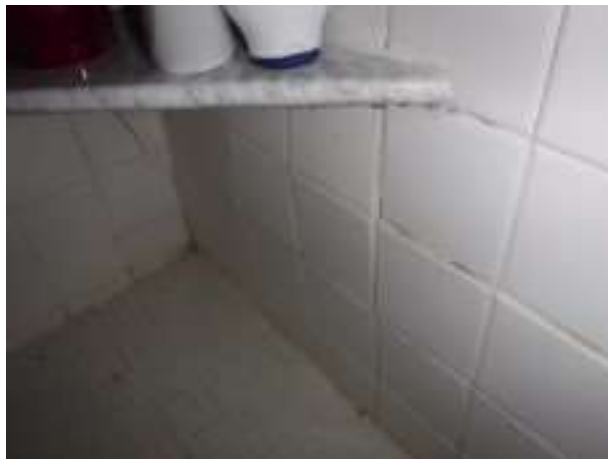
There is missing or deteriorated grout and loose tiles at the northwest shower surround. A service company should be contacted to evaluate the tile and provide a cost estimate for repair.

Obtain Cost Estimate

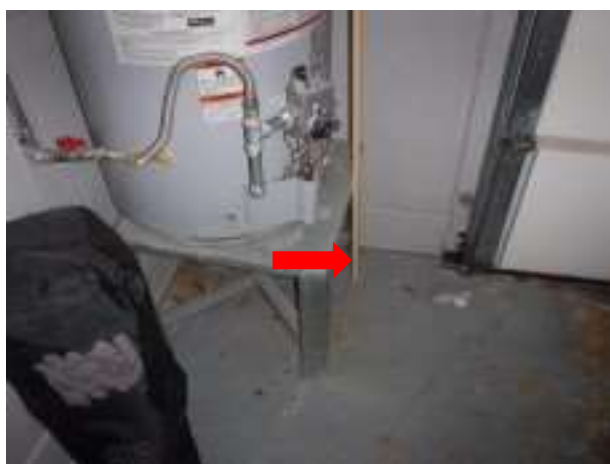
The drain line for the temperature/pressure relief valve was partially missing, and the drain line needs to be run to an outside location, turned towards the ground with a 90 degree elbow, and terminated not more than 6 inches above the ground.

Obtain Cost Estimate

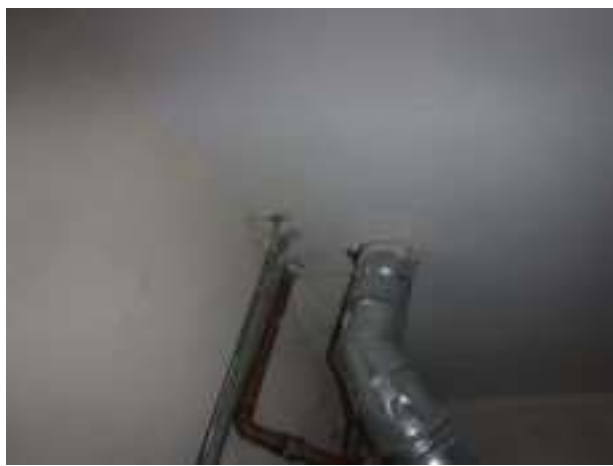
A heat shield is not installed on the vent pipe where the vent penetrates through the ceiling sheetrock. A service company should be contacted to install a heat shield.

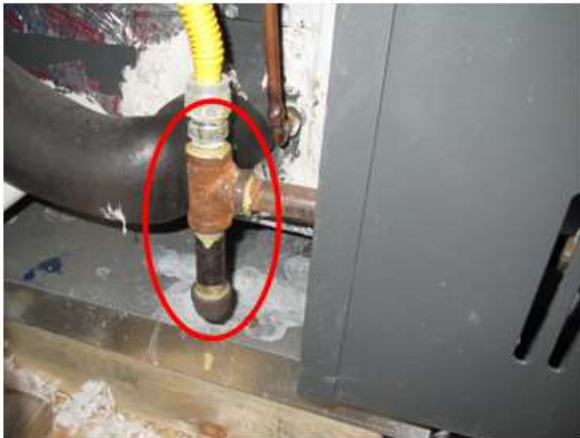
The gas supply lines were not equipped with sediment traps on the gas line. Have a plumber make the needed repairs.

HEI file photo showing sediment trap

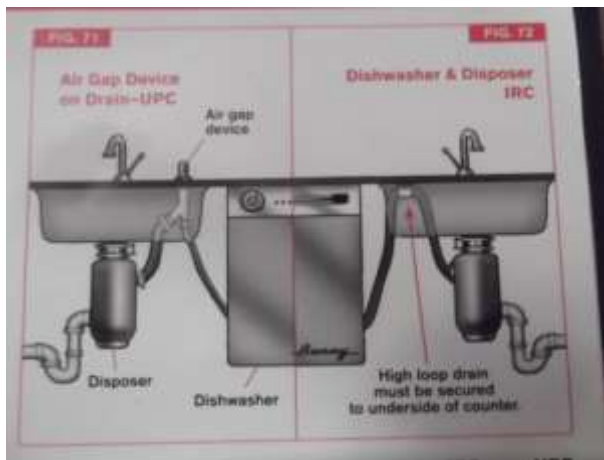
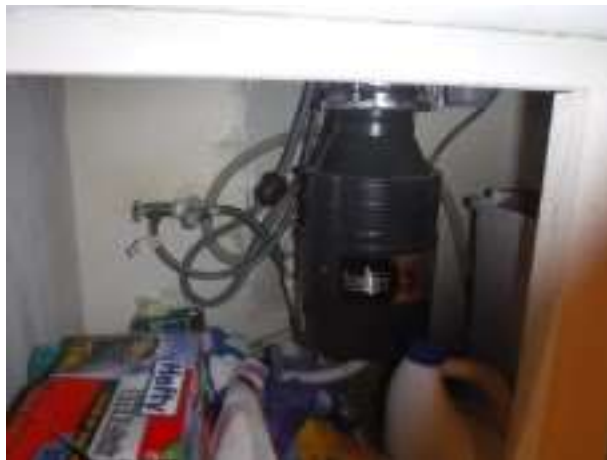
The drain line under the sink was not equipped with an anti-siphon device, nor was it looped up so that the top of the loop is at least six inches above the entrance of the drain line into the disposal. It is recommended at least that the drain line be looped to prevent the water from the garbage disposal from siphoning back into the dishwasher, or an anti-siphon device installed.

Obtain Cost Estimate
