HEDDERMAN ENGINEERING, INC.

REF: CONDITION OF PROPERTY SURVEY

At your request, a visual survey of the house located at 10834 Olympia Drive, Houston, Texas, was made by Mr. Tim Hedderman and Mr. Gabe Fitzpatrick.

10834 Olympia Drive

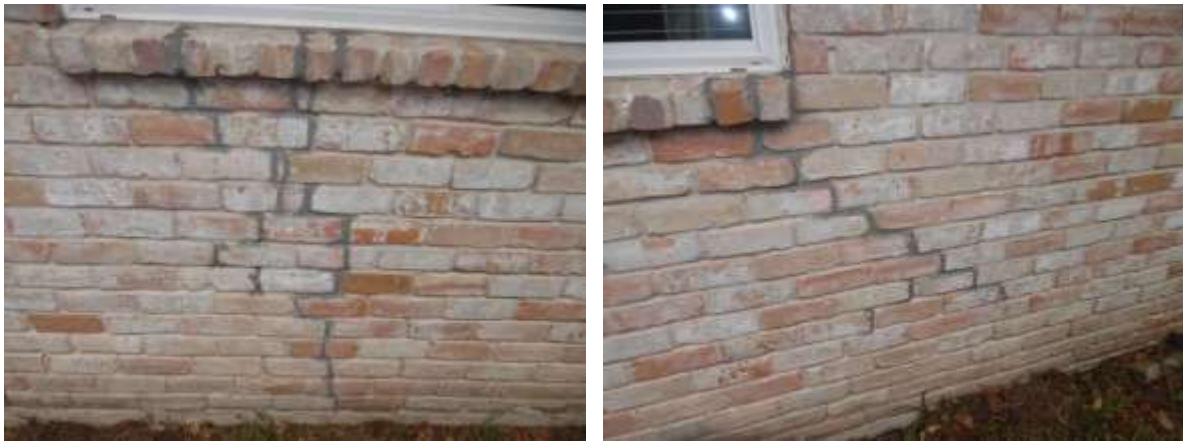
Cracks and/or patches were observed in the exterior veneer, including at the east side of the house.

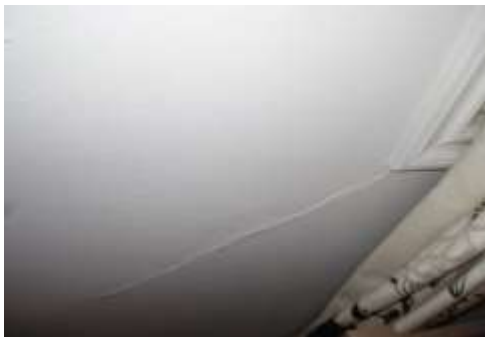
Sheetrock cracks, patches, and/or compression ridges were observed, including at the master bedroom.

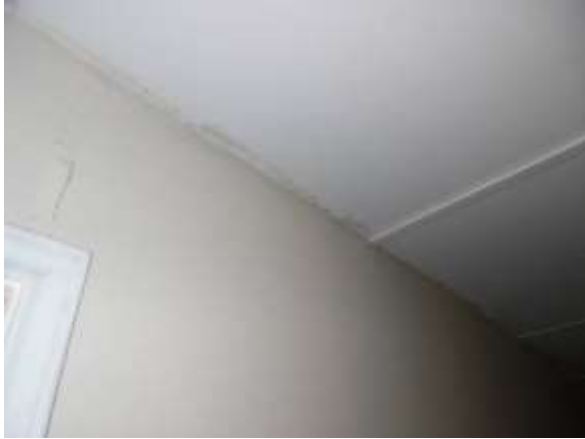
Wrinkled sheetrock tape was observed, including at the garage.

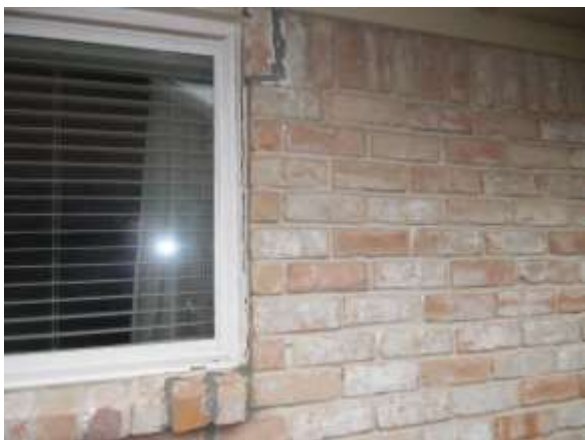
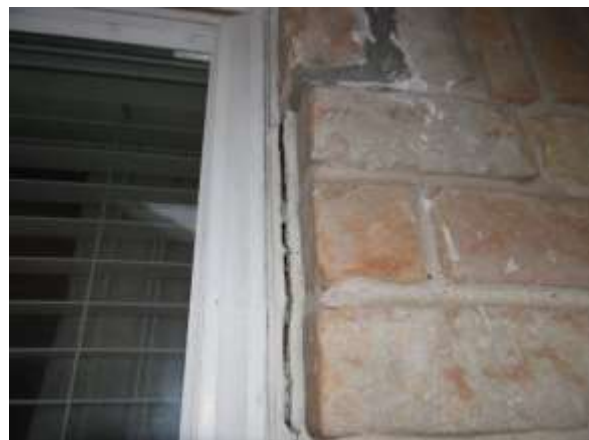
- Window frames were separated from the exterior brick veneer approximately 3/16 inch at the east side of the house.

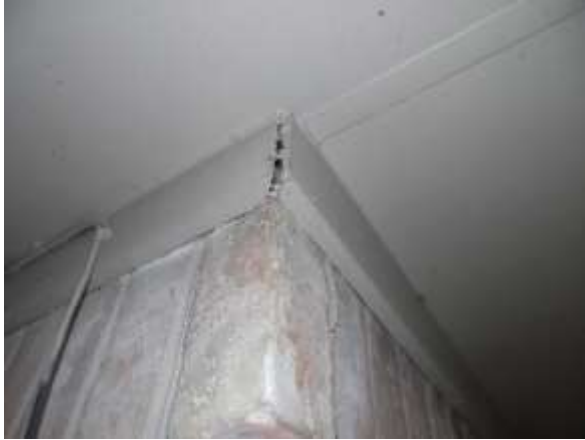
- The frieze board was separated at the roof soffit approximately 3/8 – 1/2 inch at the northeast corner of the house.

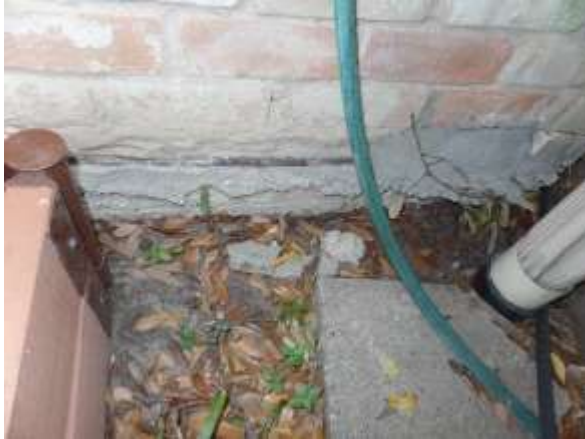
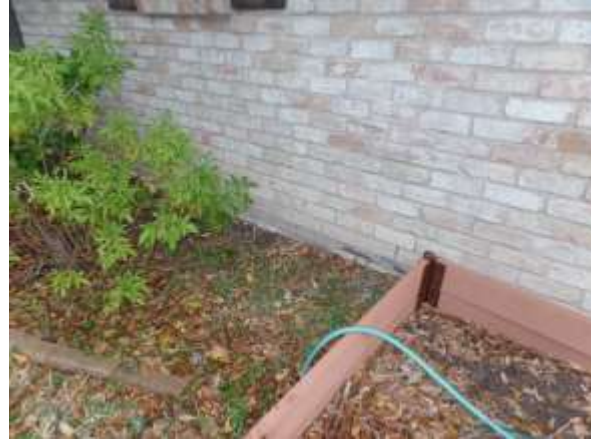
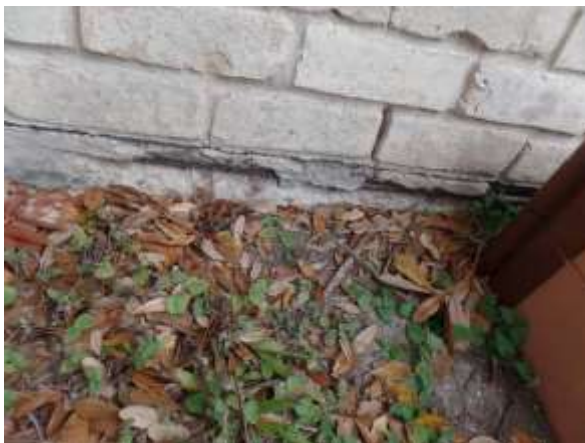
Locations included: side of the house.

The face of the foundation concrete was spalled, and the reinforcing steel used in the construction of the foundation was observed to be exposed. The rust should be removed from the rebar, and the rebar grouted to prevent further deterioration.

Obtain Cost Estimate

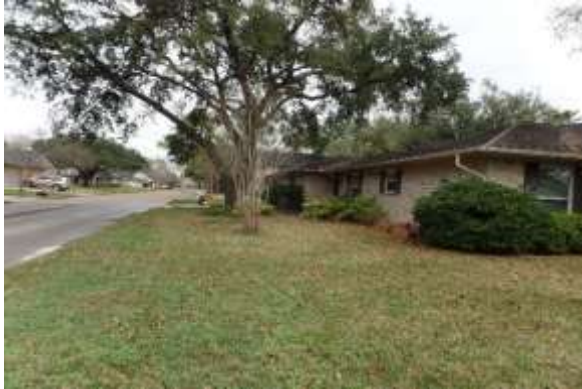
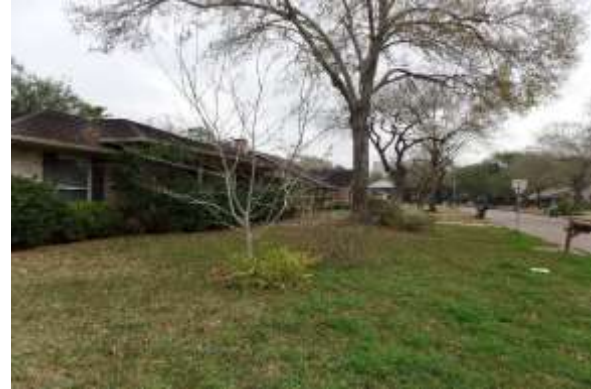
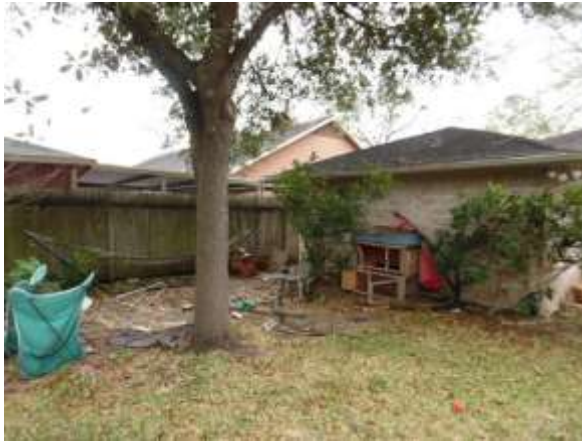
Trees and/or foliage were observed in the vicinity of the house, which can contribute significantly to differential movement of the house foundation. Care should be taken to prevent the trees and foliage from removing an excessive amount of water from near the foundation of the house. Consideration should also be given to cutting the tree roots that extend under the foundation, and installing a root barrier to prevent any further moisture from being removed from under the interior of the house.

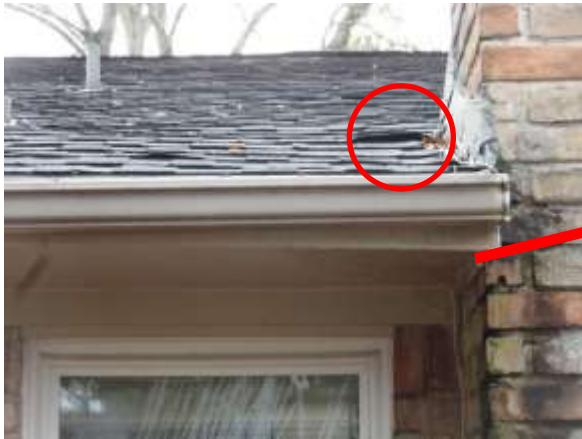
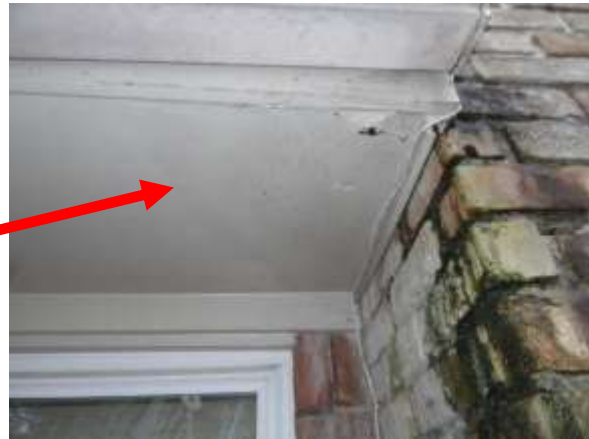
After observing the interior of the structure, evidences of roof leaks were visible at the eave at the rear of the house adjacent to the chimney, where we observed water damage to the eave. Also, the roof decking was deflected, indicating that the decking is rotted, and needs to be replaced. Further investigation is recommended with a roofing contractor to find the source of the leaks, and to make any needed repairs.

Obtain Cost Estimate

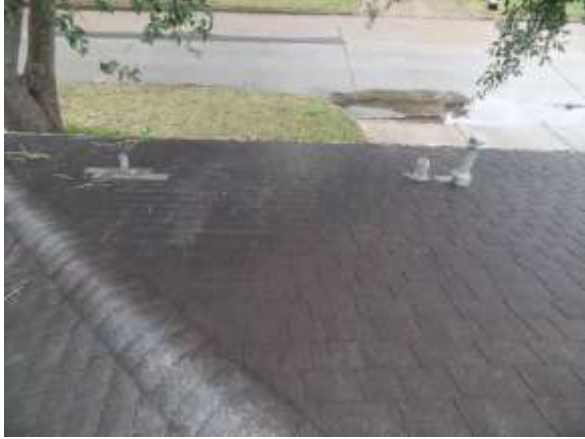
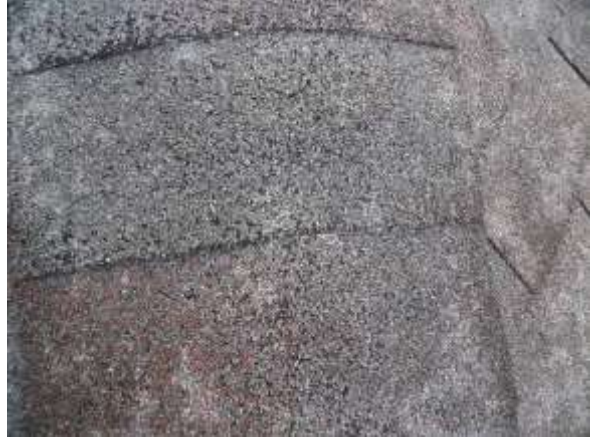
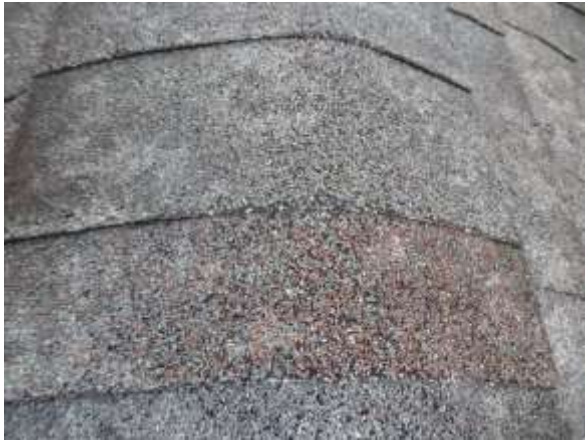
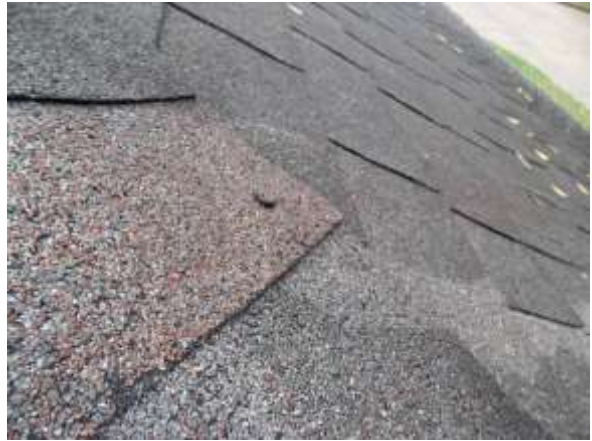
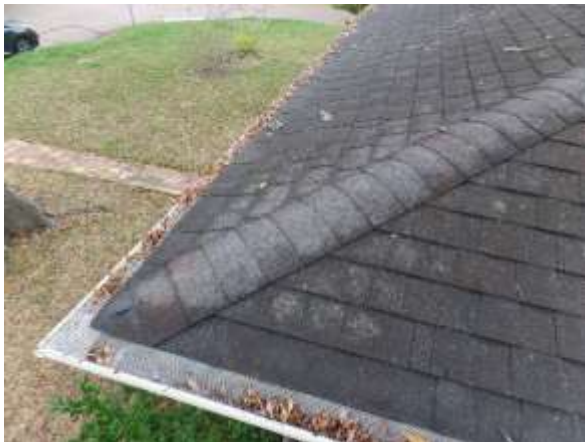
The composition roof surface was showing evidences of advanced deterioration, including the majority of shingles that were brittle, discolored, curling on the edges, cracked, and losing their aggregate.

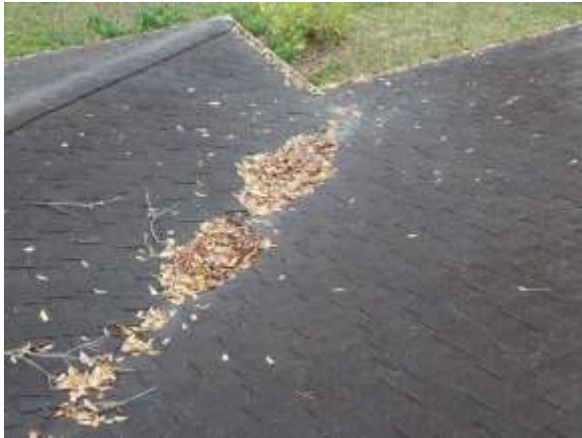
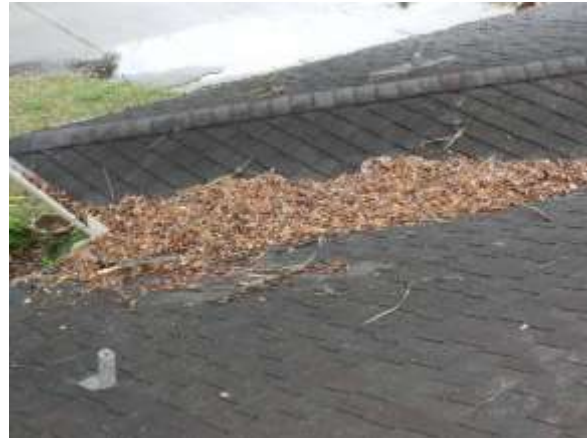
Debris was observed on the roof, and the debris should be removed to prevent premature deterioration of the roof surface.

Obtain Cost Estimate

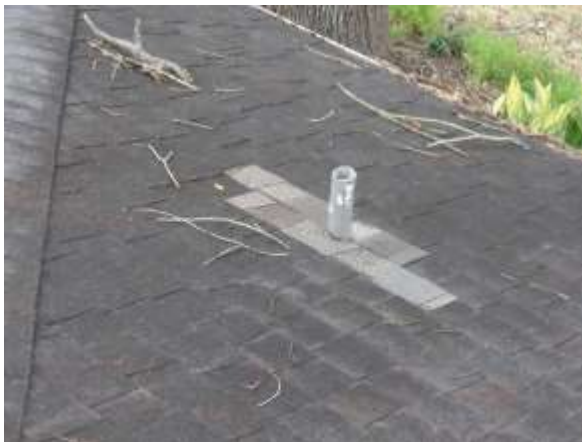
The roof surface was observed to have been patched previously at the side of the house.

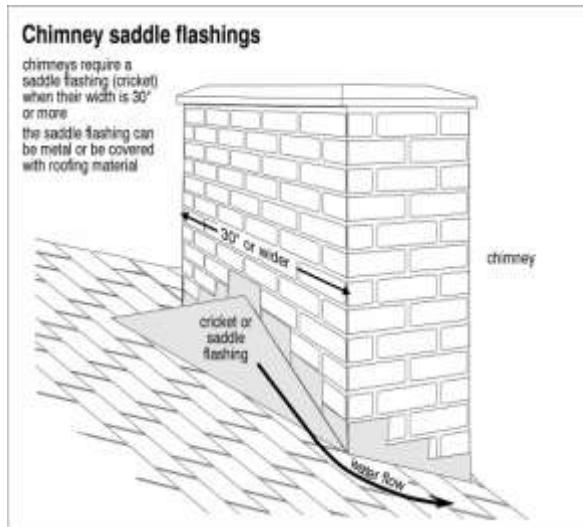
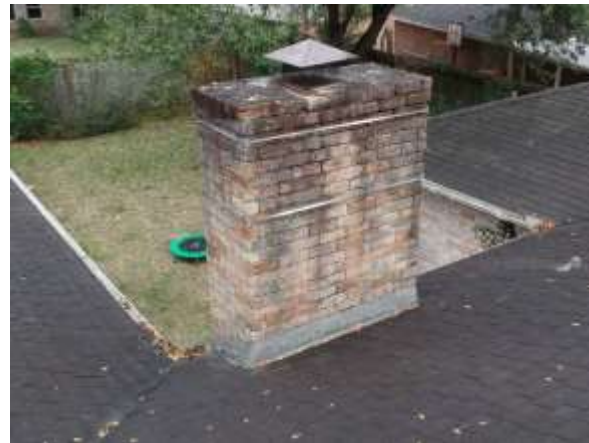
No cricket (saddle flashing) has been installed behind the chimney to divert the roof runoff around the chimney. Since the chimney is more than 30 inches wide, it is recommended that a cricket be installed.

Obtain Cost Estimate

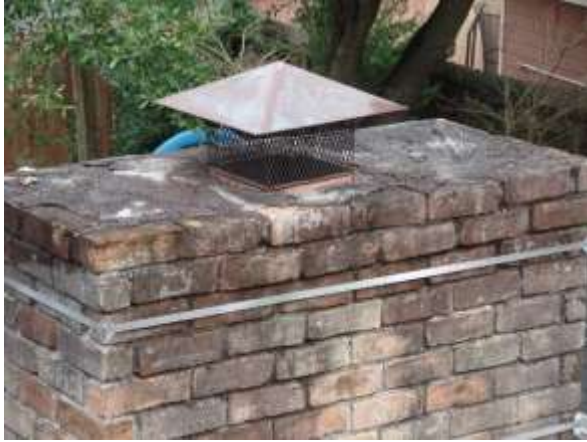
The metal cap on top of the chimney was rusted, and needs to be cleaned and properly sealed to prevent further deterioration.

Obtain Cost Estimate

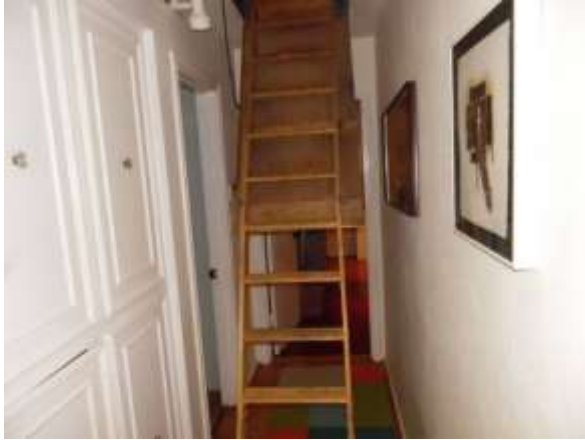
The access ladder into the attic appeared to be the original installation ladder, and, therefore, does not meet current code requirements for ladders into attics. Consideration should be given to replacing the ladder with a ladder that meets current code requirements.

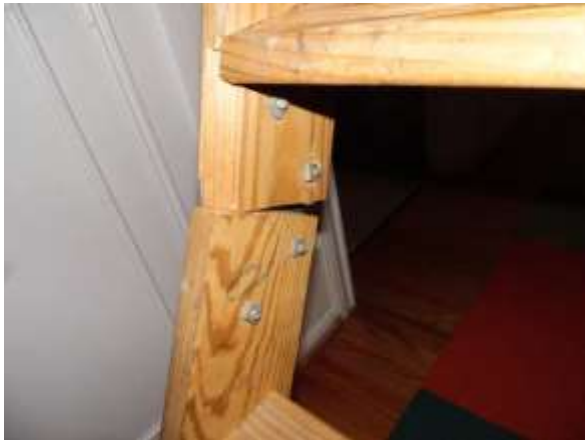
The legs for the access ladder into the attic were too short, and need to be repaired.

Obtain Cost Estimate

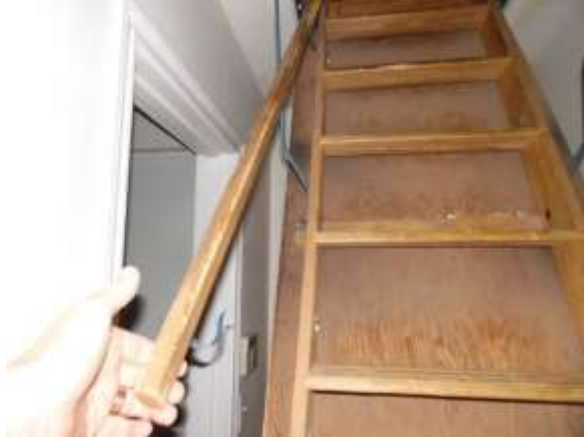
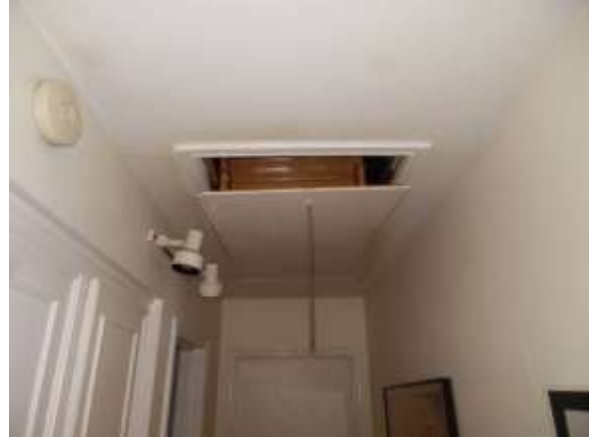
The handrail on the ladder was damaged and makes it difficult to close the ladder assembly into the ceiling.

Obtain Cost Estimate

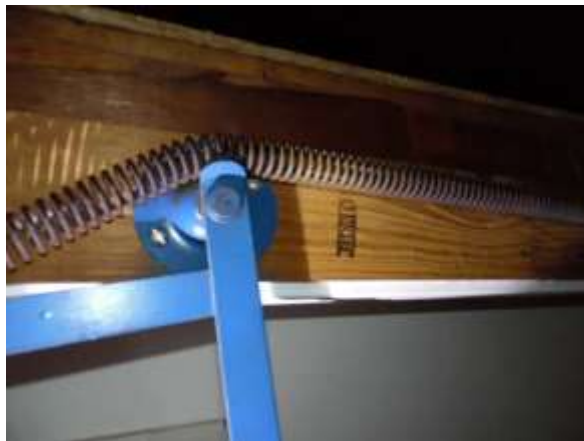
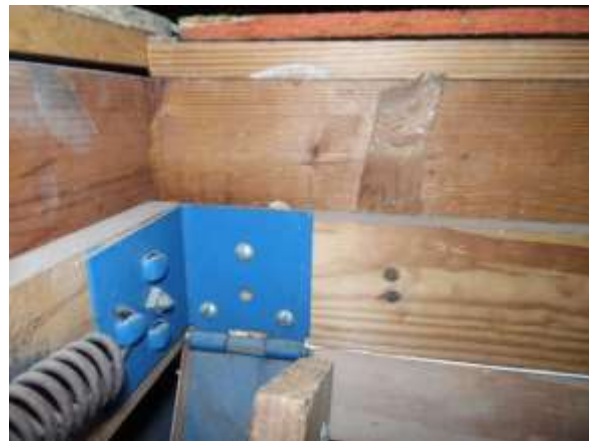
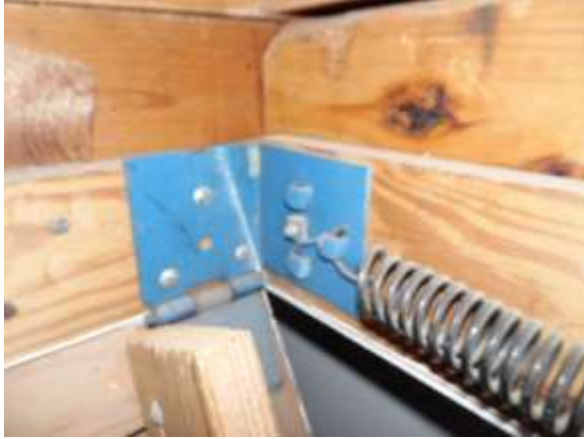
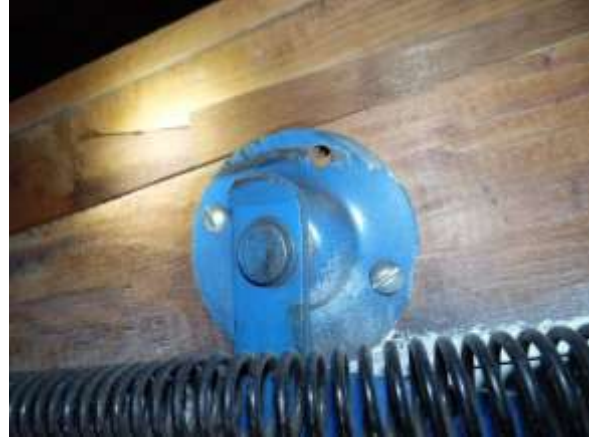
The stair assembly was not properly installed or secured to the framing members, and repair is needed for safety purposes. The condition(s) can be a safety hazard, and repair is needed, as an improperly installed stair assembly can possibly collapse.

- The nails used to secure the ladder assembly to the attic framing were not installed through the holes in the corner brackets at the top of the stairs.
- The nails used to secure the ladder assembly to the attic framing were not installed through the holes in the spring arm pivot plates on the sides of the access ladder.

Obtain Cost Estimate

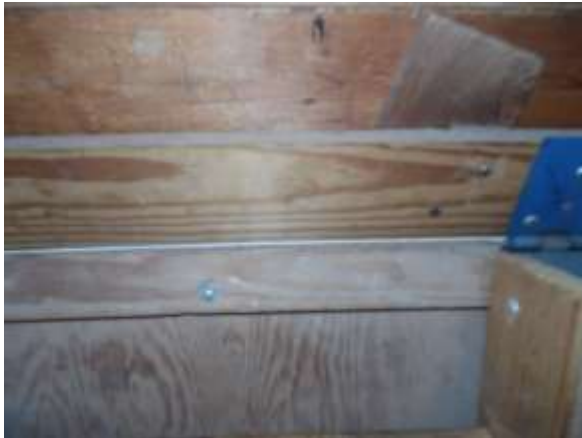
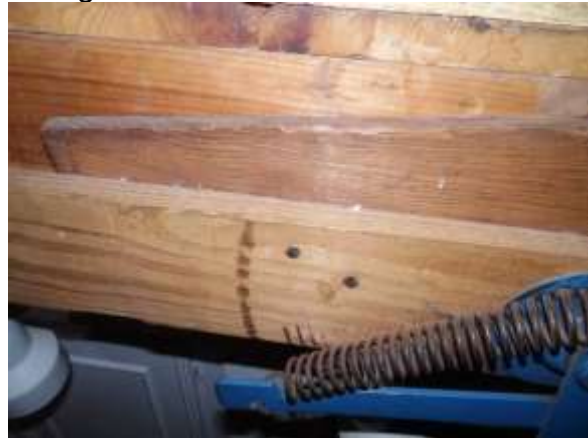
The stair assembly was not properly installed or secured to the framing members, and repair is needed for safety purposes. The condition(s) can be a safety hazard, and repair is needed, as an improperly installed stair assembly can possibly collapse.

- The ladder was secured to the framing members with 8d nails rather than a minimum of sixteen 16d nails or 1/4 x 3" lag screws.

Obtain Cost Estimate

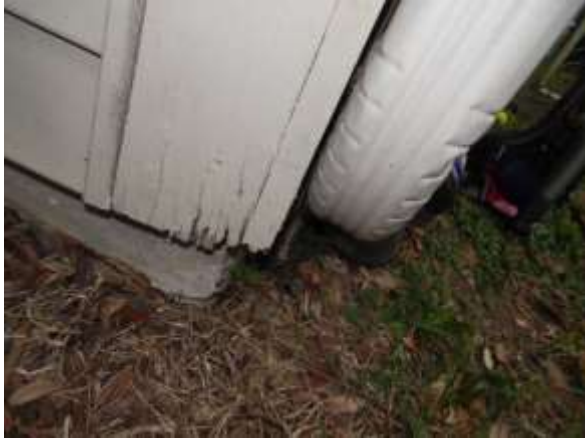
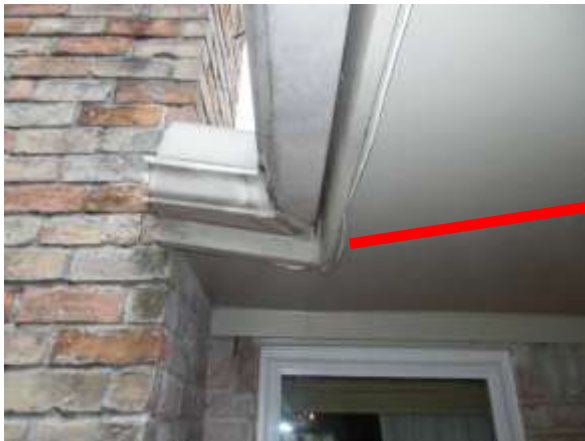
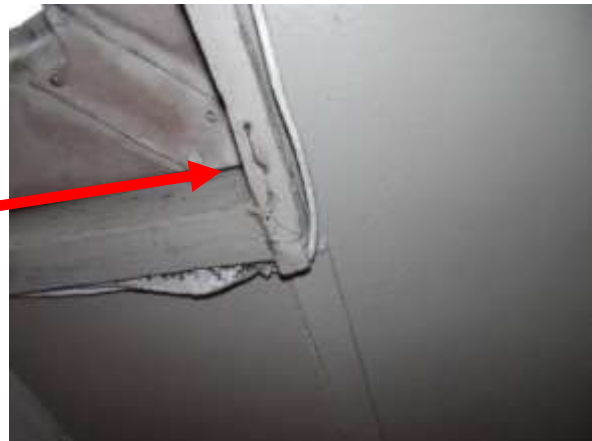
Wood rot was observed and it is recommended that the damaged wood be replaced. It is pointed out that additional damage could be present under the rotted material that will not be visible until the outer rotted materials are removed. Below is a representative sample of wood rot observed during the inspection, showing some, but not necessarily all, of the wood rot on the house. Have a service company determine the entire scope of wood rot throughout the house, and provide a cost estimate to replace all rotted wood.

Obtain Cost Estimate

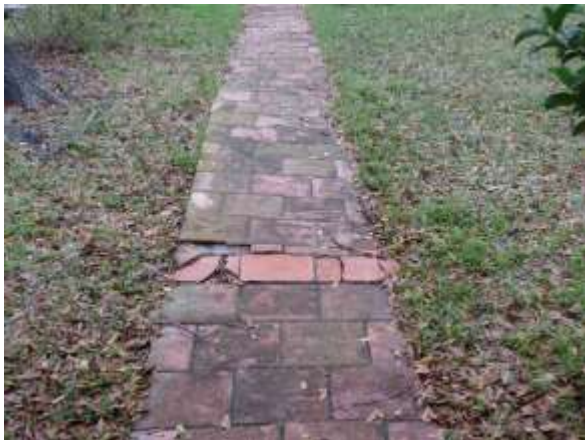
The sidewalk was cracked and uneven at the front of the house, and presents a tripping hazard.

Obtain Cost Estimate
