FOUNDATION

CHECK
INDEPENDENT FOUNDATION EVALUATIONS

October 26, 2020

Re: Foundation Evaluation
1919 Michele Dr
Missouri City, TX 77489

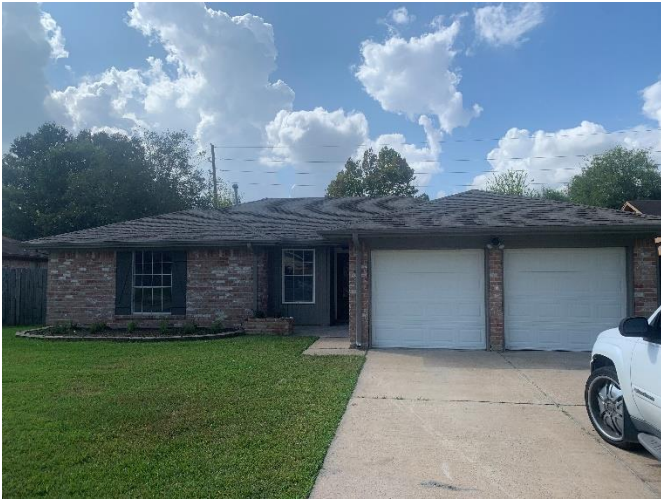
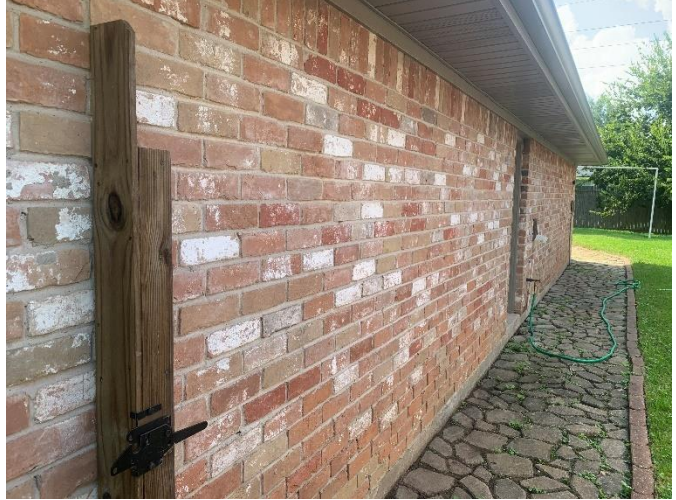
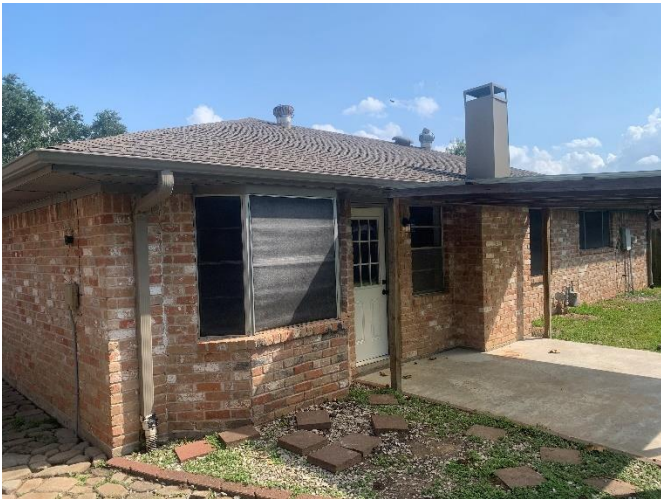
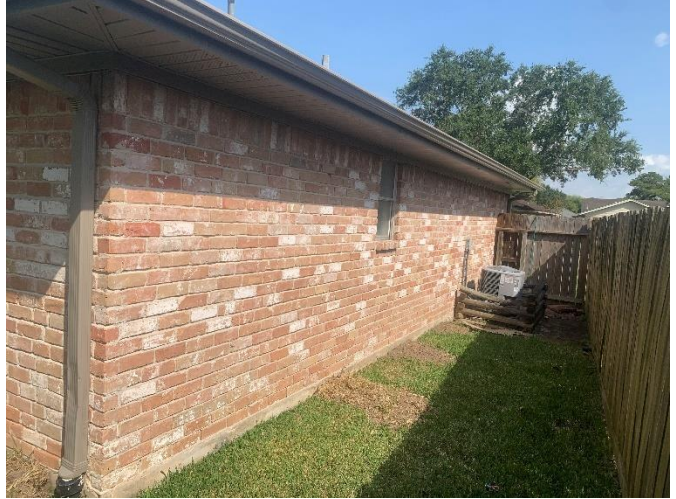
- There are large trees on this and the surrounding properties. (Pictures #1, 2, 3 and 4)
- There are no visible signs of structural distress inside of the home. (Pictures #5 and 6)
