PROPERTY INSPECTION REPORT

Concerning: 15534 Zabolio Dr #245, Webster, TX 77598
(Address or Other Identification of Inspected Property)

By: Scott Adler, Lic #4975 12/27/2019
(Name and License Number of Inspector) (Date)

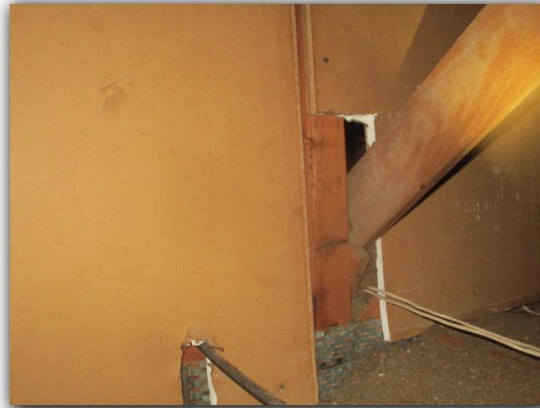
- Recommended fire walls missing between units (front and rear units). Also, the fire walls on the sides of units are not completely sealed.
- Recommended H-clips not installed between sheets of decking. These H-clips help prevent the decking from buckling

FIRE WALL NOT SEALED IN ATTIC

Recommended fire walls missing between units (front and rear units). Also, the fire walls on the sides of units are not completely sealed.

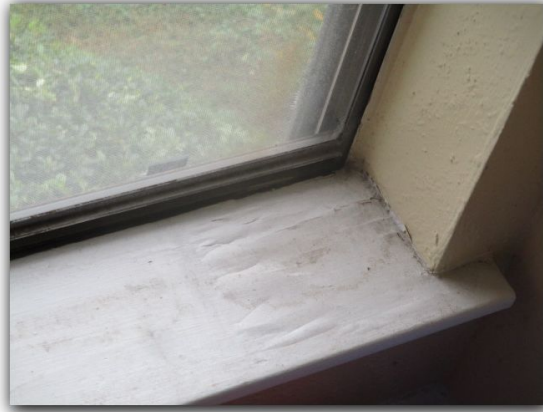
- Water stains on the following window sills (can be from condensation forming on window panes, sealant around window frames deteriorated, windows being left open, or improper window installation): guest bedroom

WATER PENETRATION TO GUEST BEDROOM WINDOW SILL

Water stains on the following window sills (can be from condensation forming on window panes, sealant around window frames deteriorated, windows being left open, or improper window installation): guest bedroom

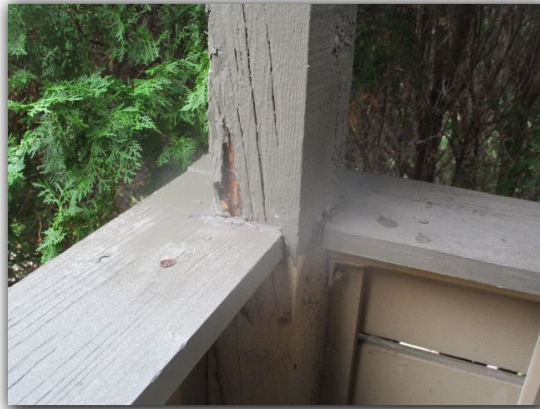
Patio column is partially damaged -appears to be from some wood rot

LITTLE WOOD ROT TO PATIO COLUMN

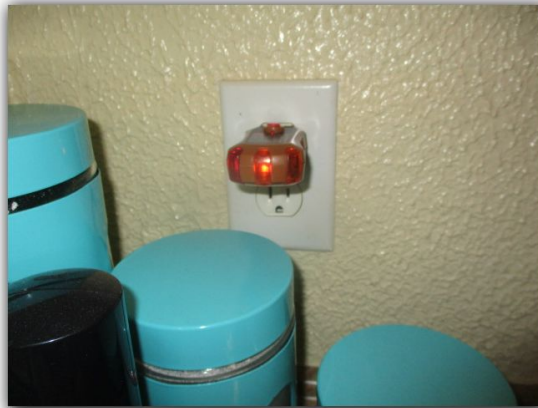
The following outlets are reverse polarized (hot/neutral): rear kitchen countertop

OUTLET REAR WALL OF KITCHEN COUNTERTOP IS REVERSE POLARIZED

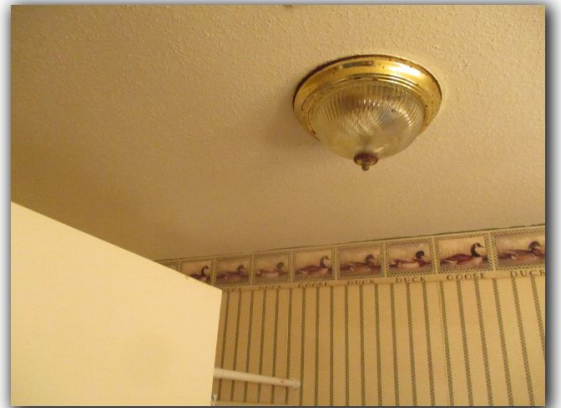
- Pull insulation away from recessed lights in the attic
- The following light fixtures do not have minimum recommended clearance from tub/shower walls: lights too close to both bath tubs (recommended to be three feet away or flush mounted)

LIGHT FIXTURES TOO CLOSE TO BOTH BATH TUBS

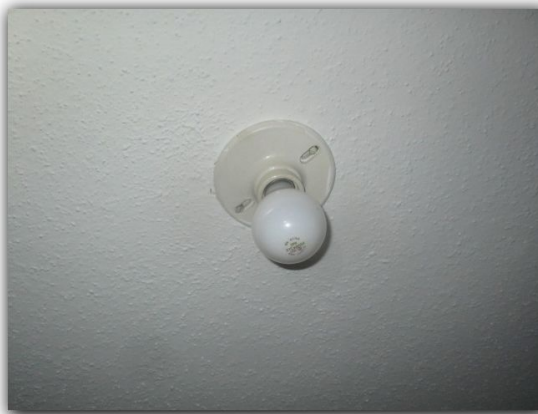
- Uncovered light fixtures in closets are no longer recommended (considered a fire hazard)
- Globe(s) missing from some of their lights

UNCOVERED LIGHT FIXTURES IN CLOTHES CLOSETS

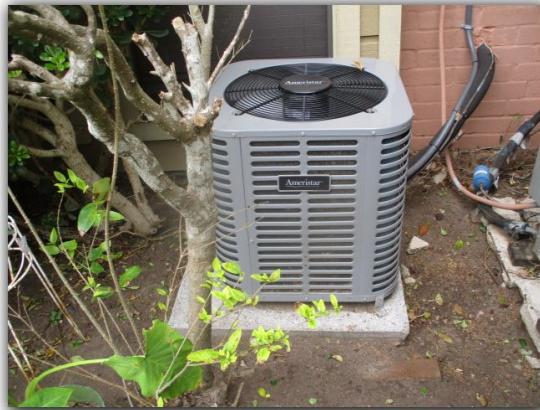
Condenser unit coil fins are a little dirty

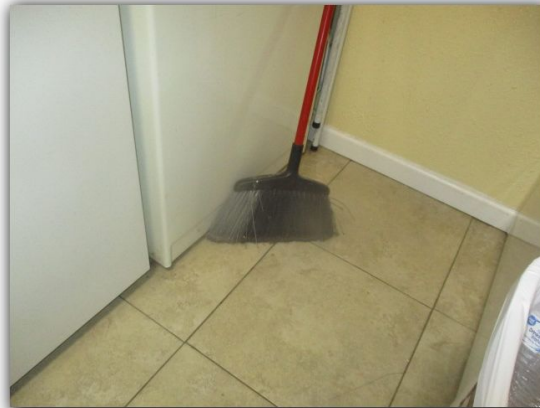
- Washing machine connected at this time - faucets, drains not tested for proper operation
- Emergency drain pan and drain line not present beneath the washing machine (recommended when washing machine is above a living area)

EMERGENCY DRAIN PAN AND DRAIN LINE MISSING FROM BENEATH WASHING MACHINE

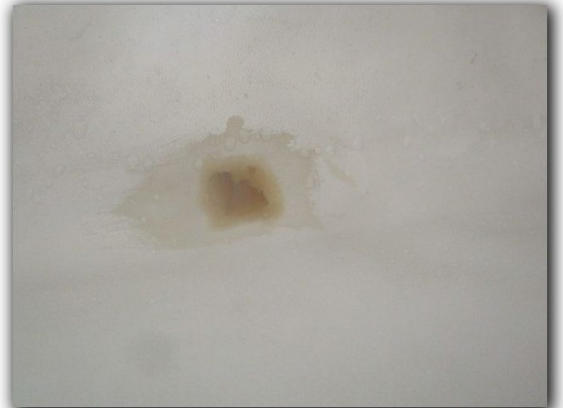
- Tub wall previously damaged at: master bath tub (patch on fiberglass tub)
- Gate at shower diverters not fully closing (allows a little water out of both shower head and spout) -both bath tubs
- Shower diverter valve not operating -both shower diverters do not reseal after disengaging water pressure
- Faucet handle(s) loose in wall at: master faucet and spout are a little loose in wall
- Bath trap(s) are not accessible/present
- Spout is not sealed to tub wall at: master bath tub

SURFACE MASTER TUB HAS BEEN PATCHED

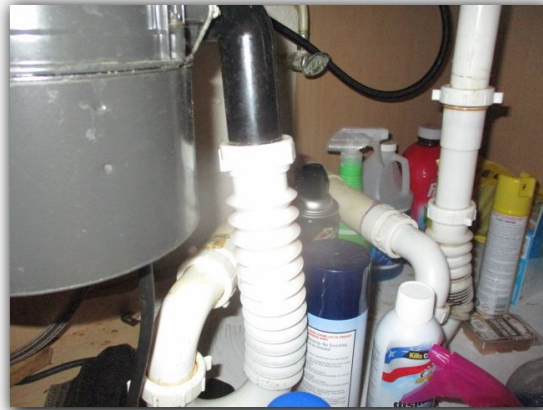
- The following commodes were observed to flush slowly (water levels raised too high before discharging) at: master commode
- Improper material used on parts of the following drain lines (it is recommended that the interior surface of drain line be smooth) -both kitchen drain lines

IMPROPER MATERIAL USED ON PARTS OF THE KITCHEN DRAIN LINES

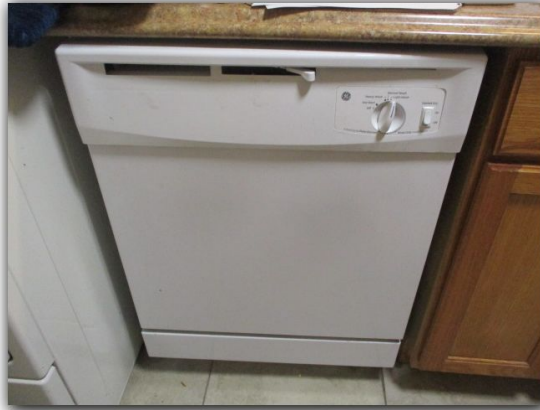
- No anti-siphon loop at the drain line

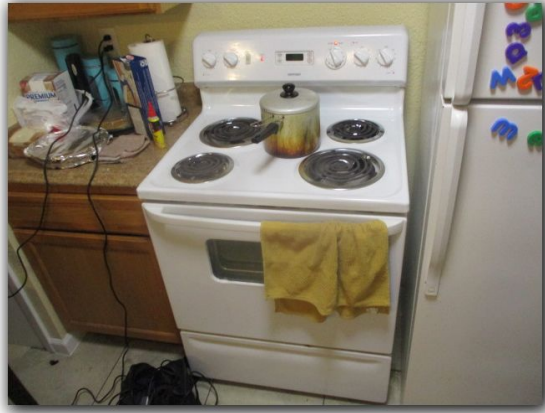
- Unit is not properly secured -absence of anti tip device
- Interior light does not operate (bulb?)
