PROPERTY INSPECTION REPORT

Concerning: 1028 E 14TH STREET, Houston, TX 77009
(Address or Other Identification of Inspected Property)

By: Stephen Perry, Lic #7854 06/19/2018
(Name and License Number of Inspector) (Date)

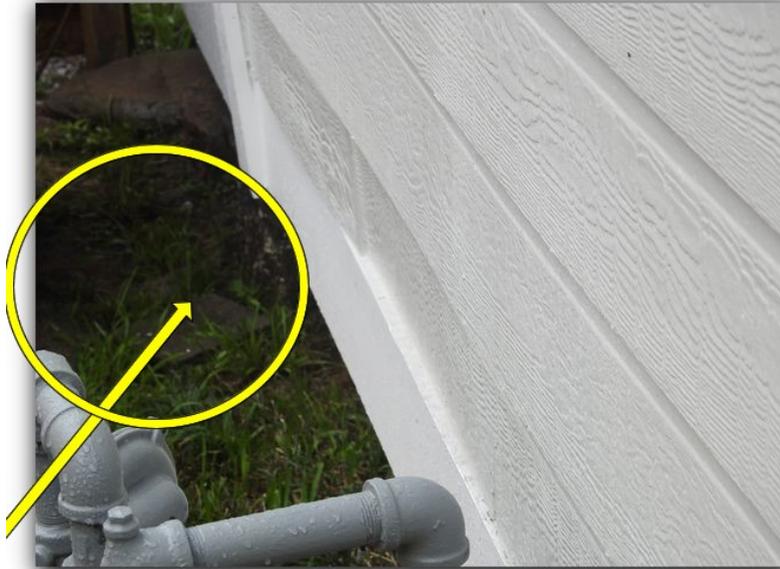
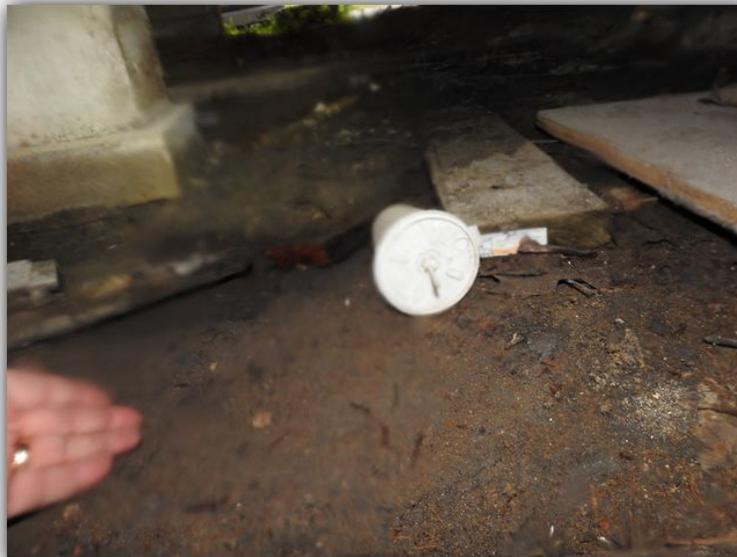
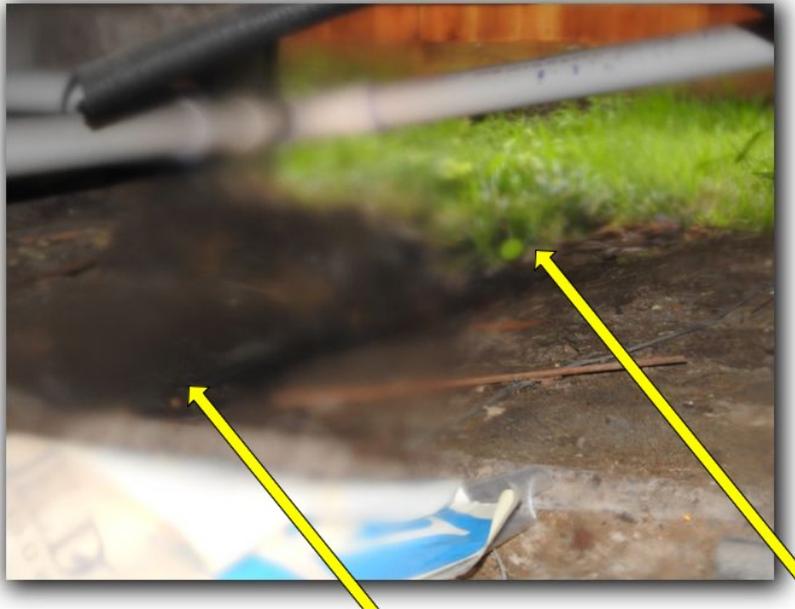
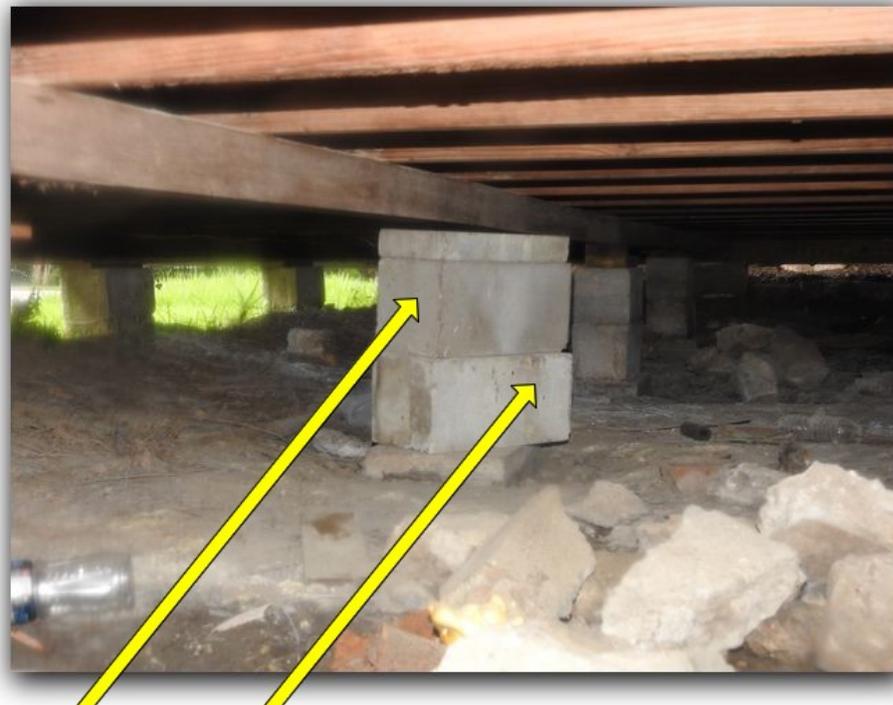
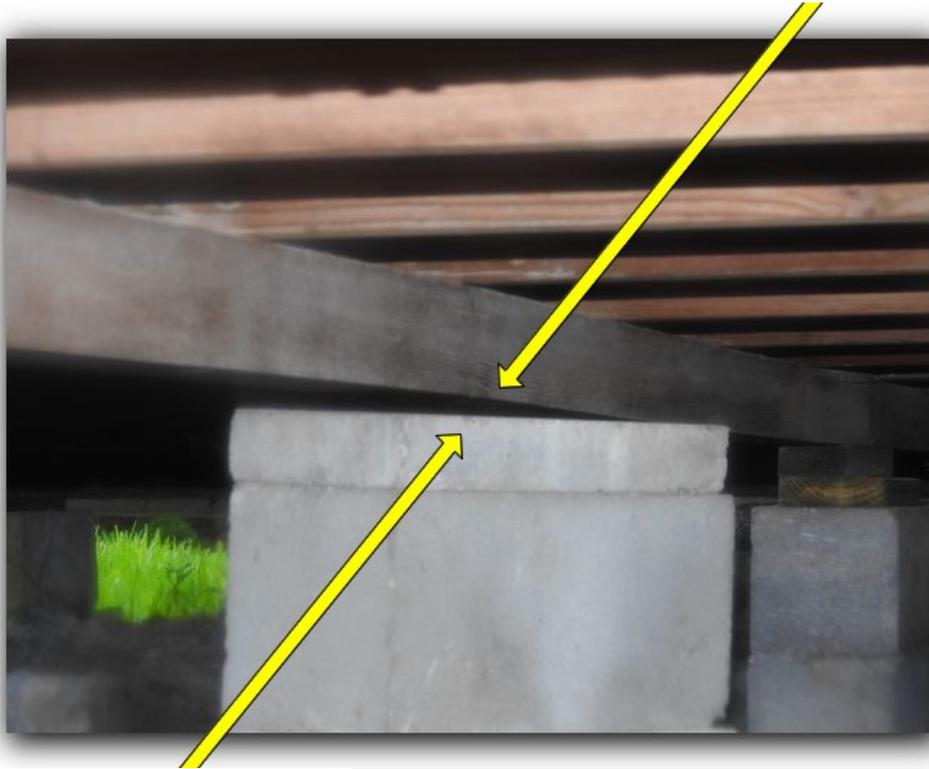
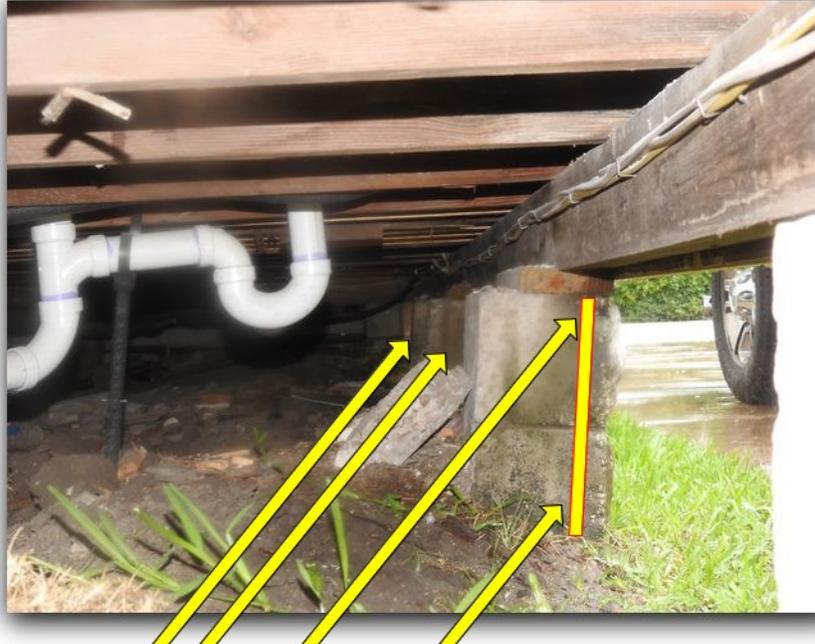
DEFICIENCY- THERE IS SOME PIERS THAT ARE NOT PROPERLY SHIMMED AND NOT SUPPORTING THE BEAM

PROPERLY. THERE IS SOME OUTER PERIMETER PIERS THAT ARE LEANING AND IN NEED OF EVALUATION BY A FOUNDATION REPAIR EXPERT.

THERE IS IMPROPER GRADING AND DRAINAGE UNDER THE HOME AND WATER PONDING UNDER THE HOME IN THE CENTER OF THE HOME THAT COULD AFFECT FOUNDATION PERFORMANCE IF NOT CORRECTED.

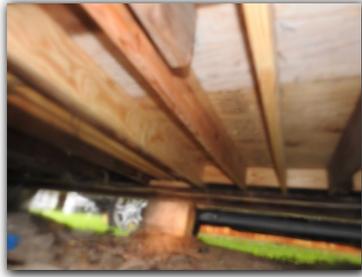
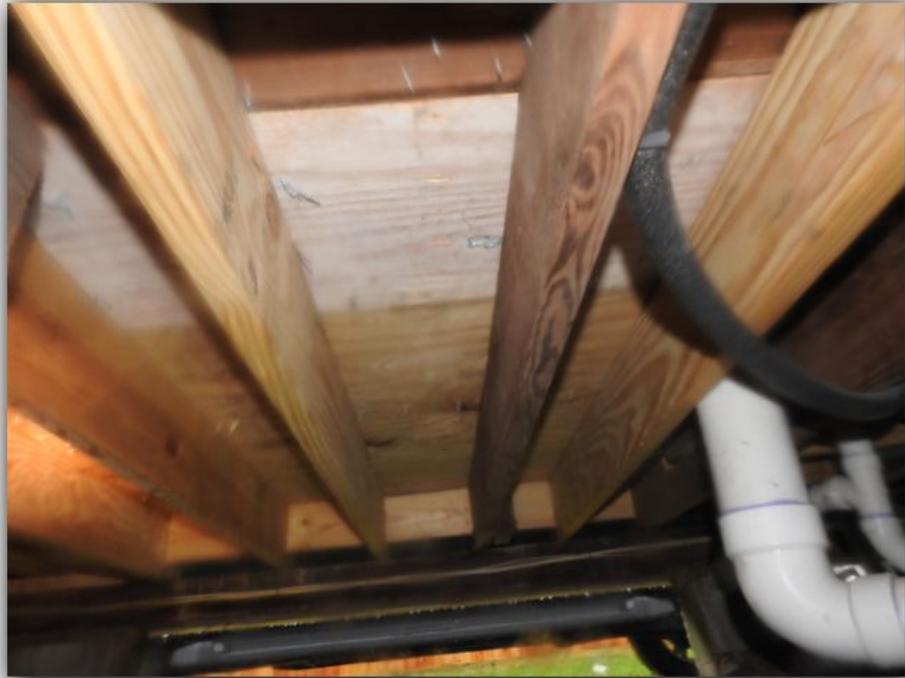
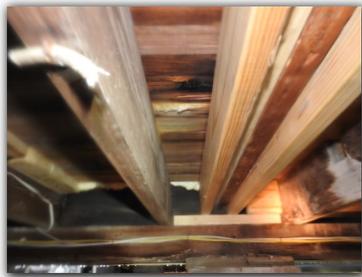
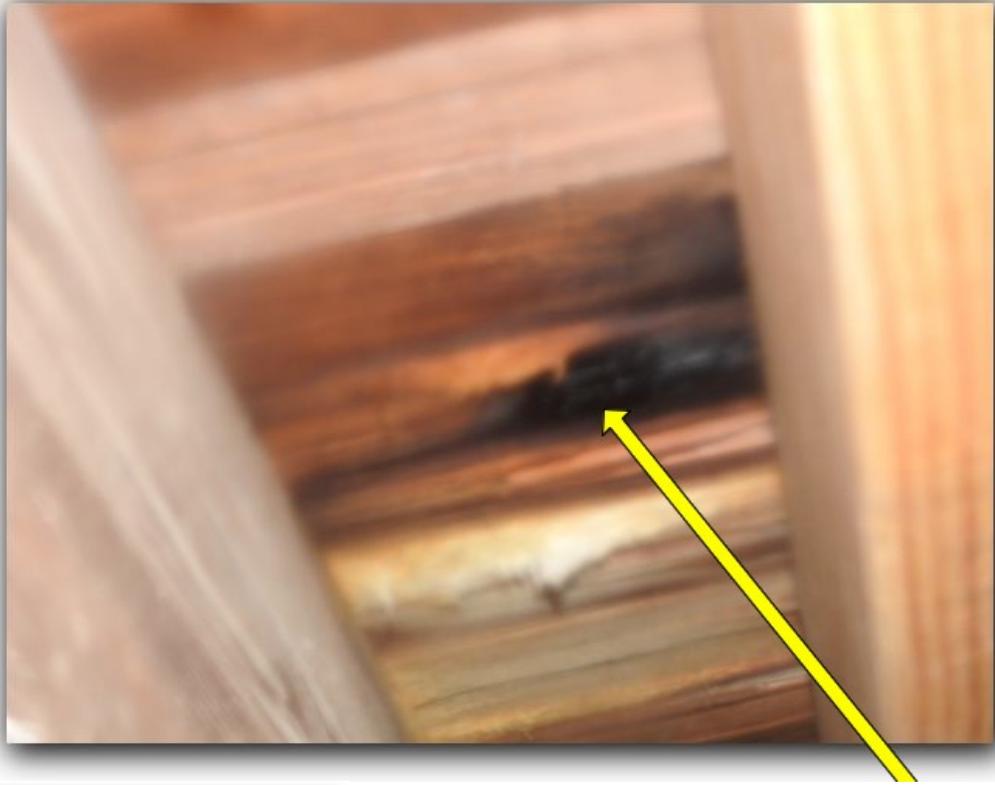
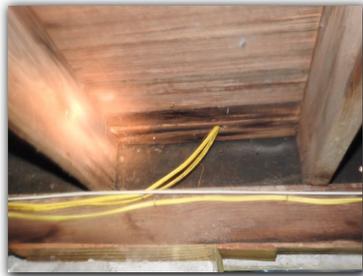
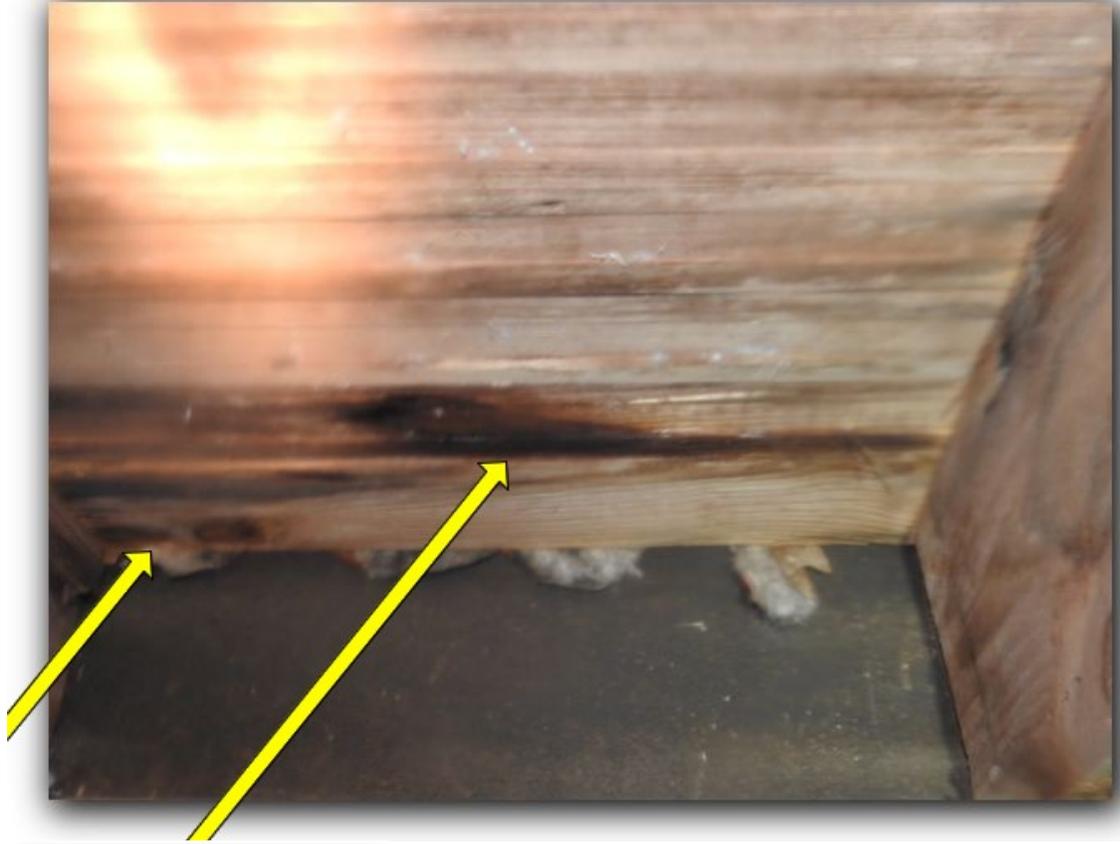
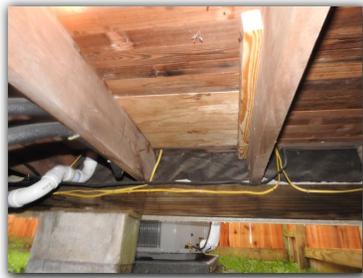
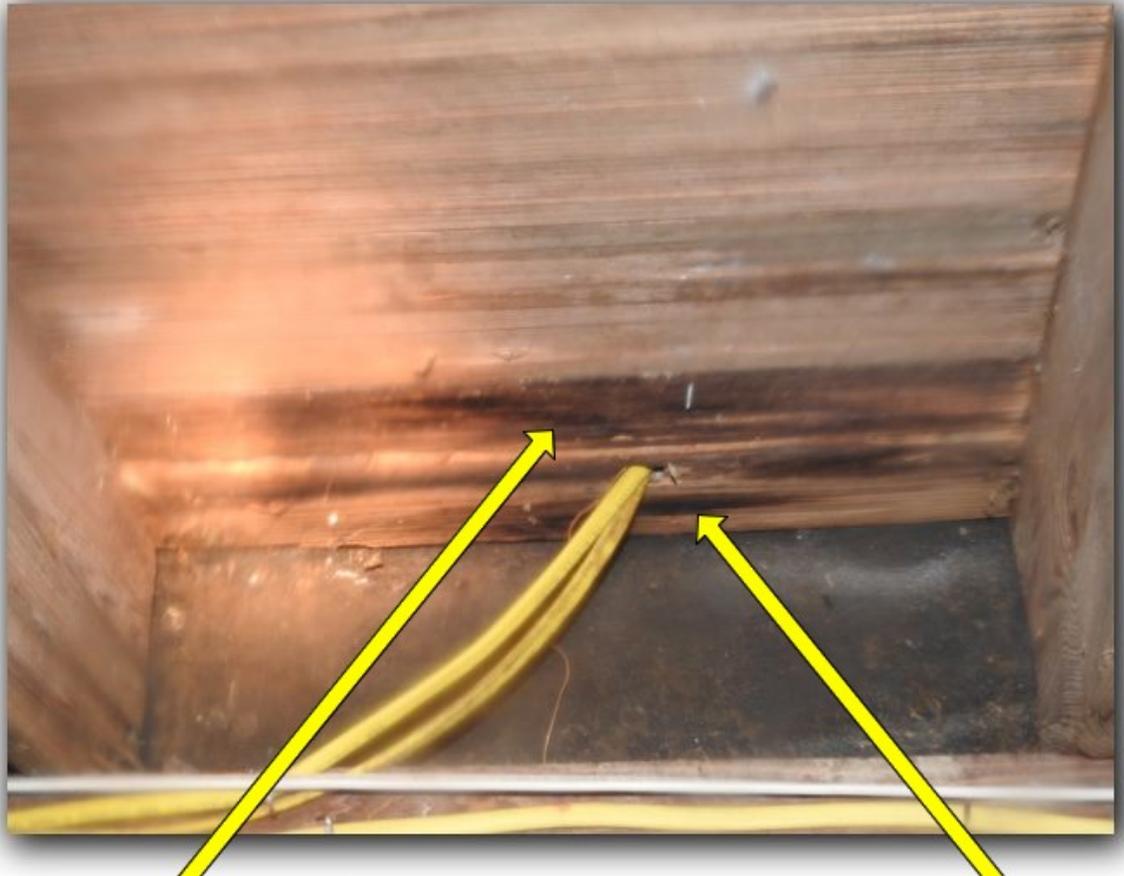
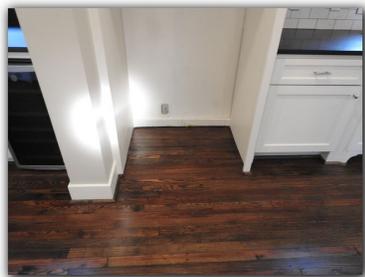
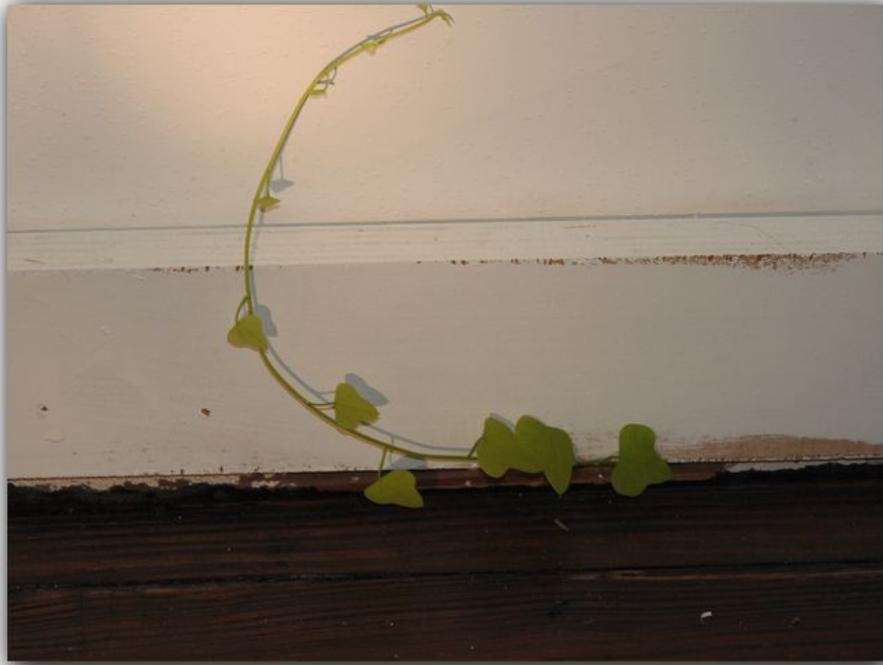
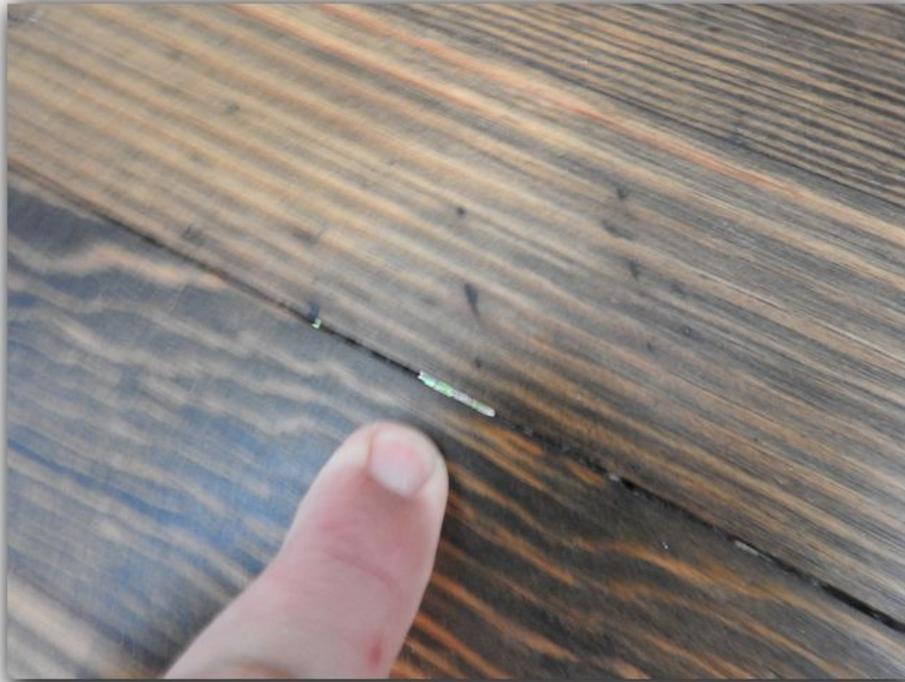
- **THERE IS SOME PREVIOUS SUB FLOORING REPAIRS AND THERE IS SOME AREAS OF DRY ROT ON THE OLDER SUB FLOORING IN SOME LOCATIONS THAT DID SHOW SUNLIGHT THROUGH THE HARDWOOD FLOORING IN SOME LOCATIONS OF THE HOME IN THE DEN AND IN THE KITCHEN THAT DOES NEED EVALUATION/REPAIRS**
- **THERE IS NO INSULATION PRESENT UNDER THE SUB FLOORING BETWEEN THE FLOOR JOIST AS RECOMMENDED AND NO "BRIDGING OR BLOCKING" AS IS RECOMMENDED. RECOMMEND EVALUATION BY A FRAMING EXPERT AND FOR INSULATION TO BE INSTALLED.**

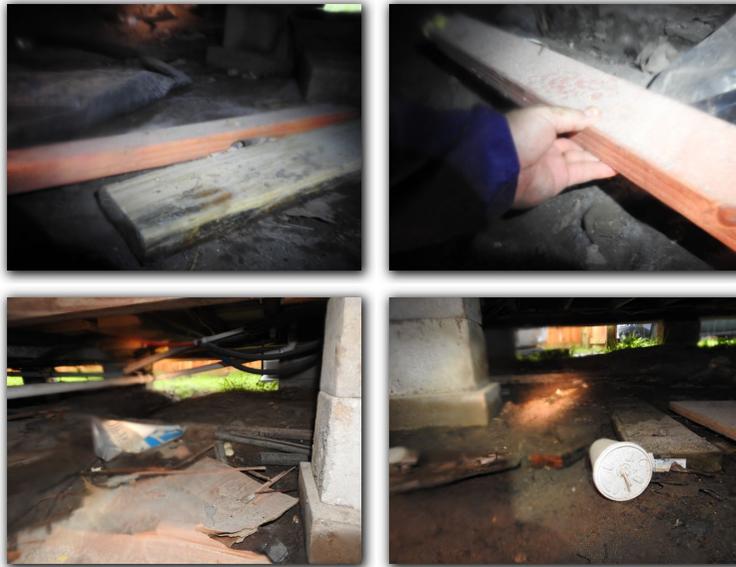
- Improper drainage from foundation**
- Erosion or ponding next to foundation, draining under the home and ponding near the pier locations.**
- Run off intrusion into crawl space**
- Grade slopes toward the structure/right side of the home near the air condenser**
- Soil / lot conditions suggest further evaluation by appropriate professional, i.e.. watering program, drains, etc.**
- THERE IS IMPROPER GRADING AND DRAINAGE UNDER THE HOME WITH LARGE DEPRESSIONS THAT CAN HOLD WATER UNDER THE HOME AND CAN AFFECT FOUNDATION PERFORMANCE. DURING THE INSPECTION WITH ACTIVE RAINFALL WATER WAS DRAINING UNDER**
- THE HOME FROM THE RIGHT SIDE OF THE HOME NEAR THE AIR CONDENSER LOCATION DUE TO IMPROPER GRADING AND EROSION. RECOMMEND EVALUATION AND IMPROVEMENTS WITH ROCK/GRAVEL**

- **RECOMMEND EVALUATION AND IMPROVEMENTS BY A LANDSCAPE AND IRRIGATION EXPERT.**
- **LOOSE LUMBER AND DEBRIS UNDER HOME THAT WOULD BE CONSIDERED CONDUCTIVE CONDITIONS FOR WOOD DESTROYING INSECTS AND NEEDS TO BE REMOVED**

AND GRADING IMPROVEMENTS UNDER THE HOME AND AROUND THE PERIMETER OF THE HOME. IN ADDTION, IT WOULD RECOMMEND GUTTERS WITH FRENCH DRAINS INSTALLED AROUND THE PERIMETER OF THE HOME.

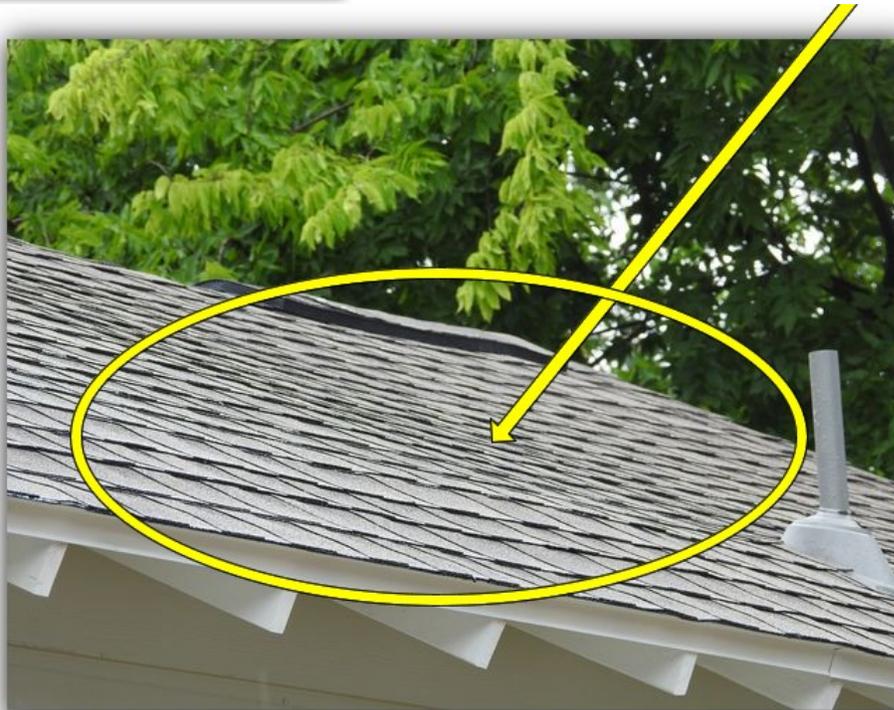
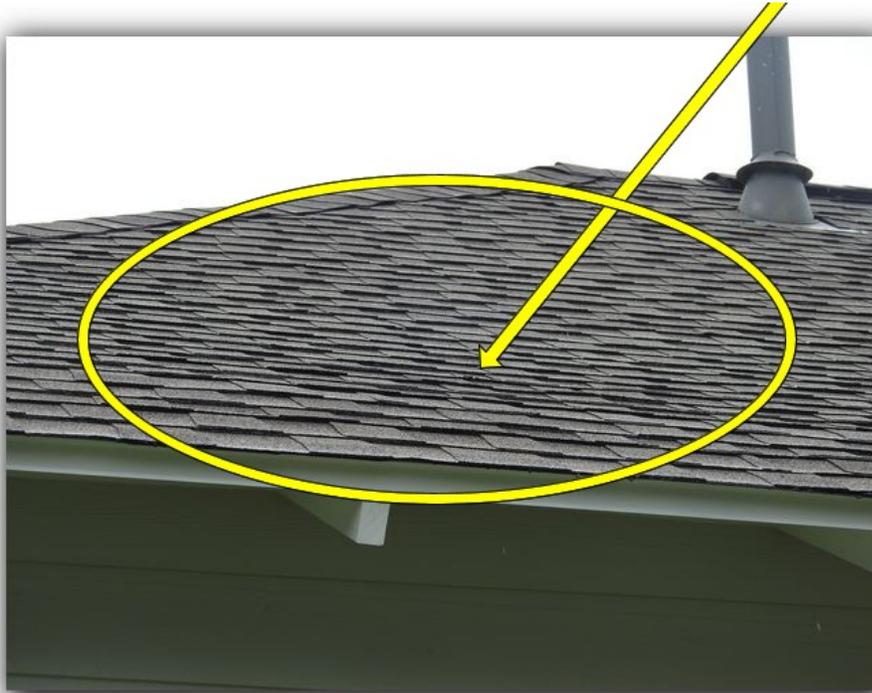
☑ Roof decking deflection and / or sagging
ON THE FRONT RIGHT AND BACK RIGHT SIDES OF THE
HOME DUE TO A LACK OF RAFTER/HIP JACK MID SPAN
SUPPORT COMMON WITH OLD HOMES THAT DOES NEED
EVALUATION AND REPAIRS TO THE ROOF STRUCTURE IN
THE ATTIC.

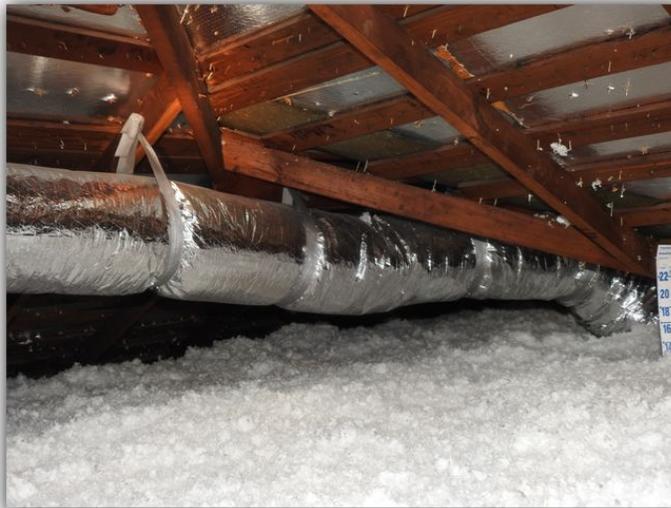
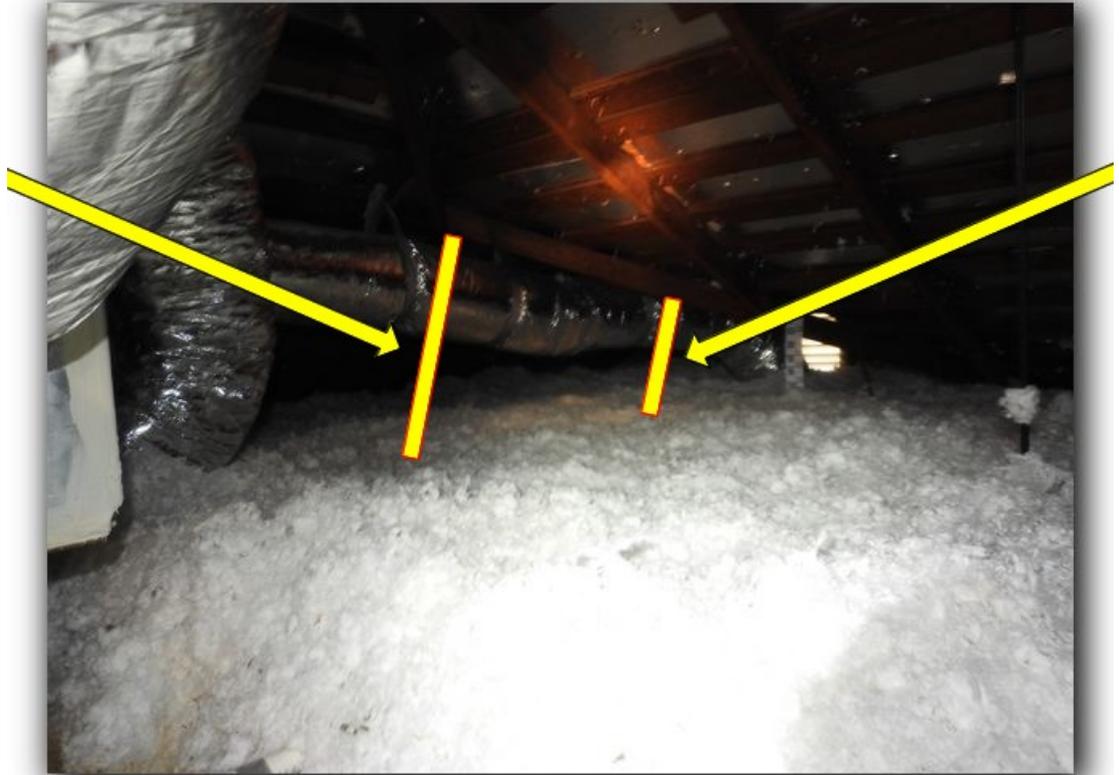
Inadequate roof support and / or failed members

Roof decking deflection and / or sagging

ON THE FRONT RIGHT AND BACK RIGHT SIDES OF THE HOME DUE TO A LACK OF RAFTER/HIP JACK MID SPAN SUPPORT COMMON WITH OLD HOMES THAT DOES NEED EVALUATION AND REPAIRS TO THE ROOF STRUCTURE IN THE ATTIC.

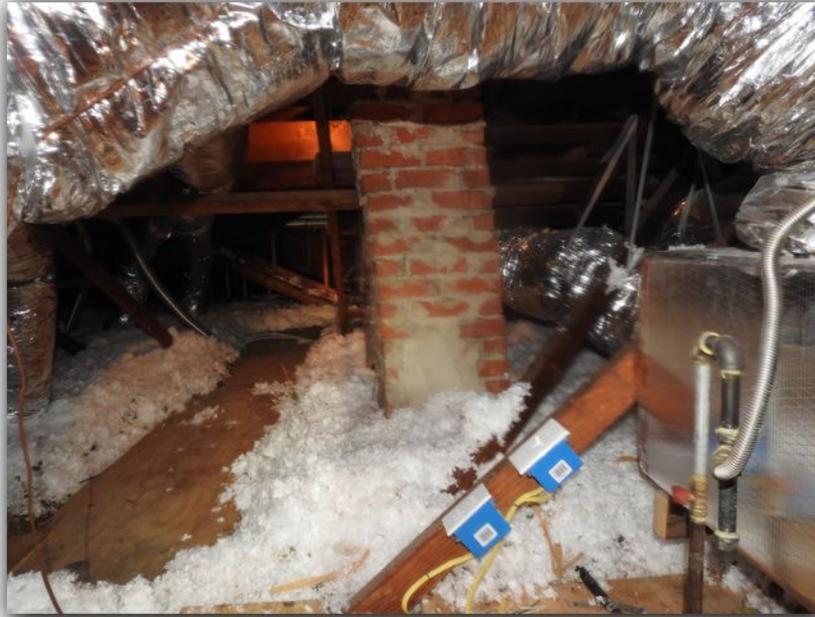
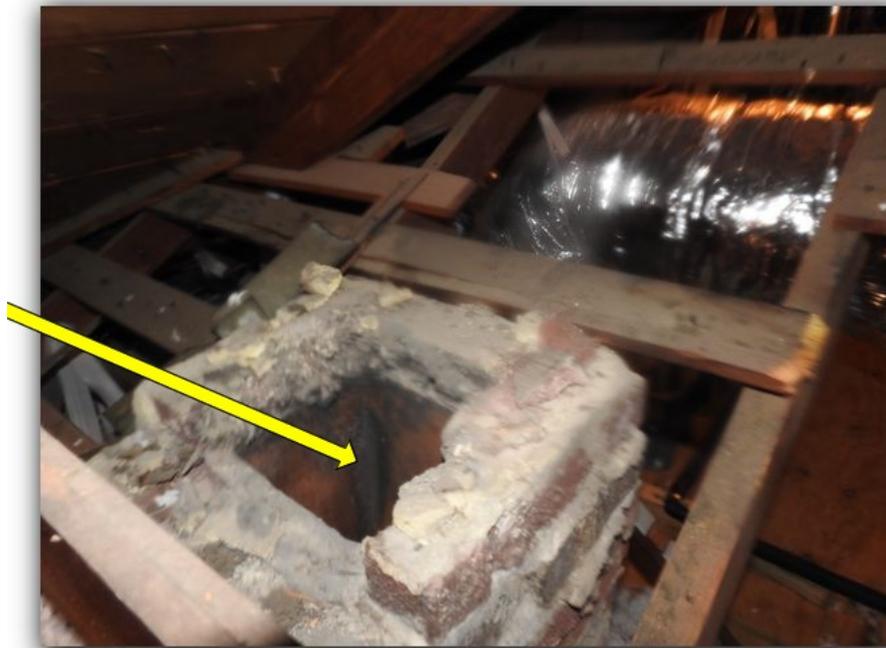
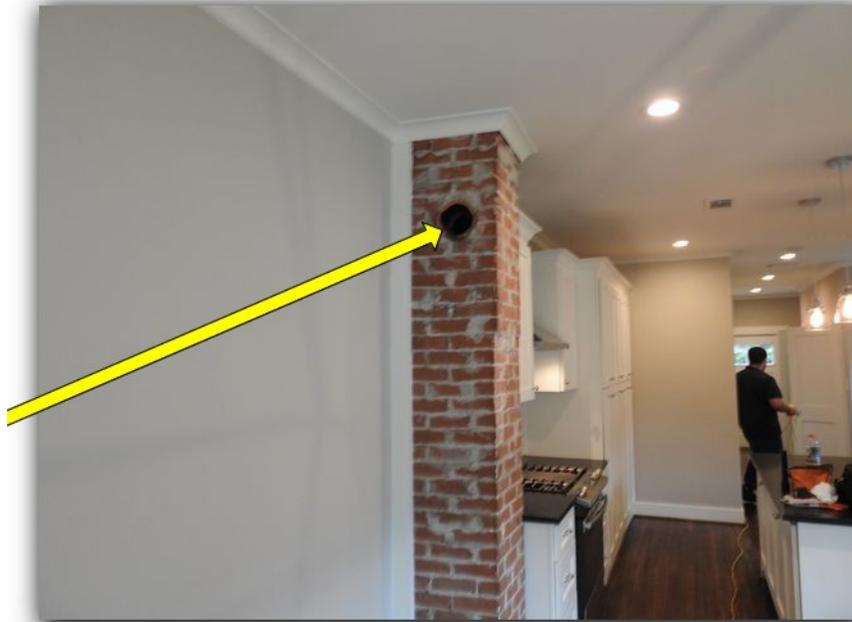
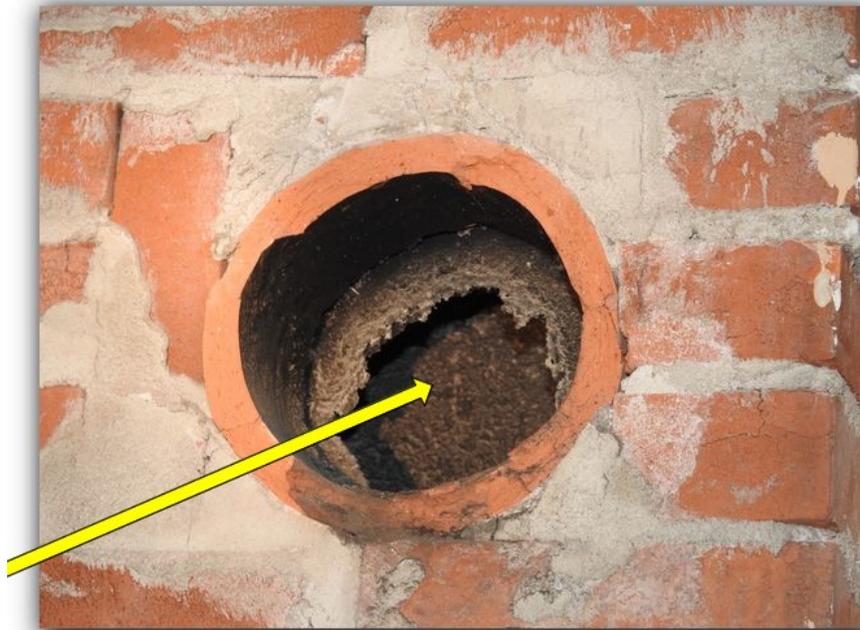
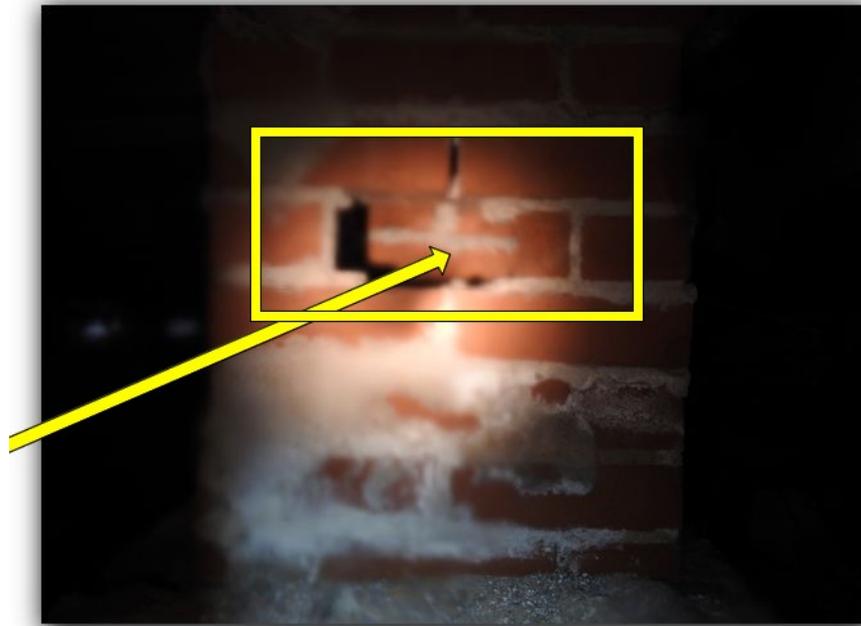
☑ THE OLD BRICK CHIMNEY STILL PRESENT AND PROPERLY SUPPORTED AT THE ORIGINAL CONCRETE PAD UNDER THE HOME IS NO LONGER IN USE BUT DOES HAVE LARGE OPENINGS IN THE CRAWLSPACE, THE KITCHEN/DEN, AND IN THE ATTIC NOT SEALED OFF AT ALL THREE LOCATIONS ALLOWING HEAT TRANSFER/DRAFTS/ AND NOT ENERGY EFFICIENT. IN ADDITION, THE OPENINGS ARE LARGE ENOUGH FOR VERMIN TO ENTER INTO THE HOME AND ALSO INTO THE ATTIC SPACE FROM THE CRAWL SPACE OPENING. IN NEED OF BEING REPAIRED/SEALED OFF WITH MORTAR AND BRICK BY A MASONRY REPAIR PERSON.

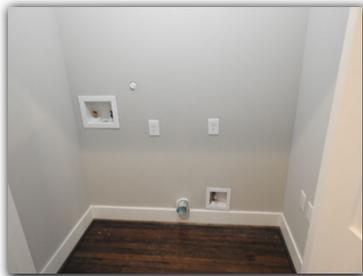
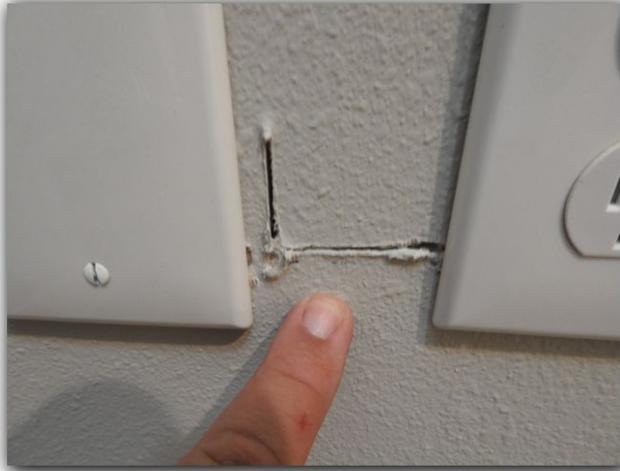
- **SOME DRYWALL DAMAGE IN THE LAUNDRY ROOM/FINISHING WORK NEEDED**

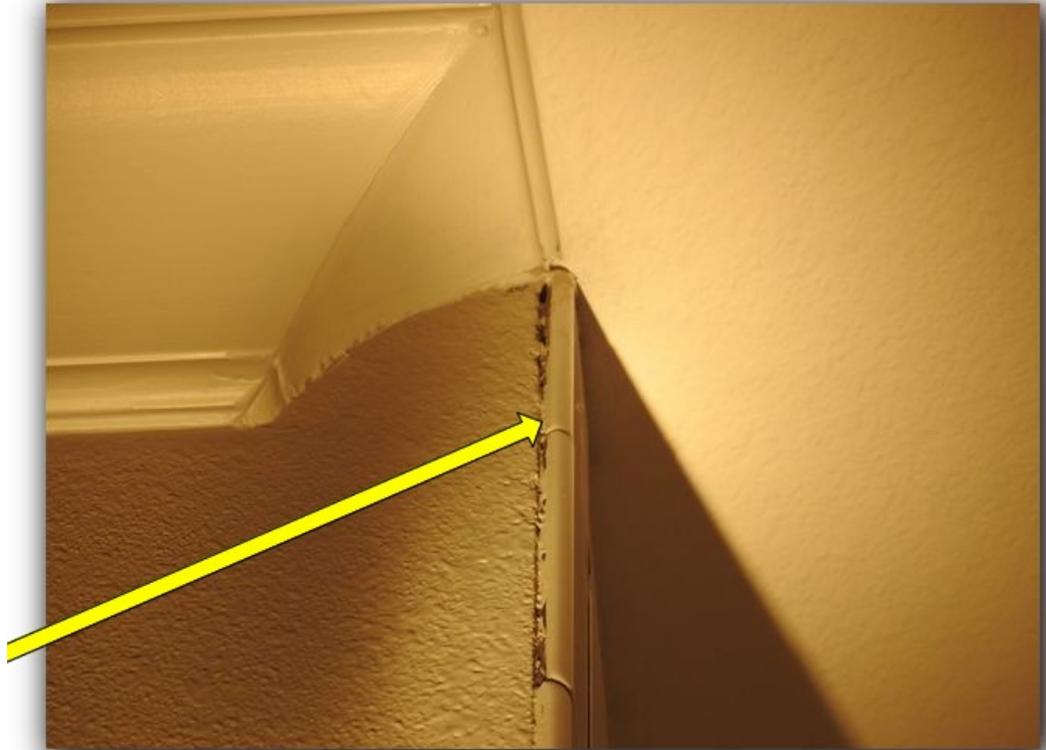
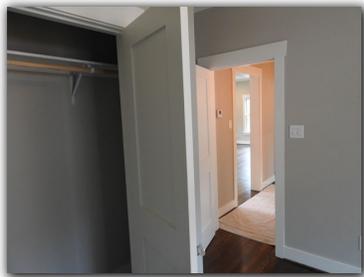
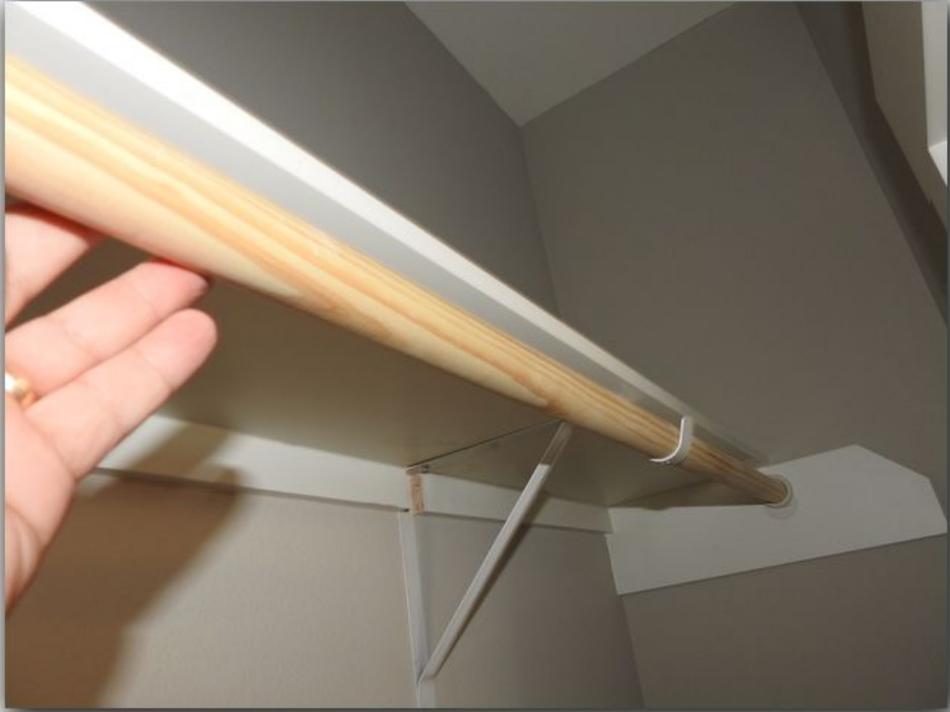
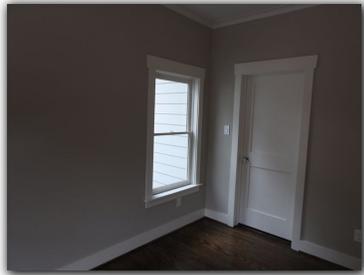
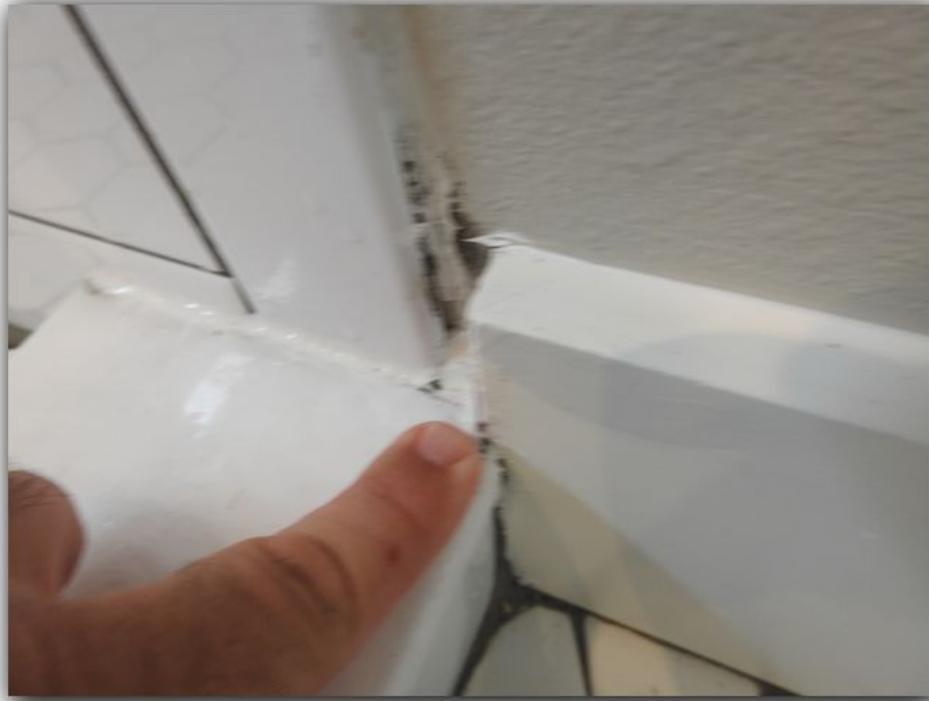
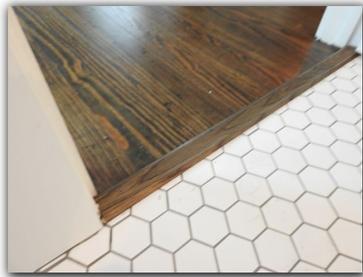
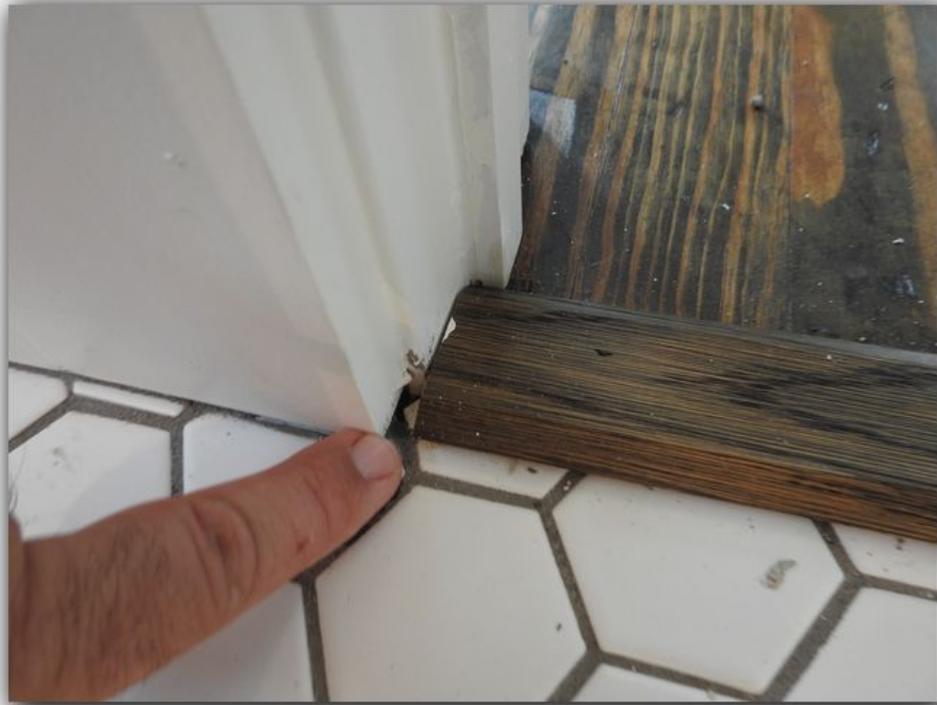
- **CALKING/GROUT AND SOME PAINT DEFICIENCIES IN THE BATHROOMS, DOOR FRAME/BASE BOARDS TRIM, AND THE CLOSET HANGER RODS NEED PAINTING**

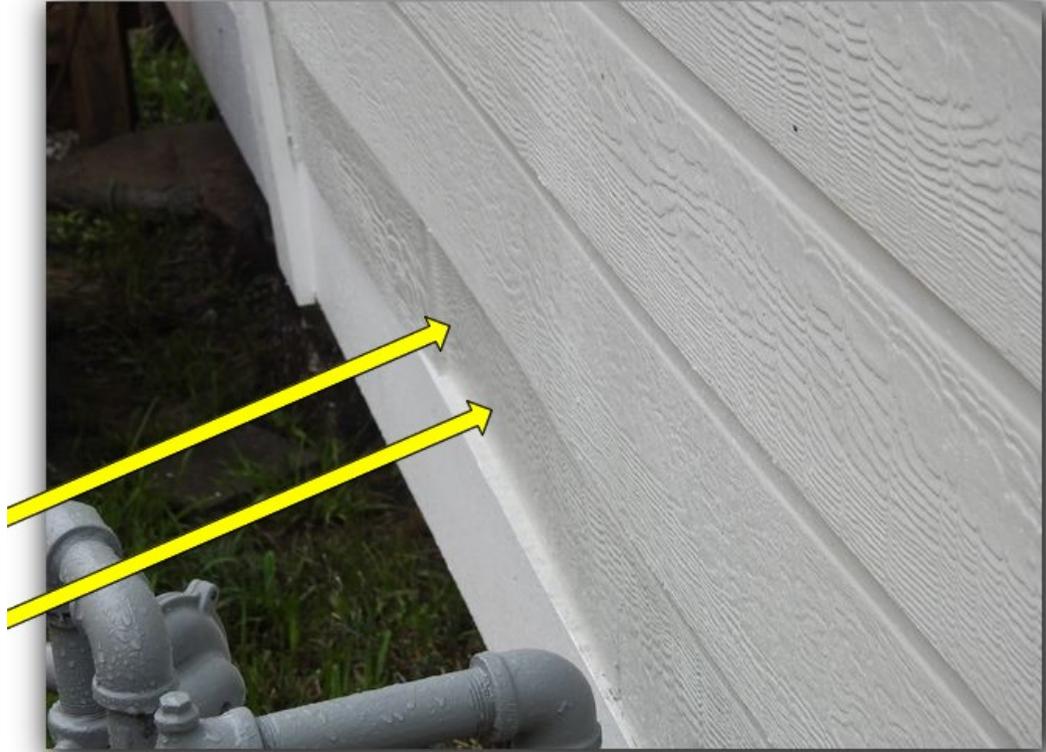
- **THERE IS A CONCAVE WARPED AREA OF THE LOWER EXTERIOR WALL ON THE RIGHT SIDE OF THE HOME THAT NEEDS EVALUATION AND REPAIRS. POTENTIAL ROTTED FRAMING MAY HAVE BEEN COVERED OVER WITH CEMENT BOARD SIDING OR JUST IMPROPERLY INSTALLED.**
