PROPERTY INSPECTION REPORT

Concerning: 1028 E 14TH STREET, Houston, TX 77009
(Address or Other Identification of Inspected Property)

By: Stephen Perry, Lic #7854 06/19/2018
(Name and License Number of Inspector) (Date)

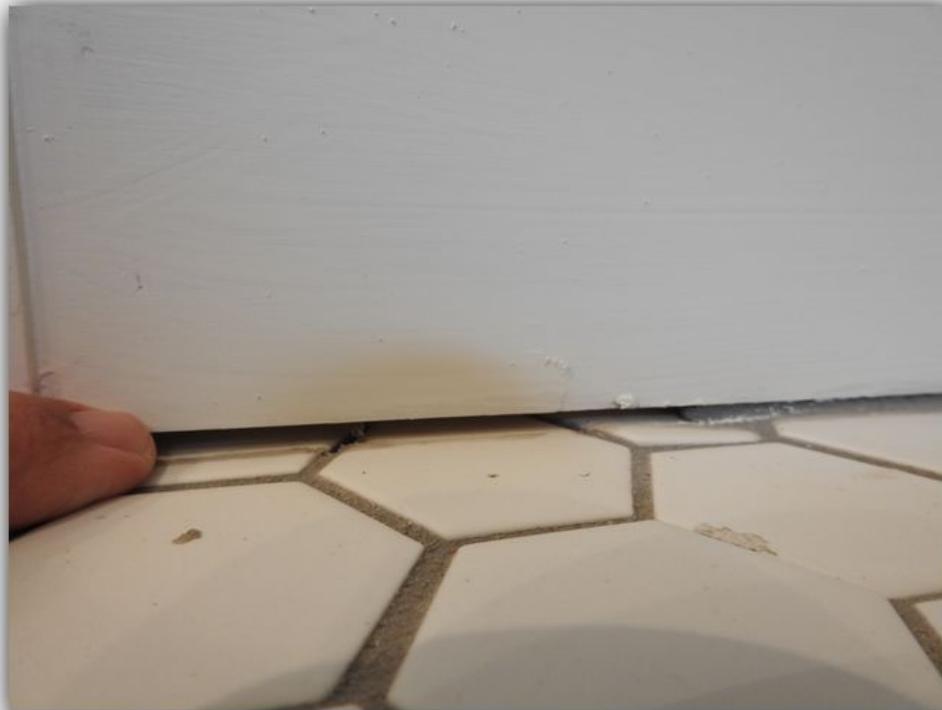
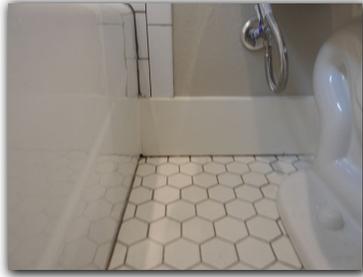
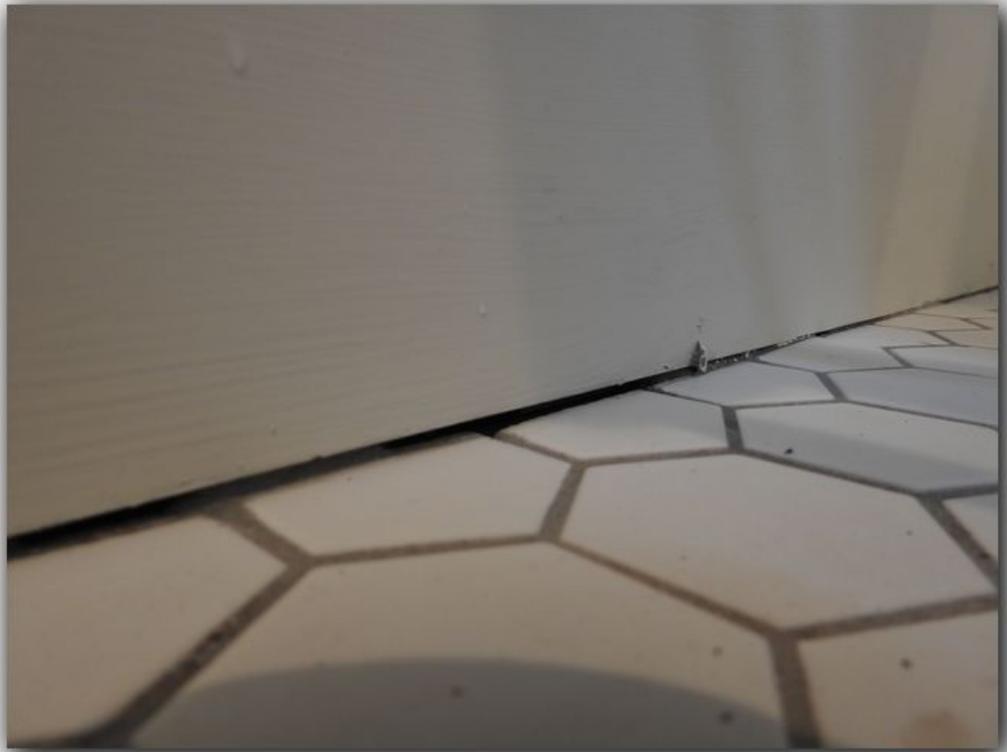
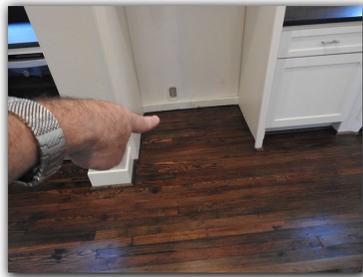
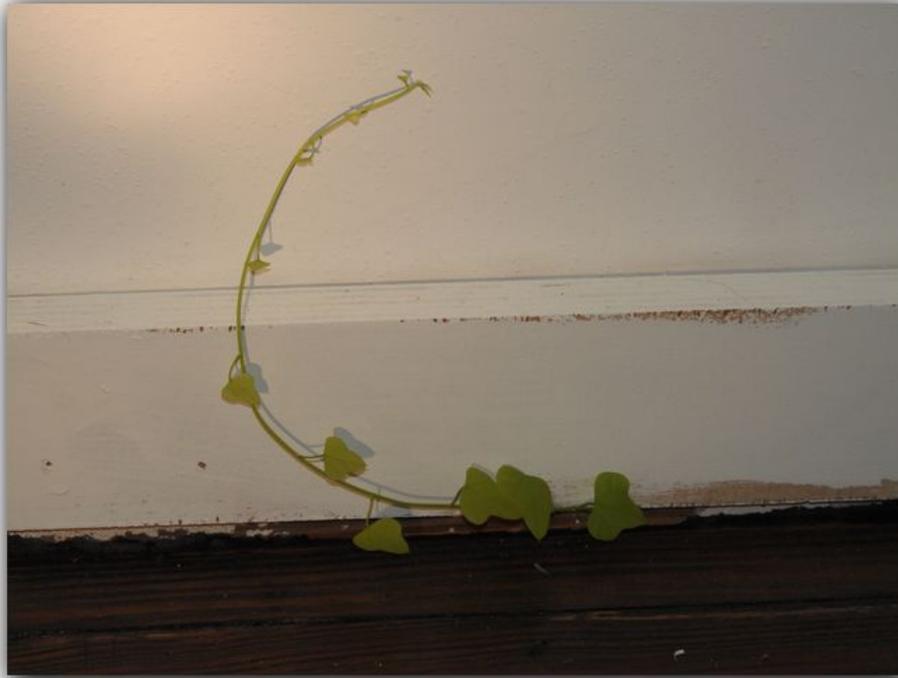
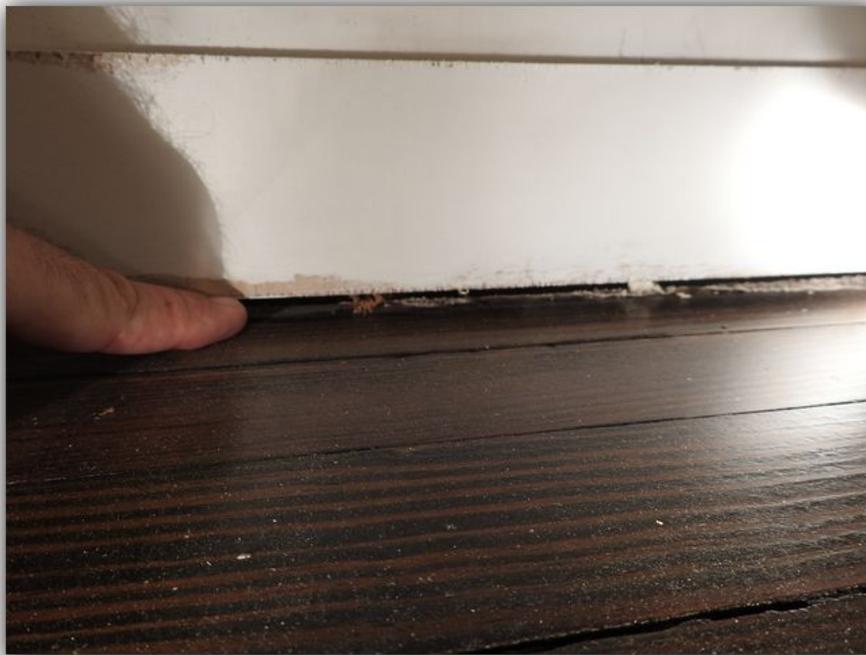
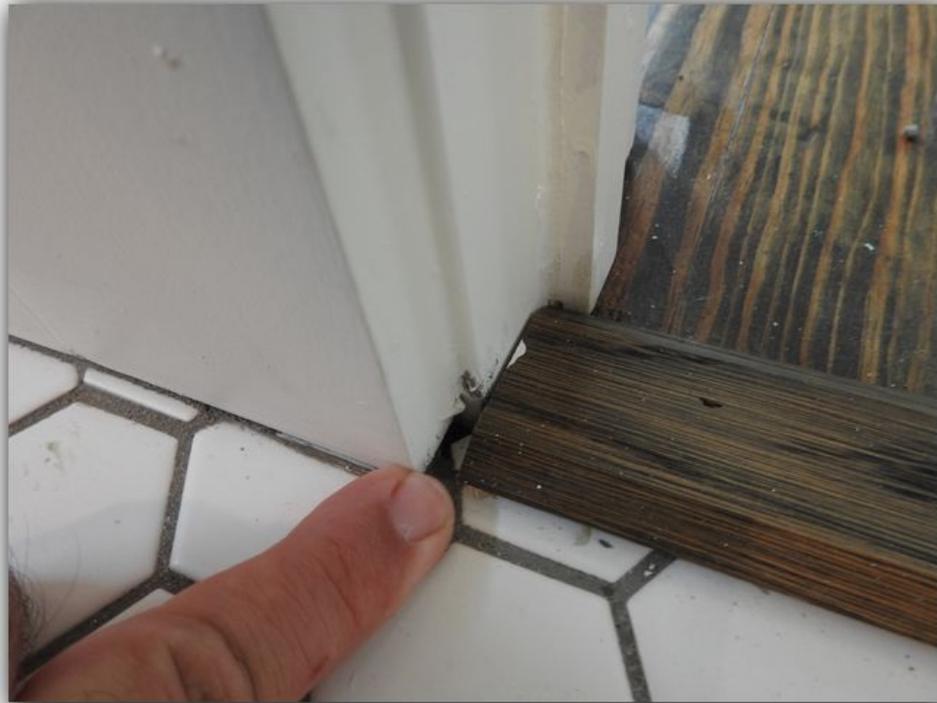
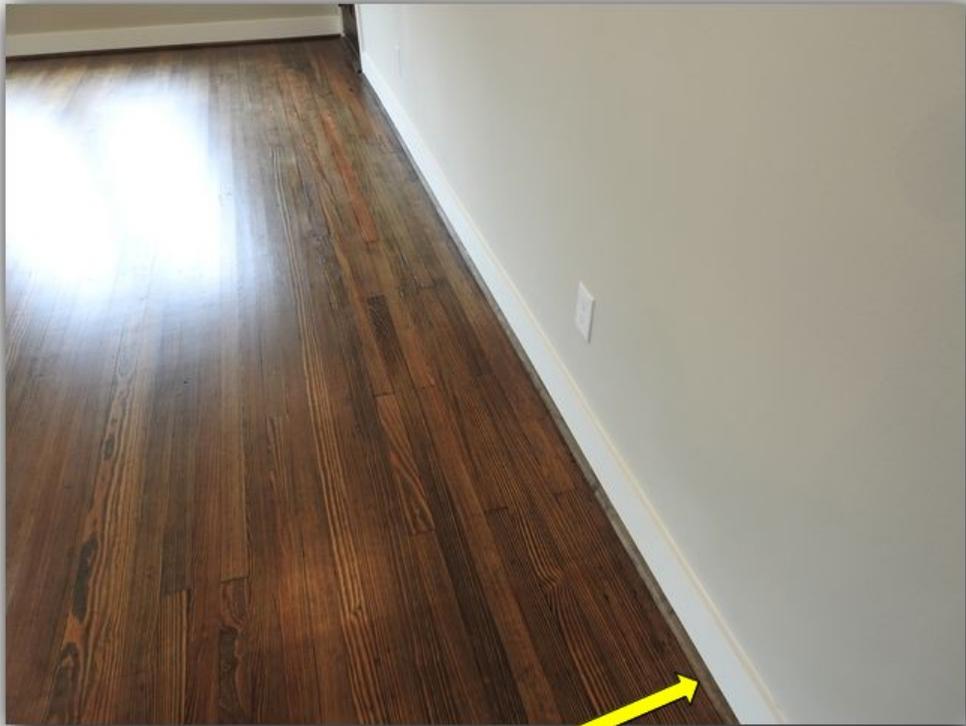
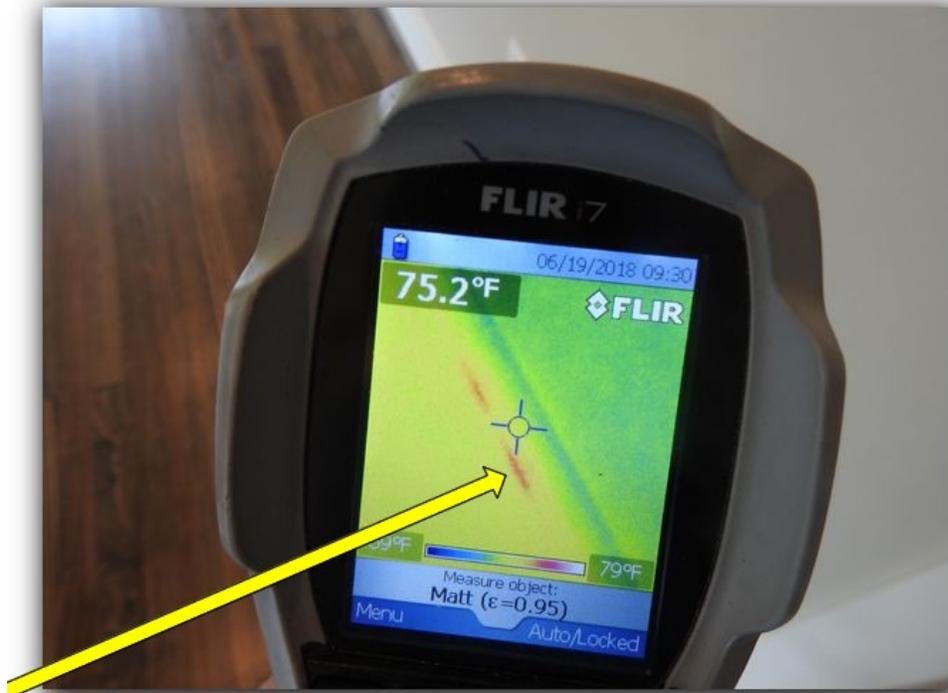
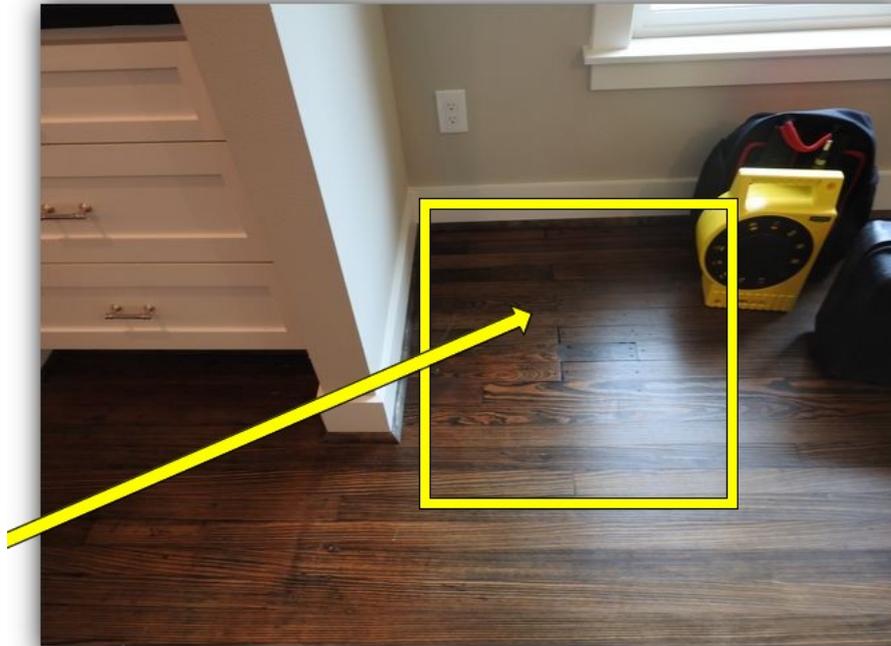
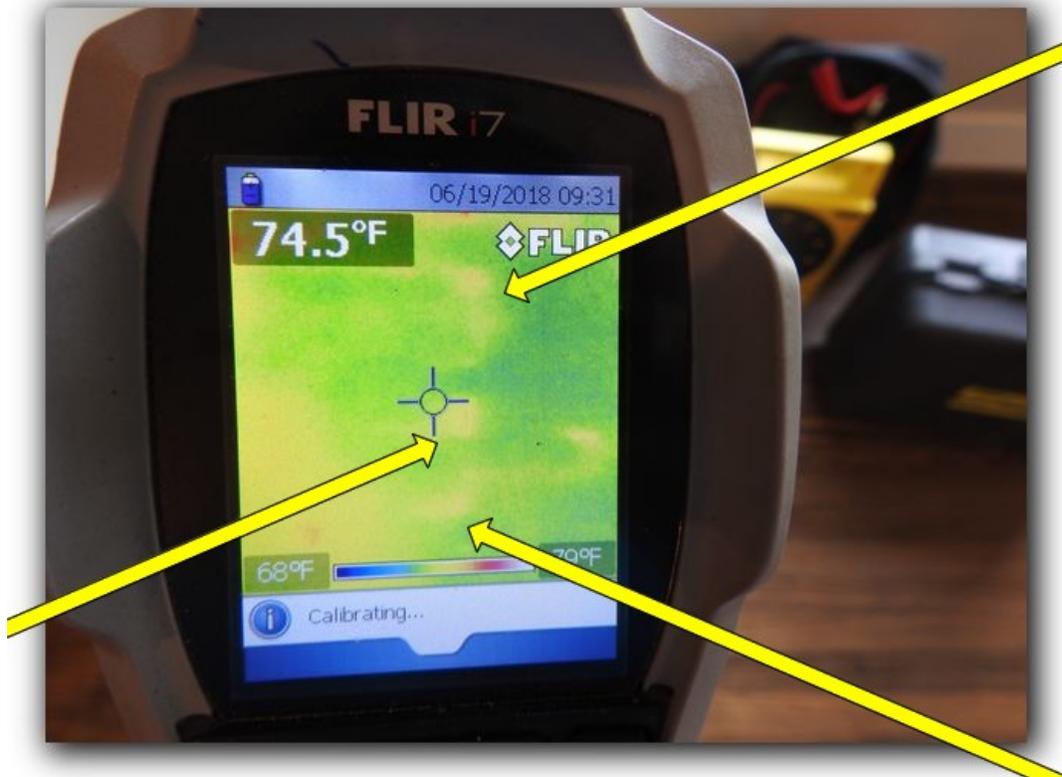
- **SOME FLOORING HAS GAPS AND OPENINGS AT THE FLOOR AND BASE BOARD INTERSECTIONS THAT HAVE**

ALLOWED DRAFTS FROM OUTSIDE AND WEEDS GROWING THROUGH THE GAPS AND NEED TO BE REPAIRED AND PROPERLY SEALED OFF. THERE IS SOME GAPS IN THE BATHROOM FLOORING AND BASE BOARDS THAT NEEDS CALKING AND AT SOME DOOR FRAME AND THRESHOLD LOCATIONS.

- **INFRARED CAMERA DID SHOW SOME DEFICIENCIES IN THE SUB FLOORING AND DRAFTS FROM DAMAGED SUB FLOORING IN THE DEN LOCATION.**

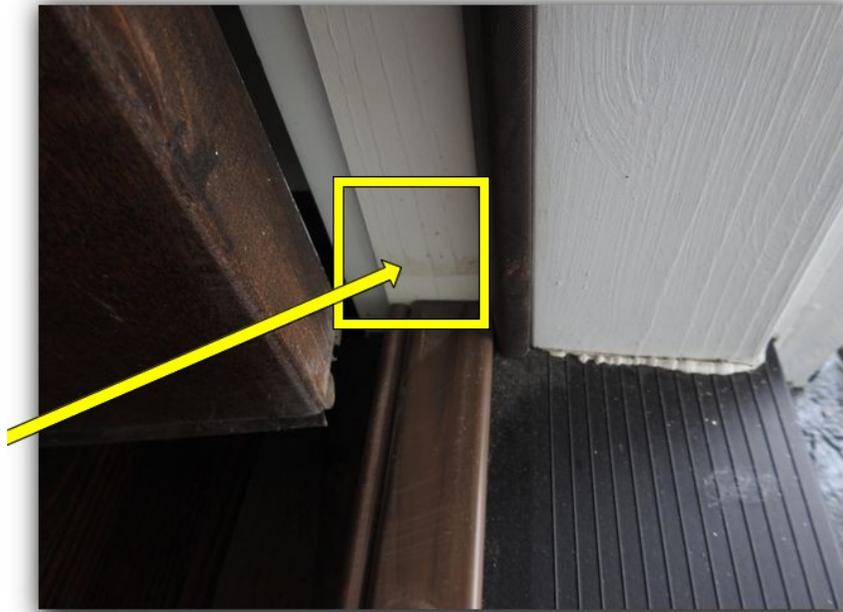
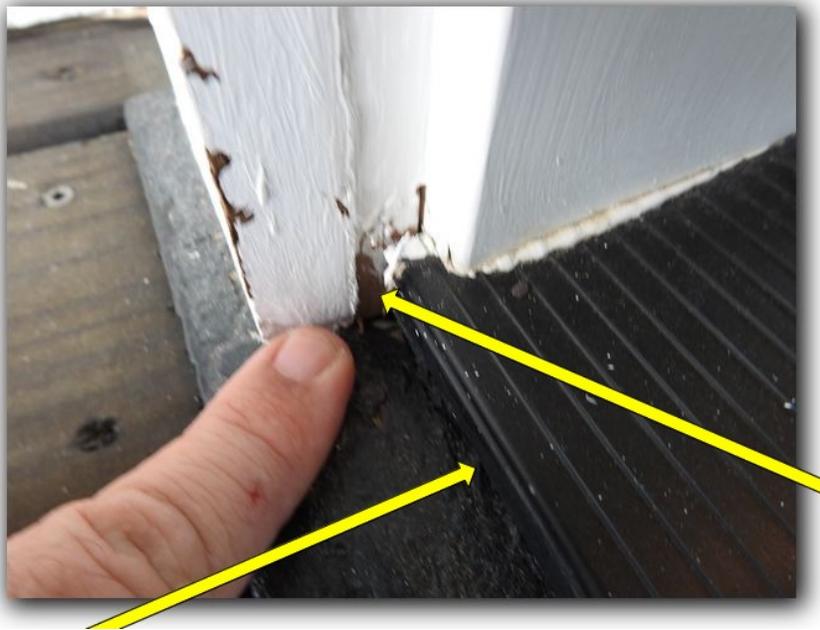
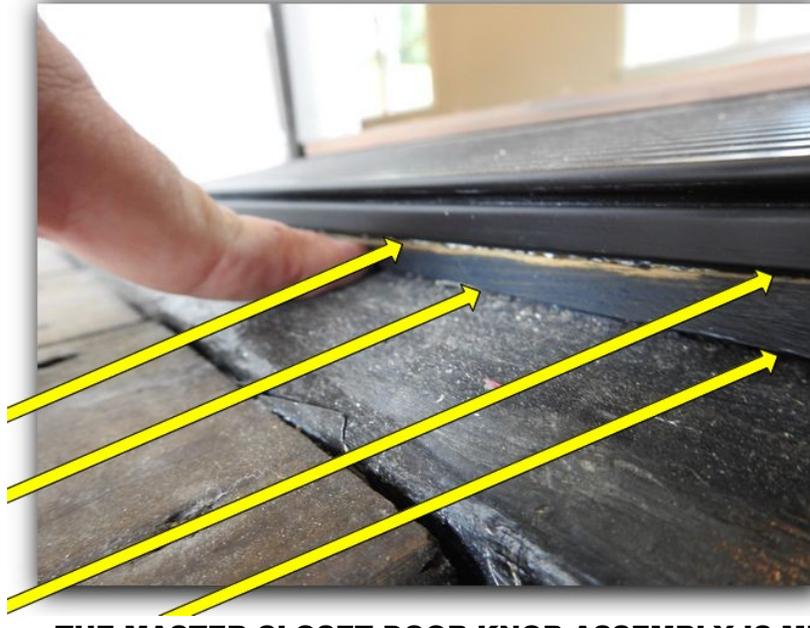
- **THE BOTTOM OF THE EXTERIOR DOOR FRAMES AT THE LOWER JAMBS NEEDS TO HAVE SMALL SQUARE FOAM RUBBER WEATHER STRIPS THAT DO PREVENT THE INSIDE JAMB FROM BECOMING ROTTED FROM WATER PENETRATIONS**
- **CALKING NEEDED AT THE EXTERIOR DOOR FRAME TRIM/THRESHOLD/FLOOR PLATE AND TRIM**

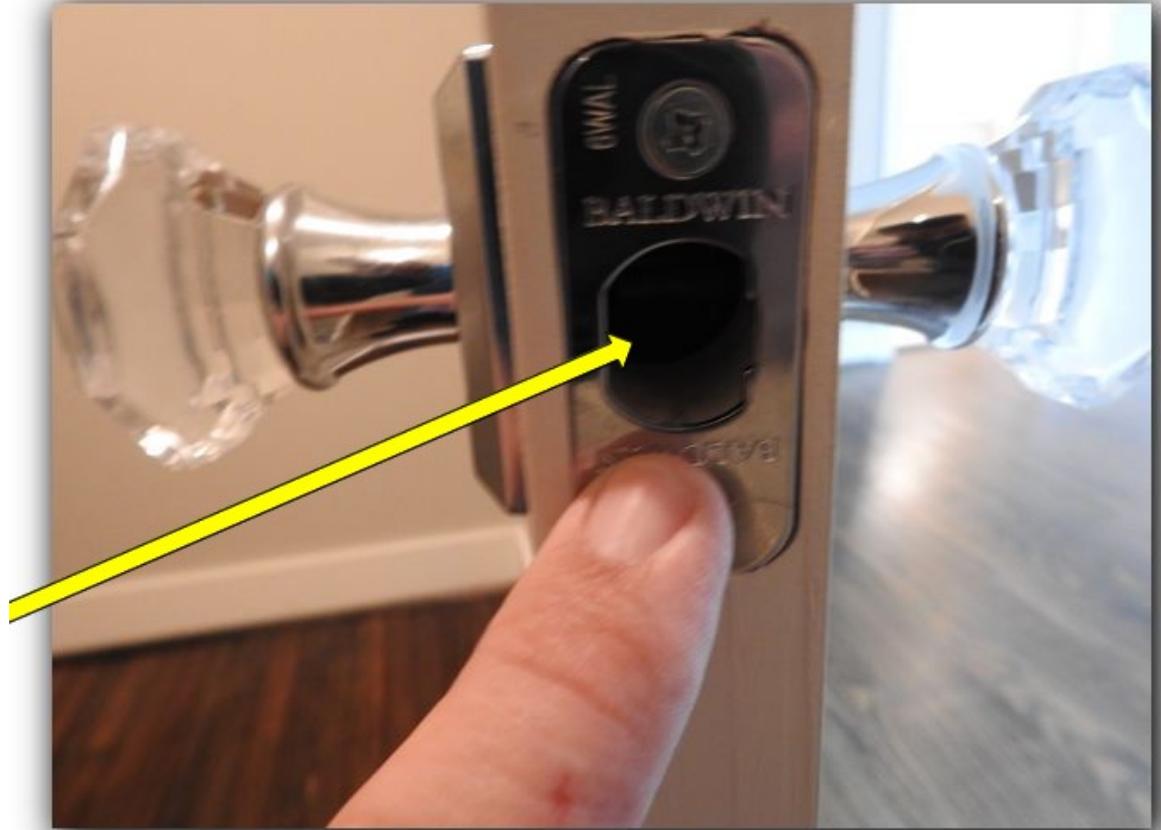
- **THE MASTER CLOSET DOOR KNOB ASSEMBLY IS MISSING A LATCH THAT NEEDS TO BE INSTALLED**

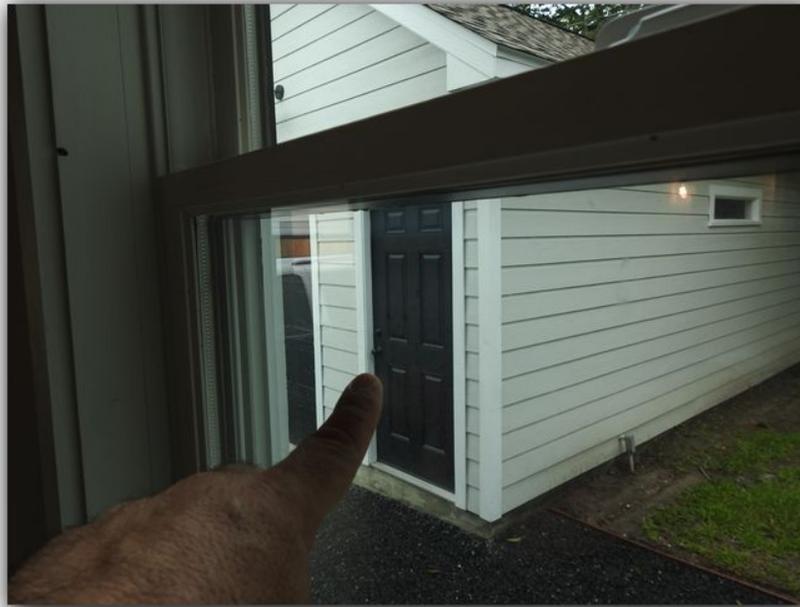
- Thermal pane window seals have failed, moisture is present**
- There appears to be a broken seal with a foggy appearance on the master bedroom window on the back right side that may require replacement on the lower sash of the double hung window. recommend evaluation by a window repair expert.**

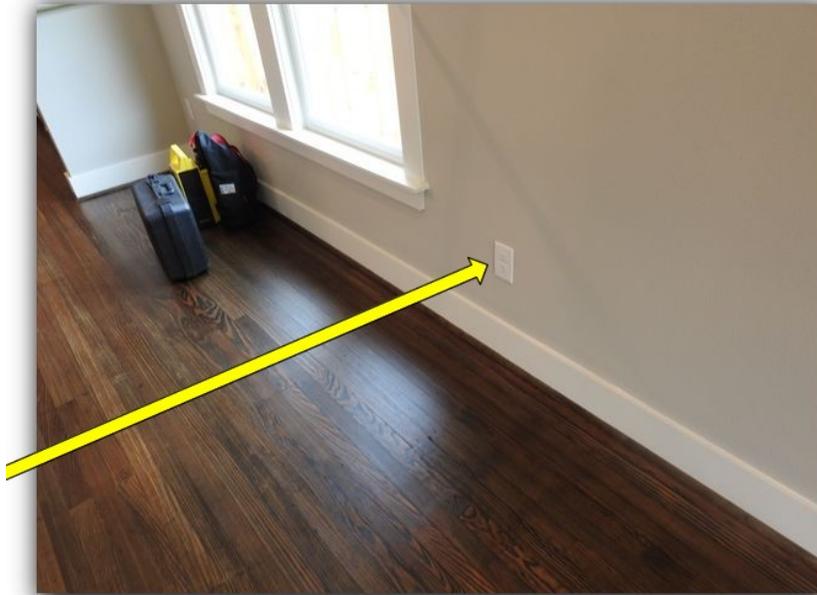
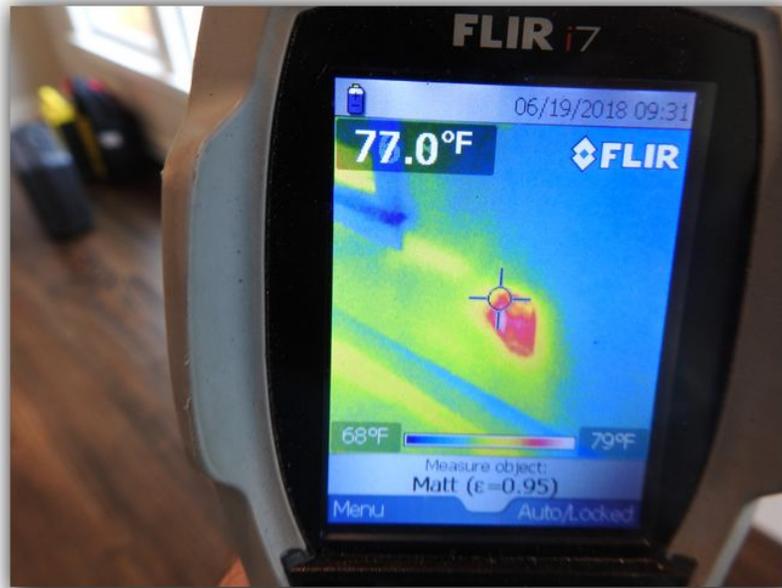
**•INFRARED CAMERA DID SHOW ONE OUTLET IN THE DEN WITH EXCESSIVE HEAT;
RECOMMEND EVALUATION BY AN ELECTRICIAN**

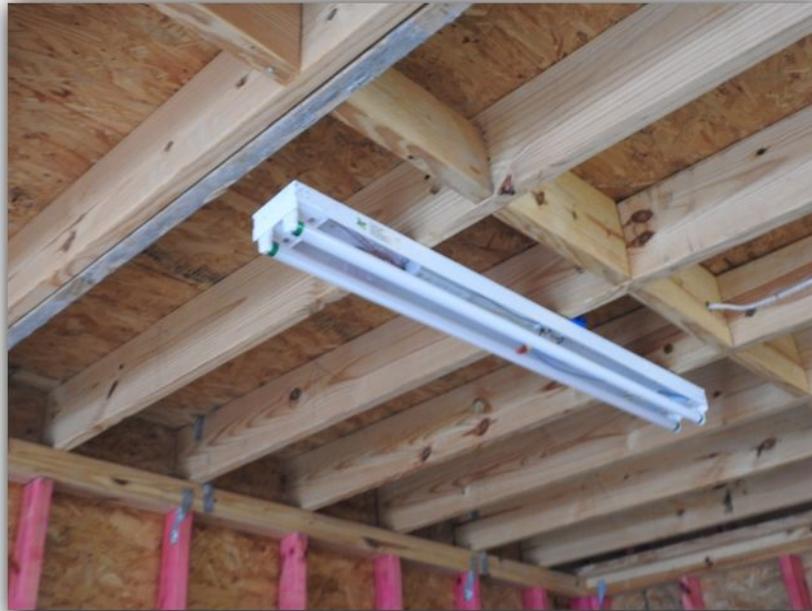
- **ONE FLORESCENT LIGHT IS OUT IN THE GARAGE THAT NEEDS TO BE REPAIRED.**

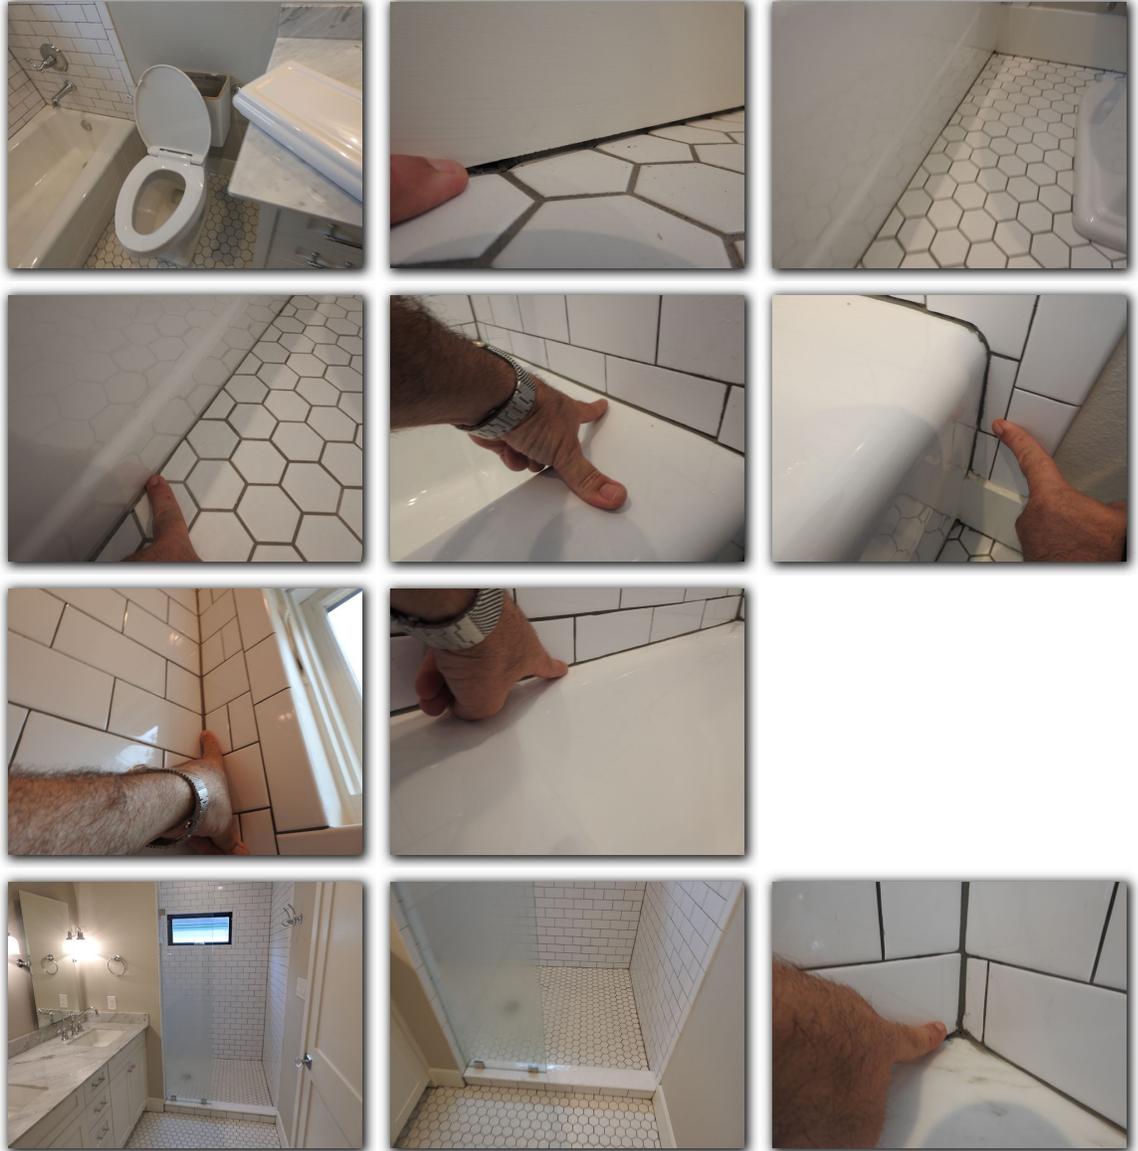
Caulking or grout missing or damaged in the corners of the tile enclosures

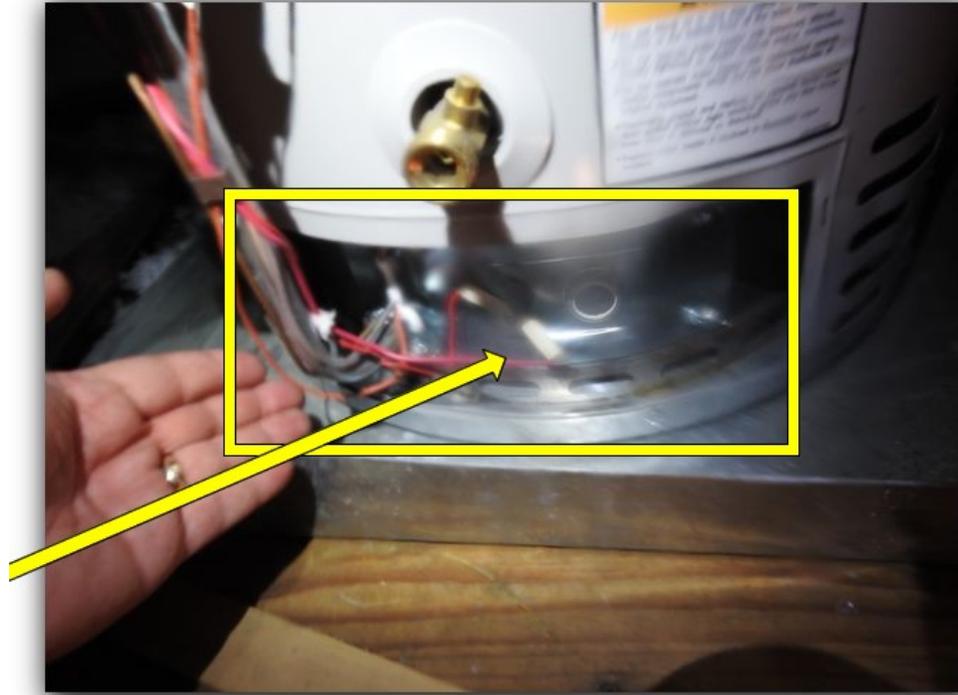
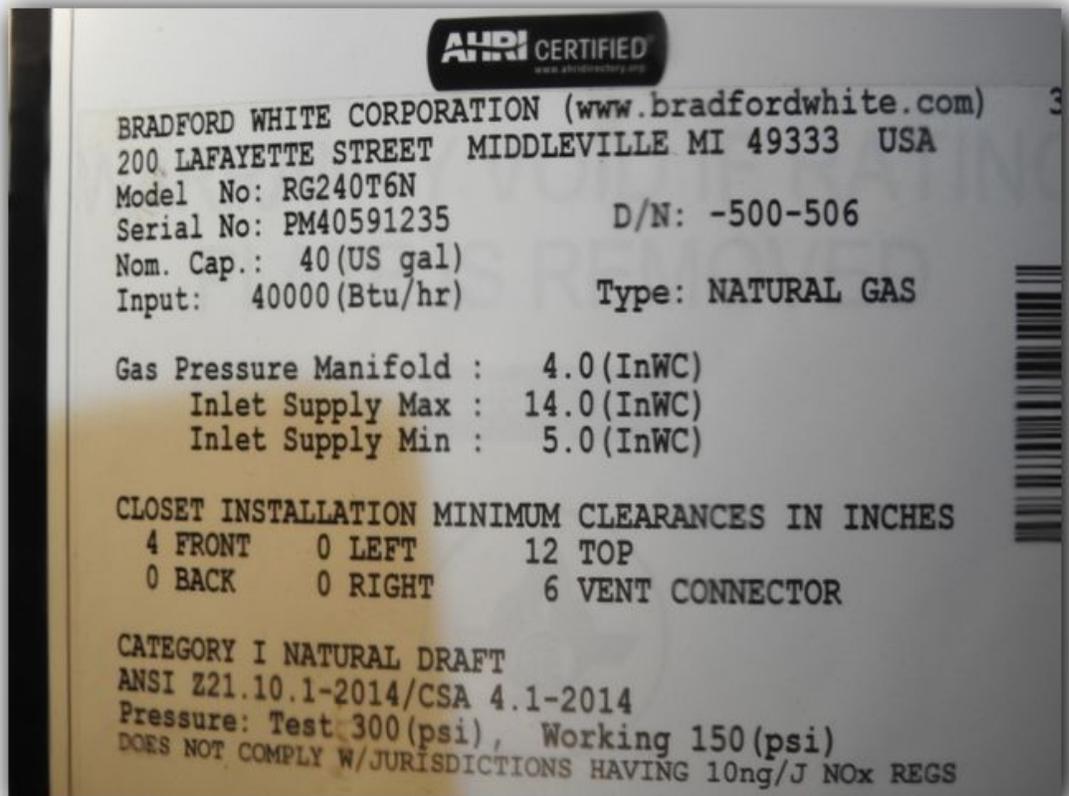
- **MISSING FLAME PLATE THAT NEEDS TO BE REPLACED**

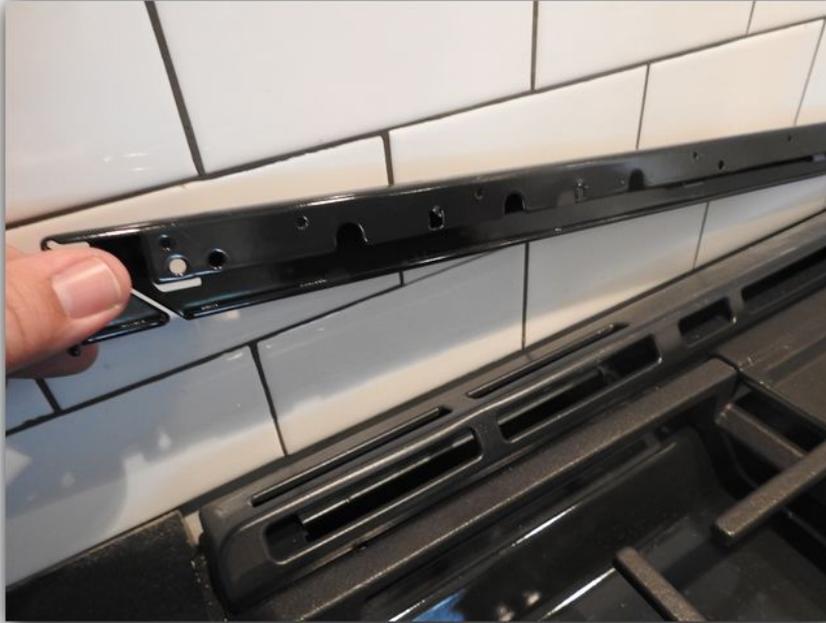
- **LOOSE TRIM PIECE ON THE BACK OF THE OVEN/RANGE THAT NEEDS REPAIRS**
