**603 Park Knoll Ln
Katy, TX 77450-2505**

COMPREHENSIVE HOME INSPECTION REPORT

603 Park Knoll Ln
Katy TX 77450

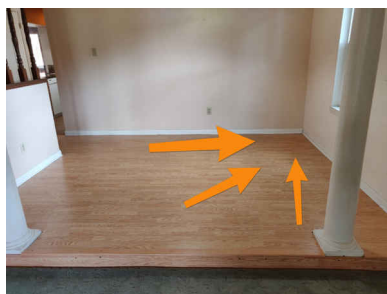
Dining area

Areas of the interior floors did not appear to be level and were an indication of movement. Settlement or other defects in need of repair. The cause of un-level or sloping floors should be determined and repaired as needed.

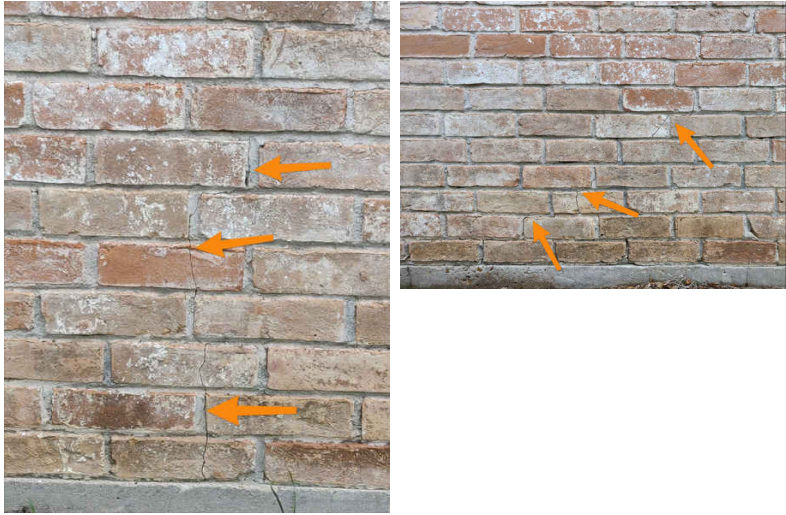
2: Cracks in exterior walls - indication of structural defect

Cracks in exterior walls were an indication of movement, settlement or other defects (See Exterior Walls).

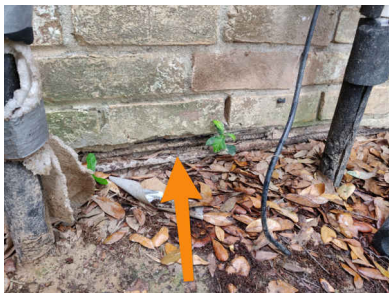
3: Exposed metal reinforcement

Exposed or damaged metal foundation reinforcement components were observed which may lead to additional foundation deterioration and adverse foundation performance. This condition should be repaired as needed by a foundation specialist.

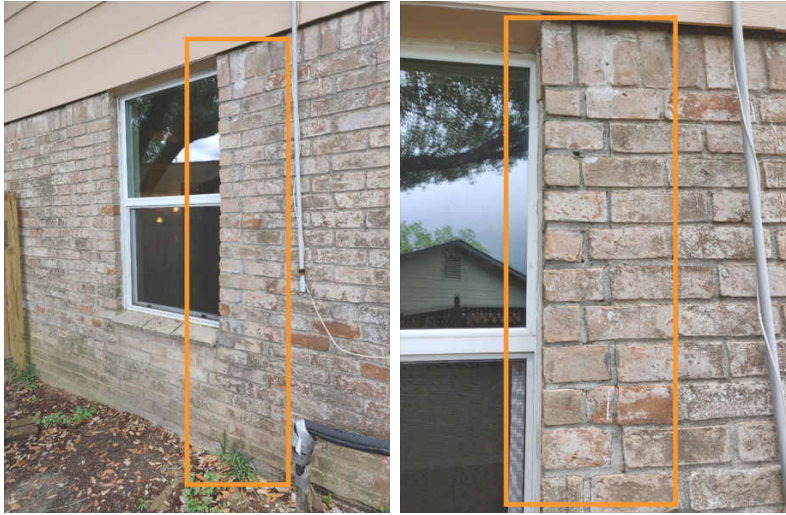
5: Ext brick walls - previous repairs

Observed previous repairs at exterior brick veneer walls. The repaired cracks appeared to be structural type cracks resulting from foundation settlement or movement. Recommend further evaluation and repair.

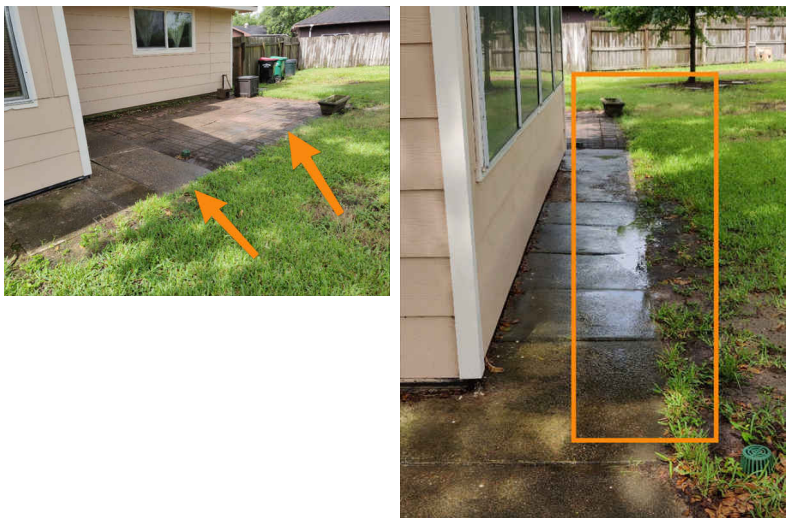
2: Grading and drainage - further evaluation recommended

Observed low point of the backyard along edge of patio and softscape area which may cause ponding of water on the patio area during rain. Recommend further evaluation and repair.

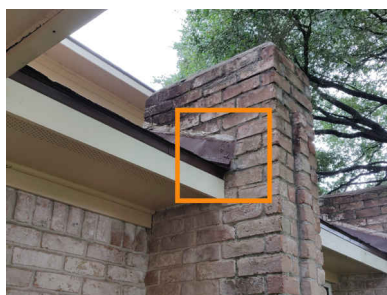
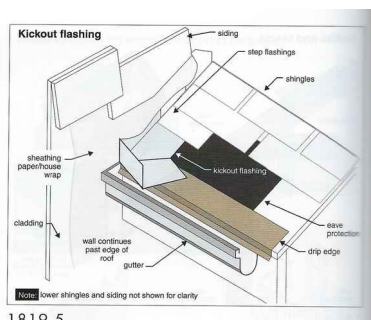
As per current requirement, a kick-out flashing is required at edge of the roof terminating against wall. Kick-out flashing helps divert rain water away from the wall. Recommend incorporating kick-out flashing to prevent or reduce damage. Observed some previous repairs done to the damaged caused by lack of kick-out flashing. Observed water damage at exterior wall, fascia and soffit due to lack of kick out flashing.

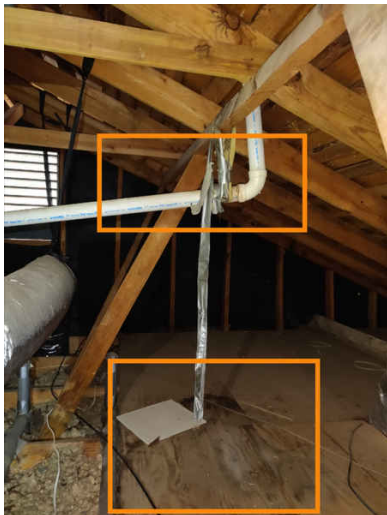
Observed evidence of previous leak from plumbing jack penetration. The area was not observed to be wet at the time of inspection despite of rain during the inspection. The observed area appears to be water damaged from a previous leak which maybe repaired by now. Recommend further evaluation and repair.

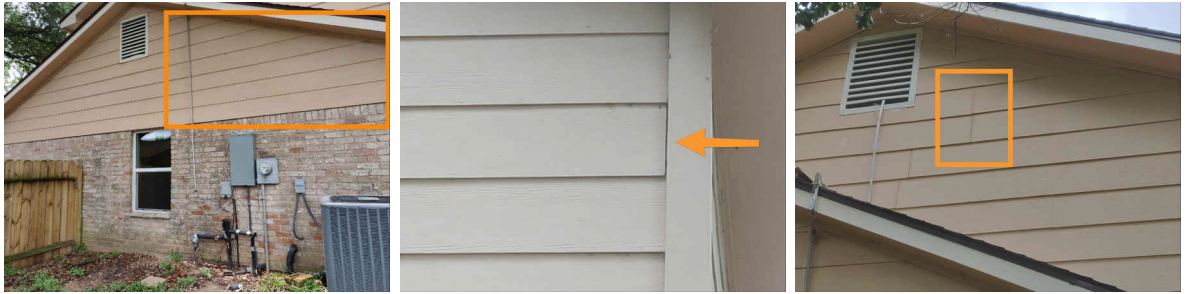
Observed several cement board siding panels with uneven gaps, and observed siding boards coming loose from fasteners which is an indication that structural movement has occurred. Recommend further evaluation and repair as needed.

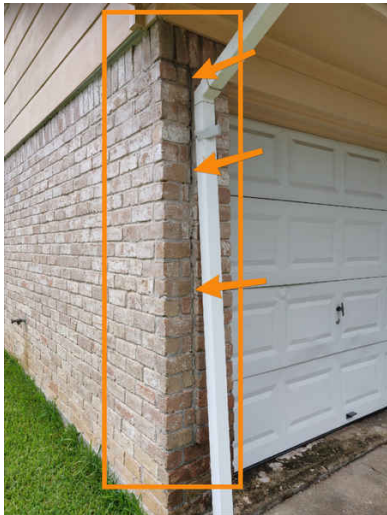
3: Contraction cracks in exterior walls

Expansion and contraction cracks (thermal cracks) in the exterior brick/stone veneer masonry walls were observed. Observed several of those cracks previously repaired, but reopened or not properly sealed. Expansion and contraction cracks in the exterior brick/stone veneer masonry walls should be repaired and closely monitored for indications of structural movement. If concerns about the current or future foundation performance exist, the inspector recommends further evaluation by a certified, licensed foundation specialist.

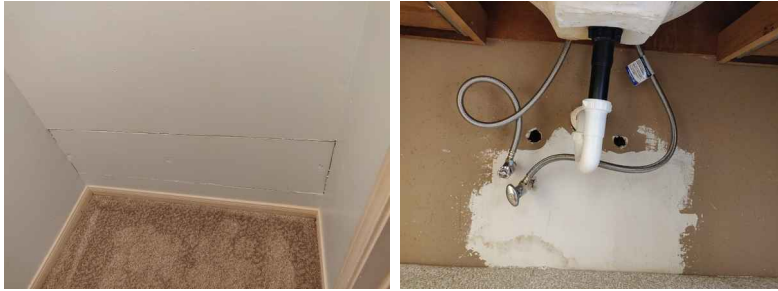
Drywall, texture and paint were observed to be in need of repair.

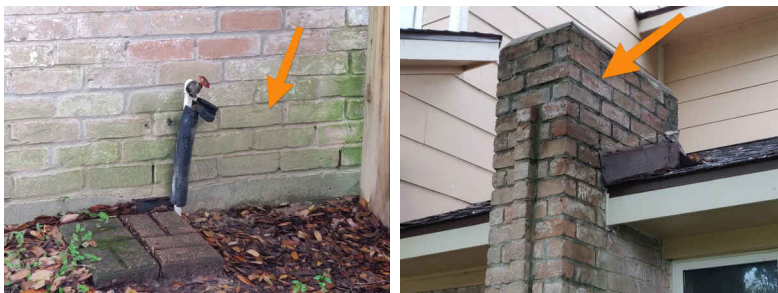
6: Discoloration at brick veneer

Observed discoloration at brick veneer which appears to be due to prolonged presence of moisture causing growth of algae or other deterioration. Recommend further evaluation and repair.

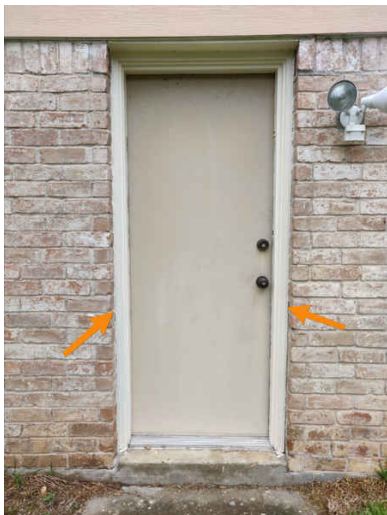
7: Exterior sealants (caulking) deteriorated

Exterior sealants (caulking) were deteriorated or missing in some areas. Sealants applied in appropriate locations prevents moisture intrusion and insect penetration. Recommended locations are: around window openings, door openings, wall penetrations, between brick and siding/trim, between stone and siding/trim.

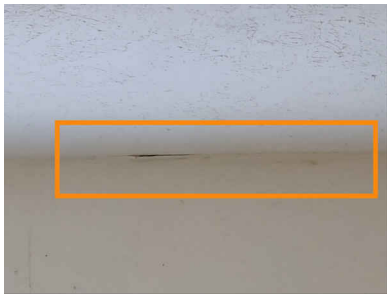
Interior drywall corner tape was observed to be pulling and twisting where walls and or ceilings intersect. This condition is related to adverse foundation or structural performance and should be further evaluated by a foundation or structural specialist and repaired as necessary.

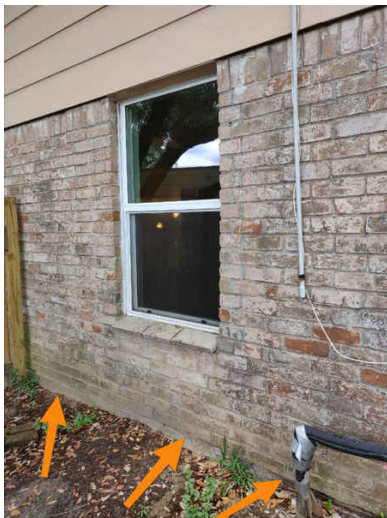
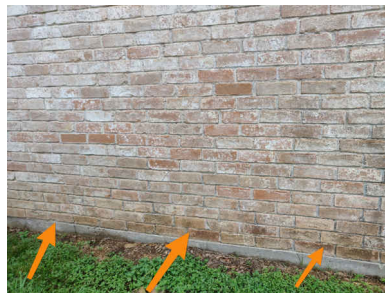
11: Weep holes - sealed

Weep holes were sealed (not open) at the lower brick/stone of the exterior walls and/or above window headers. Weep holes should always be open for adequate drainage and ventilation.

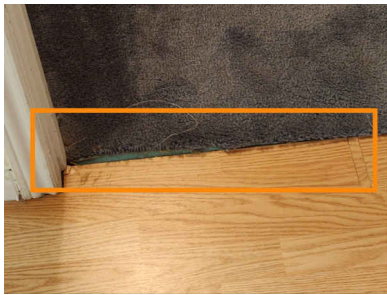
Missing, loose or damaged floor covering transition strips should be repaired to avoid additional damage and trip hazards.

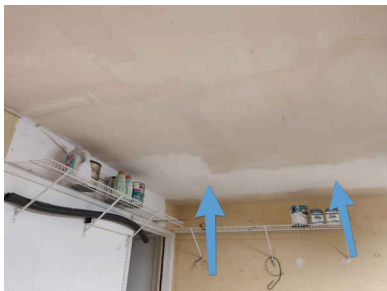
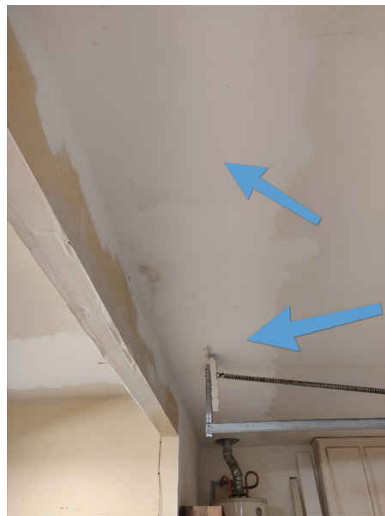
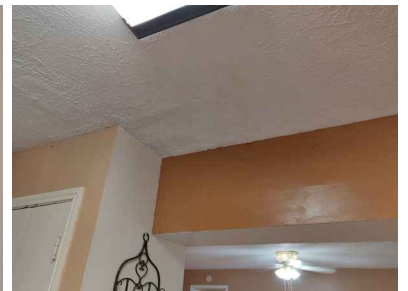
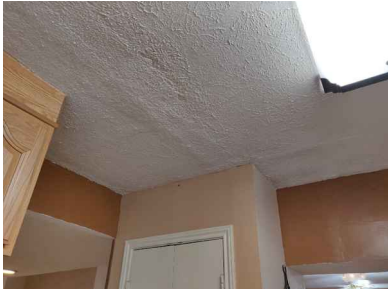
5: Previous repairs observed

Observed several previous repairs done at ceiling at garage and interior space. The observed repairs appear to be due to structural cracks at drywall ceiling as well as plumbing repair or replacement. Recommend further evaluation and repair.

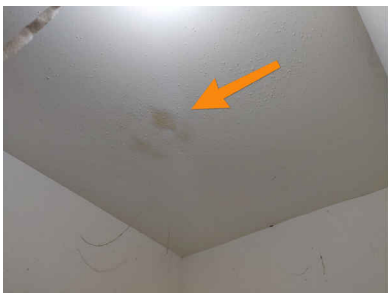
6: Water stain at ceiling

Water stains or water damage was observed at the ceiling drywall, texture and paint. The cause of the water staining or water damage should be determined and repaired as needed.

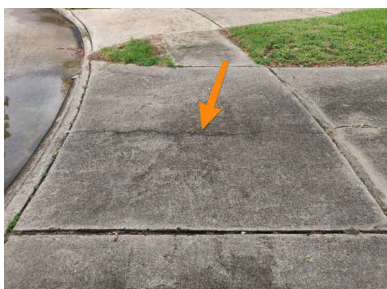
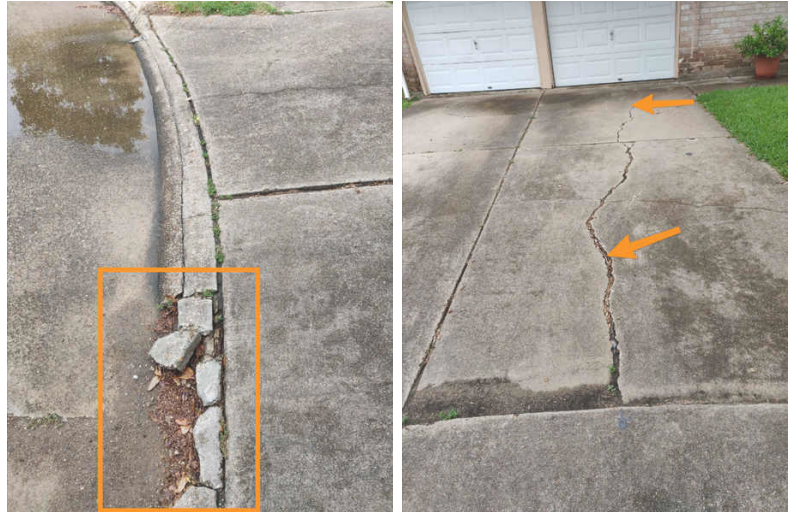
Observed cracks in poured concrete at garage floor and driveway. Recommend further evaluation and repair as needed.

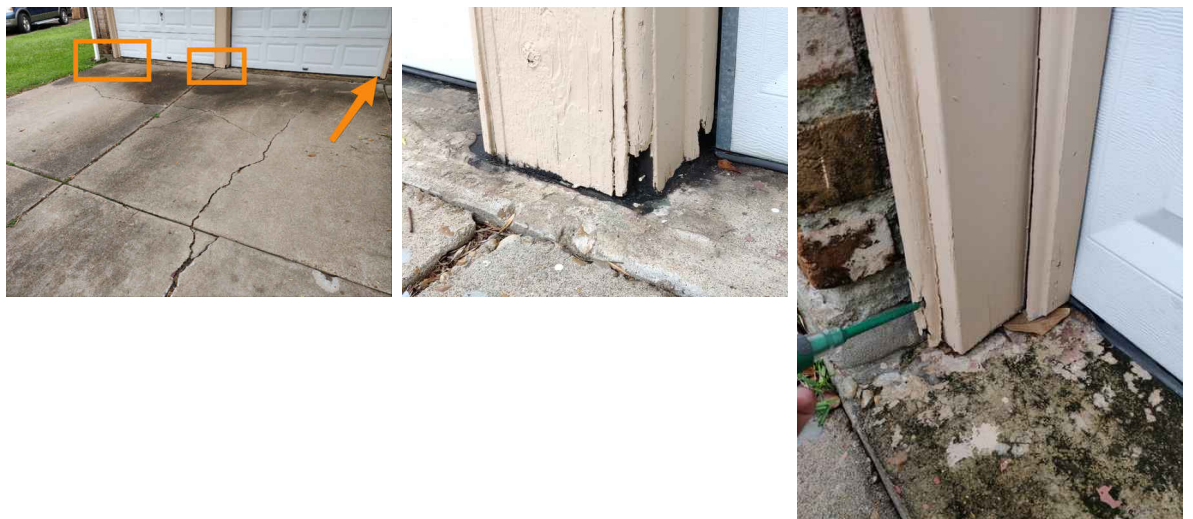
Observed wood rot at several wood trim materials, e.g. garage vehicle door trims.

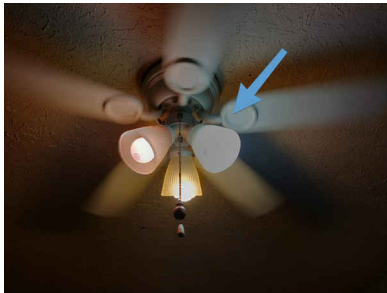
Observed missing or burnt out light bulbs.

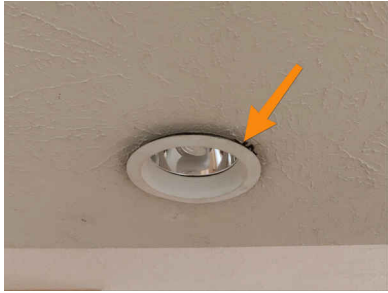
Observed ceiling light fixture deficient and in need of repair.

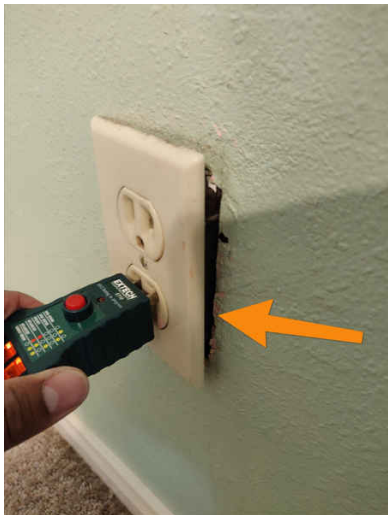
9: Receptacle loose at wall

Observed receptacle loose at wall. Recommend repair.

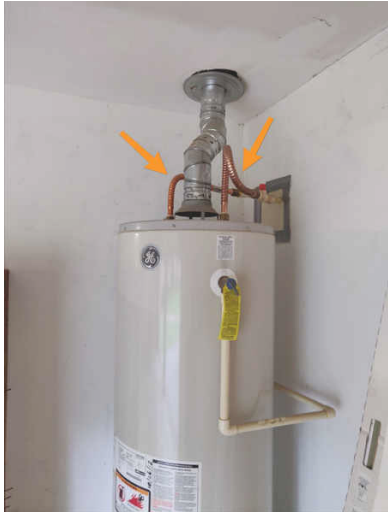
Observed lack of insulation at water lines to and from water heater. Recommend repair.

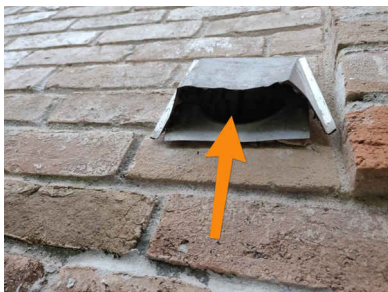
The dryer exterior wall vent cover was loose, damaged or missing and was in need of repair or replacement. Loose, damaged or missing exterior dryer vent wall covers may allow moisture, insect and unwanted wildlife intrusion.
