Lone Star Stucco, LLC

Moisture Assessment Report

2714 Newman Street

4/5/2017

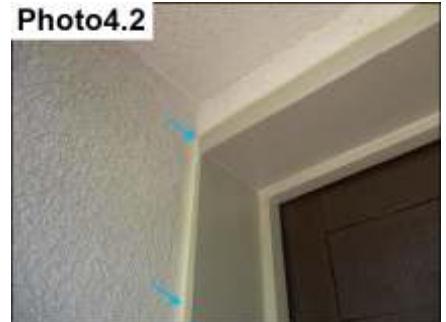
- Door trim sealants are noted. The inspector states that this is a positive detail and suggests to maintain all sealants in an effort to prevent moisture intrusion. Please refer to photos #4.2, #4.3 and #4.4 for more detail.

Door Trim Sealants/ Maintain

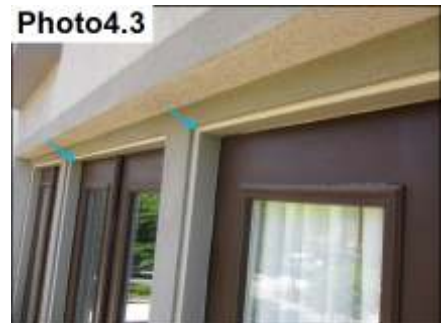
Door Trim Sealants/ Maintain

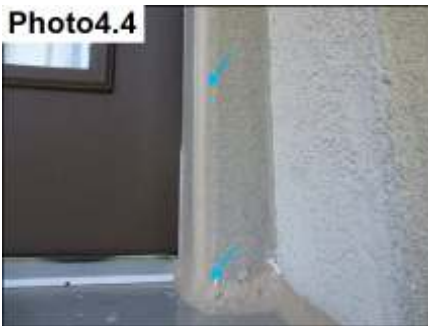
Door Trim Sealants/ Maintain

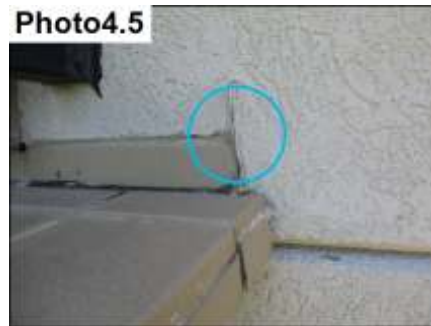
- Balcony flashing sealants are separated. The inspector suggests to touch up or seal as needed in an effort to prevent moisture intrusion. Please refer to photos #4.5 and #4.6 for more detail.

Balcony Flashing Sealants/ Seal

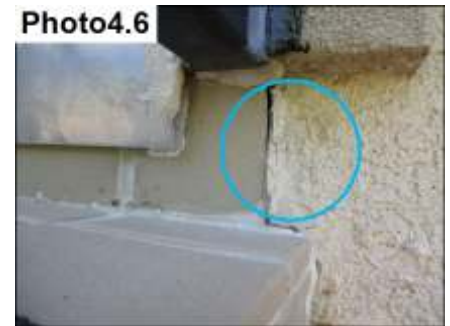
Balcony Flashing Sealants/ Seal

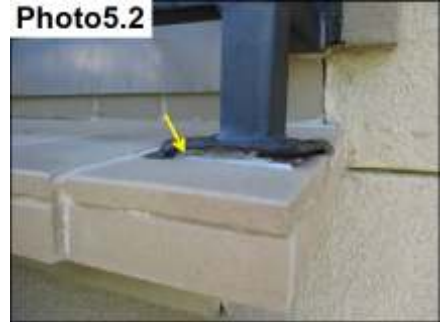
Photo5.2

- Penetration sealants are separated in several areas. The inspector suggests to seal these areas in an effort to prevent moisture intrusion. Please refer to photo #5.2 for more detail.

Penetration Sealants/ Seal

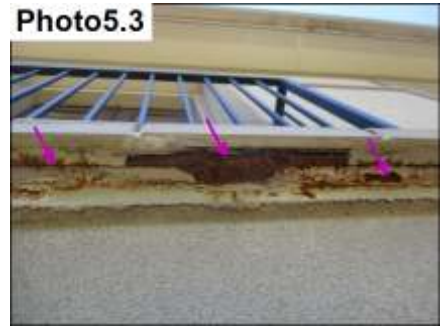
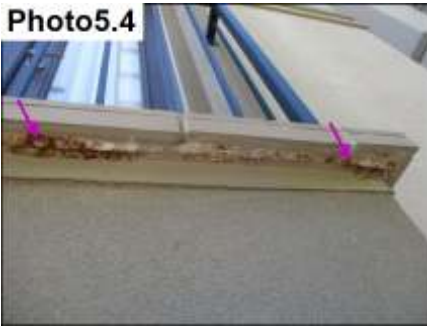
- Rust stains are noted in this area, the inspector suggests to clean with a wire brush and then paint as needed. Please refer to photos #5.3, #5.4 and #8.6 for more detail.

Rust Stains/ Clean And Paint

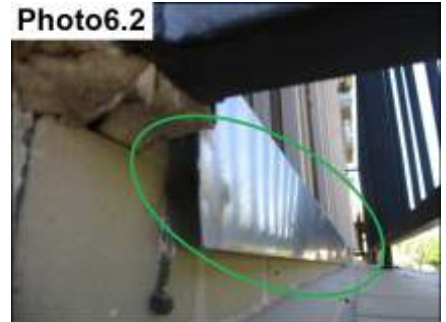
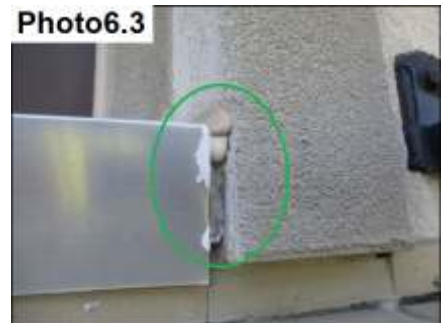
- The door trim/threshold termination sealants are separated. The inspector suggests to seal all terminations in an effort to prevent moisture intrusion. Please refer to photos #6.2 and #6.3 for more detail.

Door Trim/Threshold Sealants/ Seal

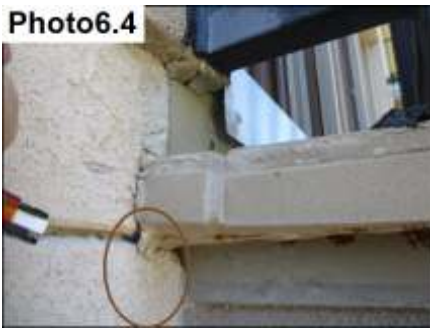
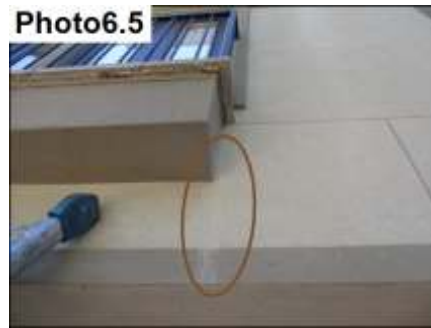
- Efflorescence has been noted in this area of the home. This is when a naturally occurring salt migrates to the surface of the system causing a coating. The inspector suggests to consult with a stucco contractor to treat this area with commercial cleaners or contact the system manufacturer for the best explanation of removal. Please refer to photos #6.4 and #6.5 for more detail.

Efflorescence Noted

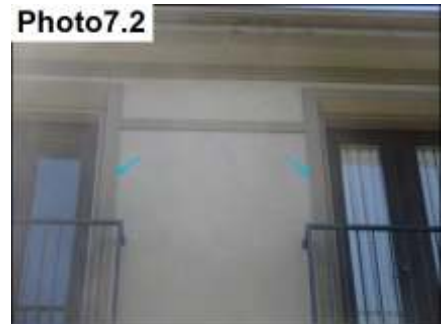
- Note the different color sealant used on the third floor right door. The inspector suggests to change the sealants in an effort to match the rest of the home. Please refer to photo #7.2 for more detail.

Photo7.2
Different Color Sealants/ Touch Up

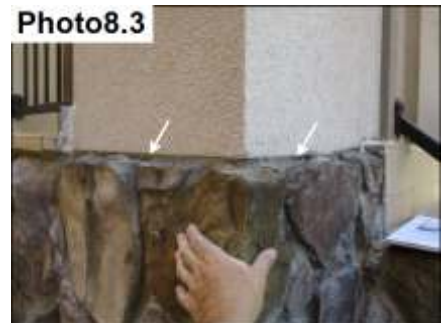
- The stone/stucco termination sealants are missing flex caulk. The inspector suggests to clean out the grout and seal all stone/stucco terminations with NP1 or like sealant in an effort to prevent moisture intrusion. Please refer to photo #8.3 for more detail.

Stone/Stucco Termination Sealants/ Seal

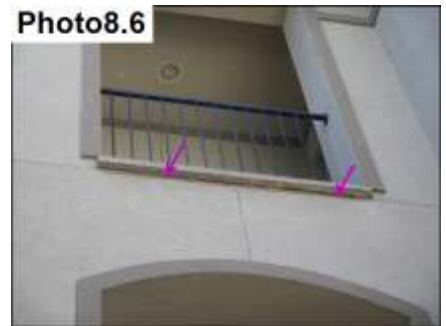
Rust Stains/ Clean And Paint

Purple Arrow	Rust Stains			Rust stains are noted in this area, the inspector suggests to clean with a wire brush and then paint as needed. Please refer to photo #8.6 for more detail.
E4	Window Lower Right	17%	Firm	A moisture probe was made below the third floor window right. The substrate was firm with no damage noted at this time.

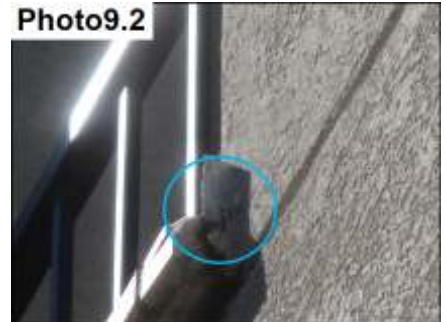
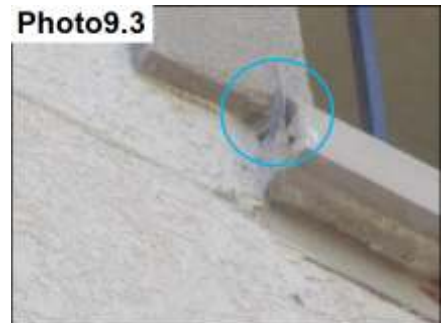
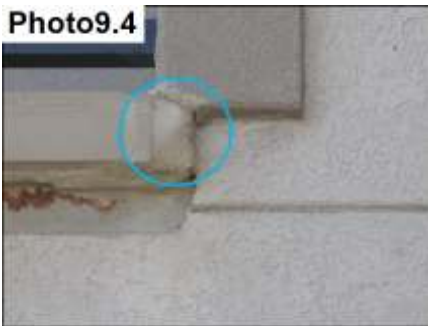
- Balcony flashing sealants are aged or separated. The inspector suggests to touch up or seal as needed in an effort to prevent moisture intrusion. Please refer to photos #9.2, #9.3 and #9.4 for more detail.

Balcony Flashing Sealants/ Seal

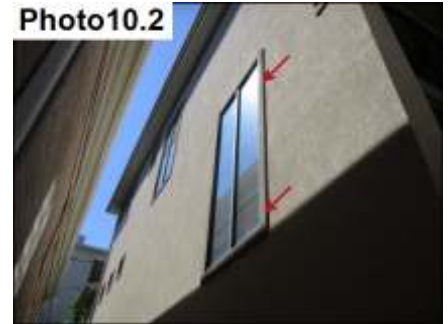
Photo10.2

- Window trim sealants are separated in several areas. The inspector suggests to touch up or seal these areas in an effort to prevent moisture intrusion. Please refer to photo #10.2, #13.1 and #14.1 for more detail.

Window Trim Sealants/ Seal

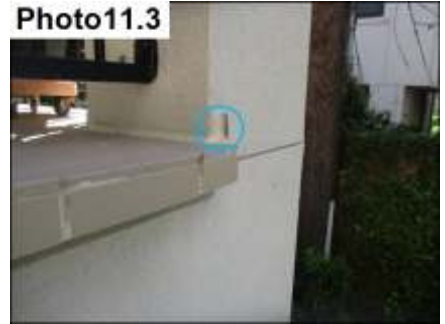
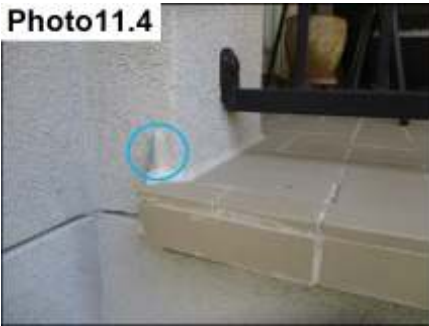
- Balcony flashing sealants are proper. The inspector states that this is a positive detail and suggests to maintain to all sealants in an effort to prevent moisture intrusion.. Please refer to photos #11.3 and #11.4 for more detail.

Balcony Flashing Sealants/ Seal

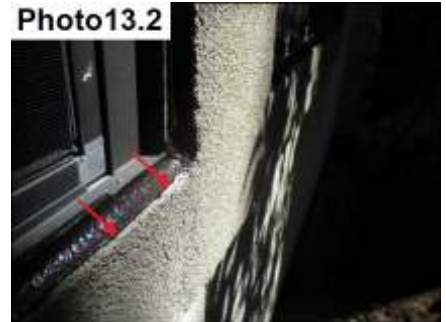
- Window sealants are noted. The inspector states that this is a positive detail and suggests to maintain all sealants in an effort to prevent moisture intrusion. Please refer to photo #13.2 for more detail.

Window Sealants/ Maintain
