Project No. 27120

November 18, 2020

Re: Foundation Evaluation
5505 Mesquite Grove Road
Austin, TX 78744

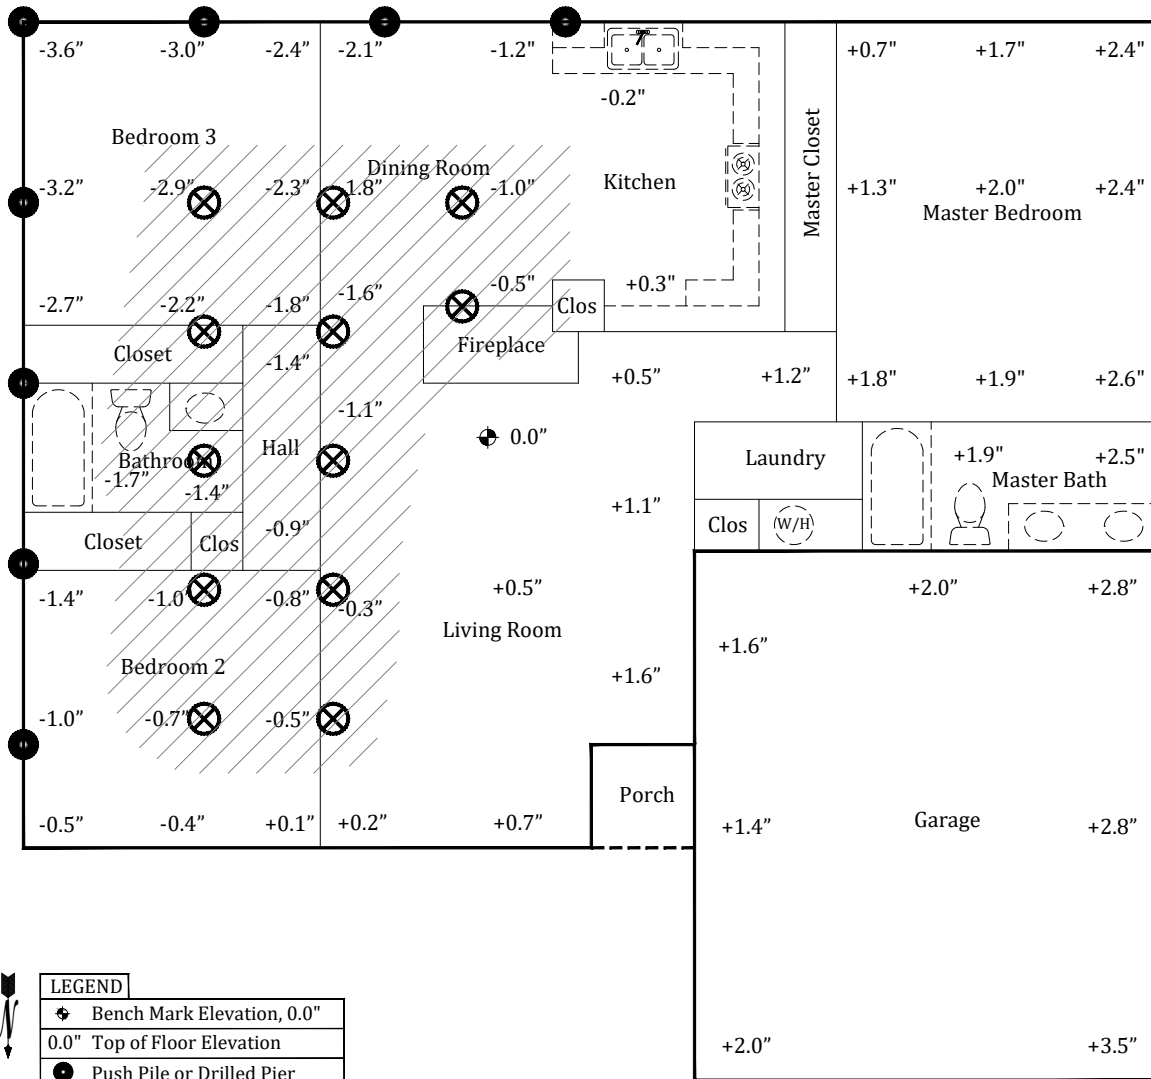
FIGURE 1

An interior floor elevation survey was performed on the living area of the house, with the elevations recorded to the nearest 10th of an inch (0.1”). Adjustments were made to account for the thickness of the floor coverings. The elevations within the garage were recorded from the ceiling, as the slab slopes to the garage door. A benchmark elevation of 0.0 inches was established near the south wall of the living room, as shown in Figure 1 of this report.

Based on our observations of the interior and exterior cosmetic distress, the floor elevations and calculations, it is our opinion that the house has undergone a permissible amount of movement. The maximum differential deflection is 0.5 inches and occurred over an approximate distance of 19.8 feet. This amount of deflection is within the standard allowable deflection of 0.7 inches for a distance of 19.8 feet. The standard allowable differential deflection is based on 1.0 inch of vertical movement, up or down, over a horizontal distance of 30 feet; expressed as Length (in inches)/ 360.

The foundation has also experienced an excessive amount of tilt. The maximum tilt measured across the foundation is 6.0 inches over an approximate distance of 41.0 feet. This amount of tilt exceeds the standard allowable tilt of 4.9 inches for a distance of 41.0 feet. The standard allowable tilt is based on 1% slope over the entire length, width, or diagonal of the foundation.

- 1) To stabilize and lift the perimeter foundation wall, install (8) perimeter and (12) interior piles or drilled piers as shown on Figure 1 of this report. The piles can be concrete cylinders, steel pipe, or helical screws. Refer to Figures 2, 3, 4, and 5 of this report. Space the piles or drilled piers along the perimeter foundation at a maximum of 7 feet on-center and within the interior at a maximum of 5 feet on-center. The number of interior piers may be reduced if the interior grade beams are located prior to pier installation. The interior piers may be placed at the interior grade beam intersections and along the grade beam at a maximum of 8-feet on center. Note, any foundation movement, even corrective movement, can cause additional cosmetic distress.
