Home Inspection Report

3117 Indiana, Baytown, TX 77520

Inspection Date:
Wednesday, December 30, 2020

Prepared For:
Bruce Cassidy

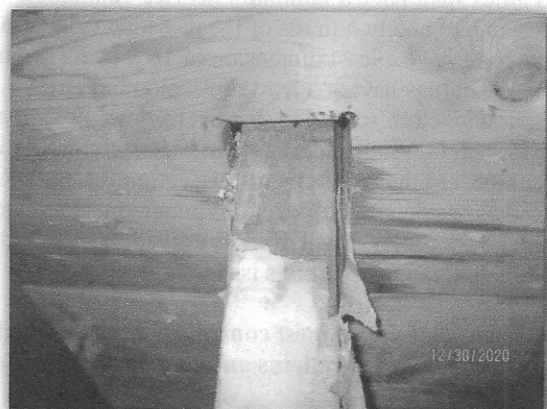
Some missing purlin supports at Various Locations. Although this does not appear to have caused any structural defects the area should be monitored for possible future repairs.

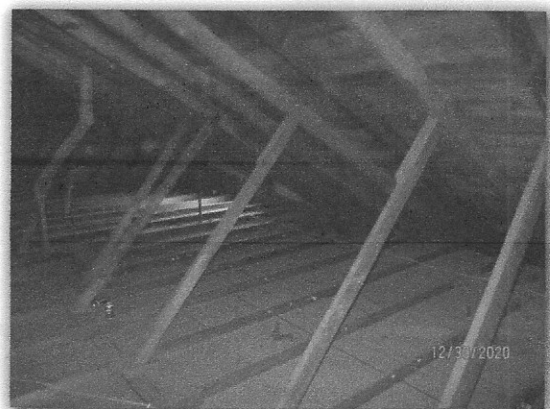
Insufficient Insulation. (9-10" Minimum Insulation depth in the attic recommended). Recommend installing blown cellulose insulation. Additional Insulation is recommended.

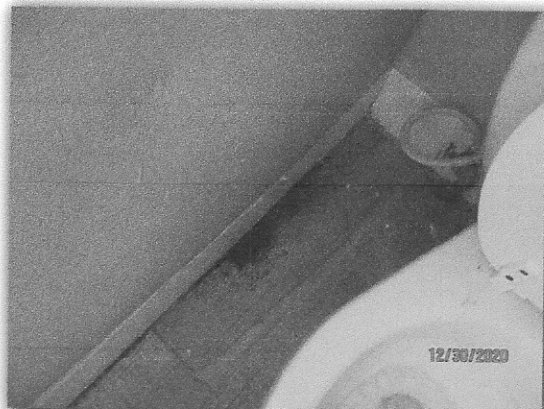
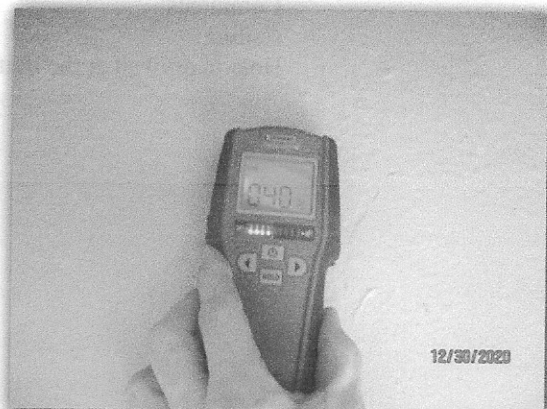
Damage wall at the East bathroom with high moisture reading. The cause of the high moisture reading should be determined and Repairs undertaken if necessary to prevent further damage to the structure.

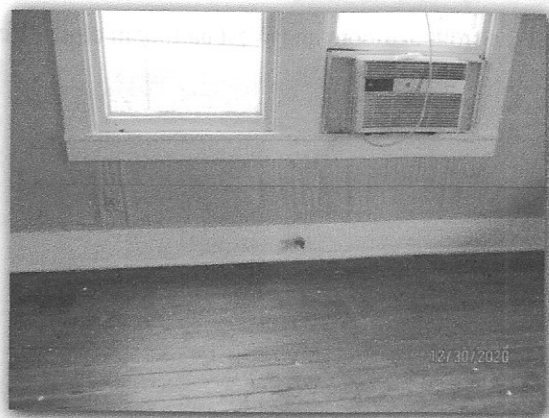
Water damage was noted at the front bedroom. The cause of the water damage should be determined and Repairs undertaken if necessary to prevent further damage to the structure.

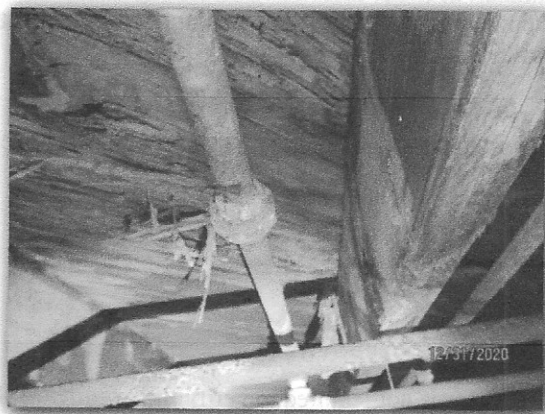
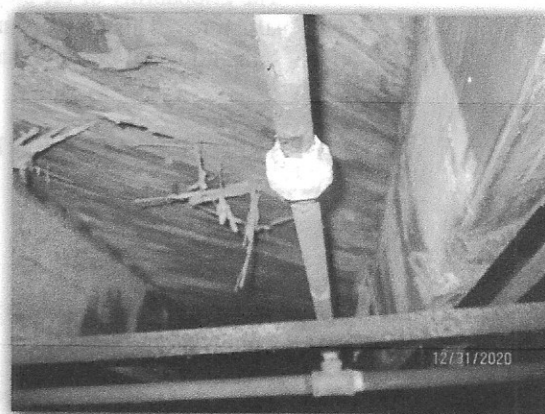
Some termite damaged sub floor/ wood flooring/trim East side. Recommend repair/replacement of the damaged flooring and further examination to determine if there is an active termite infestation or additional structural damage.

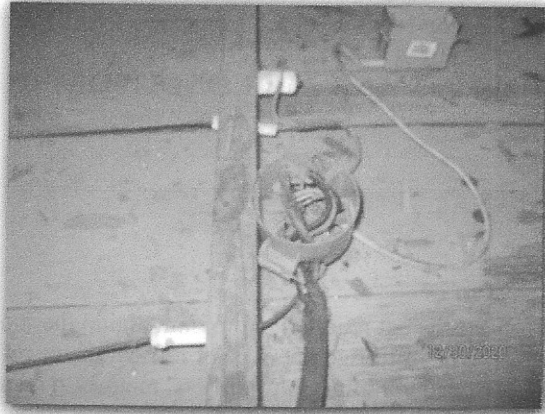
All junction boxes should be fitted with cover plates-- attic. Recommend installing missing cover plates.

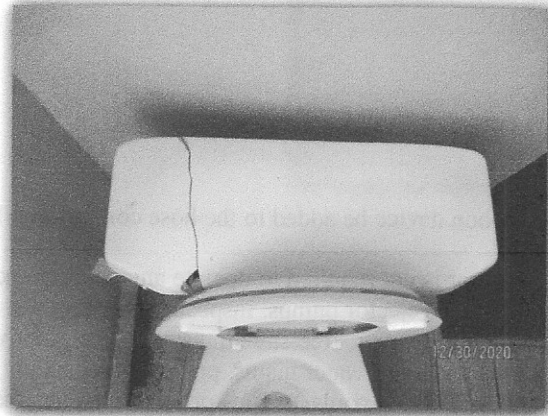
The East hall bathroom toilet lid is damaged.

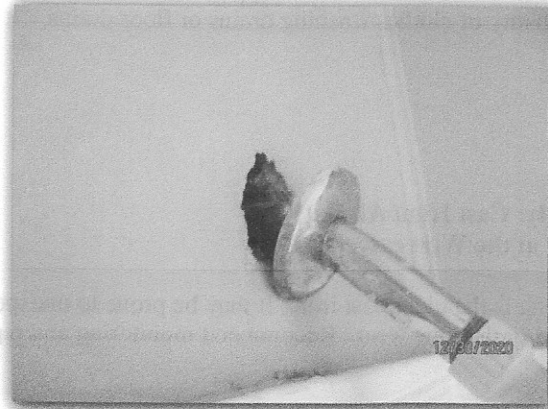
The East bathroom shower head supply line is loose and exposed. Recommend securing and sealing.

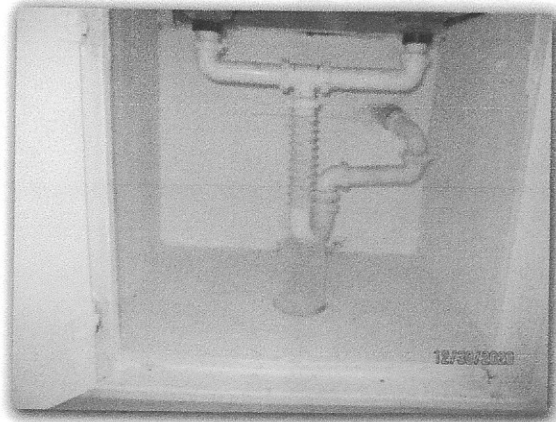
Improper repairs/materials to the drain line(s). Recommend examining the drains for improper repairs and/or materials and repairing as necessary.

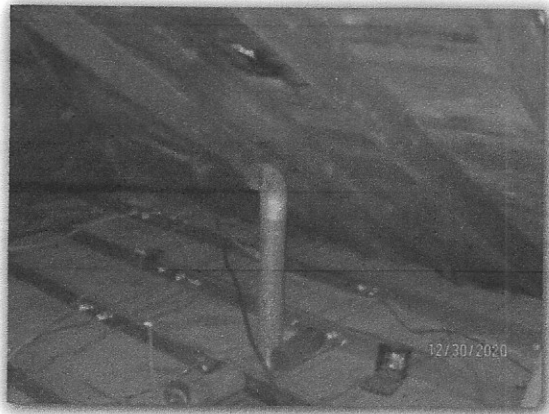
The Water heater exhaust vent pipe is discharging in the attic. The vent should be reconnected to discharge at the exterior thru the roof.

There is a single wall vent pipe connector on the water heater. This pipe cannot touch any combustible materials. Single wall vent pipe connectors should not be in confined spaces such as the attic. Recommend replacing the water heater vent pipe connector with a type B double wall vent pipe.

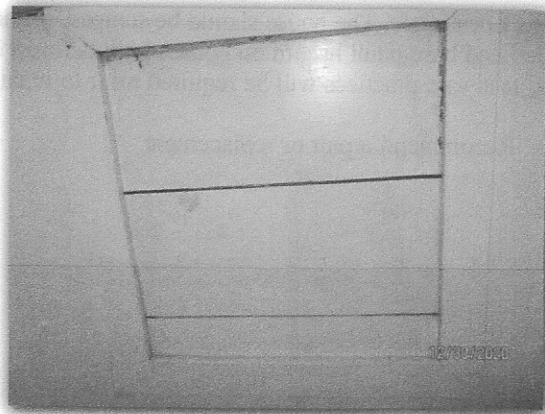
The level of ventilation should be improved. Proper ventilation will help to keep the house cooler during warm weather and may extend the life of roofing materials. installing soffit vents would help correct this issue

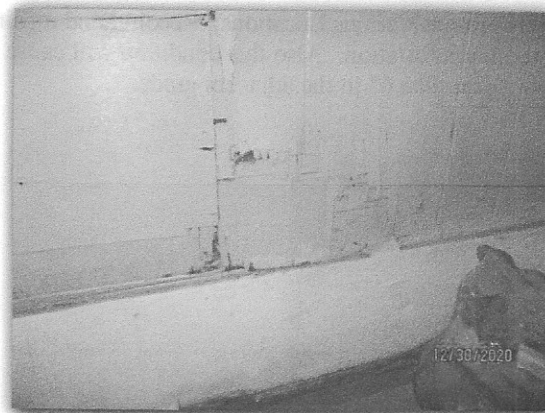
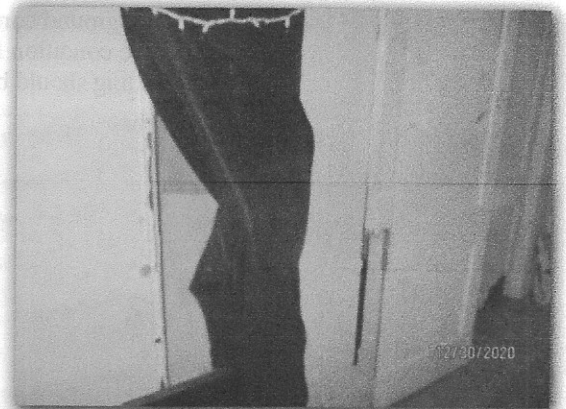
Damaged interior walls in various locations. Recommend repairs.

There is damaged siding/ trim- Various Locations Recommend repairs to prevent water penetration and damage to the structure.

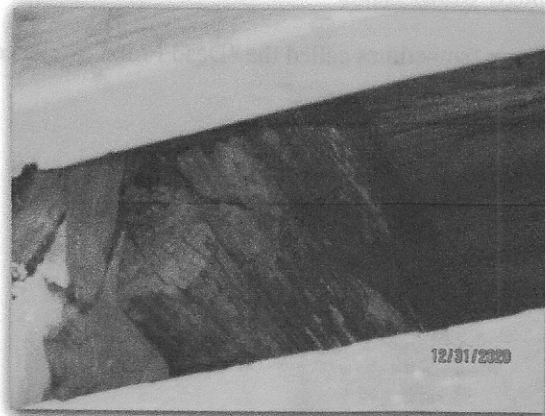
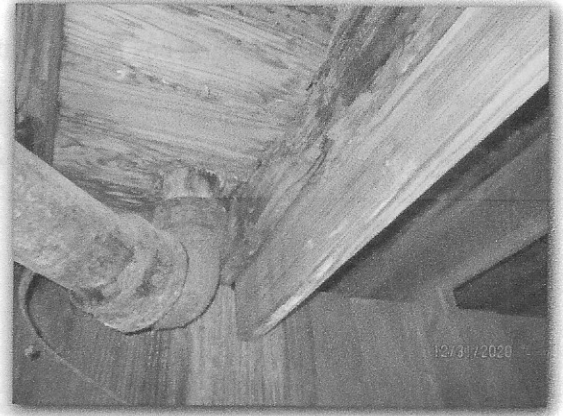
Damaged wood flooring and floor joists at various locations. Recommend Repair or replacement.

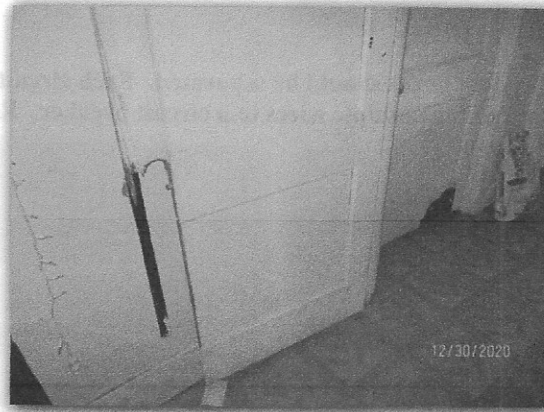
Damaged door at the bedroom. Recommend repair or replacement.

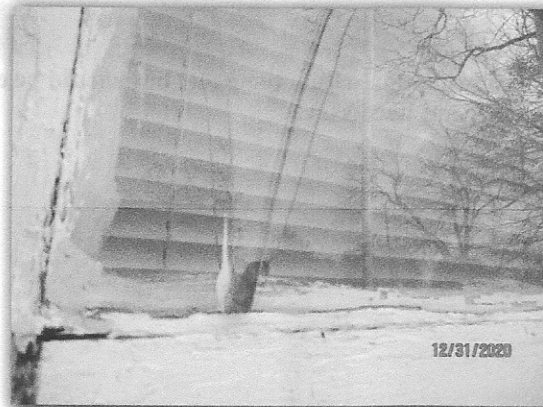
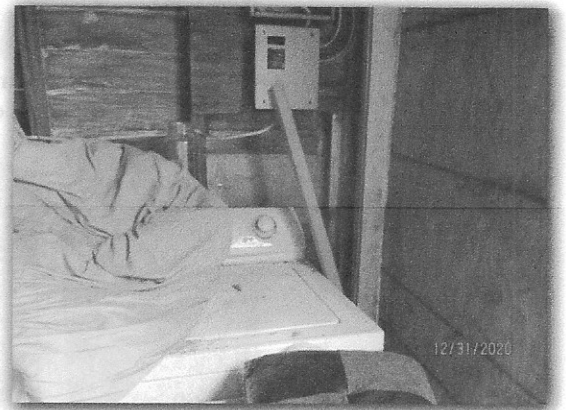
Broken/cracked window pane(s). Recommend repairs.

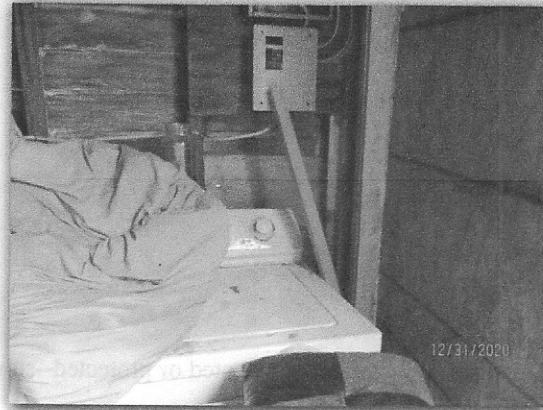
There is inadequate clearance at the front and sides of the panel box. Recommend relocating the panel box for increased safety and to conform to current building standards.

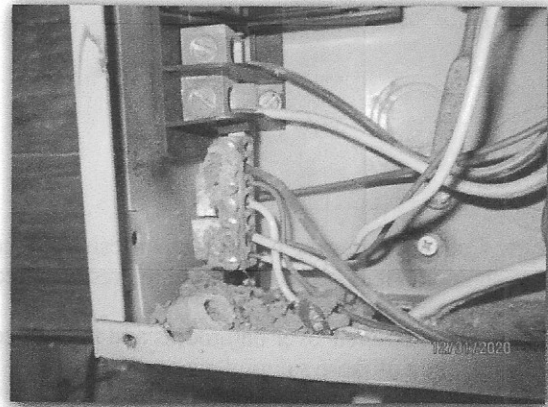
The ground buss bar and the Neutral buss bar should be separated in the subpanel box(es). Neutral wires are not allowed to touch the ground buss bar in subpanel boxes. The ground bonding is through the main panel box not the subpanel box(es). Recommend further examination and repair as needed.

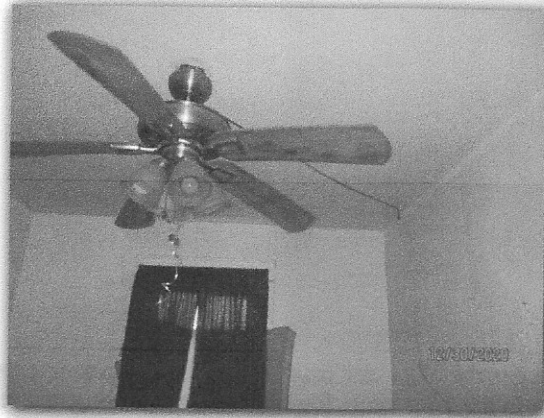
Extension cords should not be used as permanent wiring for the ceiling fan in the bedroom. Recommend replacing the extension cords with permanent wiring.

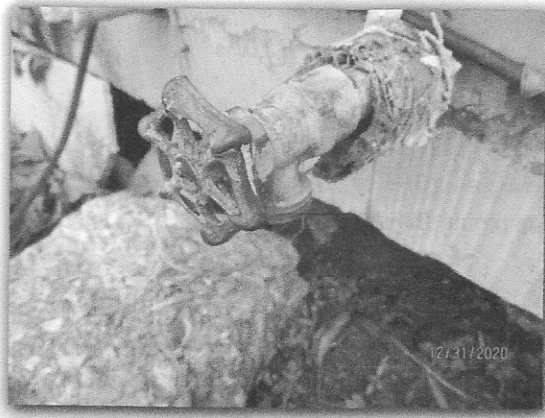
It is recommended that an anti-siphon device be added to the hose connection(s). Recommend Repair.

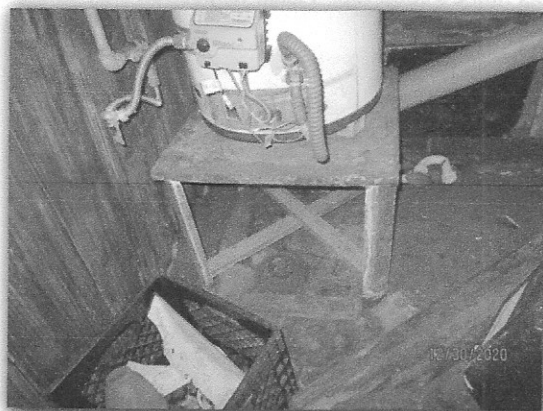
The water heater is missing the discharge tube for the temperature pressure relief line. A drain line should be run from the water heater to an approved location outside.
