Real Estate Inspection Report

**21606 Park Wick Lane
Katy, Texas 77450**

PROPERTY INSPECTION REPORT

Concerning: 21123 Park Wick Lane, Katy, TX 77450
(Address or Other Identification of Inspected Property)

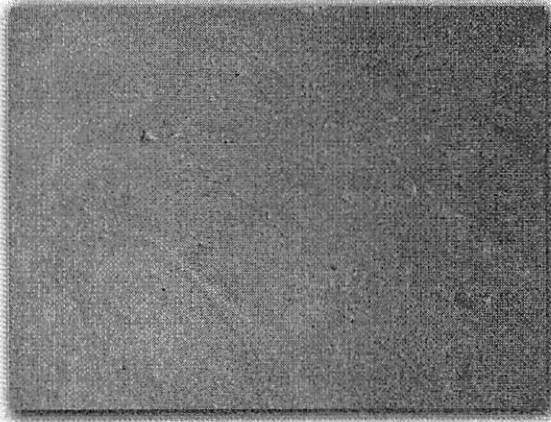
- Concrete hairline cracks noted in the garage floor; this does not appear to be a structural defect.

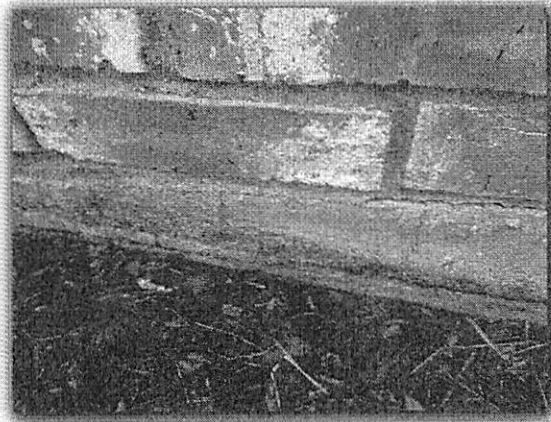
- Concrete slab was chipped in the foundation, this does not appear to be a structural defect. (grout over as necessary)

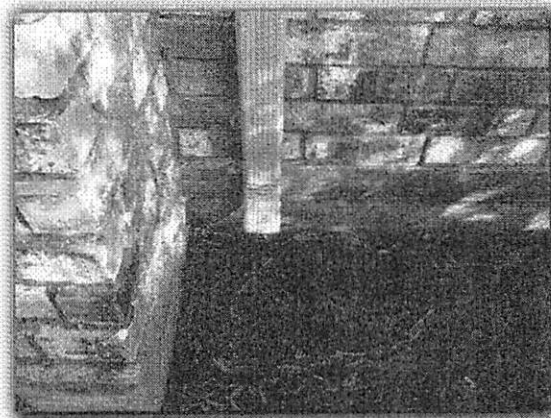
- The drainage and grading were inadequate in the yard. Yard grading should be sloped away from the foundation by 2 inches over 10 feet.

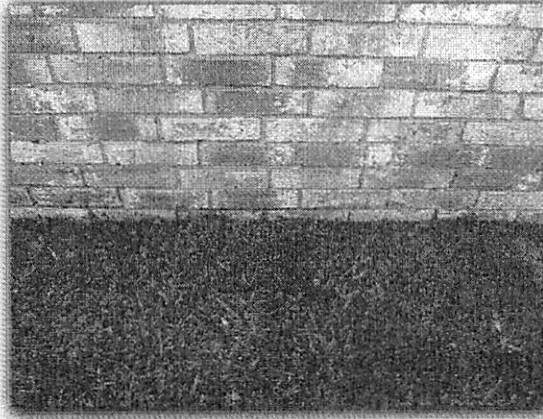
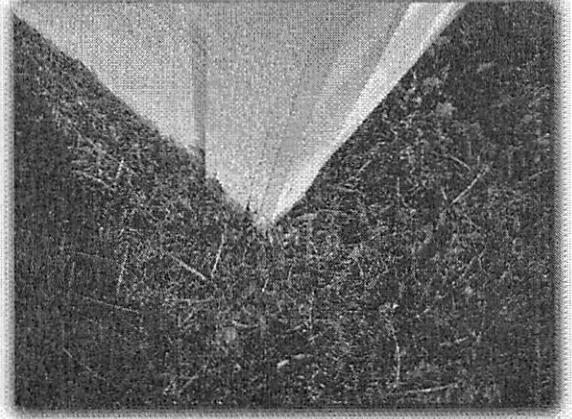
- The slab exposure was inadequate at rear side of the house and around the garage. Soil should be a minimum of 4 inches below the brick line.

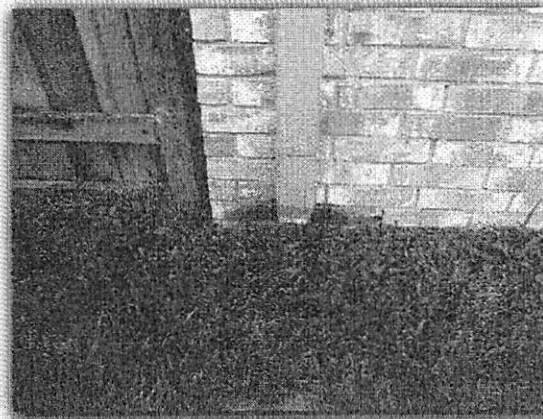
- Inadequate termination of the gutter downspout (too close to the foundation).

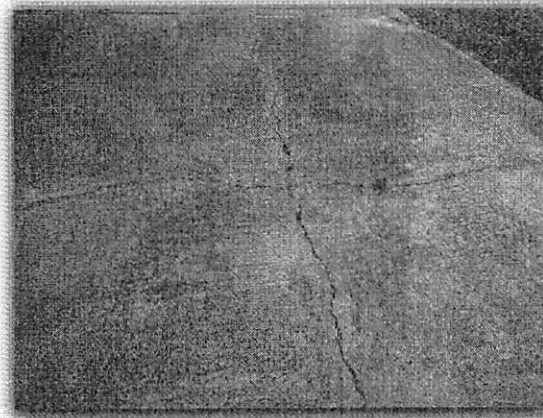
- Hairline cracks noted in concrete driveway, sidewalk and in rear patio.

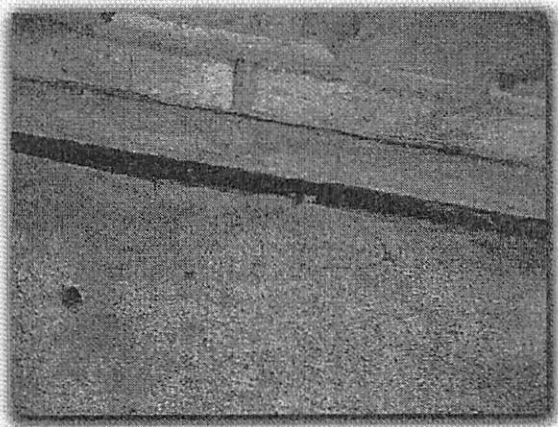
- The gap (expansion joint) between rear patio concrete floor and slab did not

seal properly.

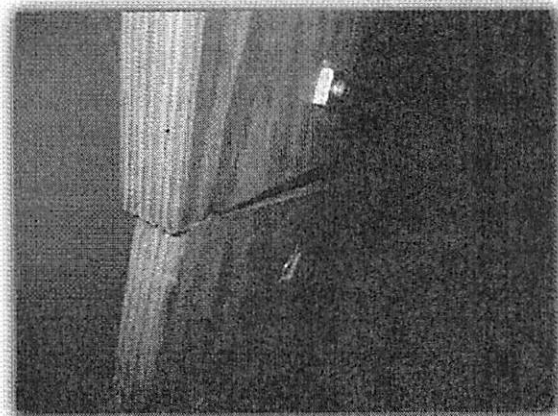
- The attic pull-down stair did not secure properly. (stringer was not straight when deployed)

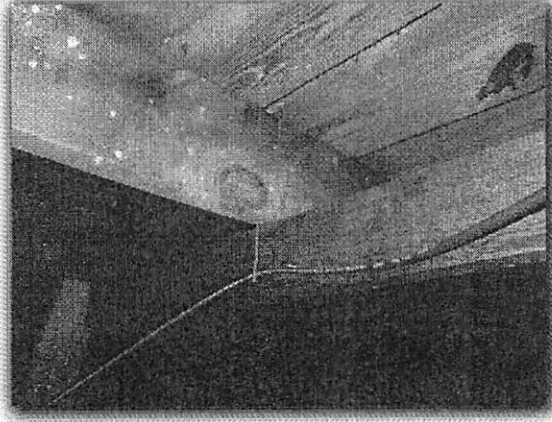
- The size of purlin (2 inches x 4 inches) needs to be the same size (or larger) as roof rafter (2"x 6") by modern standard.

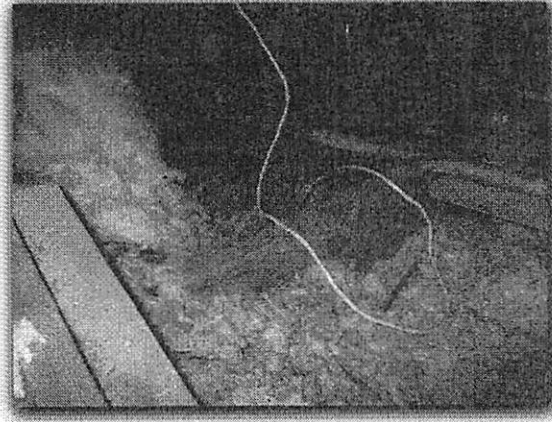
- Missing attic floor insulations near attic access door.

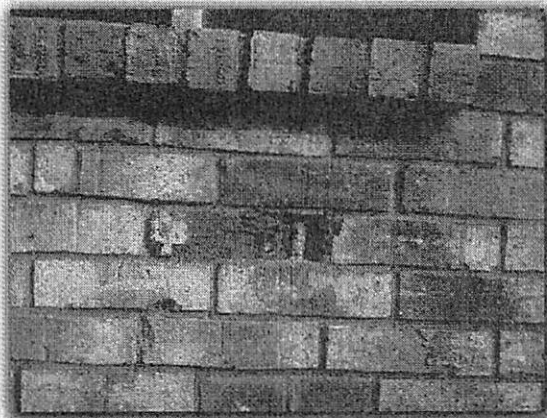
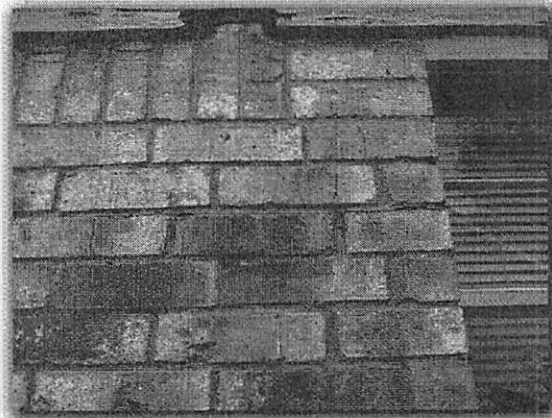
However, there were signs that the foundation of the house has settled. The signs were in the form of several brick veneer cracks in the exterior wall.

The defects (such as brick veneer cracks in the exterior wall) are mainly considered attributable to original workmanship and slight thermal movement.

The sizes of the cracks are considered within tolerances.

- Small brick veneer cracks/loose mortars observed in all side of the exterior walls.

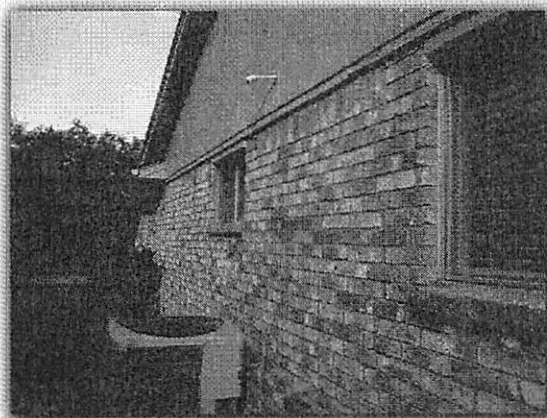
- The right side of the brick veneer wall was discolored (rusty color), cause by A/C condensate drips from roof eave.

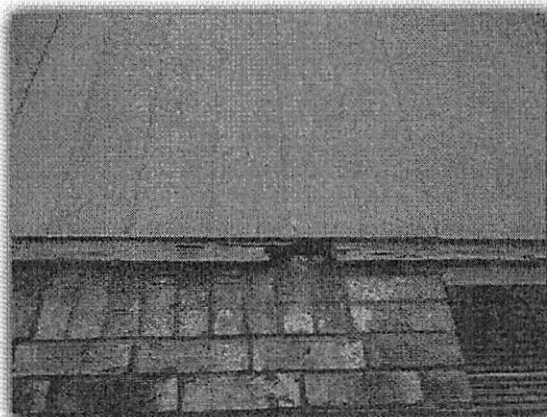
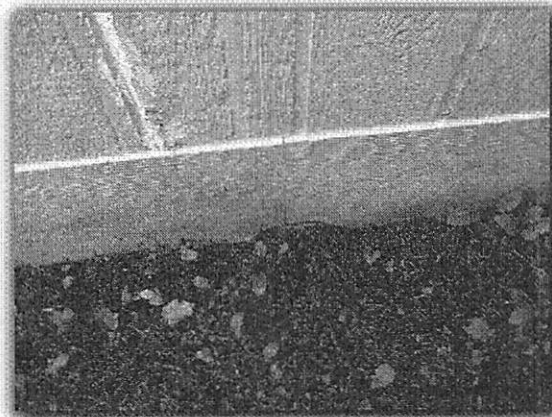
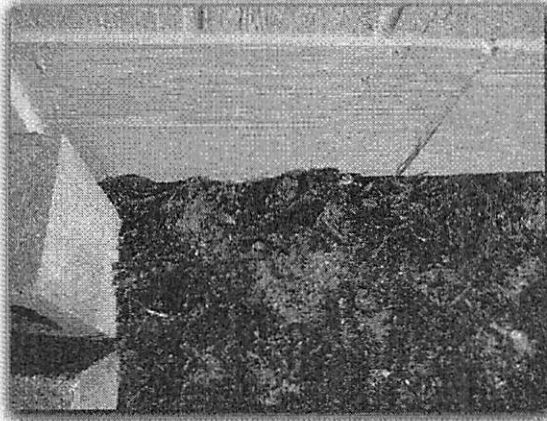
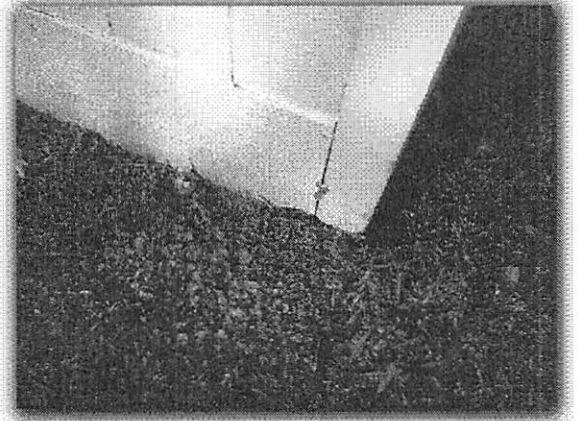
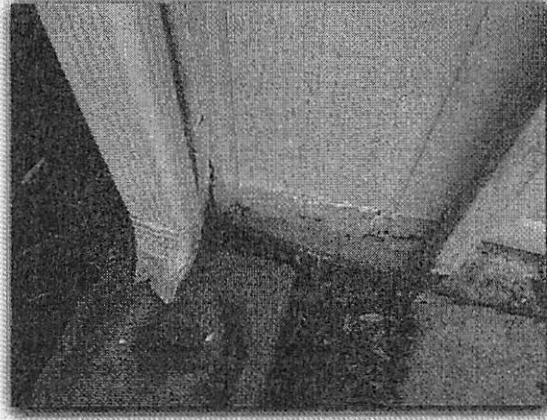
- Decay/damaged wood sidings observed around the house and garage; the bottom skirt board (cement boards) noted around the garage, the condition behind the skirt is unknown.

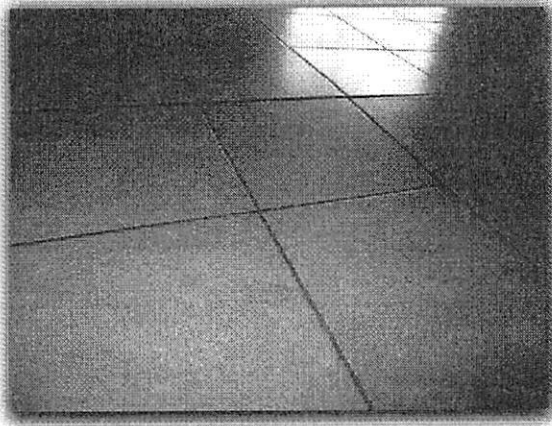
- Uneven floor tiles noted in the house (poor workmanship).

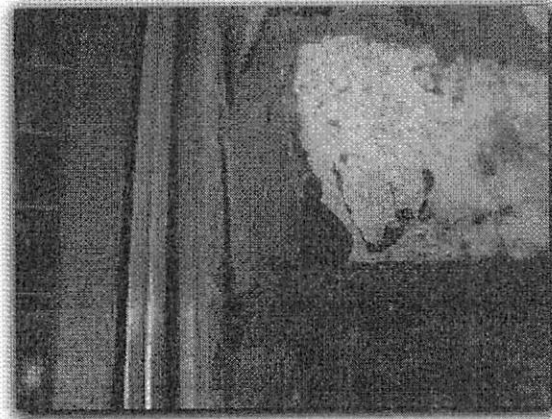
- Deteriorated exterior window caulking noted.

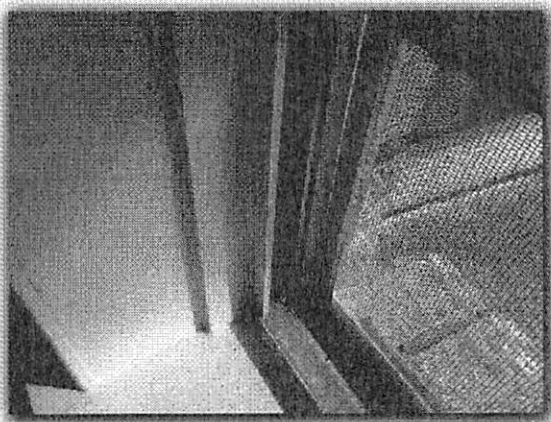
- Missing/broken (or not properly sized) 4 window screens, sticky window operations, damaged springs in window tracks noted in the house.

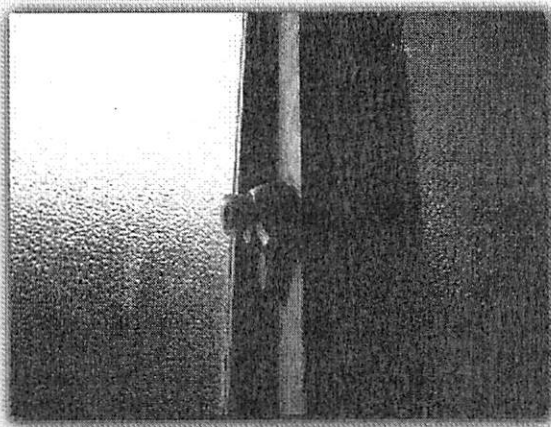
- Hallway bathroom window latch was loose.

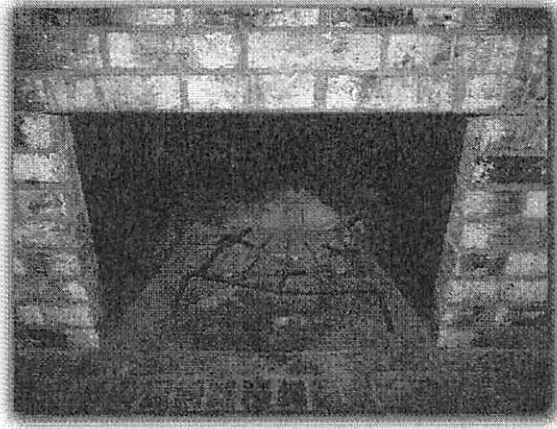
- Wood burning with gas starter fireplace: missing screen/glass door at fireplace opening; soot build up at top of the firebox and in the chimney flue.

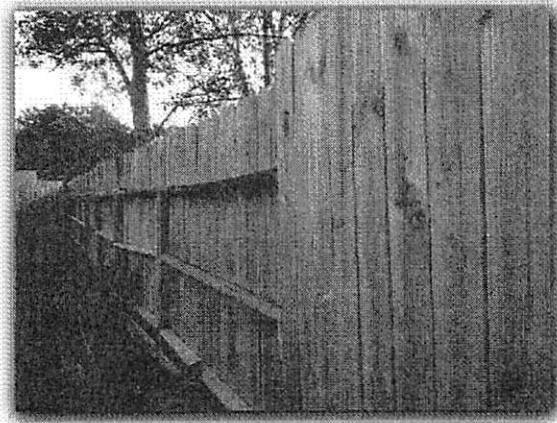
- **Leaning/damaged yard fences noted.**

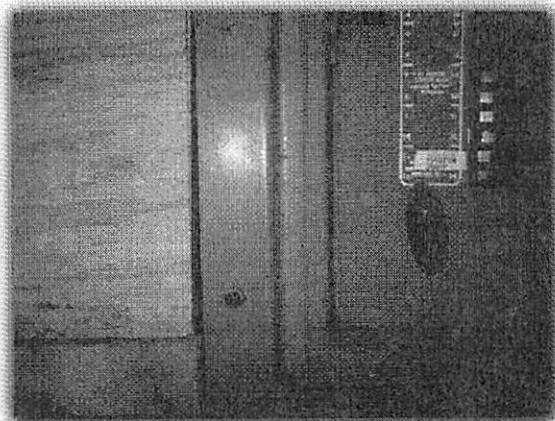
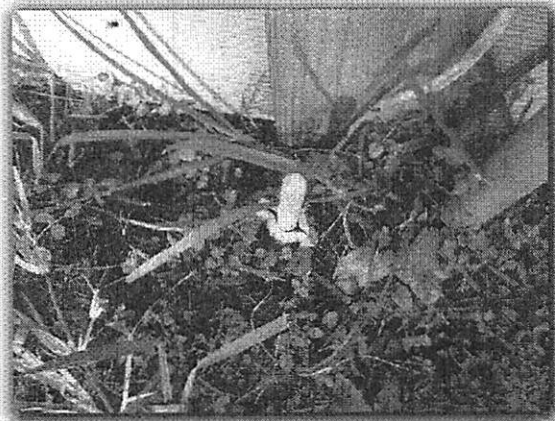
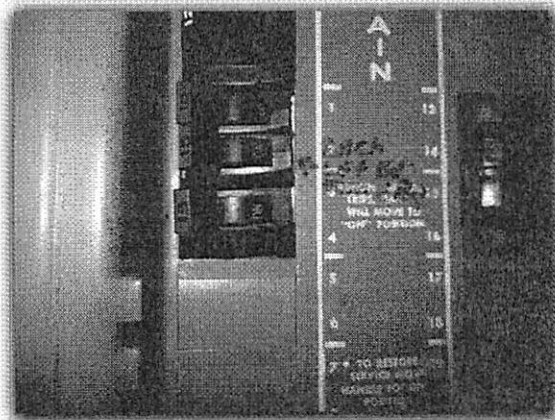
- Current electric standard (2008) requires arc fault protections in all of the living area outlets. (bedroom, living room, family room, dining room, den, study room, media room, closets, hallway ...)
- Missing labels and screws in the service panel, the service panel grounding clamp was loose; knockout should be filled in the service panel.

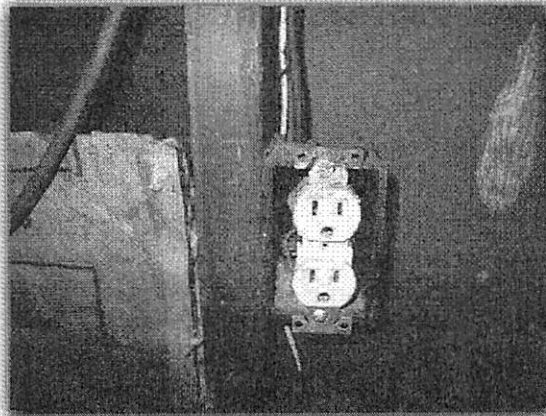
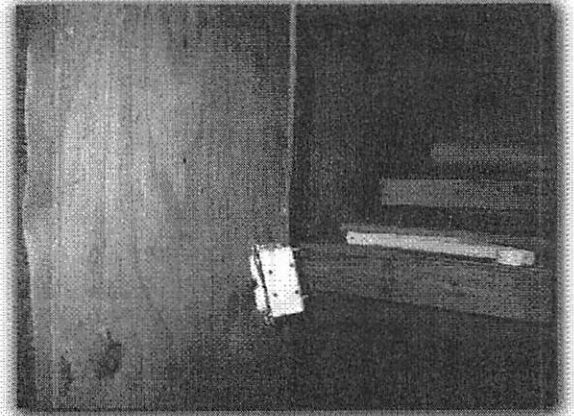
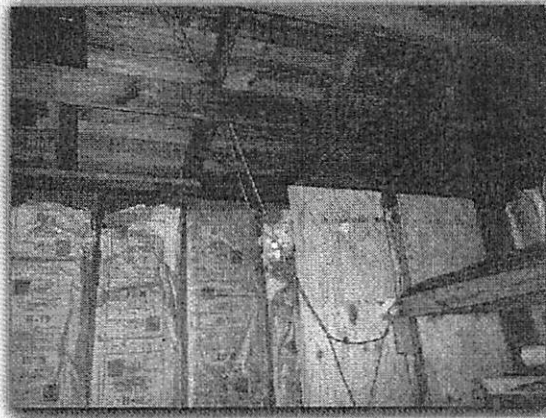
- The electric outlet box in rear patio did not secure at wall.
- Missing electric outlet cover pates in garage; extension cords noted in garage, unsecured electric outlet box and power cord noted in garage.

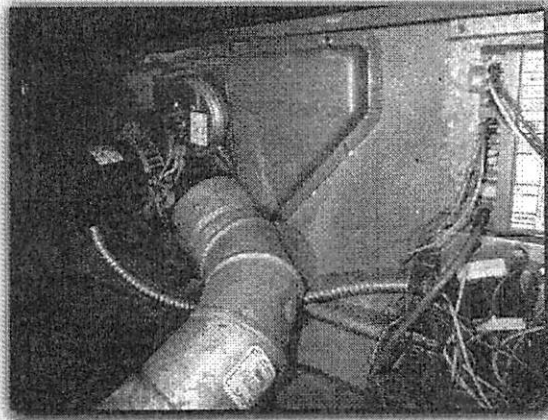
- **Exposed wires noted at front side of the furnace.**

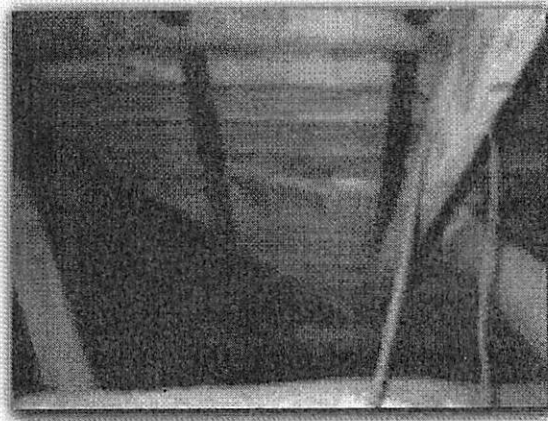
- **Current gas standard requires a sediment trap (dirt leg) to be installed at furnace gas line.**
- **The roof penetration of the furnace flue pipe did not seal properly.**

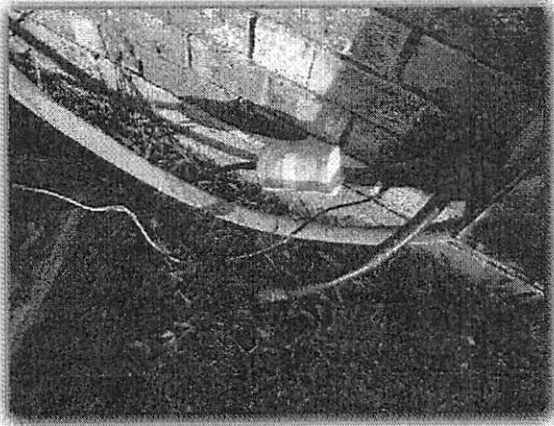
- The insulation of the freon line at condensing unit was deteriorated.

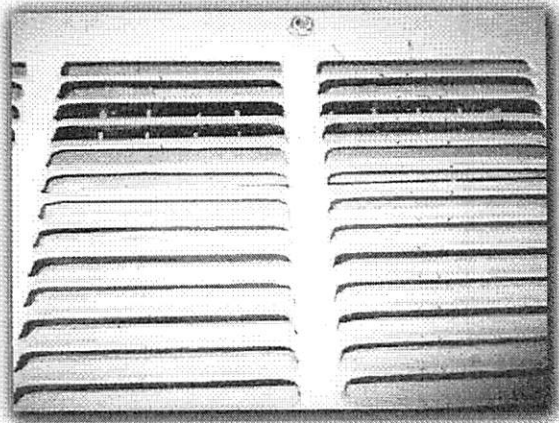
- Dirty/damaged air filter.

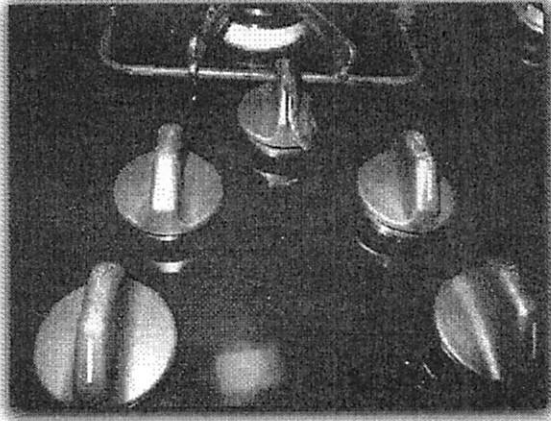
- Gas cook top: missing gas mode indicators in cook top control knobs; the middle control knob was broken.

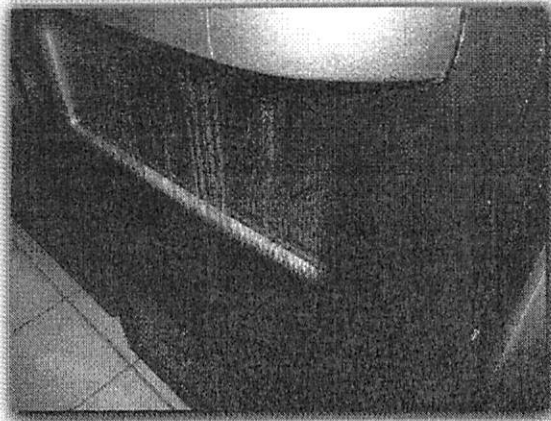
- The oven door had spills between the glass panes.

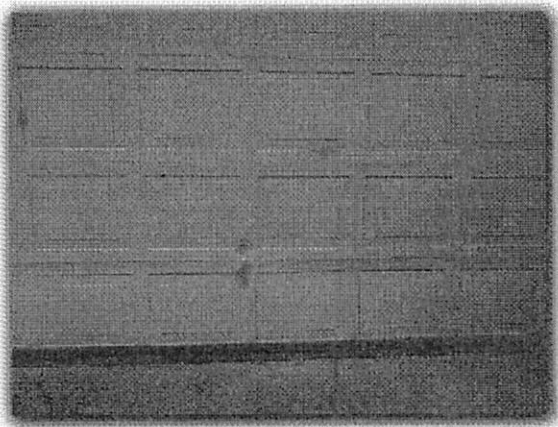
- Missing exhaust venting system in hallway bathroom. (modern standard requires bathroom venting system even with window present)
