## RESIDENTIAL INSPECTION REPORT

2402 Gerol Dr  
Galveston TX 77551

Margaret Martinez & John Martinez  
FEBRUARY 2, 2021

Inspector  
**Chance Phillips**  
TREC #3899  
(281) 484-8318  
[office@inspectorteam.com](mailto:office@inspectorteam.com)

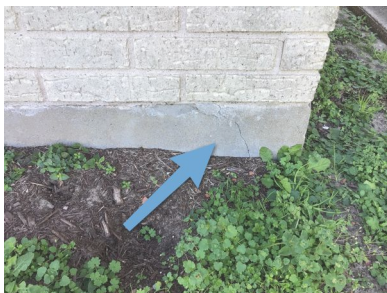
**1: Slab: Shear Cracks**

Note: Shear cracking ("corner pops") observed at foundation corners is not normally associated with structural movement or deficiencies.

Recommendation: Contact a handyman or DIY project

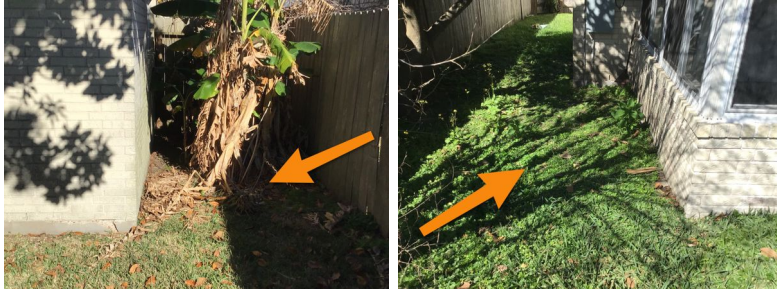
**1: Grading & Drainage: Inadequate**

Low spots, ruts, and/or damaged sod were present at the time of inspection. Regrading by a qualified landscaping contractor or foundation contractor so that water flows away from the home is recommended.

Recommendation: Contact a qualified landscaping contractor

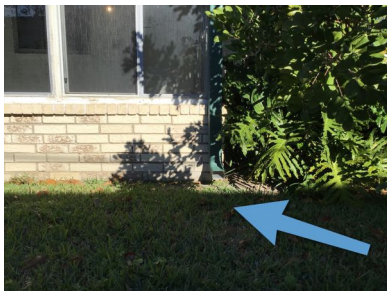
**2: Gutters & Downspouts: Missing Splash Blocks**

A splash block placed beneath the downspout elbow helps to disperse water away from the foundation and to prevent soil erosion. Remedy as needed.

Recommendation: Recommended DIY Project

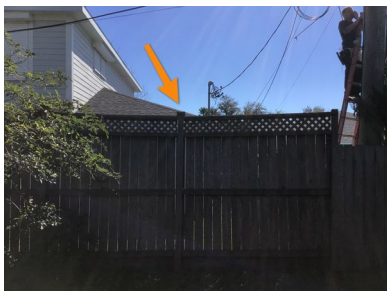
**3: Fence: Leaning**

Evaluate and remedy as needed for safety.

Recommendation: Contact a qualified professional.

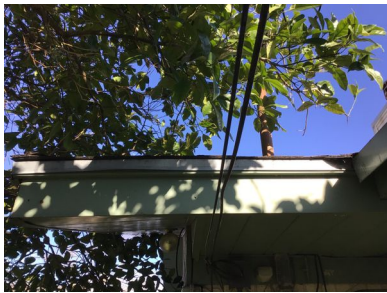
**1: Tree limbs on/near roof**

Tree limbs that are in contact with roof or hanging near roof should be trimmed to prevent damage to the roofing materials.

Recommendation: Contact a qualified tree service company.

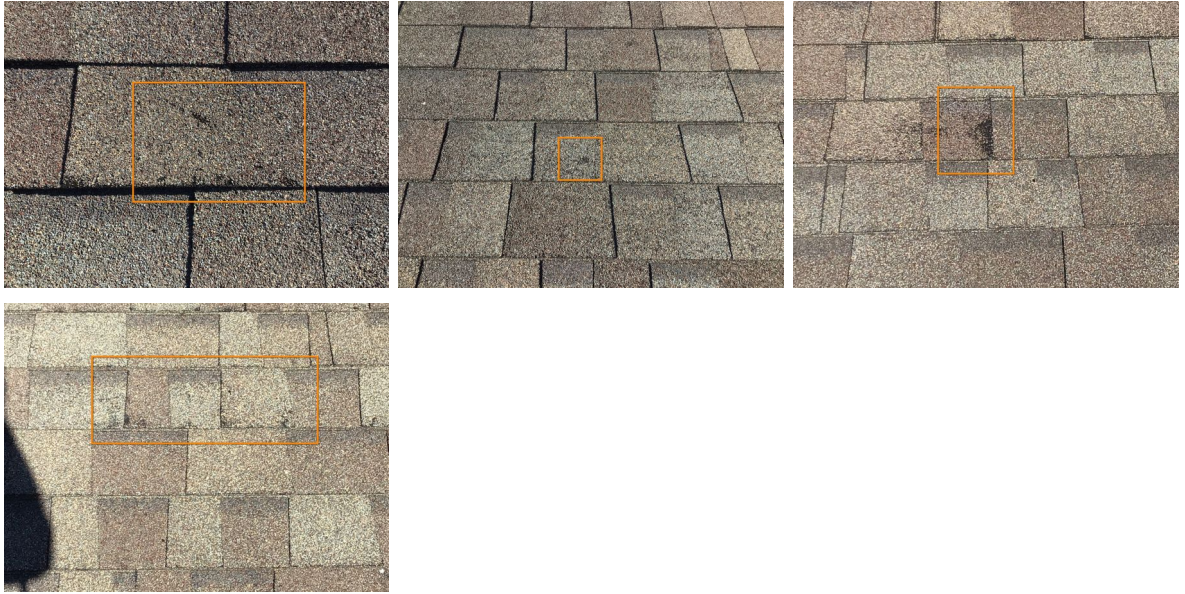
**2: Localized Granule Loss**

Localized granule loss on the shingle surface was observed. Among other things, this can be as a result of mechanical damage, impurities in the asphalt, or anomalies in the manufacturing process. Evaluation and repair by a qualified roofing professional is recommended.

Recommendation: Contact a qualified roofing professional.

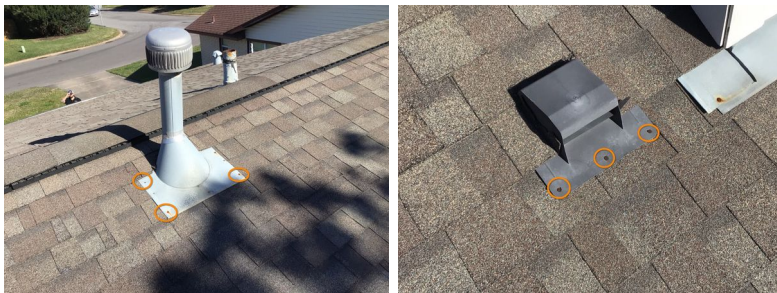
**3: Exposed fasteners**

Exposed fasteners were observed. Seal as needed to prevent moisture intrusion.

Recommendation: Contact a qualified roofing professional.

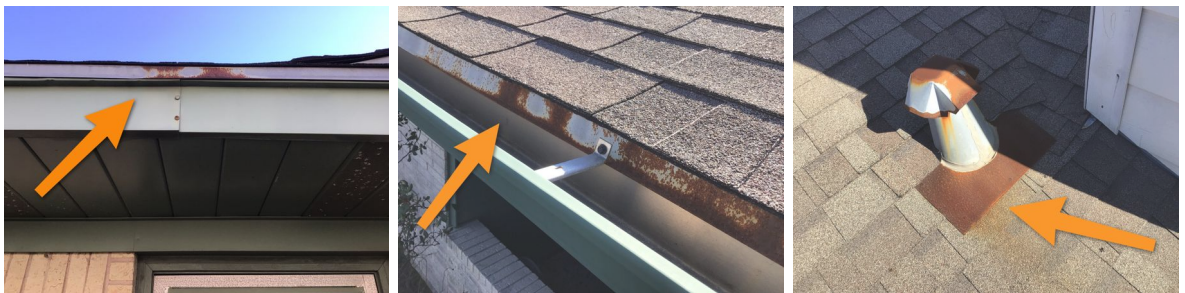
**4: Flashing: Rusted flashings**

Rusted flashings were present. Remedy as needed.

Recommendation: Contact a qualified roofing professional.

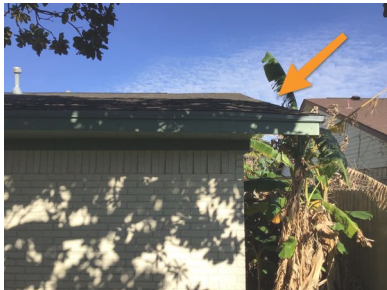
**1: Sheathing: Wavy or Sagging**

Areas of the roof were wavy or sagging, indicating sheathing or framing deficiencies. Evaluation and repair by a qualified roofing professional is recommended.

Recommendation: Contact a qualified roofing professional.

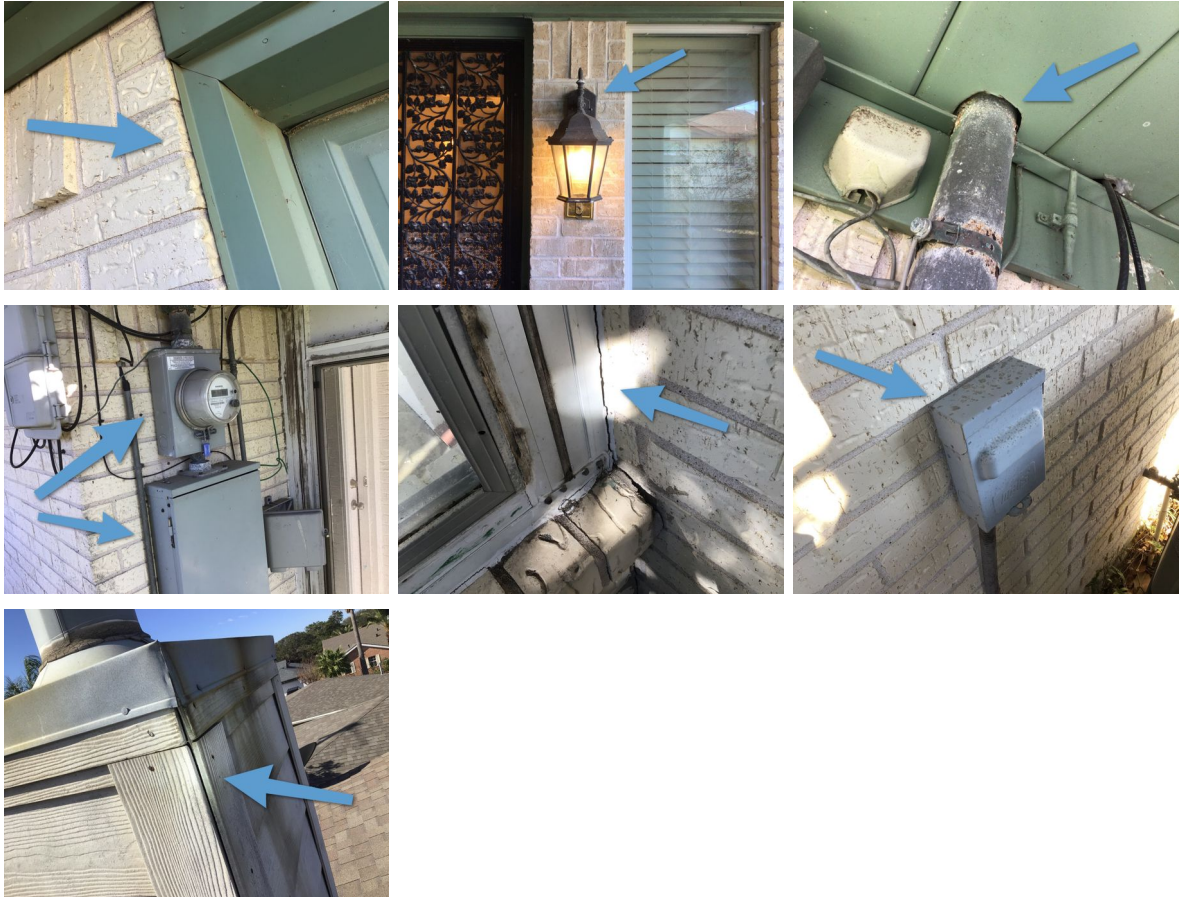
**1: Exterior: Seal Wall Fixtures**

**Note:** Modern building practices recommend sealing around components that are mounted on or pass through the exterior wall to limit moisture intrusion.

Recommendation: Recommended DIY Project

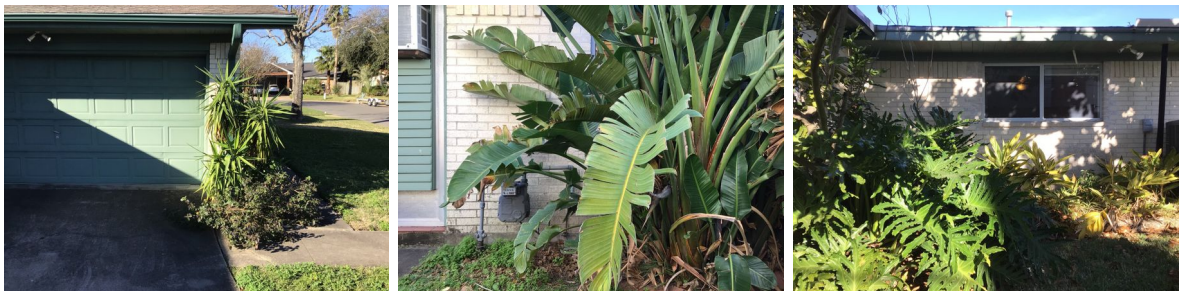
**2: Exterior: Foliage Too Close**

Foliage that is too close to siding materials can cause moisture buildup and deterioration.

Recommendation: Contact a qualified professional.

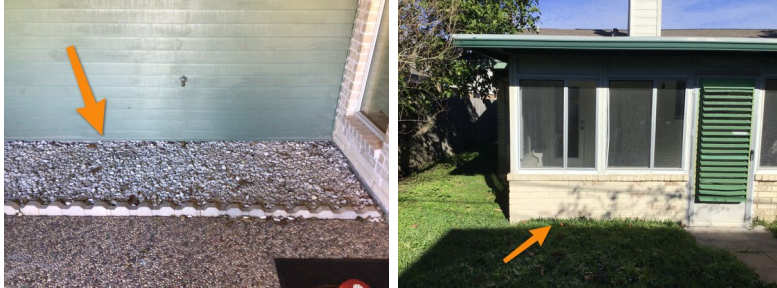
**3: Exterior: High Soil**

A high soil level was observed. The foundation should have at least 4 inches of exposure. Remedy as needed.

Recommendation: Contact a qualified landscaping contractor

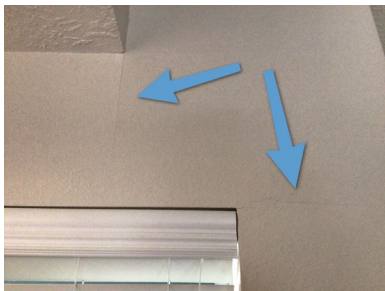
**4: Interior: Hairline Cracks on Drywall**

Hairline cracks were observed on the interior drywall. Hairline cracks may be related to the following:

Monitor and/or remedy as needed.

Recommendation: Recommend monitoring.

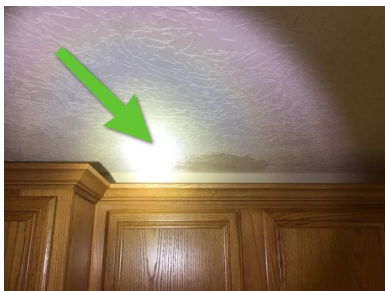
Kitchen

*Previous Repairs:*

Previous repairs were observed. Recommend obtaining repair documentation or further explanation from the seller.

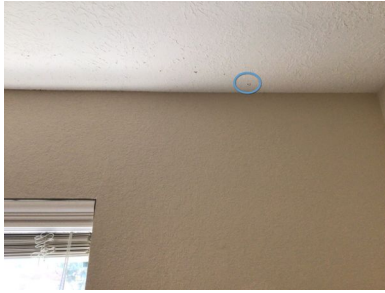
**1: Ceiling: "Popped" Nails**

"Popped" (loose) drywall nails are observed on the ceiling. This condition is typically considered cosmetic. Re-seat and seal as needed.

Recommendation: Contact a handyman or DIY project

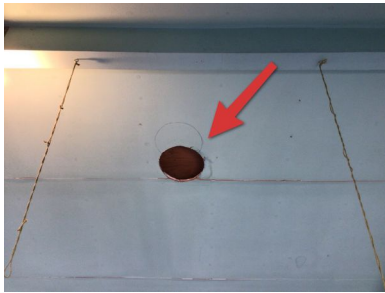
**2: Ceiling: Missing Drywall in Garage**

There is missing drywall on the ceiling in the attached garage. This is important for fire safety. Further evaluation is recommended.

Recommendation: Contact a qualified drywall contractor.

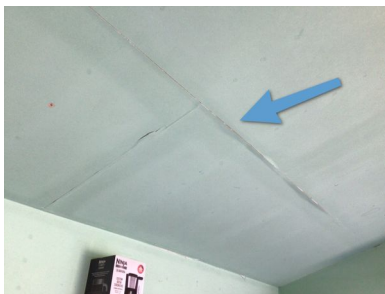
**3: Poor Joints**

This condition is typically considered cosmetic. Re-float and texture as needed.

Recommendation: Contact a qualified drywall contractor.

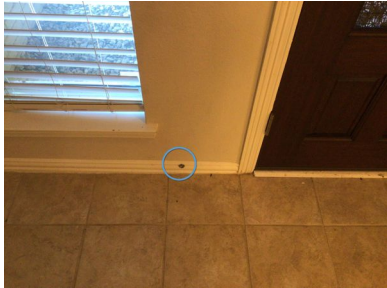
**1: Door Hardware: Missing Doorstops**

One or more missing doorstops were observed. Replace any missing doorstops to prevent damage to the drywall.

Recommendation: Recommended DIY Project

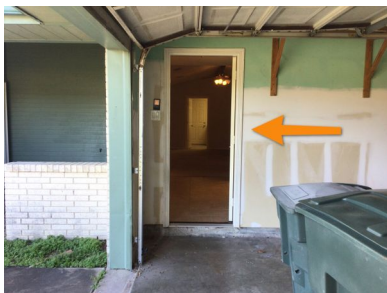
**2: Garage Door into Living Space: Self-Closing Mechanism not Present/Operable**

Entry door between the garage and living space should have a functioning self-closing mechanism.

Recommendation: Contact a qualified professional.

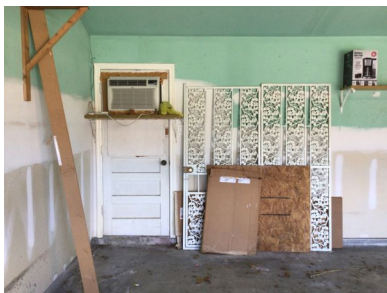
**3: Door: Obstructed**

Door was obstructed and could not be operated.

Recommendation: Contact a qualified professional.

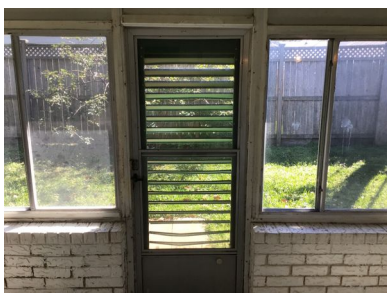
Rear patio

**4: Door: Shutters Inoperative**

Recommendation: Contact a qualified professional.

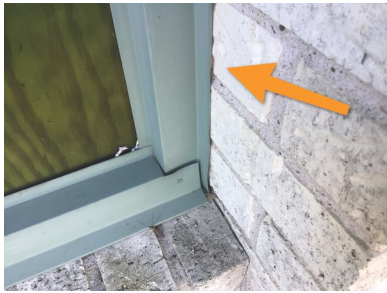
**1: Caulking: Missing/Damaged**

Caulking around window frames was missing or deteriorated. Caulking around window frames is an important barrier to moisture and air intrusion. Most exterior sealants have a lifespan of 5 to 8 years and should be regularly maintained with that lifespan in mind. Evaluate and remedy as needed.

Recommendation: Contact a qualified professional.

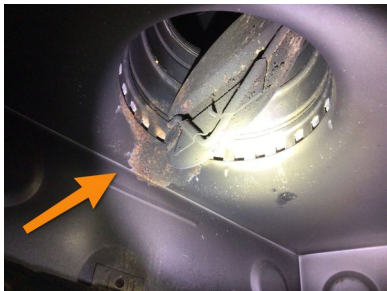
**1: Firebox: Rust/corrosion**

Rust/corrosion was observed inside the firebox. This indicates possible prior moisture contact. Evaluate and remedy as needed.

Recommendation: Contact a qualified professional.

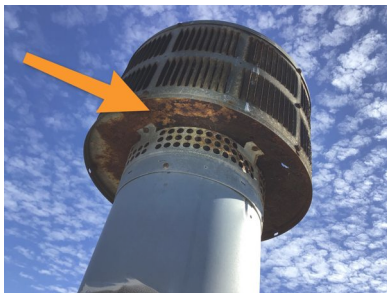
**2: Cap: Surface rusting**

Surface rusting was observed on the metal chimney cap. Evaluate and remedy as needed.

Recommendation: Contact a qualified professional.

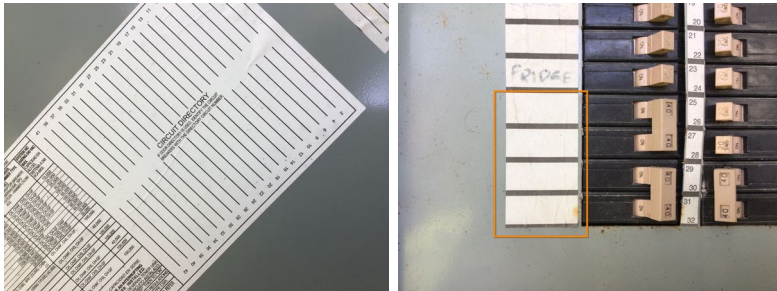
**2: Circuits Not Labeled**

Recommendation: Contact a qualified electrical contractor.

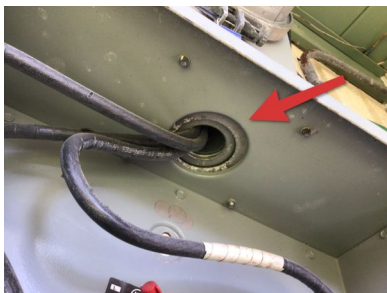
**3: Missing Wire Bushing**

There was no bushing around wires that pass through the panel into the wall to protect them from abrasion. Evaluation and/or remediation by a licensed electrician is recommended.

Recommendation: Contact a qualified electrical contractor.

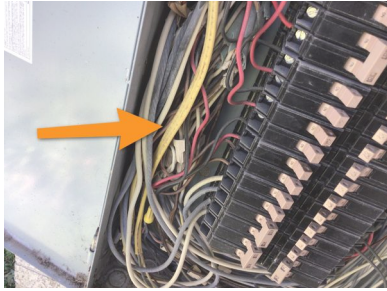
**4: Sheathing Not Removed**

Recommendation: Contact a qualified professional.

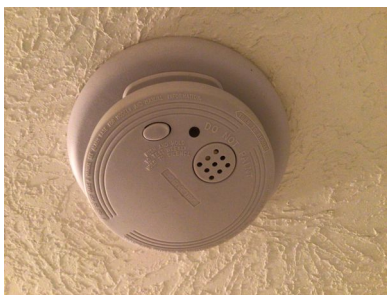
**1: Smoke Detector Defective**

Recommendation: Contact a qualified professional.

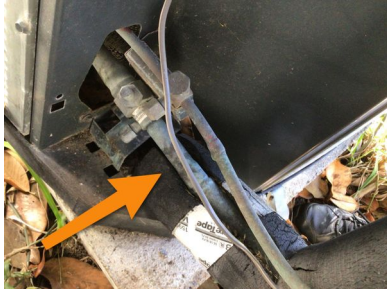
**1: Condenser: Insulation Missing or Damaged on Refrigerant Lines**

Missing or damaged insulation on refrigerant line can cause energy loss and condensation. Remedy as needed.

Recommendation: Contact a qualified HVAC professional.

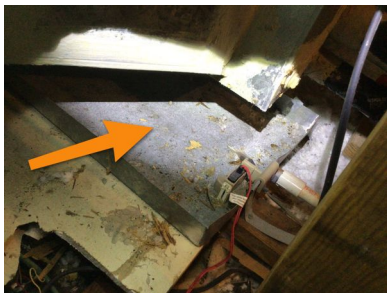
**2: Condensate System: Insulation Missing or Damaged on Drain Lines**

Missing or damaged insulation on condensate drain lines can result in moisture damage to interior components. Remedy as needed.

Recommendation: Contact a qualified HVAC professional.

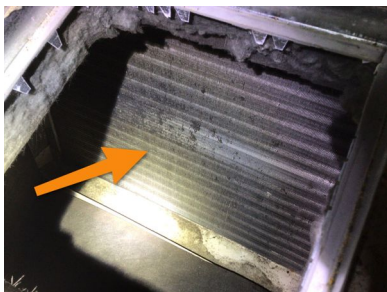
**3: Evaporator Coil: Dirty**

The evaporator coil was dirty. Full servicing by a licensed HVAC contractor is recommended.

Recommendation: Contact a qualified HVAC professional.

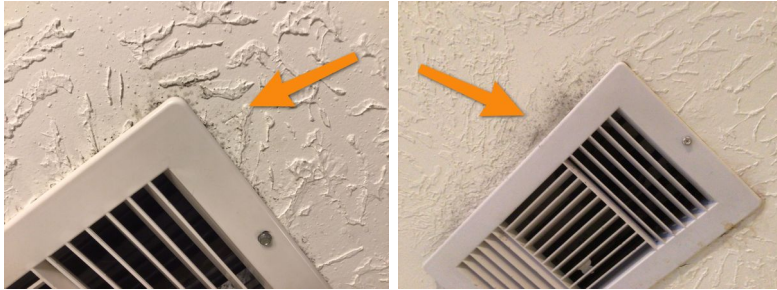
**1: Visible substance observed on Supply Register**

A dark substance was observed on an air supply register in the home. Servicing and cleaning of the system by a qualified HVAC contractor is recommended, as this can be a result of excessive water

vapor/humidity in the conditioned air.

Recommendation: Contact a qualified HVAC professional.

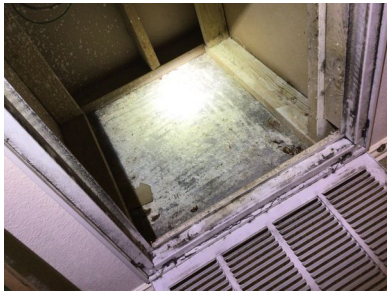
## 2: Return Air System: Dust or Debris In Chase

Dust particles can clog cooling coils and may lead to coil corrosion over time. Proper cleaning and evaluation of the return air shaft, ducts, and coils is recommended.

Recommendation: Contact a qualified HVAC professional.

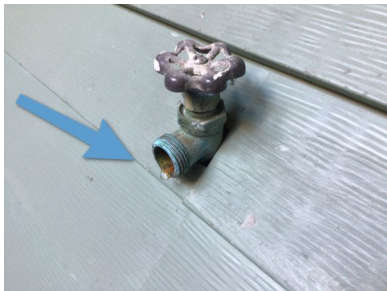
**1: Hose bibb (outdoor faucet): Backflow Prevention Missing**

A hose bibb was missing a backflow preventer. These devices are inexpensive and easily installed, and help to prevent contamination of potable water. Remedy as needed.

Recommendation: Contact a handyman or DIY project

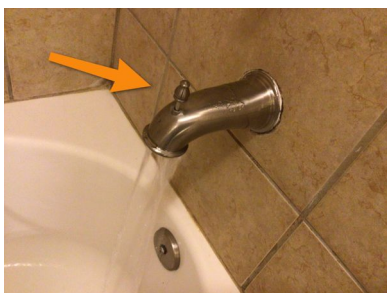
**2: Fixture: Diverter not Functioning Properly**

Recommendation: Contact a qualified professional.

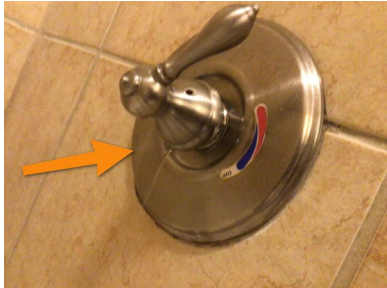
**3: Fixtures: Stem Leaking**

The faucet stem leaked when operated. Remedy as needed.

Recommendation: Contact a qualified plumbing contractor.

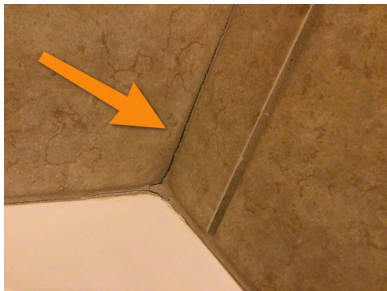
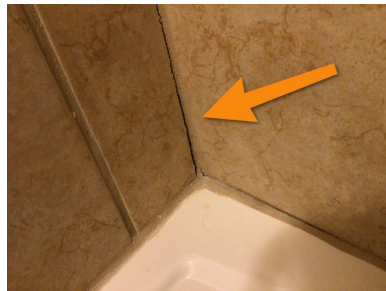
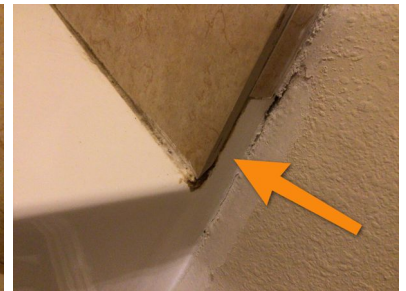
**4: Shower: Missing/Deteriorated Caulking or Grout**

Recommendation: Contact a qualified professional.

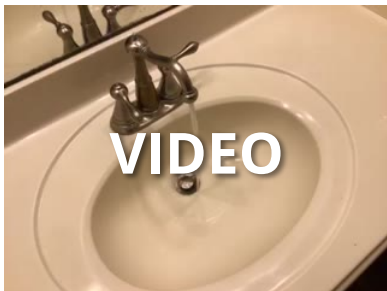
**5: Supply piping: Water Pressure Drop at Fixtures**

Water pressure decreased when multiple fixtures were in use at the same time. This is not uncommon for homes with older metal pipes that may have some corrosion in the lines. If evaluation is desired to determine a method of remedy, consult with a qualified plumber.

Recommendation: Contact a qualified plumbing contractor.

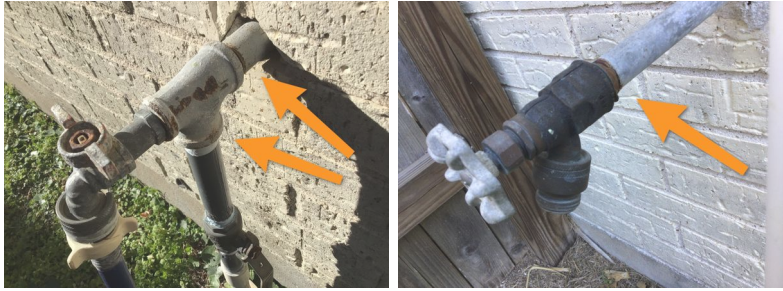
**6: Supply piping: Corrosion on Galvanized Pipes**

Galvanized water supply piping was corroded. The extent of rusting on the piping is not determined. Evaluation and/or remediation by a licensed plumber is recommended.

Recommendation: Contact a qualified plumbing contractor.

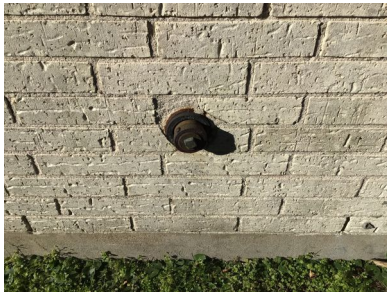
Hydrostatic Testing or Scoping of the latent plumbing drain lines under the house is recommended due to the age and type of materials currently installed.

Recommendation: Contact a qualified plumbing contractor.

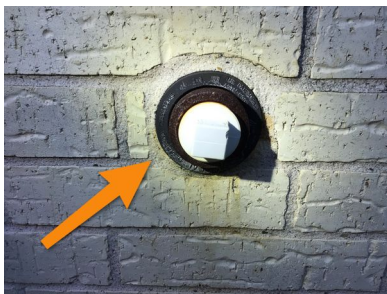
**2: Drain piping: Rust**

Rusted drain piping was observed at time of inspection. Evaluation and/or remediation by a licensed plumber is recommended.

Recommendation: Contact a qualified plumbing contractor.

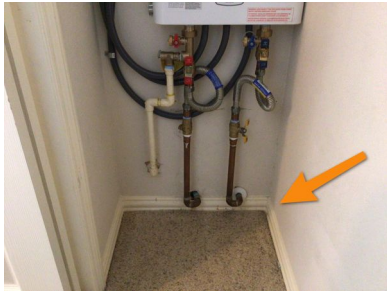
**1: Tank: Missing Drain Pan**

Recommendation: Contact a qualified professional.

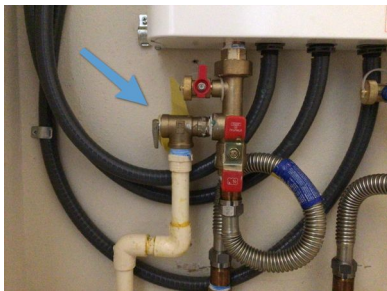
**2: TPR Valve Note: Replacement may be needed**

The manufacturer recommends replacement of the pressure relief valve every three years to ensure proper emergency function. The inspector does not test TPR valves due to safety hazard or possible damage to unit.

Recommendation: Contact a qualified professional.

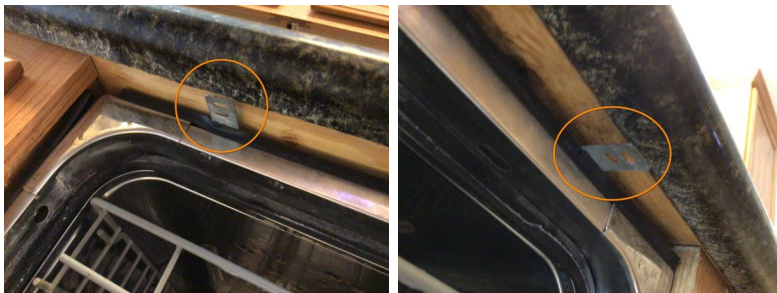
The dishwasher was not mounted securely. This may cause the unit to shift during operation which may compromise the plumbing connections.

Recommendation: Contact a qualified professional.

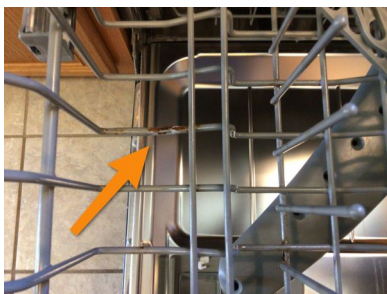
**2: Rusted Dish Racks**

There is evidence of rust on dishwasher racks. Evaluate and remedy as needed.

Recommendation: Contact a qualified professional.

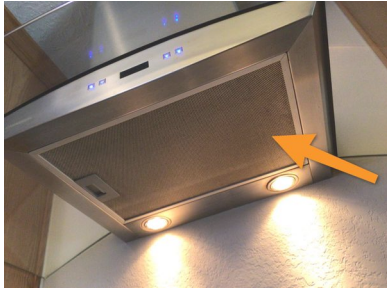
Kitchen exhaust filter had excessive grease build-up. Clean and/or replace as needed.

Recommendation: Contact a qualified professional.

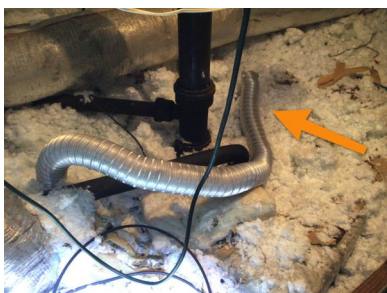
**2: Vent Duct Terminates in the Attic**

Recommendation: Contact a qualified professional.
