Henson Home Inspections

Property Inspection Report

22257 Round Valley Drive, Katy, Texas 77450

Date of Inspection: 5/9/2020 Time: 9am

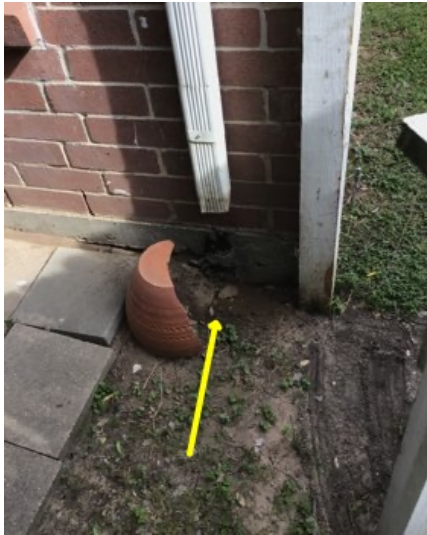
Splash pad is missing

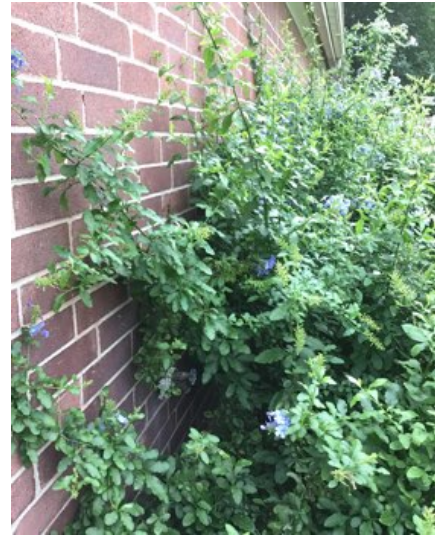
Shrubs are too close to the dwelling on the west side

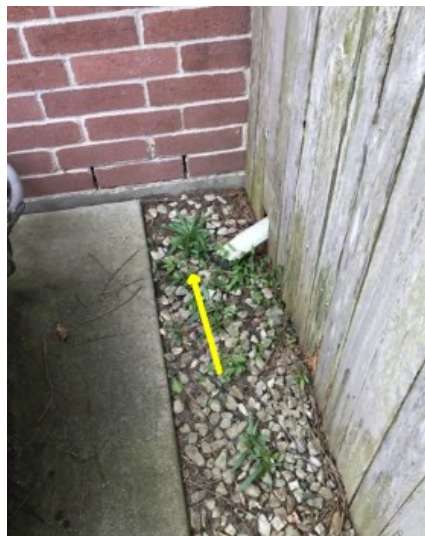
Splash pad missing

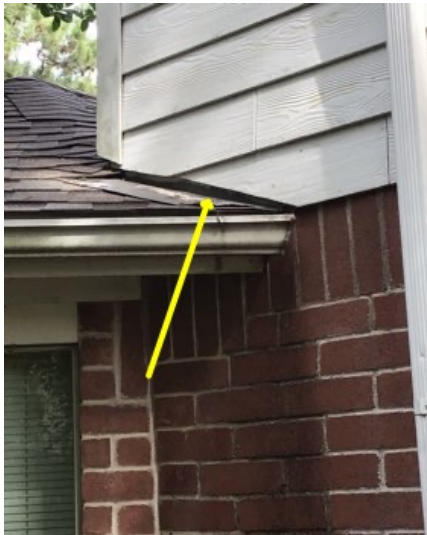
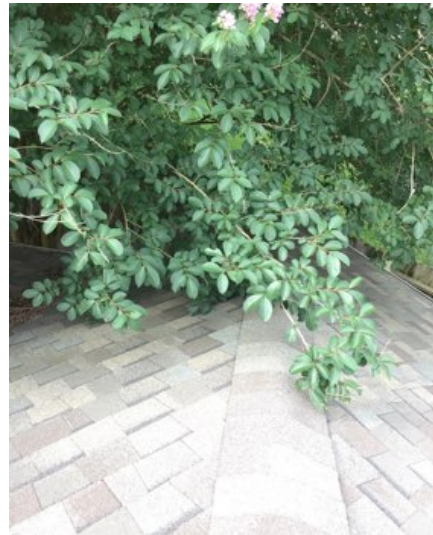
Kick out flashing is missing. This would prevent water shedding from the roof onto the brick veneer

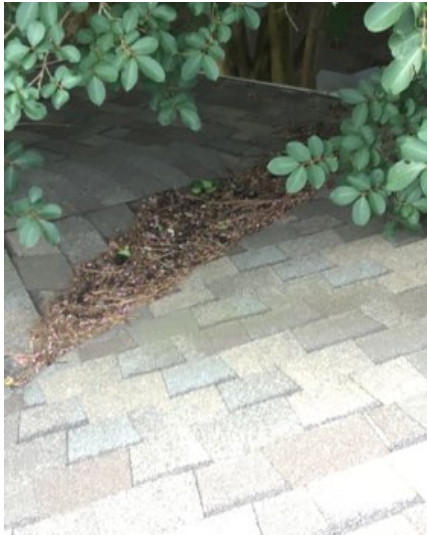
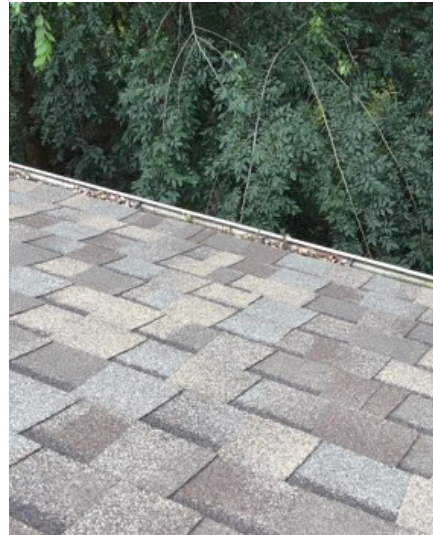
Debris in the gutter on rear of home

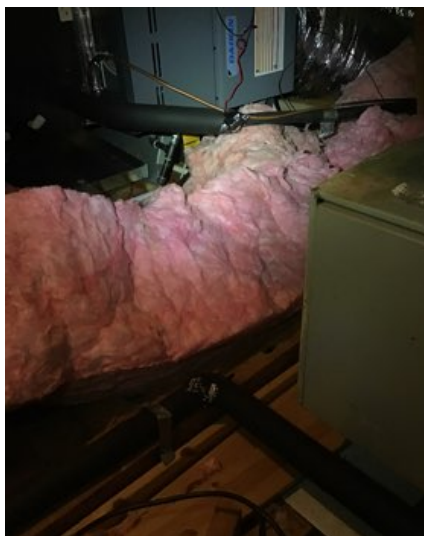
Insulation needs to be spread out and removed from the pathway to the air handler™s

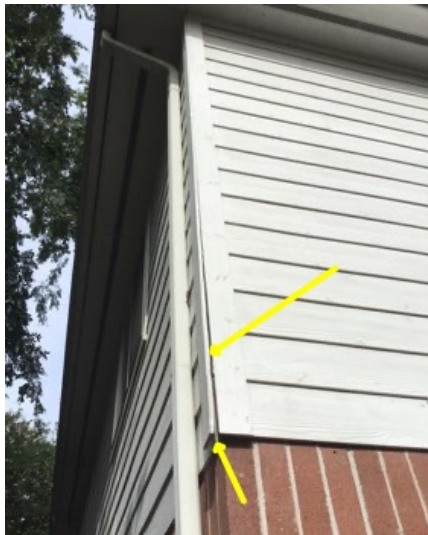
Trim board on east side rear needs to be repaired

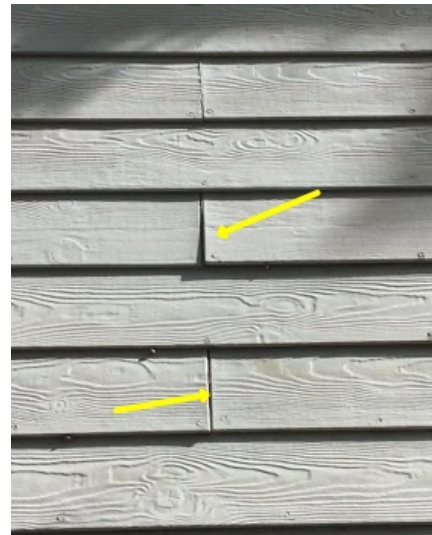
Siding on rear of dwelling needs to be caulked and re nailed on spots

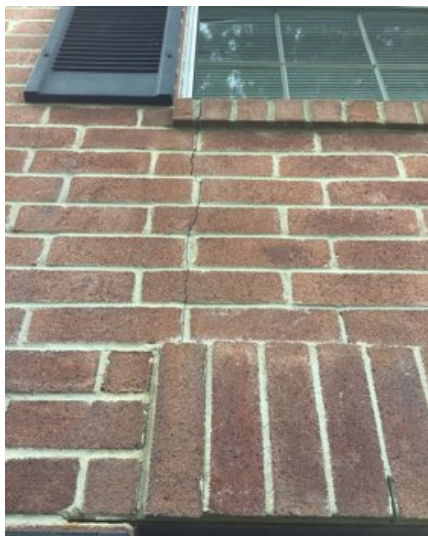
Crack in brick veneer on north side front of dwelling
This is normal settlement for a home this age

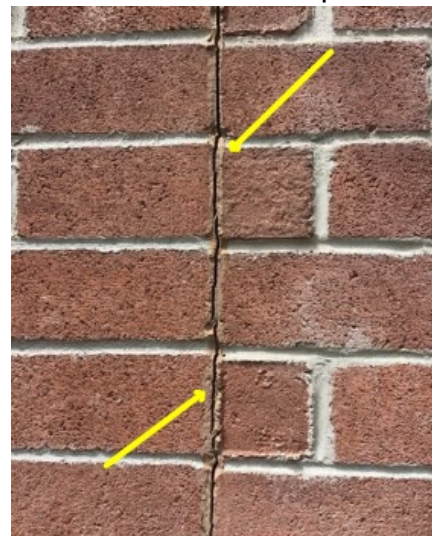
Expansion joints on the brick veneer needs to be caulked.

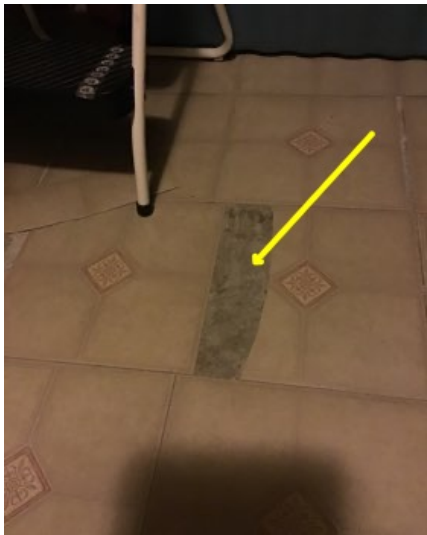
Flooring tile missing in master bedroom closet

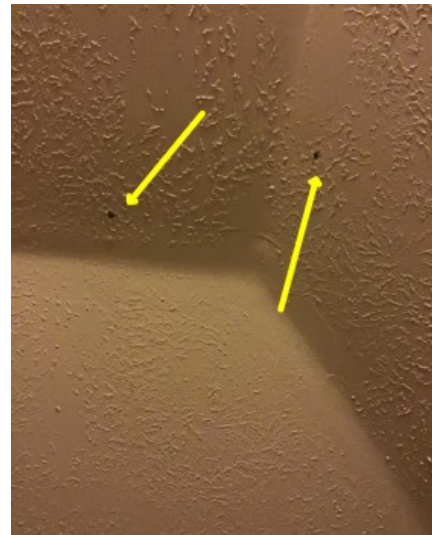
- **Nail pops were noted. These are bulges in the drywall where the nails are backing out of the studs, nail pops are usually due to the expansion and contraction of shrinkage of the framing. In extreme cases the joint cement and tape can pop off and expose the nails. Assuming there are no structural problems nails can be reset to solve the problem.**

Ceiling nail pops in master bedroom closet

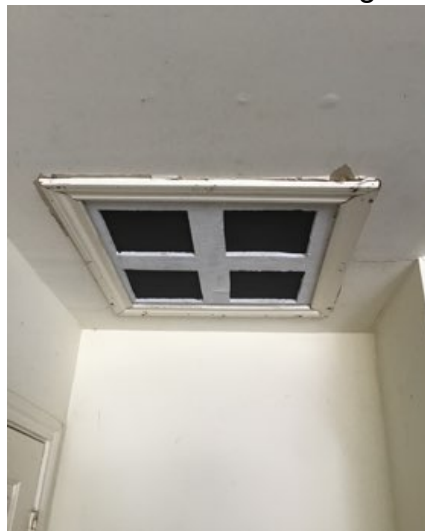
Garage ceiling has an opening which breaches the fire rated ceiling.

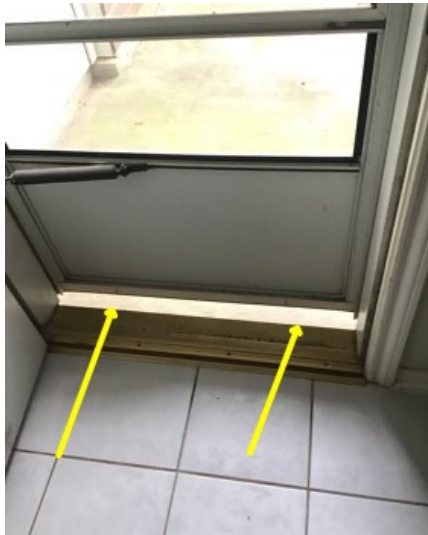
Screen door threshold missing

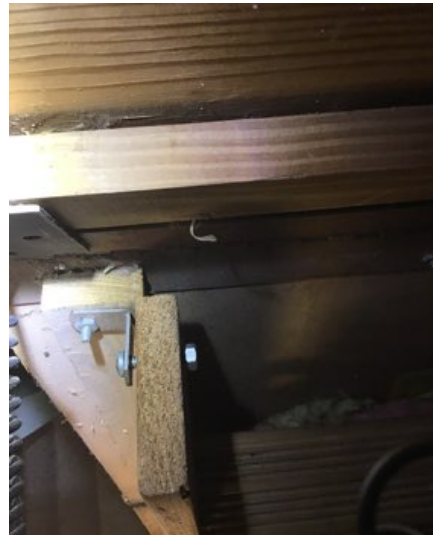
Attic access door photo shows screw and nut backing out. This could be a safety hazard

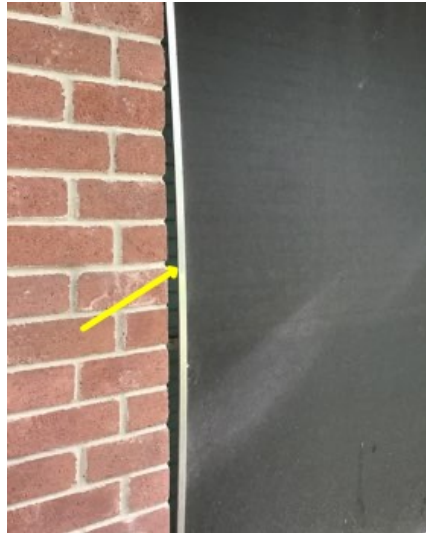
The screens on the backside are bowing and need attention .

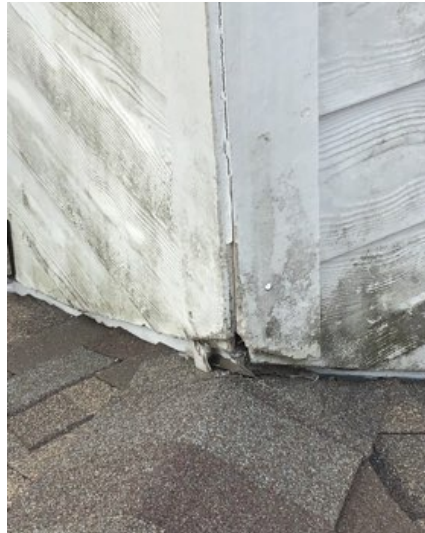
Chimney needs attention

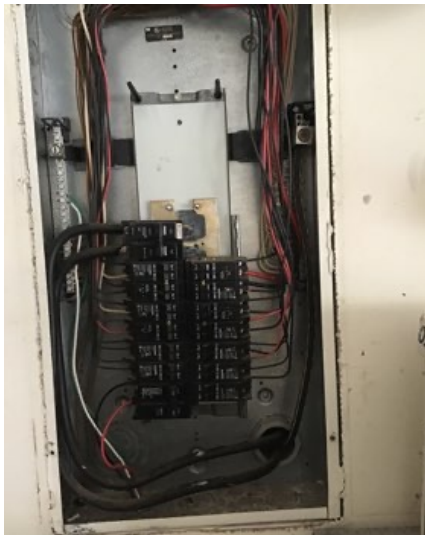
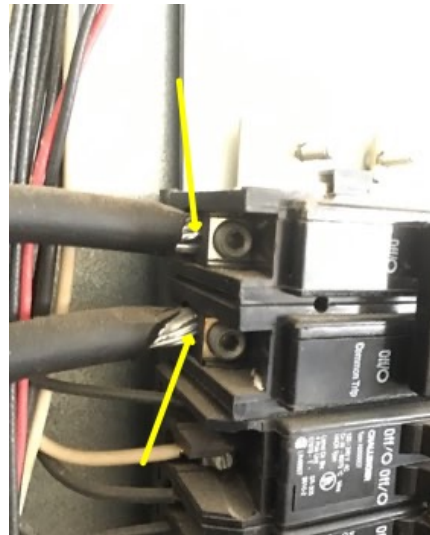
- **There is aluminum wiring present that does not have anti-oxidant grease**

Dielectric grease is missing at the main feed junction.

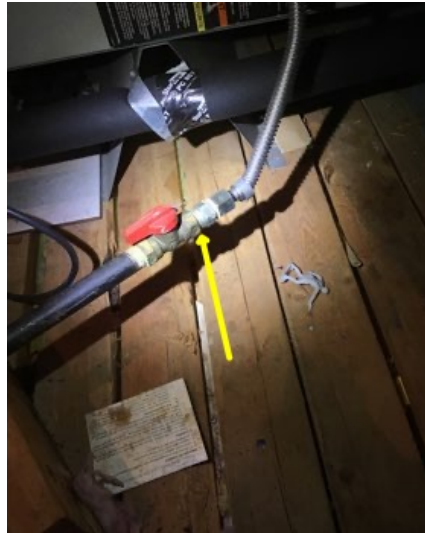
- There were no sediment trap or dirty leg installed on the natural gas distribution partners prior to the connections to the heater. Sediment traps are required to collect debris in the natural gas. Debris can cause gas valve to stay open which will keep the gas flowing to the burners. We continue operation of the burners and carve the units to catch fire proper settlement draft should be installed where required.

No drip leg present on gas line on upstairs furnace

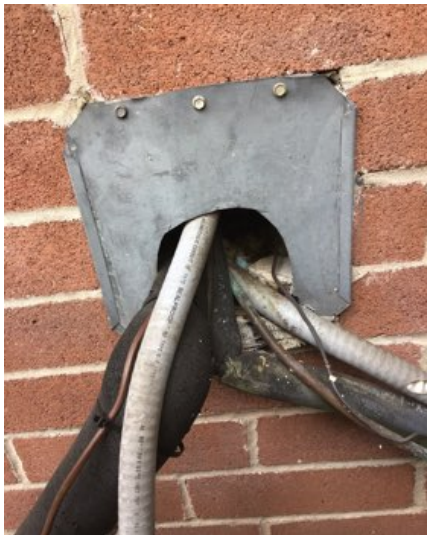
The area where the refrigerant lines enter the dwelling needs to be sealed to prevent insects and rodents from entering the premises

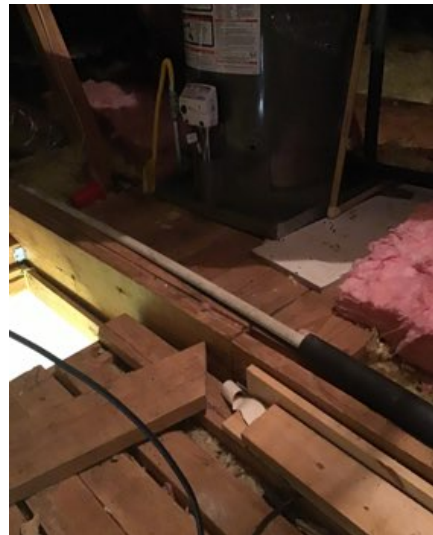
Condensation line is not fully wrapped with insulation

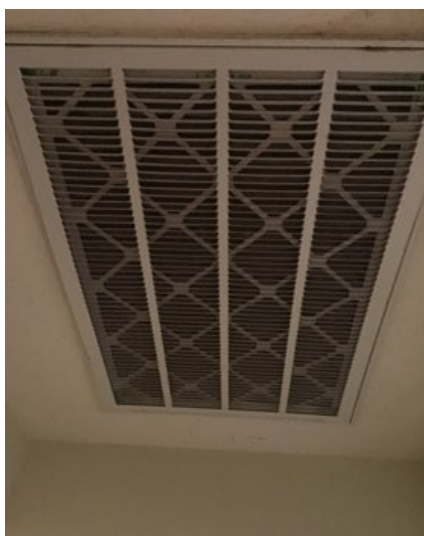
Air filter is dirty downstairs

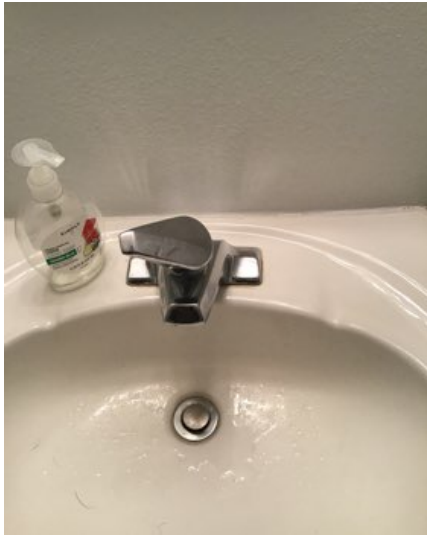
Cold side of faucet in downstairs guest bathroom does operate.

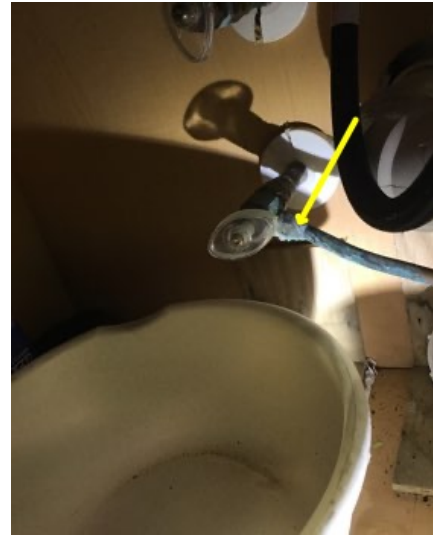
Corrosion present at dishwasher feed line

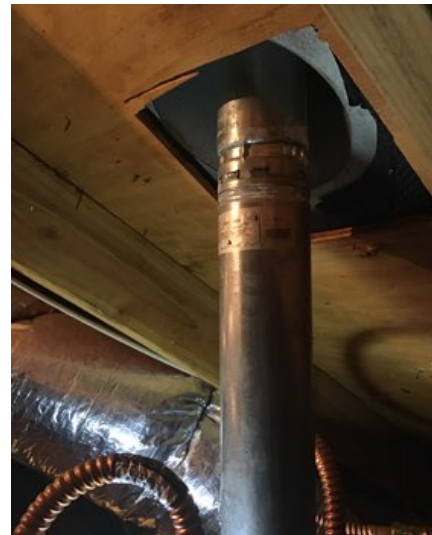
No seismic straps and present on the water heater flue

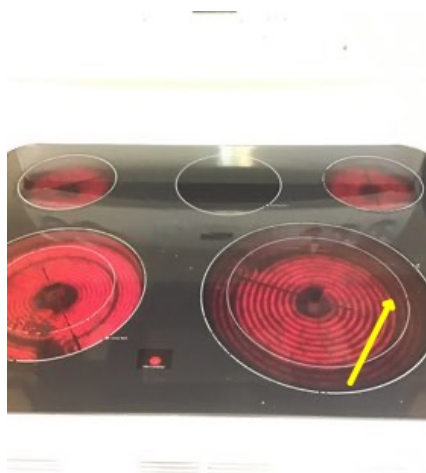
General Electric cooktop. All burners operated but the glass stove top was fractured.

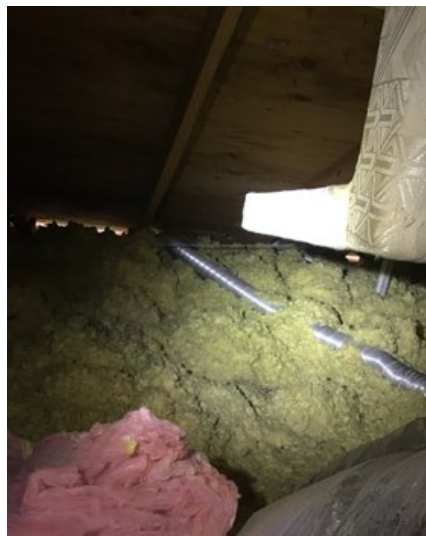
- The bath fan was operated and no issues were found.
- The fan terminates improperly in the attic. This can create excessive moisture. Recommend directing the vent towards the exterior to allow for proper ventilation.
- The vent pipe from the exhaust fan in the terminates and is pointed at the attic roof ridge vent/soffit vent/gable vent. Although, this was within standard building practice at the time this house was built--This is less efficient and can cause a buildup of moisture and eventually mold in the attic. Recommend upgrading to properly route vent(s) to the exterior of the home.

Bath fan is vented to the soffit
