### PROPERTY INSPECTION REPORT

Prepared For:	MARGARET TAYLOR				
r roparou r or.	(Name of Client)	_			
Concerning:	cerning: 10919 Barker Gate Court , Cypress, TX 77433  (Address or Other Identification of Inspected Property)				
Ву:	Dan Romero Lic.#: 5674 (Name and License Number of Inspector)	01/30/2020 (Date)			
(Name, License Number of Sponsoring Inspector)

# PROPERTY INSPECTED: 10919 Barker Gate Court Cypress, TX 77433

DATE OF INSPECTION: 01/30/2020 Inspection No. 521097-48

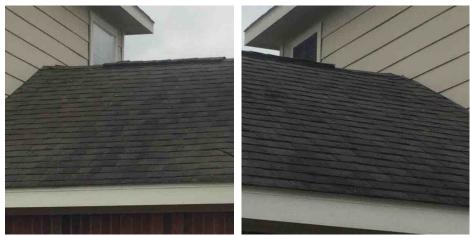
• NOTICE: THE INSPECTION WAS A LIMITED VISUAL INSPECTION. Roof surface was viewed from the ground level and from the attic space unless noted otherwise due to possible roof surface damage caused by walking on roof and or injury to the inspector due to a high pitch roof deemed by the inspector as unsafe.

The roof was visually inspected for excessive wear, damaged or lifted shingles, unusual or abnormal deflection and sagging or roof surface. Flashing and roof jacks were inspected for proper installation, damage and deterioration. The roof was inspected for leakage by viewing readily accessible areas of decking visible from the attic space. Visible and accessible flashing and roof penetration points such as plumbing vent pipes, water heater vent pipes and furnace vent pipes were also inspected from the attic.

A roofing specialist should be contacted if any concerns exist regarding the current condition of the roof covering, life expectancy or the potential for future problems. The client is advised that the opinions related to the roof are based upon limited, visual inspection and should not be considered a guarantee or warranty against future leaks.

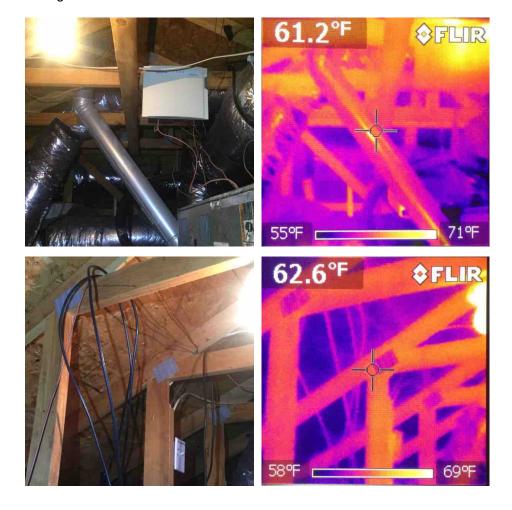
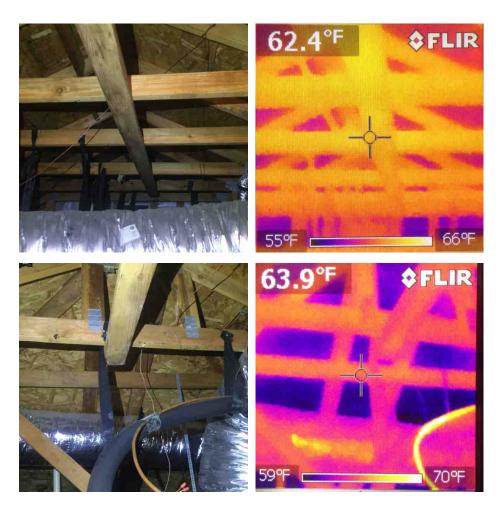
#### • ATTIC STRUCTURE

The roof structure is truss system with 2x4 wood members and attached with metal gusset plates.

Roof Decking Type: OSB Board.

Approximate Average Depth of Insulation: Between 8 and 12 inches in depth. Approximate Average Depth of Vertical Insulation: 4 to 6 inches in thickness. Blown & Batt insulation was noted with a depth between (10" –13").

Portions of attic were inaccessible due to inadequate catwalk and vaulted ceiling.
