HOME INSPECTIONS INC.

Concerning: 3315 Barkers Forest Lane Houston, Texas 77084

October 26, 2020

Report Identification: 201026-2 3315 Barkers Forest Lane

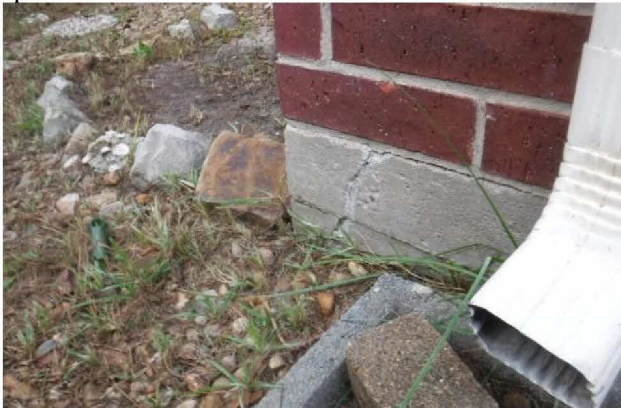
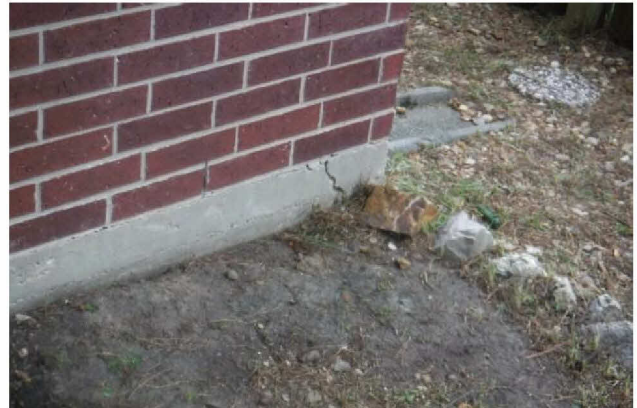
Note: The foundation has corners that have spalled. Corner spalling is cosmetic and has no effect on foundation performance but can mask the presence of termites entering the home. The insects can enter between the separations in the concrete. Recommend quarterly treatment from a licensed pest control operator.

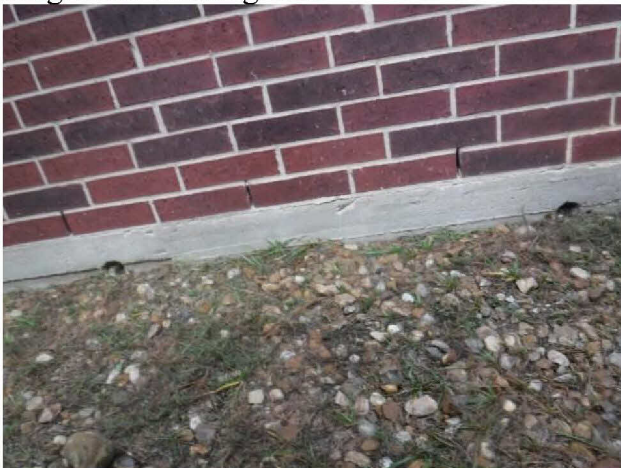
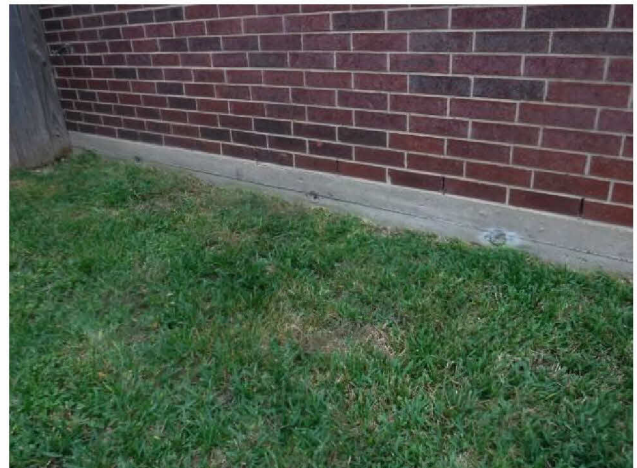
★ The foundation cable ends are exposed which over time can rust and weaken the strength of the cables possibly causing foundation problems/repairs in the future if the current condition is not repaired. Remove the rust from the cable and cover with rust inhibitor primer and seal with a high strength non-shrink grout.

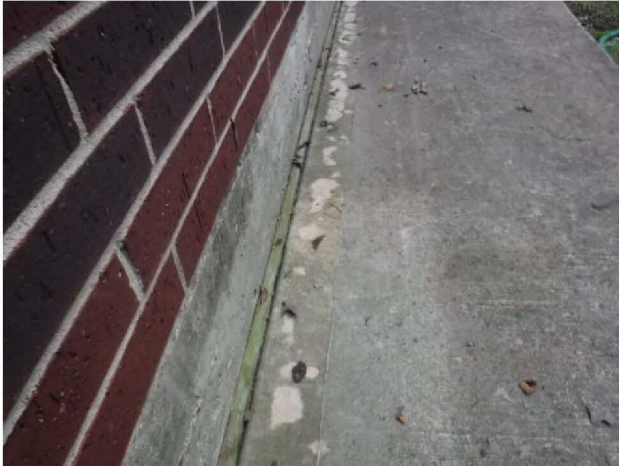
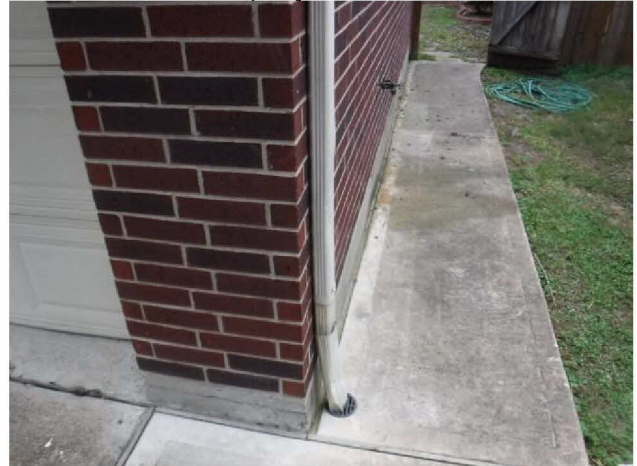
- ★ The wood form-boards and all wood in contact with the ground should be removed from around the foundation; this condition is conducive for wood rot and wood destroying insects.

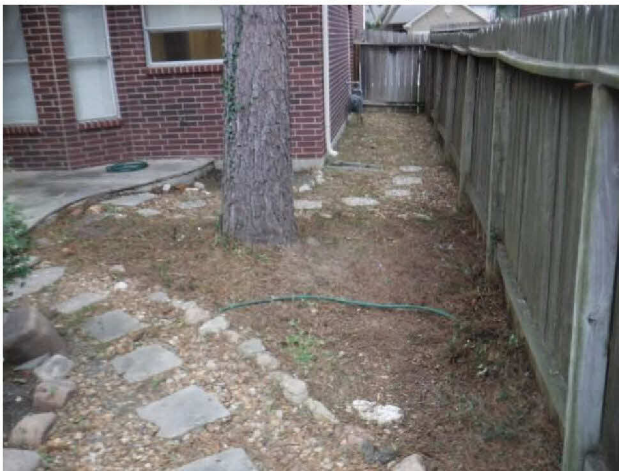
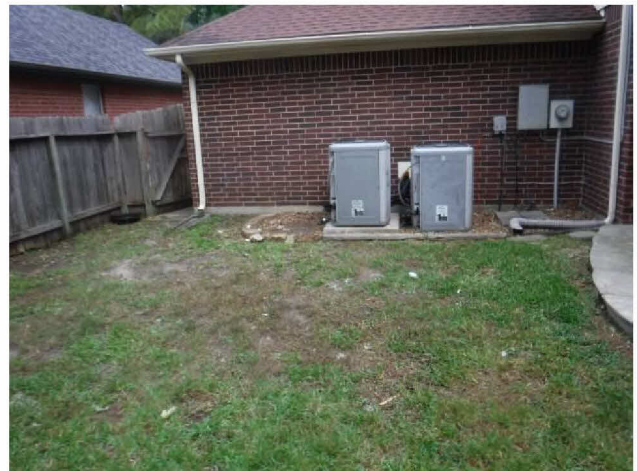
- ★ There are low areas around the house that allow standing water; back left and right corners of house. Recommend installing an underground drainage system with downspouts connected. Standing water can cause foundation problems, mosquito infestations and lawn disease.

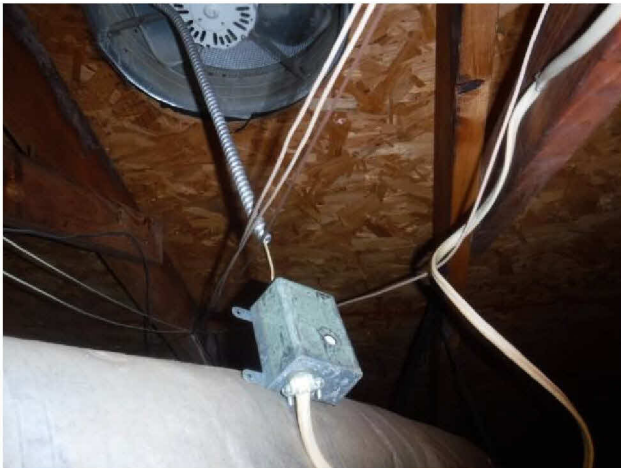
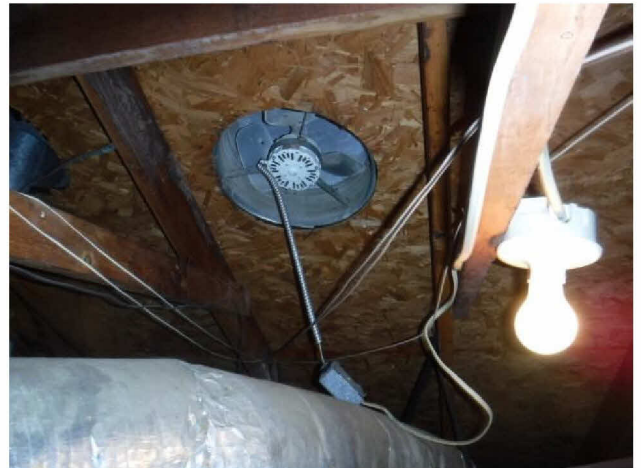
★ The attic power vent was inoperable at the time of inspection. The thermostat is hanging by wiring.

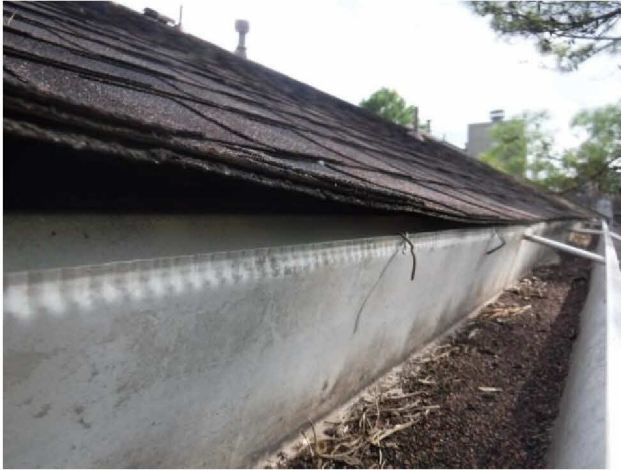
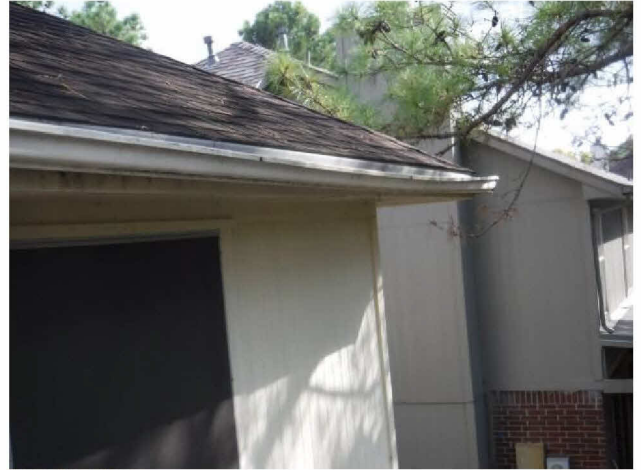
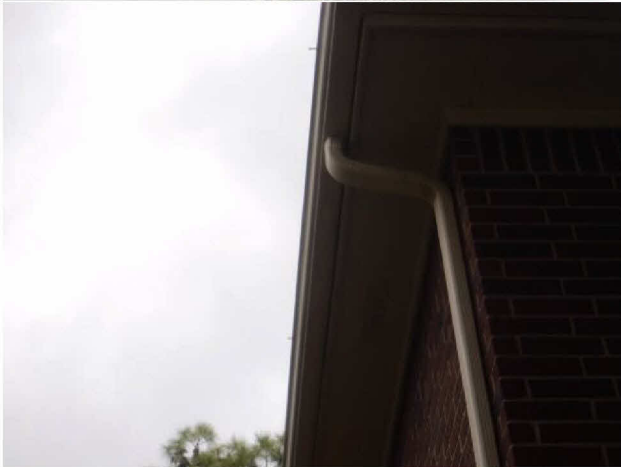
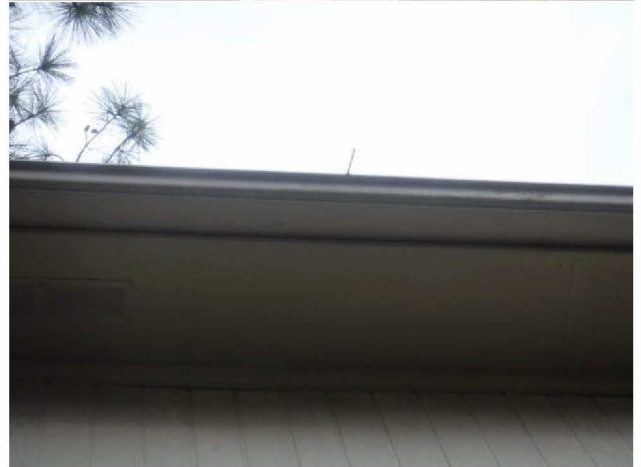
- ★ The back side of gutter should be installed behind the drip edge flashing to prevent water from running down the back side of the gutter and fascia board.
- ★ The gutter system requires maintenance / repair at the following areas; ensure that the sections have the proper slope to encourage drainage to the downspouts, reattaching to the fascia board, many loose gutter spikes and sealing at connections to prevent leaks
- ★ The rain gutters are full of debris at several locations. Recommend the installation of debris guards at all sides for less maintenance and longer gutter life.

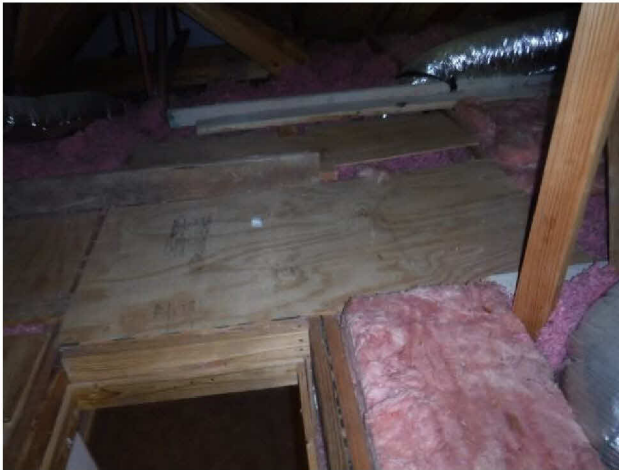
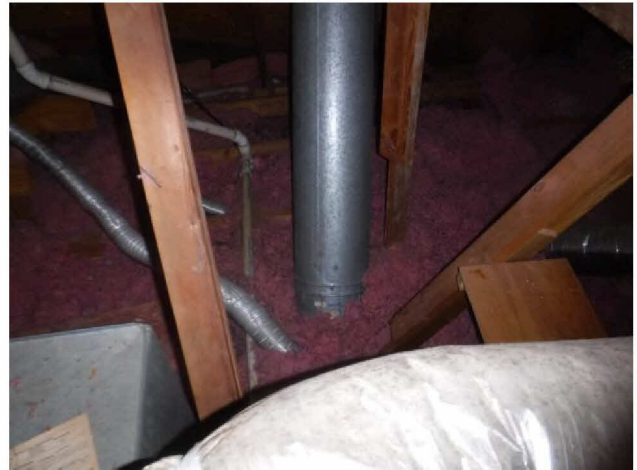
- ★ There is decking not rated as decking material (too thin) in attic.
- ★ There is inadequate clearance of combustible or attic insulation around the chimney vent pipe. A minimum of 1 1/2" - 2" clearance is required.

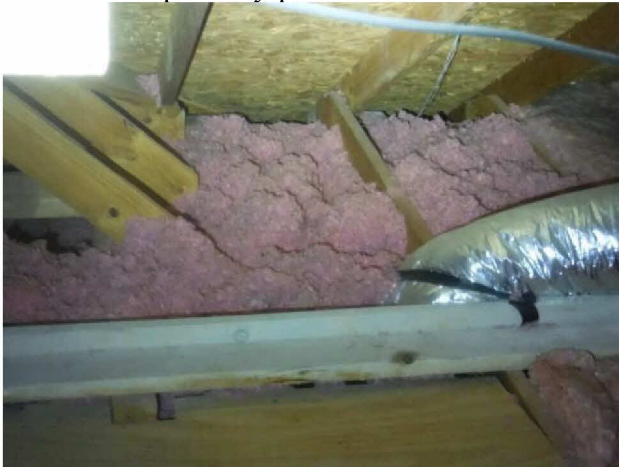
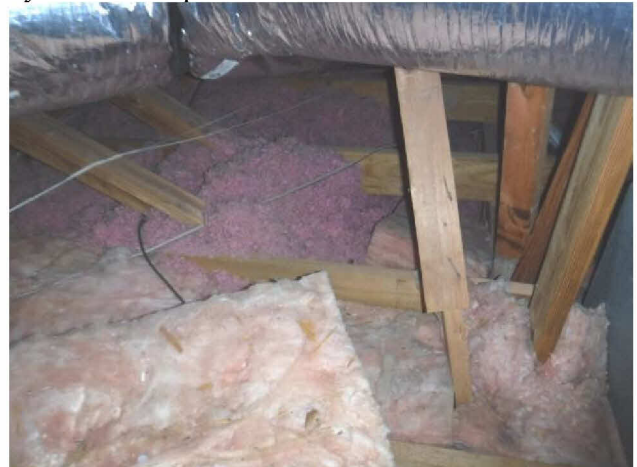
- ★ There is evidence of rodents in the attic by trampled, uneven insulation and of rodent droppings. Recommend quarterly pest control and eradication by a licensed professional.

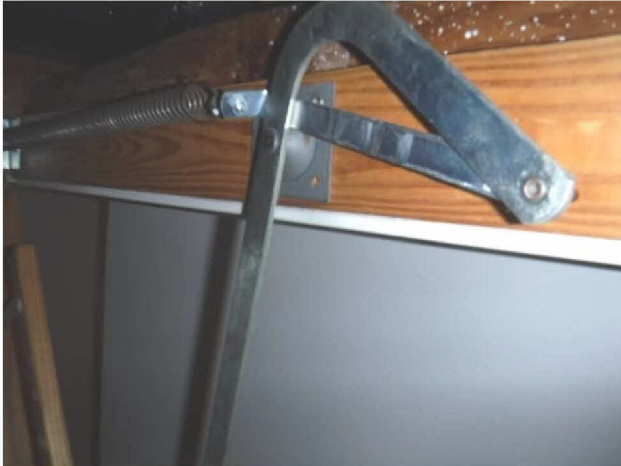
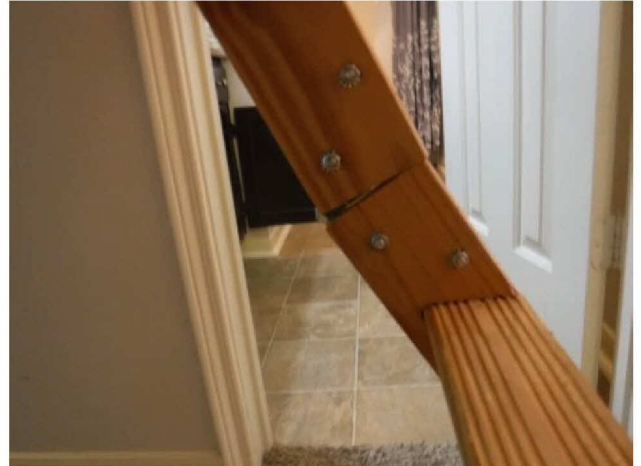
- ★ The attic stairs are not cut to fit. There are gaps between the attic stairs sections that allow movement.
- ★ The attic door attachment points to the frame are missing the required 16d nails or lag screws. All holes should be filled.
- ★ The attic stairs sag; the springs need adjustment or add weather stripping as needed.

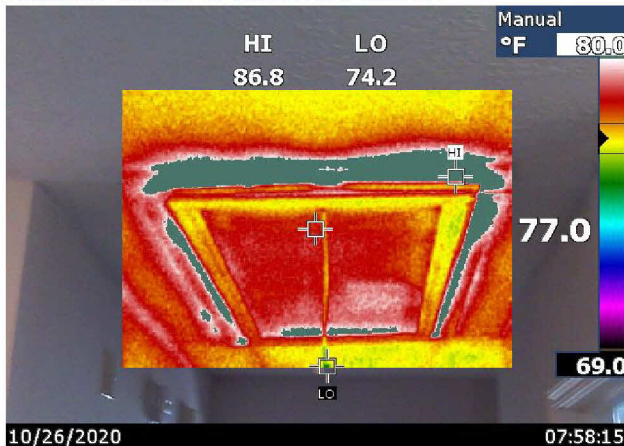
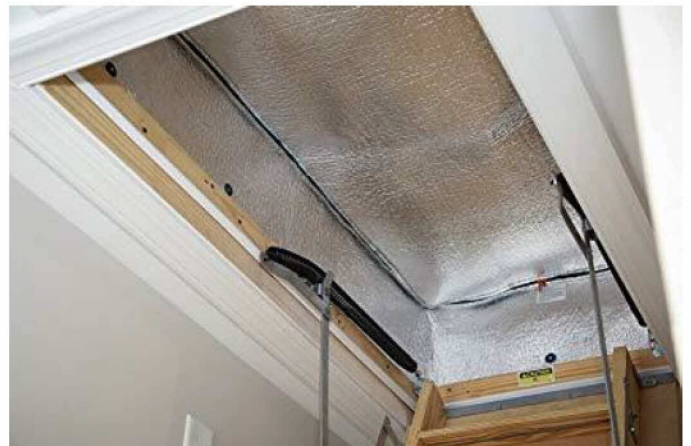
- ★ The attic access door is not insulated and the gap at the door frames are not properly sealed / insulated with expanding foam. The door should be insulated with a hardboard insulation panel. The thermal image shows the transfer of heat and temperature differential. Recommend installing a full door insulation tent or cover as seen in image at right. There are many different types available online or hardware stores.

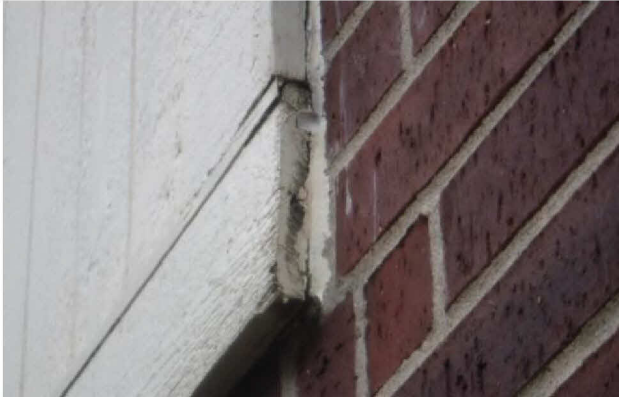
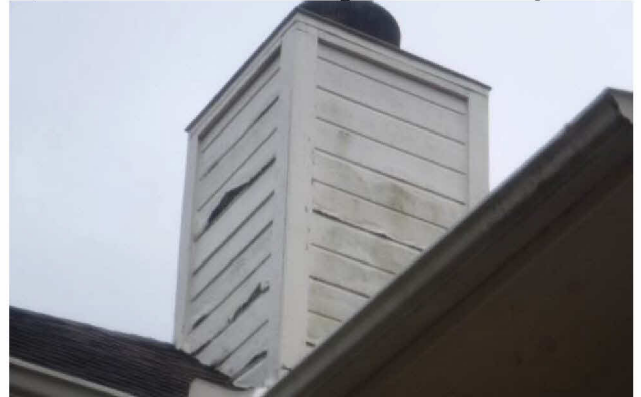
- ★ There are areas of wood rot observed around the house; trim material and siding at the chimney.

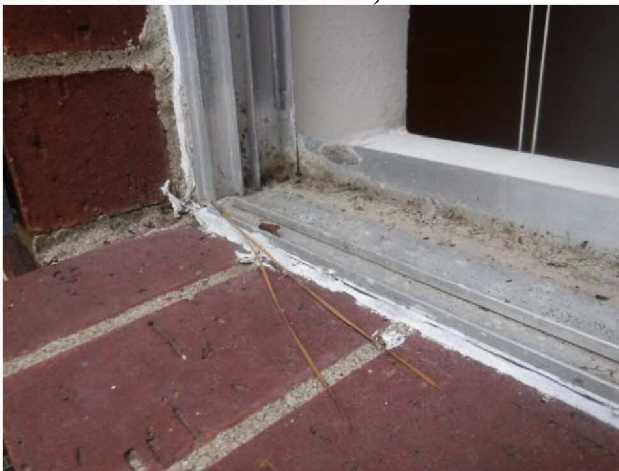
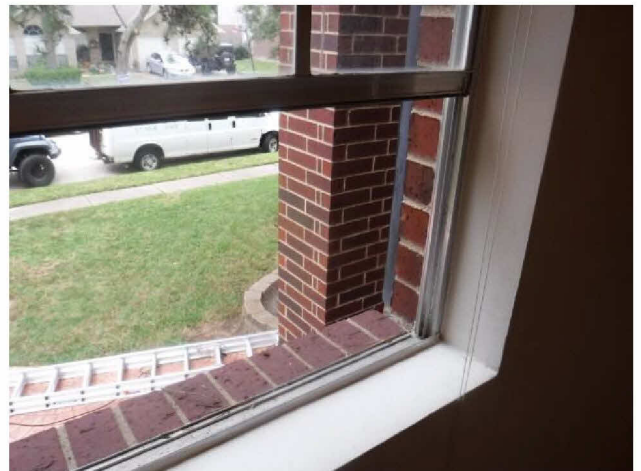
- ★ The sealant at most penetrations of the house is deteriorated or gaps in material. All penetrations and openings around the exterior should be properly sealed with caulk, screen mesh, expanding foam or mortar as needed to keep out moisture and unwanted pests (Do not seal up weep holes where the brick meets the slab).

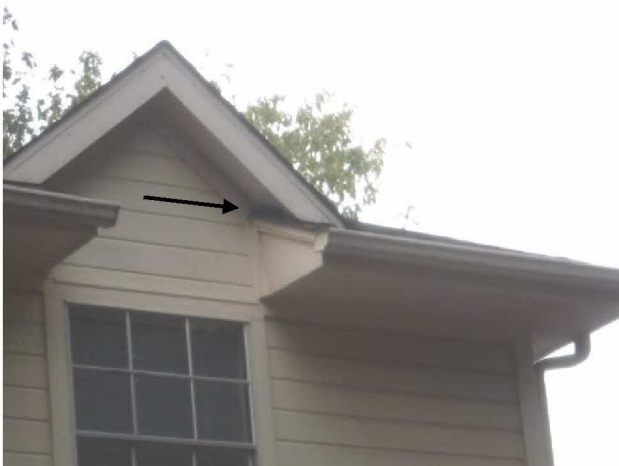
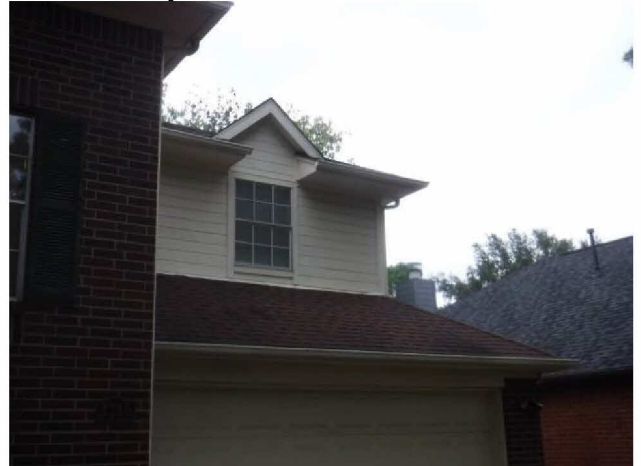
- ★ There is a hole in the soffit material at the front due to rodent entry.

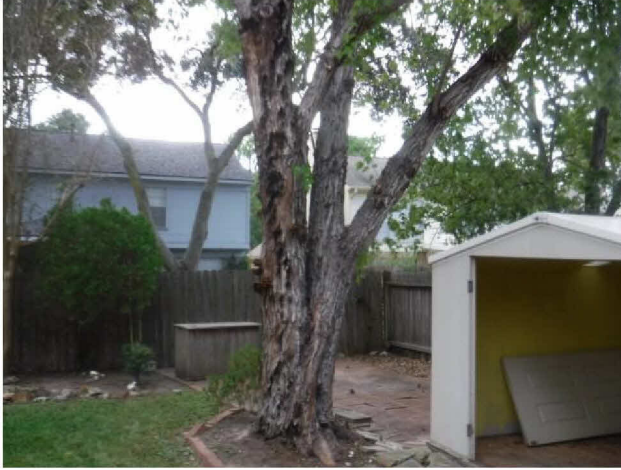
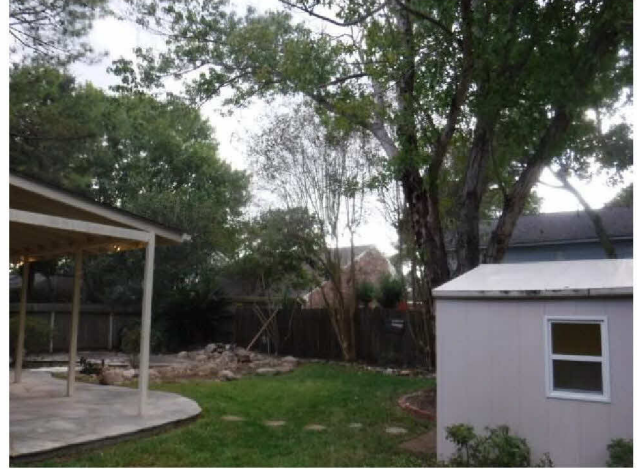
- ★ There is a rotted / infested tree at the back yard.

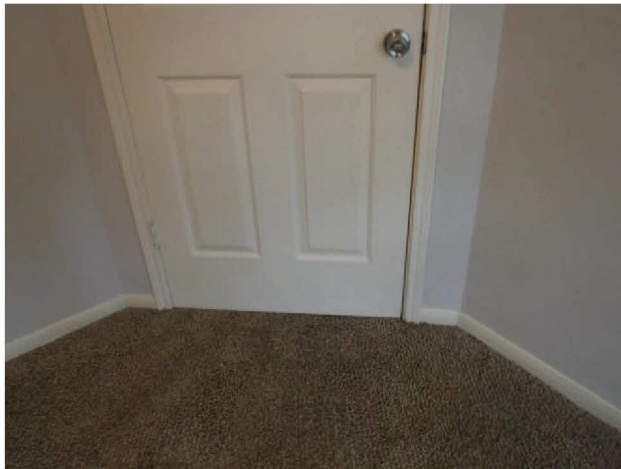
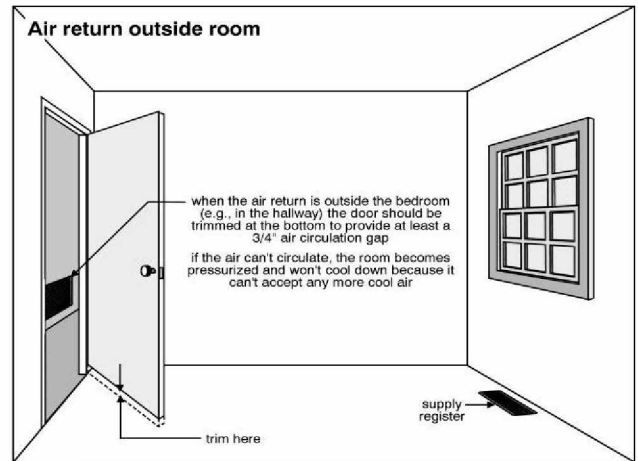
- ★ There are one or more doors in the house that rubs the carpet. Recommend having jumper ducts installed at all carpeted rooms to improve air flow and more even temperatures throughout the home.

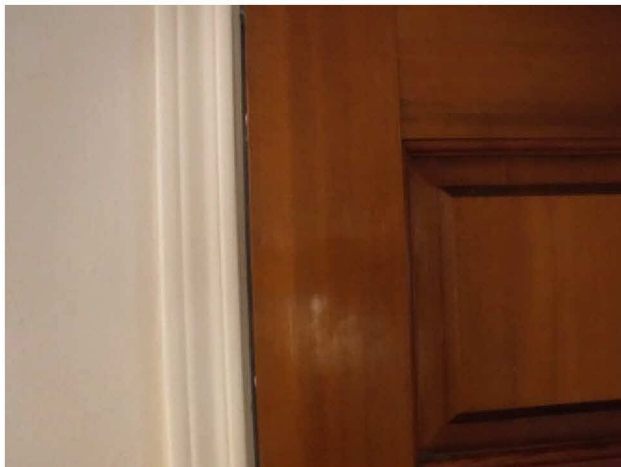
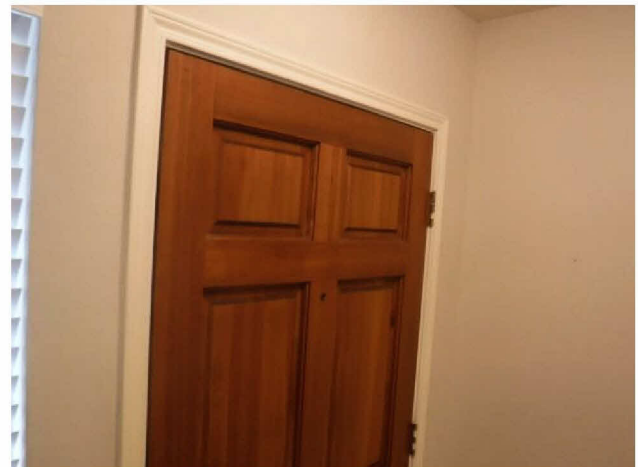
- ★ The door rubs the frame at top and requires adjustment to close properly; garage door.
- ★ The front door has visible daylight showing around the sides of the door. The weather stripping should be replaced, or the door adjusted to provide an air tight fit to prevent loss of conditioned air.

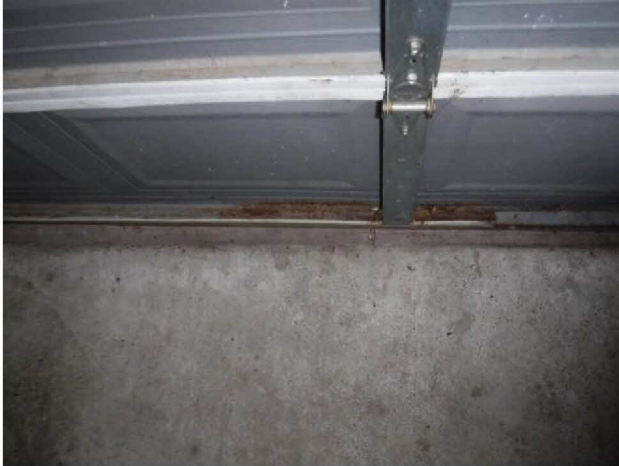
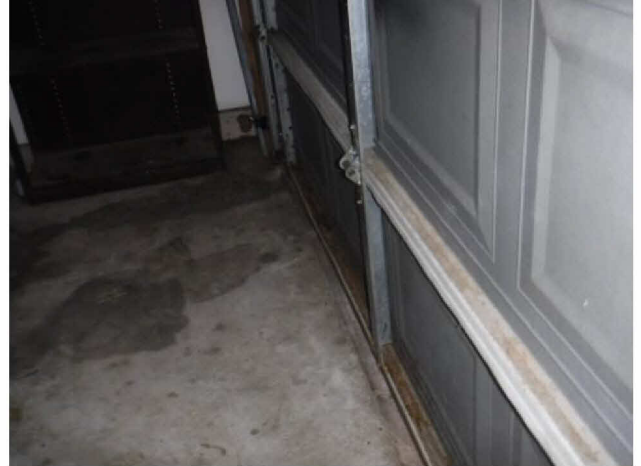
- ★ The garage door lock should be made inoperable when an automatic opener is installed to prevent damage if opened while the door is locked.
- ★ There is rust at the bottom of the door.

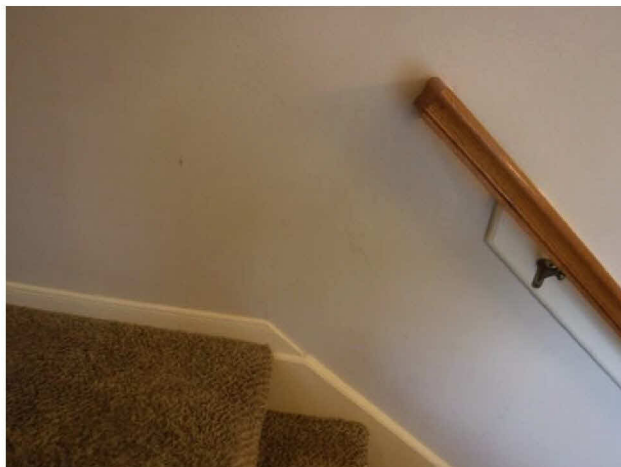
- ★ The stairway handrail is not continuous. "Handrails for stairways shall be continuous for the full length of the flight, from a point directly above the top riser of the flight to a point directly above lowest riser of the flight." REF IRC R311.5.6.2

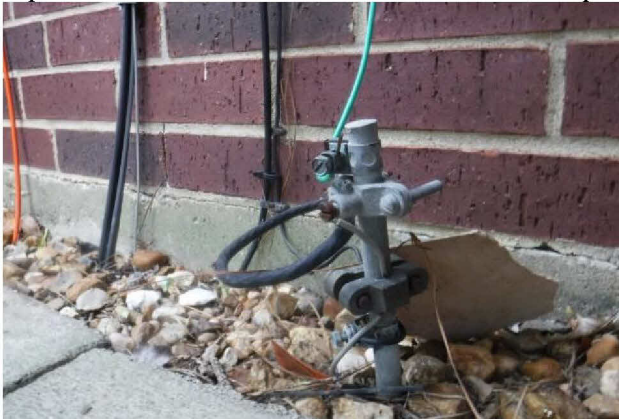
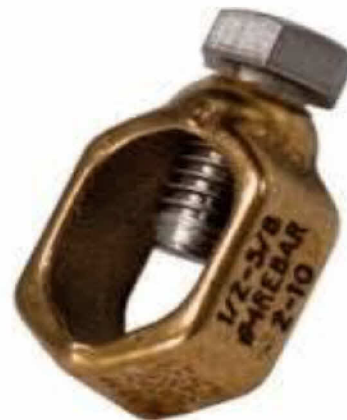
- ★ There are circuit disconnects / breakers not properly labeled. All service disconnects should all be permanently labeled and specifically listed for their purpose. REF IRC E3501.6.1
- ★ The ground rod clamp is not rated as a grounding clamp. A proper grounding clamp rated for the purpose should be used such as the acorn clamp.

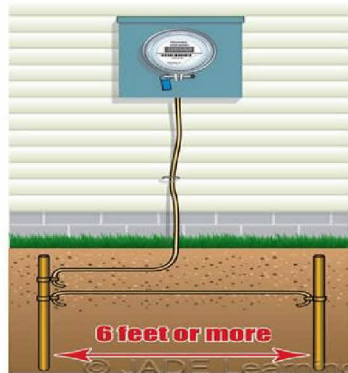
- ★ The inspector did not observe a supplemental grounding system (2 grounding rods no closer than 6 feet apart) as required in the 2011 National Electric Code. The exception is a primary grounding system with less than 25 ohms to ground. (NEC 250.53(A)(3). Note: Concrete encased electrodes "Ufer Grounds" are no longer acceptable due to the inability to verify full ground contact. It is recommended that a licensed electrician be contacted for further information/evaluation. (Typical for a house of this age. House was built before the new electrical code update).

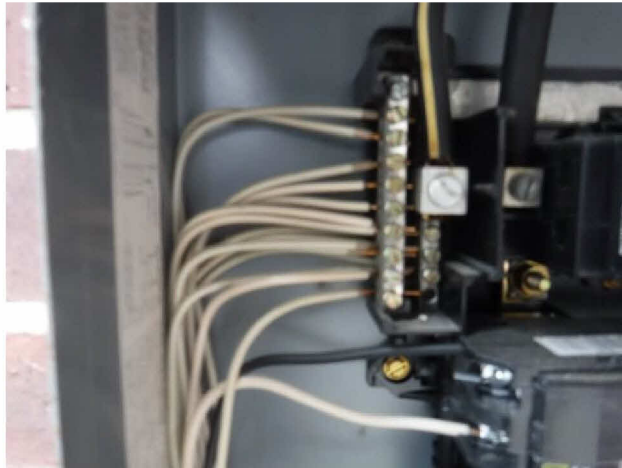
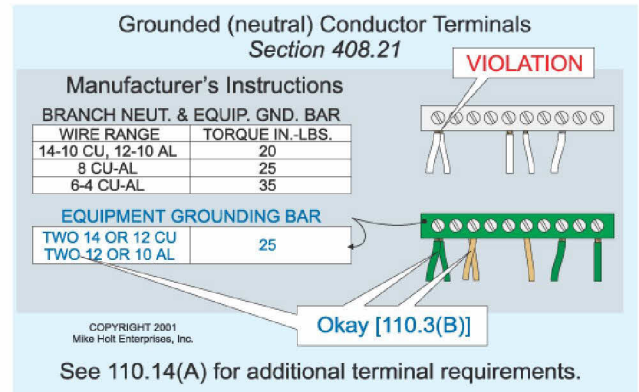
- ★ The neutral wires are current carrying conductors and should not be double lugged. Grounded Conductor Terminations—Each grounded conductor shall terminate within the panelboard in an individual terminal that is not also used for another conductor. NEC 408.21

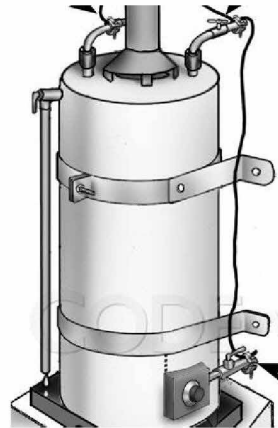
★ The gas line and water lines should be bonded together at the water heater(s). The gas line bond was not observed. REF IRC 3509.6

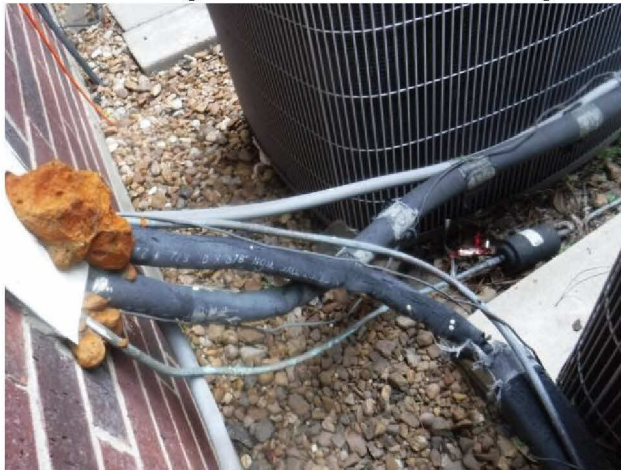
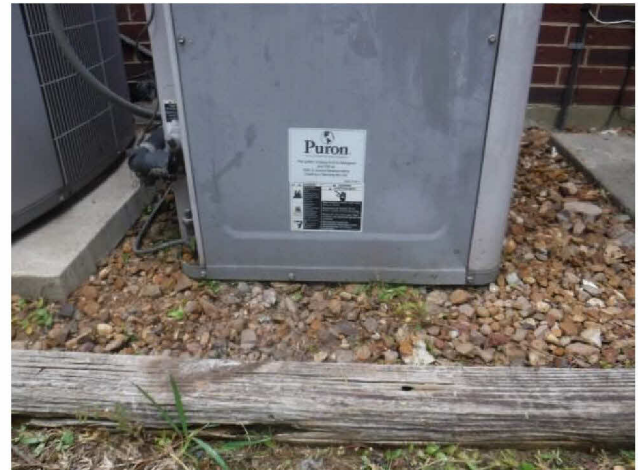
- ★ The a/c suction line insulation is damaged at areas exposing the line causing the system to be less efficient.
- ★ The yellow foam should be painted / sealed to prevent deterioration.
- ★ The condensing unit is on or near the ground. Recommend elevating 3 inches from the ground to protect from vegetation and moisture damage.

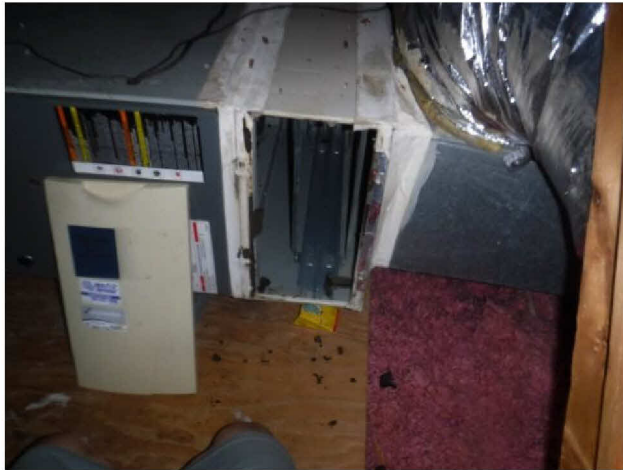
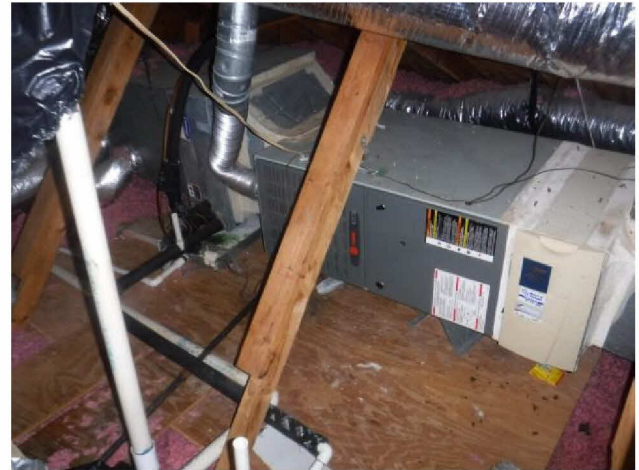
Note: The air conditioners have a media filter installed in the attic system but is not being used. These filters should be changed every 4-6 months to ensure proper operation and efficiency of the system.

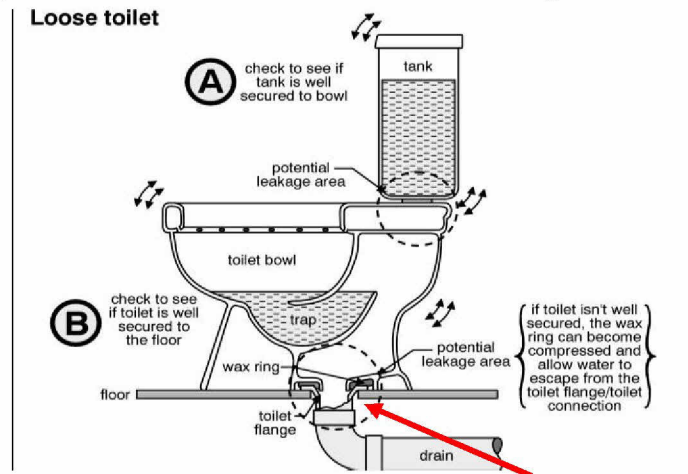
★ The base of the commode is loose where it connects to the floor. Recommend replacing the hardware and wax ring for the bowl and ensure there is not leakage at the floor; master bath.

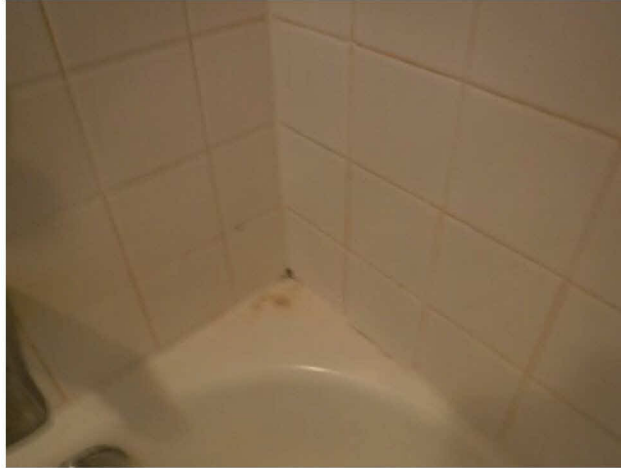
- ★ The corners in the tile must be sealed as the grout will separate / crack. All corner seams must be properly sealed to prevent potential water penetration behind the material. Note: A clear matt finish will produce an invisible seal.

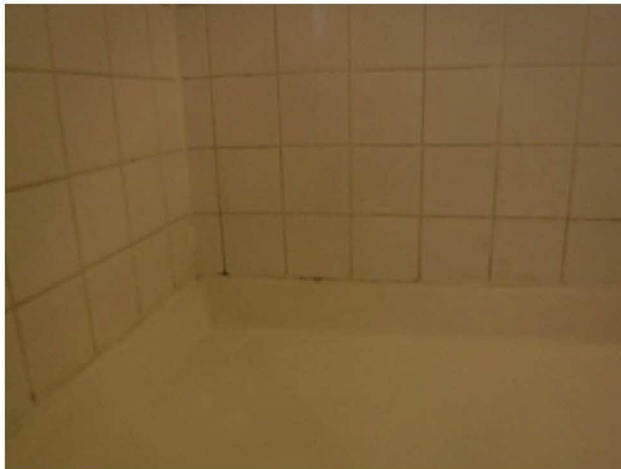
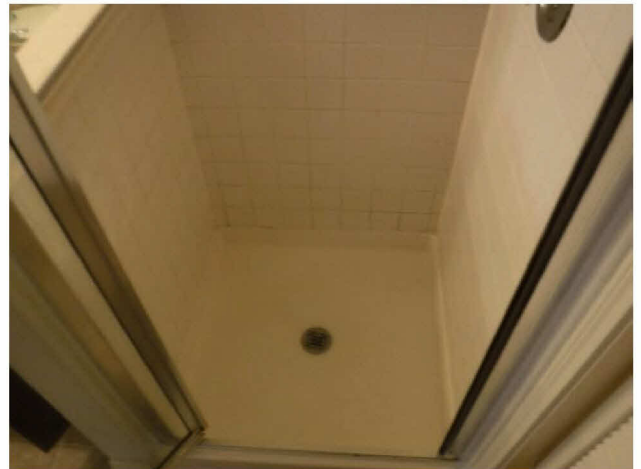
- ★ The bath shower sealant is deteriorated or missing at the corner locations. These areas must be properly sealed to prevent water penetration. Recommend a clear matt finish for an invisible seal. The grout must be sealed over as it will crumble over time at the corner locations.
