PROPERTY INSPECTION REPORT

Report I.D. # 111620-A

Concerning: 3510 Stratford Plaza Lane
Sugar Land, Texas 77498

Lee Fasbinder, T.R.E.C. #7507

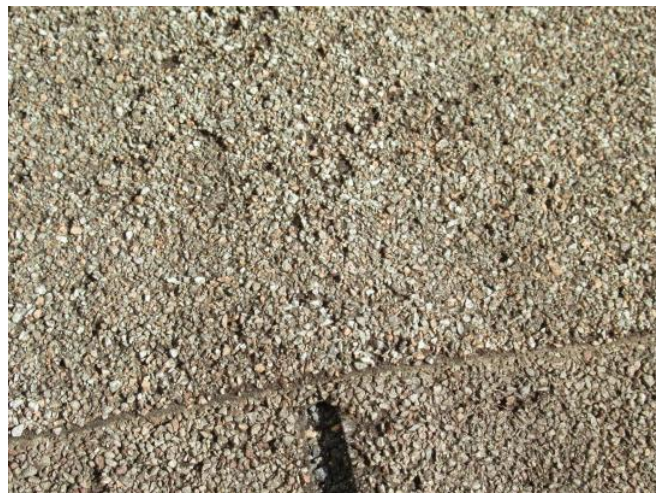
The shingles are showing normal wear for its age. Pitting, topical granular loss and fiberglass frayed edging is just starting to occur. Minor repairs were noted. At the time of this inspection, the covering is functioning as intended.

Pitting present.

I estimate that this covering will need to be replaced within the next four years.

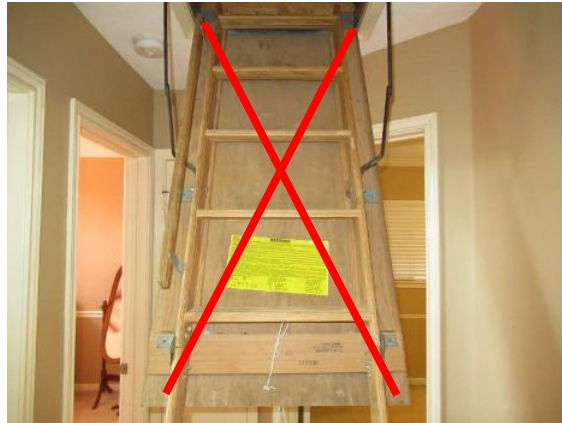
The attic, pull down ladder hatch in the hall ceiling needs to be insulated on the inside of the hatch (attic side). Weather stripping also needs to be installed along the edges. The hatch is part of the ceiling that connects conditioned space to unconditioned space.

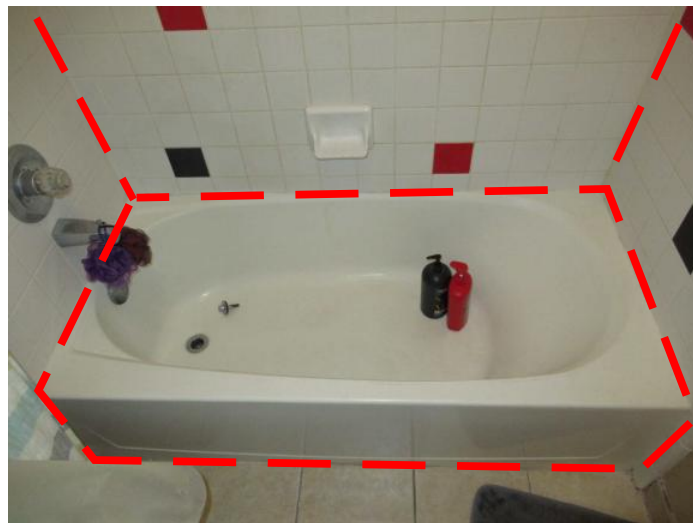
The grout in the right angle corners (vertical and horizontal) inside the upstairs shower/bath tub is cracked. The corners must be water tight sealed with silicone type caulking.

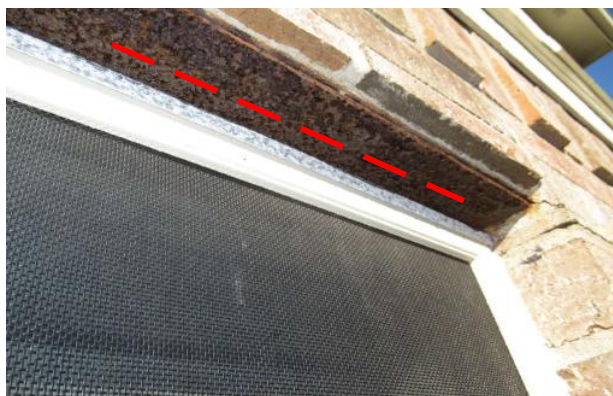
All (metal) lintel plates over the windows and doors need to be refinished (remove rust, caulk, prime, paint).

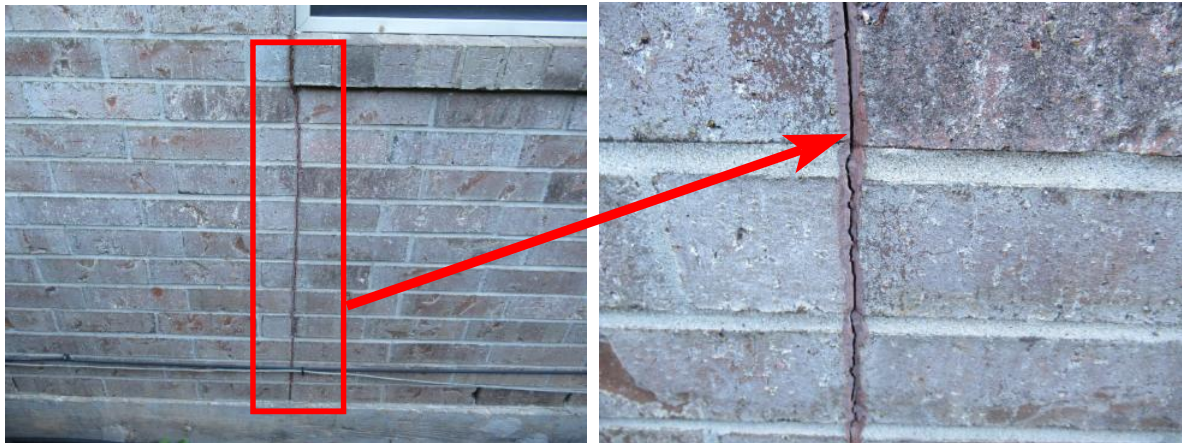
The brick expansion joint on the left side of the home (left of the master tub window) of the home needs to be filled in with exterior caulking (silicon sealant).

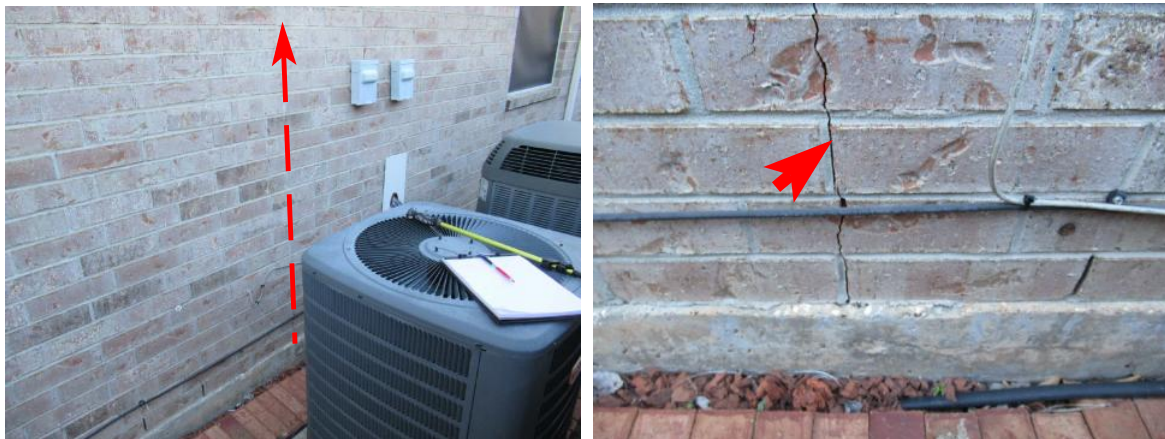
The structure has experienced a range of very minor movement, which has caused a “stairs step” crack in the brick mortar on the left side of the home (see “Exterior Wall” section in this report). However, the evidence of such minor foundation movement is not within a range that would be indicative of a structural distress condition, or that would require foundation repair work. At the time of this inspection, the general condition of the residence indicates that the foundation is functioning as intended, with no foundation or structural repairs needed.

The (very small) brick crack on the left side of the home, behind the Goodman® A/C condensing unit, needs to be caulked in.

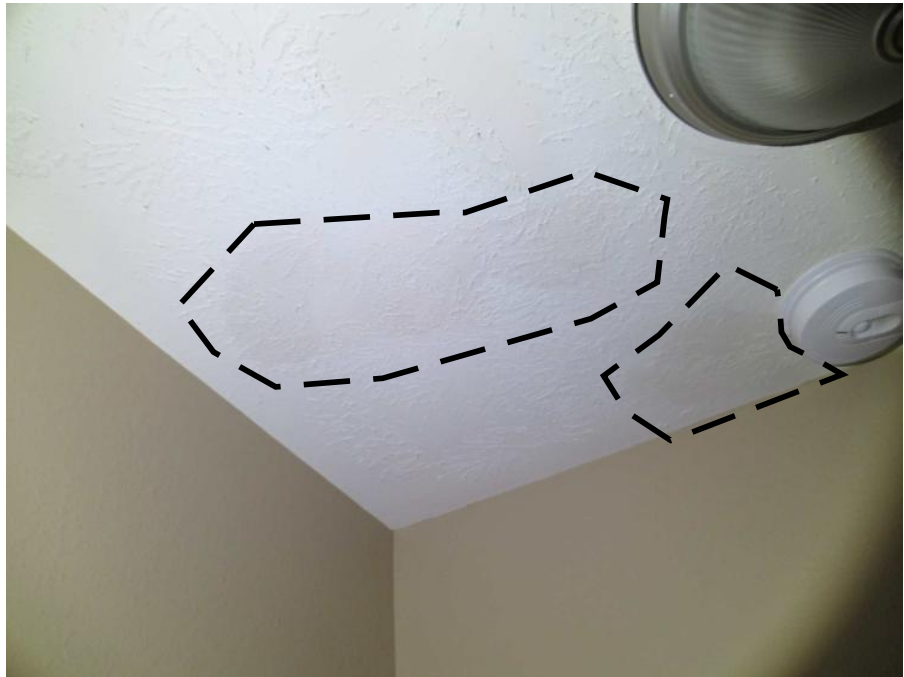
There are two water stains on the ceiling outside the master bedroom. The stains are completely dry and do not show any physical damage. It appears that these stains have been therefor quite some time. The upstairs hall bathroom is directly above. I would as the sellers about these water marks along with what repairs, if any, were made.

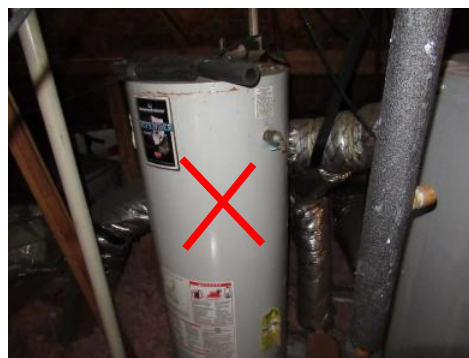
The old (non-function) water heater inside the attic needs to be removed.

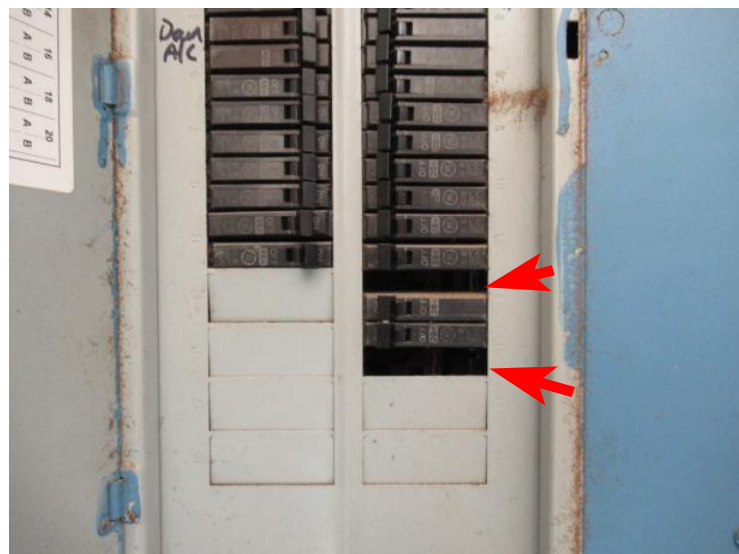
There are two open knockouts on the inside (electric) breaker panel. These need to be closed off with plastic "dummy" plates.

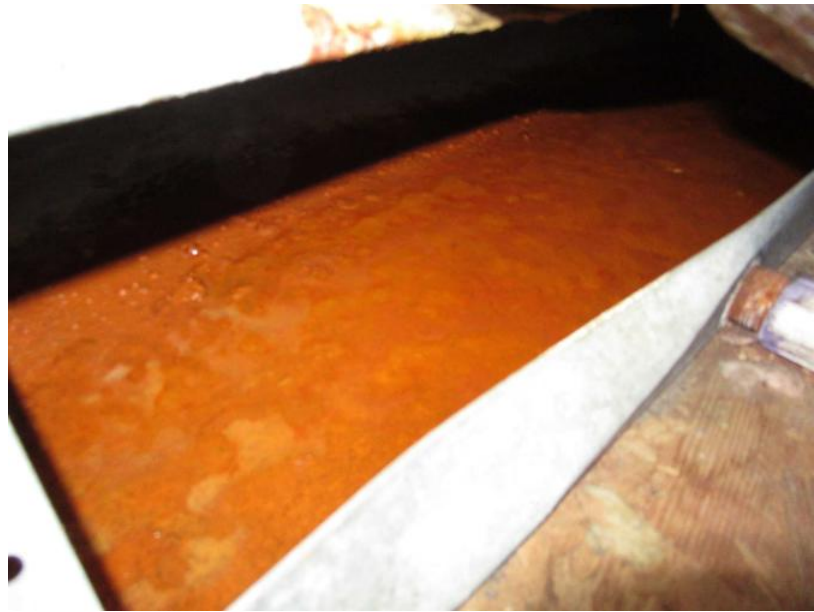
Pan is filled with water.

- *The suction refrigerant line on the zone 1 evaporator coil, inside the attic, needs to be wrapped in HVAC piping insulation.*
- *The drain pan under the zone 1 evaporator coil is filled with water.*
- *Both evaporator drain pans are rusted. Replace.*
- *Any additional repairs needed/advised by the technician.*

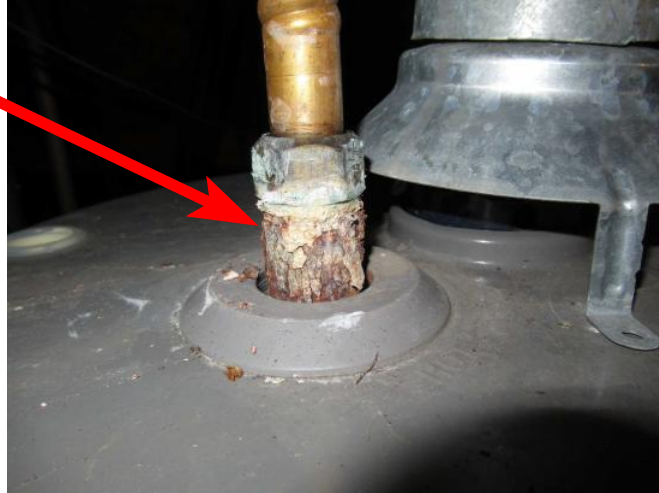
Corroded

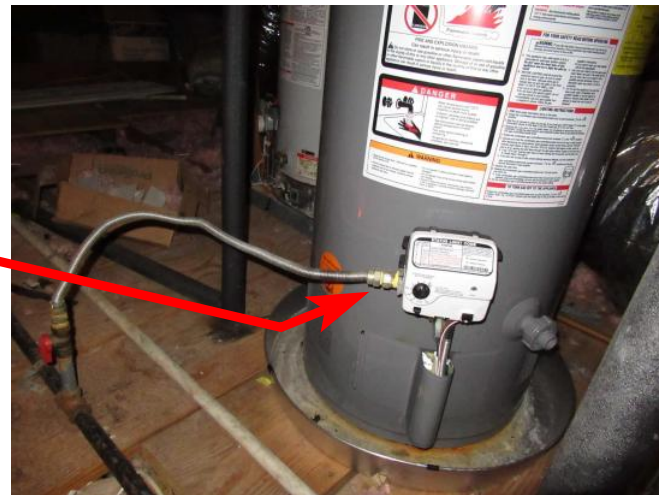
Sediment trap goes here

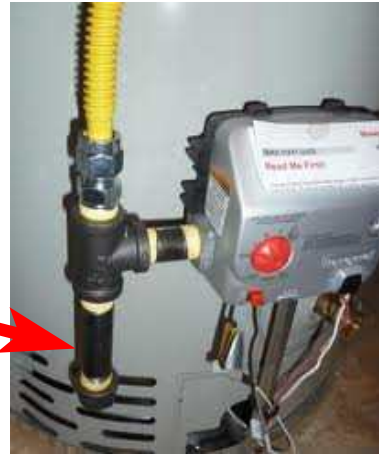
Sediment trap on a gas line for water heater
