HOUSTON INSPECTIONS

Chad & Taylor McCoy
313 Eado Park Circle
Houston, TX 77020

November 9, 2018

PROPERTY INSPECTION REPORT

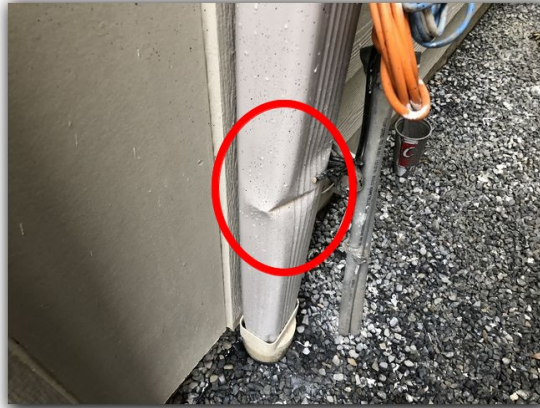
Damaged downspouts were found at gutters.

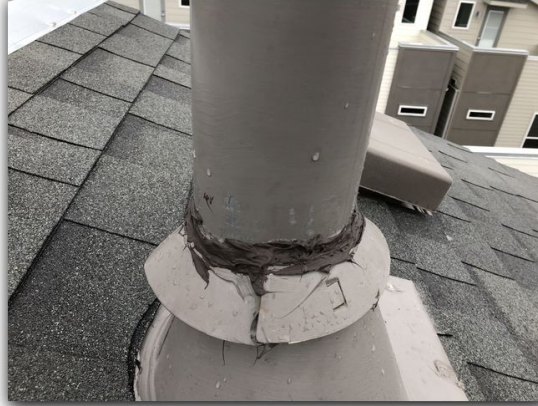
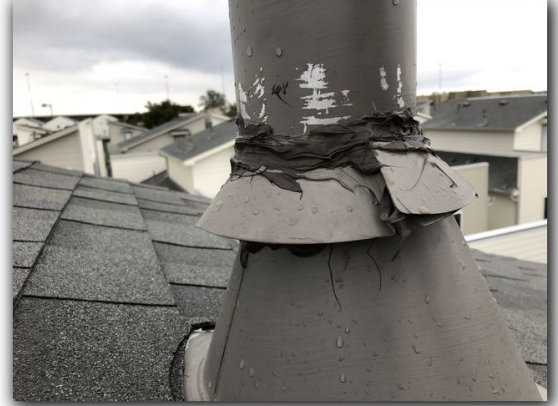
The water heater rain cap is damaged and does not appear to be installed correctly. Recommend repairs by a qualified tradesman.

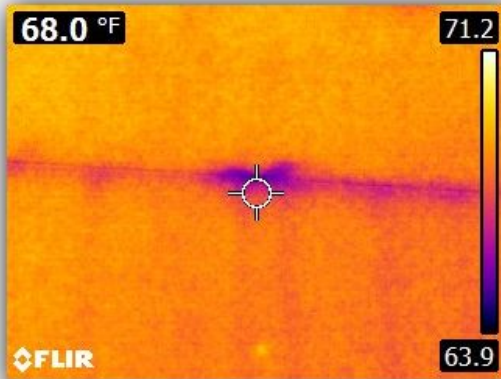
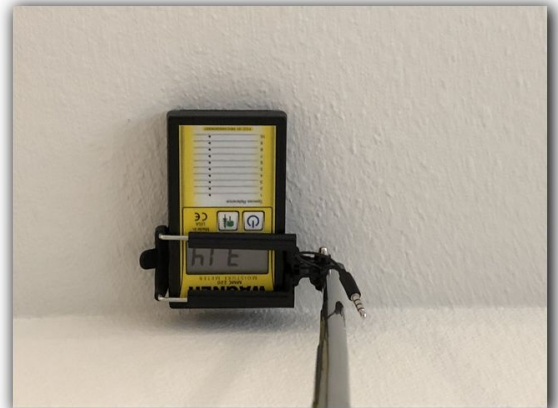
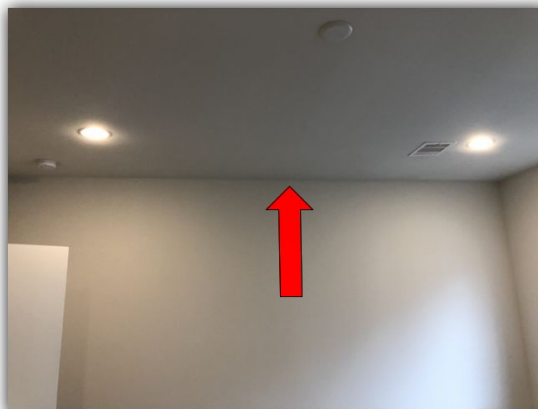
During the inspection of the ceilings in the property with a infrared an abnormality was found at the ceiling in the master bedroom. The area was further evaluated with a pinless moisture meter which revealed elevated moisture conditions. The source of the problem cannot be specifically pinpointed without performing more invasive inspections. It is recommended that a qualified tradesman be consulted to fully evaluate this area and make the needed repairs to correct the source of moisture and any damage.

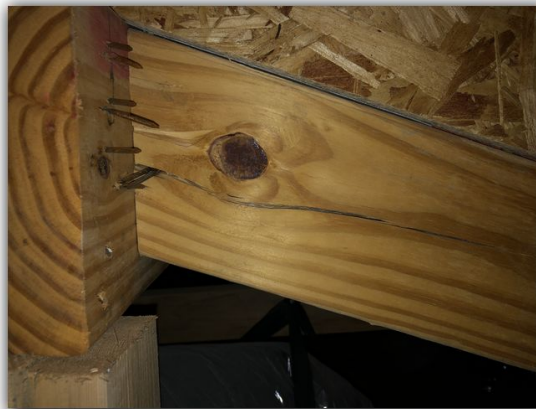
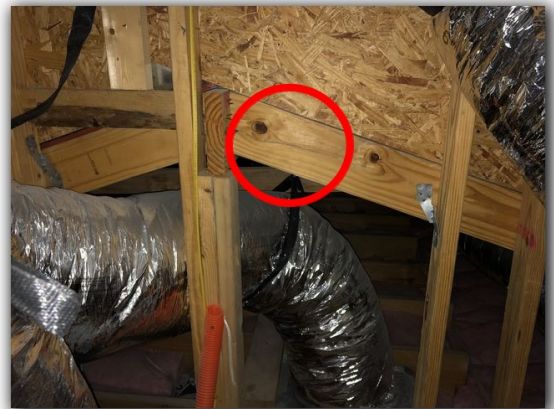
Damaged / cracked rafters were found in the attic. Recommend repairs by a qualified tradesman.

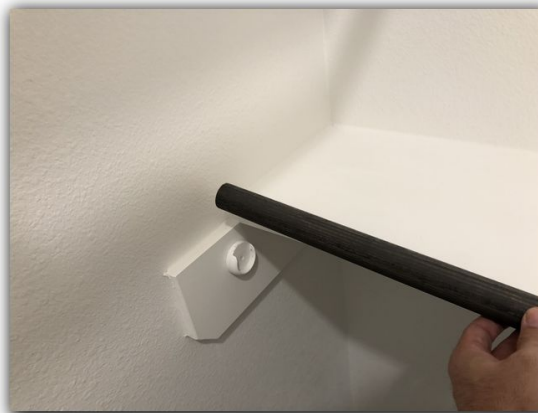
- Improper clearance of the exterior veneers from flatwork (2").
- Closet rods are not secured at the wall hangers.

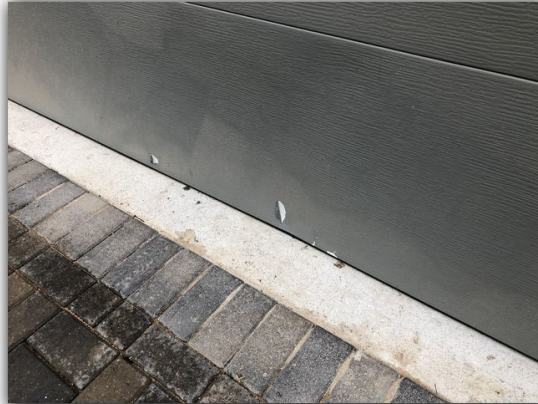
The paint appears to be wearing down on the exterior garage door of the structure as evident of flaking.

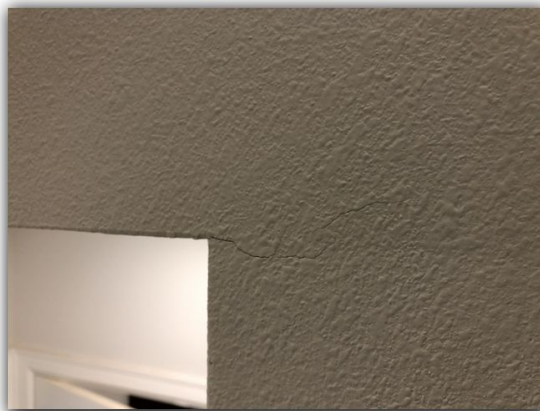
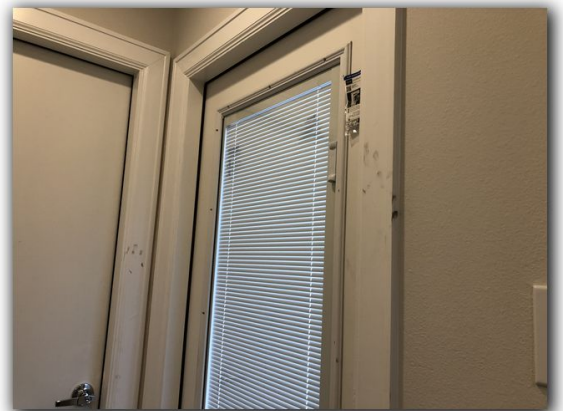
Many items at the property have not been completed at the time of the inspection. Missing paint, caulking, other items on the walls have not been completed for the inspection. The client is urged to perform a final walk-through prior to closing to insure all items have been completed satisfactorily.

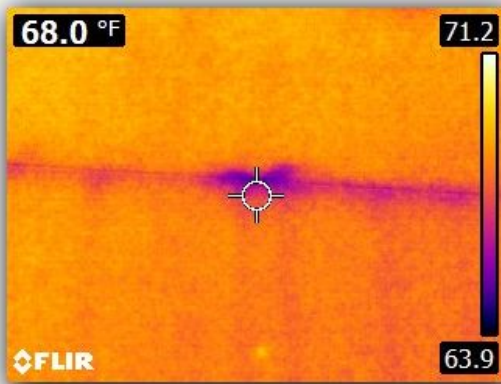
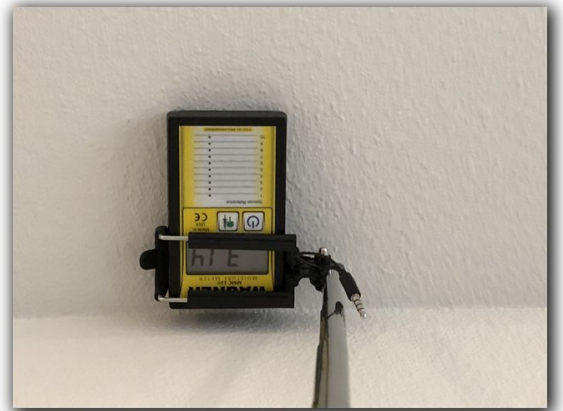
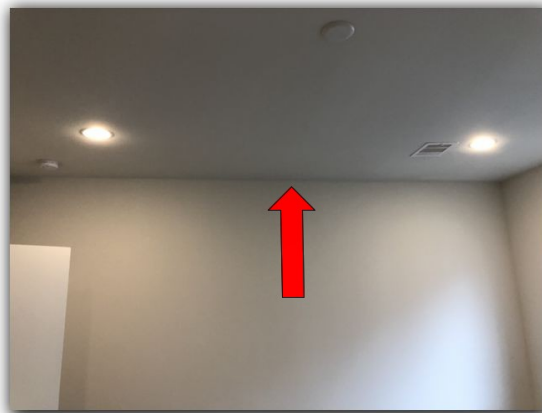
During the inspection of the ceilings in the property with a infrared an abnormality was found at the ceiling in the master bedroom. The area was further evaluated with a pinless moisture meter which revealed elevated moisture conditions. The source of the problem cannot be specifically pinpointed without performing more invasive inspections. It is recommended that a qualified tradesman be consulted to fully evaluate this area and make the needed repairs to correct the source of moisture and any damage.

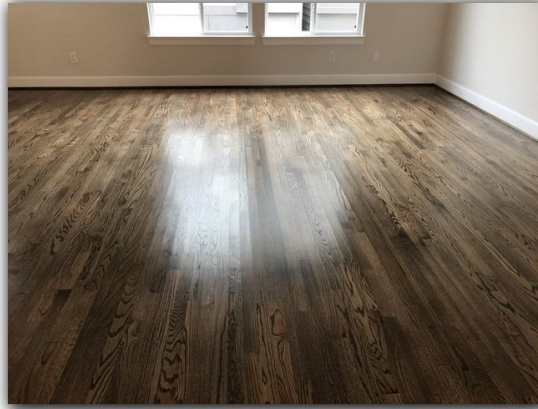
Warped / buckled wood floors were found in the second floor. A qualified tradesman should be consulted to determine the source of moisture and needed repairs.

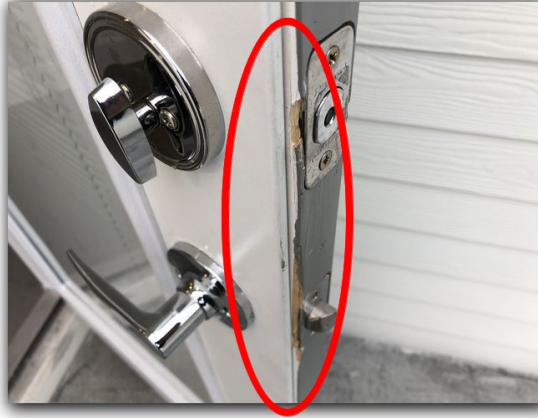
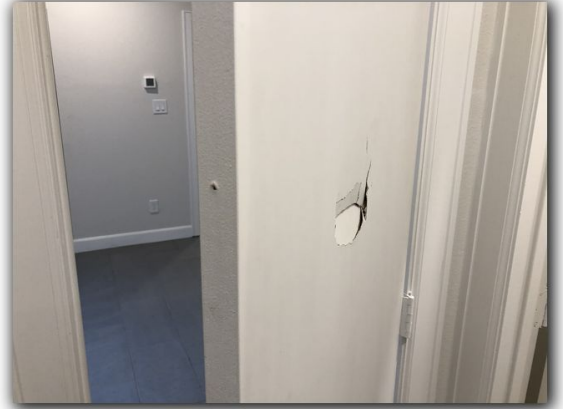
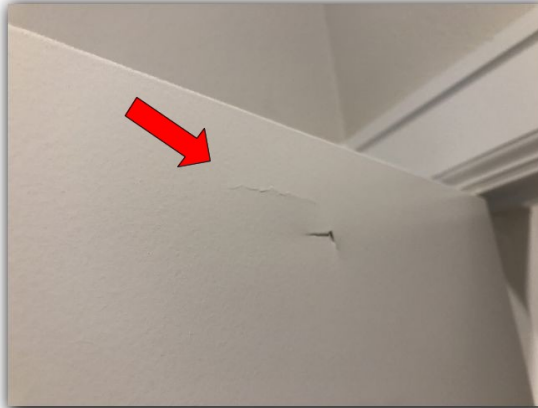
Damage was found at the Balcony, first floor guest bathroom, and third floor laundry room doors. Replacement of the damaged items is recommended.

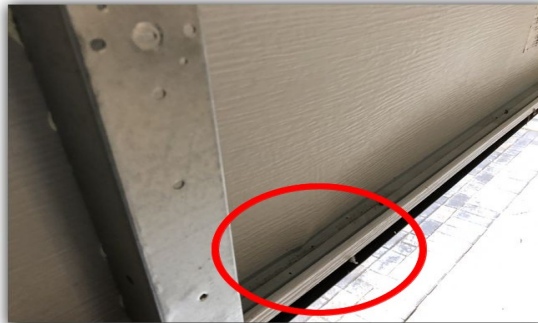
Damage was found at the garage door panels. Recommend repairs.

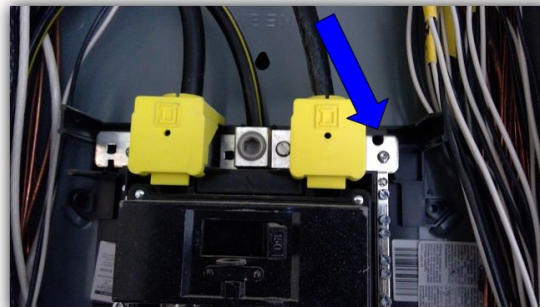
Bonding not present at panel raceway(s)

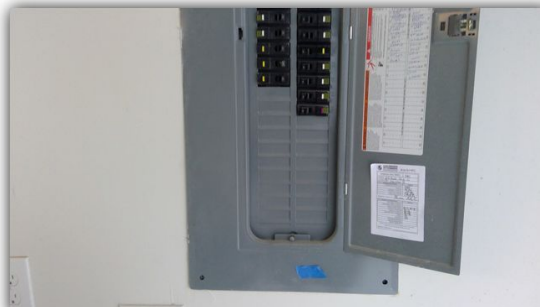
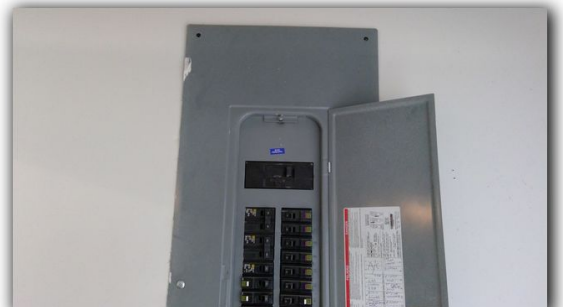
Missing screws were found at the dead front cover located at the main service panel. Approved screws should be installed at the dead front to properly secure the cover.

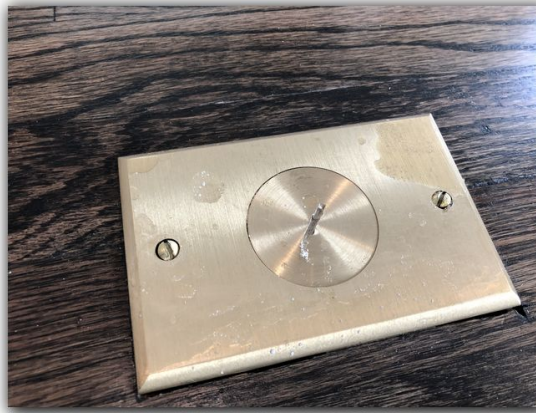
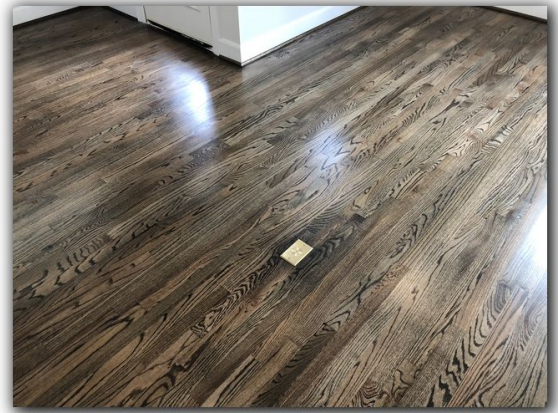
A damaged floor receptacle cover was found in the living room. The cover would not turn off to test the receptacle. Recommend replacement of the receptacle cover.

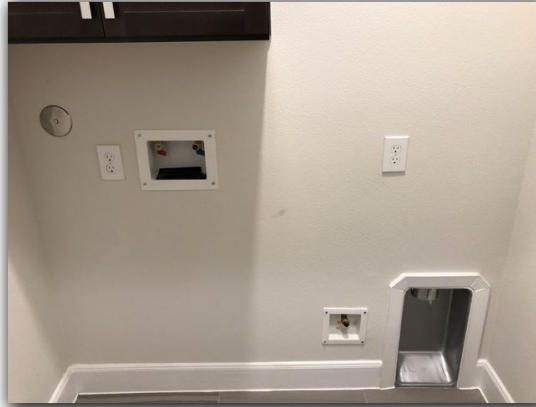
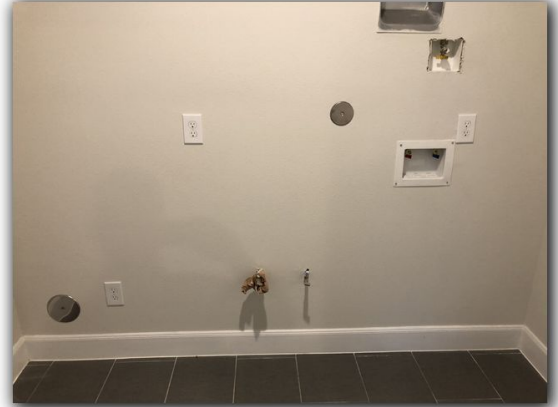
A 240 volt dryer receptacle is not installed in the laundry room. A gas dryer must be used in this home.

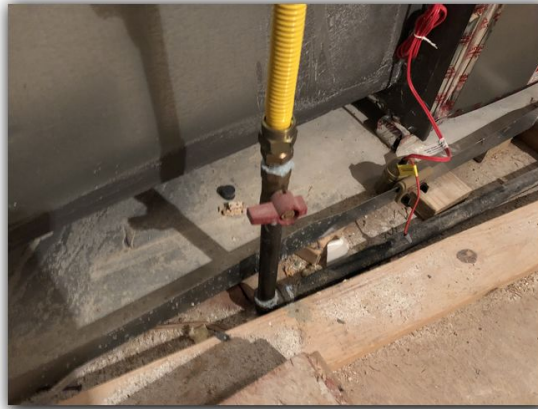
The gas heater(s) was not inspected for proper operation due to the gas valve being turned off at the unit during the inspection. We do not turn gas valves on due to the associated risks and liabilities associated with such a practice. The gas should be turned on and the unit inspected for proper operation prior to closing.

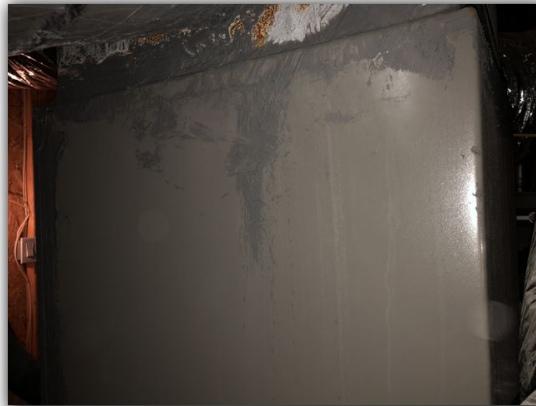
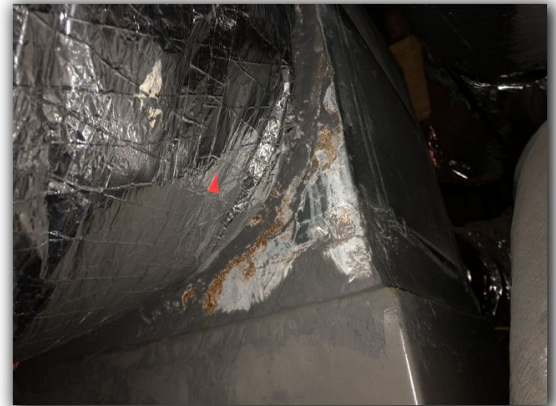
Corrosion and staining was found at portions of the a/c housing and other components in the attic. Recommend further investigation by a licensed HVAC contractor to determine if corrective actions are needed.

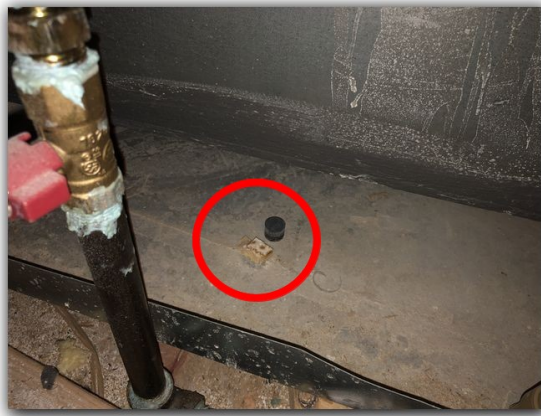
The debris in the emergency drain pan below the evaporator of unit(s) # 1 should be removed.

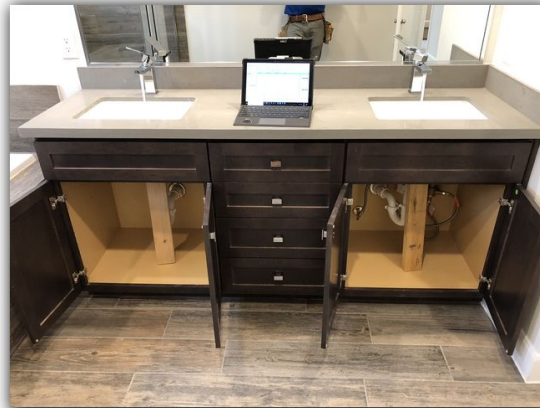
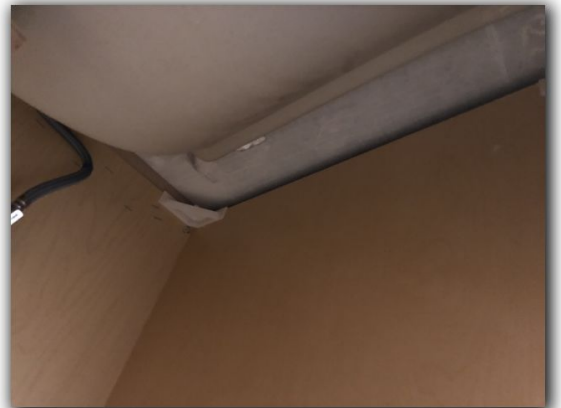
Water level In toilet tanks too high / provide 1" airgap

Master Bathroom under-mount kitchen sink not supported at countertop

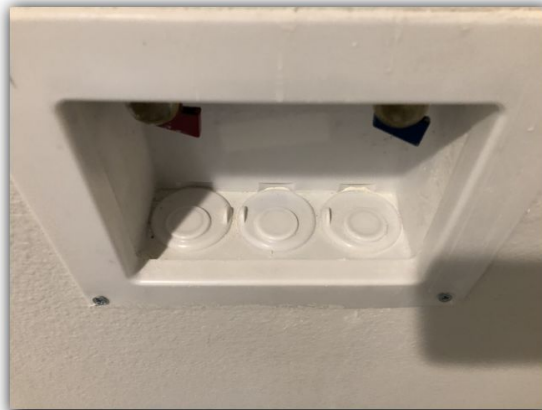
The drain for the laundry room washing machine was not opened at the time of the inspection.

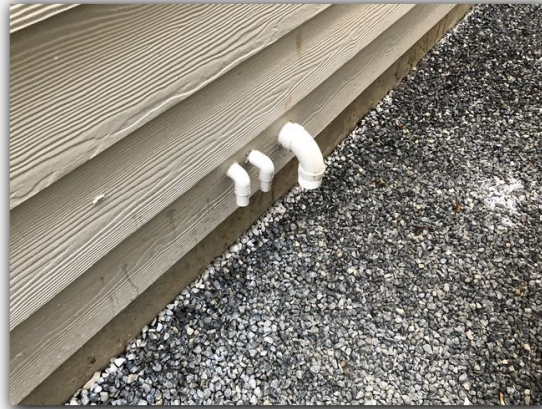
T & P valve terminates too high at exterior of property - >6"
