**North Star Inspections, Inc.**

**443 Oak Chase Dr. Conroe Tx 77304**

**PROPERTY INSPECTION REPORT**

**Concerning:** 443 Oak Chase Dr., Conroe, TX, 77304  
(Address or Other Identification of Inspected Property)

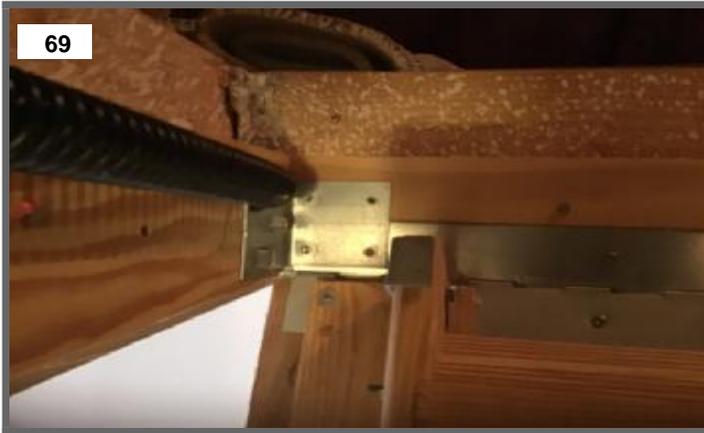
The attic stairs are missing nails in key locations in the steel plate at the top and sides of the stairs. These nails are needed for the manufacturers load capacity to be met .

Missing fasteners

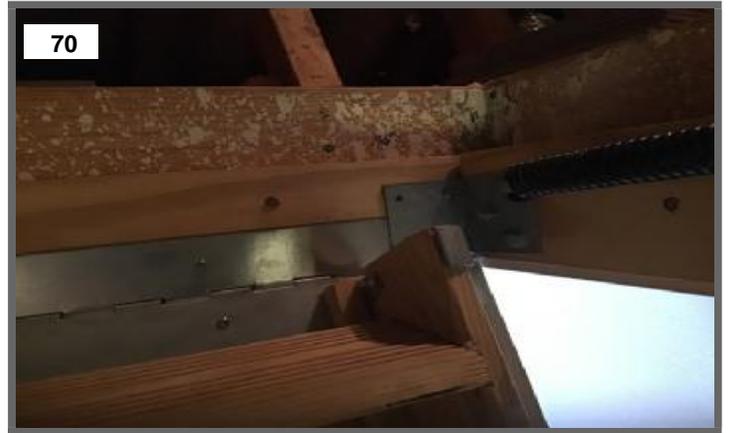
Missing fasteners

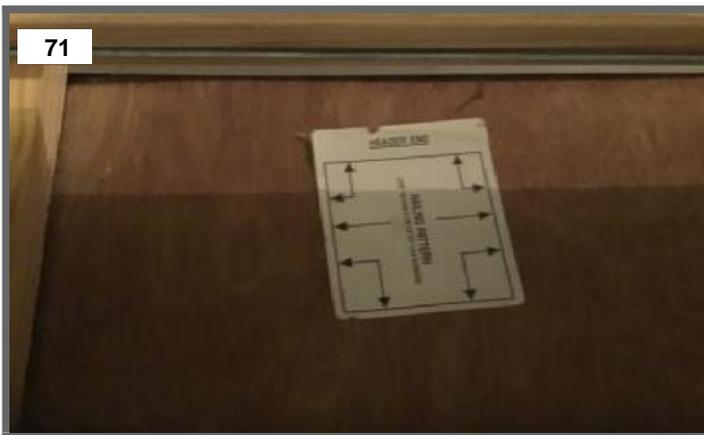
Nail pattern

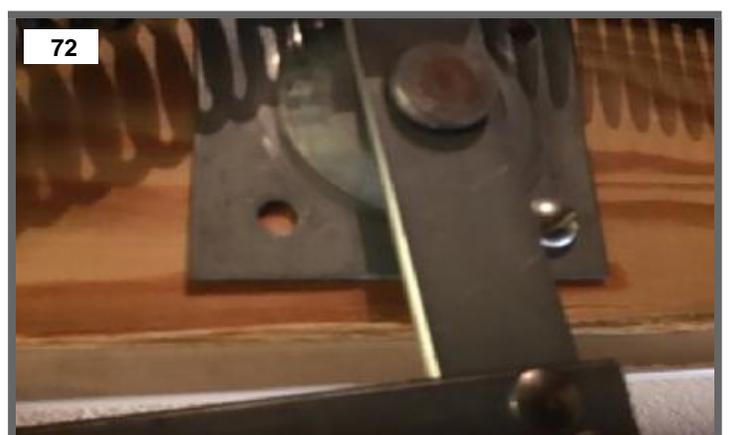
Missing fasteners

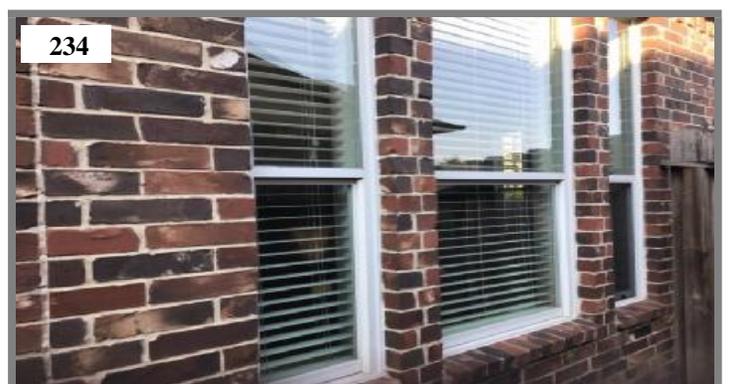
Missing screens

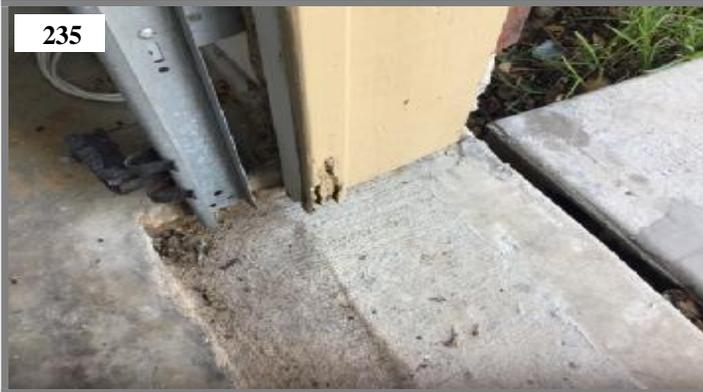
Wood rot

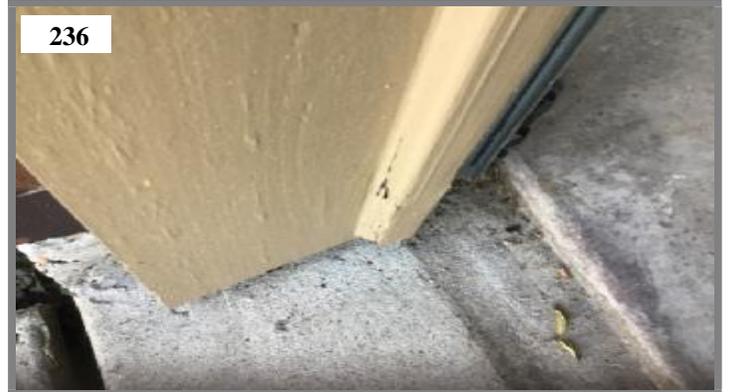
Wood rot

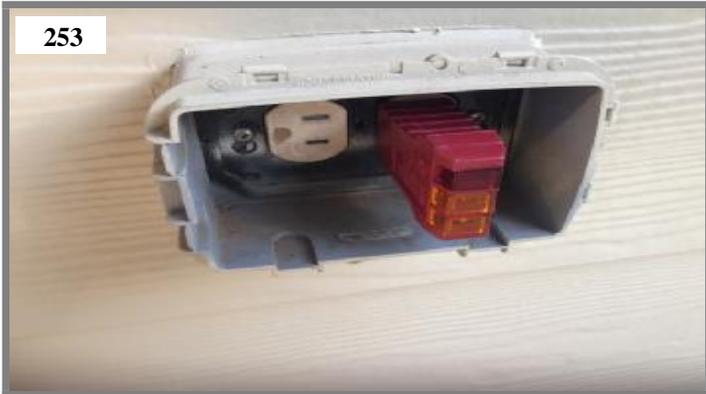
253  
Outdoor outlets  
Missing all weather cover

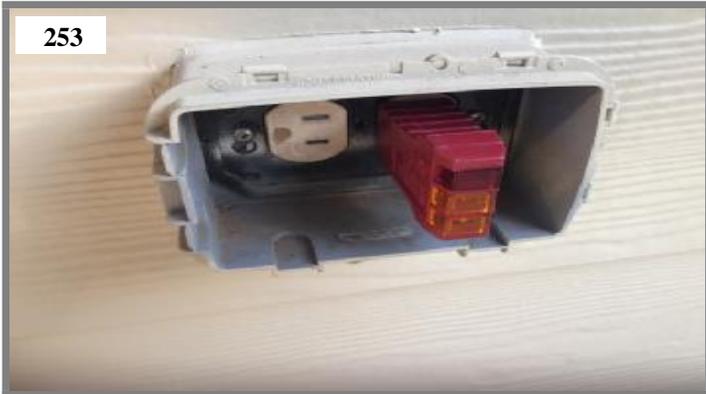
Outdoor outlets  
Missing all weather cover
