MEC^x
8864 Interchange Dr., Houston, TX 77054-2512
Phone (713) 585-7000 • Fax (713) 585-7049

21 November 2017

Re: Post-Flood Mitigation Moisture Inspection
100-192 Litchfield Lane, Houston, Texas 77024
Building 21, Unit 87

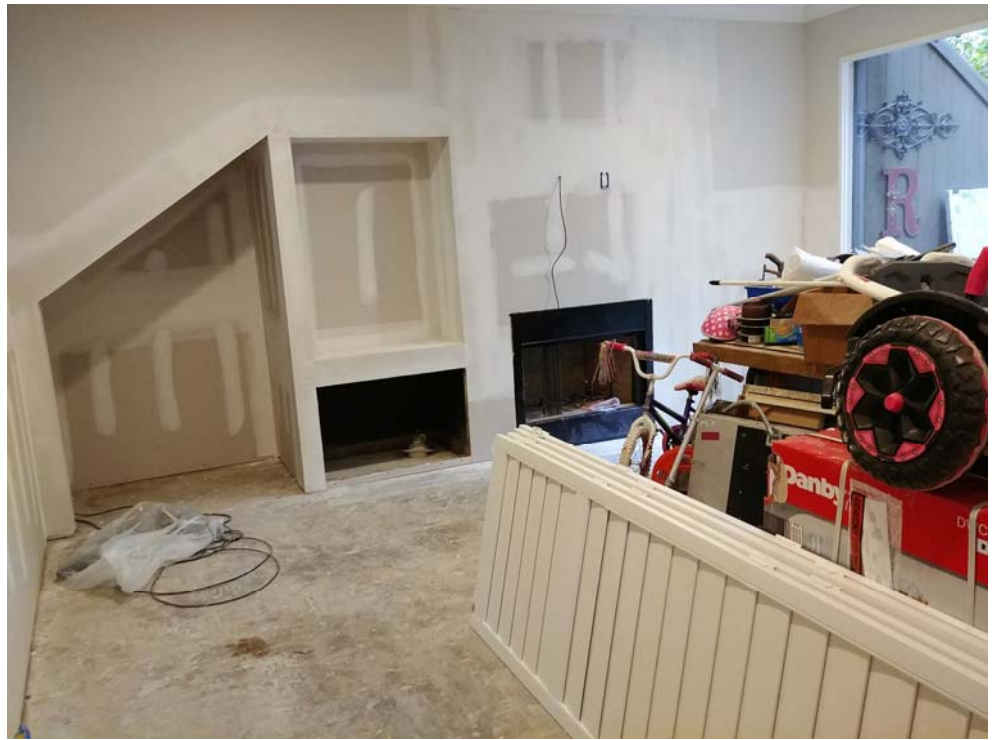
Photo No.: 1	Date: 11/21/17
Build back observed throughout the residence:

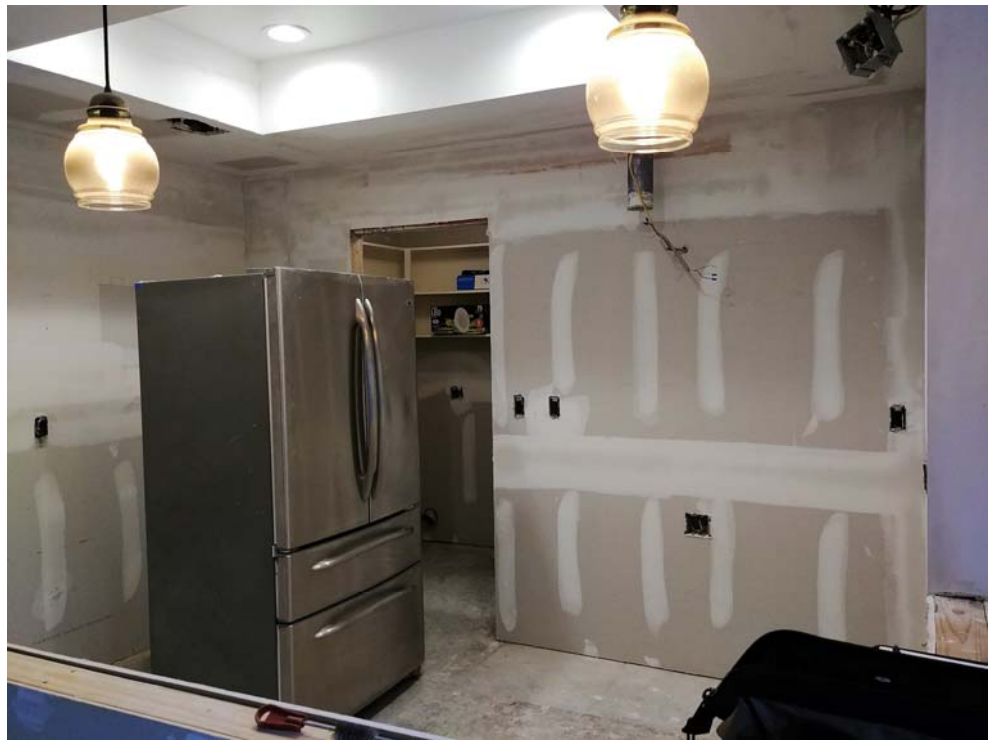
Photo No.: 2	Date: 11/21/17
Build back observed throughout the residence:

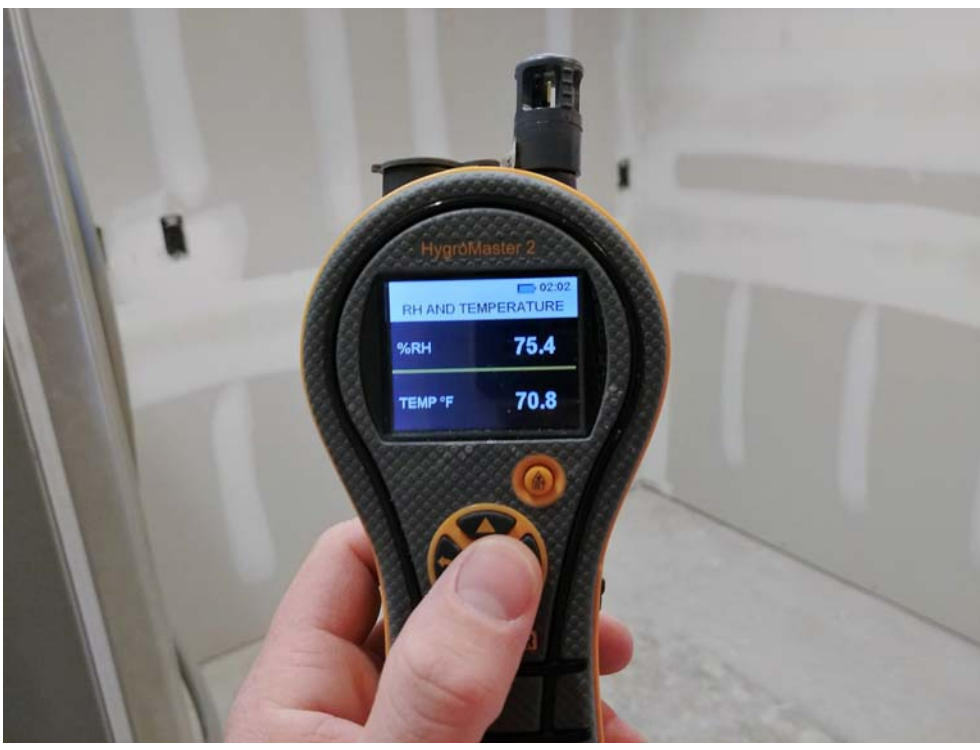
Photo No.:	Date:
3	11/21/17

- Ambient air conditions at the Site were above 70% humidity. Elevated humidity levels promote growth and amplification of mold spores.
- Moisture levels in building materials were acceptable.
- On the date of the inspection described herein, MEC^X did not observe visible mold and/or mold damage at the Site.
 - **Recommendation 1:** MEC^X recommends that the heating, ventilating and air conditioning (HVAC) condenser coils and air distribution ducts be professionally cleaned.
 - **Recommendation 2:** Where practical, MEC^X recommends applying U.S. EPA-approved biocide (i.e., fosters 40-80) to the exposed studs and building materials and encapsulating the exposed wood studs and wall cavities (i.e., using fosters 40-20) prior to build back.

Humidity levels at the time of the inspection.

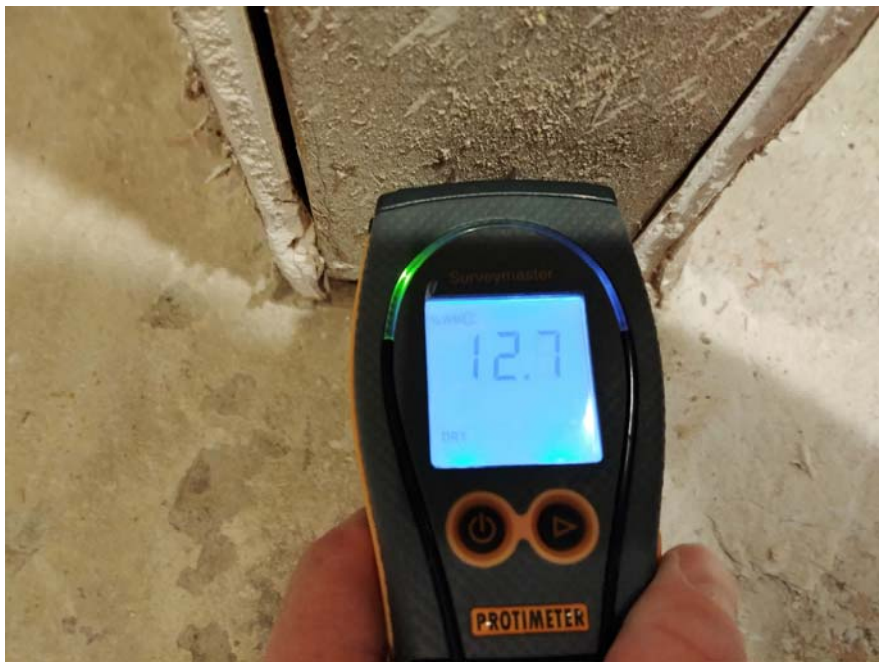
Photo No.:	Date:
4	11/21/17

Moisture Reading:

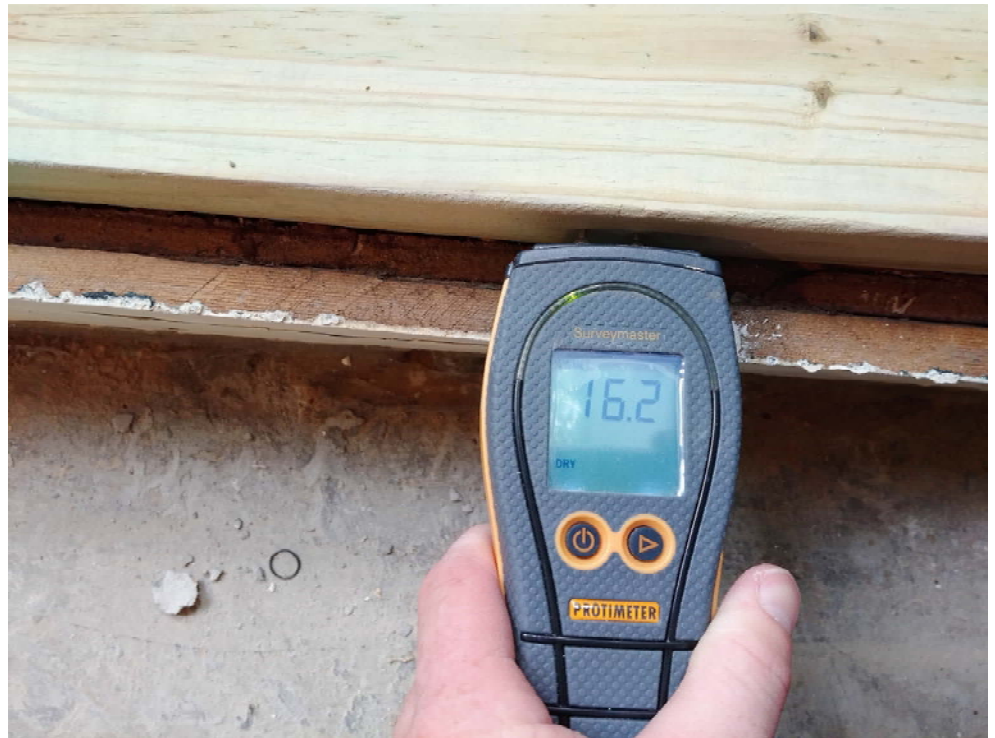
Photo No.: 5	Date: 11/21/17
Moisture Reading:

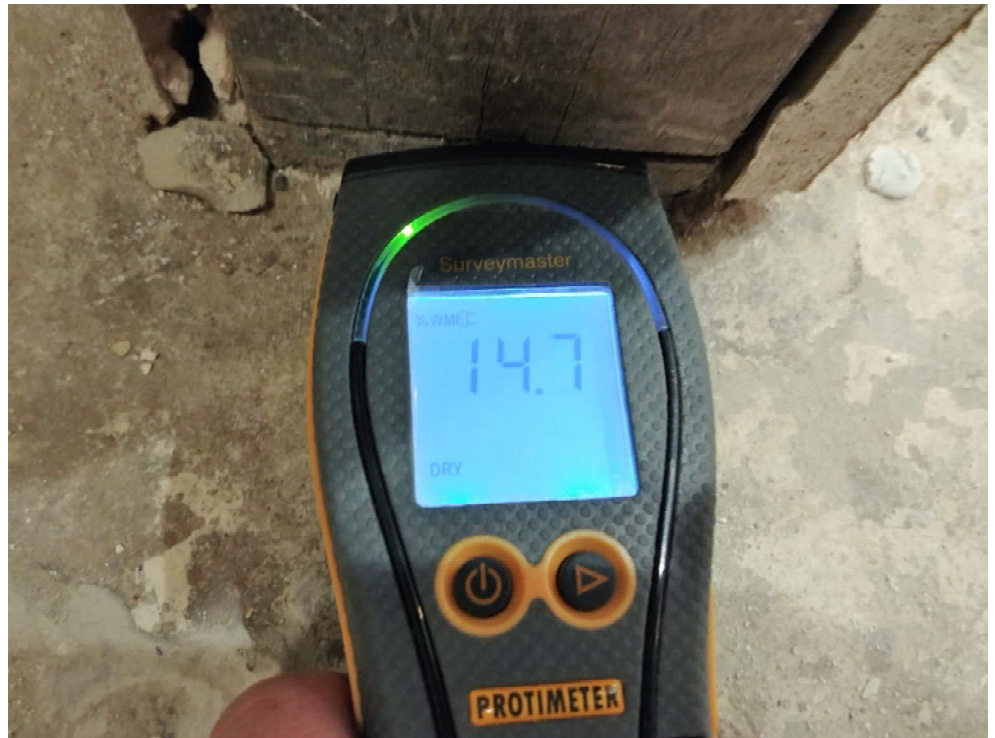
Photo No.: 6	Date: 11/21/17
Moisture Reading:

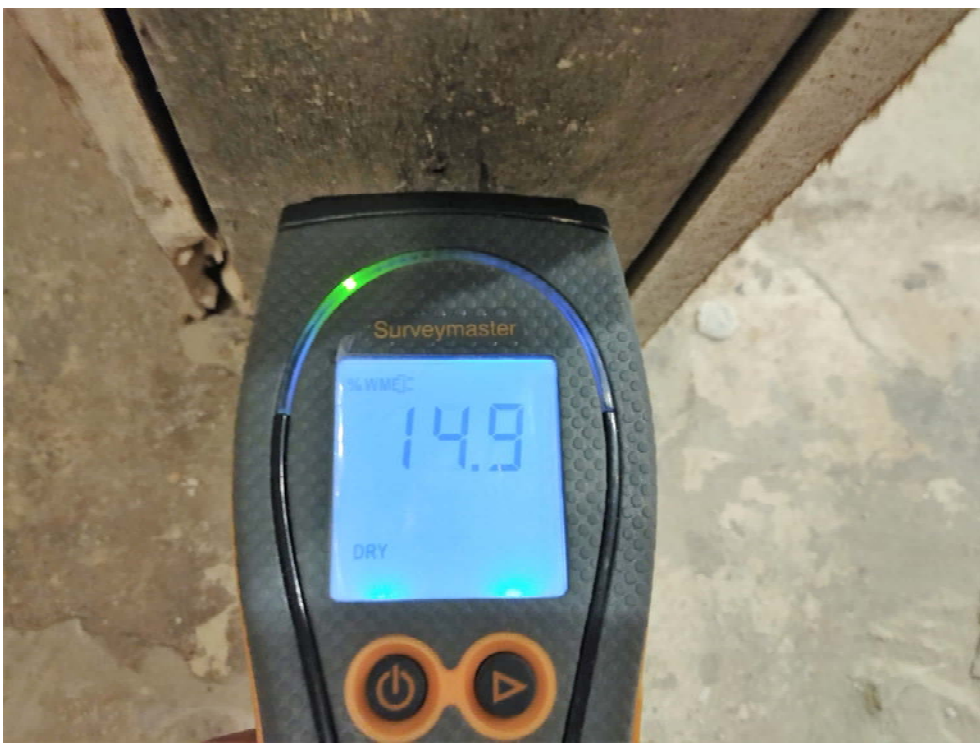
Photo No.:
7

Moisture Reading:

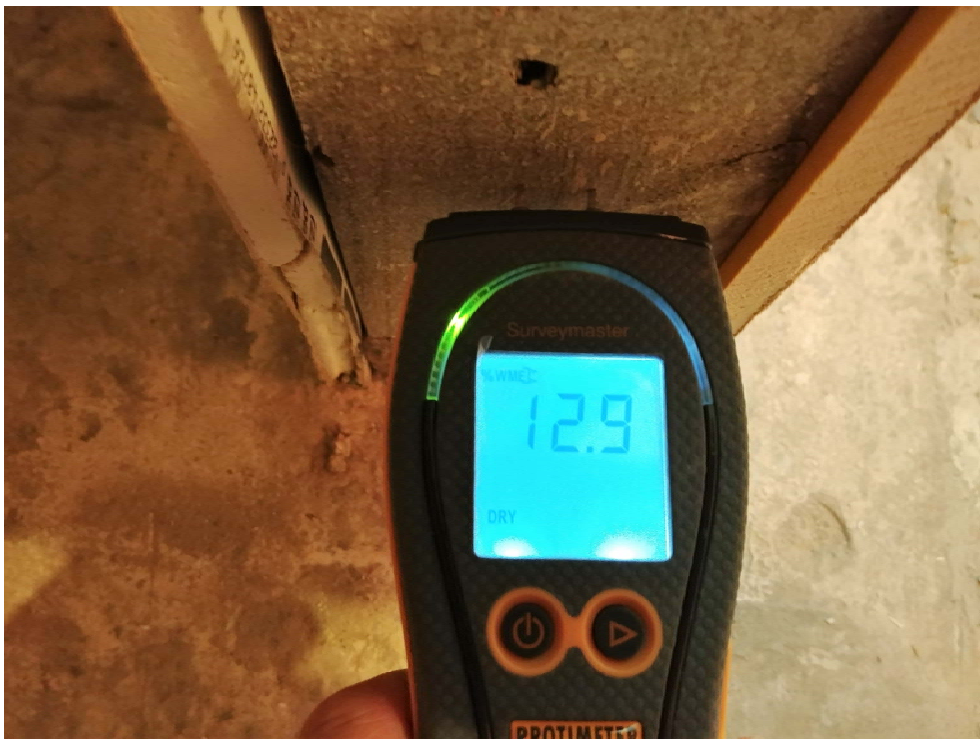
Photo No.:
8

Moisture Reading:
