PROPOSAL FOR REPAIRS 307 BETHJE HOUSTON 77007

Moisture Assessment Report

307 Bethje
Houston, TX 77007
10/04/2017

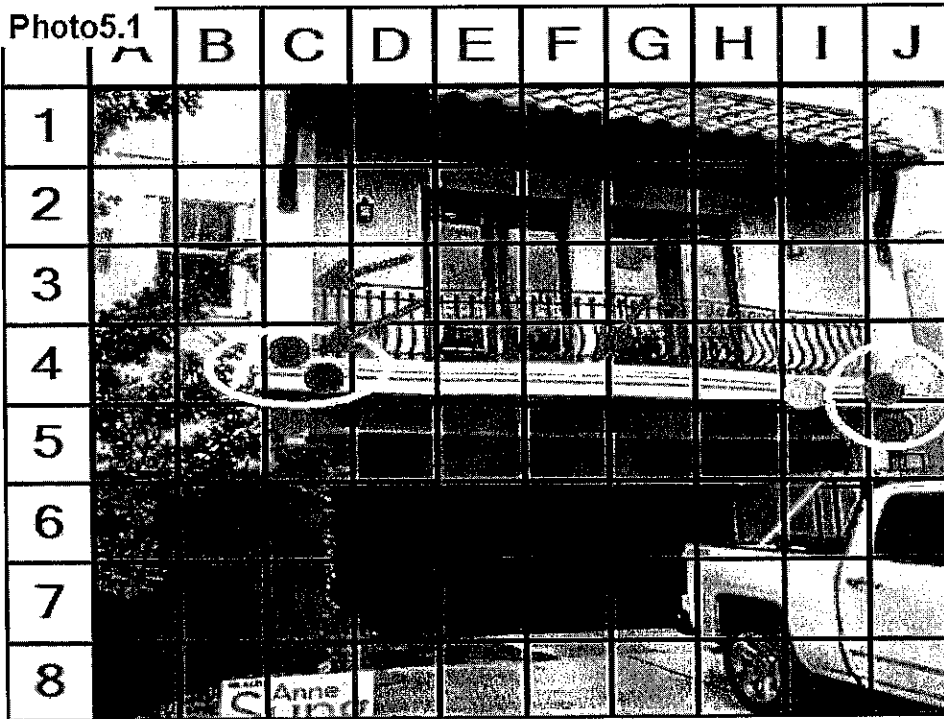
Photo5.1

Grid Location	Item Description	Moisture Readings	Substrate Condition	Observations (Photo #5.1)	Chapter Reference
				Seal / reseal all windows, doors, flashing terminations and penetrations. Always maintain sealants.	Ch 3.1,3.2
Yellow Circles	Moisture stains			Moisture stains noted at bottom of wall below balcony. See details 5.2 and 5.3.	Ch 3.2
Red Arrows	Balcony			Reseal all balcony terminations, penetrations and fasteners. See details # 5.4, 5.5 and 5.6.	Ch 3.1
C4 (Red Dot)	At corner above balcony termination	40%	Soft	Elevated moisture reading was made at balcony lower left. Soft resistance recorded. Possible substrate damage.	Ch 3.7
C4 (Purple Dot)	Balcony lower left	32%	Semi-firm	Elevated moisture reading was made below balcony.	
C5	Back column below moisture stains	40%	Soft	Elevated moisture reading was made at back column below moisture stains. Soft resistance recorded. Possible substrate damage.

I4	Below balcony	28%	Firm	Elevated moisture reading was made below balcony.	
J4 (Red Dot)	Balcony lower right	40%	Soft	Elevated moisture reading was made at balcony lower right. Soft resistance recorded. Possible substrate damage.	
J4 (Green Dot)	At corner above balcony termination	40%	Soft	Elevated moisture reading was made at corner above balcony termination. Soft substrate recorded. Possible substrate damage.	
J5	Back column below moisture stain	40%	Semi-soft	Elevated moisture reading was made at back column below moisture stain. Semi-soft resistance was recorded. Possible substrate damage.

Yellow Arrows, C4 Red Dot, C4 Purple Dot, J4 Red Dot, J4 Green Dot, J5: Cut out and remove these areas down to the rotted substrate. Remove all rotted sheathing and framing members. The

substrate will be replaced with new OSB, replace rotted framing members with either 2X4 or 2X6, (which ever was used prior). Once the new substrate is in place we will apply liquid applied waterproofing membrane and a slip sheet of building felt. A new 3/4 inch stucco system will be installed to match the current stucco texture and color. The system will include a slip sheet of building paper, 3.4 self-furring metal lath, galvanized casing bead, two applications of Sto 108 stucco base, one application of Sto primer, one application of textured finish tinted to match the existing home.

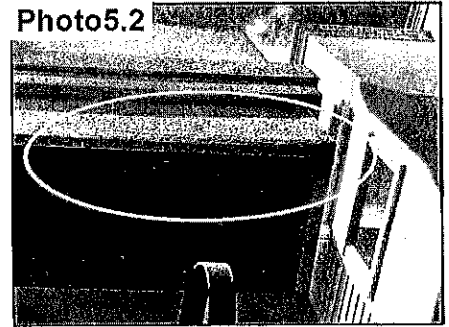
Photo5.2

- Seal / reseal all windows, doors, flashing terminations and penetrations. Always maintain sealants.
- Moisture stains noted at bottom of wall below balcony. See details 5.2 and 5.3.

Moisture stains at bottom of wall.

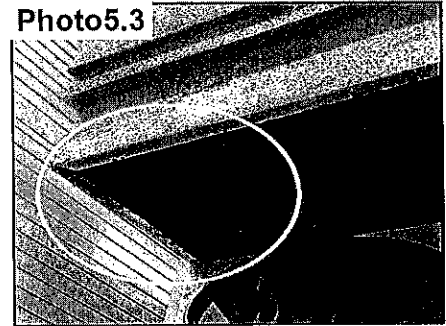
Photo5.3

Moisture stains at bottom of wall.

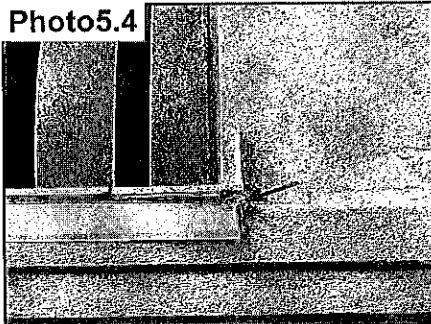
Photo5.4

Reseal all balcony terminations, fasteners and penetrations.

- Reseal all balcony terminations, penetrations and fasteners. See details # 5.4, 5.5 and 5.6.
- Roof flashing lacks sealants at some locations. See detail #6.2. Assess and seal all roof flashing as needed.

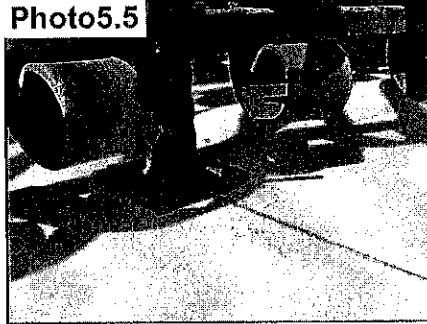
Photo5.5

Reseal all balcony terminations, fasteners and penetrations.

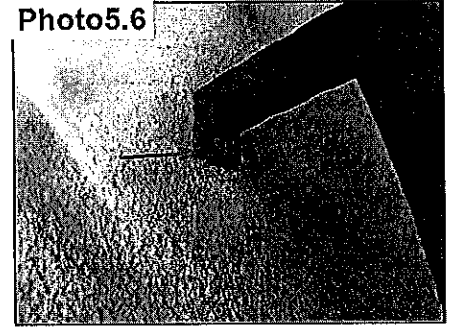
Photo5.6

Reseal all balcony terminations, fasteners and penetrations.

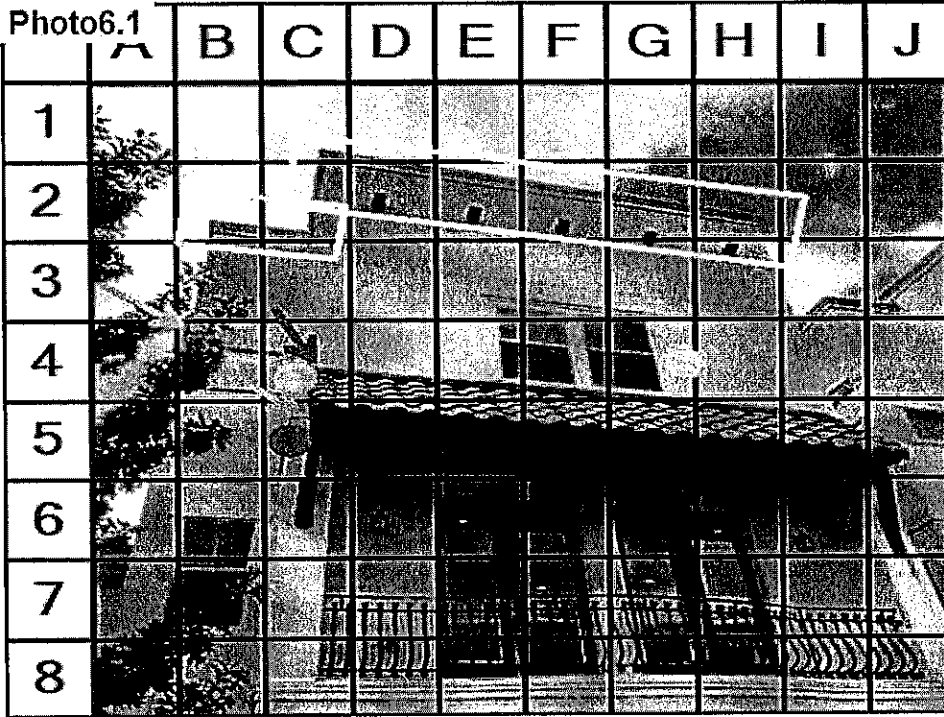
Grid Location	Item Description	Moisture Readings	Substrate Condition	Observations-Photo #6.1	Chapter Reference
				Seal / reseal all windows, doors, flashing terminations and penetrations. Always maintain sealants.	Ch 3.1,3.2
Red Arrow	Roof flashing			Roof flashing lacks sealants at some locations. See detail #6.2. Assess and seal all roof flashing as needed.	Ch 3.10
Yellow Boxes	Parapet			It is suggested to core sample below parapet at various locations due to elevated moisture and possible substrate damage found below. See details #6.3 and 6.4. Repair all damage as needed.	
Orange Arrow	Metal cap			Metal cap at flat wall is possibly failing. See detail #6.5. - Rework Metal Cap.	
Blue Arrow	Scupper / Roof flashing			Have contractor assess and seal all scuppers / Roof flashing. See detail #6.6.	
C5	Below metal cap at corner	40%	Soft	Elevated moisture reading was made below metal cap at corner. Soft resistance recorded. Possible substrate damage.

C4	At corner below parapet	40%	Semi-firm	Elevated moisture reading was made at corner below parapet.	
G4	Side of window	18%	Firm	Moisture reading was made at side of window below parapet.

Red Arrow, Yellow Box, Orange Arrow, C5, C4: Cut out and remove these areas down to the rotted substrate. Remove all rotted sheathing and framing members. The substrate will be replaced with new OSB, replace rotted framing members with either 2X4 or 2X6, (which ever was used prior). Once the new substrate is in place we will apply a liquid applied waterproofing membrane and a slip sheet of building felt. A new 3/4 inch stucco system will be installed to match the current stucco texture and color. The system will include a slip sheet of building paper, 3.4 self-furring metal lath, galvanized casing bead, two applications of Sto 108 stucco base, one application of Sto primer, one application of textured finish tinted to match the existing home.

A new metal cap will be installed.

Parapet wall will be tested for wood rot. If discovered, the price is shown below.

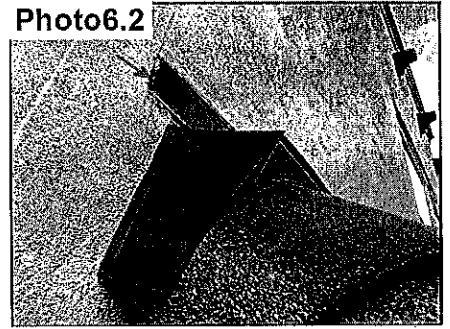
Seal roof flashing.

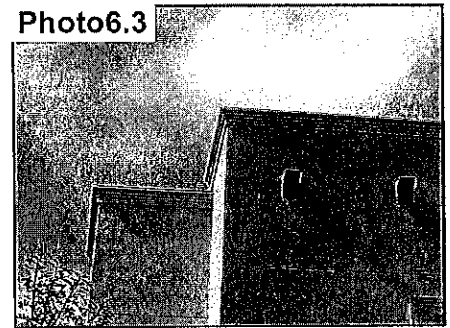
- It is suggested to core sample below parapet at various locations due to elevated moisture and possible substrate damage found below. Repair all damage as needed. See details #6.3 and 6.4.

It is suggested to core sample below parapet to assess substrate integrity

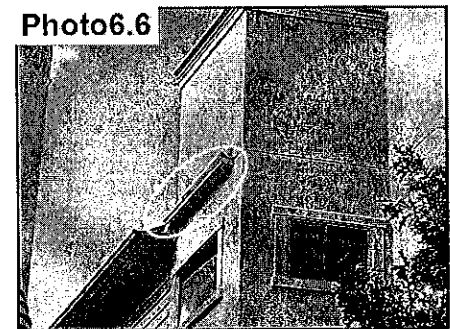
Have contractor assess and seal all flashing terminations.

- Metal cap at flat wall is possibly failing. See detail #6.5. - Rework metal cap.
- Have contractor assess and seal all scuppers / Roof flashing. See detail #6.6.

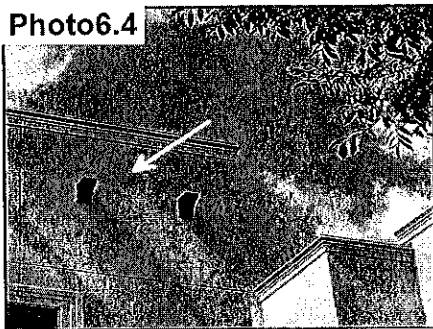
It is suggested to core sample below parapet to assess substrate integrity

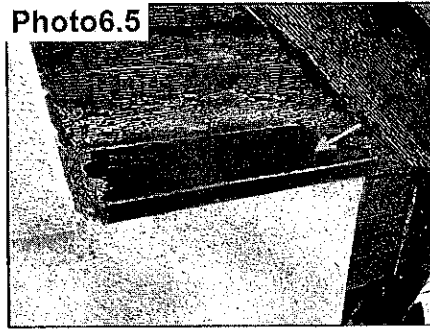
Metal cap at flat a wall appears to be failing.

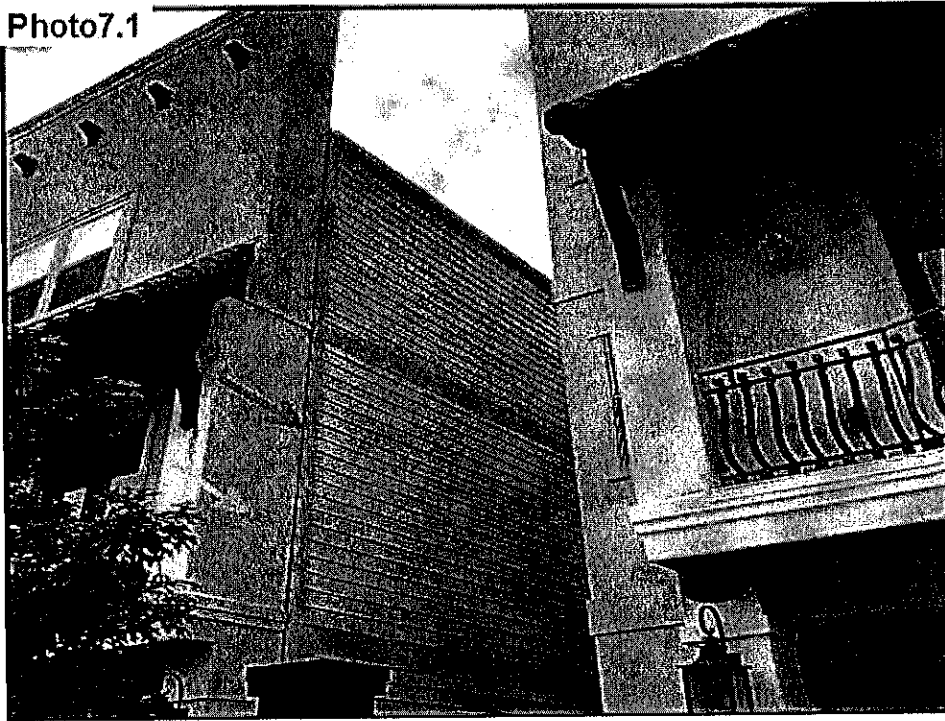
Photo7.1

Grid Location	Item Description	Moisture Readings	Substrate Condition	Observations-Photo #7.1	Chapter Reference
				Seal / reseal all windows, doors, flashing terminations and penetrations. Always maintain sealants.	Ch 3.1,3.2
Orange Arrow	Vines			Evidence of vines noted on stucco. See detail #7.2. It is suggested to not allow vines to grow on stucco due to the damage they can cause to the finish coat.	
Red Arrow	Siding transition			Reseal all siding transitions. See detail #7.3.	Ch 3.10

Orange Arrow: Vine pitting will be re-skimmed with an application of flexible stucco base. Once cured we will finish to match the home.

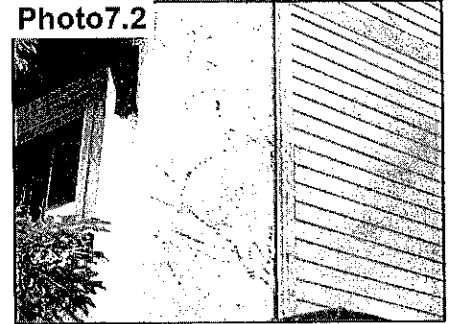
Photo7.2

- Evidence of vines noted on stucco. See detail #7.2. It is suggested to not allow vines to grow on stucco due to the damage they can cause to the finish coat.

Evidence of vines noted.

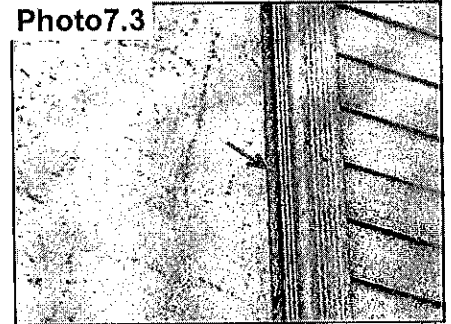
Photo7.3

Reseal siding transition.

- Reseal all siding transitions. See detail #7.3.
- Some penetrations lack sealants. See details #8.2 and 8.3. Assess and seal all penetrations.
- Rust noted from HVAC overflow. See detail #8.4. Assess and clean as needed.

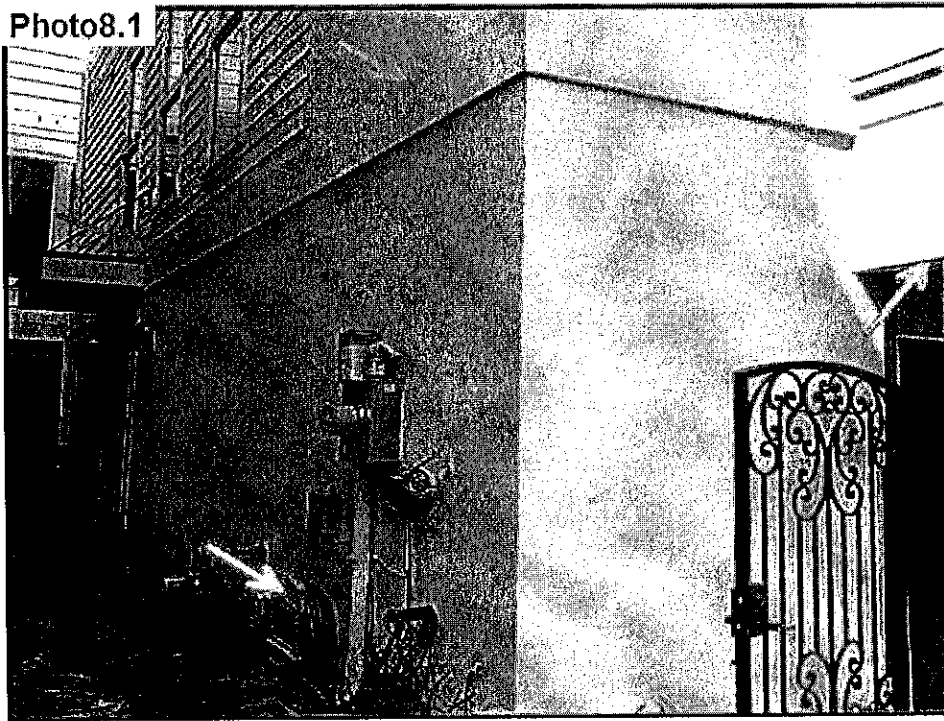
Photo8.1

Grid Location	Item Description	Moisture Readings	Substrate Condition	Observations-Photo #8.1	Chapter Reference
				Seal / reseal all windows, doors, flashing terminations and penetrations. Always maintain sealants.	Ch 3.1,3.2
Yellow Arrow	Penetrations			Some penetrations lack sealants. See details #8.2 and 8.3. Assess and seal all penetrations.	Ch 3.1
Red Arrow	Rust			Rust noted from HVAC overflow. See detail #8.4. Assess and clean as needed.	
Orange Arrow	Flat accents			Reseal the tops of all flat accents. See detail #8.5.	
Blue Arrow	Moisture stains			Moisture stains noted at bottom of wall. See detail #8.6.

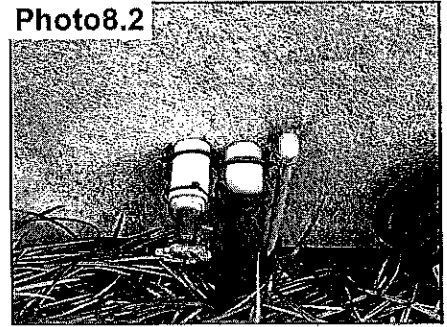
Photo8.2

Seal all penetrations.

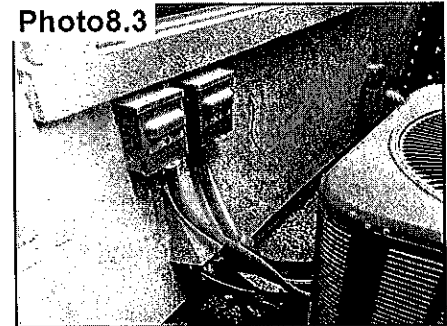
Photo8.3

Seal all penetrations

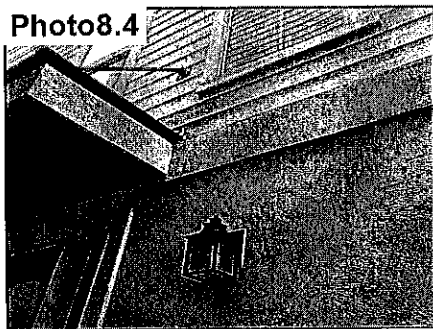
Photo8.4

Rust noted from HVAC overflow.

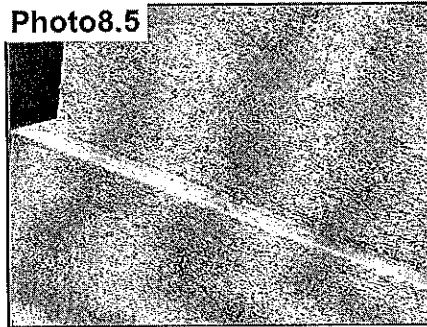
Photo8.5

Reseal tops of all flat accents.

- Reseal the tops of all flat accents. See detail #8.5.
- Moisture stains noted at bottom of wall. See detail #8.6.
- Sealant separation noted at window. See detail #9.2. Assess and reseal all windows.

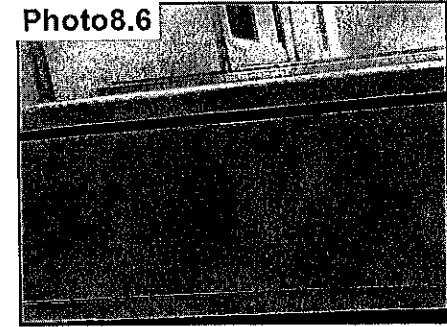
Photo8.6

Moisture stains noted at bottom of wall.

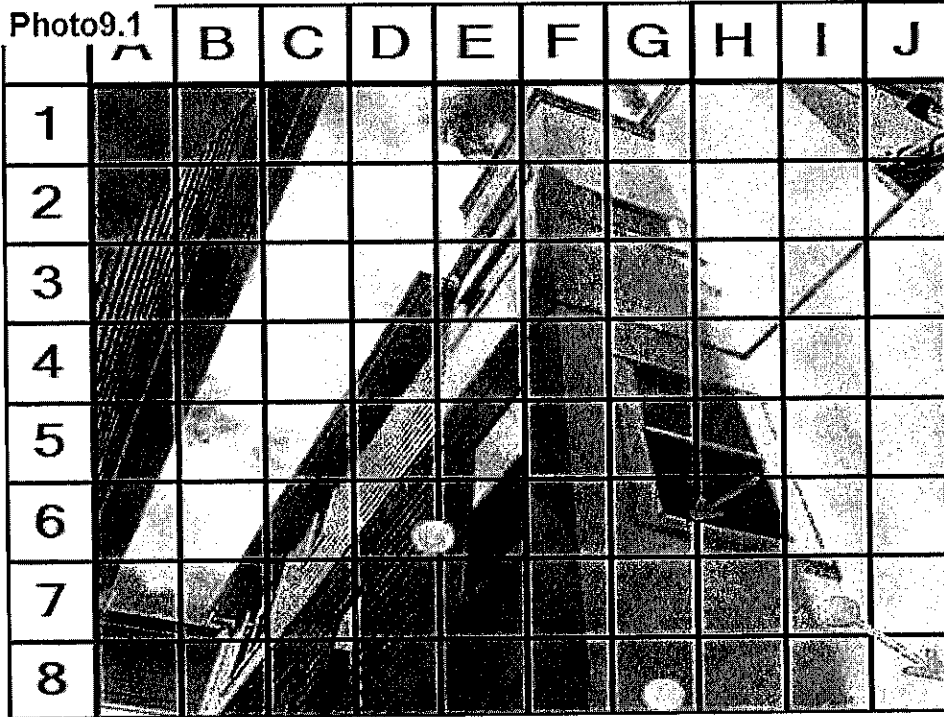
Grid Location	Item Description	Moisture Readings	Substrate Condition	Observations-Photo #9.1	Chapter Reference
				Seal / reseal all windows, doors, flashing terminations and penetrations. Always maintain sealants.	Ch 3.1,3.2
Red Arrow	Window			Sealant separation noted at window. See detail #9.2. Assess and reseal all windows.	Ch 3.2
G8	Window lower left at accent band	29%	Semi-firm	Elevated moisture reading was made at window lower left at accent band.	
D6	Below roof termination	12%	Firm	Low moisture reading was made below roof termination.	
I7 (Dot with Arrow)	At accent band below parapet above moisture stains	17%	Firm	Moisture reading was made at accent band below parapet above moisture stains.

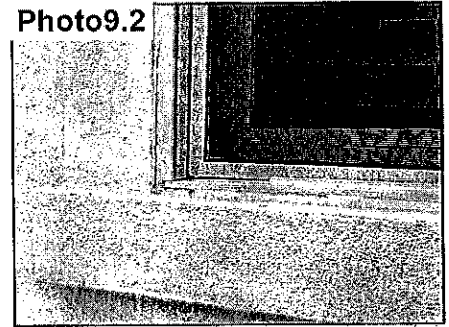
Sealant separation noted at window.

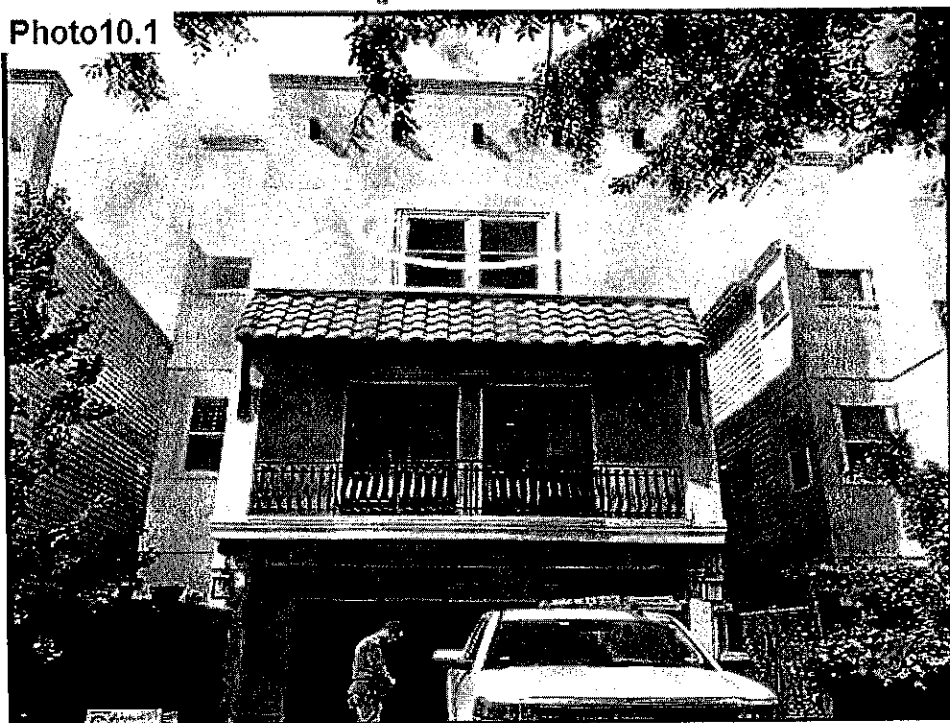
Photo10.1

Grid Location	Item Description	Moisture Readings	Substrate Condition	Observations-Photo #10.1	Chapter Reference
				Seal /reseal all windows, doors, flashing terminations and penetrations. Always maintain sealants.	Ch 3.1,3.2
Blue Circle	Interior moisture stains			Interior moisture stains noted at windows. See details #10.2 and 10.3.

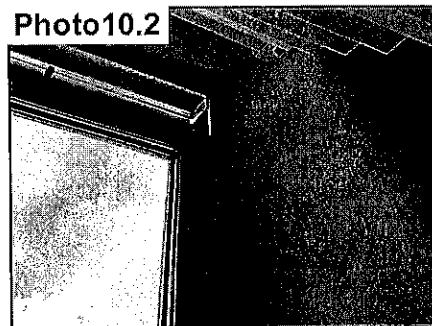
Photo10.2

Interior moisture stains noted at windows.

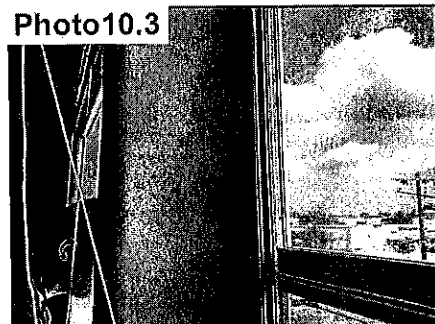
Photo10.3

Interior moisture stains noted at windows.
