HOME INSPECTION REPORT

14130 E Cypress Forest Dr.
Houston, Texas 77070

Inspection Date:
09/10/2020

PROPERTY INSPECTION REPORT

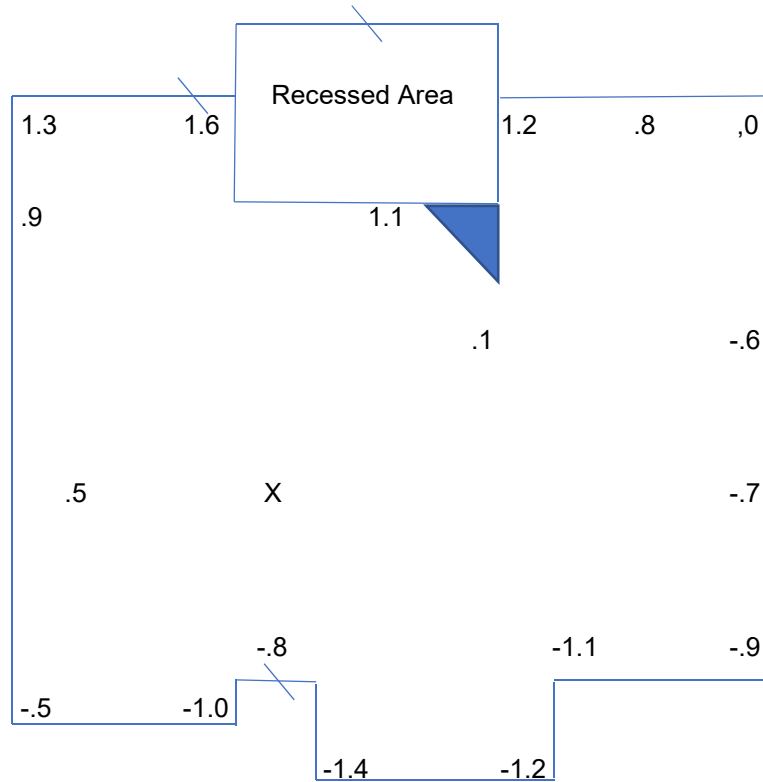
FOUNDATION LEVEL SURVEY

A foundation elevation differential of 3.0 inches was recorded on the main structure (refer to the Elevation Survey).

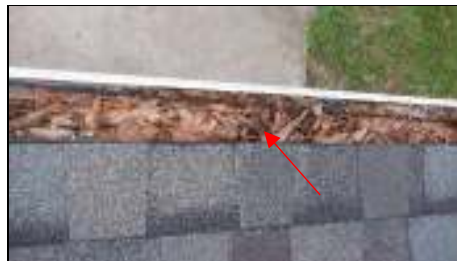
The gutters in various locations require cleaning to avoid spilling roof runoff around the home – a potential source of water entry or water damage.

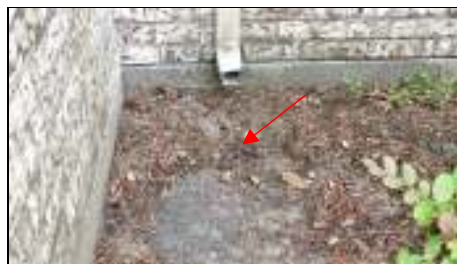
It is recommended that splash blocks be installed under the gutter downspouts where needed to help prevent ground erosion.

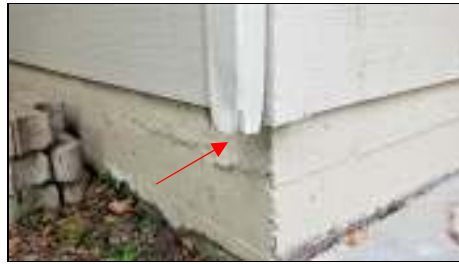
The missing gutter downspout turnout at the garage should be replaced.

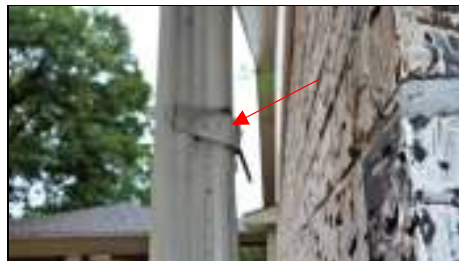
Loose or damaged gutter downspouts at the north west corner of the home should be repaired promptly.

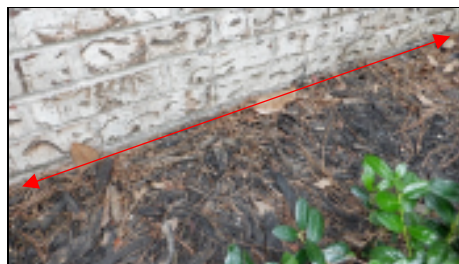
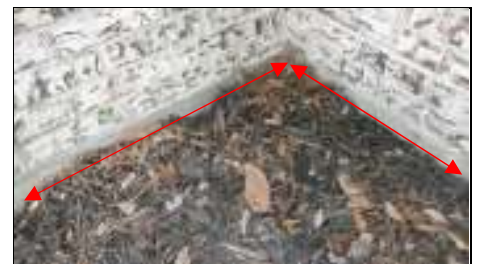
The soil line was too high against the foundation at the front of the home. Ideally the top 4-6 inches of the slab is visible above ground. Improvement is needed.

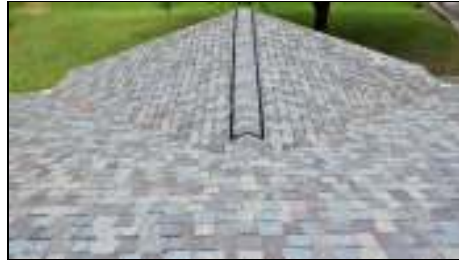
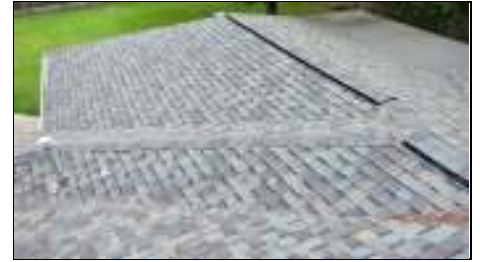
Generally speaking, the roof covering appeared to be in good condition at the time of the inspection. The roof coverings show evidence of normal wear and tear for a home of this age and location.

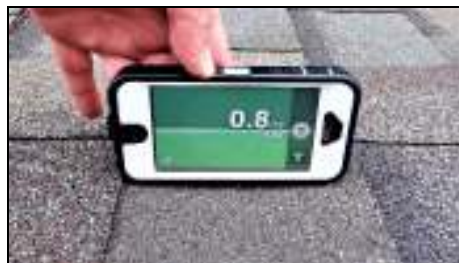
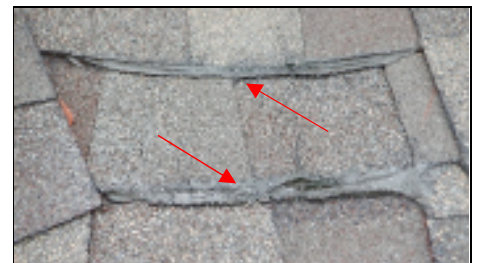
The roofing material is not intended for this low slope application at the rear of the garage and at the breezeway. There is a higher potential for unanticipated repairs. While this condition does not pose a serious short-term concern, it may affect the reliability and longevity of this section of roof.

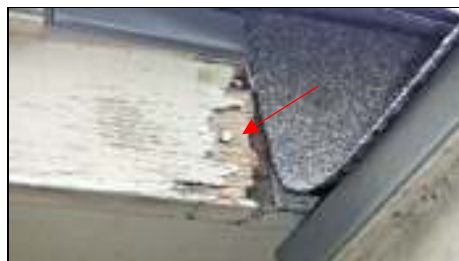
Fascia boards showing signs of minor water damage and/or wood rot in the rear attic should be repaired or replaced to reduce further structural damage.

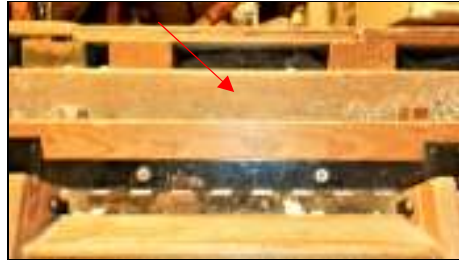
Screws are installed in the attic stair frames. Under today's building standards it's recommended that 16d penny nails should be installed in the frame and spring/hinge plate of the attic stairs. This should be improved.

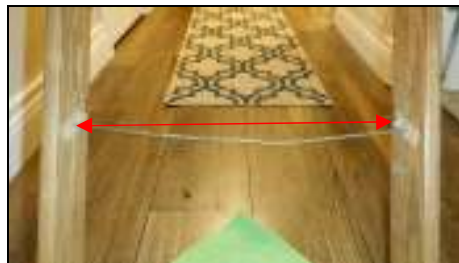
Loose or missing hardware at the hinge connections and/or missing steps were observed on the attic stairs and should be repaired for improved safety.

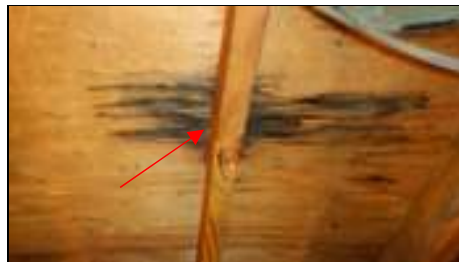
Water staining was observed on the underside of the roof decking. This did not appear to be from active leaks; however, the area should be monitored, and repairs made as necessary.

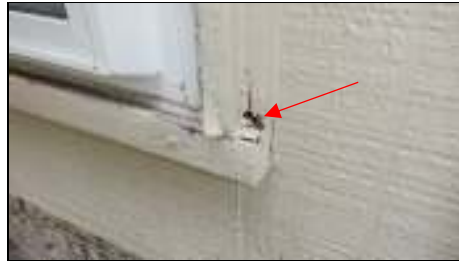
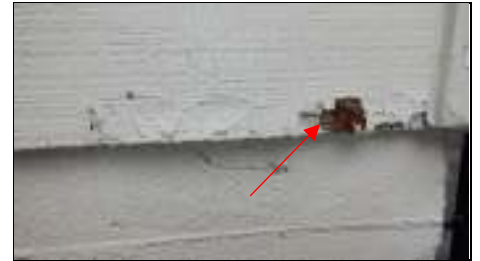
The wood veneer/trim in various locations was found to have minor deterioration and/or damaged. Repairs should be made, and measures taken to prevent further damage.

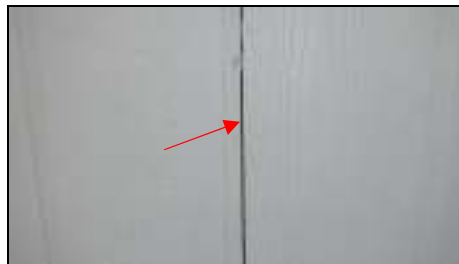
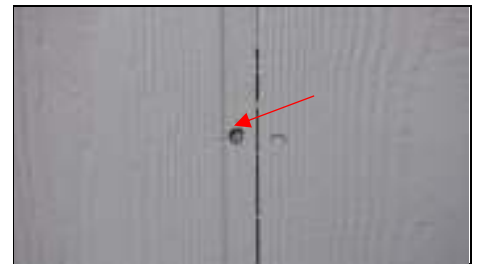
Caulking improvements are recommended for the siding seams and exposed nail heads at the garage.

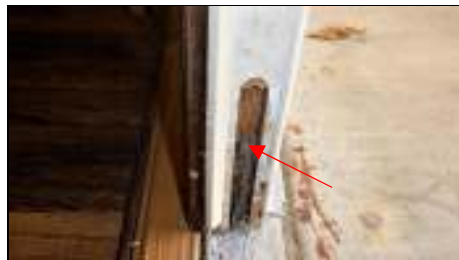
Missing or non-functional door hardware at the rear French doors of the house should be repaired/installed.

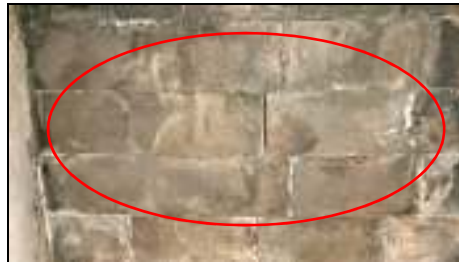
The rear wall of the fireplace firebox was found to be cracked and should be repaired for improved safety.

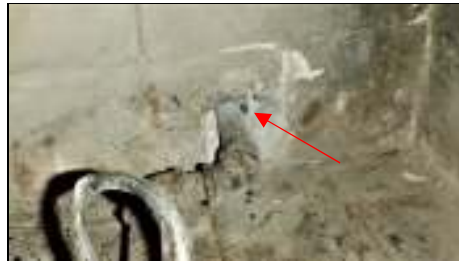
Fire stopping/caulking was missing at the gas starter bar. This should be installed as this poses a possible fire hazard.

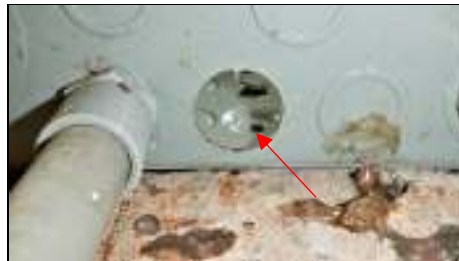
The missing "knock-out" in the bottom of the main electrical panel should be replaced.

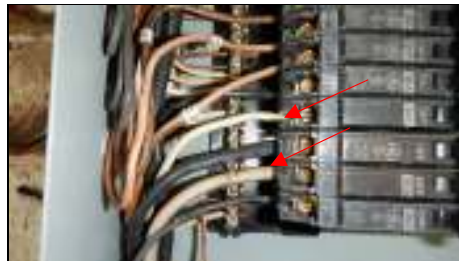
By today's electrical standards, white wires in the electrical panel and disconnects being used as hot wires should be marked with black markings to identify them as "hot wires".

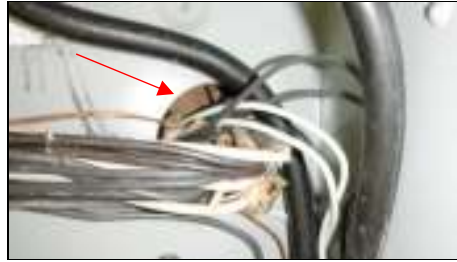
A missing cable clamp (sometimes referred to as bushings or grommets) was observed in the electrical panel. These are required where wiring passes into the main distribution panel. Cable clamps serve to protect the wiring from the metal edges of the panel openings. Repairs should be made.

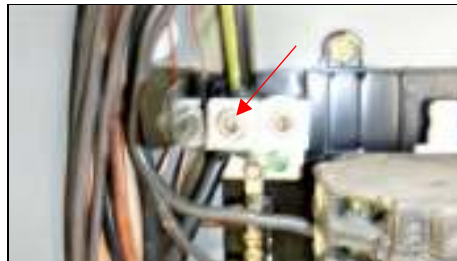
By today's electrical standards, conductors within the main distribution panel with doubled up neutral wires on the neutral chair lug should have the wires separated.

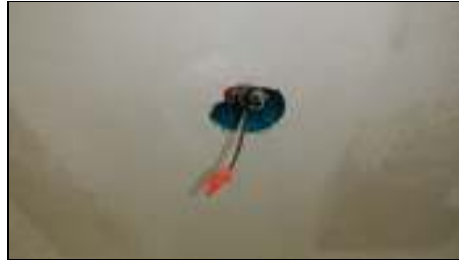
Open junction boxes located in the garage/shop should be properly enclosed.

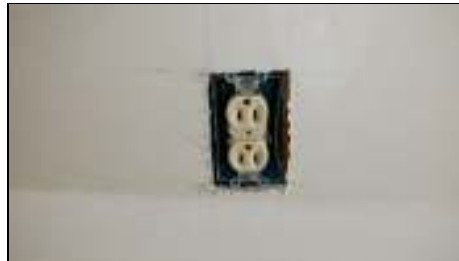
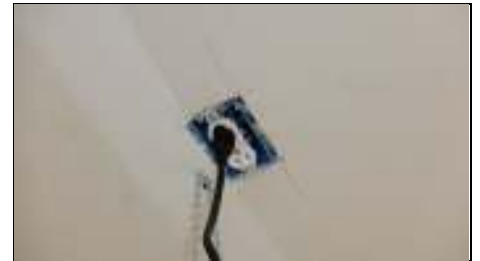
Missing outlet/switch cover plates in the garage/shop should be replaced.

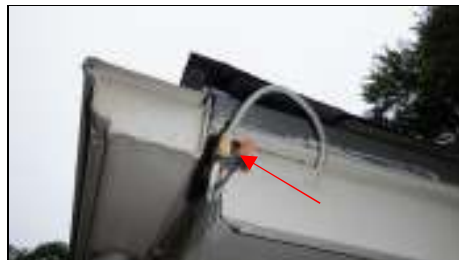
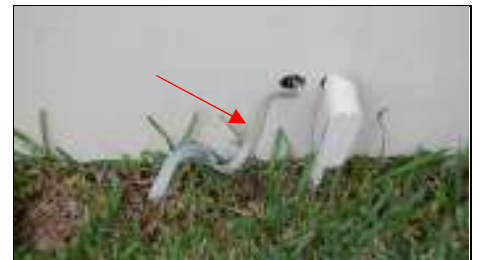
Abandoned wiring at the rear of the garage should be appropriately terminated.

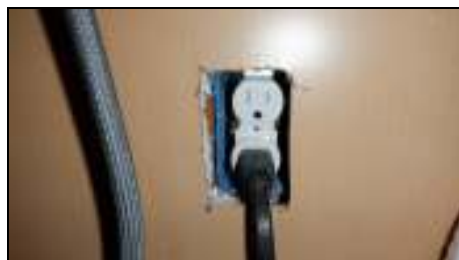
Missing outlet cover plates in the kitchen sink cabinet should be replaced.

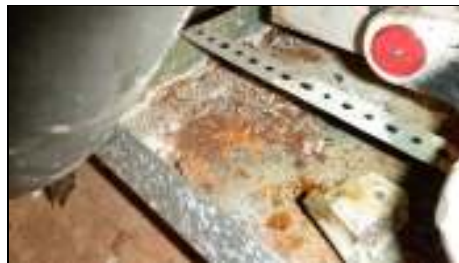
Minor rust was noted at the auxiliary drain pan under the attic portion of the air conditioning system. It is recommended that this be investigated and replaced if needed in order to reduce the potential for water damage.

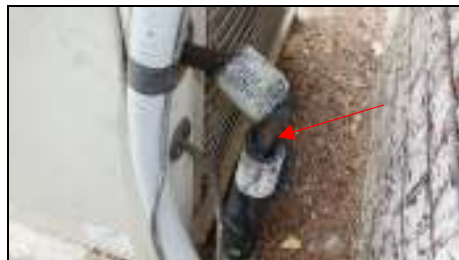
Damaged insulation on A/C refrigerant lines should be repaired.

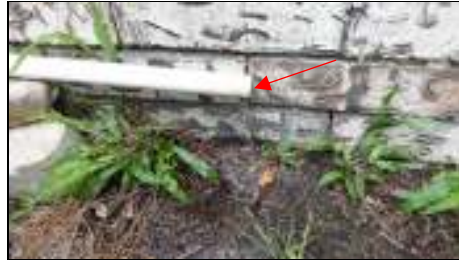
The discharge location of the primary condensate line for the air conditioning system should be improved. The discharge location has been plumbed to the south exterior of the home. Primary drain lines are intended to drain to the DWV system of the home. Restoring them to their original configuration is recommended.

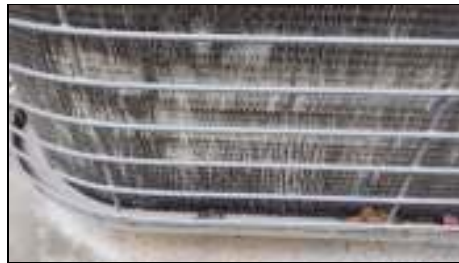
The fins on the outdoor portion of the air conditioning system were observed to have minor damage/dented. This condition can reduce the efficiency of the system.

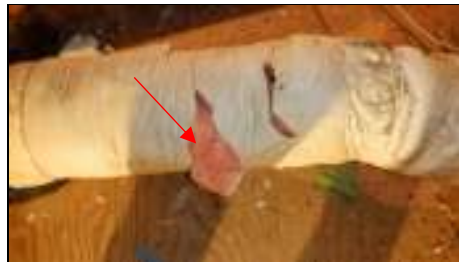
Some of the insulation on the ductwork is falling off and should be repaired as necessary.

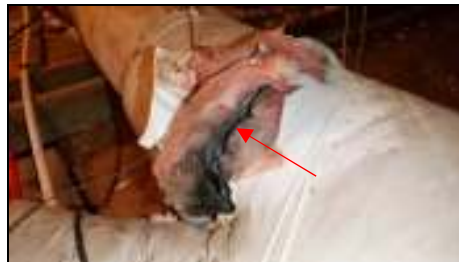
Loose fitting joints and/or openings in the ductwork should be improved in various locations.

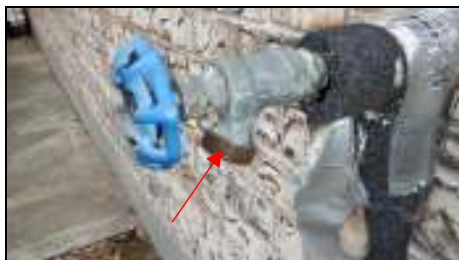
No anti-siphon devices were found on the exterior hose spigots. These are now required by today's building standards. It is recommended that this be improved.

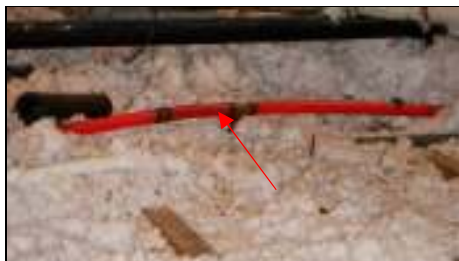
Visible/exposed PEX piping in the attic and any unconditioned space should be properly insulated. Discretionary improvements are recommended.

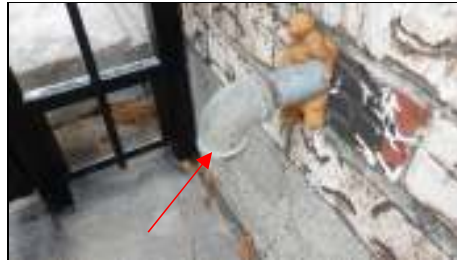
The discharge piping serving the Temperature and Pressure Relief (TPR) Valve for the water heater should terminate with piping not having a threaded end piece.

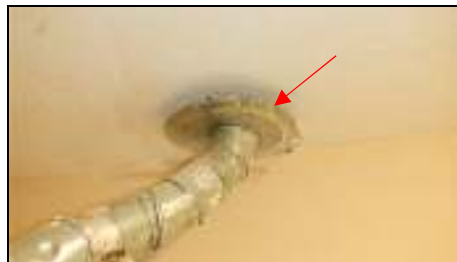
The water heater vent pipe collar should be properly secured to the ceiling.

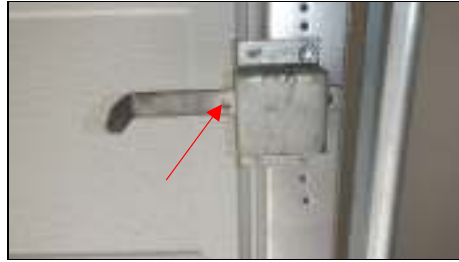
It is recommended by today's building standards that the manual lock on the garage door be disabled when using a garage door opener.

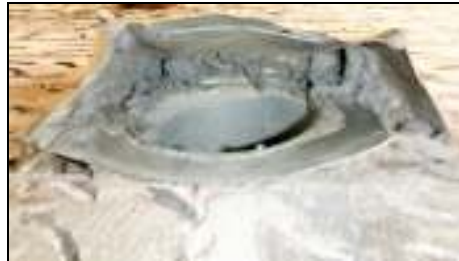
The exterior trim for the dryer vent is damaged. The dryer vent flap was missing at the time of inspection. Improvements are recommended to allow for the flap to be in the fully closed position when the dryer is not in use.
