Inspection for Property located at 1406 Eberhard St
06/04/2019
Prepared for : Carol Y. Chung

PROPERTY INSPECTION REPORT

Concerning: 1406 Eberhard St, Houston, TX 77019
(Address or Other Identification of Inspected Property)

This inspection is a "Re-inspection" update as of 6/4/2019. This purpose of this inspection is to check the previously noted defects and their current condition as of the re-inspection date.

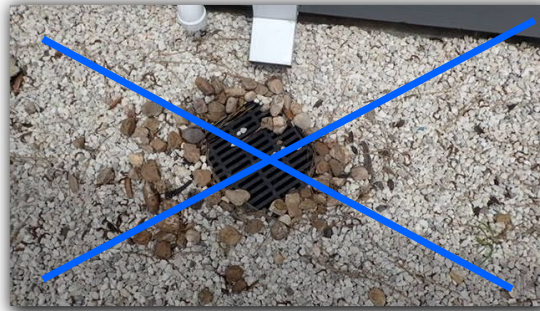
~~Comments: Underground yard and/or pool deck drainage system not checked / inspected. Did not verify yard drains operate properly and that there are no collapsed or clogged areas. Inspector (or anyone else) is unable to induce sufficient quantity of water to determine if system will operate properly when needed. Recommend observing performance during heavy rains and ensure system is maintained / cleaned.~~

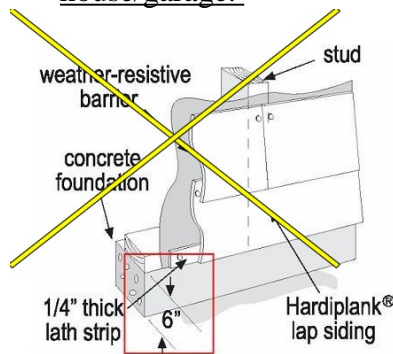
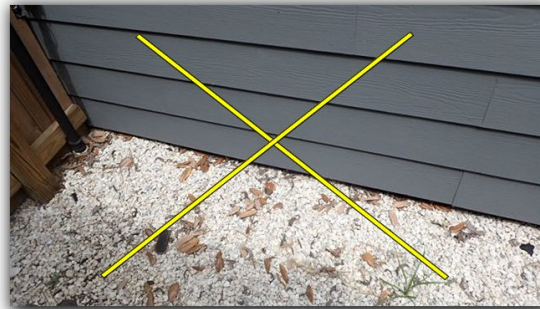
~~Soil level too high, or close to cement board siding, promotes wood rot and is considered a conducive condition to termite activity at one or more locations around house/garage.~~

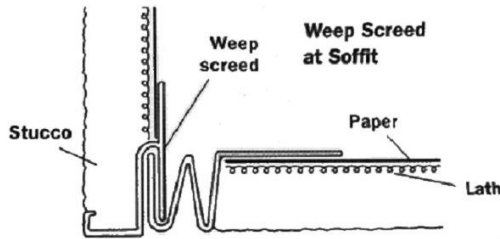
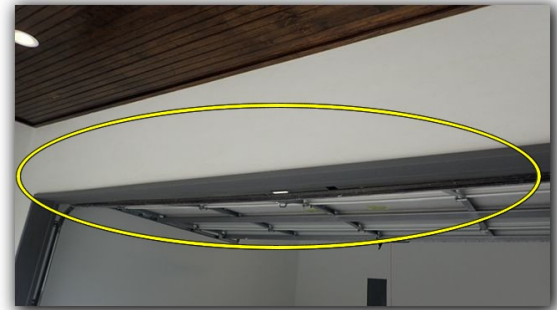
Comments: Did not observe weep screed at bottom of the stucco wall, where it intersects with the soffit. The following diagram depicts a "best practice" procedure as defined in the Texas Lathing and Plastering Contractor's Association (TLPCA) Stucco Resource Guide. This detail provide a means for moisture to exit from behind the stucco if the wall assembly leaks (we seldom see a weep screed at these locations on most stucco homes / buildings). If this exhibits a problem with moisture collecting in this area, a weep screed should be installed.

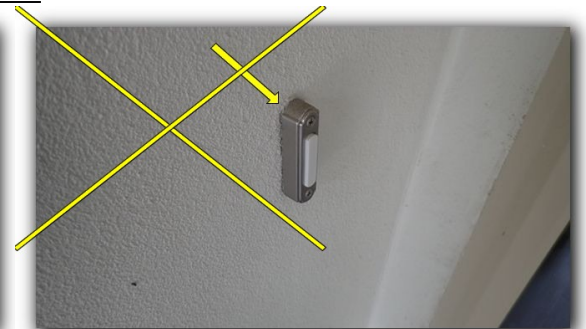
Need sealing / caulking around all holes and exterior siding penetrations on top and both sides, (leave bottom open) to prevent water entry. Including but not limited to dryer, bath and range top vents, light fixtures, etc.

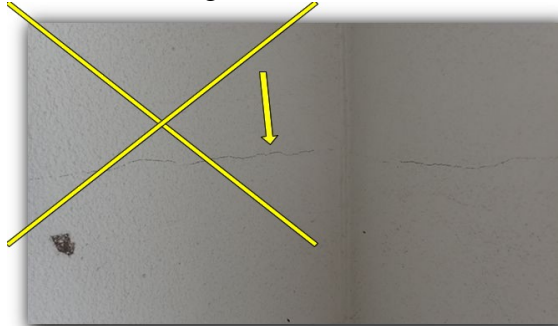
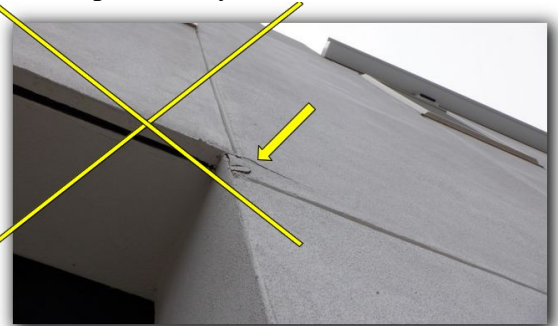
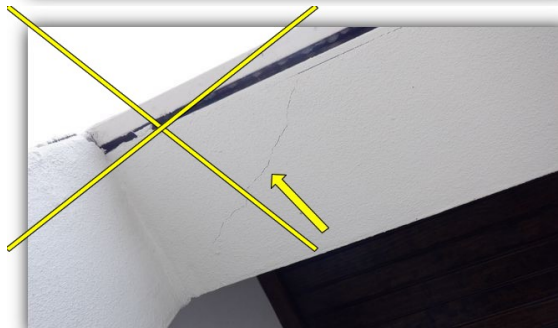
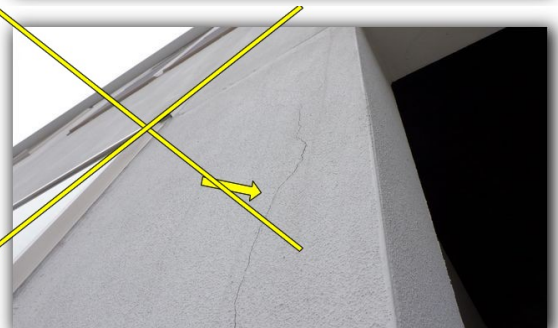
Possible water entry from cracks and/or penetrations in stucco siding. Recommend sealing / caulking around all cracks and exterior siding penetrations including but not limited to light fixtures, electrical outlets/service panels, dryer, bath vents, etc.

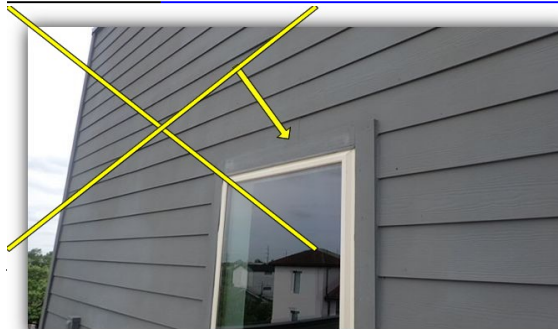
There is no flashing over the cement board trim as required by the siding manufacturer. Reference : James Hardie Installation Guide

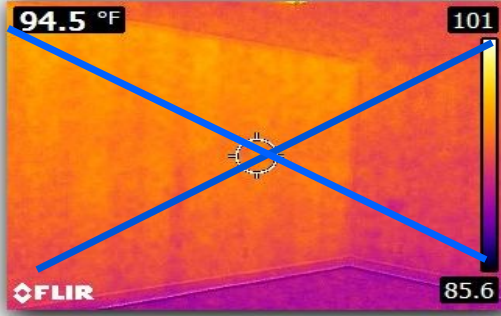
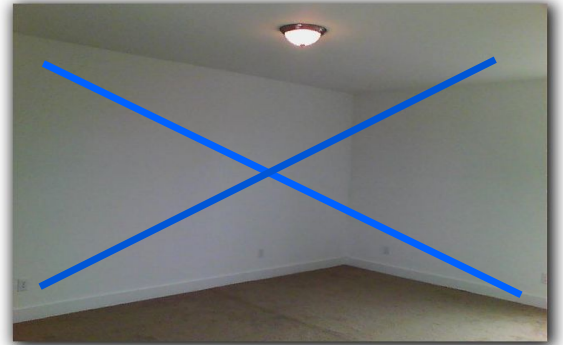
~~Exterior wall is not insulated at bonus room. There are no air registers for air conditioning. A return should also be installed along with removal of entry door seals to allow for proper air flow/cycling.~~

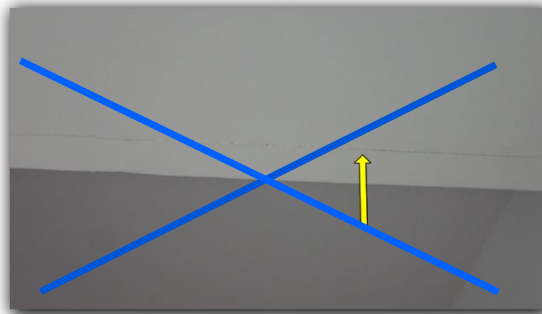
~~Comments: Observed cosmetic cracks and/or repaired cracks in sheetrock ceiling of several rooms.~~

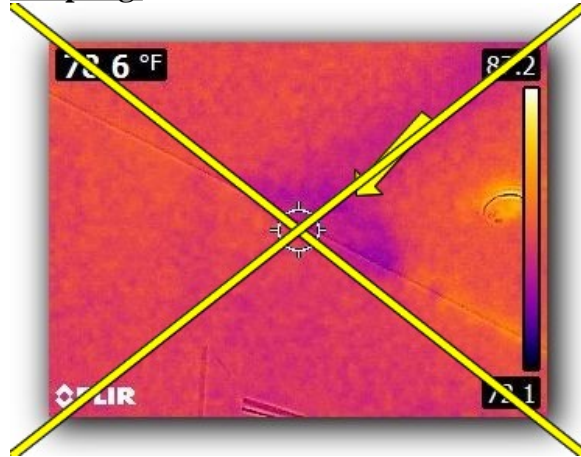
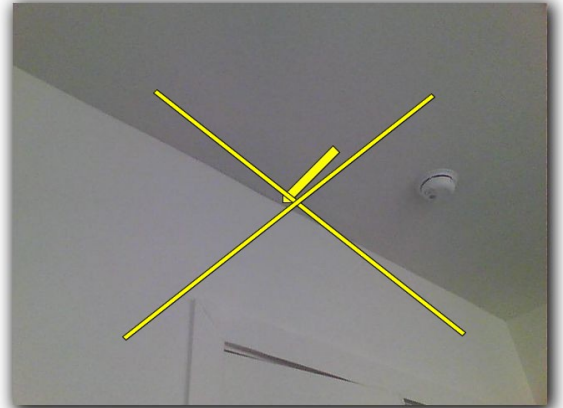
Active moisture registered via thermal camera over Master bed entry door. Source of moisture not confirmed but appears to be from the decking above. If mold is a concern please contact Texas House Check to schedule a Mold Assessment with sampling.

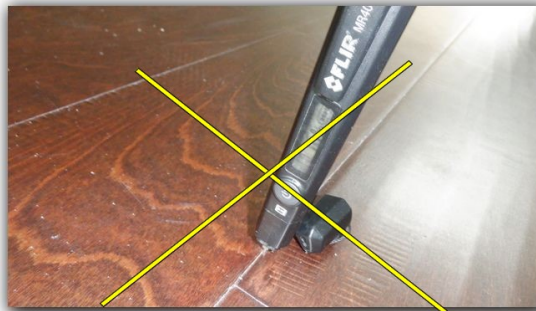
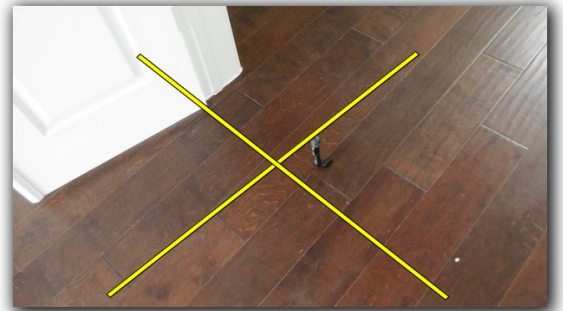
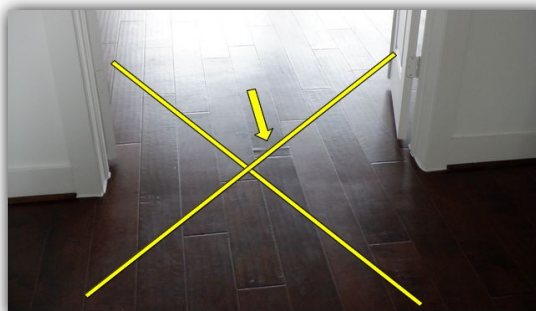
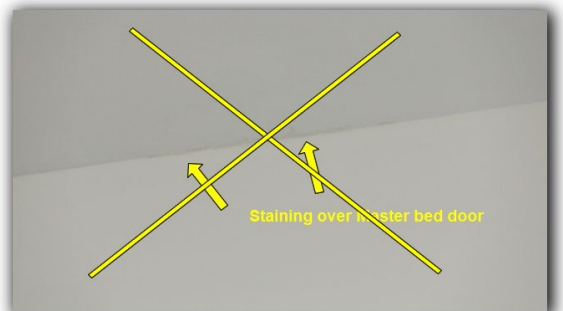
Elevated moisture registered on flooring below Master bedroom door frame:

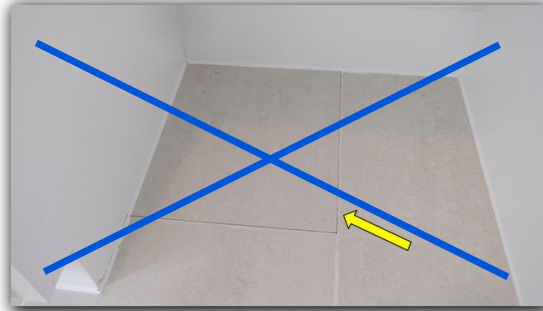
Loose tile in Master bath.

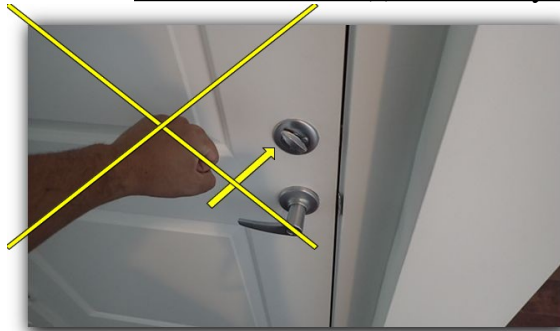
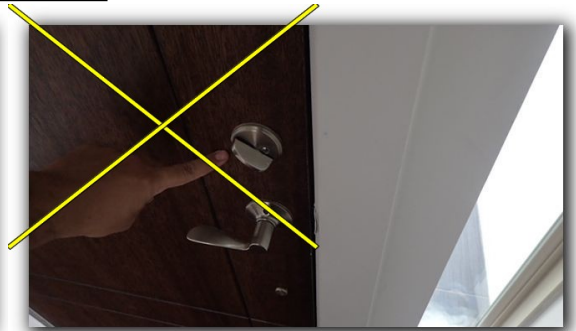
Comments: One or more door(s) have sticky hardware.

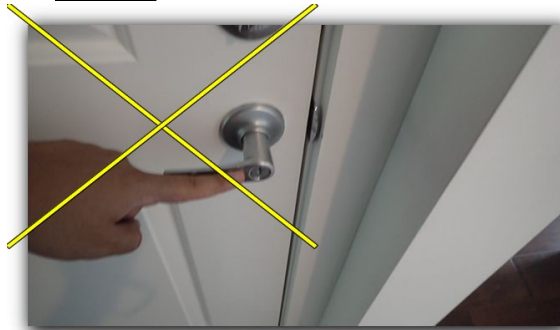
Exterior door does not have latch to unlock door. All egress doors shall be opened from the inside without the use of a key or special knowledge or effort. Ref. IRC code R311.2.

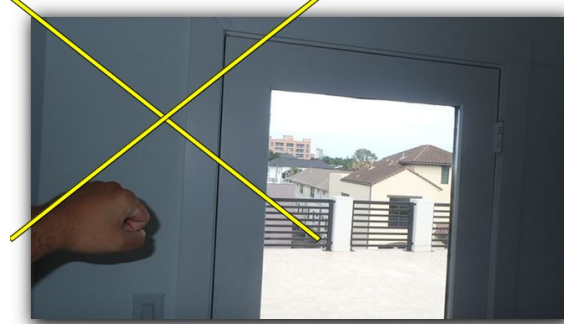
~~One or more doors in house are not square in jamb.~~

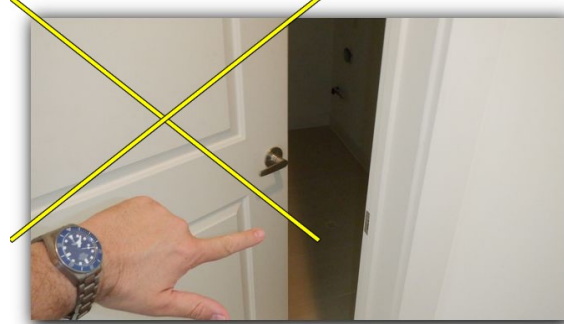
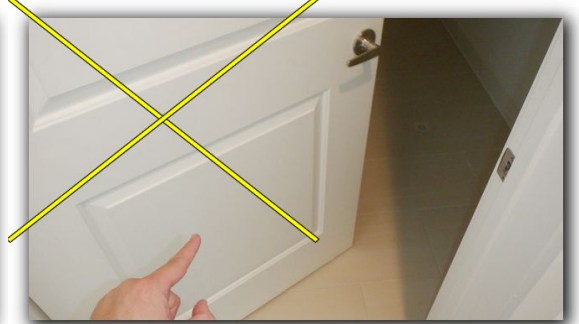
~~Laundry room door does not latch and is self-closing.~~

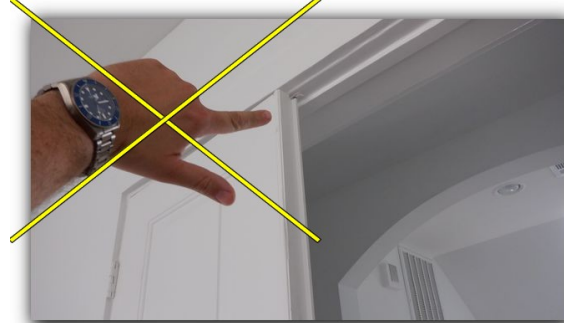
~~Master bedroom entry door does not latch properly, needs to be fitted properly.~~

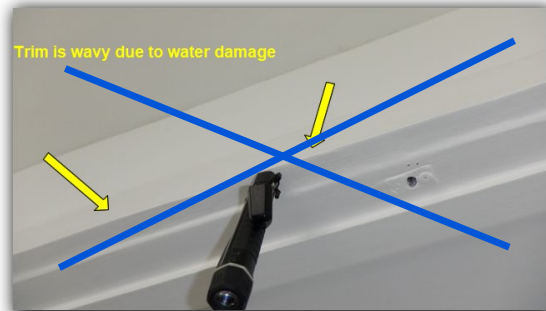
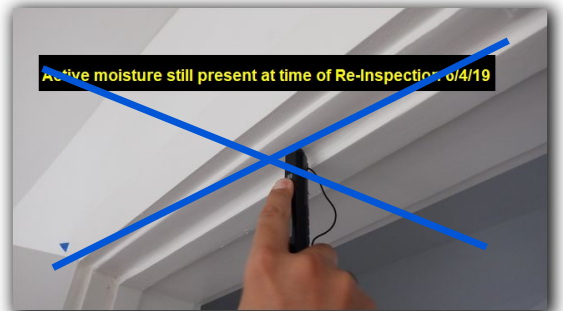
~~Master bed entry door frame is registering active moisture. This is due to a leak above. Recommend complete replacement of all water saturated trim to prevent mold damage. If mold is a concern please contact Texas House Check to schedule a Mold Assessment with sampling.~~

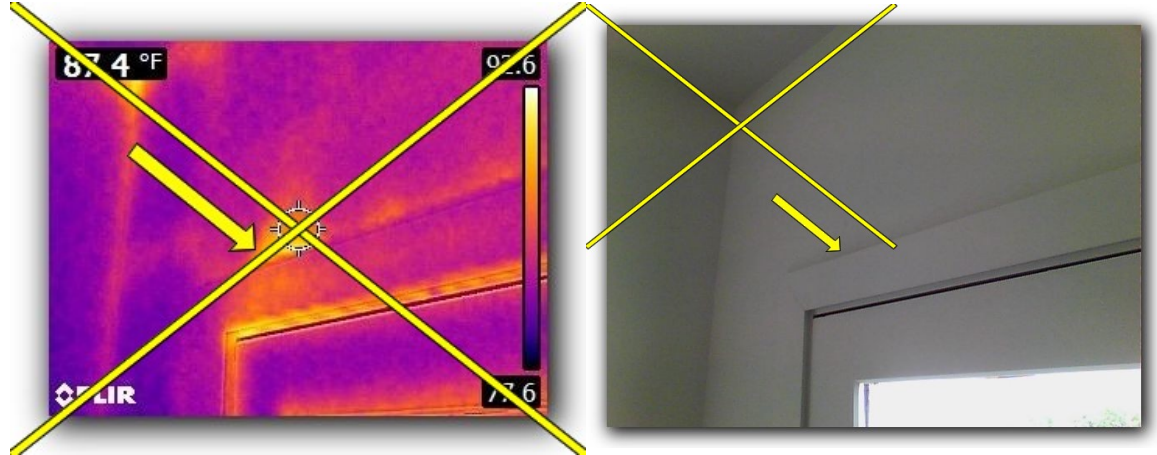
Excessive air loss over exterior door trim at one or more locations.

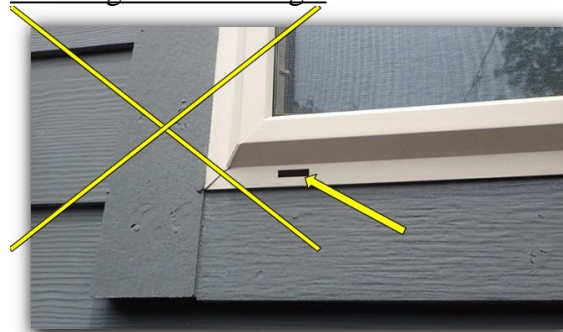
Comments: One or more window drain covers are not in place. The window drain covers are needed to prevent insects/debris from entering the window drainage system and blocking water drainage.

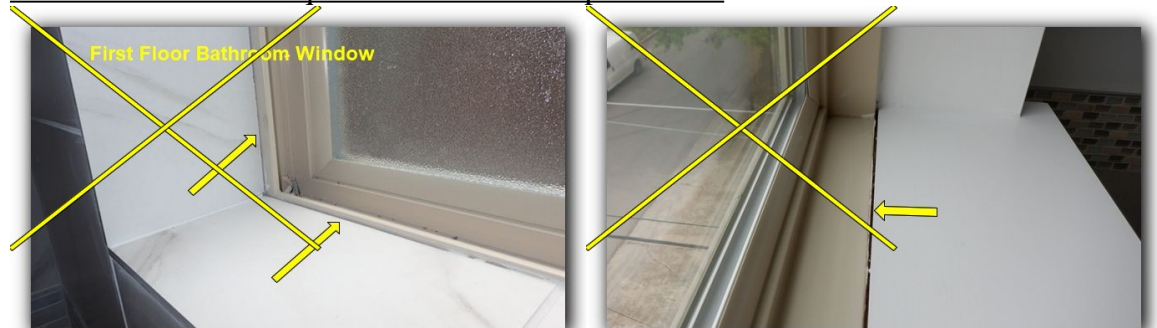
The window frames require caulk or caulk replacement.

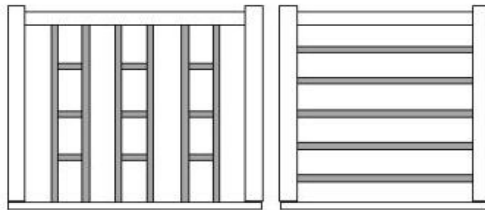
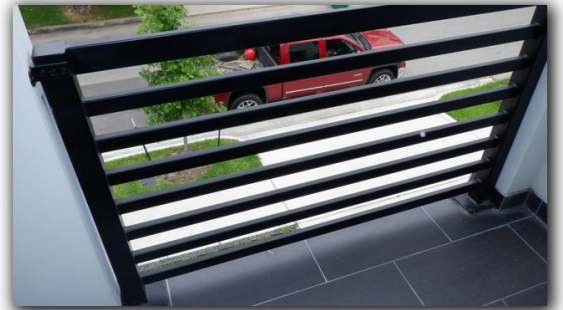
Comments: Nautical style railings of stairway and balconies are known to be potential hazard around small children who like to climb the horizontal rails.

LADDER TYPE DESIGNS ARE NOT ACCEPTABLE

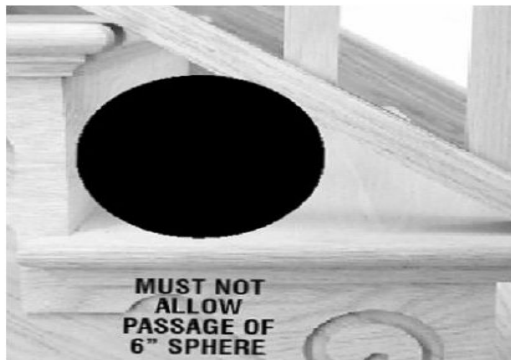
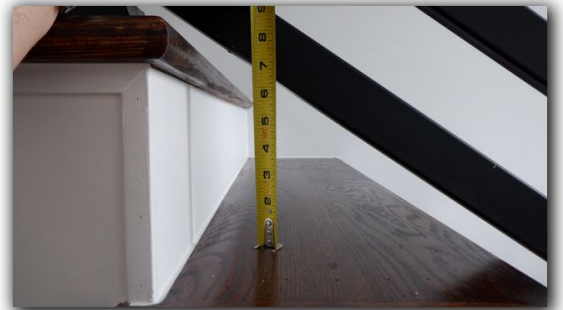
Space between lower treads and railing does not comply with current industry standard, (code). Requires spacing between treads and lower edge of railing does not allow passage of an object six (6) inches in diameter. Recommend covering large openings in stair rails with temporary type nylon netting if small children are present in house to prevent injury.

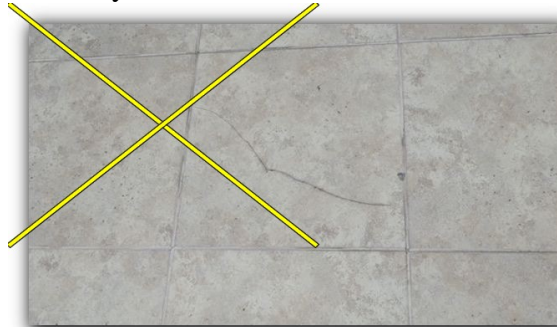
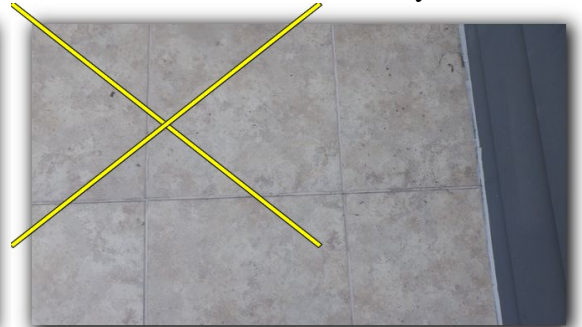
Comments: ~~Observed many cracked tiles or cracks in the grout on the top floor balcony. This may be the source of moisture observed below over the Master bed entry door.~~

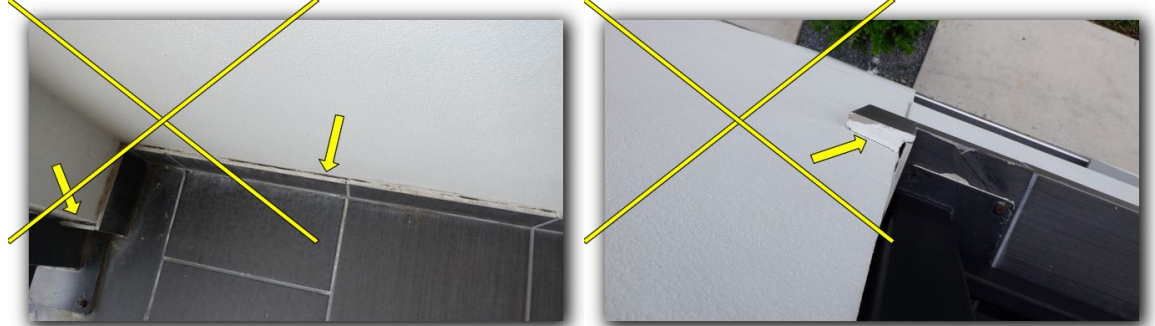
File/trim faces not sealed, numerous locations:

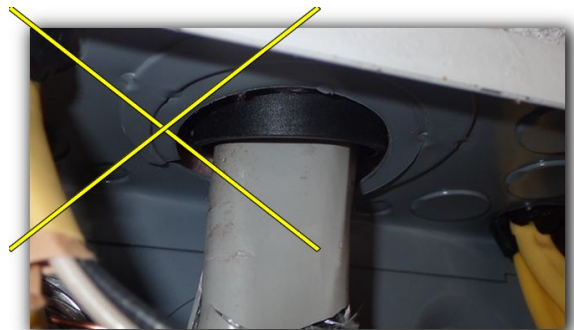
Protective bushing not present around electrical wire as it passes through metal box.

cables should be clamped where they enter the panel
they should also be secured within 12 inches of the panel

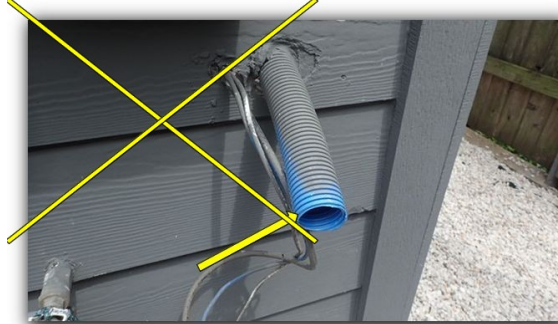
Comments: Blue plastic electrical conduit is not rated for exterior use.

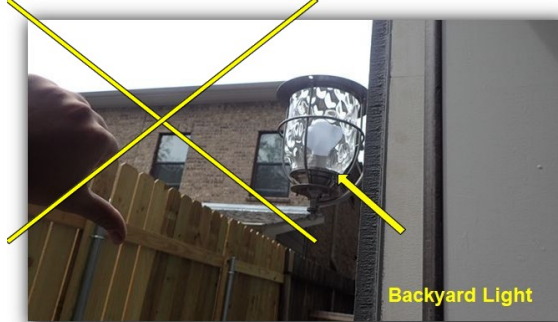
Light(s) found to be not functioning. Probably just a burned out bulb, or it could be a broken fixture / switch or improper wiring. Including but not limited to:

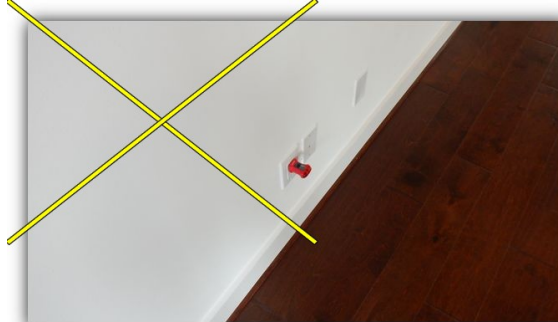
No power at exterior family room wall at time of inspection.

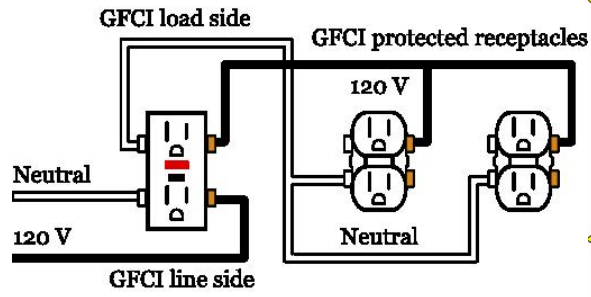
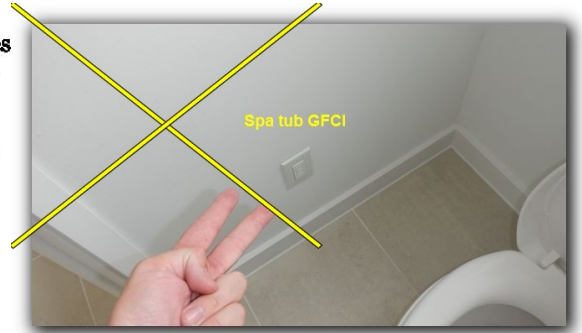
Multiple GFCI resets on the same circuit. This condition is un-necessary and creates confusion for the homeowner. There should only be 1 GFCI reset per circuit.

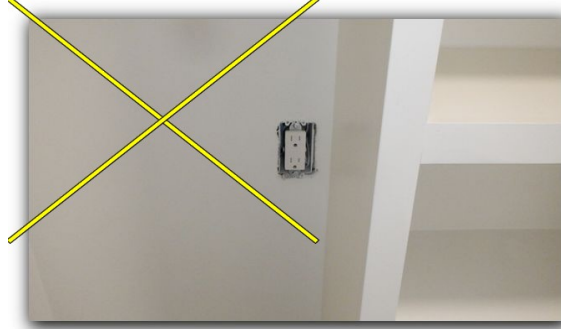
Cover plate missing at Master closet outlet.

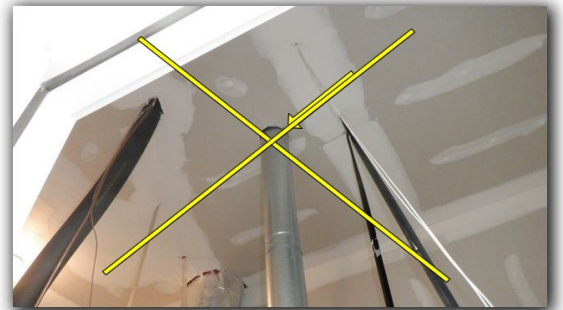
Comments: Exhaust vent pipe is in contact with combustible material. Current industry standards (code) require 1" clearance for double wall vent pipe.

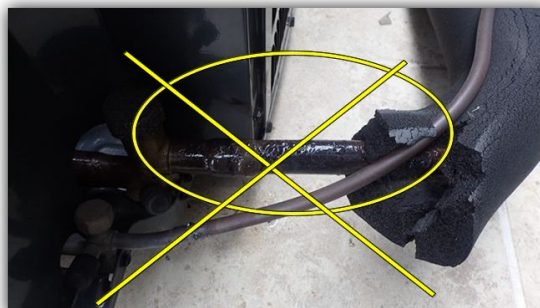
~~Section of suction line insulation missing or deteriorated near condenser.~~

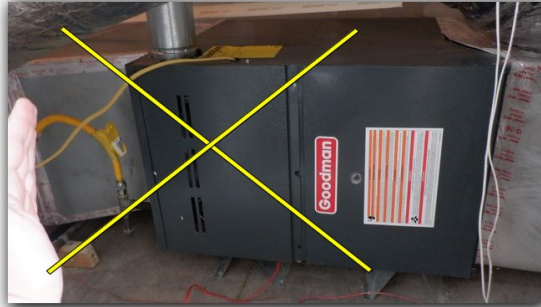
Excessive noise/vibration at unit during cooling cycle. Further assessment needed by HVAC contractor.

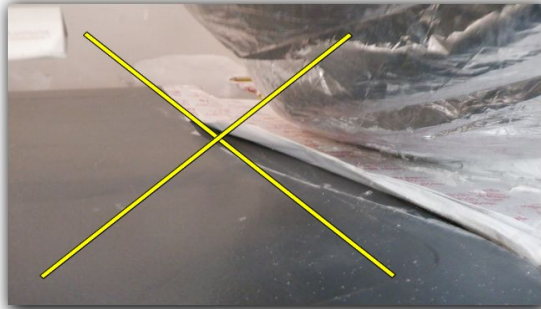
Comments: Lifted tape/seals on unit should be repaired. Recommend using mastic/hard-caste instead of tape at joints.

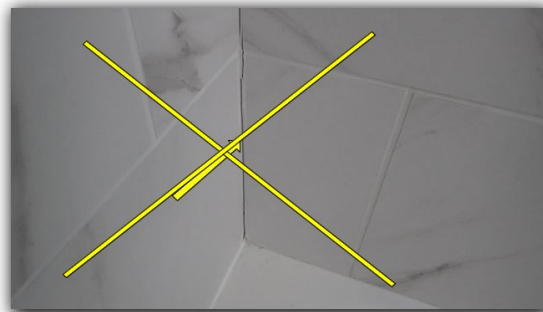
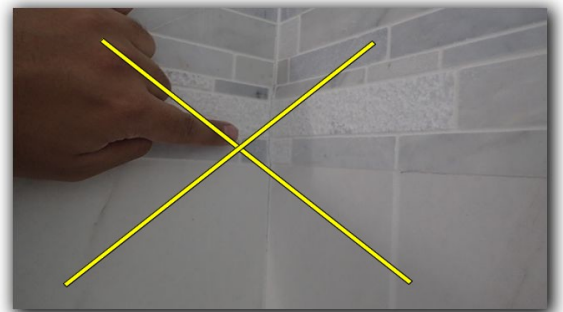
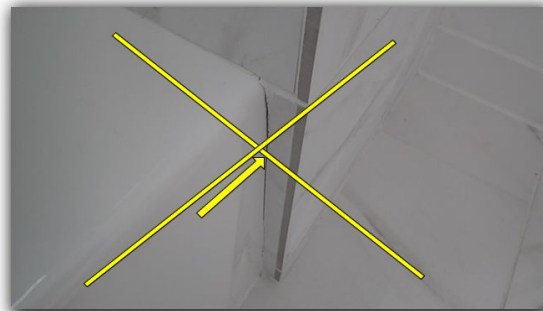
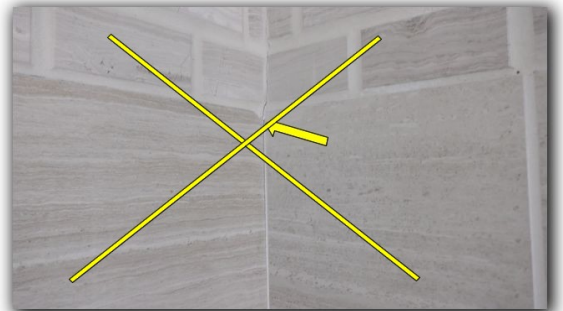
Comments: Grout / caulking needed at vertical tile corners, cracks in tile and/or mortar between tiles, and where tile meets tub to prevent water entry behind wall.

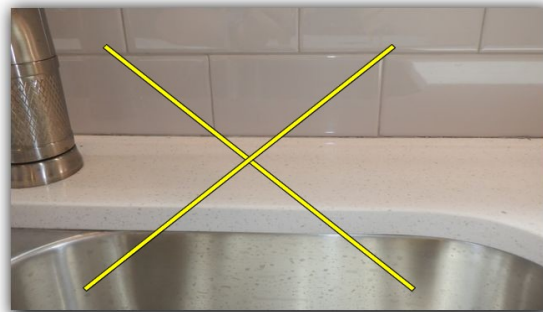
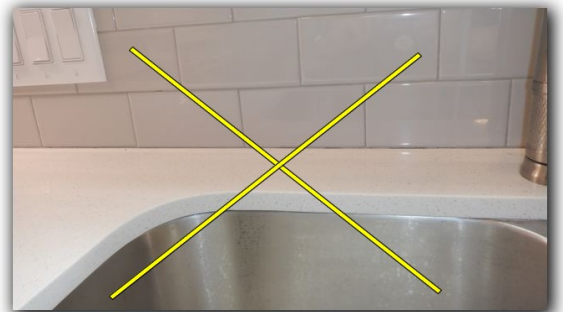
Countertop needs to be caulked so that water cannot penetrate behind countertop backsplash or beneath to the cabinet.

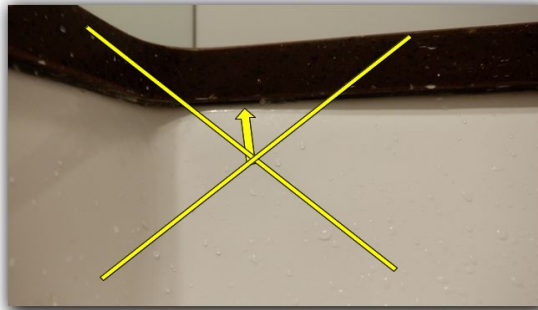
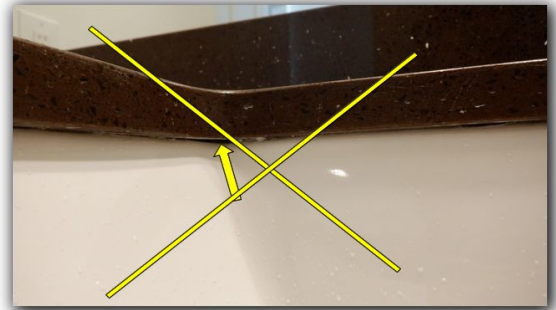
Where the sink connects to the countertop the caulk is either missing/damaged and should be reapplied to create a smooth surface to prevent surfaces prone to fouling. Refer to IRC P2701.1 Quality of fixtures

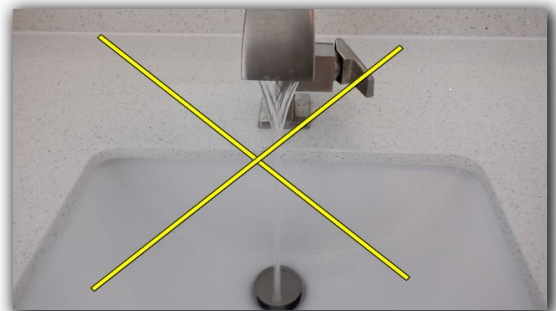
Very low water pressure at Master bath sink faucets.

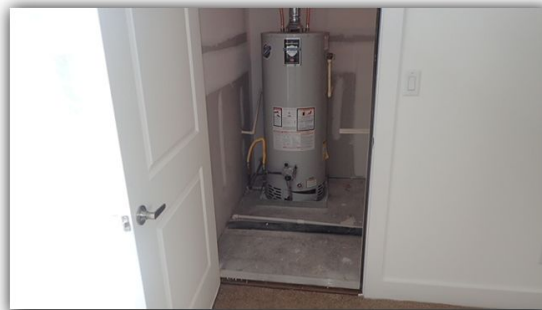
Inadequate provisions for combustion air as required by manufactures installation instructions. Common industry standards (CABO Code 2002.1) require; One opening at top and bottom 12" of door, Each opening shall have "free area" (grills reduce free area) equal to a minimum of 1 square inch per 1,000 Btu/h rating of all appliances installed within the space, but not less than 100 square inches IRC 2407.10.

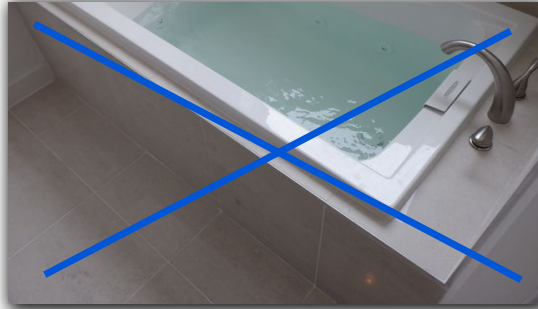
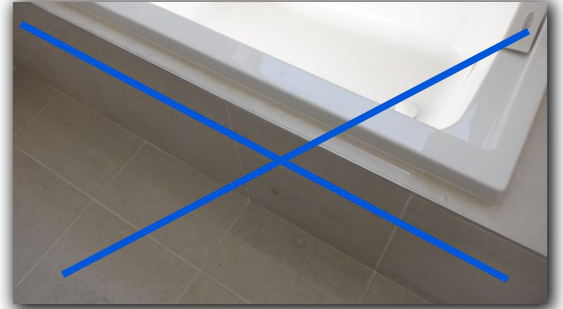
Comments: ~~Was not able to access motor for visual inspection. Does not comply with National Electric Code (Reference NEC 680-72. Accessibility. "hydromassage bathtub electrical equipment shall be accessible without damaging the building structure or building finish".) Recommend client have builder demonstrate actual access to the pump and motor that does not cause such damage. Have them remove skirting without damage IRC 4109.3.~~
