# Inspection Report

**Property Address:**  
9336 Old River Ct.  
Montgomery TX 77356

**JASE Home Inspections**

<b>Date:</b> 10/11/2020	<b>Time:</b> 09:55 AM	<b>Report ID:</b>
<b>Property:</b> 9336 Old River Ct. Montgomery TX 77356	<b>Customer:</b> Monte Gibbs	<b>Real Estate Professional:</b> Jeff Deutschmann

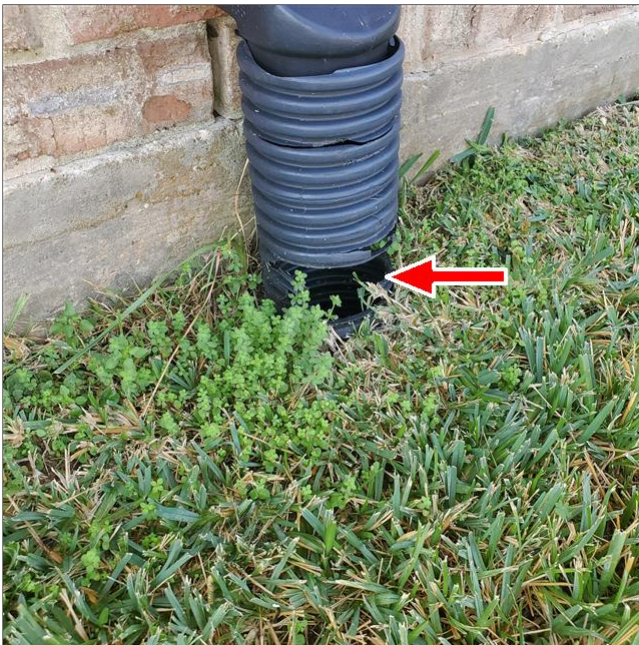
(2) Black plastic drain connections at downspouts at the left side of the home are damaged and will likely not function properly. Repair or replacement is recommended.

B. Item 2(Picture) Hole in black plastic downspout connector.

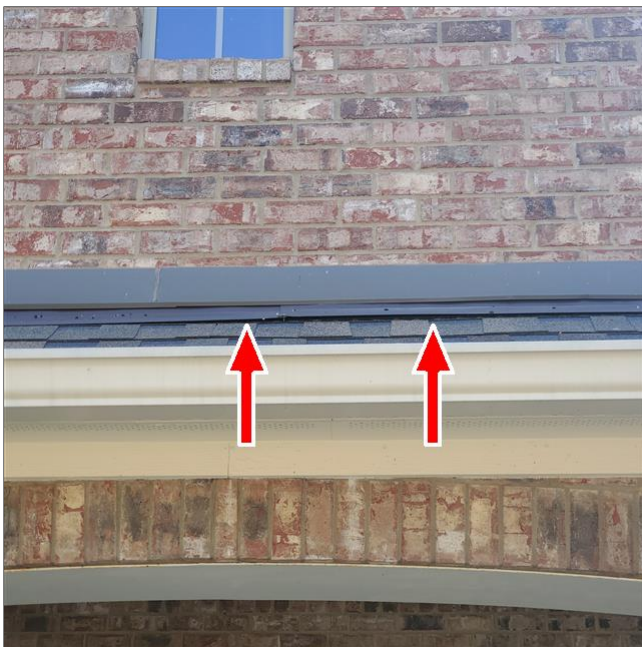
(2) A slight nail pop was observed at the flashing above the garage. Repairs need to be made to ensure flashing lays flat on the shingles.

C. Item 4(Picture) Lifted flashing.

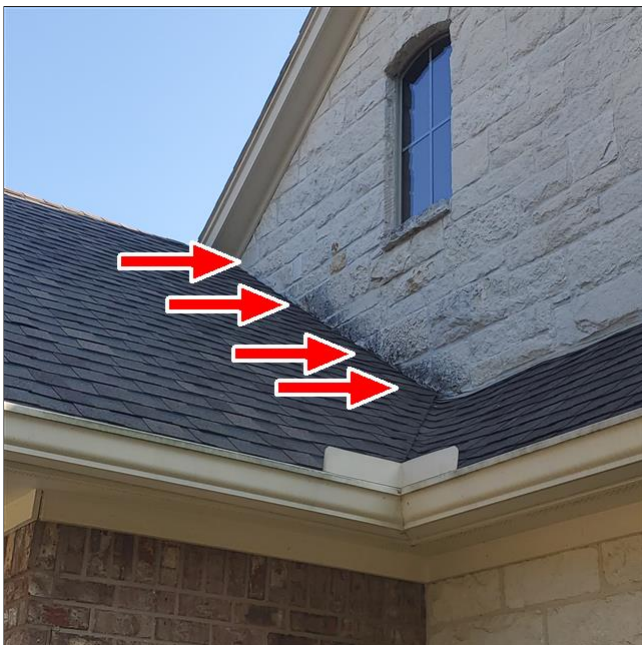
(3) Counterflashing is not installed at the front of the home where the stone veneer meets with the shingles on the roof. The stone is discolored as a result. The inspector recommends a qualified roofing professional install counter flashing.

C. Item 5(Picture) Counterflashing not installed.

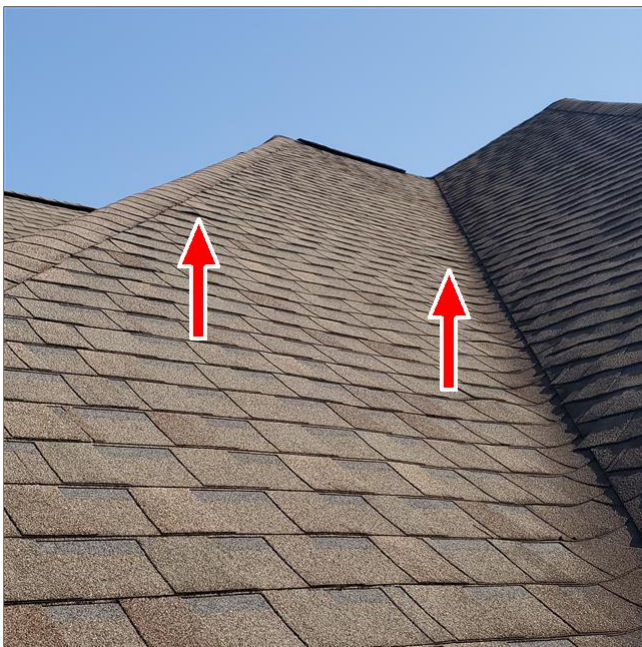
(4) Nail pops were observed it to shingles at the front right side of the roof. The nail pops need to be repaired to ensure the shingles lay flat and seal.

C. Item 6(Picture) Lifted shingles at the right slope.

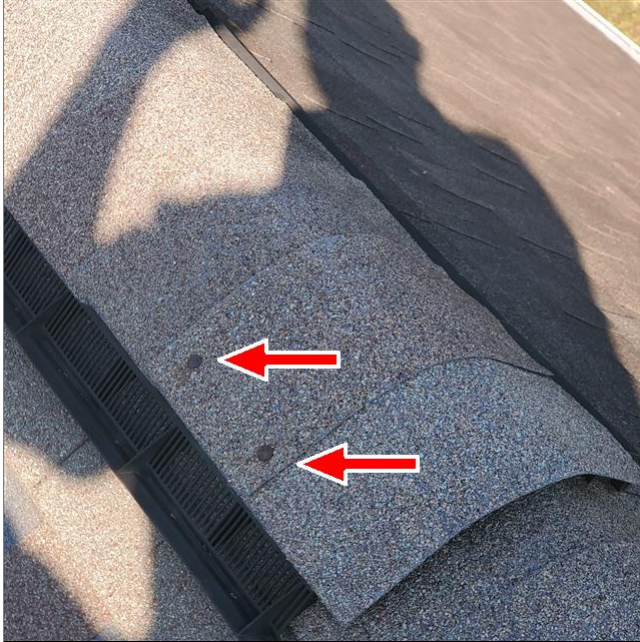
(5) Unsealed nails were observed on the roof at flashings and on shingles. If nails are used at flashings, these nails should be sealed so they are not exposed to the elements are less likely to rust over time. Rusting nails will become loose and may allow water penetration into the attic space. I recommend sealing all nails that are exposed on the roof.

C. Item 7(Picture) Photo of two of the unsealed nails.

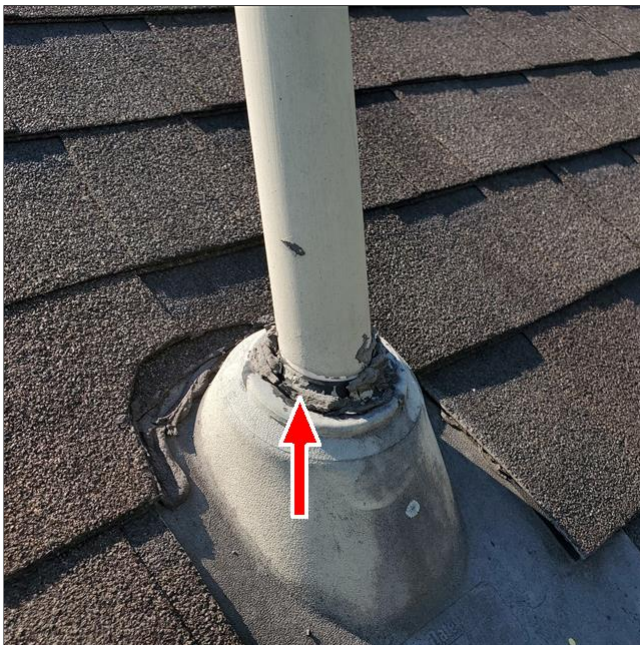
(6) The inspector observed that many of the pipe jack boots on the roof have been caulked and sealed to the vent stack pipes. It was noted that the sealant is deteriorating. There were water stains observed on the ceiling in the master bedroom that may be due to a leak at the pipe jack shown in the photo. A qualified roofing professional should replace the pipe jacks that are in need.

C. Item 8(Picture) This sealant deteriorates and leaks will occur here.

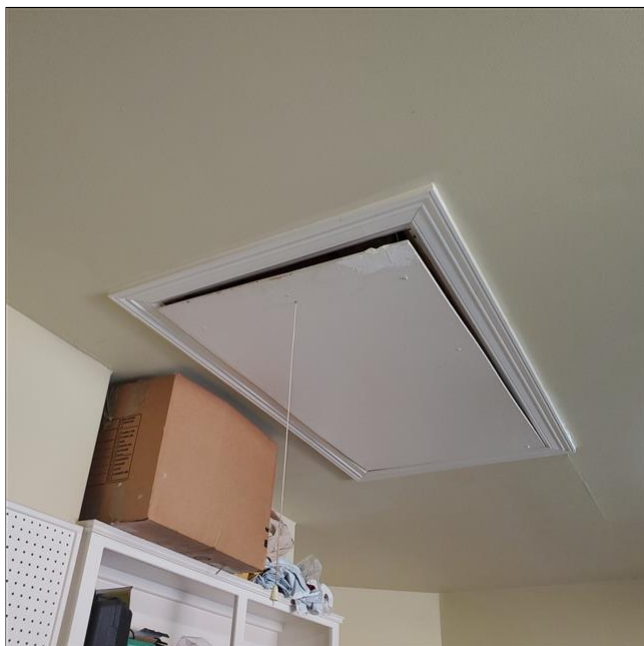
The attic pull down is not sealed to the ceiling in there is a large gap in the garage. Repairs need to be made to ensure the pull down is sealed to the ceiling in order to provide proper fire separation.

D. Item 1(Picture) Pull down not sealing.

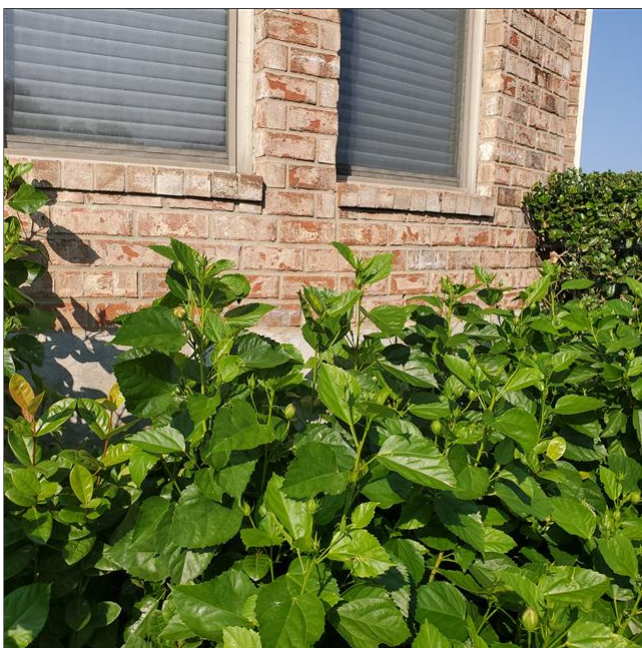
(1) There is overgrowth of vegetation and foliage against the exterior walls at the right side and back of the house. I recommend trimming back all overgrowth and foliage. Over grown vegetation and foliage against a wall can hold moisture in that area and may damage the siding or brick. It can also provide a good avenue for insects to penetrate the wall.

E. Item 2(Picture) Overgrown vegetation against the home at the back.

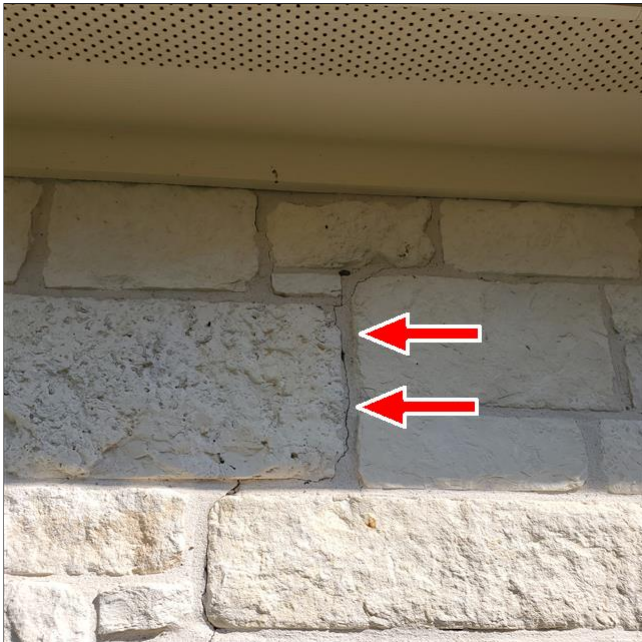
(2) Small cracks were observed in various areas at the exterior walls. The inspector recommends monitoring the cracks for growth as they are not wide enough to typically indicate a structural concern.

E. Item 3(Picture) Photo of one of the common cracks in the mortar.

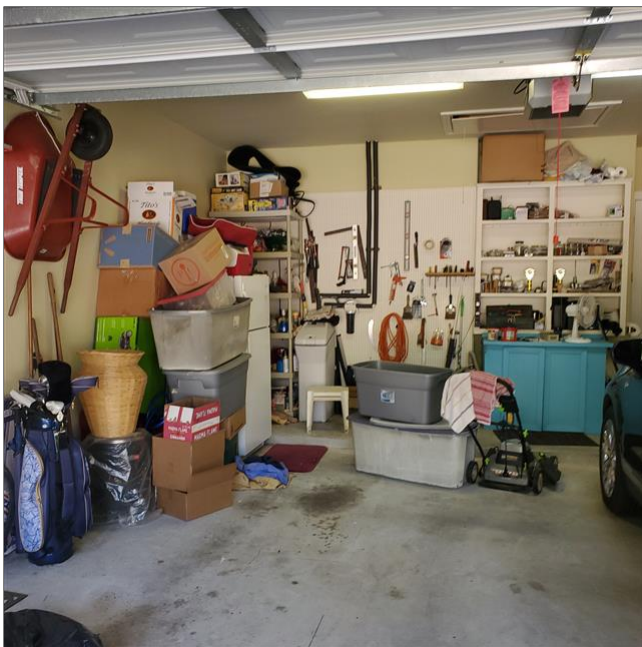
(3) The inspector was unable to perform a full evaluation of the garage walls due to a large amount of personal items being stored.

E. Item 4(Picture) Items were stored in the garage.

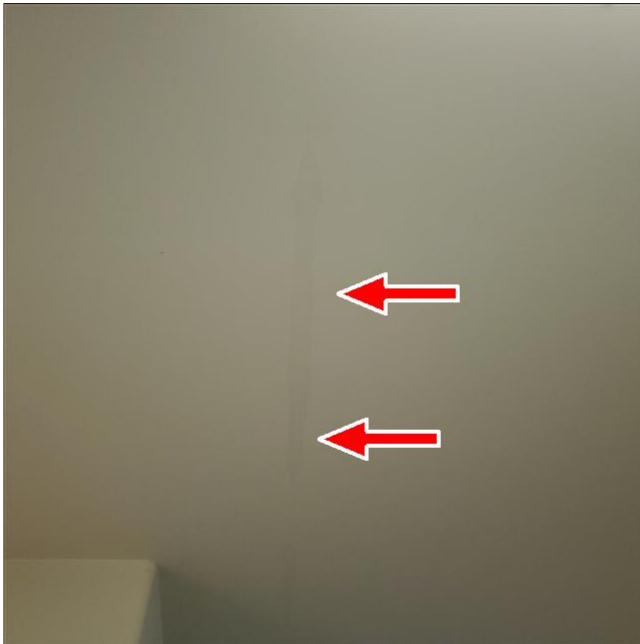
(1) There were three stains on the master bedroom ceiling that appeared to be due to the ceiling getting wet. The inspector attempted to locate the cause of the damages and could only find that it may be related to leaks around pipe jacks on the roof. Further investigation may be needed by removing the drywall to determine if there is a different source such as plumbing that is covered by insulation.

F. Item 1(Picture) Photo of one of the stains.

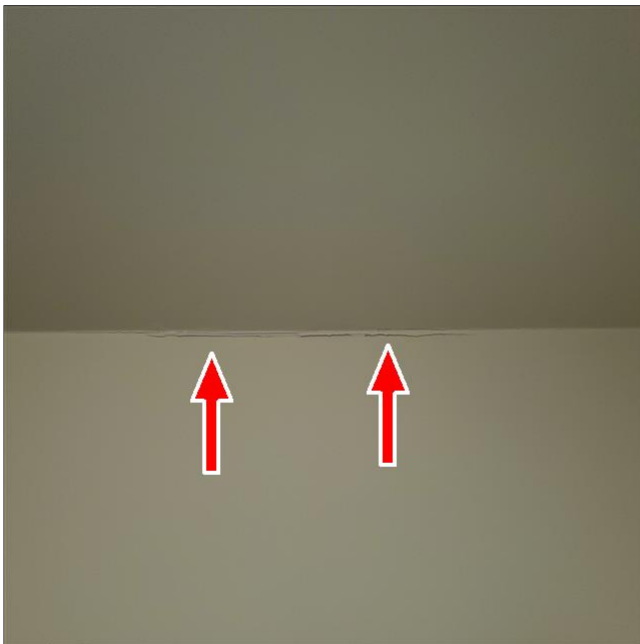
F. Item 2(Picture) Drywall tape was peeling at the wall/ceiling intersection.

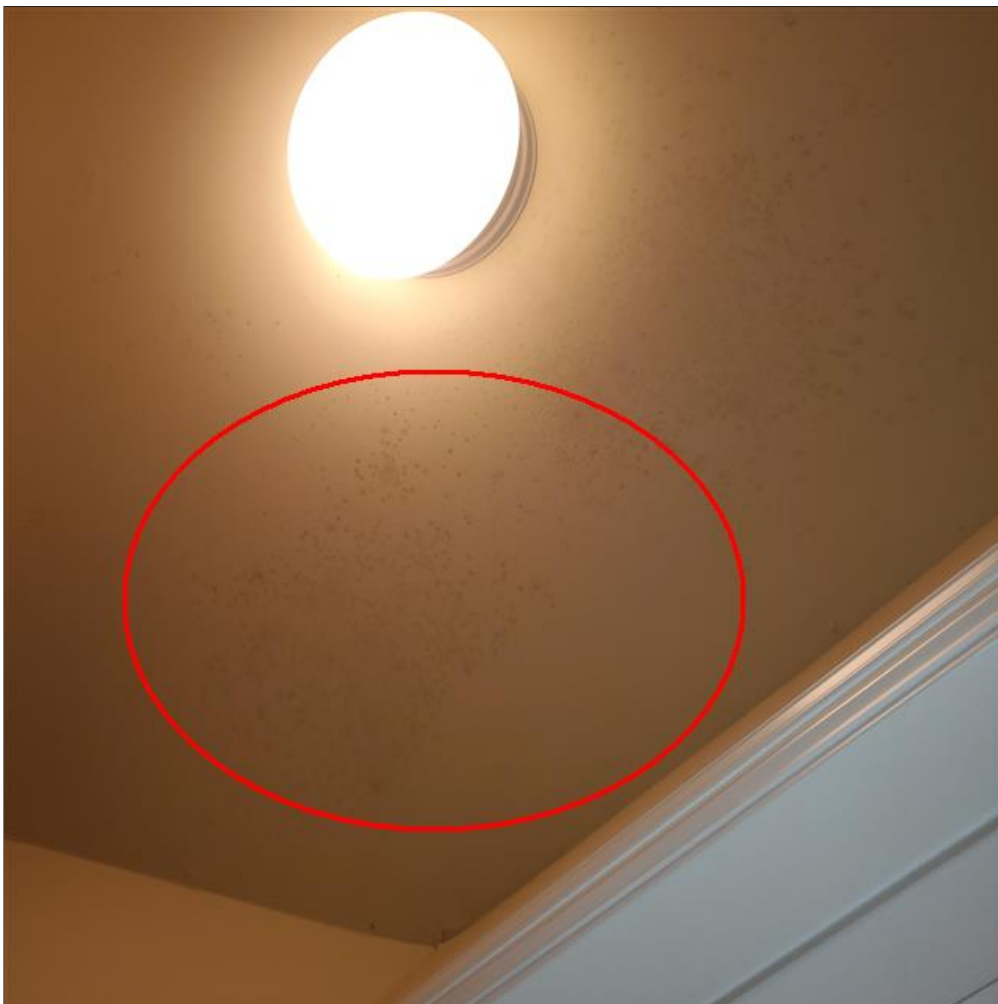
(2) Splotchy discoloration was observed at the ceiling in the front right bedroom closet and in the bedroom hallway closet. The inspector could not determine the causes of the discoloration and recommends further investigation by a qualified professional.

F. Item 4(Picture) Photo of discoloration.

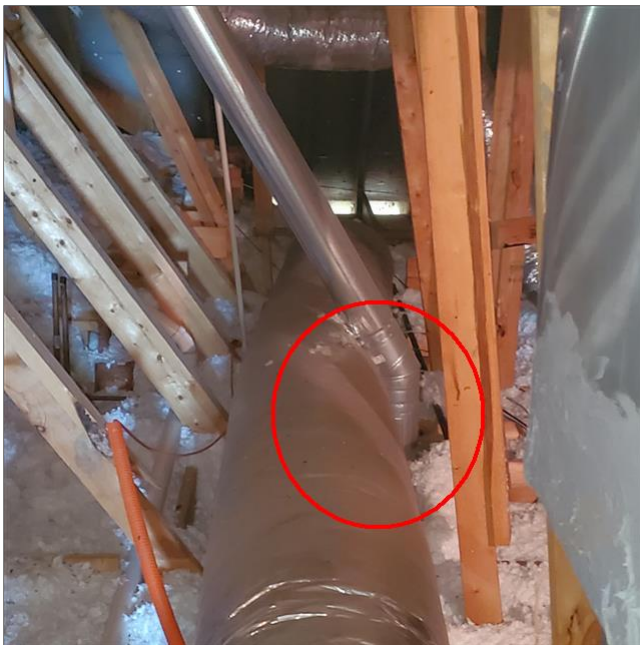
(1) The chimney flue was in contact with a piece of ductwork and with insulation in the attic. There should be at least 1" of clearance around the chimney flue from all materials that may catch fire.

J. Item 1(Picture) Photo shows chimney flue in contact with duct.

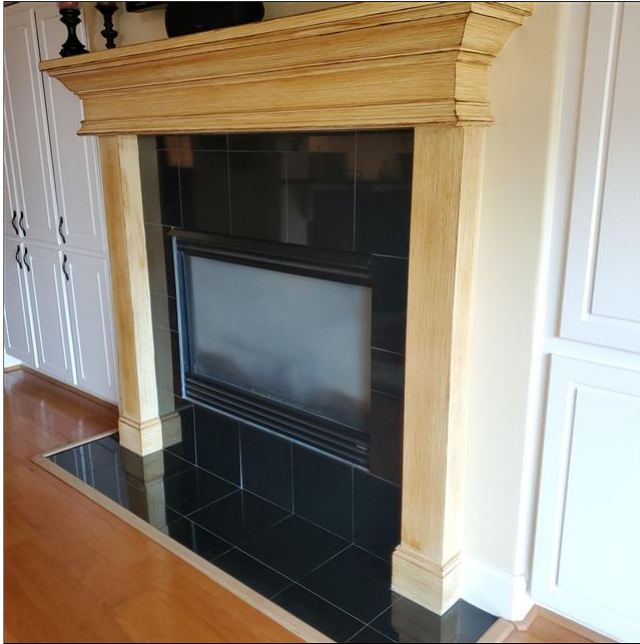
(2) The glass for the enclosed fireplace was fogged. The inspector recommends having a qualified professional determine if the glass can be cleaned or if replacement is needed.

J. Item 2(Picture) Photo of foggy glass.

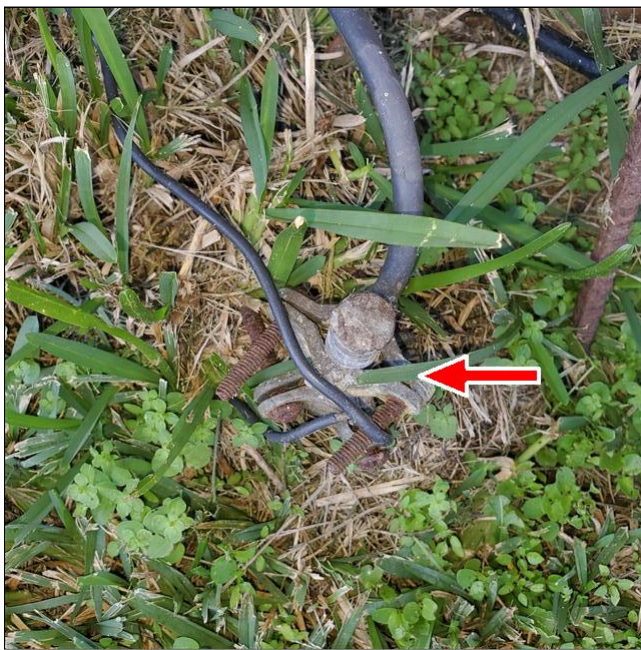
(1) The clamp at the ground rod did not appear to be proper (i.e. rated for ground rods). The clamp observed was listed as a pipe clamp for metal or gas lines. I recommend the use of a brass "acorn" style clamp, U. L. listed and approved for direct burial on the ground rod for a more secure, longer lasting connection.

A. Item 1(Picture) Photo shows clamp.

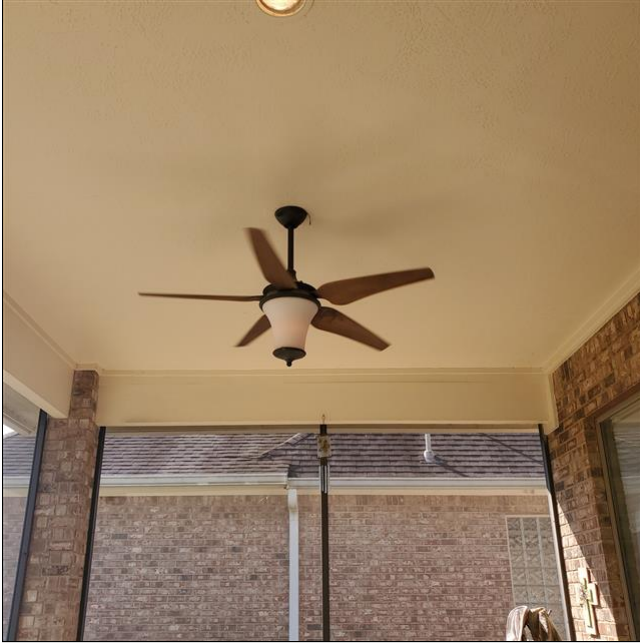
(2) The right side ceiling fan on the back porch was wobbling during the inspection and is in need of repair.

B. Item 1(Picture) Ceiling fan was wobbling.

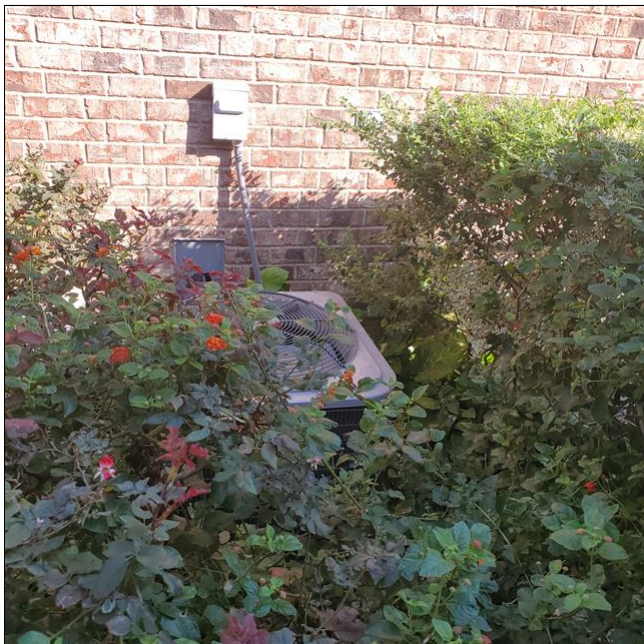
(2) Air flow to the air-conditioner condenser coils was restricted by vegetation growing near the compressor

housing which may limit their ability to dissipate heat. These shrubs should be cut back in order to improve air flow, maintain cooling system efficiency and avoid problems from overheating of the compressor.

B. Item 2(Picture) Lots of vegetation growth around unit.

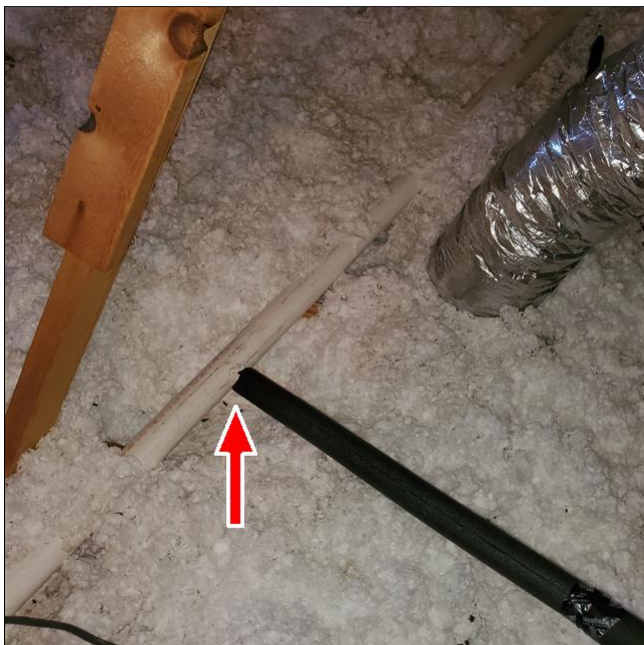
(3) The condensate tube, the purpose of which is to safely discharge condensate produced by the operation of the air-conditioning evaporator coils, discharged condensate to a plumbing waste pipe. Because the condensate line had no trap, this condition may allow sewer gas or bacteria to enter the home air ducts and living space. The Inspector recommends correction of this improper condition by a qualified HVAC technician.

B. Item 3(Picture) Primary drain line terminates at a drain, waste, vent pipe.

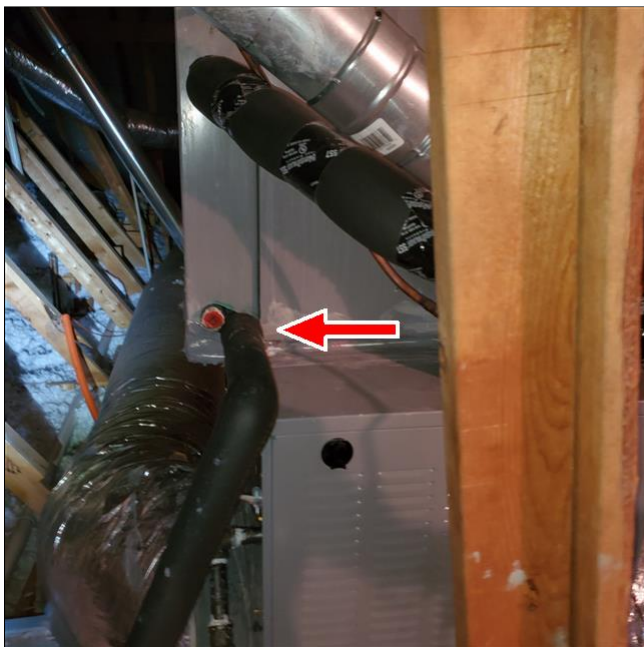
(4) Cold air was felt is blowing from the evaporator coil housing in the attic space. It is recommended that a licensed HVAC professional properly seal this area.

B. Item 4(Picture) Inspector felt cold air blowing around this area.

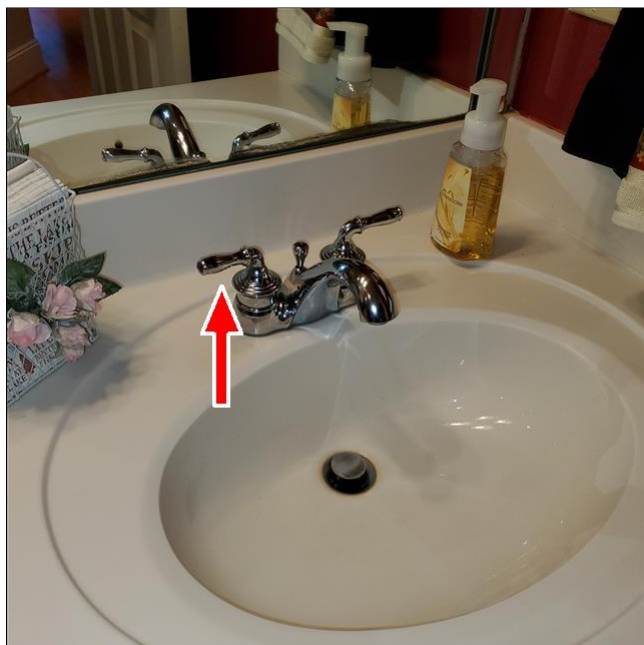
(3) The valve handle for the hot water supply at the guest bathroom vanity was extremely difficult to turn. Replacement of the fixture may be needed.

A. Item 1(Picture) Valve handle was difficult to turn.

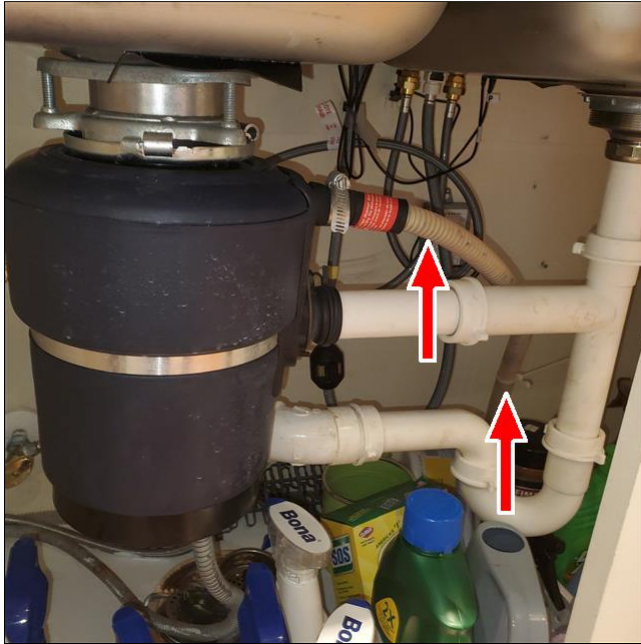
B. Item 1(Picture) No high loop at the drain line.

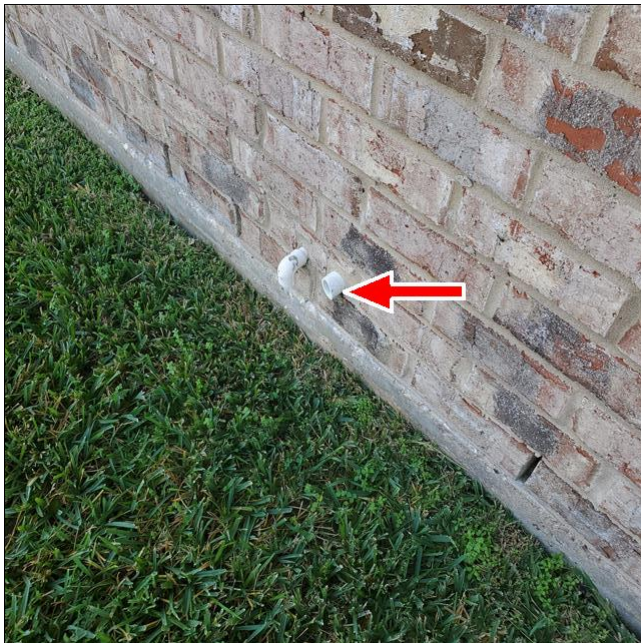
(2) A turn down elbow is missing at one of the water heater discharge pipes at the left side of the home.

C. Item 2(Picture) Turndown was broken off.

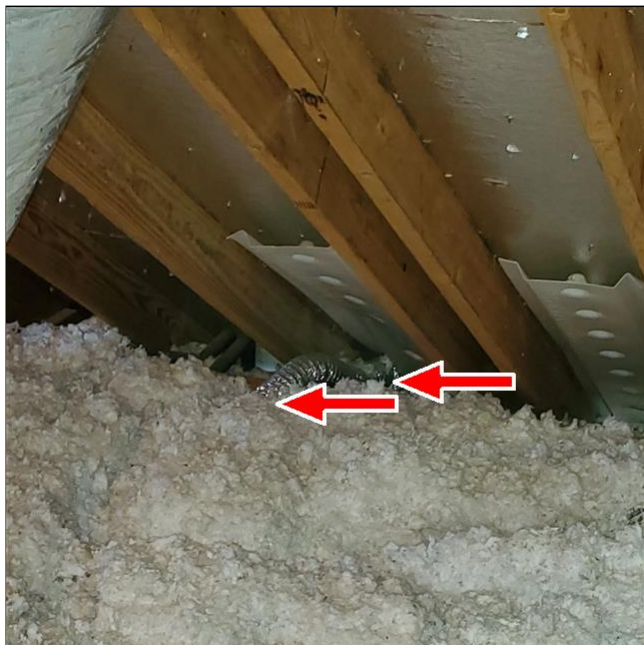
Exhaust fan ducts appeared to terminate at the soffits. Exhaust fan ducts should terminate at the top of the roof as the purpose of soffits is to draw air in to the attic. I recommend re-location of the exhaust ducts to the top of the roof.

F. Item 1(Picture) Ducts terminate at soffit.

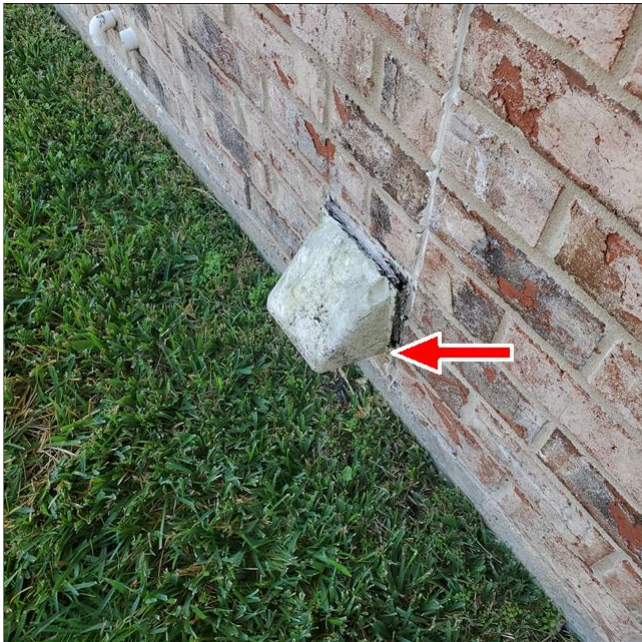
H. Item 1(Picture) Wall cap was loose.

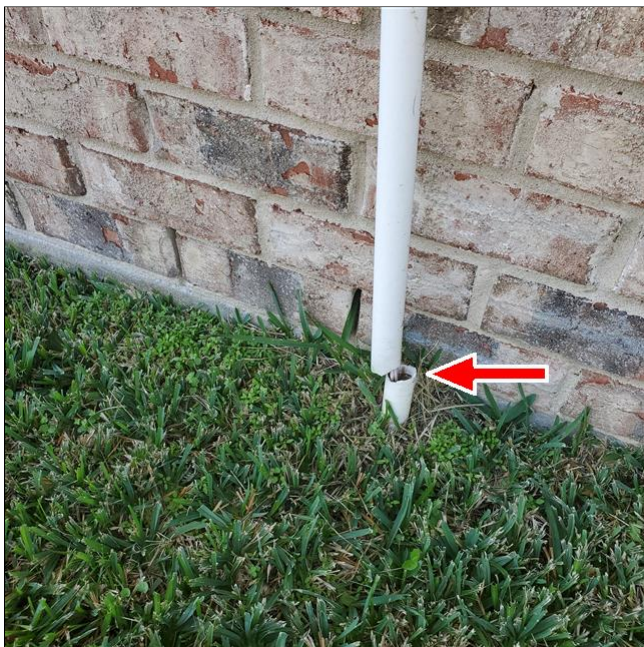
(3) The conduit for the electrical wiring to the control box at the left side of the home is damaged and is in need of repair to protect the wires.

A. Item 3(Picture) Conduit was damaged.

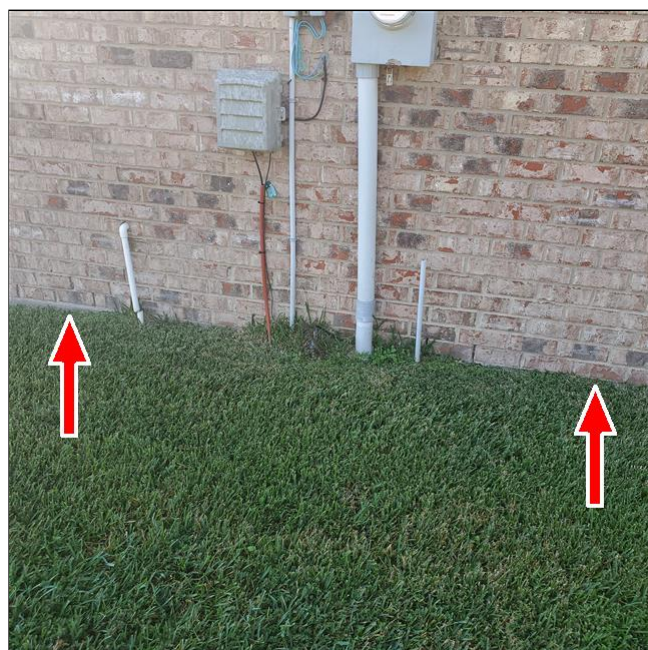
(1) High soil was observed at the left side of the home. It is recommended that at least 4-6 inches of slab be visible around the entire home to keep extra moisture out of the brick and to deter unwanted insects out of the weep holes. I recommend re-grading the areas where at least 4-6 inches of slab is not visible.

B. Item 1(Picture) High soil at the left side.

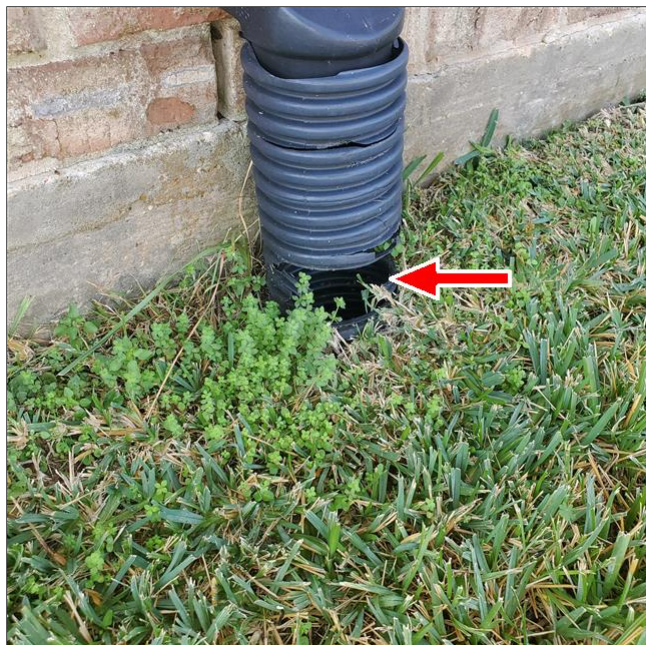
(2) Black plastic drain connections at downspouts at the left side of the home are damaged and will likely not function properly. Repair or replacement is recommended.

B. Item 2(Picture) Hole in black plastic downspout connector.

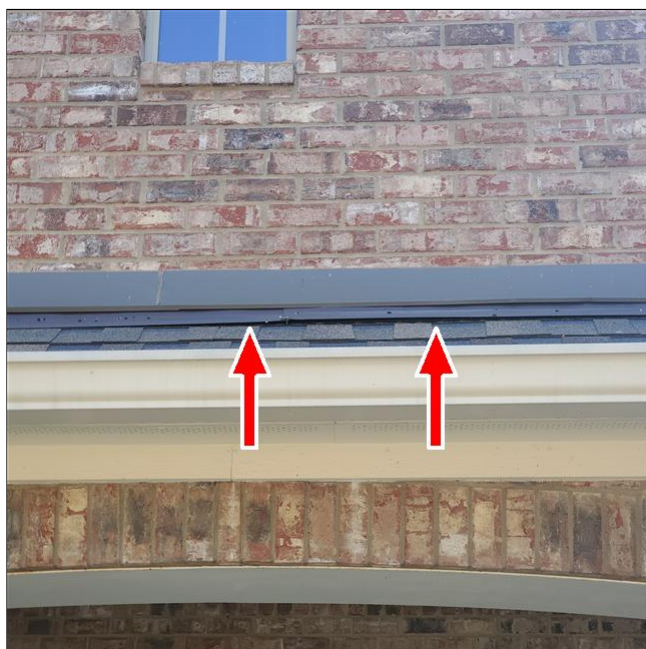
(2) A slight nail pop was observed at the flashing above the garage. Repairs need to be made to ensure flashing lays flat on the shingles.

C. Item 4(Picture) Lifted flashing.

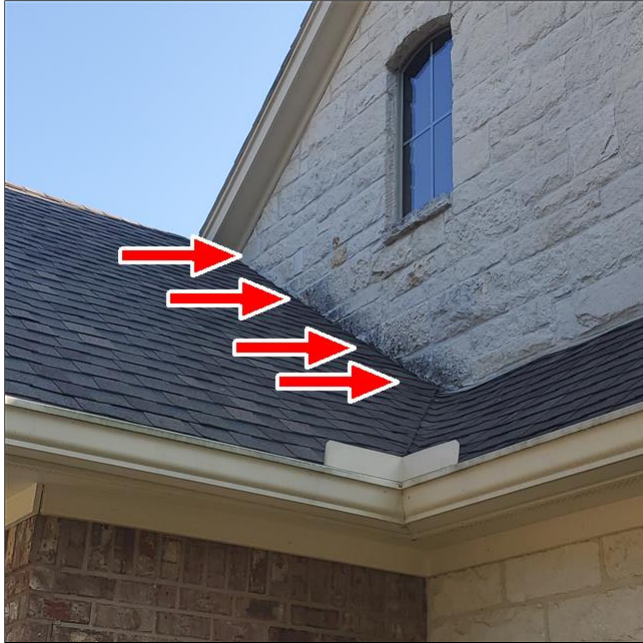
(3) Counterflashing is not installed at the front of the home where the stone veneer meets with the shingles on the roof. The stone is discolored as a result. The inspector recommends a qualified roofing professional install counter flashing.

C. Item 5(Picture) Counterflashing not installed.

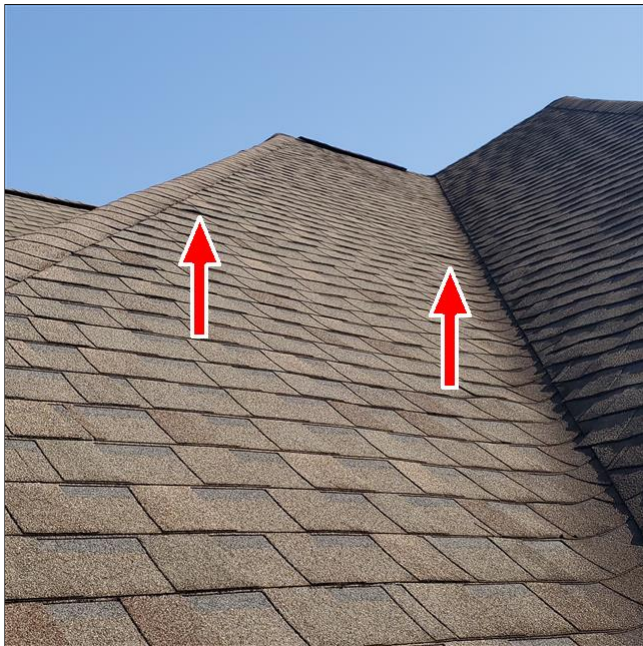
(4) Nail pops were observed it to shingles at the front right side of the roof. The nail pops need to be repaired to ensure the shingles lay flat and seal.

C. Item 6(Picture) Lifted shingles at the right slope.

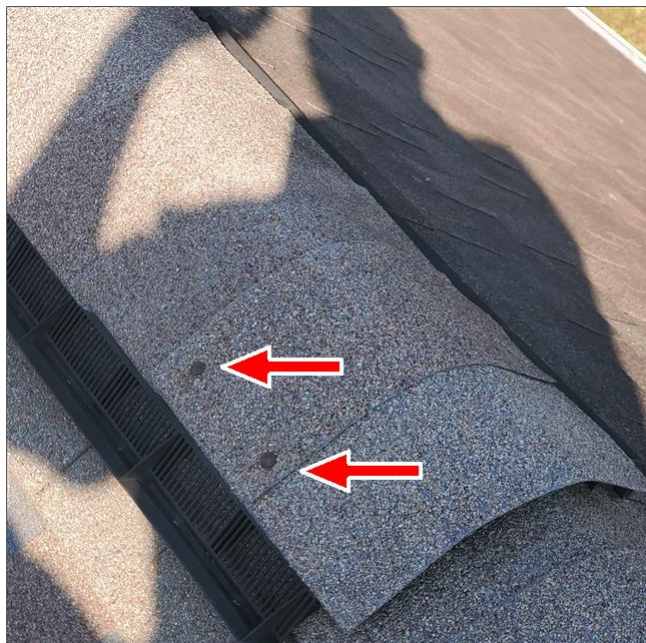
(5) Unsealed nails were observed on the roof at flashings and on shingles. If nails are used at flashings, these nails should be sealed so they are not exposed to the elements are less likely to rust over time. Rusting nails will become loose and may allow water penetration into the attic space. I recommend sealing all nails that are exposed on the roof.

C. Item 7(Picture) Photo of two of the unsealed nails.

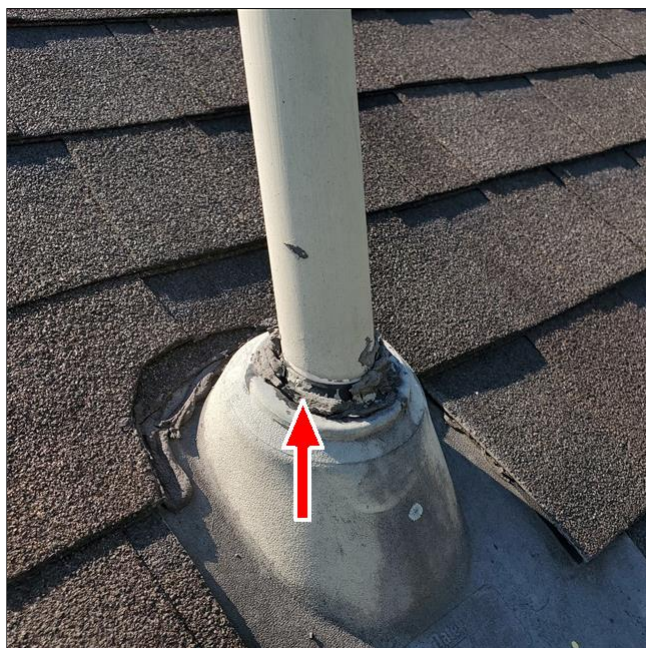
(6) The inspector observed that many of the pipe jack boots on the roof have been caulked and sealed to the vent stack pipes. It was noted that the sealant is deteriorating. There were water stains observed on the ceiling in the master bedroom that may be due to a leak at the pipe jack shown in the photo. A qualified roofing professional should replace the pipe jacks that are in need.

C. Item 8(Picture) This sealant deteriorates and leaks will occur here.

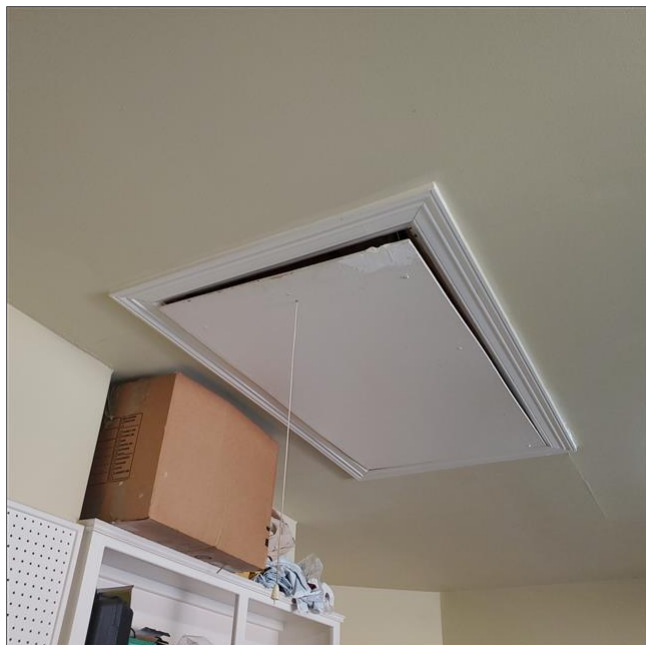
The attic pull down is not sealed to the ceiling in there is a large gap in the garage. Repairs need to be made to ensure the pull down is sealed to the ceiling in order to provide proper fire separation.

D. Item 1(Picture) Pull down not sealing.

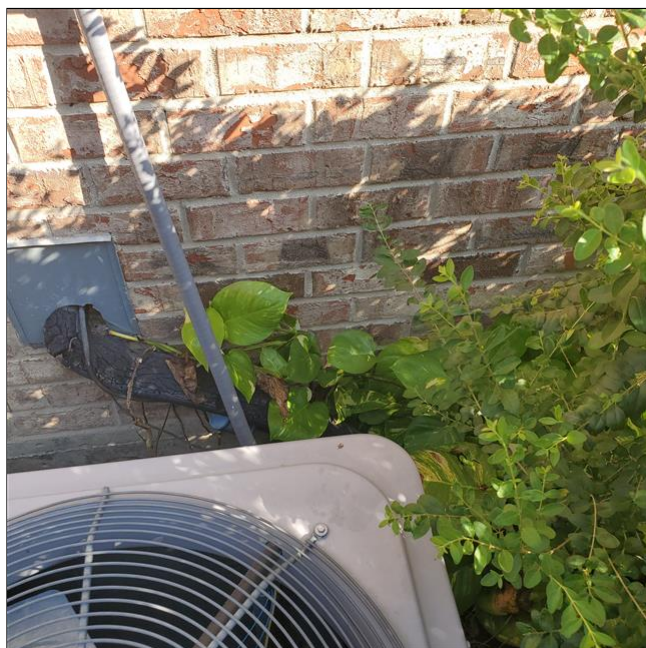
(1) There is overgrowth of vegetation and foliage against the exterior walls at the right side and back of the house. I recommend trimming back all overgrowth and foliage. Over grown vegetation and foliage against a wall can hold moisture in that area and may damage the siding or brick. It can also provide a good avenue for insects to penetrate the wall.

E. Item 1(Picture) Overgrown vegetation around the AC.

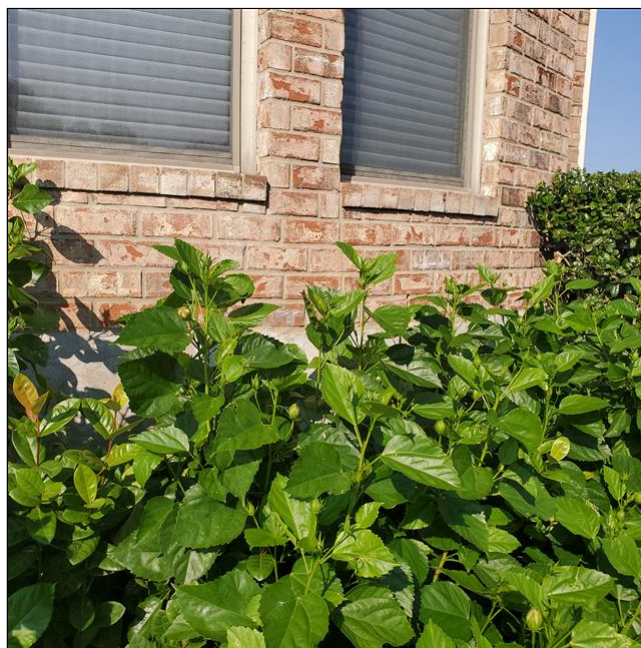
E. Item 2(Picture) Overgrown vegetation against the home at the back.

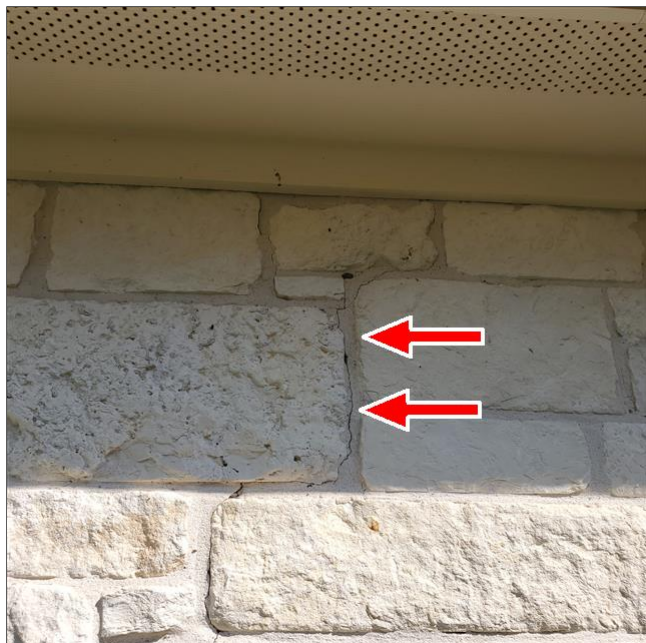
(2) Small cracks were observed in various areas at the exterior walls. The inspector recommends monitoring the cracks for growth as they are not wide enough to typically indicate a structural concern.

E. Item 3(Picture) Photo of one of the common cracks in the mortar.

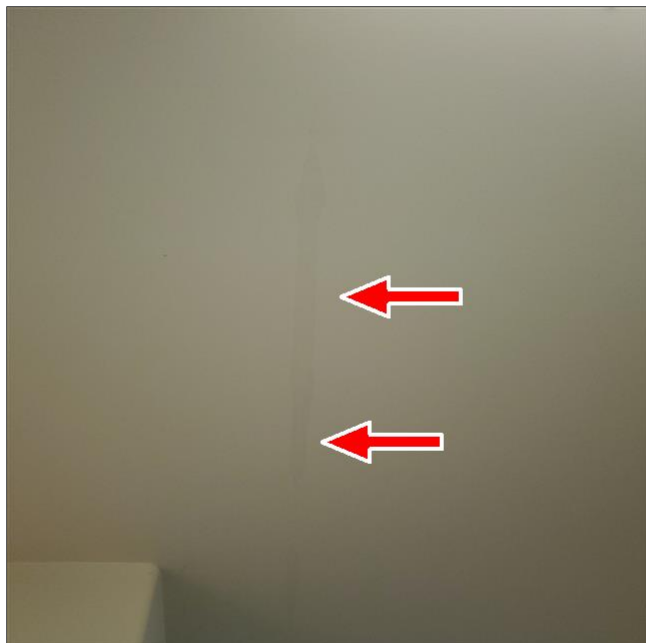
(1) There were three stains on the master bedroom ceiling that appeared to be due to the ceiling getting wet. The inspector attempted to locate the cause of the damages and could only find that it may be related to leaks around pipe jacks on the roof. Further investigation may be needed by removing the drywall to determine if there is a different source such as plumbing that is covered by insulation.

F. Item 1(Picture) Photo of one of the stains.

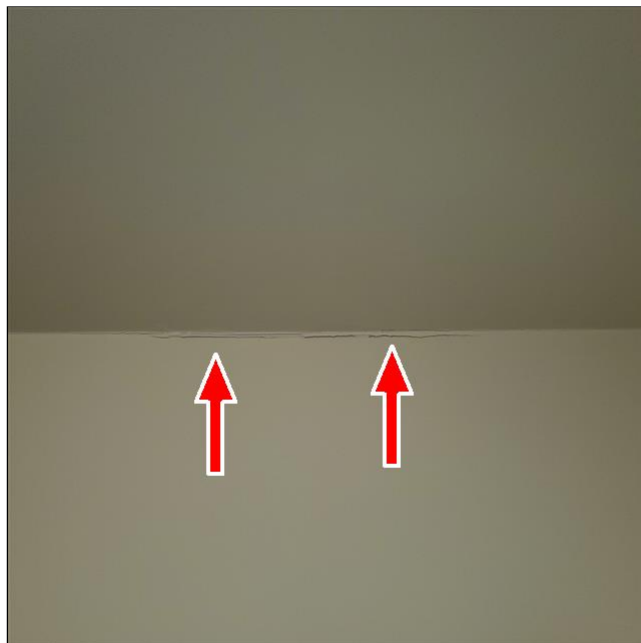
F. Item 2(Picture) Drywall tape was peeling at the wall/ceiling intersection.

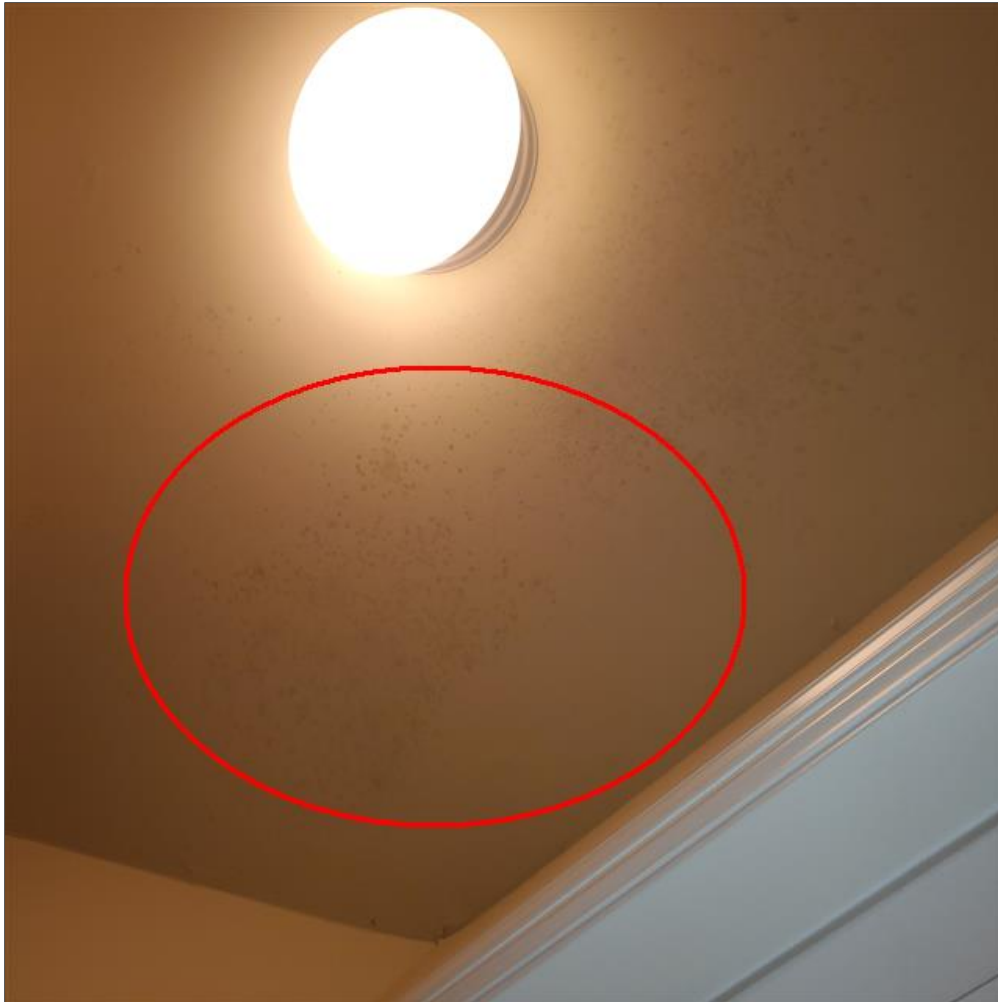
(2) Splotchy discoloration was observed at the ceiling in the front right bedroom closet and in the bedroom hallway closet. The inspector could not determine the causes of the discoloration and recommends further investigation by a qualified professional.

F. Item 4(Picture) Photo of discoloration.

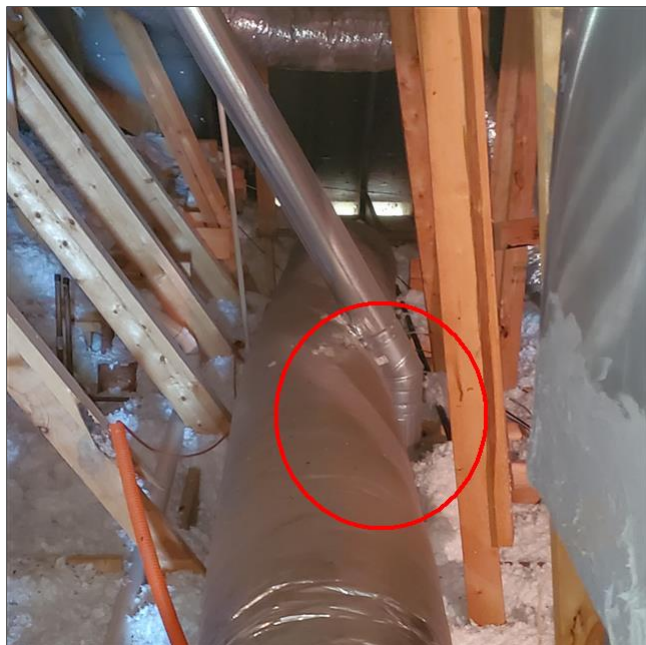
(1) The chimney flue was in contact with a piece of ductwork and with insulation in the attic. There should be at least 1" of clearance around the chimney flue from all materials that may catch fire.

J. Item 1(Picture) Photo shows chimney flue in contact with duct.

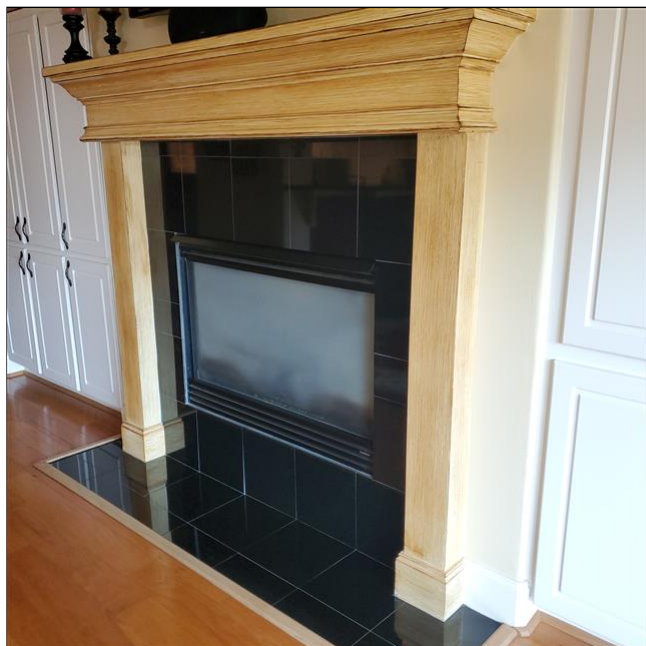
J. Item 2(Picture) Photo of foggy glass.

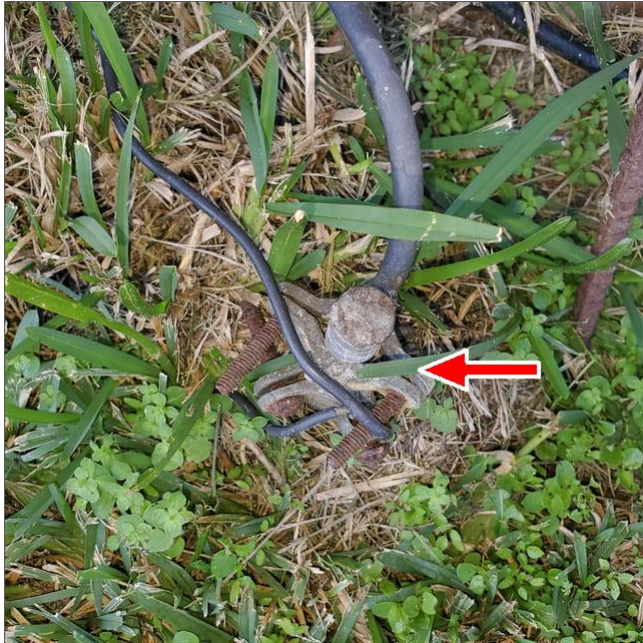
(1) The clamp at the ground rod did not appear to be proper (i.e. rated for ground rods). The clamp observed was listed as a pipe clamp for metal or gas lines. I recommend the use of a brass "acorn" style clamp, U. L. listed and approved for direct burial on the ground rod for a more secure, longer lasting connection.

A. Item 1(Picture) Photo shows clamp.

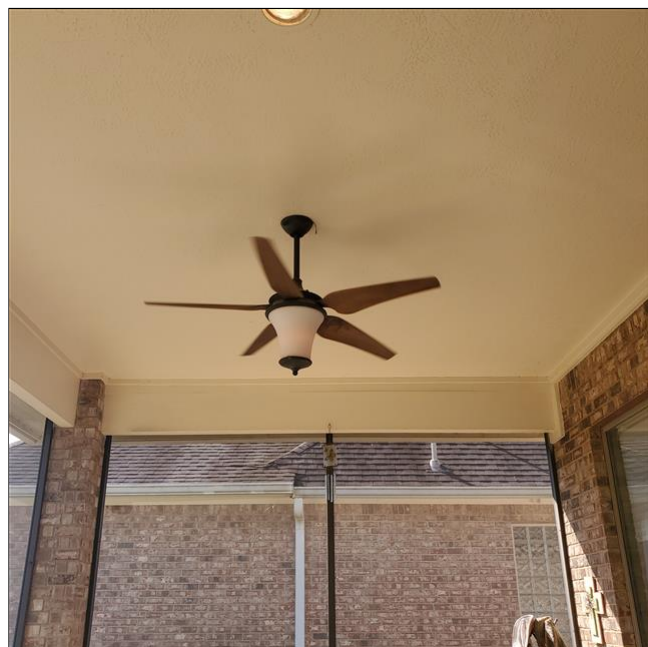
B. Item 1(Picture) Ceiling fan was wobbling.
