# Inspection Report

**Property Address:**  
9336 Old River Ct.  
Montgomery TX 77356

**JASE Home Inspections**

<b>Date:</b> 10/11/2020	<b>Time:</b> 09:55 AM	<b>Report ID:</b>
<b>Property:</b> 9336 Old River Ct. Montgomery TX 77356	<b>Customer:</b> Monte Gibbs	<b>Real Estate Professional:</b> Jeff Deutschmann

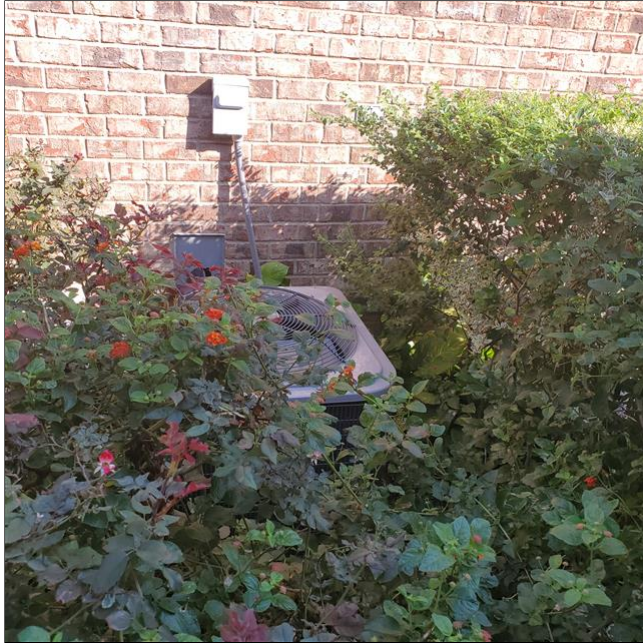
B. Item 2(Picture) Lots of vegetation growth around unit.

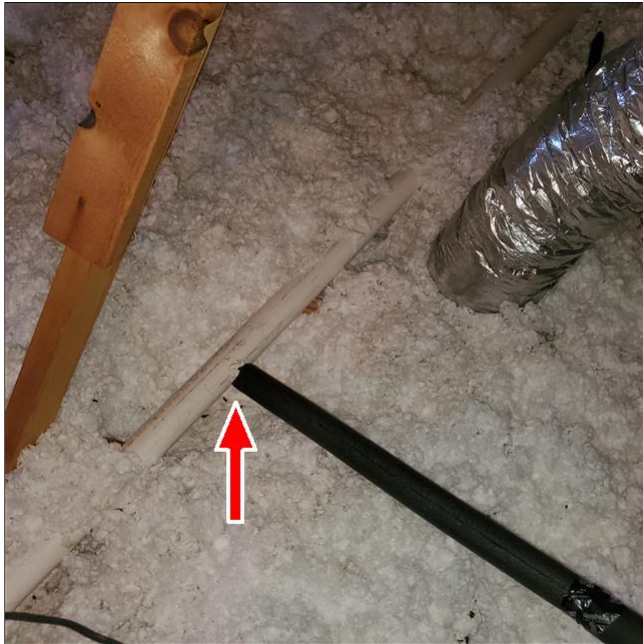
B. Item 3(Picture) Primary drain line terminates at a drain, waste, vent pipe.

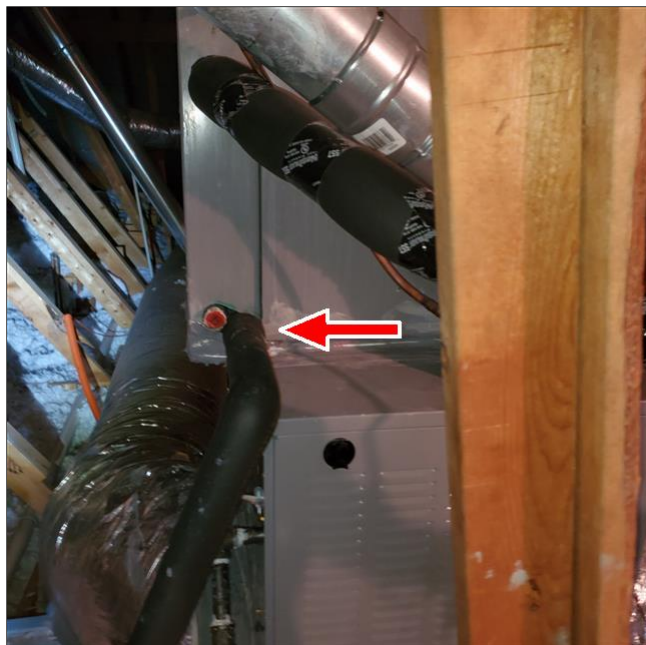
B. Item 4(Picture) Inspector felt cold air blowing around this area.

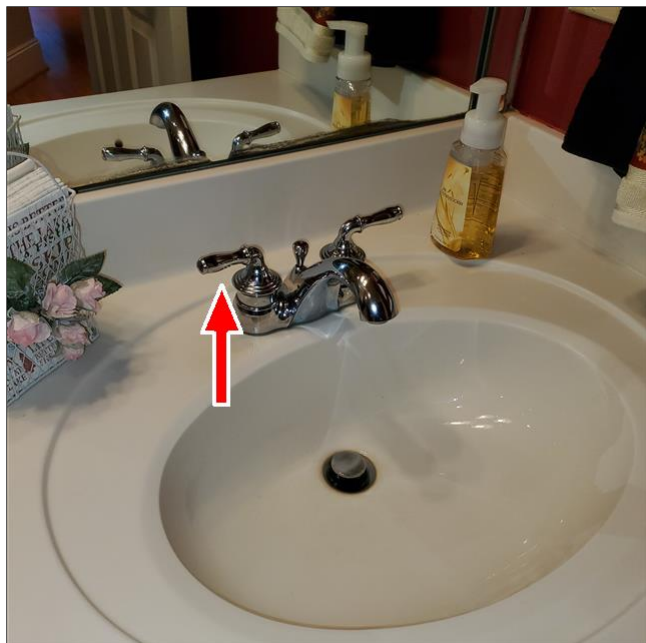
A. Item 1(Picture) Valve handle was difficult to turn.

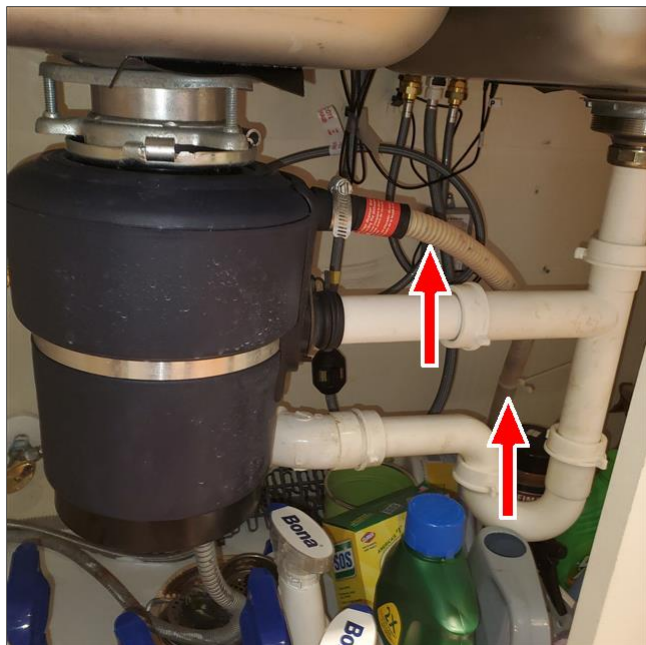
B. Item 1(Picture) No high loop at the drain line.

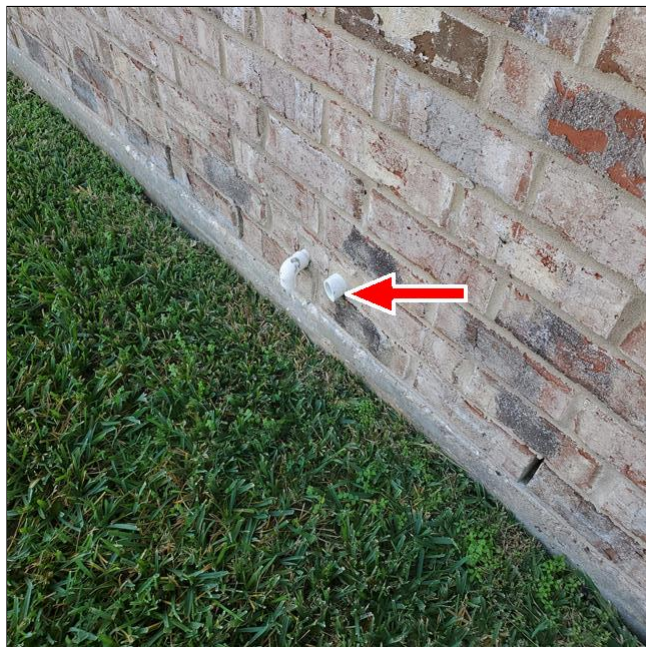
C. Item 2(Picture) Turndown was broken off.

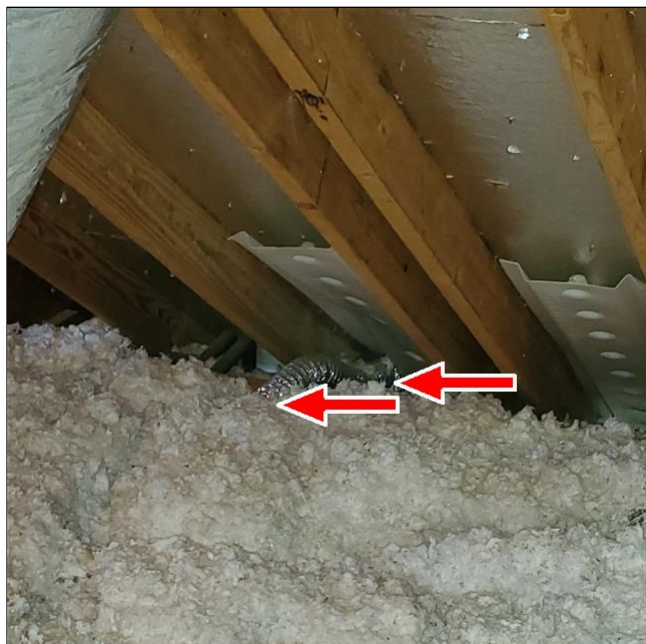
F. Item 1(Picture) Ducts terminate at soffit.

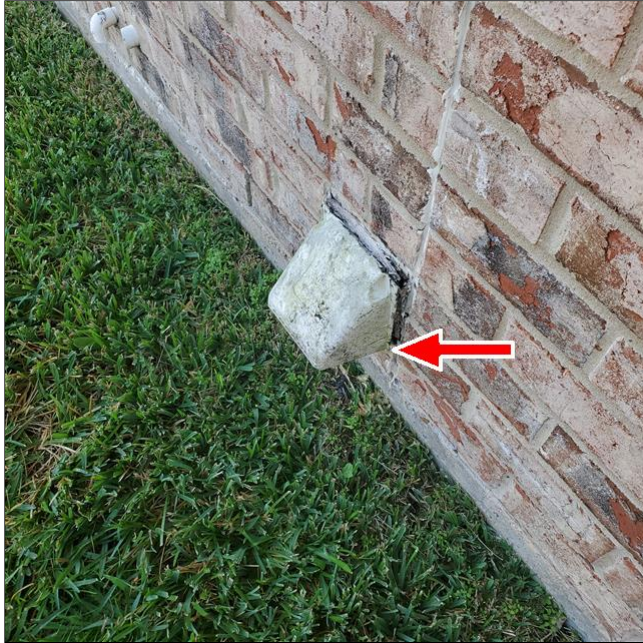
H. Item 1(Picture) Wall cap was loose.

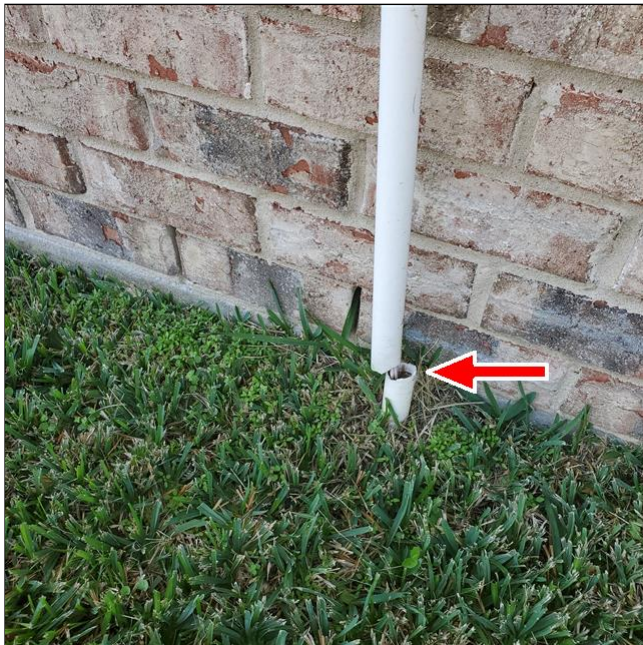
A. Item 3(Picture) Conduit was damaged.

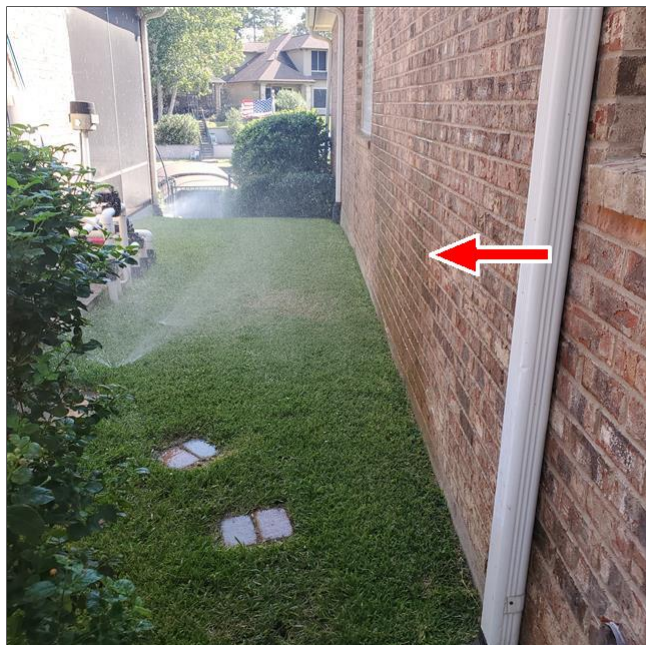
A. Item 4(Picture) Photo of neighbor's home getting sprayed.
