ENGINEERING INSPECTION REPORT

**May 15, 2017
Rpt #TCC-0115-1701**

**Reference: Engineering Services: Structural Inspection Report
Single Family Residence @:
1843 Willow Point Drive, Kingwood, Texas 77339**

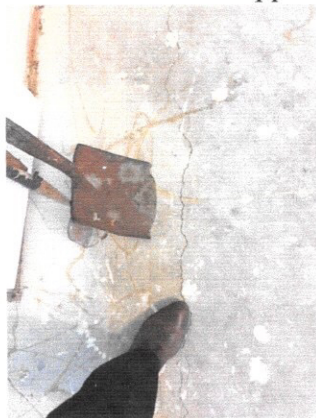
Please find the following regarding the inspection. There were many photos taken during this inspection. Some of these photos have been included in this report for purposes of clarity and reference. After inspecting the front bedroom floor, it was noted that there was a crack in the slab that ran from the front of the house to the hallway. It was noted that this crack did not continue into the bedroom on the opposite end of the hall.

The left photo above is the crack in the front bedroom slab. The center photo show the continuation of the crack toward the hall. The right photo is the exterior wall on the back side of the house that had a hairline crack in the brick veneer only. It was noted that there were no cracks in the bedroom slab in the bedroom on the other side of this exterior wall.

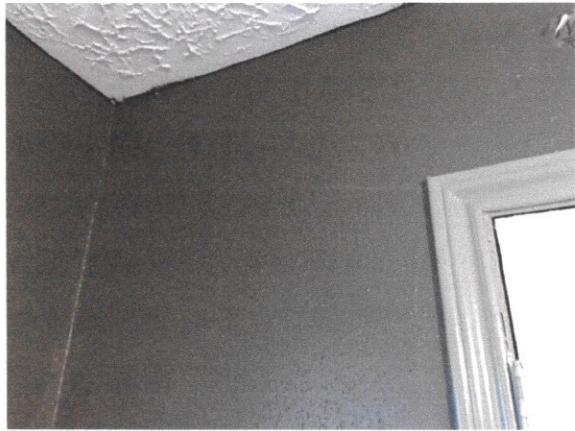
It was noted that there was a hairline crack in the bedroom wall at the top left of the door, but it was believed to be the result of a structural defect. It is the opinion of the undersigned that this was a crack caused by minor movement of the wood frame superstructure. This crack is shown in the left photo below. The right photo is a vertical hairline crack in the high ceiling in the living room. It was believed to be a minor separation crack in the joint between the separate sheets of dry wall board, at the taped and floated joint. The crack is believed to be the result of material shrinkage caused by temperature and moisture changes in the ceiling area.

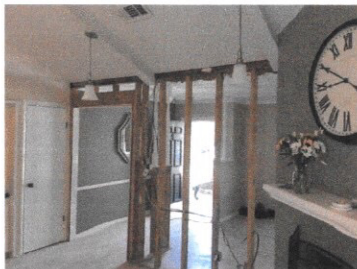
The left photo below is the wall between the foyer and living room that was to be removed and replaced with a header beam. The center photo is the newly installed header beam that was confirmed by the undersigned to be of adequate capacity to carry the ceiling load previously supported by the stud wall in the below left photo. The right photo is the new support column used at both ends of the new header beam.
