Home Inspection Report

5824 Ave T, Galveston , TX 77551

Tuesday April 7, 2020

040720

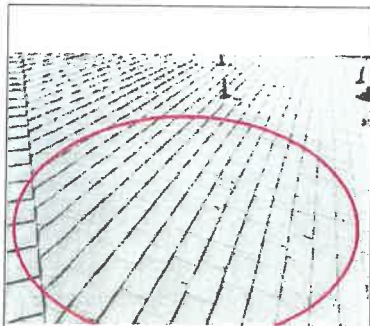
(D) There are multiple rusty nails showing on the northeast side of the roofing materials.

A few rusty nails that need sealed at the northeast corner of the roof

(R) Recommend that the rusty nails be sealed properly.

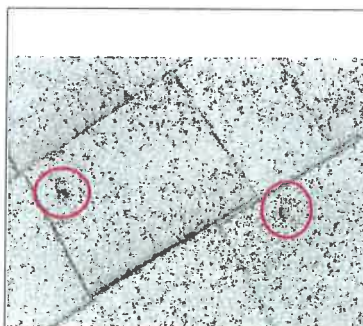
Rusty nails coming through the shingles

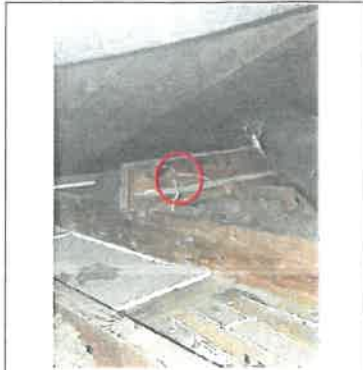
Comments:(D) The attic and roof structure were functioning properly however there were multiple areas of spliced wiring throughout the attic. There was also a piece of wiring that was "nicked" and has exposed wiring.

Wire on northeast side of attic was "nicked"

(R) It is recommended that the wiring be placed in a junction box with the proper cover to prevent someone from getting shocked by exposed wiring. Recommend that the cut wiring be properly repaired. It is recommended that the insulation be improved to R30.

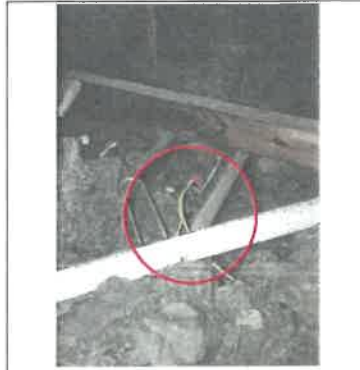
Spliced wiring on northwest side of attic

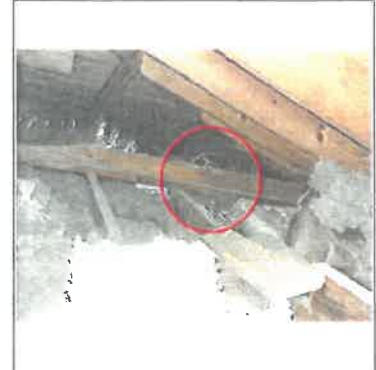
Spliced wiring on the northwest side of the attic

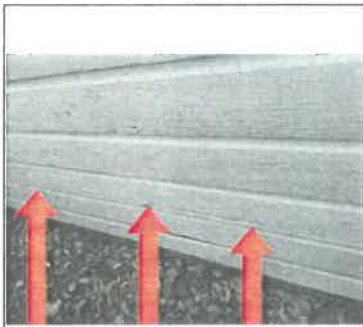
West side exterior wall had deteriorating/rotting wooden siding

(R) It is recommended that a qualified contractor repair these deteriorating/rotting areas of the wooden siding. Recommend that the cement shingle be replaced with a fiber cement shingle.

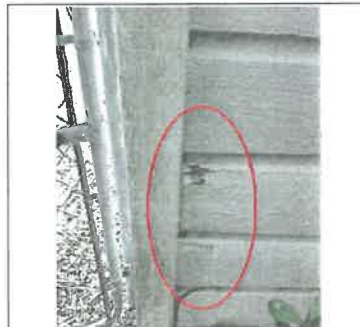
NW corner had deterioration

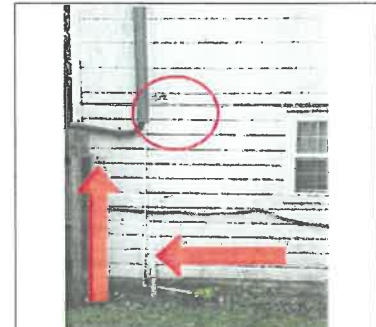
Multiple deteriorating areas of wooden siding on the north side of the structure

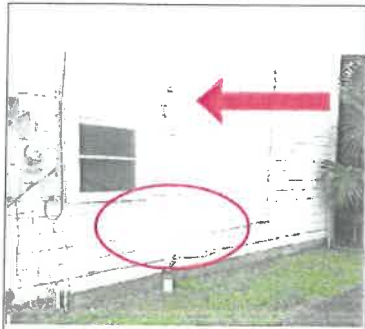
North side has deteriorating/rotting wooden siding and a cracked cement tile

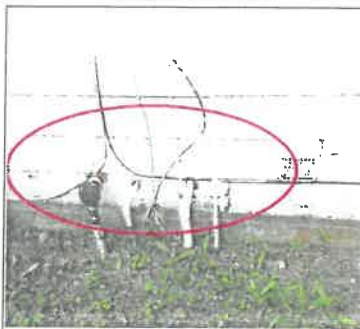
North side had deteriorating/rotting areas of wooden siding near the water heater piping

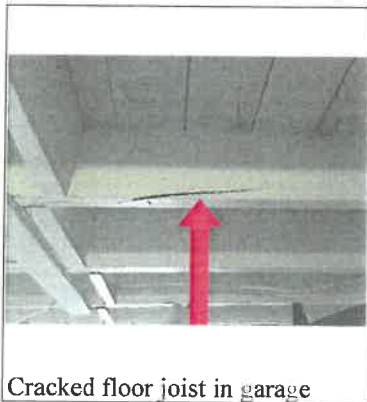
(D) The only issue observed aside from minor settlement was there was a cracked 2x10" floor joist located in the garage.

Cracked floor joist in garage

(R) It is recommended that the joist be repaired or replaced. A joist of the same size and length could be added right next to the cracked one.

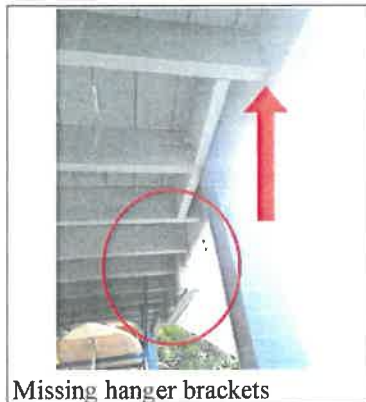
Comments: (D) The east side of the deck is missing the hanger brackets that help support the joists. The west side deck joists have the brackets however most do not have enough nails in the bracket.

Missing hanger brackets

(R) Recommend adding joist hanger brackets to the deck boards and filling all of the nail holes with a 16D nail.

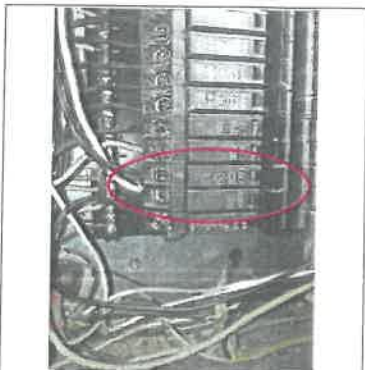
There are two 50amp breakers that are oversized for the wiring.

(R) Recommend that an electrician properly install the correct breakers for the wiring where they're oversized. Recommend that protective grommets be added to the panel box where they're missing to protect the wires as they enter the box. Recommend tightening the ground clamp properly to the grounding rod.

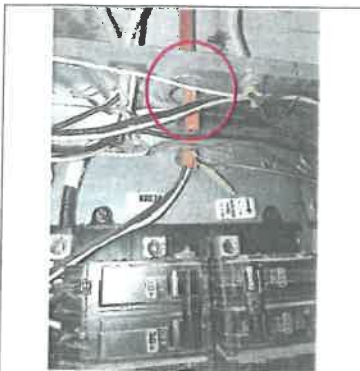
Missing grommet

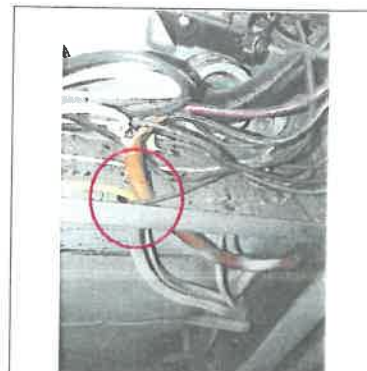
Missing protective grommets

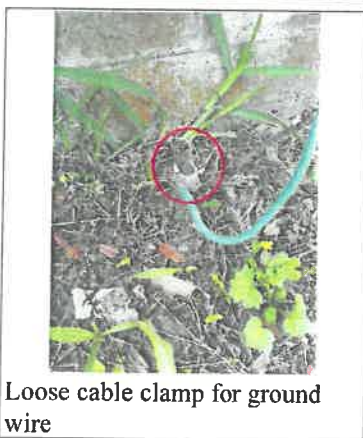
Loose cable clamp for ground wire

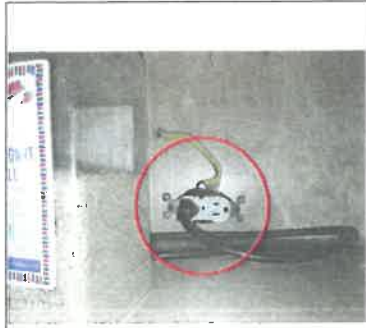
Receptacle above microwave needs to be in a junction box

(R) It is recommended that a qualified electrician repair the deficiencies with the electrical wiring. It is also recommended that smoke detectors be placed in every bedroom and outside of every bedroom. The batteries in the downstairs smoke detector need to be replaced and if this doesn't work then the detector needs replaced. Also recommend carbon monoxide detectors be placed in the home.

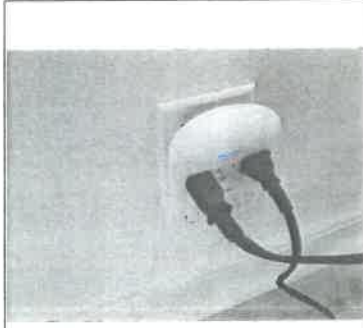
East wall outlet ungrounded

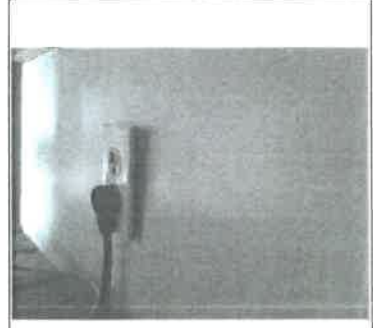
SW living room outlet is loose

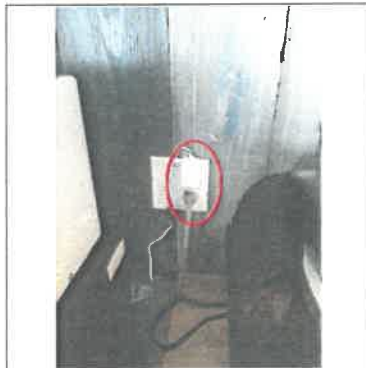
Ungrounded outlet and not on GFCI on kitchen counter downstairs

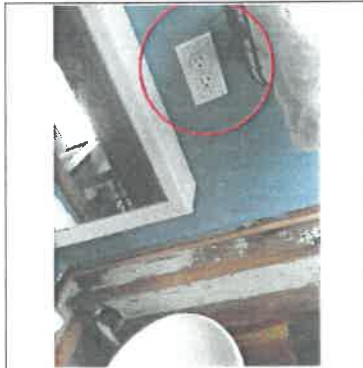
Downstairs bathroom outlet above sink not on GFCI

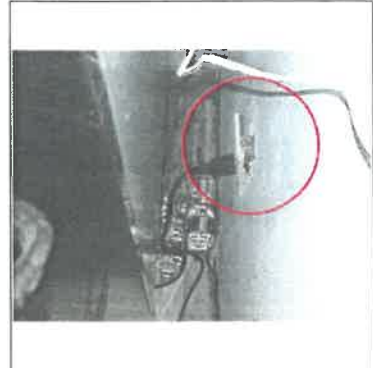
Loose outlet behind mini fridge downstairs

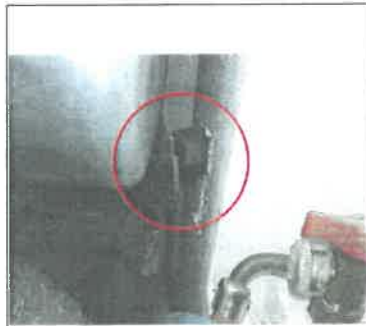
Dryer receptacle is not properly secured in a junction box in the downstairs laundry room

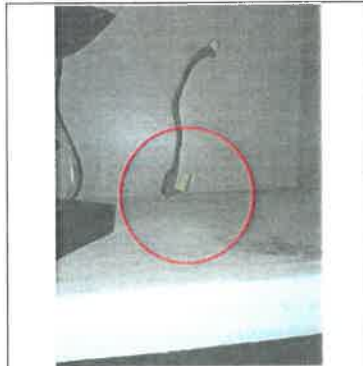
Loose "live" wiring above downstairs kitchen sink

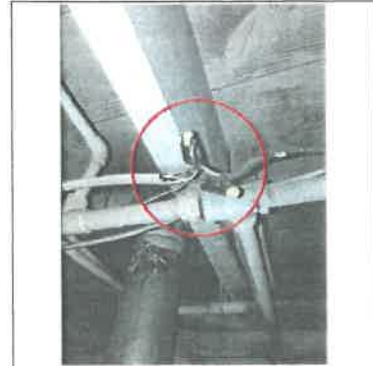
Wiring above water heater spliced and not in a box

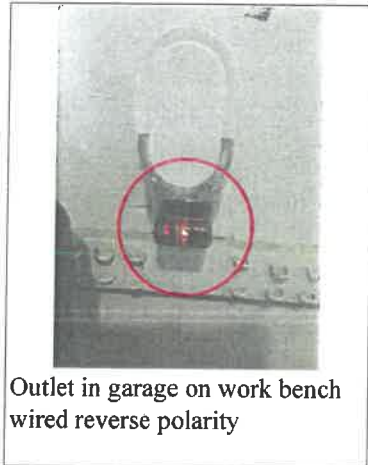
Outlet in garage on work bench
wired reverse polarity

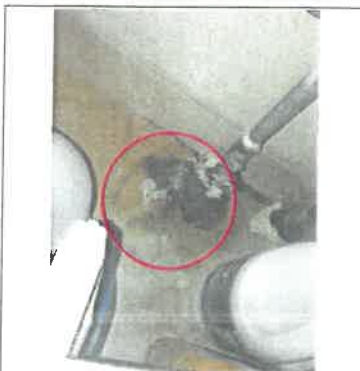
Previous moisture damage under kitchen sink

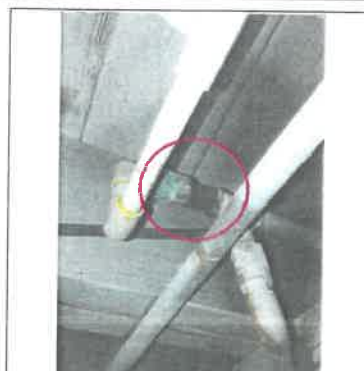
Water supply line above water heater is moderately rusted

(R)It is recommended that the rusted lines be repaired or replaced by a qualified plumber/contractor and the water hose be repaired so it will come off of the hose bib when needed.

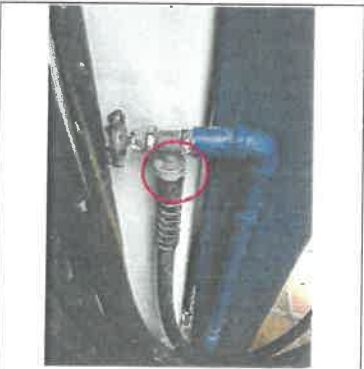
Could not get the hose off of the hose bib

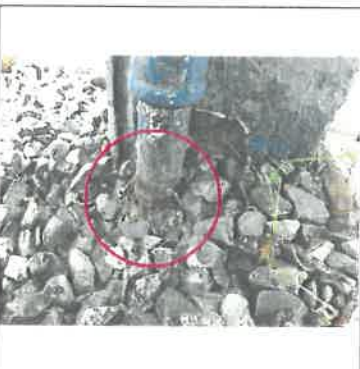
Hose bib supply line on front side of home is rusted at ground level

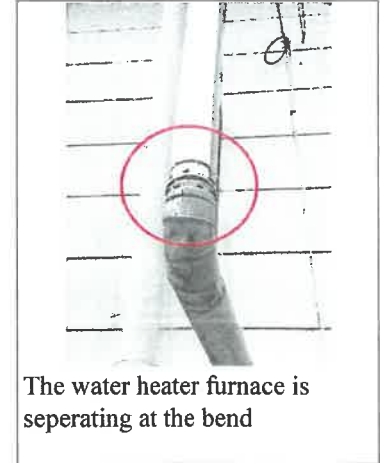
(D) The water heater furnace is seperating at the bend most likely due you the weight.

The water heater furnace is separating at the bend

(R) It is recommended that the vent pipe be repaired. To help prolong the life of the hot water heater it is recommended that 10-15 gallons be drained annually to get rid of all the sediment built up in the unit.

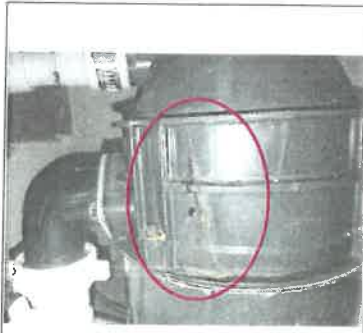
Disposal had a crack in the side

(R) It is recommended that the disposal be replaced along with the attachment bracket and the disposal be properly wired.

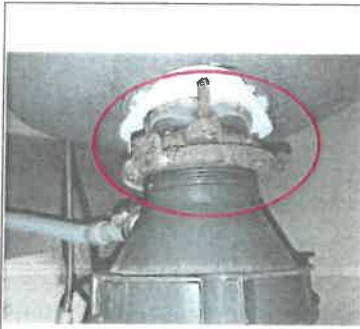
Connection bracket was significantly rusted

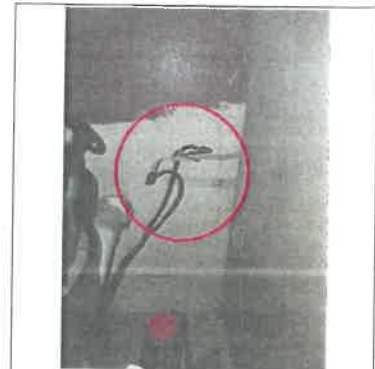
Wiring not in junction box, unit should have designated outlet

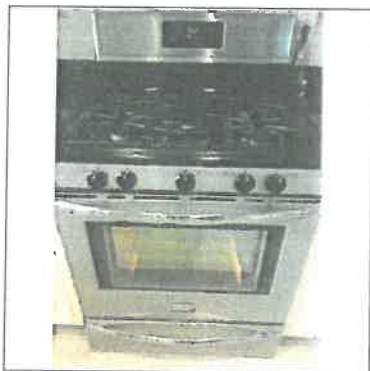
(D) The ovens are missing the anti-tip device that secures the unit to the floor.

(R) Recommend installing for safety reasons to keep the oven from tipping over and causing injury.
