Professional Inspection Report

**Vicky Philips
402 Shirlington Rd
Montgomery, TX 77316**

February 1, 2021

ProVantage Inspections, PLLC

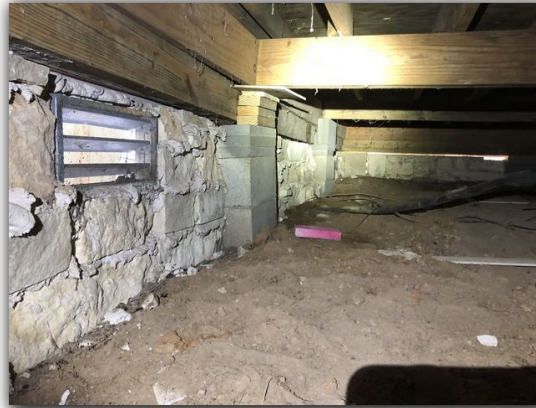
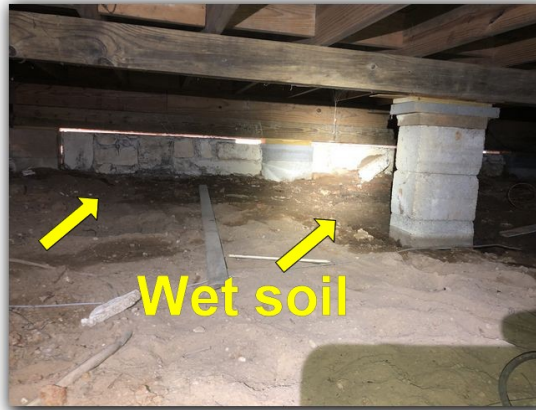
- Some of the crawl space was observed to be wet / damp from possible drainage in the front area of the house. See comments below under "Grading and Drainage" about the slope / grading of the property. The crawl space area should be dry at all times without water intrusion.

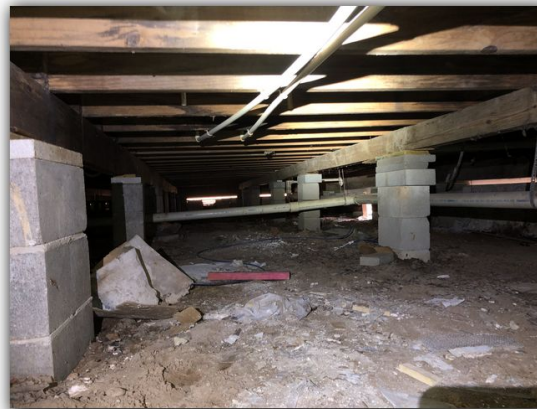
- Recommend cleaning the trash and debris from the crawl space.

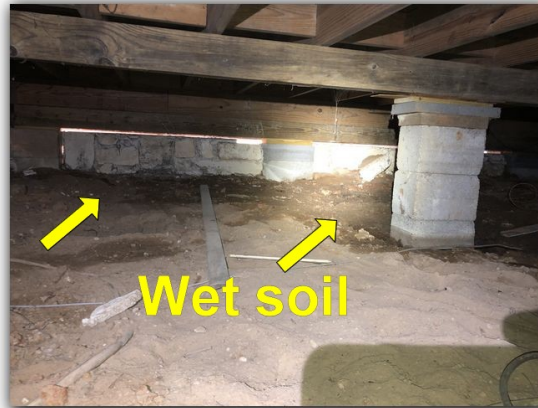
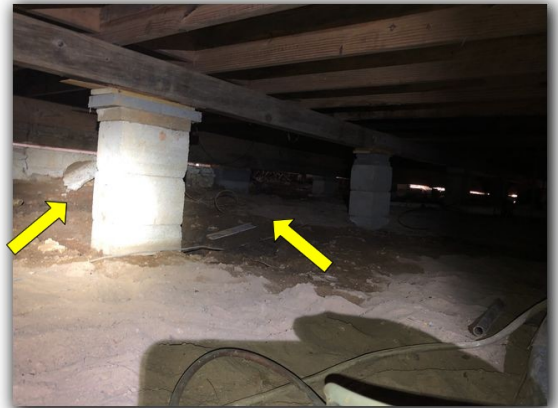
- There appeared to be a negative slope in the front yard from the street toward the house. While the area was totally dry at the time of the inspection and there had been no rain for an extended period of time prior to the day of the inspection, the soil in the crawl space in the front area of the structure was wet. Recommend installing corrective measures and/or grading the slope of the property so that there is no storm drainage into the crawl space under the house.

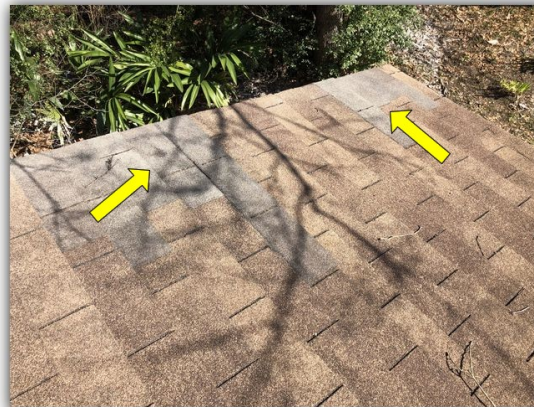
- Prior repairs to some of the the roofing material and/or flashing were observed in one or more locations.

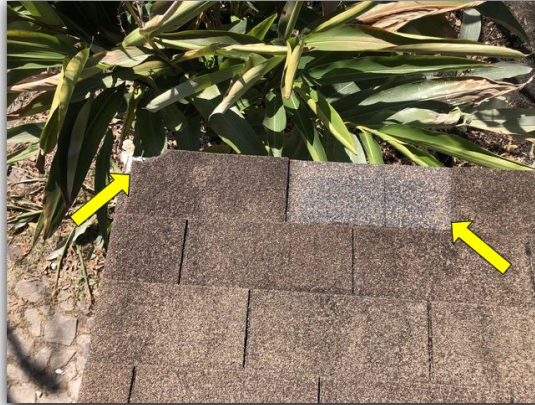
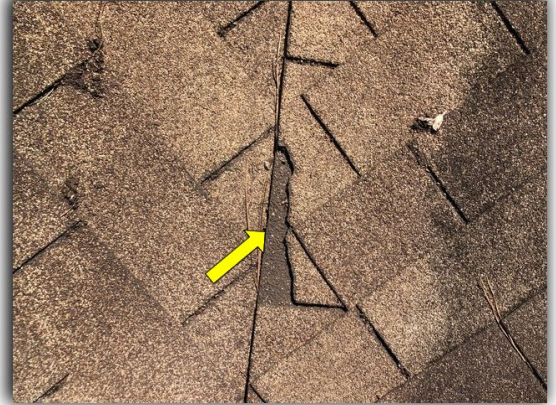
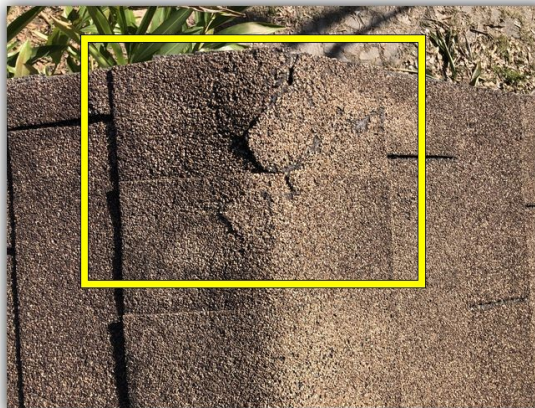
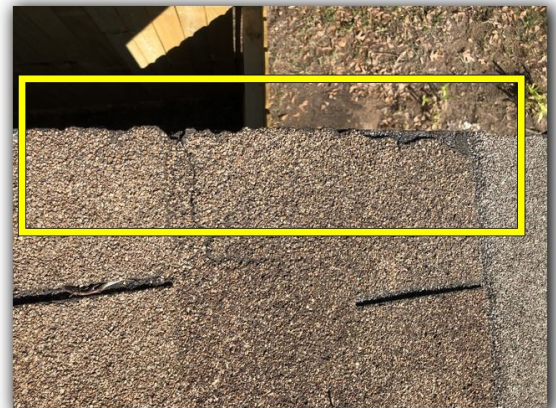
- Damaged shingles were observed in multiple locations of the roof structure.

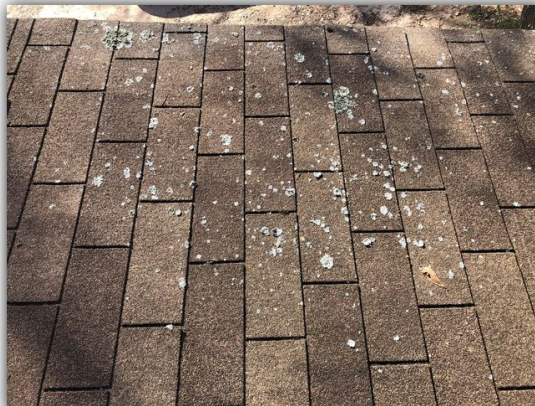
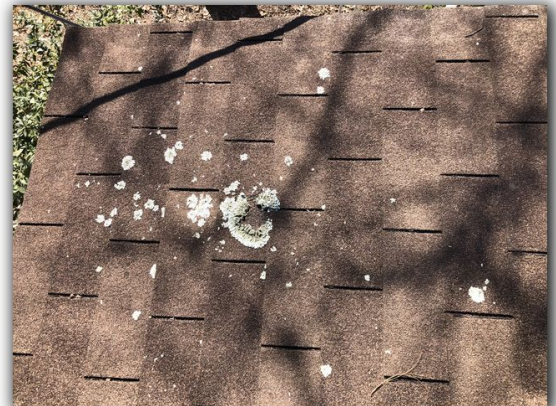
- There was excessive algae growth in multiple shingles.

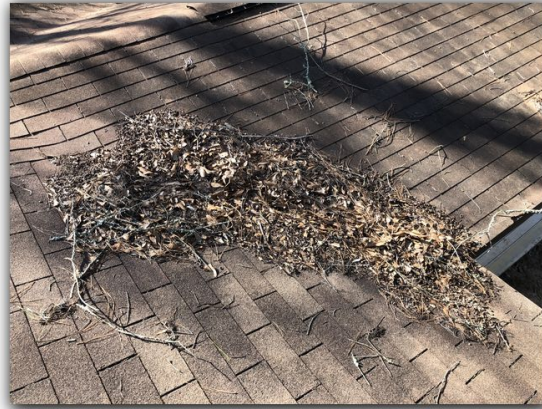
- There was excessive amounts of leaves / debris in the valley, which can cause deterioration / damage to the shingles and cause moisture penetration. All debris, such as leaves and branches, should be removed from the roof structure.

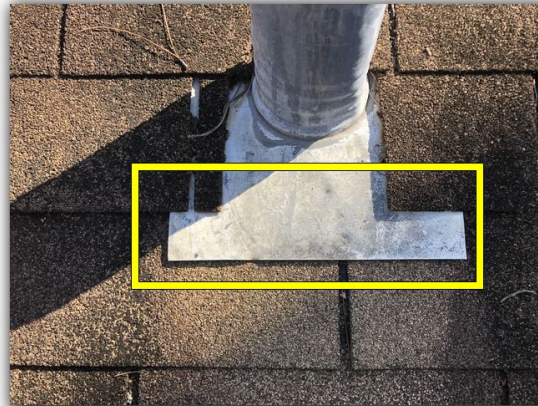
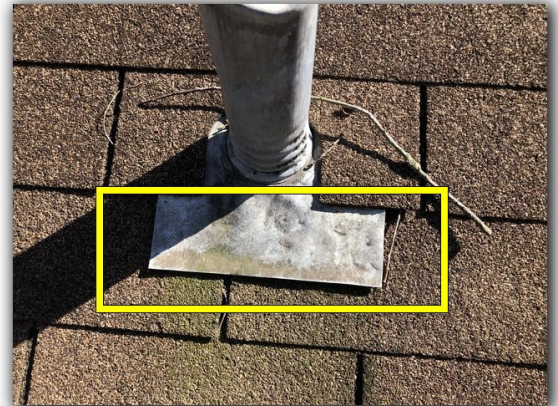
- The lead flashing to the plumbing vents were not nailed / secured to the roof surface.

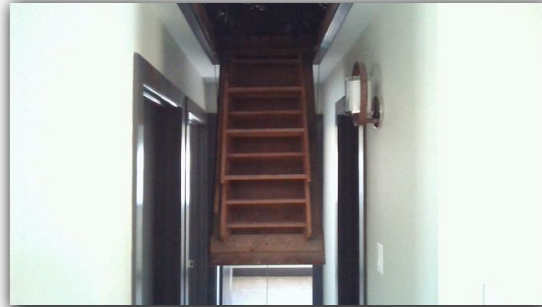
- The pull-down attic stairs, rails, and hinges were in poor condition. The butt joints of the ladder did not open flush and the ladder was unsatisfactorily stable. Recommend repair / improvement or replacement, for safety reasons.

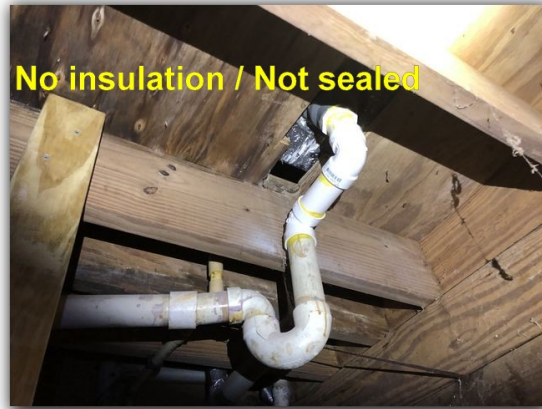
- The area between the flooring joists in the crawl space was observed to be uninsulated / unsealed. There were some open areas around plumbing penetrations that were not sealed. This is not uncommon for a structure of this type and age construction. Buyer may consider sealing all penetrations into the sub-flooring and insulation for increased energy efficiency.

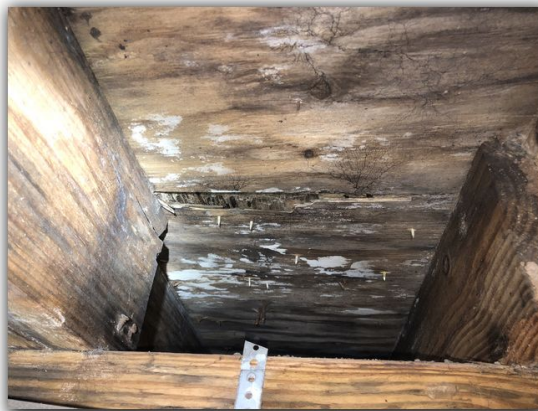
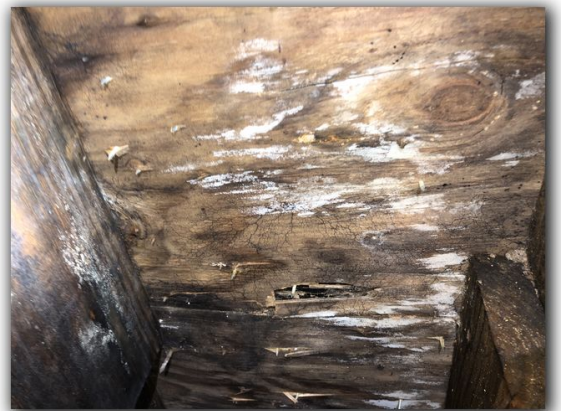
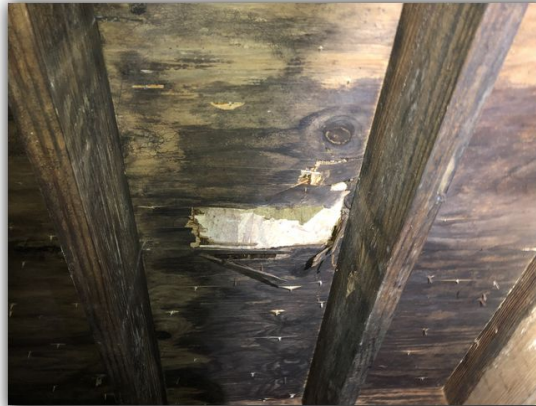
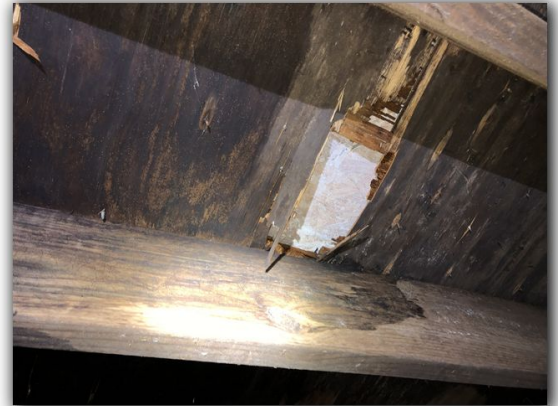
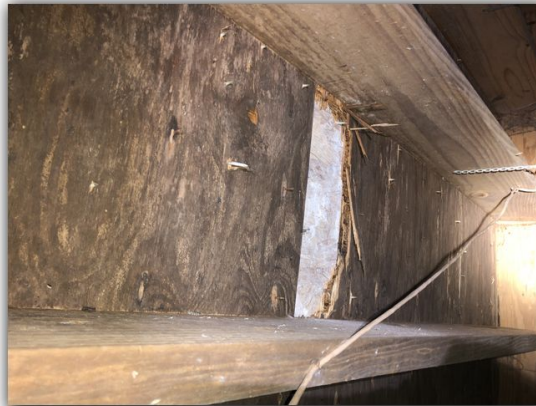
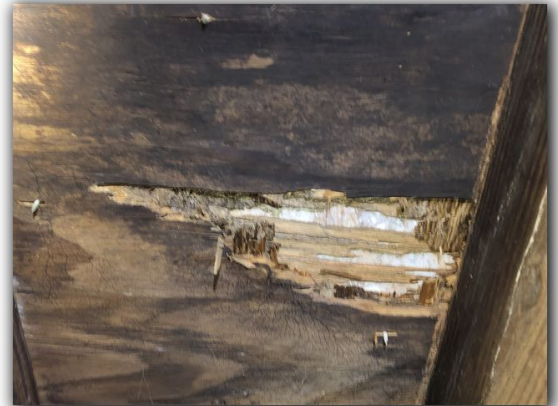
- The wood sub-flooring plywood was observed in multiple locations to be deteriorated from previous moisture damage. There were multiple areas where the sub-flooring had large holes in the wood from deterioration / damage. The sub-flooring appeared to be dry at the time of the inspection, and there appeared to be cement backer board installed on top of the wood sub-flooring.

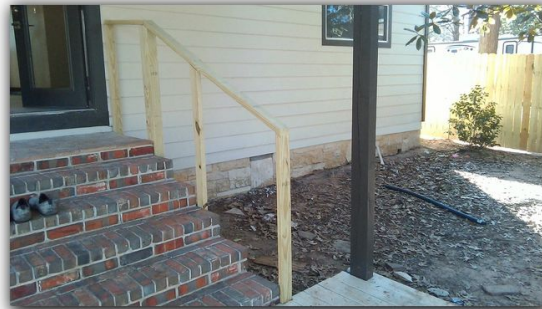
- The handrail on the rear steps was unsatisfactorily constructed. Handrails shall have an outside diameter of at least 1 1/4" and not greater than 2". If the handrail is not circular, it shall have a perimeter dimension of at least 4" and not greater than 6 1/4" with a maximum cross section dimension of 2 1/4". There were no guard railing balusters and/or spindles installed a minimum of 4" apart on the porch railing.

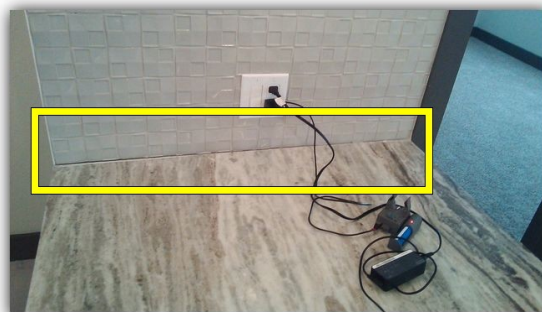
- The kitchen counter was not caulked to the wall on the left side area of the range.

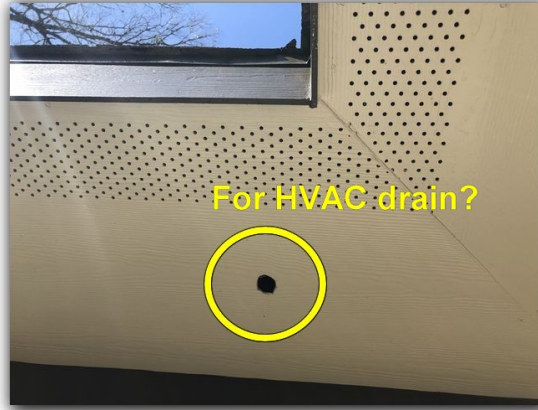
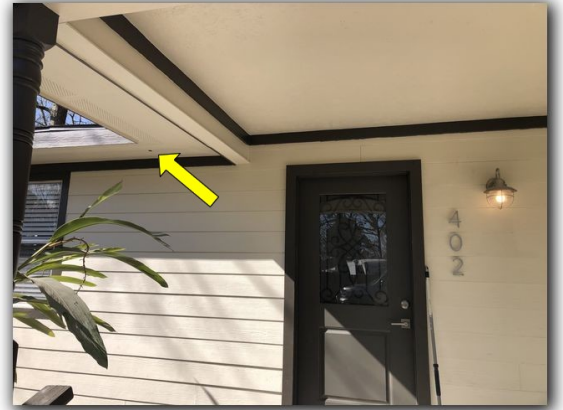
- There was a hole in the soffit material in the front of the house to the left of the front entry door. It was unknown if this was supposed to be for the overflow pan secondary drain to the exterior. Recommend ensuring that the secondary overflow pan is properly draining to the exterior or repairing the hole as needed.

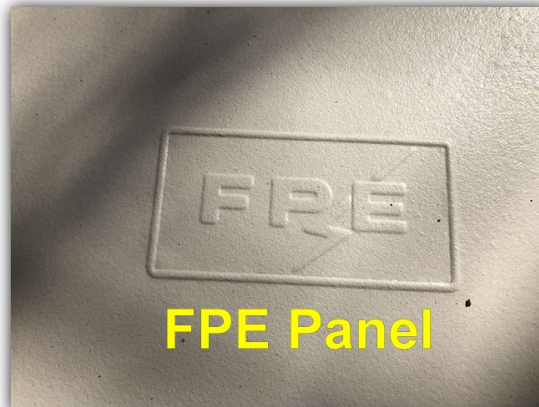
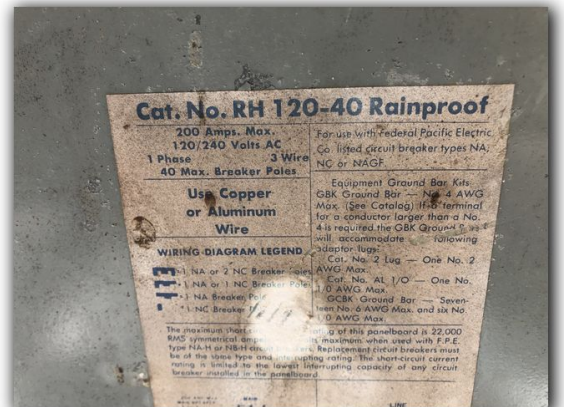
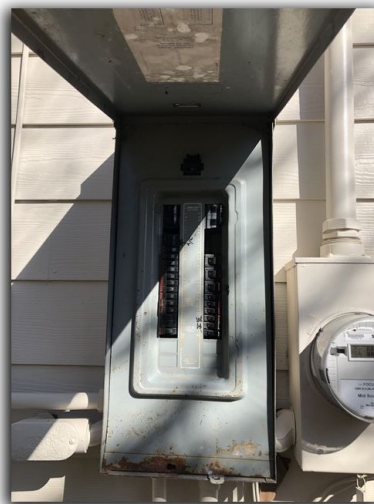
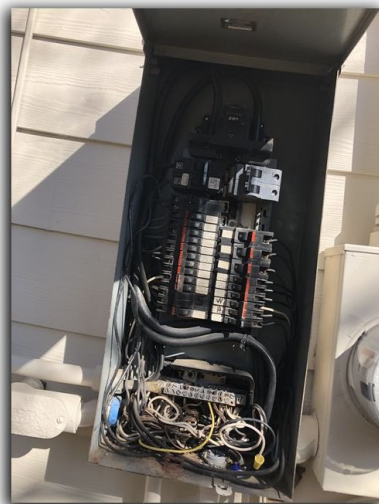
- There was an old Federal Pacific Electric - FPE Electrical Panel Box installed at the time of the inspection. Federal Pacific Electric is no longer in business and FPE panels are known to have various problems, deficiencies and fire hazard. Full evaluation of this panel box is beyond the scope of this inspection. It is recommended that a qualified licensed electrician fully evaluate the electrical service panel for service and/or replacement.
- All blank spaces in the electrical cabinet cover plate (dead front) and /or cabinet need to have fillers.
- There were screws on breakers that appeared to have rust on them. The interior of the panel was dirty.

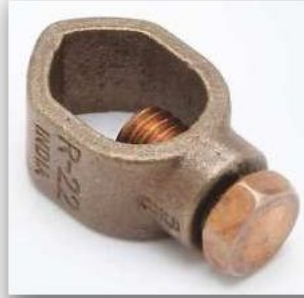
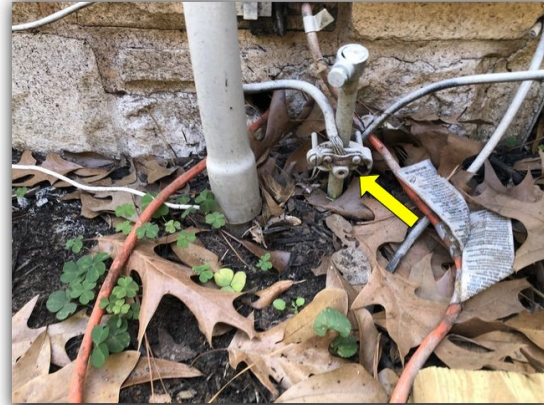
- The clamp for the ground rod is an improper style of grounding clamp. Recommend an acorn style clamp to be installed.

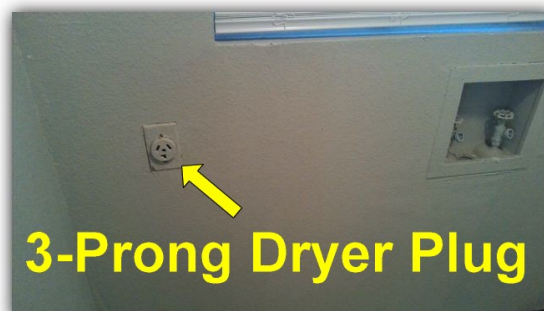
Old Style 3-Prong Electric Clothes Dryer Receptacle

- The electric clothes dryer receptacle has an old style 3-prong type of receptacle. If an electric dryer is installed with a different type cord, be aware that the receptacle or the electrical cord will need to be changed to the correct matching type. A licensed electrician or qualified appliance technician can assist with either of these.

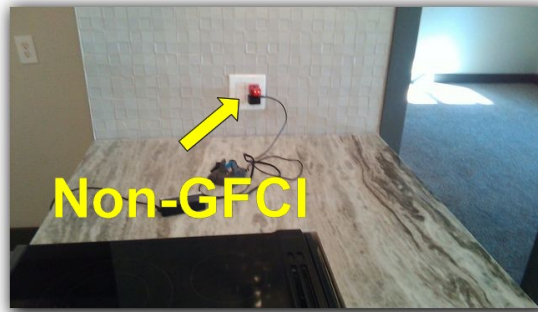
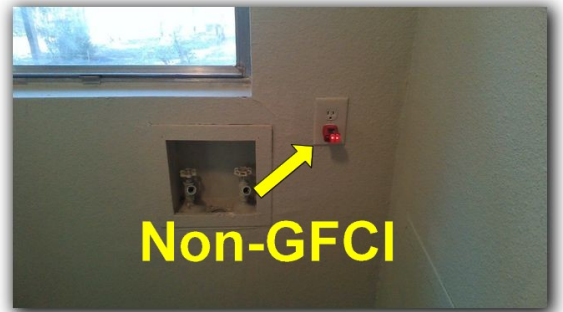
- All receptacles located on the exterior of the home, kitchen counter tops, and laundry room are required to be GFCI protected as a safety precaution. GFCI receptacles are missing in multiple required locations. Recommend repairs by a licensed electrical contractor.

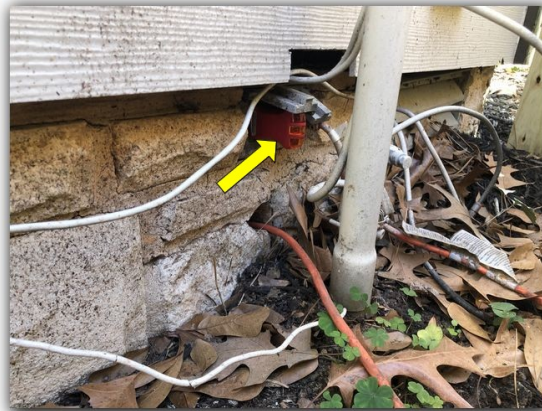
- There was an electrical receptacle installed on the lower perimeter wall on the left side of the house that did not appear to have any power.

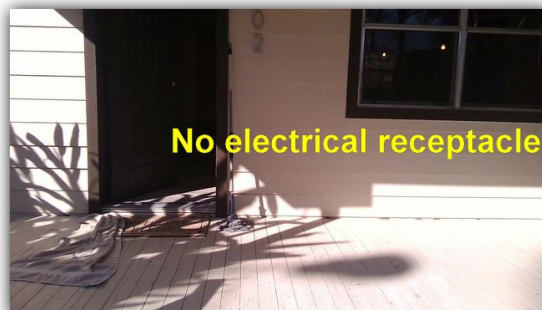
- There was no electrical receptacle installed on the exterior wall of the front entry area. As per IRC 3901.7, there is to be an accessible electrical receptacle at the front and rear of the dwelling.

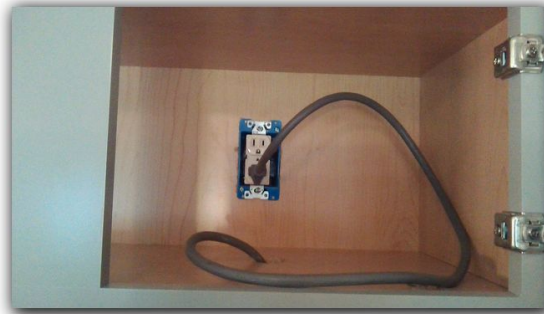
- The cover plate was missing to the receptacle in the cabinet above the microwave.

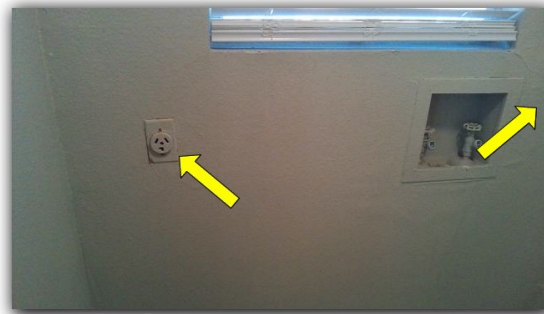
- The receptacles / covers in the laundry room had been painted. Recommend replacing receptacles that have been painted.

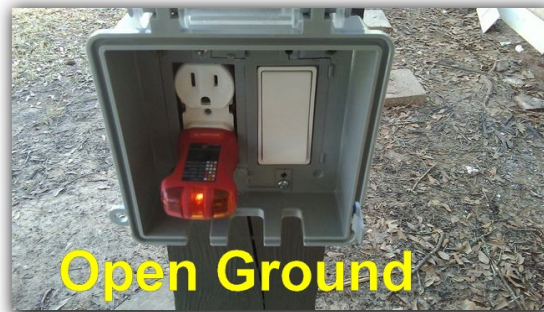
- The receptacle on the pole on the rear exterior covered patio area had an open ground connection. In addition, the receptacle is to be GFCI-protected.

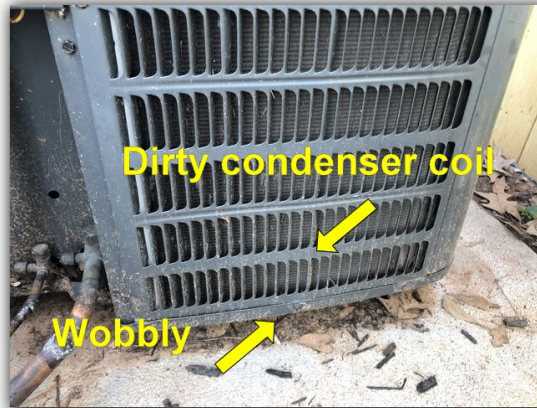
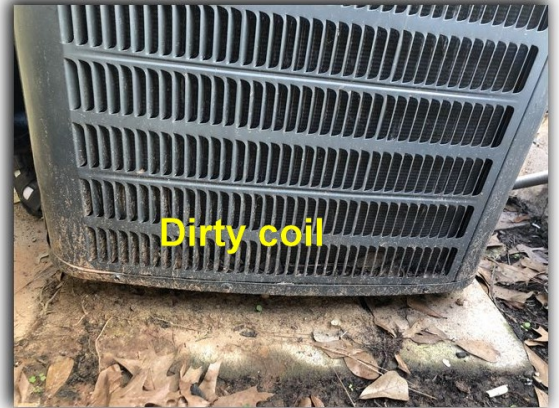
- Given the condition of the excessively broken and/or separated plenum / ductwork connections in the attic space that was observed, it is recommended that a full evaluation of the HVAC system components, plenums, and ductwork be fully evaluated by a licensed HVAC technician for service and repairs needed.
- The condenser was wobbly and was not stable on the exterior slab.
- The condenser coil on the exterior unit was dirty and needs to be cleaned.

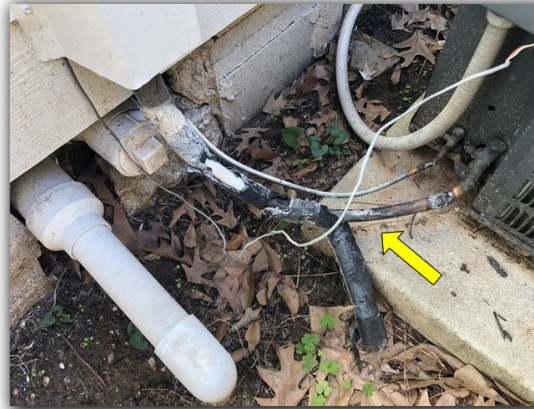
- Damaged, deteriorated and/or missing insulation on the refrigerant lines should be repaired or replaced at the outside condenser.

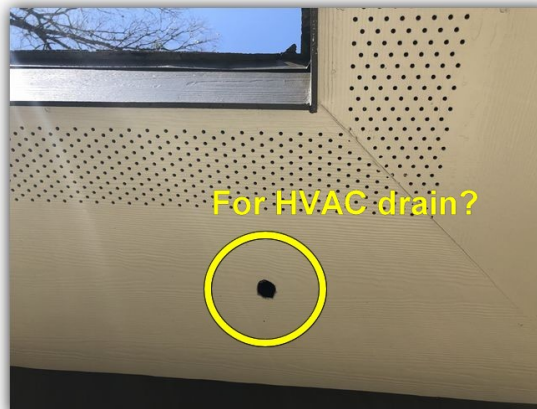
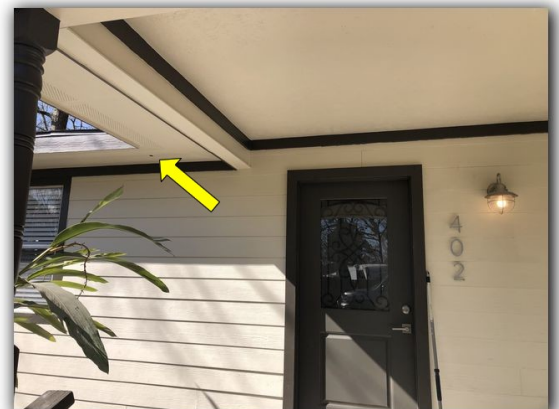
- There was a hole in the soffit material in the front of the house to the left of the front entry door. It was unknown if this was supposed to be for the overflow pan secondary drain to the exterior. Recommend ensuring that the secondary overflow pan is properly draining to the exterior or repairing the hole as needed.

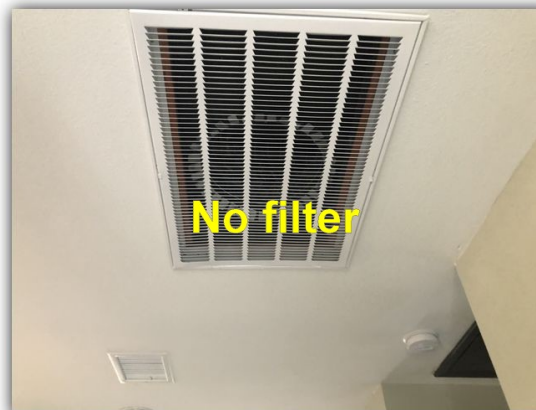
- There was no filter installed in the air return grille in the ceiling in the home interior.

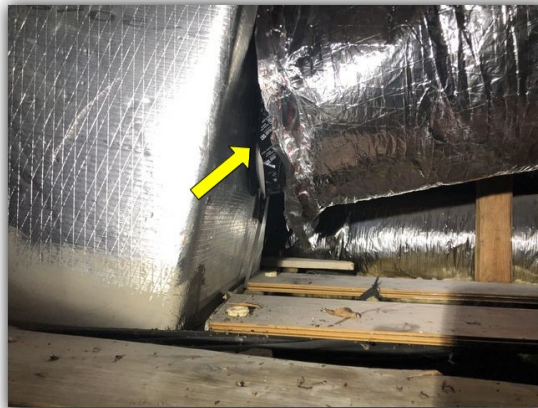
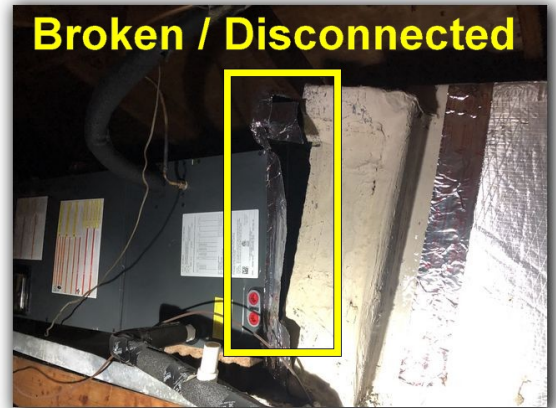
- There were various areas in the attic or at the supply plenum where the flex ducts were not provided with separation. Condensation (sweating) and mildew problems can occur when the ducts are touching each other.
- The air return plenum was excessively disconnected from the HVAC components and was allowing unfiltered air to be drawn into the HVAC system.

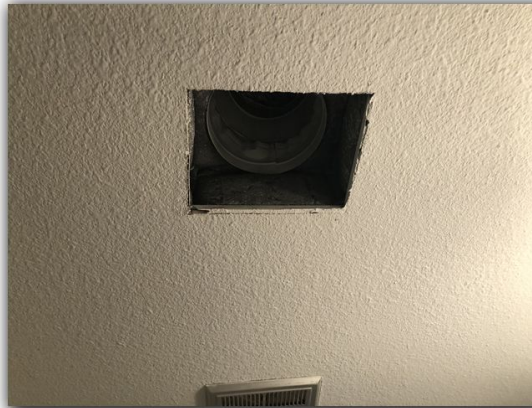
- The cover to the air register was missing in the hallway bathroom.

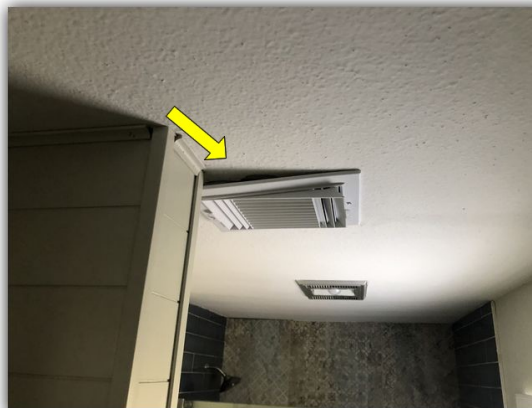
- The cover to the air register in the right bedroom bathroom was loose / installed unsatisfactorily.

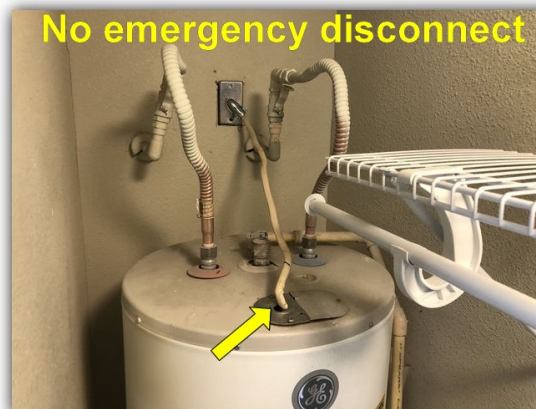
-
- There was no emergency disconnect installed with the vicinity of the electric water heater. As per IRC 4101.5, an accessible means of electrical disconnect is to be installed within the vicinity of the appliance. Recommend a licensed plumber or a licensed electrician to install the required emergency disconnect.
- The electrical wires were not properly secured to the water heater housing.

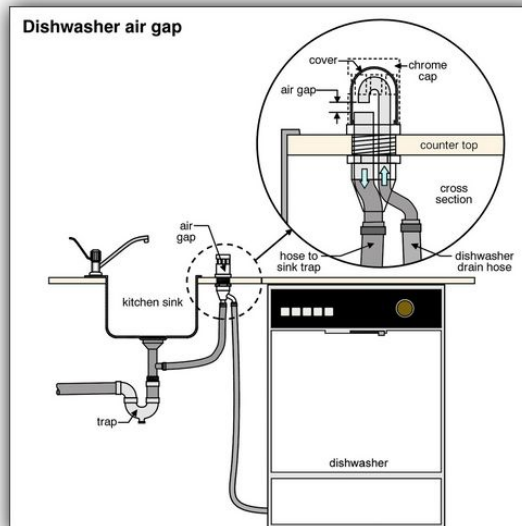
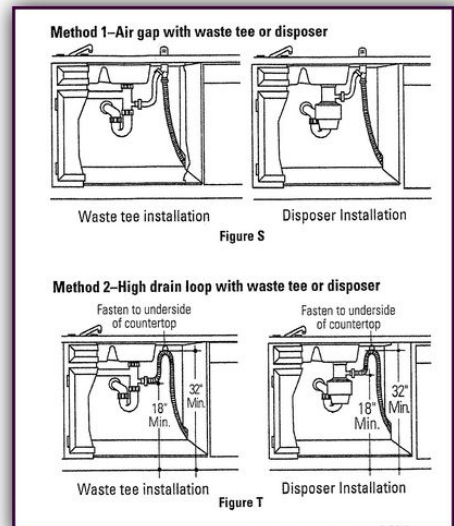
- The dishwasher drain hose was not properly installed to prevent back flow or anti-siphoning. There are some newly manufactured dishwashers in which the drain hose is installed on the side of the dishwasher cabinet with an air gap. This was inaccessible to view at the time of the inspection. If this is not installed on the side of the dishwasher, it is recommended that an air gap device or high drain loop be installed in the drain line.
