FOUNDATION INSPECTION REPORT

Job No. LC081820

Prepared for:
Kelly Elliott**Prepared by:**
Cliff Nguyen, P.E.
TRM Engineering, LLC**Location:**
118 Highland Terrace Drive
League, TX
on 8/18/2020**Scope:**

118 Highland Terrace Drive, League City, TX

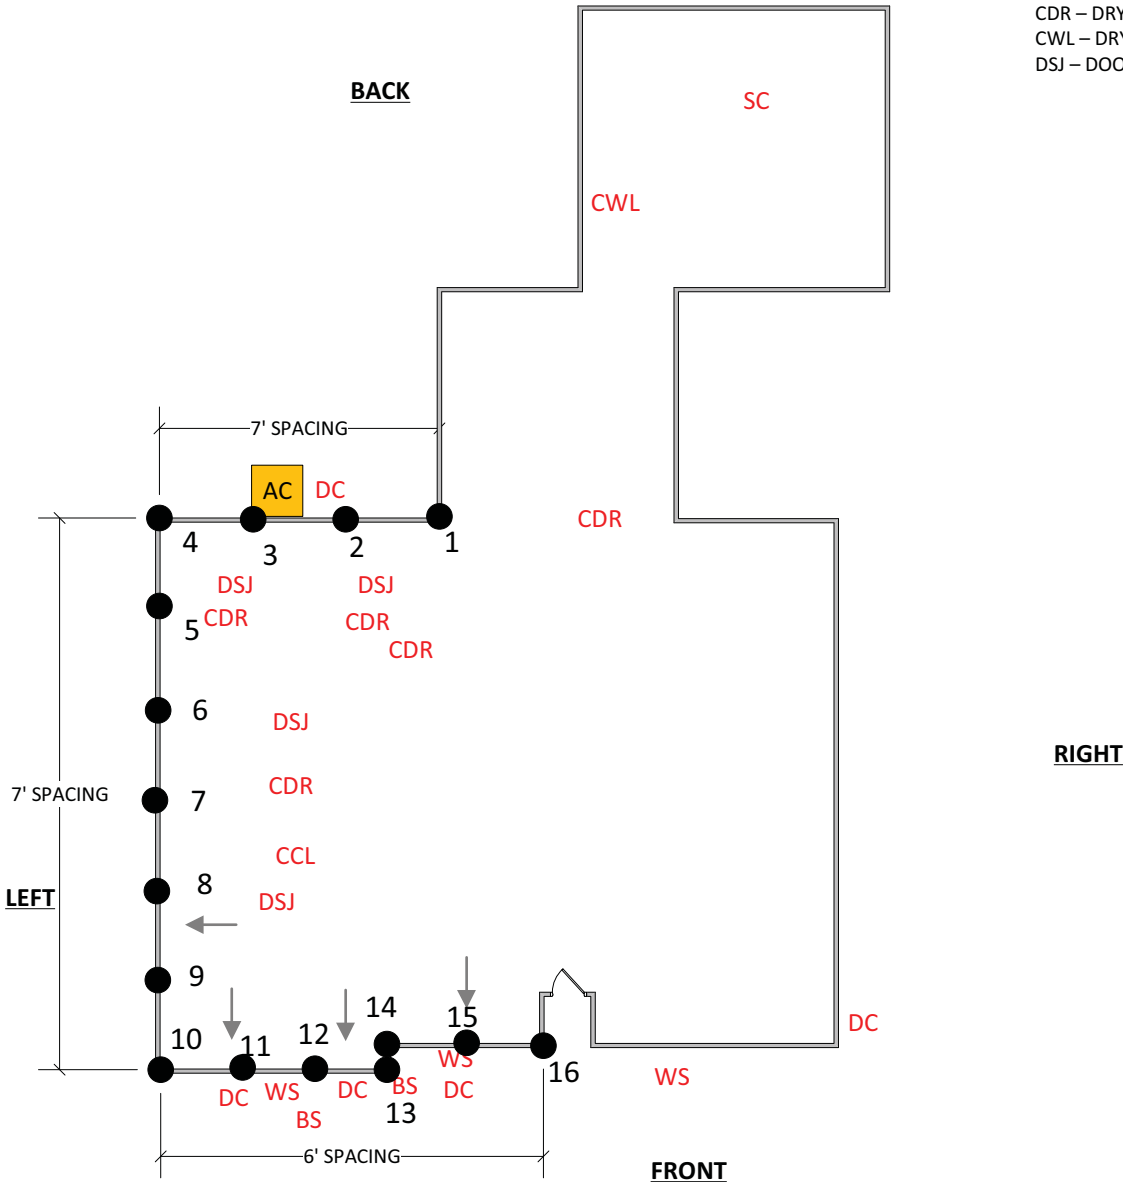
DEFICIENCIES

Exterior foundation distress symptoms are shown on SKETCH 1. There are some brick cracks along the front side of the house. There is a large tree in front the front-left side of the house with roots potentially extending underneath the foundation causing the soil to shrink.

Interior foundation distress symptoms are mostly on the left side of the house. There are several doors that are skewed or jammed, sheet rock cracks above the doors and ceiling as shown in SKETCH 1. The crack above the opening in the back side of the main house and along the wall to the second story are not attributable to foundation movements. The floor in this area is within acceptable levelness.

I checked the floor levelness throughout the house using a 4-foot leveler and self-leveling laser. The floor, counter tops, windowsills, and door framing were cross checked. The floor levelness is within acceptable tolerance of 1% rise-over-run except for the areas shown as arrows in SKETCH 1. However, floor levelness is not a sole consideration for foundation repair. Extent of any damage must be

- BS – FRIEZE BOARD SEPARTION
- DC – DIAGONAL CRACK IN BRICKN
- SC – EXPOSED SLAB CRACK
- WS – WINDOW FRAME & BRICK SEPARTION

- CCL – DRYWALL CRACKS IN CEILING
- CDR – DRYWALL CRACKS OVER DOORS
- CWL – DRYWALL CRACKS IN WALL
- DSJ – DOOR SKEWED/JAMMED

1. Install sixteen (16) piles in the left side of the house as shown in SKETCH 1 to stabilize this area. This area of the house has numerous deficiencies. This side has nearby trees. Trees remove moisture from the soil and cause the foundation to drop and move.
