RESIDENTIAL INSPECTION REPORT

4023 Addicks Clodine Rd
Houston TX 77082

Orlando McCuin
JANUARY 12, 2021

Inspector
Charles Pyle
TREC 20638
713-885-6000
alltex@alltexinspections.net

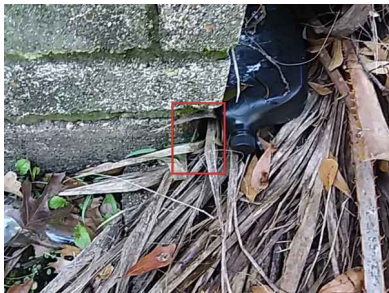
West side

Cracks- Compression crack(s):

Corner cracks were noted at foundation wall. Minor corner compression cracks of triangular shape located at foundation corners are merely cosmetic and not of structural significance. Consider sealing and monitoring as needed to prevent pest intrusion.

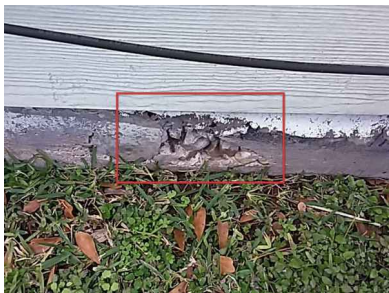
South side

Edge Finish:

The foundation edge finish is distorted at one or more locations. This is typically the result of air pockets near the form boards or the cement bonding to the form boards and "chipping" off when the forms are removed (aka Honeycomb effect). This is merely a cosmetic distortion and typically does not require any type of repair.

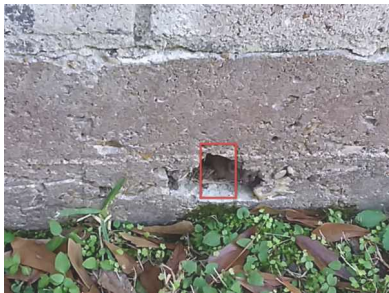
Item: Exposed post tension cable end(s) Cable ends are located around the exterior foundation grade beam.

Impact: This condition may allow moisture to wick into the cable causing it to rust and possibly lose it's connection from the support clamp.

Suggestion: Consider cleaning and applying an approved sealant to prevent deterioration.

Recommendation: Contact a handyman or DIY project

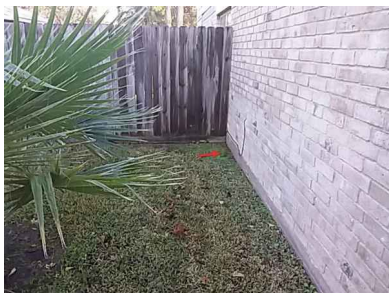
1: Grade Improper Slope

Surface grading/slope is not adequate for proper drainage (minimum 6 inches of slope for 10 foot). Water may become trapped in these areas and could potentially cause differential movement and/or damage to the foundation. If possible, regrade the area to achieve a slope away from the home. If regrading is not possible consider installing underground drain system or install a swell to remove surface water. This will reduce foundation movement, prevent risk of moisture intrusion and prevent pooling.

[IRC R401.3](#) and [IRC R801.3](#)

Recommendation: Contact a qualified landscaping contractor

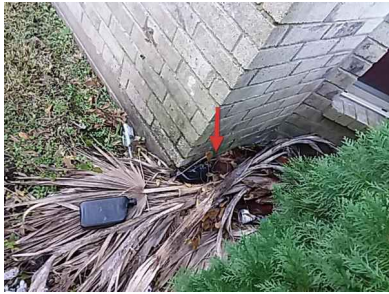
Some portions of the foundation wall were concealed and could not be inspected due to high soil levels. May allow moisture intrusion through weep holes and conceal pest intrusion. If possible lower soil to a minimum of 4 inches below brick veneer and/or 6 inches below wood or stucco siding to allow proper inspection. Additionally, any soil to wood contact should be thoroughly evaluated by a wood destroying insect inspector.

[IRC R404.1.6](#)

Recommendation: Contact a qualified landscaping contractor

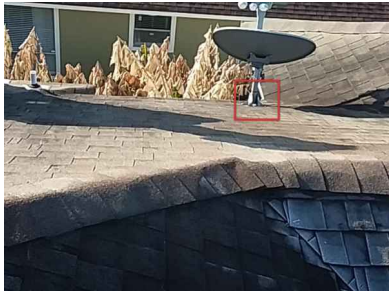
Antenna on Roof:

Satellite penetrations observed at roof coverings. When possible, satellites should not be installed on roof coverings. When no other solution exists, extra caution should be used to ensure that all penetrations are properly sealed and flashed. Monitor periodically.

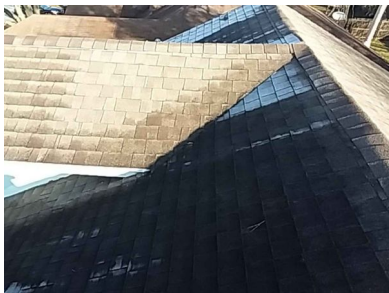
Covering Serviceable:

Shingle granule loss consistent with age of roof coverings. Roof coverings appeared to be in serviceable condition. Minor to moderate granulation loss or other wear indicators such as broken bond (glue that holds each row of singles to the row above) failure or pitting may be present. This type of roof covering has an anticipated life expectancy. During that anticipated life the primary responsibility of the roof covering is to prevent water from entering the dwelling and protecting the underlayment. While some wear indicators may be present, the roof appears serviceable. Determining the remaining life expectancy exceeds the scope of this inspection.

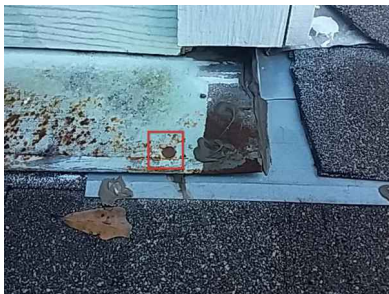
Exposed fasteners observed in shingle or flashing. One or more nails and/or staples observed. Consider sealing all exposed fasteners with an approved sealant to prevent further deterioration.

Recommendation: Contact a handyman or DIY project

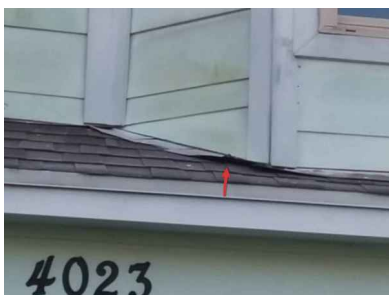
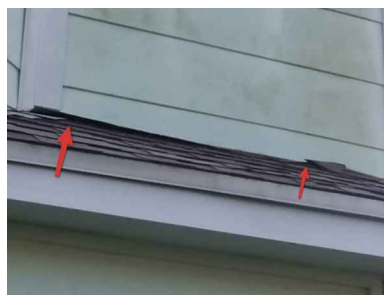
3: Flashing - Raised

One or more of the shingles, ridge caps or flashings are lifted and/or not sealed. To prevent possible wind lift and moisture intrusion (as a result of wind driven rain) all shingles and flashings should lay flat and be sealed to the respective components.

Recommendation: Contact a qualified roofing professional.

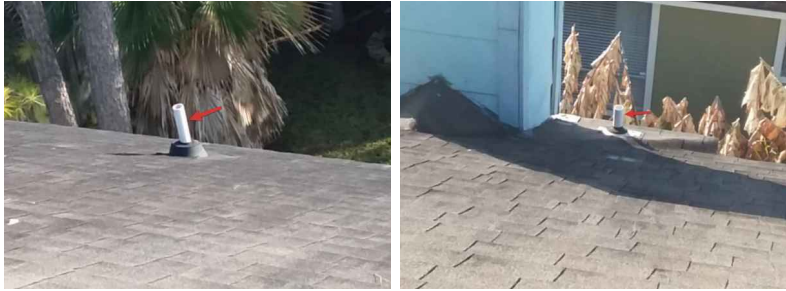
4: Plumbing Vent - UV Protection

The plumbing vent pipes were not painted at roof coverings. Current standards require sealing or painting to prevent UV rays damage and eventual deterioration the exposed areas.

Recommendation: Contact a qualified roofing professional.

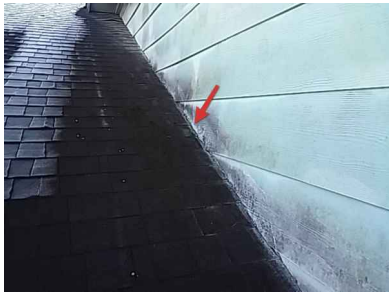
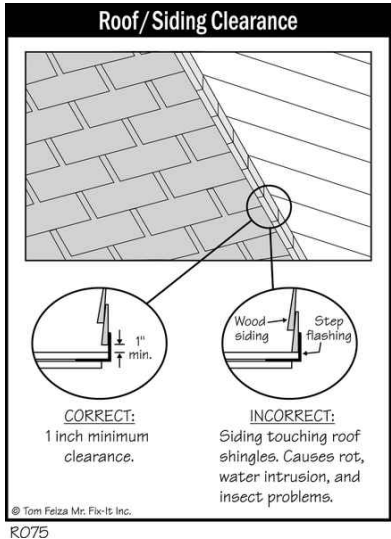
5: Siding Contact

Wood or other siding materials in contact with roof coverings. Manufacturer specification require a minimum of 3/4 inch separation between the siding and roof coverings to prevent moisture intrusion. If moisture damage should occur, consider trimming wall covering back or installing counter flashing.

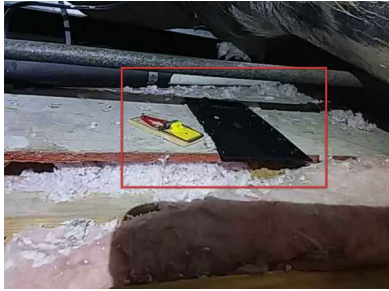
Observed evidence of past or present pest activity. Numerous traps and/or pest debris were located within the attic space.

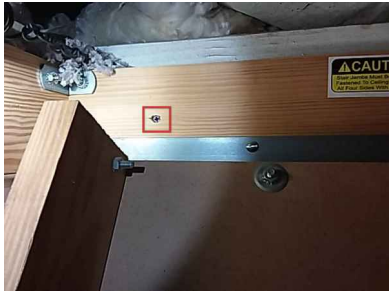
1: Door - Fasteners Missing

Fasteners are missing or improperly installed at the attic service entrance. Manufacturer's specifications require that 16D Nails or 1/4 inch lag bolts shall be installed at the specified intervals including hinge and torsion spring brackets.

Recommendation: Contact a handyman or DIY project

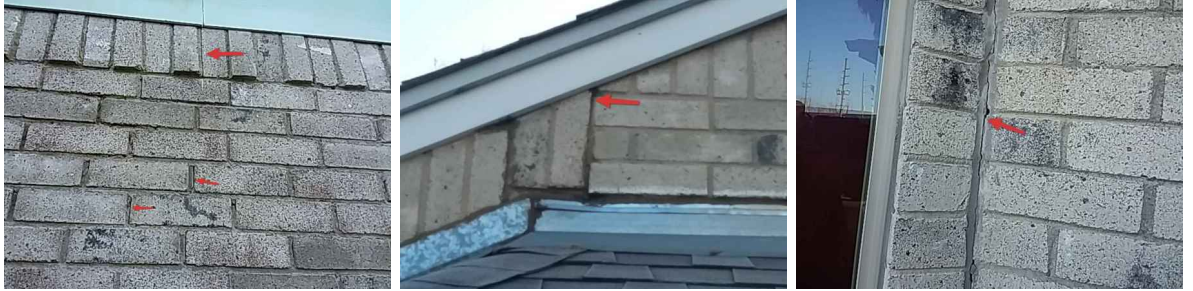
1: Exterior - Minor Crack

Minor cracks observed at exterior wall coverings. While minor cracking typically does not require repairs, consider sealing all areas to prevent possible moisture intrusion.

Recommendation: Contact a qualified masonry professional.

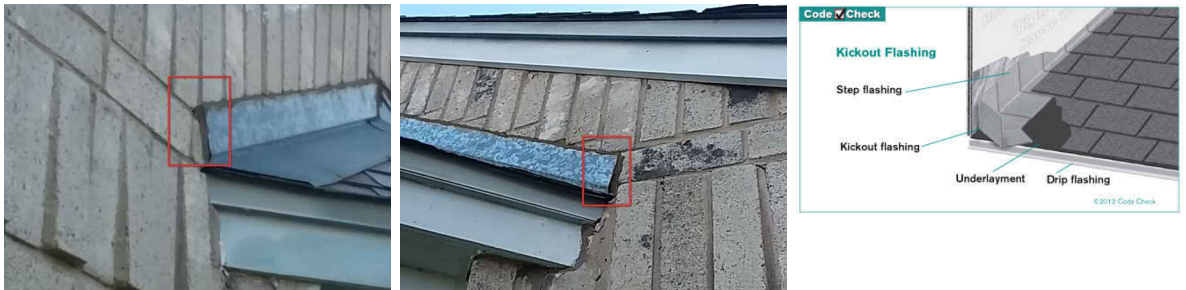
2: Flashing - Kick Out

Flashing (kick out) missing - Roof coverings that terminate at a wall should have "kick out" flashing installed. Without the proper flashing installed at this location, runoff from the roof coverings may enter the wall coverings. Consider installing the proper flashings to prevent moisture intrusion.

[IRC R703.8](#)

Recommendation: Contact a handyman or DIY project

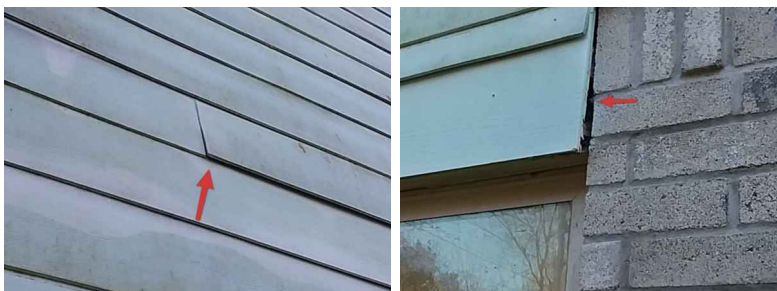
3: Loose Wall Coverings

Wall coverings were loose, damaged and/or improperly secured. Consider repairs to prevent moisture intrusion.

Recommendation: Contact a handyman or DIY project

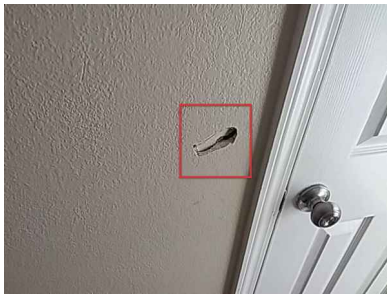
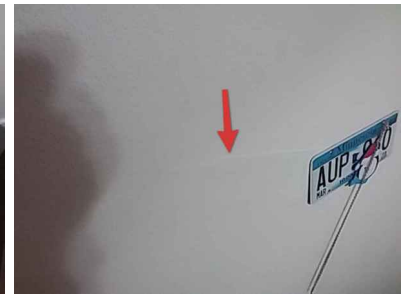
5: Physical Damage

Bedroom 2, bedroom 3

Wall coverings are damaged and/or improperly sealed.

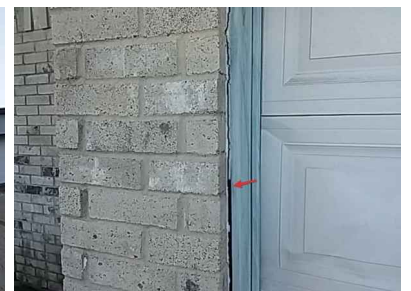
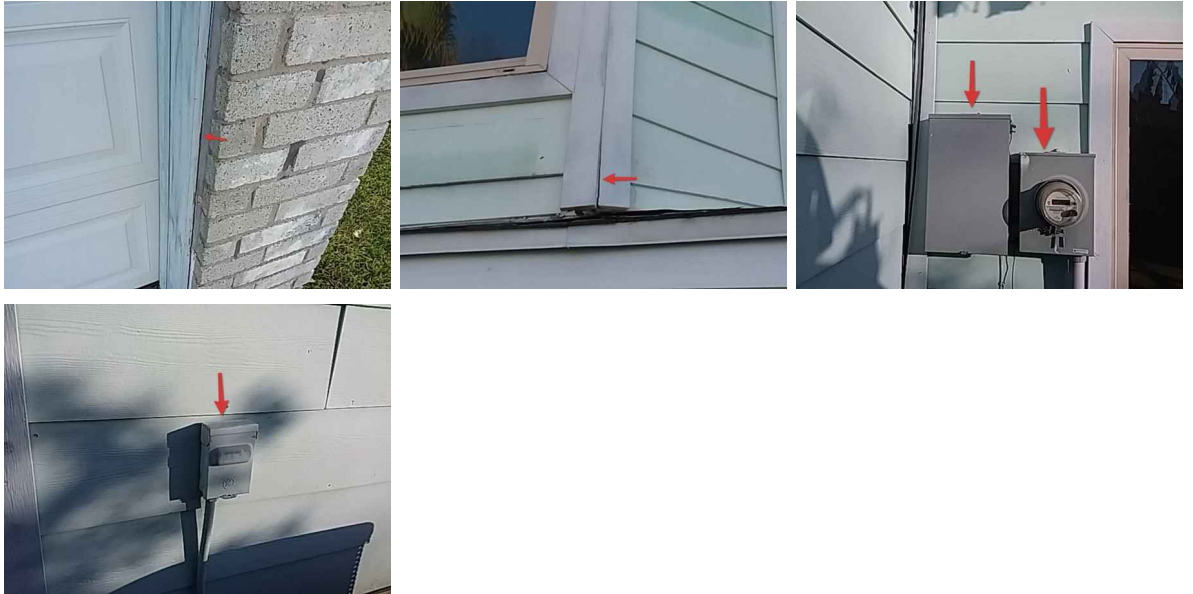
6: Seal - Penetrations

Wall coverings are not properly sealed. All penetrations should be flashed and/or properly sealed to prevent moisture penetration. Typical homeowner/handyman maintenance consisting of sealing cracks with a silicone, polymer or epoxy based product. Example: Electrical and plumbing penetrations, seams in siding, exterior trim, windows and door trim.

[IRC 703.1.1](#)

Recommendation: Contact a handyman or DIY project

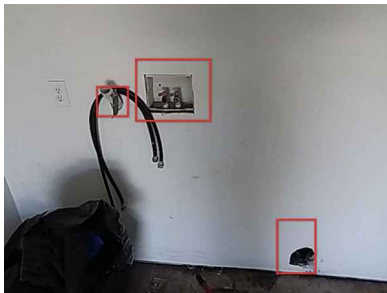
7: Separation Wall - Penetrations

Penetrations observed in the Garage/Dwelling Separation Wall. Current standards require Wall/Ceiling coverings between the garage and dwelling and/or attic space to be a minimum of 1/2" gypsum board. Additionally a 5/8" Type X is required and all wall and ceiling penetrations must be sealed if a habitable room exists above the garage. All penetrations or openings in this wall must be fire rated for such use.

[IRC R302.6 Table](#)

Recommendation: Contact a handyman or DIY project

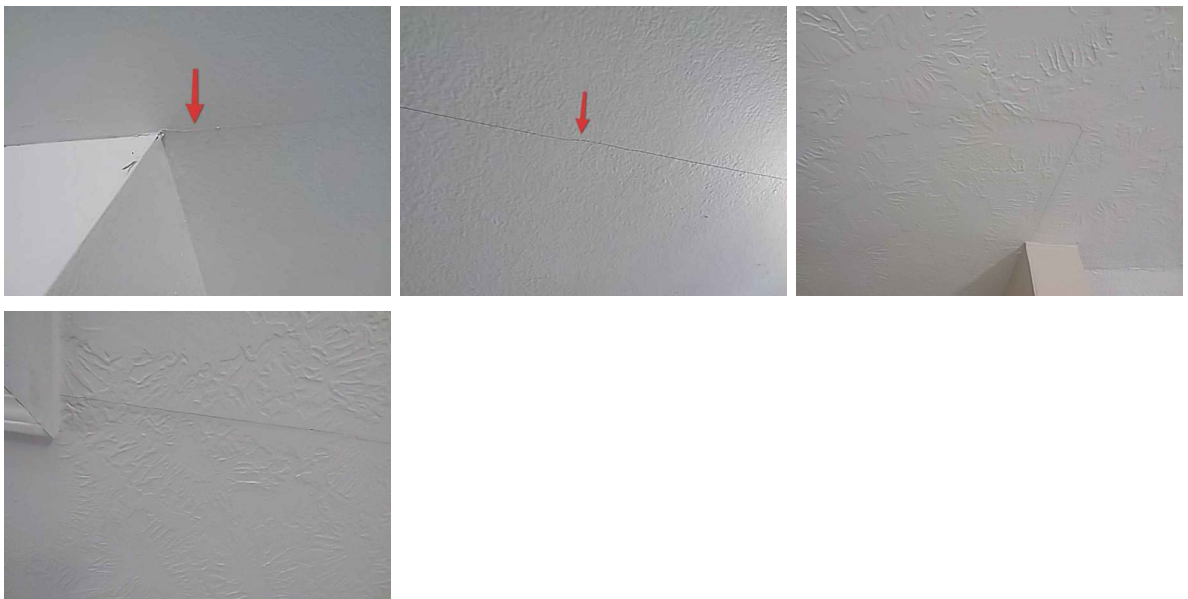
Garage, game room

Ceiling - Cracks Minor:

Common cracks (seam tape separation, cracks along joints) observed at interior wall coverings. Due to construction in areas where known expansive soils exist, cracks are considered typical and consistent with the age of the structure. Repairs beyond aesthetic are typically not needed.

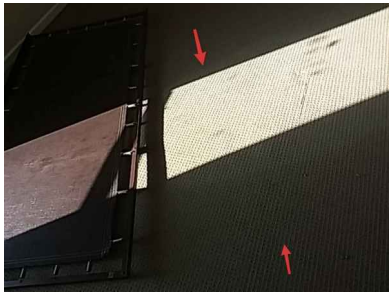
Bedroom 2

Slopes noted in flooring. Sloped floors may be the result of settlement and/or past repairs or could indicate structural or subfloor issues.

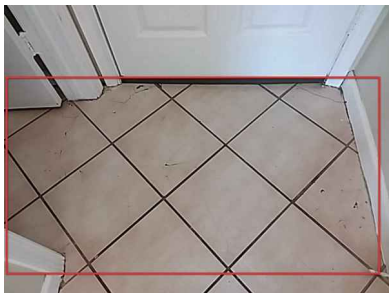
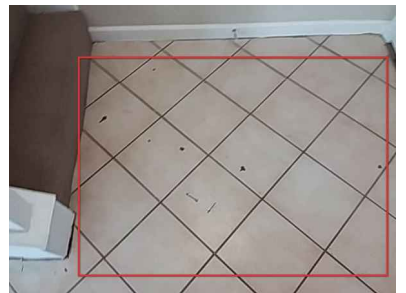
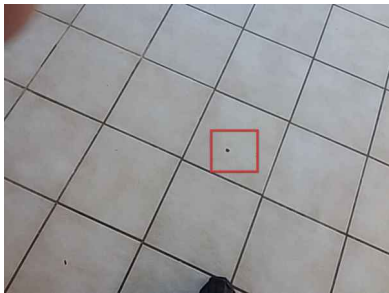
3: Flooring - Tiles Improper

Down stairs hall, entry, breakfast nook, den, living room
Loose, cracked or damaged tiles observed.

Recommendation: Contact a qualified professional.

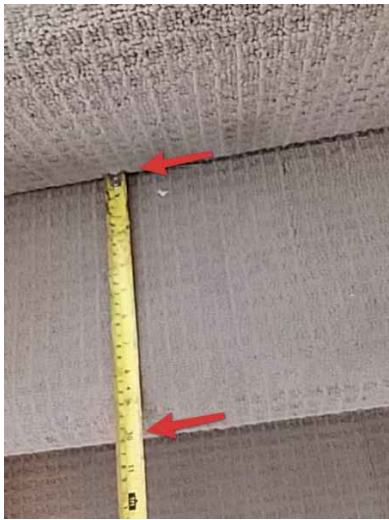
Improper tread depth noted. Current standards require that a stair tread shall be a minimum of 11" deep unless a 3/4" stair nose profile is present.

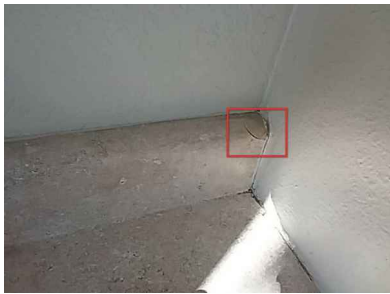
4: Coubter top damaged

Coubter top damaged.

Recommendation: Contact a qualified professional.

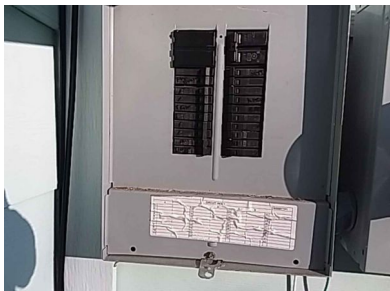
Service panel labels were missing/deteriorated or improper.

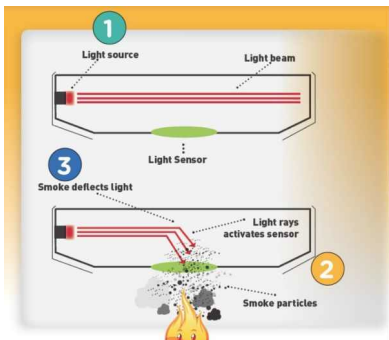
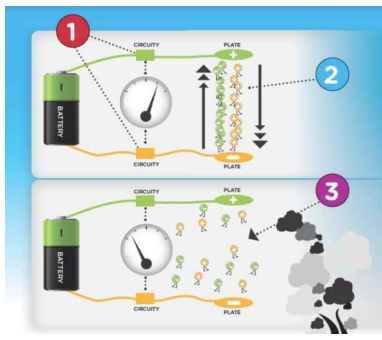
Existing smoke detection systems are single purpose (Ionization or photoelectric) Ionization typically provides the earliest warning for a fast burning fire (low smoke). Photoelectric systems typically work best for a slow smoldering fire (high smoke). Since there is no way to determine what type of fire may occur, consider replacing units with dual purpose systems (Ion and Photo) to improve occupant safety.

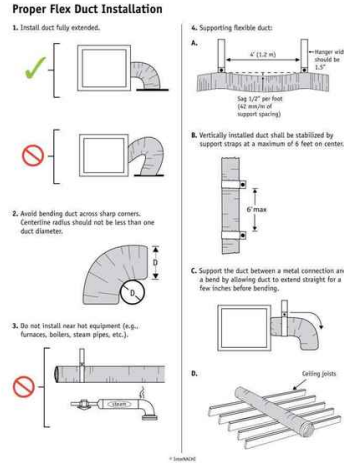
The flexible ducts are improperly supported. Current building practices require that the ducts be hung from the attic framing and supported at 4.5 maximum intervals. Ducts in contact with other ducts and at potentially different temperatures may cause condensate to form (internal or external) on the duct. Consider separating ducts with batt insulation or equivalent.

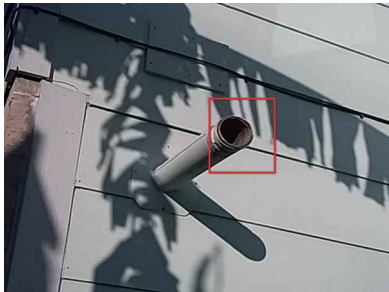
Furnace exhaust flue cap was missing, damaged or improper. Current standards require the use of a "B" vent cap properly sized based on the roof slope. Repair is needed to ensure proper exhaust and/or prevent moisture from entering the unit.
