## STRUCTURAL INSPECTION

907 Blue Willow Dr  
Houston TX 77042

Steve Gordon & Cynthia Mattice

DECEMBER 29, 2020

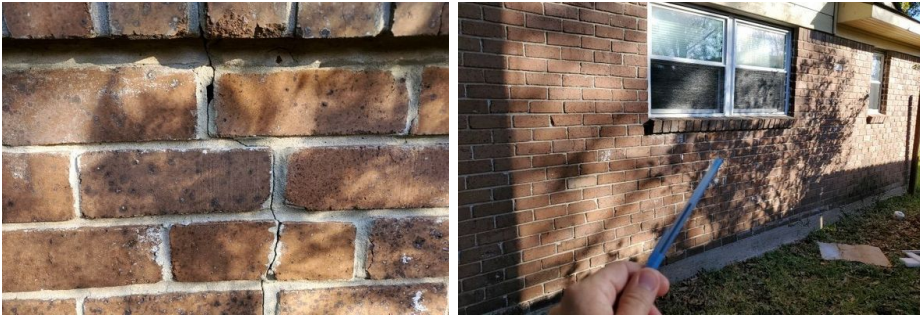
South

**Differential Movement: Veneer - Cracks/Patches**

Cracks and/or patches were observed in the exterior veneer at the time of the inspection, including at the above locations.

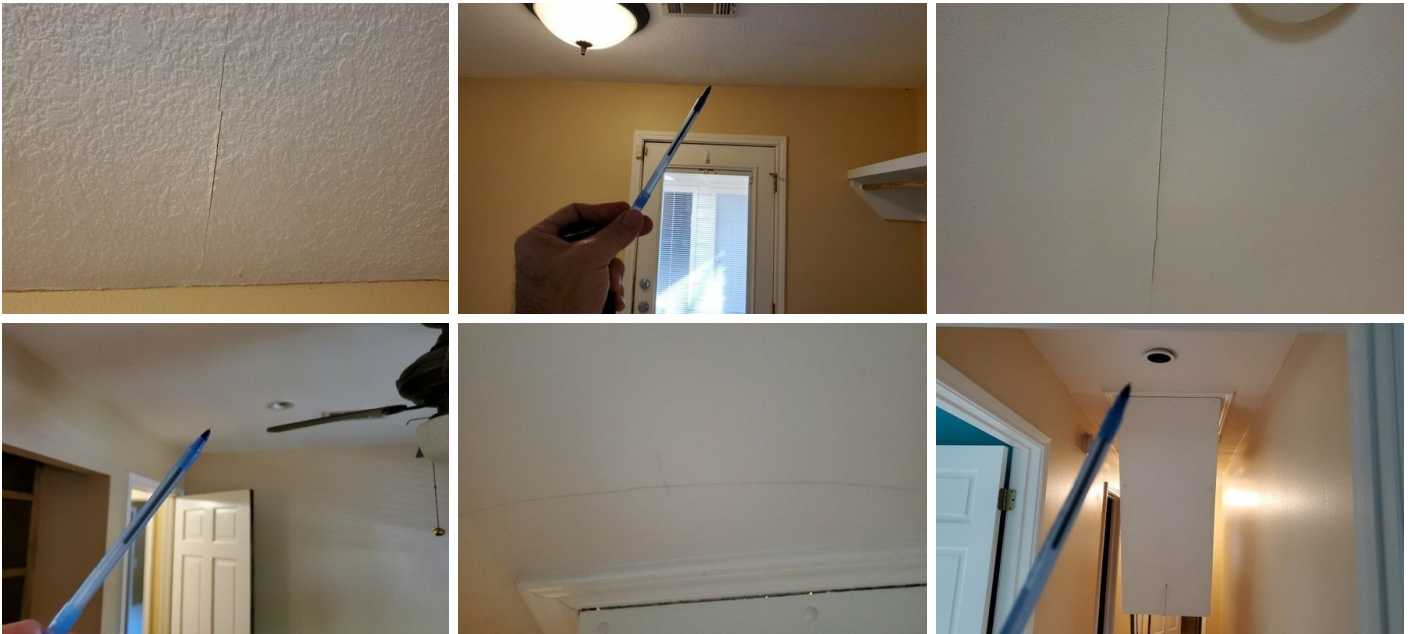
Study , Utility Room, Hallway

**Differential Movement: Sheetrock Cracks/Patches/Compression ridges**

Sheetrock cracks, patches, and/or compression ridges were observed in the house during the inspection, including at the above locations.

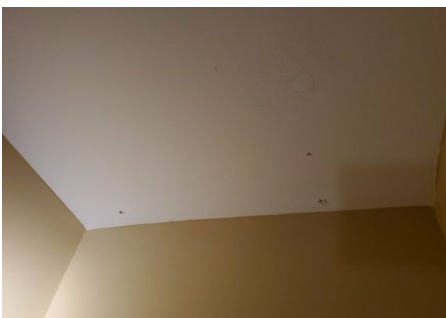
South West Bedroom Closet

**Differential Movement: Sheetrock - Nail pops**

Nail pops were observed in the surface of the sheetrock at the time of the inspection including at the above locations.

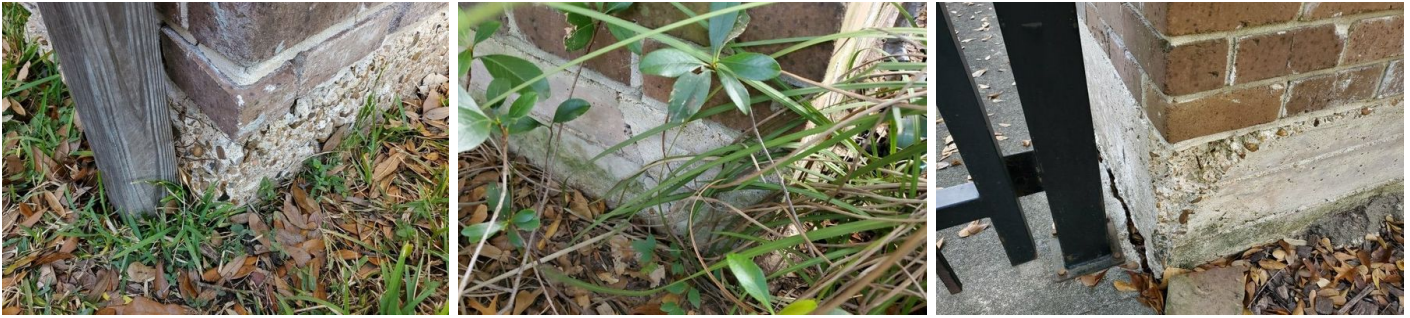
South East , South West , North West

**Differential Movement: Corner Chipped**

The corner of the foundation was observed to be chipped at the above locations. This condition is typically caused by differences in thermal expansion between the brick veneer and the concrete foundation. Also, this condition can be caused by a lack of reinforcement in the corner of the foundation during original construction. In our opinion, this condition does not affect the overall structural integrity of the foundation.

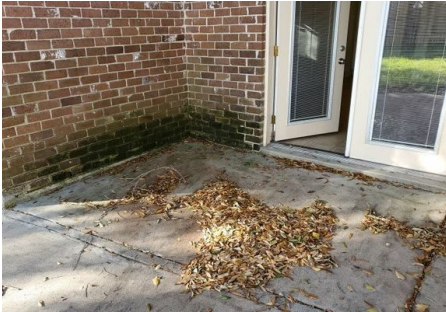
### Differential Movement: Slab not Visible - Patio

It is pointed out that a portion of the foundation concrete could not be viewed due to the concrete patio that adjoined the foundation.

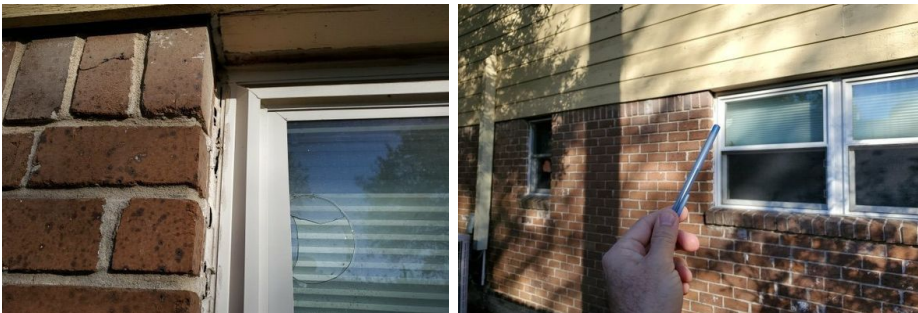
South

### Separation of Materials: Window frame

The window frame was separated from the exterior brick veneer apparently due to movement. The separation was observed to be approximately 1/2 inch.

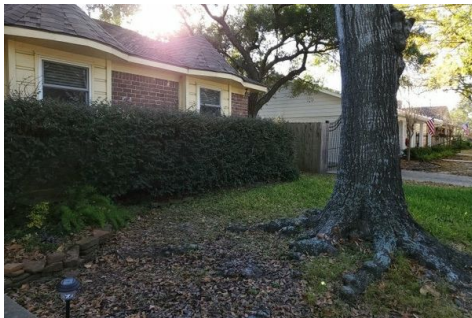
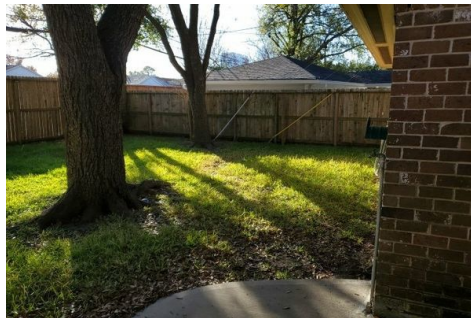
4.4.1 Other Observations

Trees and/or foliage were observed in the vicinity of the house which can contribute significantly to differential movement of the house foundation. Care should be taken to prevent the trees and foliage from removing an excessive amount of water from near the foundation of the house.

Contact a qualified professional.

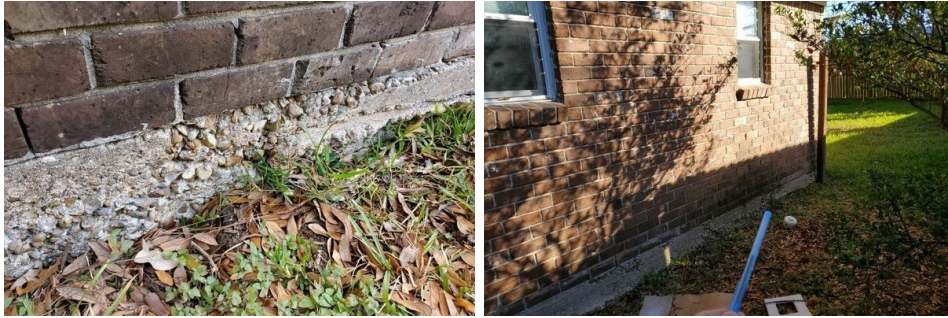
#### 4.4.2 Other Observations

### **FOUNDATION - HONEYCOMBED**

The foundation concrete was observed to be honeycombed due to poor original construction workmanship. The honeycombed area should be grouted to present a smooth surface finish.

Contact a qualified professional.

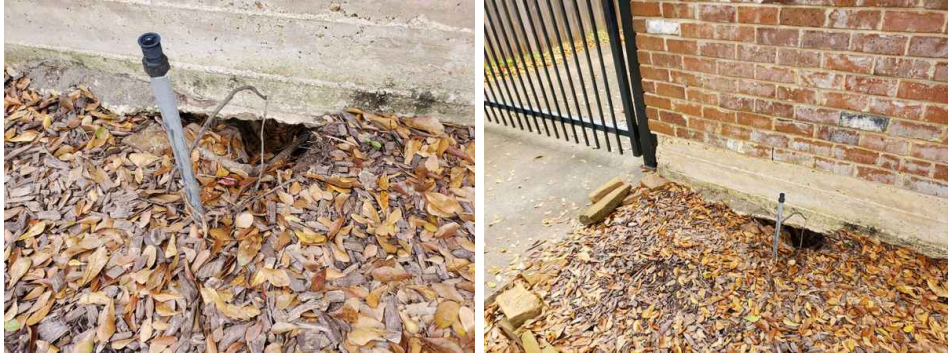
**GROUND SUNKEN AT REPAIR PIERS**

The ground was observed to be sunken in at one or more locations where the repair piers were installed. This indicates that they did not backfill the piers properly and additional soil needs to be installed.

Contact a qualified professional.

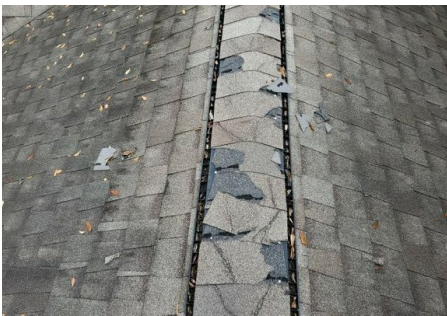
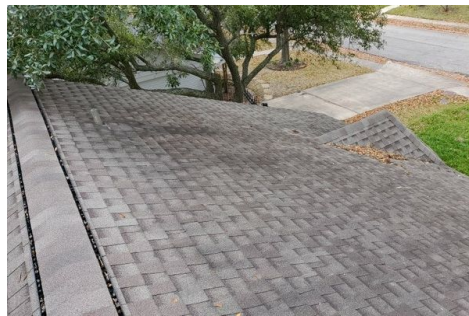
**Wear and Deterioration: Composition - Some**

Discolored, Brittle, Nail Heads not Sealed, Deteriorated Ridge Shingles

The composition roof surface was showing evidences of some deterioration of the roof surface as described above and shown below.

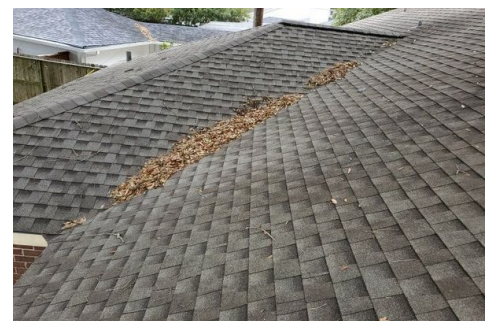
We observed some miscellaneous items related to the surface of the roof, including the items listed above. Have a roofing contractor provide a cost estimate to make any needed repairs.

Contact a qualified professional.

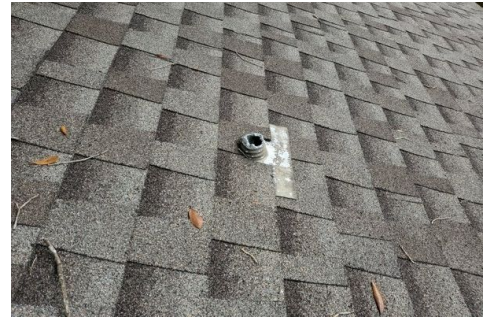
We observed PVC plumbing vent pipes at the roof surface that were in need of some repairs as described above. Have a service company provide a cost estimate to make all needed repairs.

Contact a qualified professional.

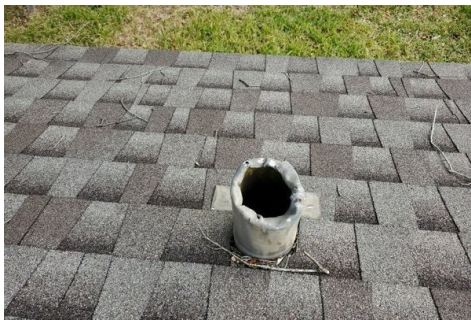
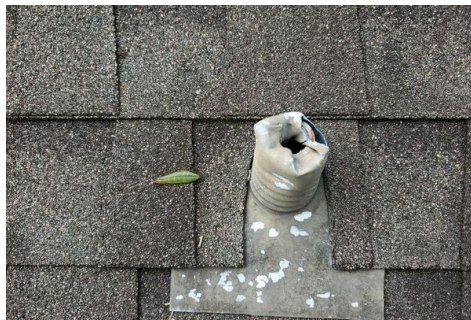
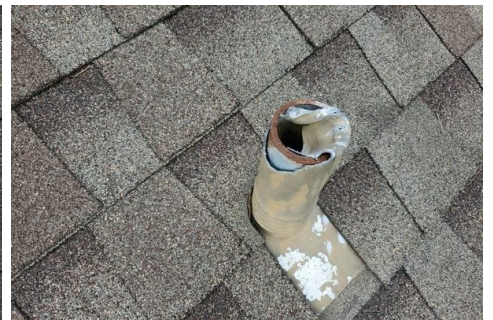
5.4.4 Roof Details

**ROOF JACKS**

Lead - Squirrel Damage (Slight), Lead - Squirrel Damage

The roof jacks at the plumbing vent pipes were observed to have the conditions as described above. Further investigation with a roofing contractor is recommended to make all needed repairs.

Contact a qualified professional.

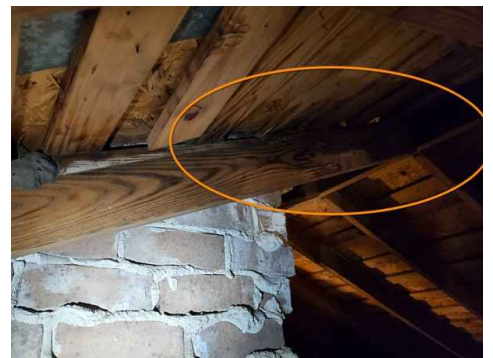
5.5.1 Roof Leaks

**ATTIC ROOF DECKING AND/OR FRAMING MEMBERS**

After observing the interior of the structure, evidences of roof leaks were visible in the attic, where the roof decking and/or roof framing members were water stained. It is recommended that a roofing contractor be contacted to find the source of the leaks, and to make any needed repairs.

Contact a qualified professional.

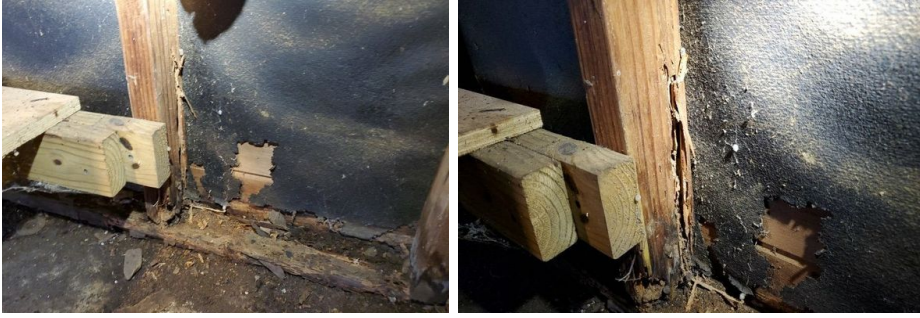
#### Wood Destroying Insect Damage: Garage - Minor

Damage was observed on some of the visible framing members in the garage, apparently due to wood destroying insects. The degree of the damage was minor and only affected the surface of the studs. The structural integrity of the studs has not been affected by the slight damage, and no repairs are recommended. It is recommended that an inspection for wood destroying insects be performed by a licensed pest control operator.

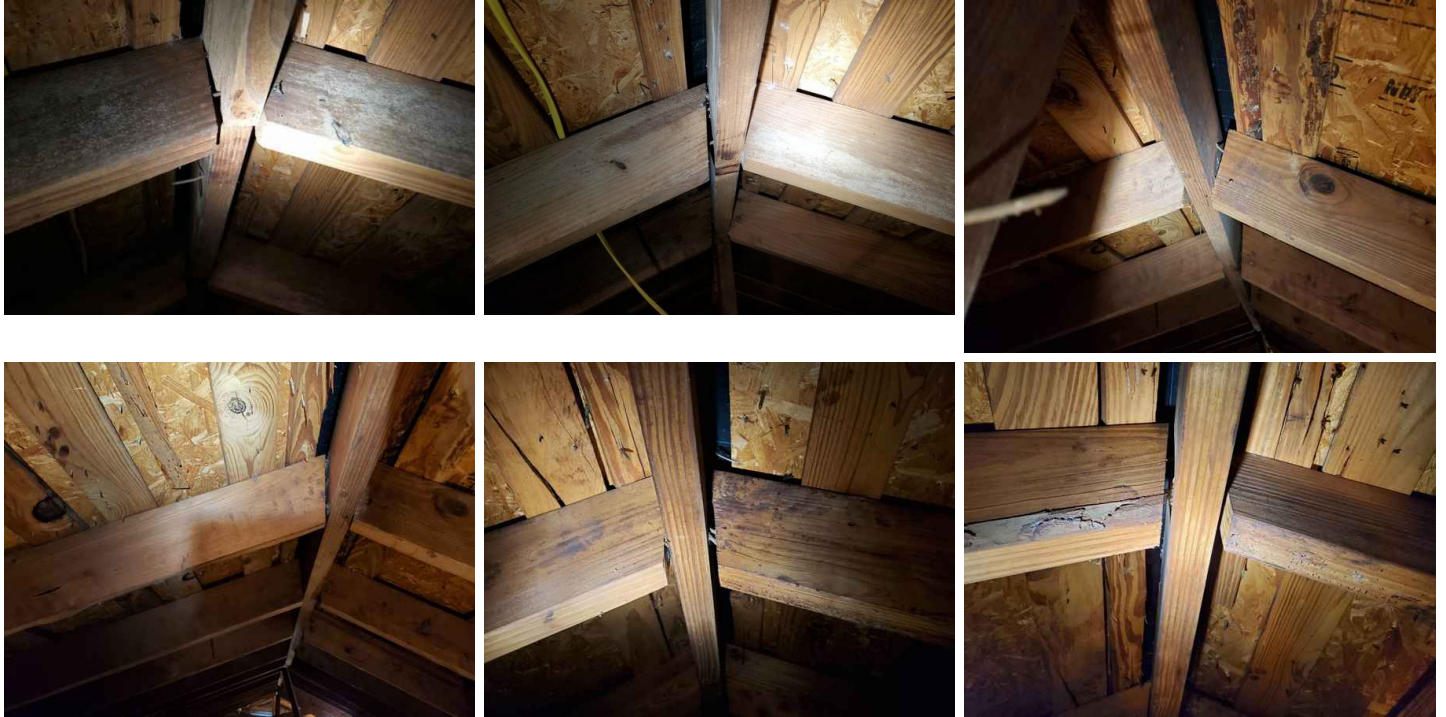
**REPAIR - RAFTER NOT FLUSH ON RIDGE BEAM**

We observed rafters that were separated at the top of the rafter, where the rafter meets the top ridge beam. Rafters should be flush against the ridge beam, and it is recommended that 3 foot make-up pieces be "sistered" onto the rafters, so that the make-up pieces are flush against the ridge. This will allow the rafters to bear against the ridge beam for the entire length of the miter cut on the rafter.

Contact a qualified professional.

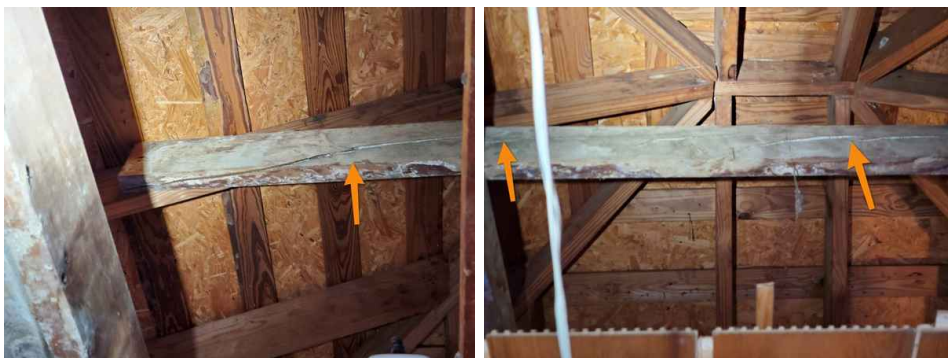
6.7.1 Collar Ties

**REPAIR - CRACKED**

One of the collar ties between the roof rafters was cracked and is in need of repair.

Contact a qualified professional.

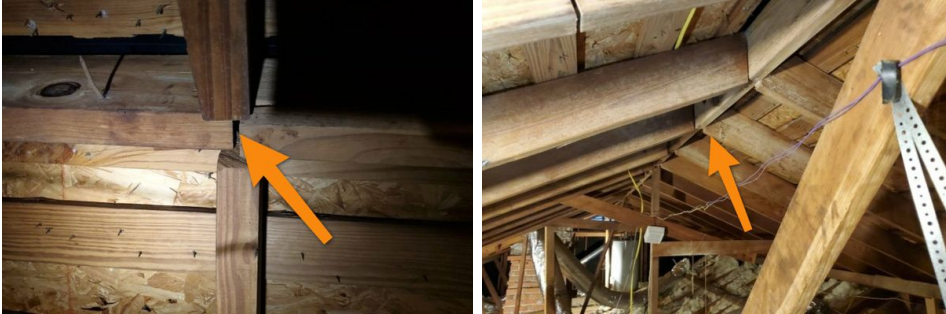
## 6.8.1 Ridge Beam

**REPAIRS - SPLICED, NOT BRACED**

Contact a qualified professional.

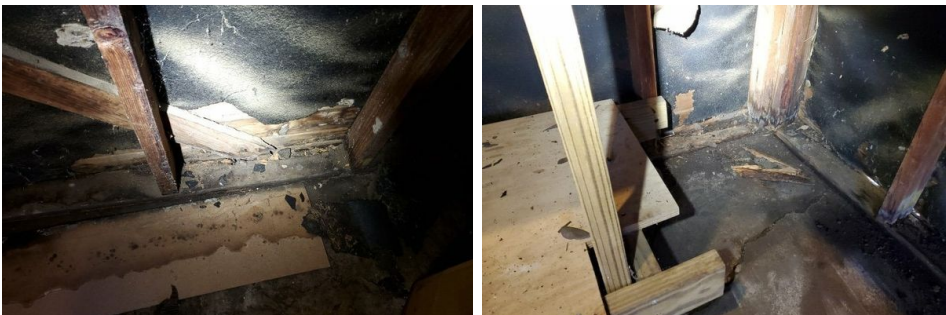
The bottom plate in the garage was partially rotted and the damaged portion is in need of replacement.

Contact a qualified professional.

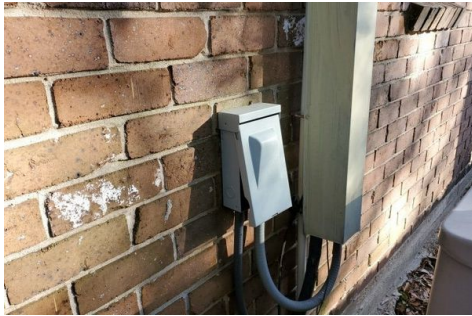
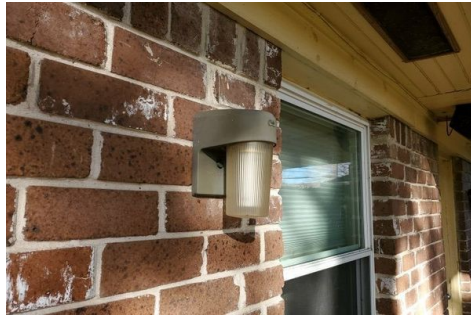
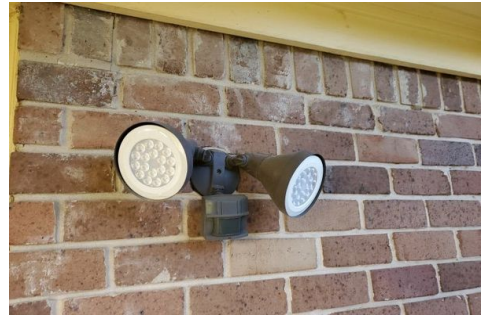
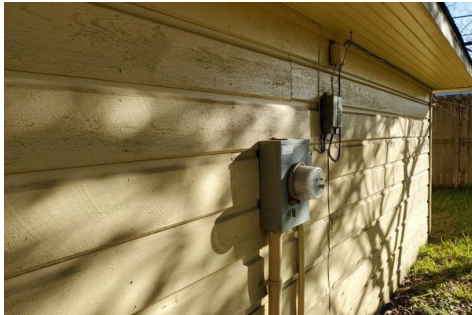
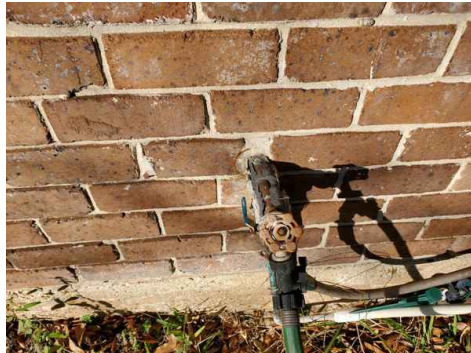
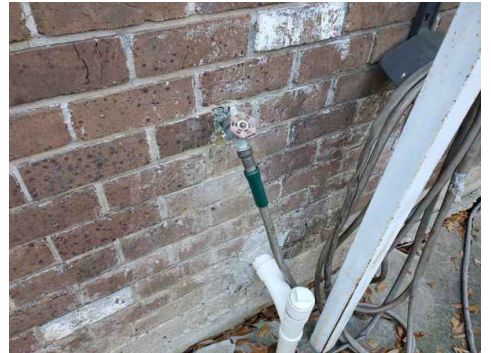
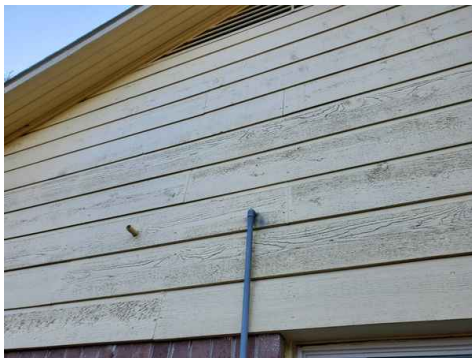
A substantial vulnerability to water penetration was observed at penetrations/openings through the exterior building envelope, and it is recommended that all penetrations/openings be sealed against water penetration. Typical examples on a structure may include light fixtures, air conditioning refrigerant lines, water piping, gas piping, vent caps, windows, doors, expansion joints, etc. Below is a representative sample of locations and/or photographs showing some, but not necessarily all, locations where there is a vulnerability to water penetration. Have a contractor provide a cost estimate to seal all vulnerable areas on the exterior building envelope against water penetration and/or open up any clogged weepholes in the veneer.

Contact a qualified professional.

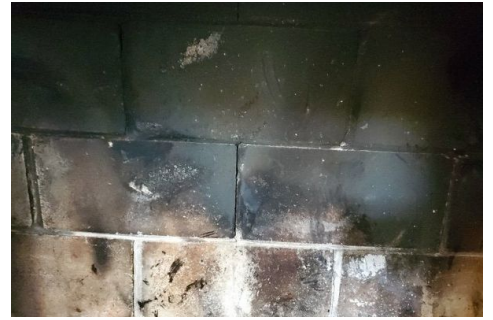
**GROUT MISSING - FIREBOX**

Some of the grout was missing at the joint of the front wall of the firebox, which can be a fire hazard as it can allow the heat of the fire to enter the wall cavity, and it is recommended that the separation be properly filled with mortar.

Contact a qualified professional.

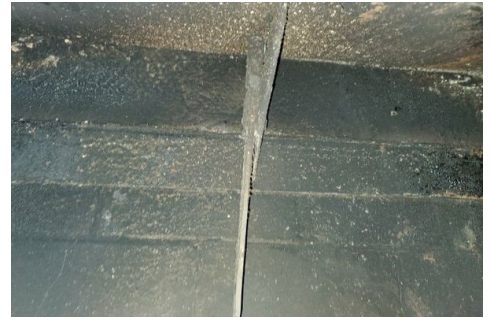
8.2.2 Masonry fireplace

**DAMPER - C CLAMP MISSING**

The fireplace was equipped with a ceramic gas log. The smoke chamber and flue pipe were free from built-up soot, the damper was operational, and the firebox was properly sealed. While the draw of the chimney was not able to be checked, no evidences of poor draw were visible, and no repairs were needed to the fireplace. It is pointed out that the damper was not equipped with a spacer device to prevent the damper from closing completely. This device keeps the damper open slightly, even when it is in the closed position, to prevent combustion gases from building up in the living space should the gas log be operated when the damper is closed. It is recommended that the clamp be installed for safety purposes.

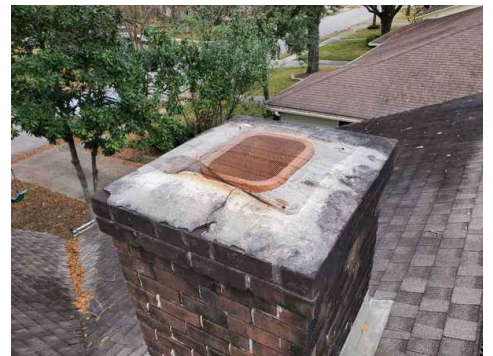
**WEATHER CAP - MISSING**

The top of the chimney flue did not have a spark arrester/weather cap installed in the flue to prevent water penetration down the chimney and bird entry into the chimney. Evidences of water penetration were visible at the firebox, where the firebrick was stained.

Contact a qualified professional.

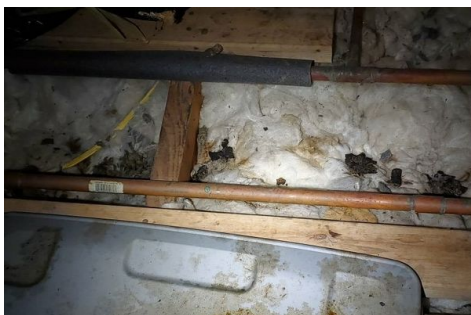
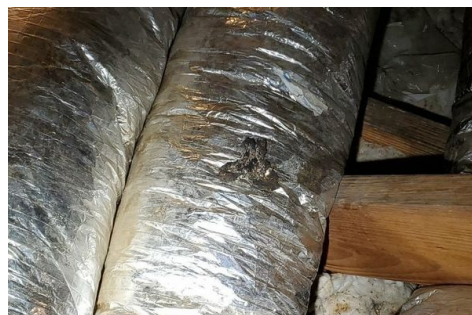
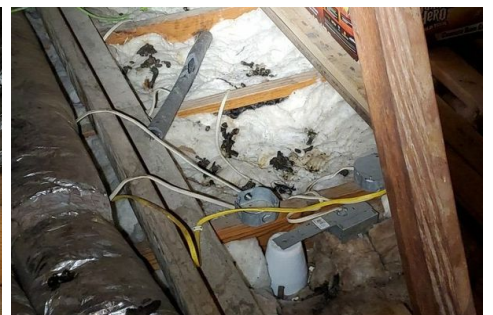
9.6.1 Miscellaneous

**RODENTS, BIRDS, BEES, OR OTHER PESTS**

Contact a qualified professional.

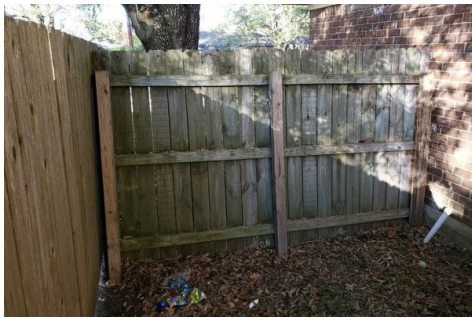
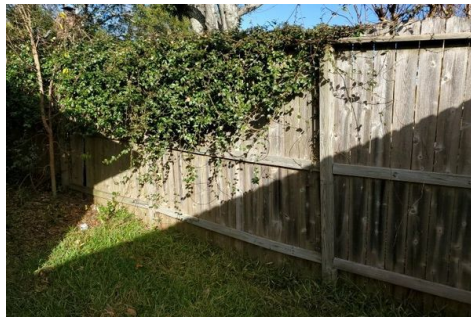
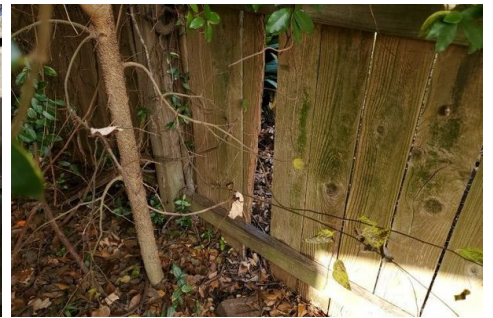
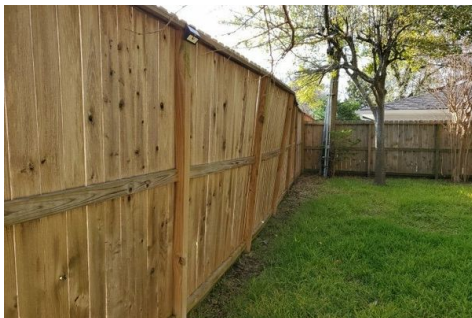
11.3.2 Gates and Fences

**WOOD FENCE**

Contact a qualified professional.

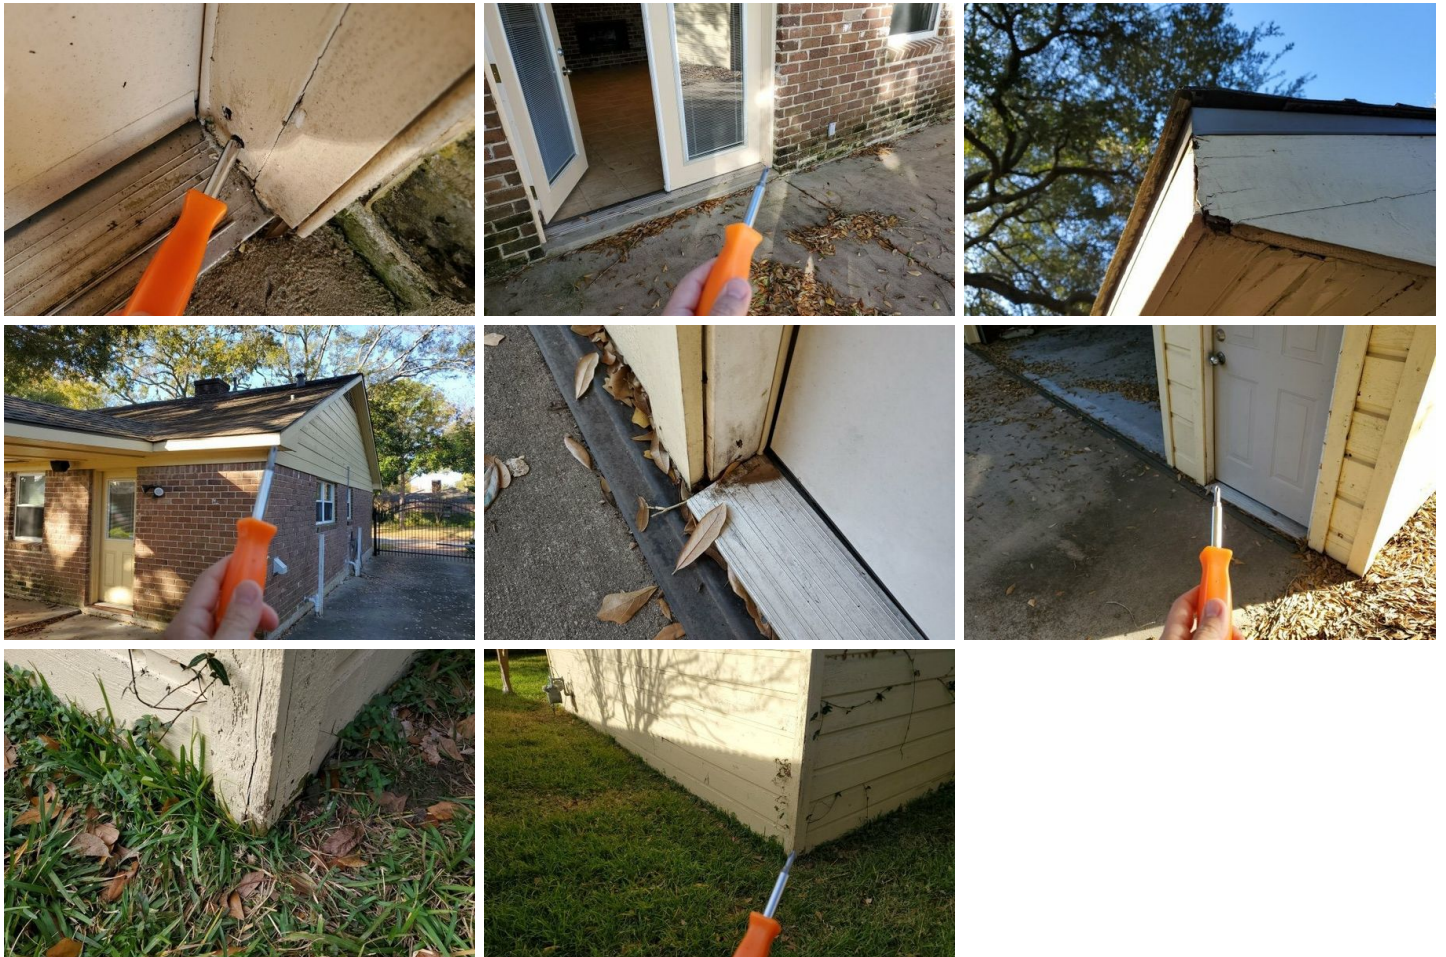
11.4.1 Wood Rot

**WOOD ROT**

Contact a qualified professional.

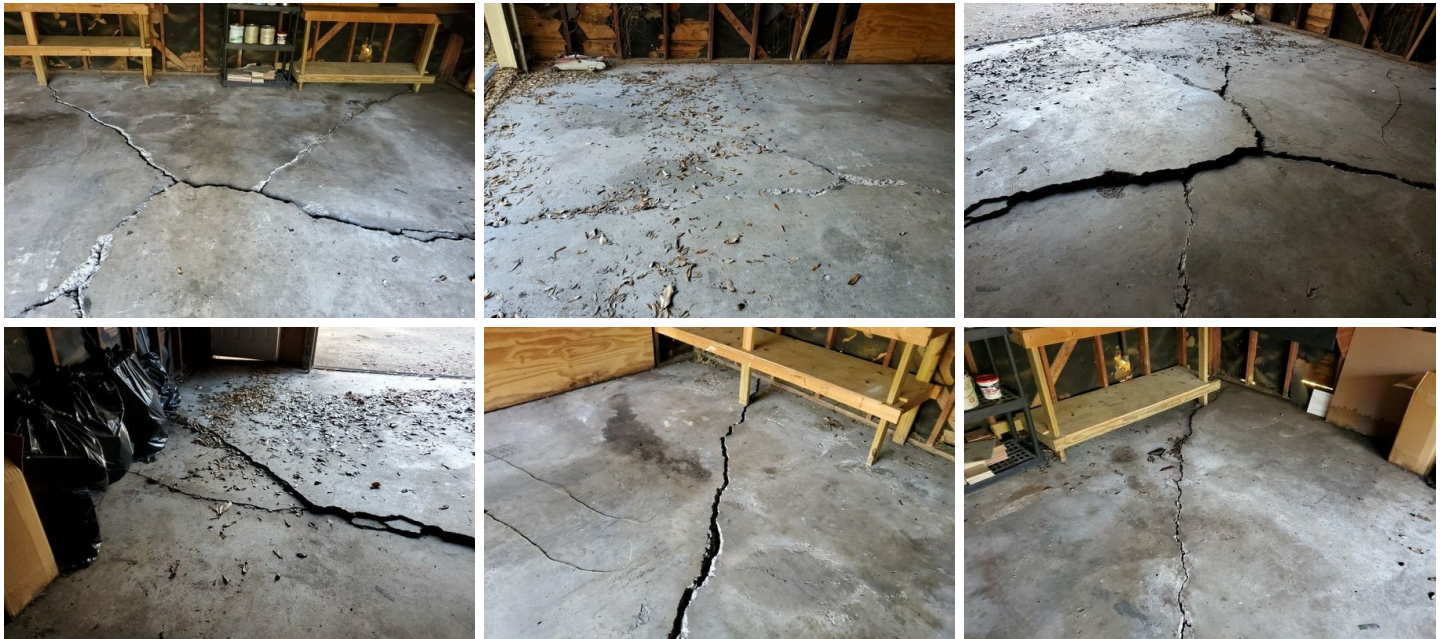
11.6.1 Garage

**FOUNDATION IRREPAIRABLE**

Contact a qualified professional.

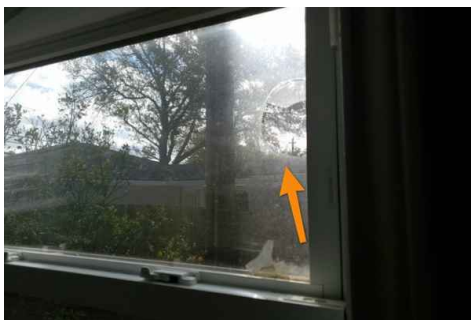
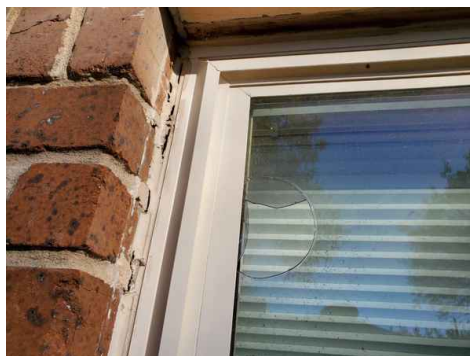
12.2.2 Windows

**CRACKED/BROKEN**

Contact a qualified professional.

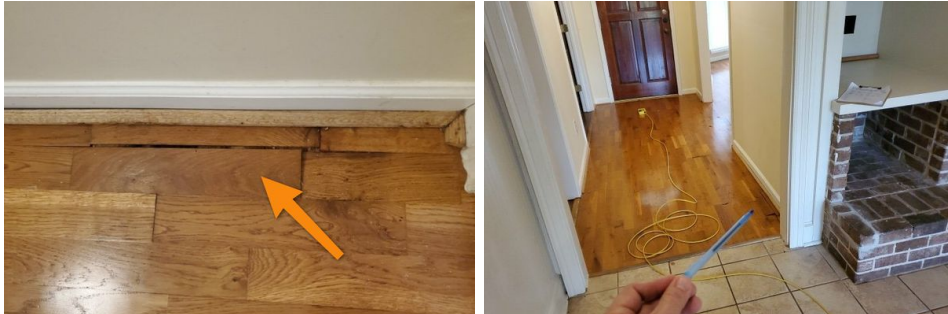
## 12.3.1 Floor coverings

**WOOD FLOOR - SEPARATION BETWEEN BOARDS**

Contact a qualified professional.

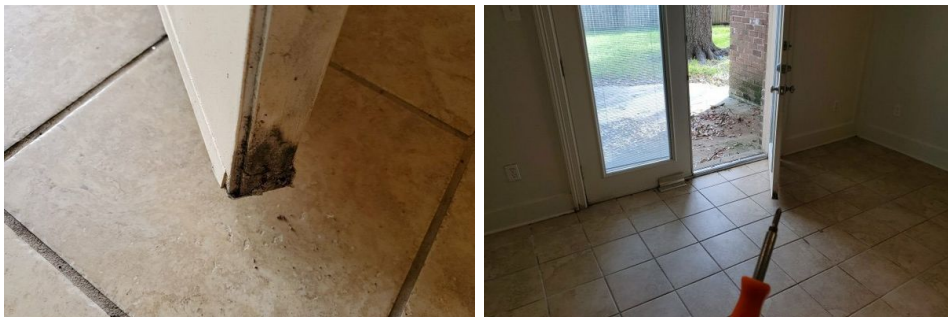
## 12.8.1 Wood rot interior

**INTERIOR**

Contact a qualified professional.
